Clover Creek Solar Project LLC d/b/a New Frontiers Solar Park Second Set of Supplemental Responses to Siting Board Staff's First Request for Information Case No. 2024-00253

Geophysical Investigation

New Frontiers Solar Park

February 3, 2025

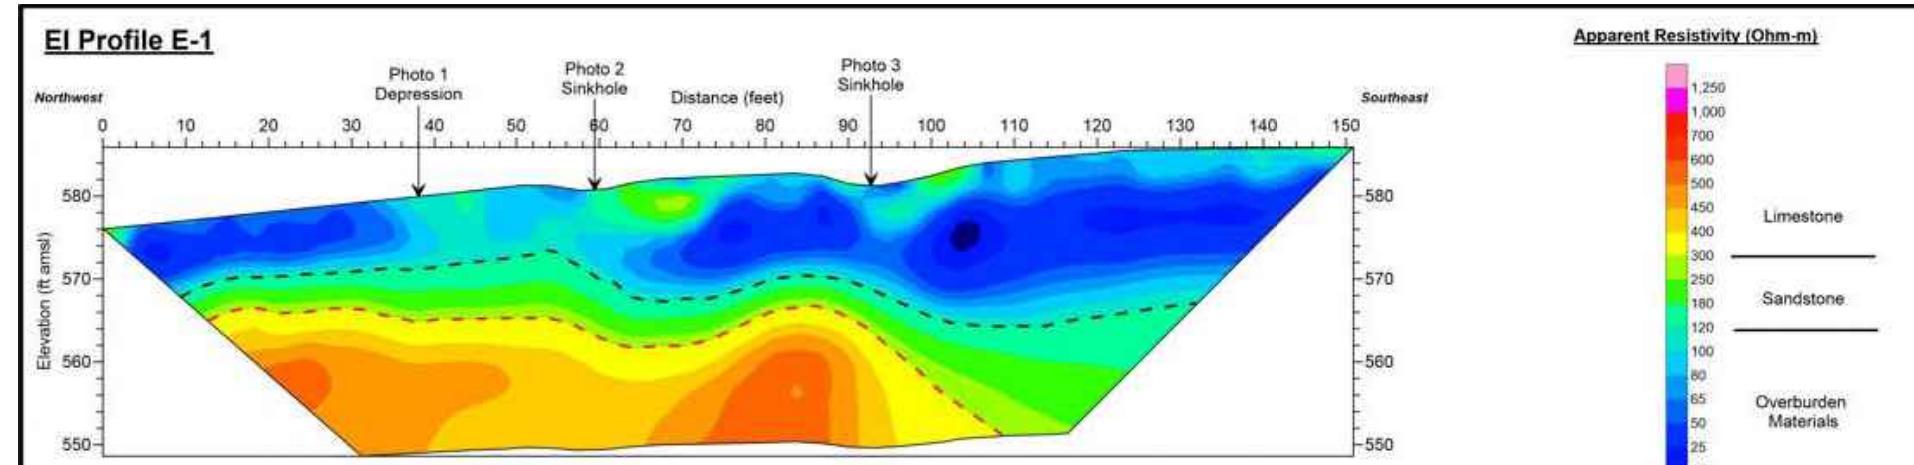
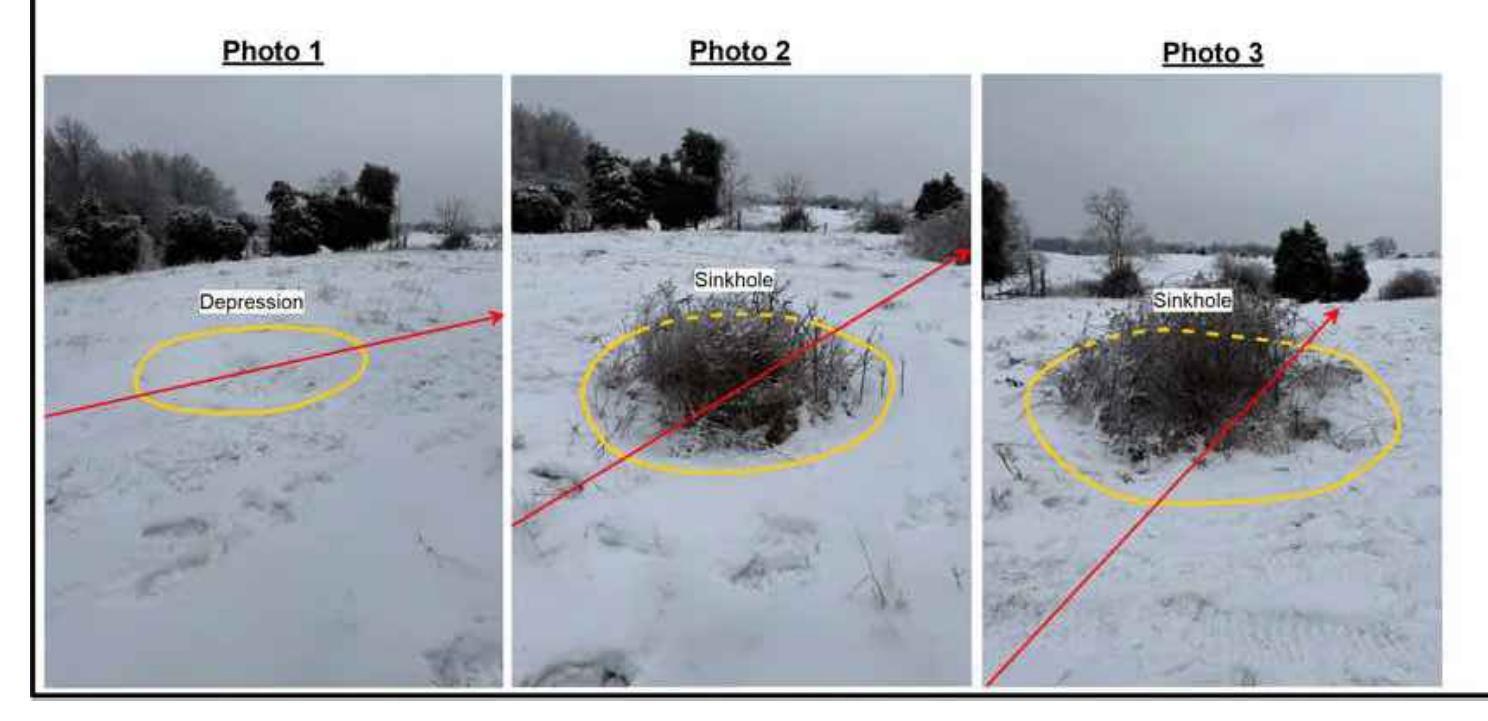
Slightly elevated apparent resistivities measured beneath each surficial karst feature are interpreted as poorly consolidated overburden materials related to differential settlement over deeper karst formations. The interpreted top of limestone is hummocky, consistent with limestone pinnacle formation. Variable apparent resistivities within the interpreted limestone are interpreted to indicate a range of competency within the unit, where lower apparent resistivities are interpreted as sections of increased weathering and may be more porous and vuggier than adjacent sections displaying higher apparent resistivities. No voids are interpreted within this profile.

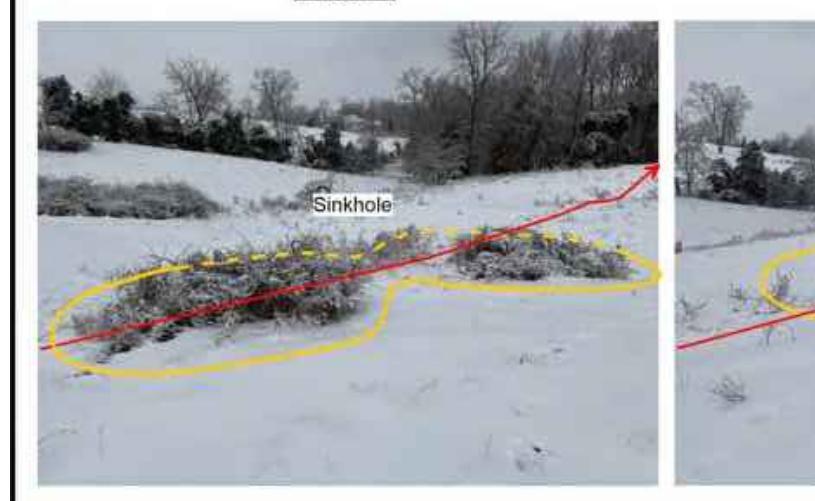
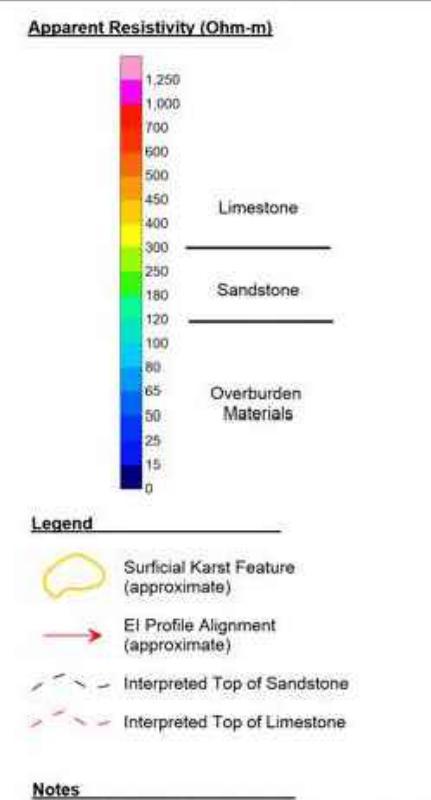
Photo 2

Below the sinkhole, elevated apparent resistivities are interpreted as poorly consolidated sediments overlying shallow, fractured sandstone, permitting the downward movement of materials into deeper karst units. Near the depression, a pocket of low apparent resistivities is interpreted as saturated sediments overlying a dipping interpreted bedrock surface that is likely related to deeper collapse within limestone or differential weathering of the limestone, leading to the formation of pinnacles. Also near the depression is a section of near-surface elevated apparent resistivities interpreted as very shallow rock overlying a shallow limestone pinnacle. Pockets of very high apparent resistivities within the two (2) most prominent pinnacles are interpreted as competent limestone separated by sections of lower competency limestone. No voids are interpreted within this profile.

Depression

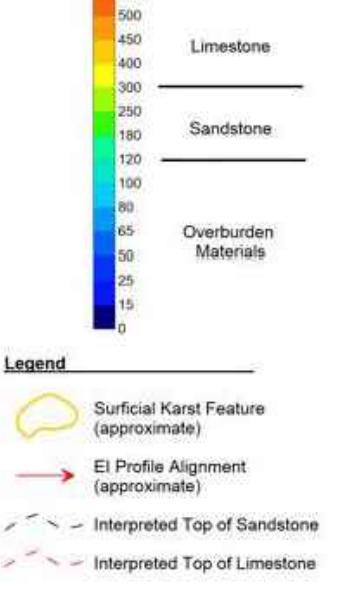
Photo 1

Below the depression is a small pocket of elevated apparent resistivities interpreted as poorly consolidated overburden materials related to differential settlement over deeper carbonate formations. The interpreted sandstone top of rock is somewhat hummocky, suggesting differential weathering of the underlying limestone. The interpreted limestone top of rock is highly irregular and contains gaps interpreted as highly fractured and vuggy intervals of limestone that are also present in deeper sections of the unit. No voids are interpreted from this profile; however, the limestone appears to severely weathered and likely has very low competency.

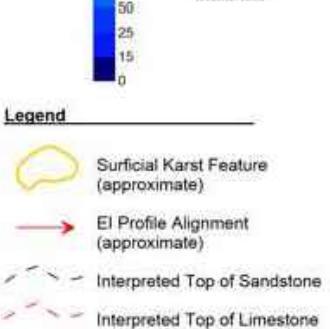
Photo 1

This profile images highly irregular interpreted top of sandstone and limestone surfaces that are indicative of differential weathering and erosion of the limestone unit. Beneath the open sinkhole feature, this profile images a section of elevated apparent resistivities interpreted as poorly consolidated sediments related to the downward movement of materials into deeper karst voids. The shallow limestone beneath the open sinkhole likely contains numerous fractures or small voids that lead to the development of the sinkhole. Additionally, variable apparent resistivities within the interpreted limestone indicate a range of competency within the unit, where lower apparent resistivities are interpreted as sections of increased weathering and may be more porous and vuggier than adjacent sections displaying higher apparent resistivities. No voids are readily apparent within this profile but may be present at deeper depths.

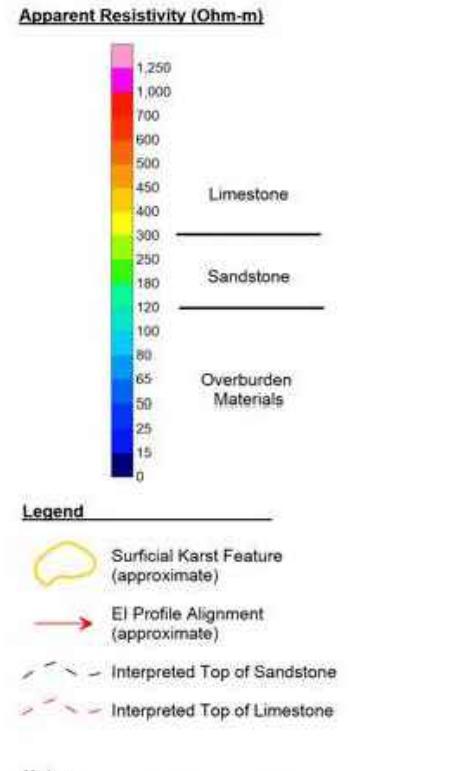
Photo 1

Below the open sinkhole is a small pocket of very high apparent resistivities interpreted as an air-filled void or fracture zone. The interpreted sandstone top of rock is irregular and hummocky, suggesting differential weathering of the underlying limestone. The interpreted limestone top of rock is highly irregular and contains gaps interpreted as highly fractured and vuggy intervals of limestone that are also present in deeper sections of the unit. The limestone appears to severely weathered and likely has very low competency.

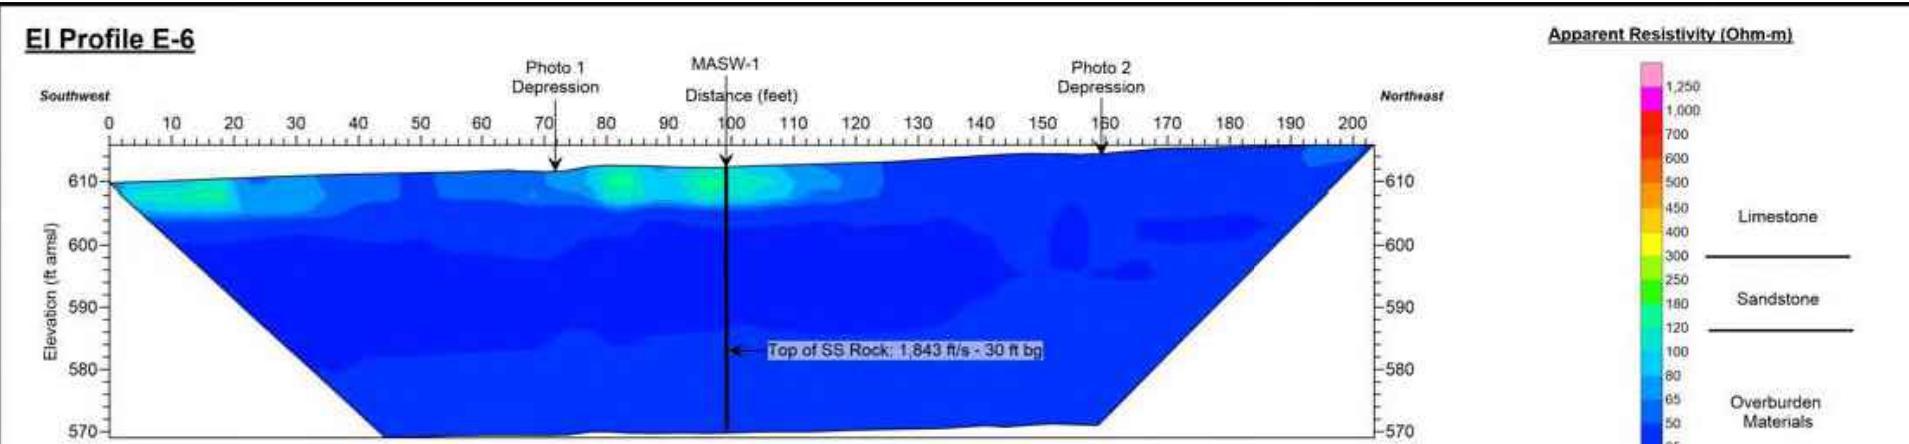
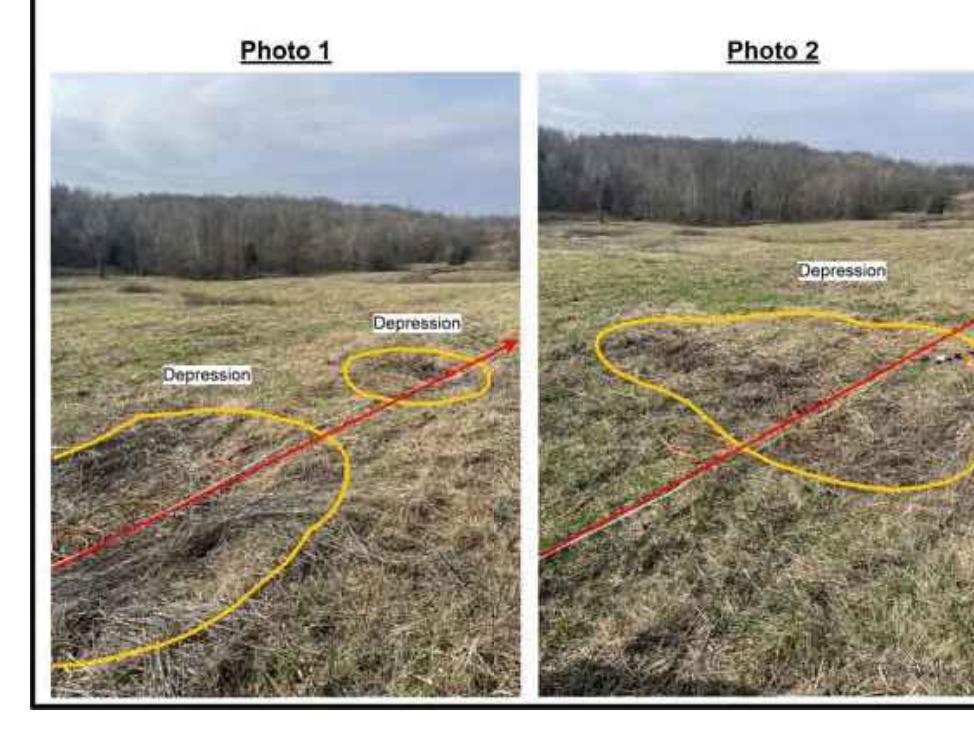
This profile displays very low apparent resistivities to depth, interpreted as deep soils. Top of rock is not mapped in this profile; however, MASW data collected along the profile suggests sandstone should occur approximately 30 feet bg. If rock is present, it is interpreted to be heavily saturated resulting in much lower apparent resistivity values. No karst features are identified in the profile and the source of the surface depressions are interpreted to be related to karst features within deeper limestone beyond the maximum profile imaging depth.

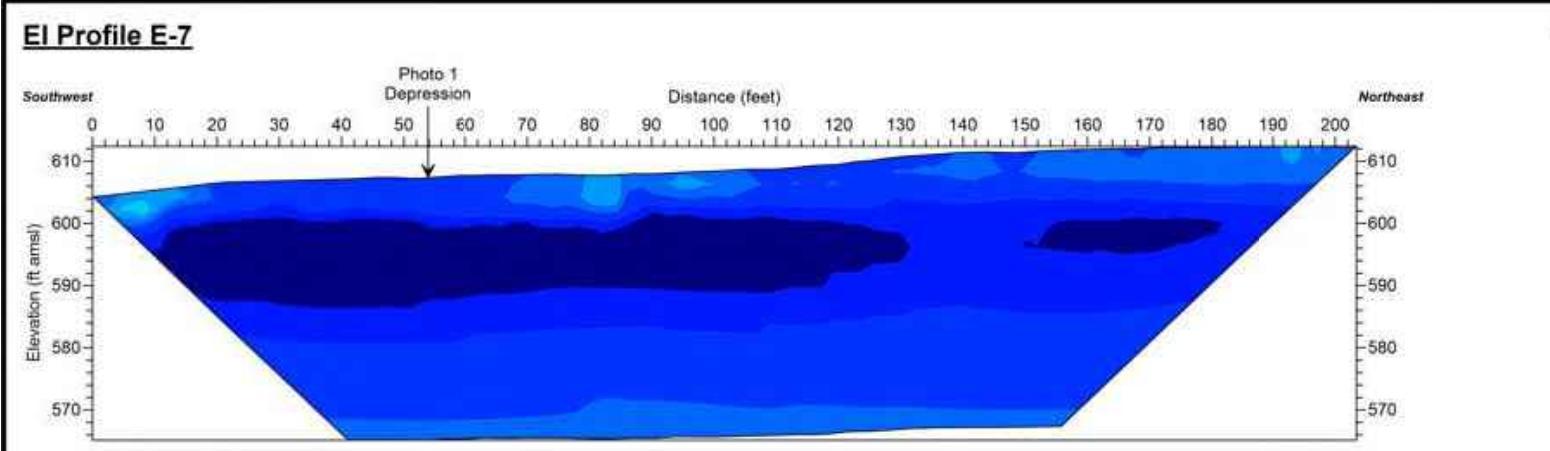
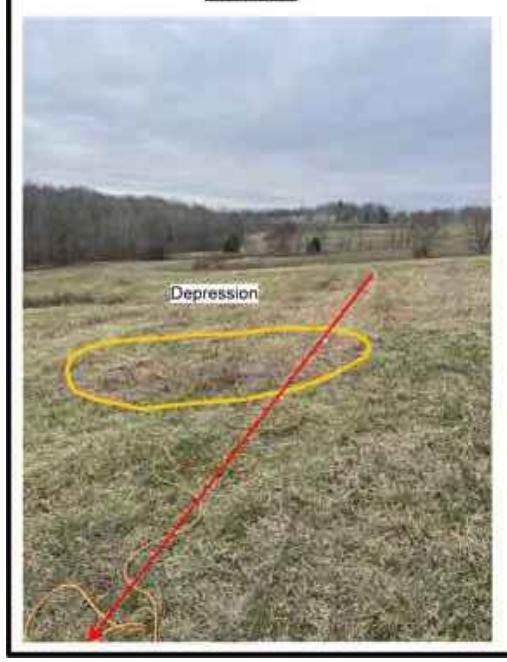
Photo 1

This profile displays very low apparent resistivities to depth, interpreted as deep soils. Top of rock is not mapped in this profile, however, MASW data collected along profile E-6 suggests sandstone should occur approximately 27 feet bg. If rock is present, it is interpreted to be heavily saturated resulting in much lower apparent resistivity values. No karst features are identified in the profile and the source of the surface depressions are interpreted to be cretated to karst features within deeper limestone beyond the maximum profile imaging depth.

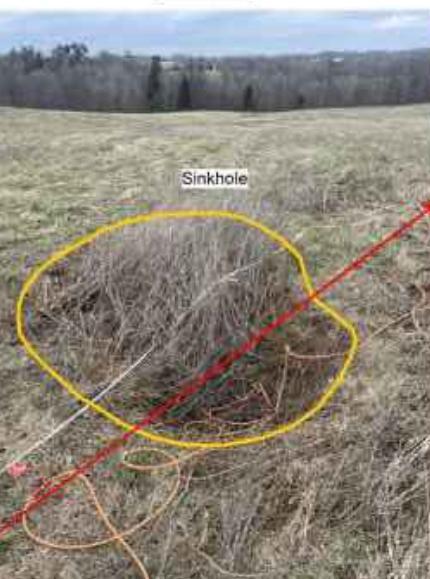
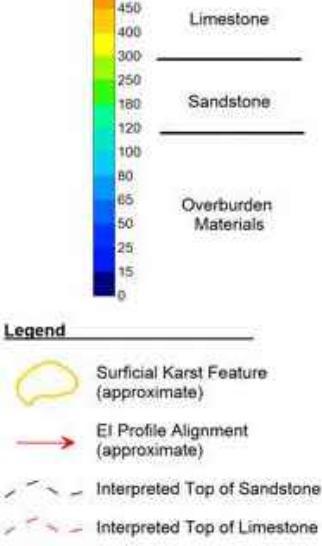
Photo 2

Both the Hardinsburg Sandstone and the Haney Limestone are well-displayed in this profile. The bedrock surface for each unit is variable indicating differential weathering and dissolution of the limestone. A section of elevated apparent resistivity within the interpreted limestone from approximately 60 to 88 feet along the profile and approximately 12 to 30 feet bg may be indicative of severe limestone weathering resulting in the formation of an air-filled fracture zone.

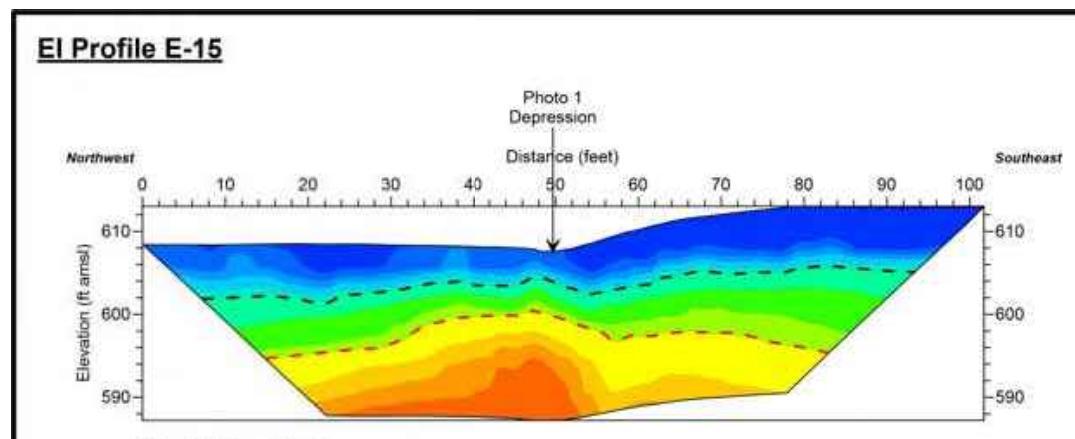
The top of both interpreted sandstone and limestone are well-displayed along this profile. Although the bedrock profiles are variable, indicating differential weathering of the limestone, likely near the contact of the two units, no indications of air- or clay-filled voids are present in the data. The somewhat irregular and hummocky top of limestone surface is consistent with limestone pinnacle formation.

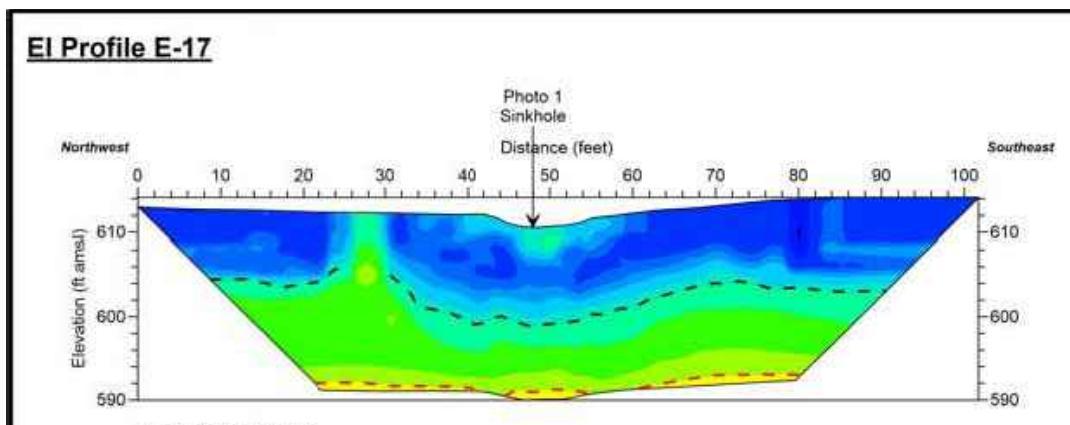
The top of sandstone is well-displayed along this profile, and some sections of interpreted top of limestone are imaged along the base of the profile. A resistive column extends towards the surface at approximately 28 feet along the profile, and is similar to interpreted sinkhole throats containing poorly consolidated soils imaged in other profiles. No depression or sinkhole was identified on the surface near this feature; therefore, this resistive feature may be indicative of an increased potential for sinkhole development in its vicinty. Additionally, a dp in the sandstone bedrock beneath the location of the observed sinkhole likely indicates dissolution or collapse of limestone beneath this interval. No air- or clay-filled voids are evident in this El profile.

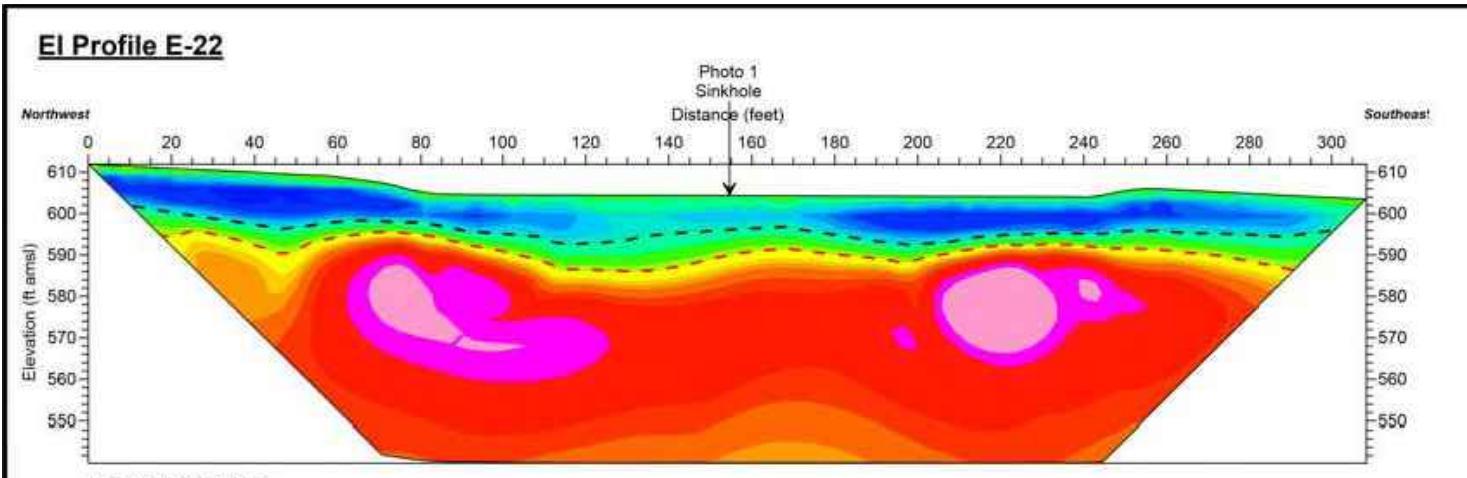
Both the interpreted top of sandstone and limestone are mapped within this profile and are much less irregluar than imaged in other profiles collected in this area. The interpreted limestone predominantly displays elevated apparent resistivities indicating it is likely competent. Two very resistive pockets are imaged within the limestone from 65 to 125 feet and 205 to 255 feet along the profile, both between 15 to 35 feet bg. These very resistive pockets are interpreted as very competent sections of limestone. Beneath the interpreted limestone, apparent resistivities begin decreasing, suggesting that deeper limestone is less competent and the source of the large sinkhole is likely related to karst within deeper rock. No air- or clay-filled/saturated voids or fractures are interpreted within this profile.

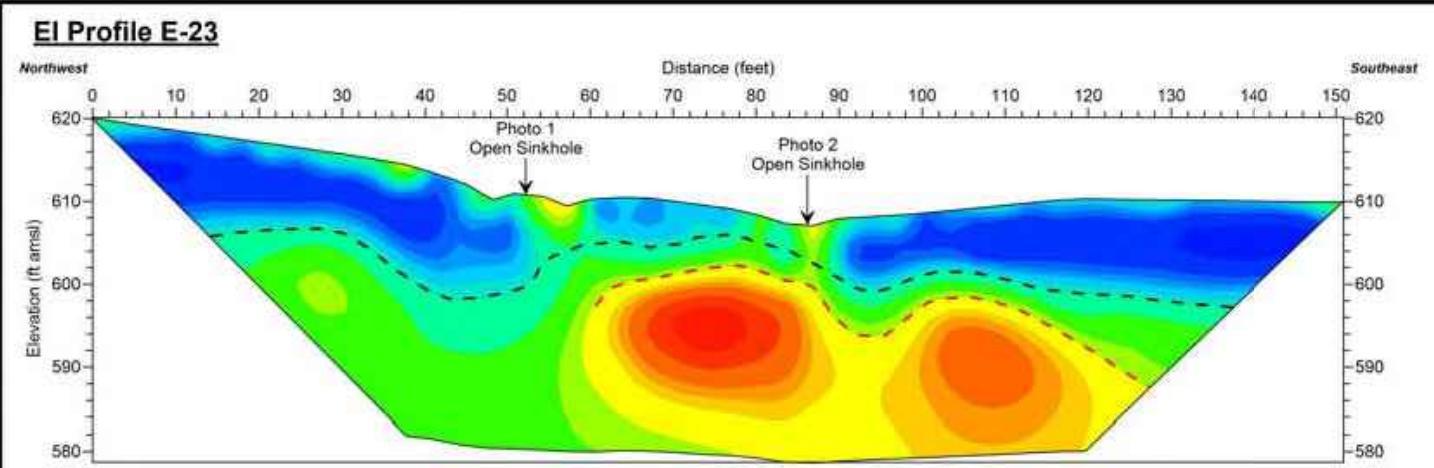
The interpreted top of sandstone and limestone are both well-imaged in this profile and display very irregular and hummocky profiles consistent with limestone pinnacles. Vertical columns of elevated apparent resistivities are imaged beneath each open sinkhole, indicating poorly consolidated soils and possible throats extending into deeper limestone voids. Limestone is only imaged from 60 to 125 feet along the profile and displays highly variable apparent resistivities indicating a range of competency within the rock. If limestone is present along the first half of the profile, it is displaying anomalously low apparent resistivities and is severely weathered and weak. It is likely that both open sinkholes imaged along this profile will continue to develop.

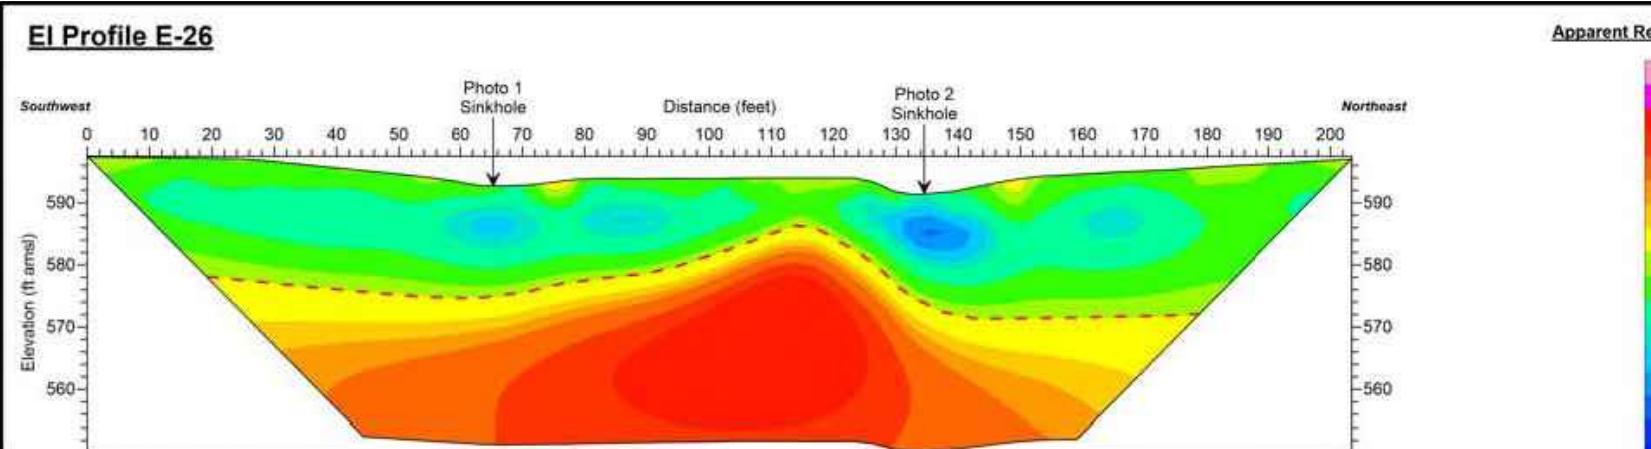
The interpreted top of limestone is well-imaged in this profile; however, the top of sandstone appears to be at or near the surface, if present at all. The limestone imaged within this profile displays an irregular interpreted top of rock surface consistent with limestone pinnacles. The highest apparent resistivities measured within the limestone occur near 115 feet along the profile and correspond to an interpreted pinnacle that extends towards the surface. No vertical resistivity features are imaged beneath either sinkhole; however, pockets of low apparent resistivities suggest that soils are more saturated beneath each feature which likely indicates that water and sediments are draining downward at each sinkhole. Additionally, the limestone imaged beneath each feature displays lower apparent resistivities than the interpreted pinnacle suggesting lower competency in these intervals and likely the presence of clay-filled fractures and vuggs.

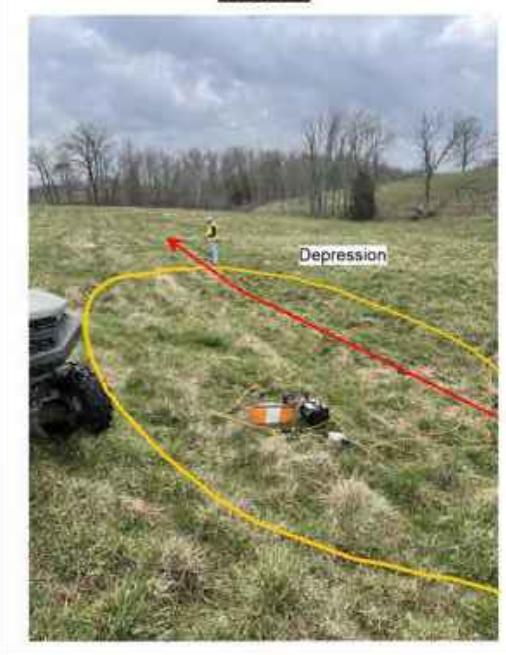
Photo 1

This profile displays very low resistivities to depth, indicating deep saturated soils. No rock is imaged in this profile and no indications of karst are interpreted from the profile. The source of the depression is assumed to be related to karst within deeper limestone.

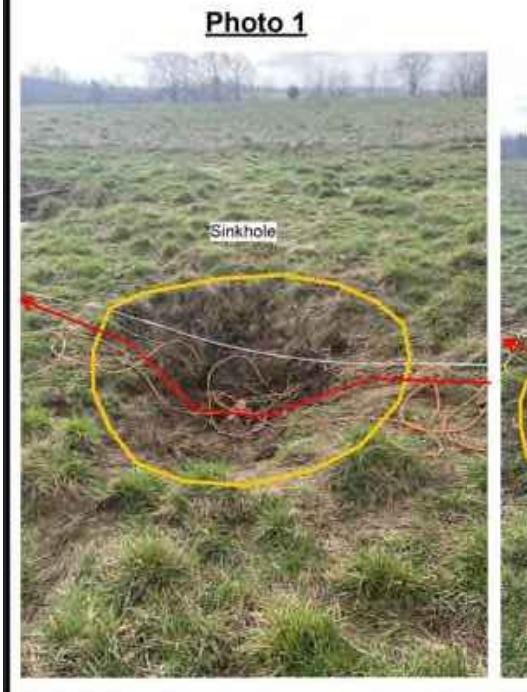
Photo 2

The interpreted top of sandstone is mapped only along the second half of the profile near its maximum imaging depth. This section of sandstone undulates, suggesting karst development in deeper limestone. The mechanism for the formation of the first sinkhole, at approximately 40 feet along the profile, is not evident in the Ef data; however, the absence of sandstone bedrock along this section suggests that deeper limestone may have a well-developed karst feature that is impacting the overlying materials. A column of slightly elevated resistivities extends upward from this interval to the first sinkhole, interpreted as poorly consolidated sediments, and may provide additional evidence to support the downward movement of materials into a deeper void feature. A sag in the interpreted sandstone profile is present directly beneath the center of the second sinkhole, at approximately 60 feet along the profile, and is likely the source of this sufficial karst feature. No air- or clay-filled or saturated fractures or voids are interpreted within this profile.

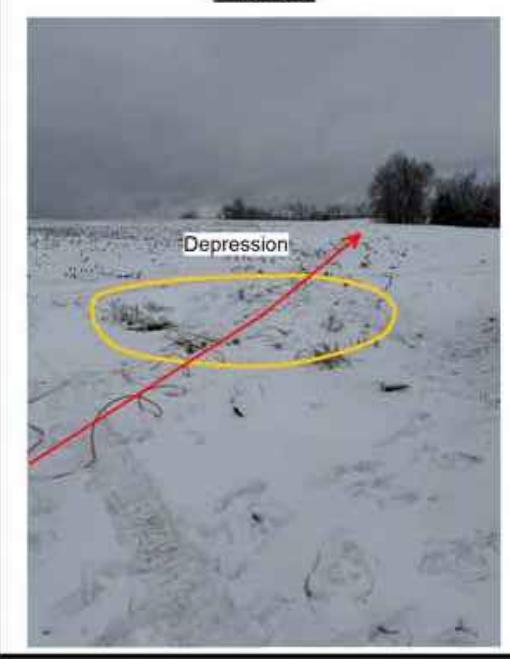
Photo 1

The interpreted top of sandstone and limestone are well-imaged in this profile. The sandstone surface is relatively flat-lying while the underlying limestone is more irregular and undulating. The profile appears to map a deep collapse feature near the beginning of the profile that is below a vertical column of slightly elevated apparent resistivities interpreted as poorly consolidated sediments extends to the surface; however, no surficial karst feature was identified in that location indicating the potential for a surficial karst feature to form. Beneath the depression, the interpreted limestone appears to be competent suggesting that the source of the depression is related to deeper limestone karst features not imaged in the profile. No air- or clay-filled or saturated voids or fractures are interpreted within this profile.

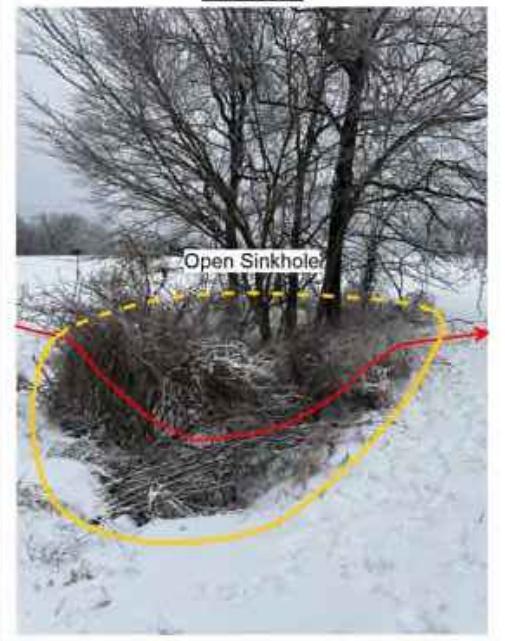
Photo 1

This profile imaged a very deep open sinkhole. The interpreted top of sandstone is mapped across the profile and displays highly variable elevations suggesting severe karst within the deeper limestone. Beneath the open sinkhole, the interpreted sandstone appears to dip sharply which is interpreted as severely weathered and fractured rock. Below this zone of fractured sandstone is a small pocket of apparent resistivities consistent with limestone; however, this interpreted limestone does not appear to continue laterally and displays lower apparent resistivities beneath it. It is likely that this portion of limestone is a severely weathered limestone pinnacle situated within a section of very low competency limestone. Additionally, a vertical column of elevated apparent resistivities extends to the surface near the base of the open sinkhole indicating that sediments are poorly consolidated and continuing to move downard into deeper karst volds and fractures. No air-filled voids or fractures are interpreted from this profile.

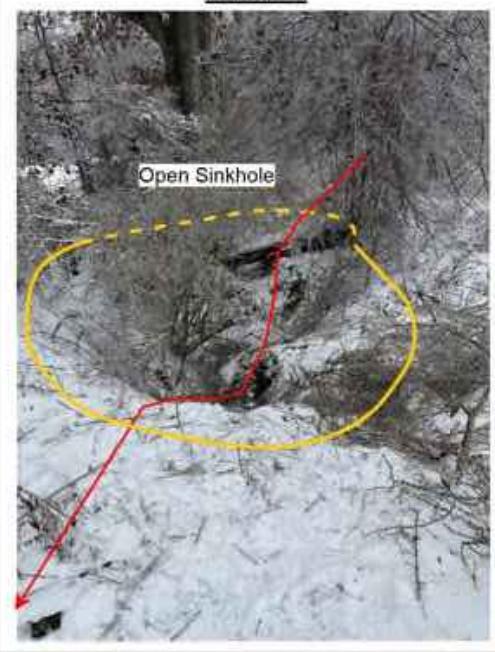
Photo 1

This profile imaged a very deep open sinkhole. The interpreted top of sandstone and limestone are mapped across the profile and display variable elevations suggesting severe differential dissolution of the limestone, consistent with deeper collapse or pinnacle formation. Directly beneath the open sinkhole is a pocket of elevated apparent resistivities that are interpreted as poorly consolidated sediments related to the sinkhole throat that are continuously moving downward into deeper karst voids or fractures. The abrupt dip in both interpreted top of rock surfaces is likely the source of the sinkhole formation and both rock types are interpreted to contain clay-filled and saturated fractures. No air-filled voids or fractures are imaged in this profile.

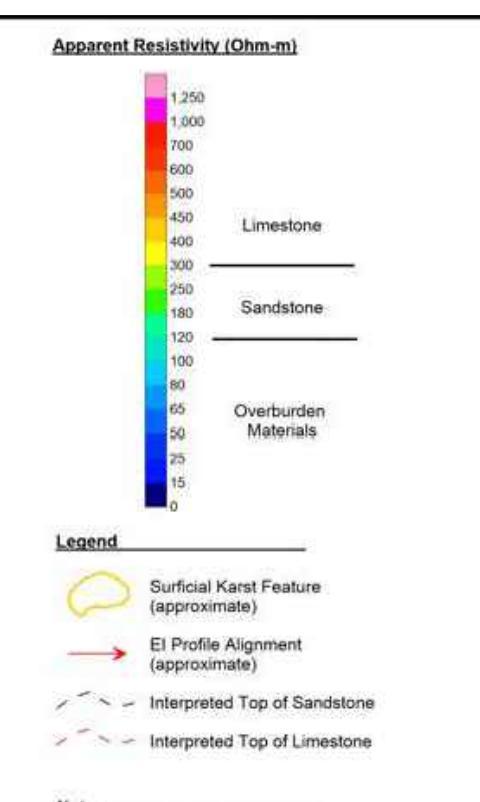
Photo 1

The interpreted top of sandstone is partially imaged near the base of the profile and is absent by 100 feet along the profile. The interpreted rock surface is undulating indicating differential dissolution and potential collapse of deeper limestone units and is likely the source of the sinkhole. No limestone is imaged in this profile. No air- or clay-filled voids or fractures are interpreted from this profile.

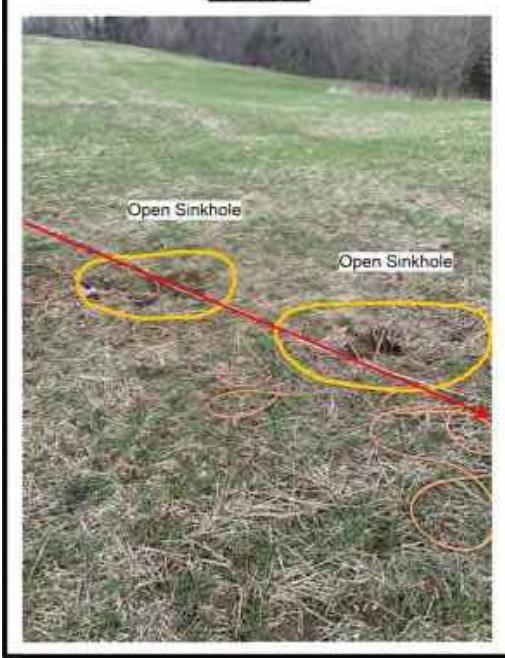
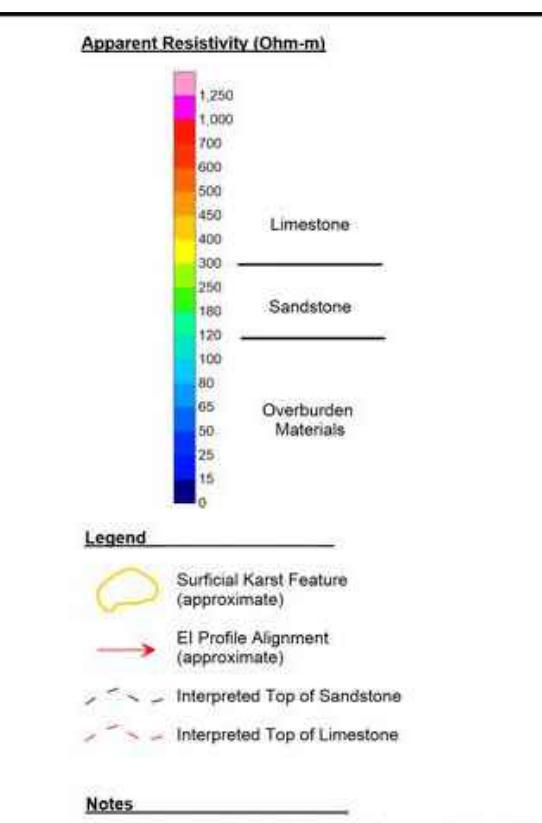
Photo 1

Both the interpreted sandstone and limestone top of rock are imaged in this profile, which is consistent with this EI profiles proximity to the documented geologic contact. Both bedrock profiles are inconsistent and uneven, suggesting differential settlement from weathering and dissolution of the Haney Limestone member below. Just below the open sinkholes, three slightly resistive columns extend towards the surface from the interpreted sandstone. These columns may represent pathways through which sediment is migrating downward into karst features within the Haney Limestone member. No air-filled voids or fractures are interpreted in this EI profile.

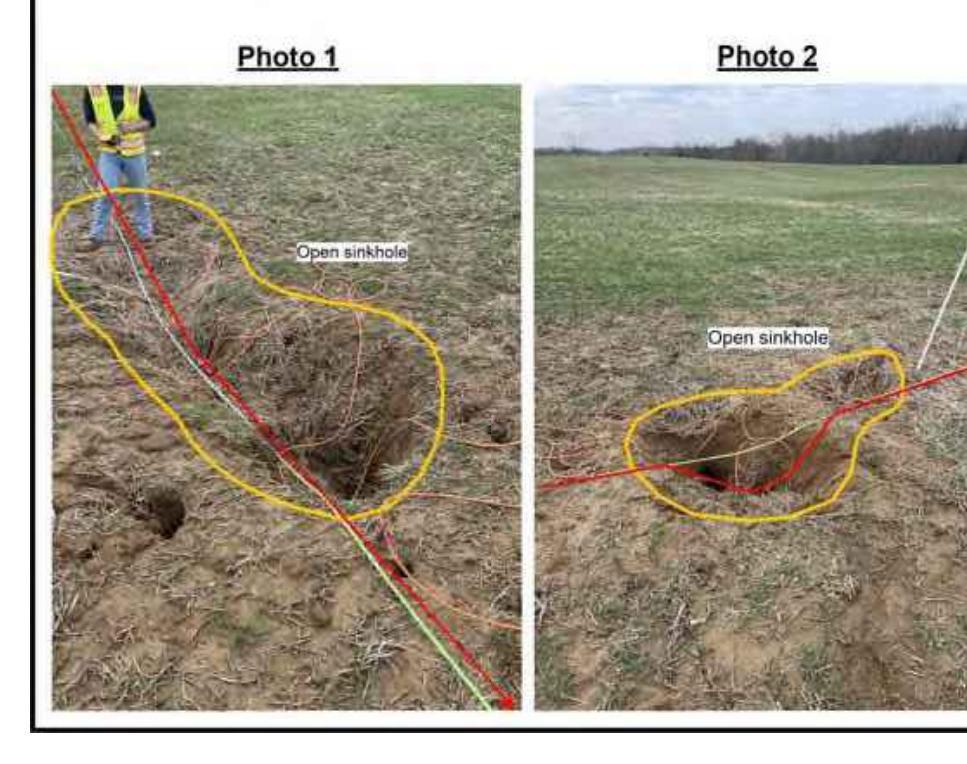
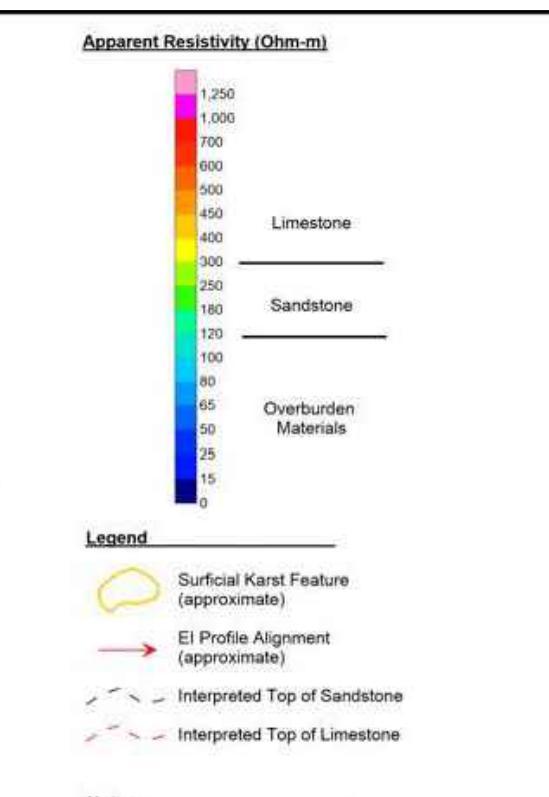
Based on the geologic map, this profile appears to be located within the Haney Limestone; however, no limestone is imaged in the El data. The top of sandstone is mapped across the profile and is highly irregular. Towards the end of the El profile, the interpreted sandstone appears to be at or very near the ground surface. Beneath the open sinkholes, a relatively deep sag is present in the interpreted sandstone rock surface suggesting settlement from karst feature collapse in the deeper Haney Limestone member. The highly irregular sandstone imaged at approximately 78 feet along the profile, appears to show a small section of isolated collapse and may serve as a future pathway for the downward movement of sediment. This feature is interpreted sandstone collapse lies in the deeper soluble limestone. No air-filled voids or fractures are interpreted from this profile.

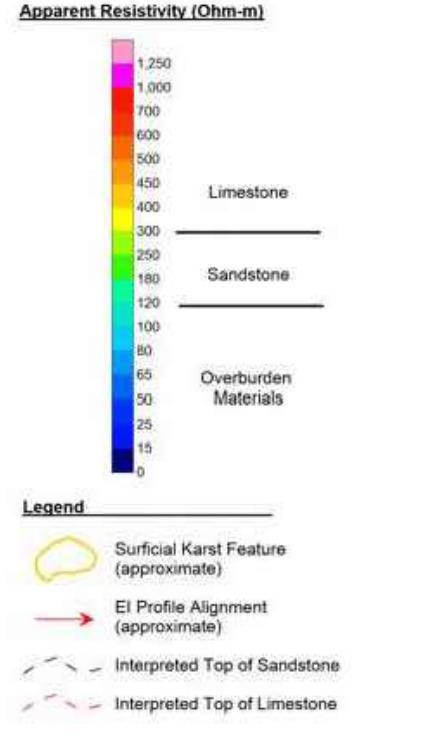
Photo 1

The apparent resistivities measured in this profile are consistent with interpreted sandstone indicating that sandstone is present at or near the surface. No limestone is imaged in this profile. Directly beneath the open sinkhole, a pocket of very low apparent resistivities is interpreted as a saturated, clay-filled through feature and appears to connect to a larger feature that extends towards the end of the profile. This extended low-resistivity feature is interpreted as a section of sandstone containing clay-filled/saturated fractures. Although limestone is not imaged, this sandstone fracture zone is likely related to deeper karst within underlying limestone. No air-filled voids or fractures are interpreted from this profile.

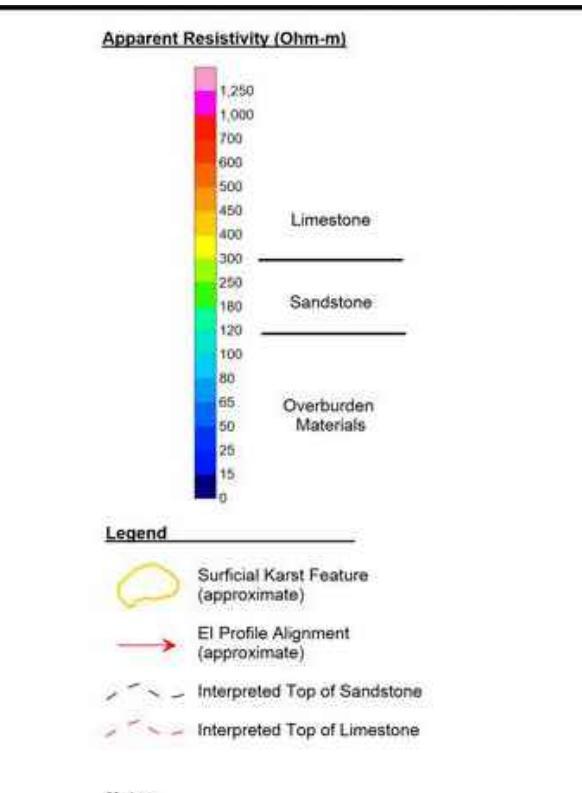
Photo 1

No rock is imaged in this EI profile and the profile is interpreted to map saturated soils to depth. No air- or clay-filled voids or fractures are interpreted in this EI profile and the source of the depression is likely related to karst within deeper limestone units.

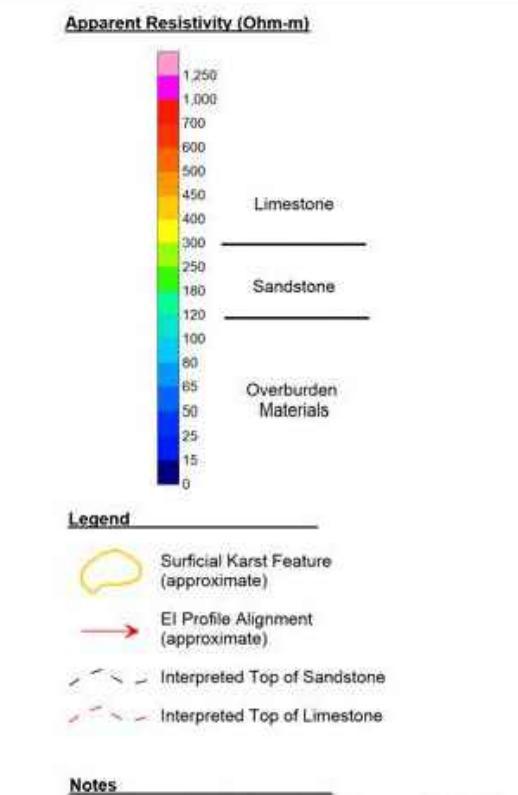
Photo 1

This profile measured very low apparent resistivities to depth interpreted as saturated soils. No rock is imaged in this profile. If rock is present, it is interpreted to be highly saturated. The source of the depression is unclear as rock is not imaged; however, it is possible that this feature is related to sediment piping along potential drainage tile that may be within this agricultural field. No air- or clay-filled voids or fractures are interpreted from this profile.

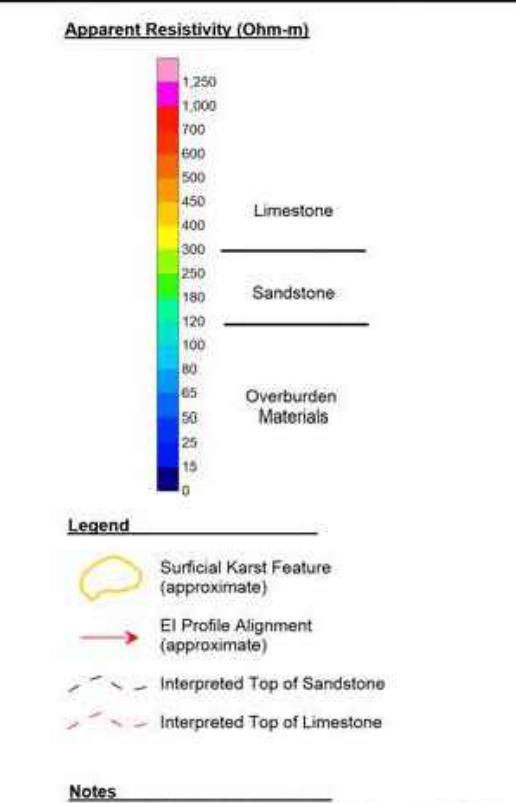
Photo 1

This profile measured very low apparent resistivities to depth interpreted as saturated soils. No rock is imaged in this profile. If rock is present, it is interpreted to be highly saturated. The source of the depression is unclear as rock is interpreted to be related to collapse of deeper limestone units. No air- or clay-filled voids or fractures are interpreted from this profile.
