| EASTERN KENTUCKY POWER COOPERATIVE (EKPC) |
| J.S. COOPER GENERATING STATION |
| JOB NO. 43-24-0331a |

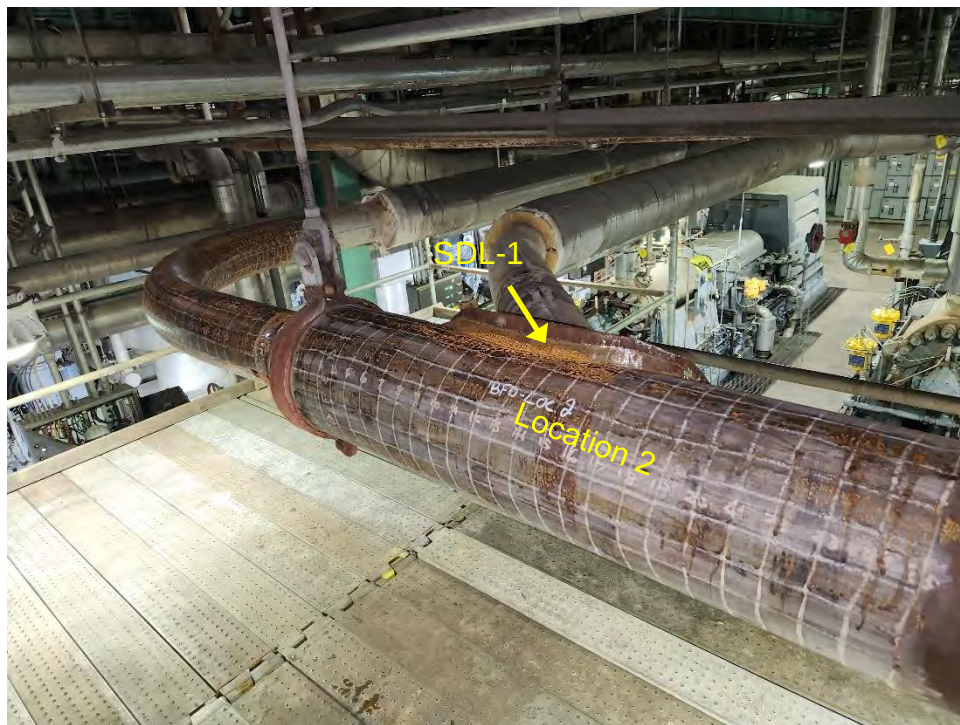
Fig. 36. Photographs of the inspection locations on the Boiler Feedwater Discharge piping system.

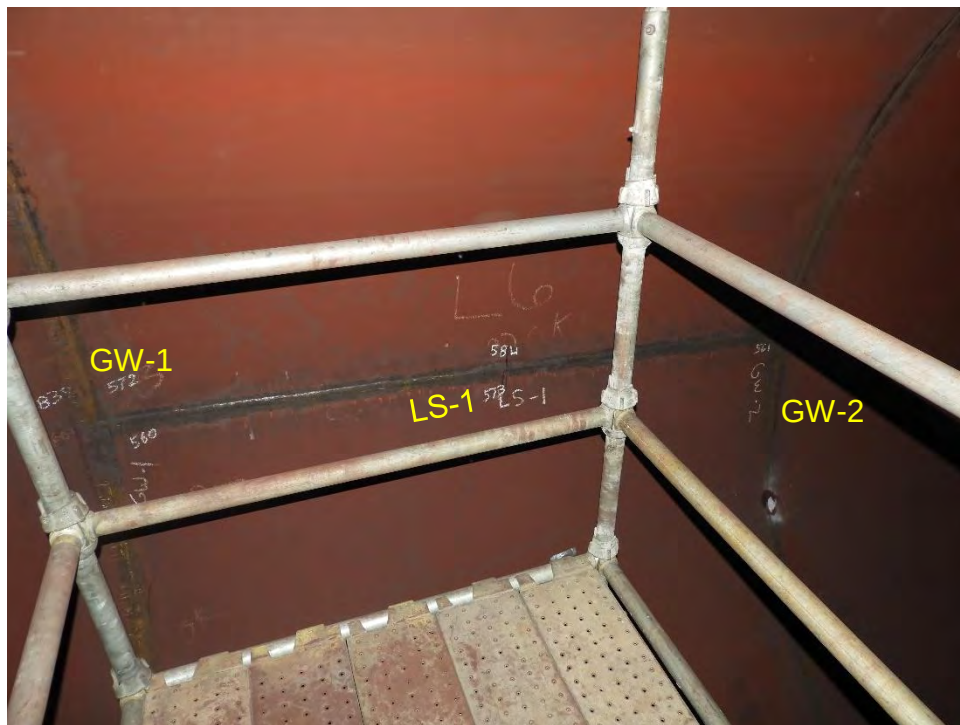
Fig. 53. Photographs of the inspection locations on the deaerator storage tank.

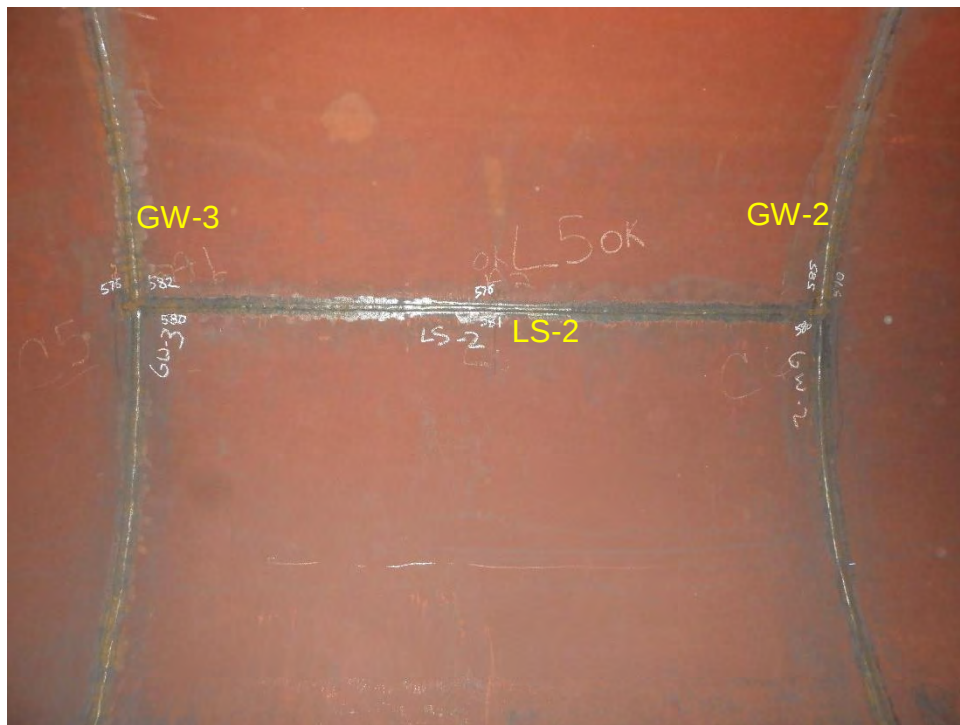
Fig. 55. Photographs of the inspection locations on the deaerator storage tank.

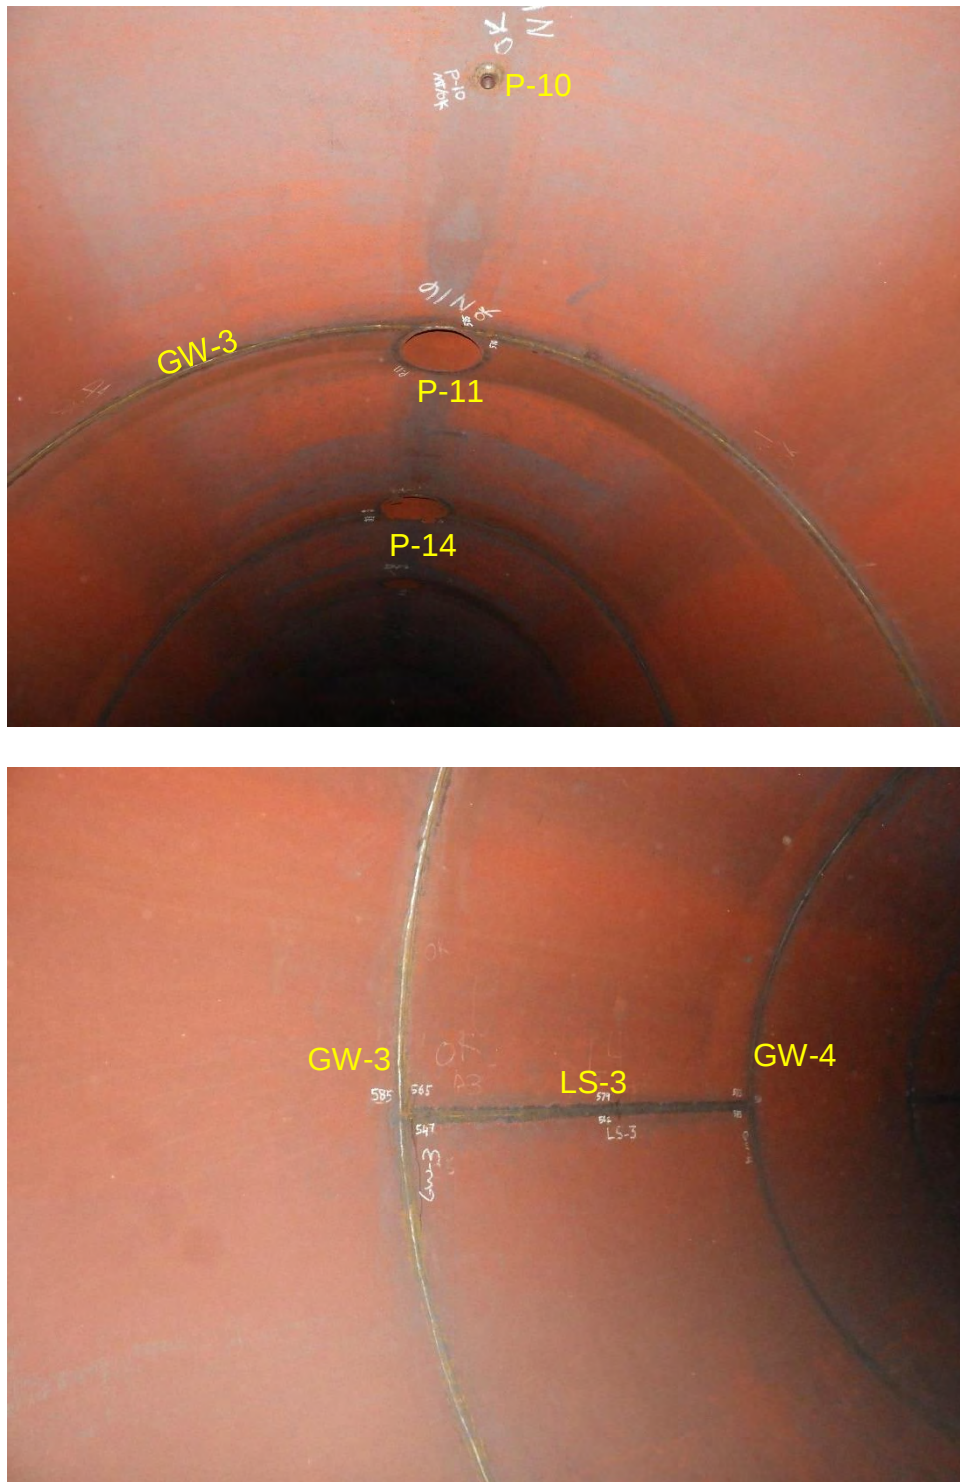
Fig. 56. Photographs of the inspection locations on the deaerator storage tank.

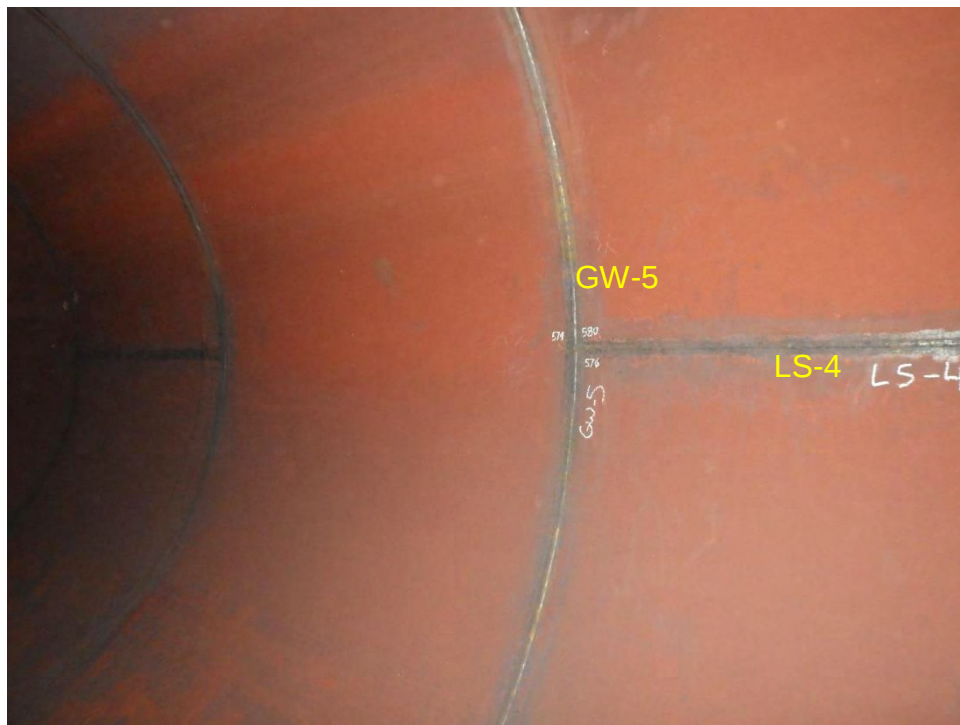
Fig. 57. Photographs of the inspection locations on the deaerator storage tank.

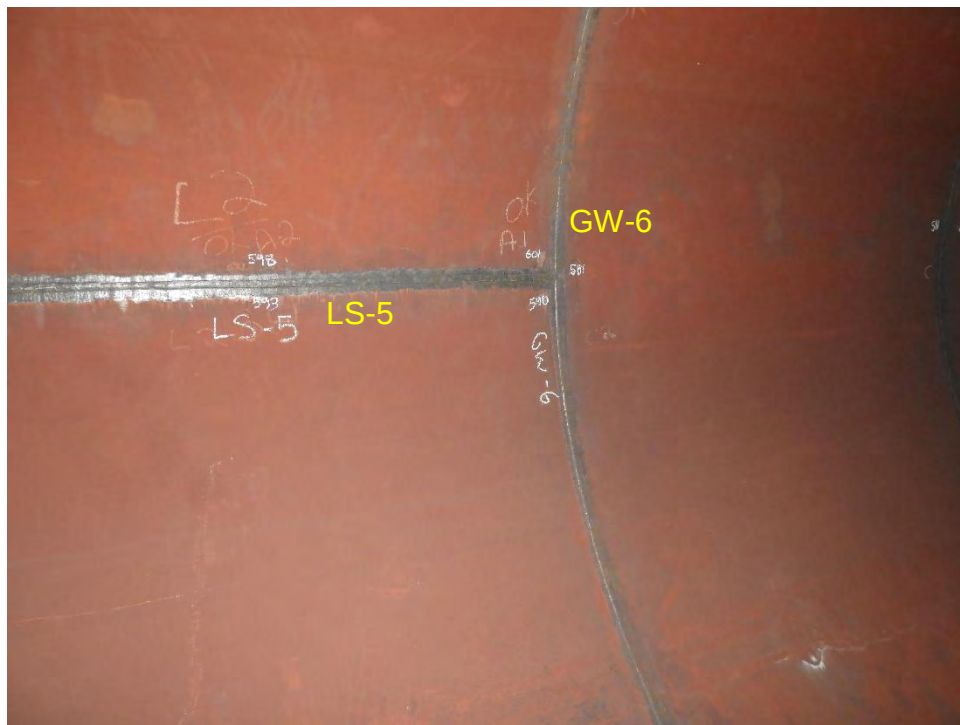
Fig. 58. Photographs of the inspection locations on the deaerator storage tank.

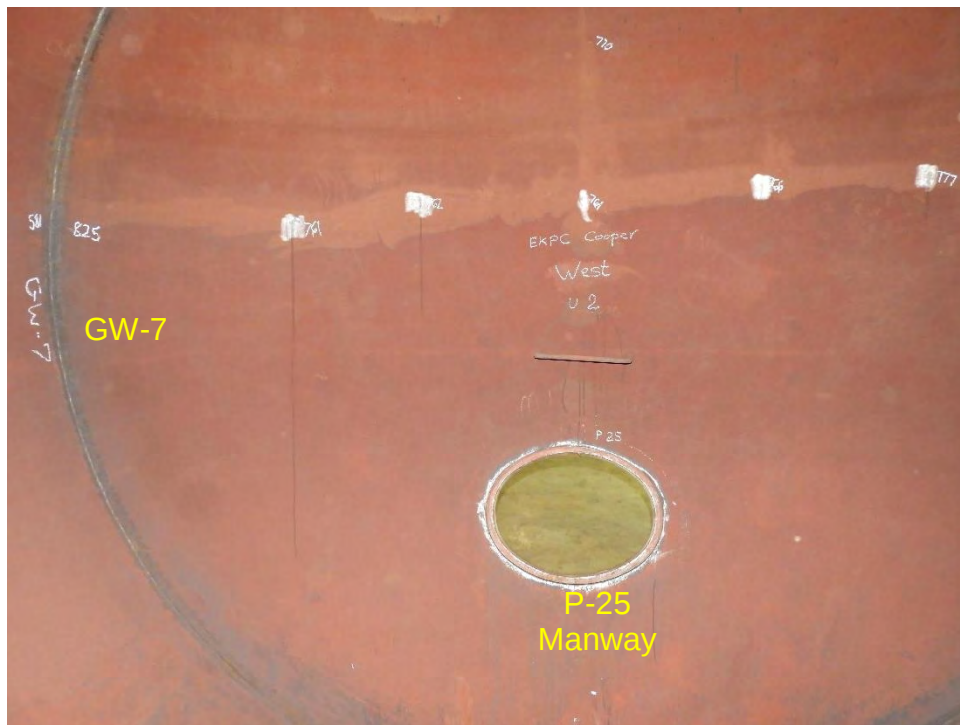
Fig. 60. Photographs of the inspection locations on the deaerator storage tank.
