INSPECTION REPORT

CUSTOMER : EKPC - Cooper
REPORT NO. : 55294-IR1

REPORT DATE : 04/20/16
PAGE : 2 of 4

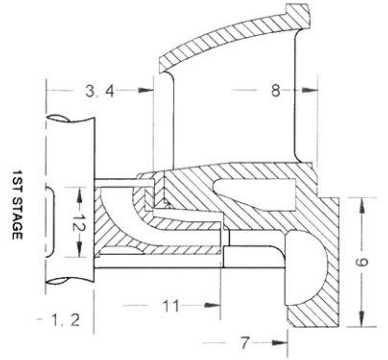
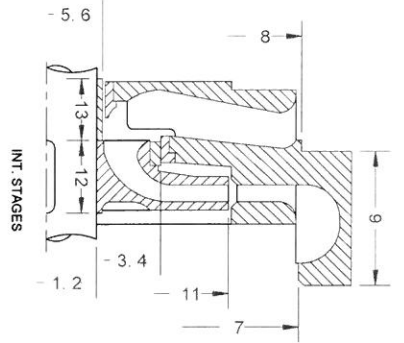
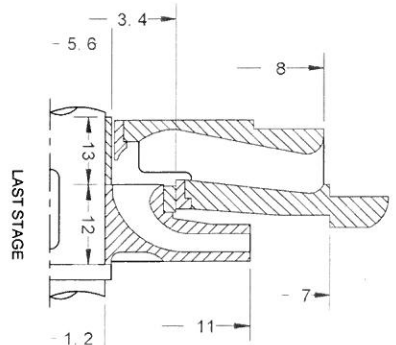
- a) Both gasket faces have some very light water erosion or pitted areas; for the internal gaskets, it looks like there are wash or drag marks on the fit turn to the discharge diffuser.
- b) Similar to the discharge diffuser, there is light working damage from the gasket spacer.
- c) There is a very small area of overlay weld at the flange to fit turn interface. It can only be assumed that this was an attempt to get a metal to metal seal on the inside of the flange face. The weld has started to corrode.

Photo 8: Gasket Face Damage On End Head
