MARCH 2024
INSPECTION OF
HIGH-ENERGY PIPING SYSTEMS AND PRESSURE VESSELS
UNIT NO. 2
J.S. COOPER GENERATING STATION
EASTERN KENTUCKY POWER COOPERATIVE
SOMERSET, KENTUCKY

April 12, 2024

Report No. 18577

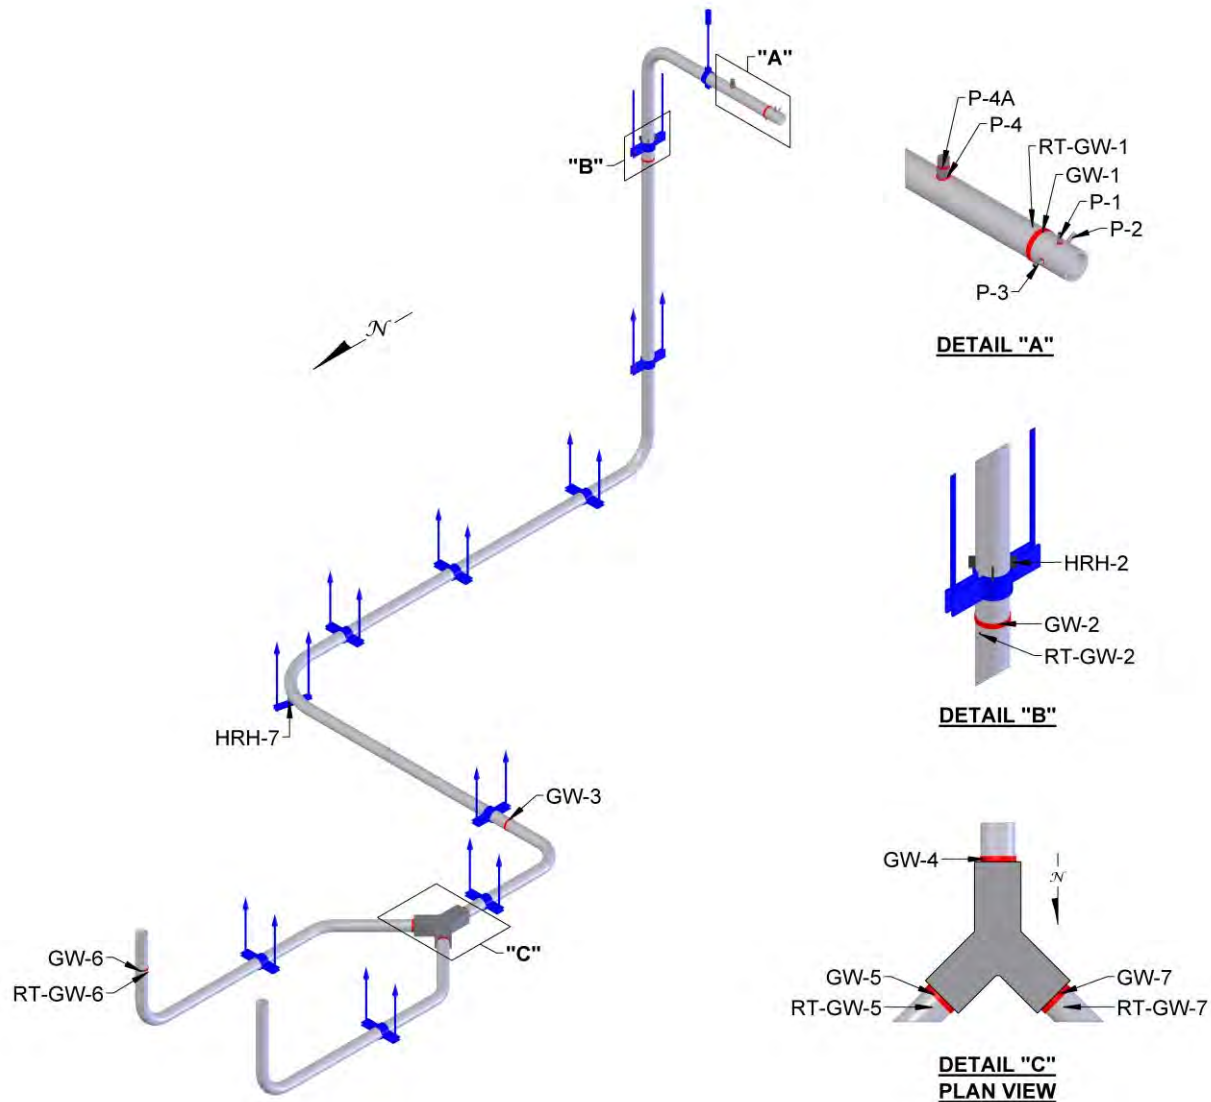
Fig. 16. Sketch of the inspection locations on the Hot Reheat piping system.

The visual examination performed on the Hot Reheat piping system did not reveal gross misalignment, weld defects, indications of cracking, distortion, or other service-related deterioration at the inspection locations.

Two of the diameter measurements recorded on the Hot Reheat pipe spools fell slightly beyond the permissible diameter limits. There was no metallurgical evidence in the replicas of general swelling such as would be produced by creep deterioration. As such, the results of the diameter measurements confirm that this portion of the Hot Reheat piping system was fabricated using the appropriate specified outside diameter.
