The Babcock & Wilcox Company

**Eastern Kentucky Power Cooperative
Spurlock Station, Unit #2**

U2 SPRING 2023 OUTAGE BOILER INSPECTION REPORT

B&W Project No.: BA9312817

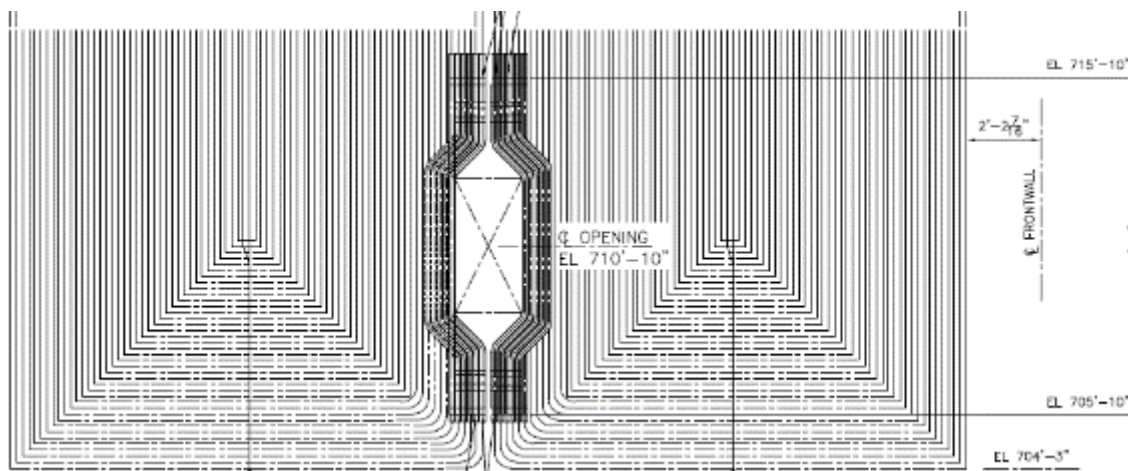
Figure 2. SH Division Panel IK Openings

SH Division Panels showed only slight wear this year as there had been considerable repairs performed in this area in the past. New IKs were installed through the side walls along with WOL SH Division panel openings between the panels (See Figure 2 below). The damage found in 2021 is a result of three (3) mechanisms - mechanical rubbing at flex ties, damaged tube shields and mechanical rubbing at the horizontal spacer tube. Gas temperatures are high in this area, so when installing tube shields they should be short in length, thin gauge, welded to the tubes on one end, and clipped on the other to take advantage of cooling from internal steam flow.

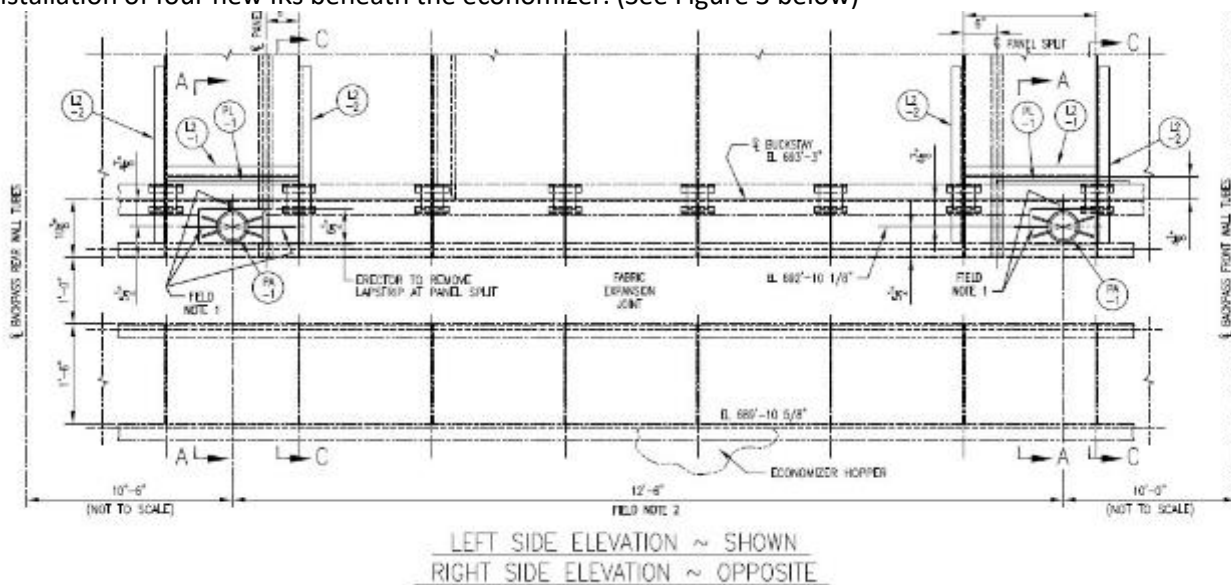
Figure 3. IK Installation beneath the Economizer

The Economizer was also in good condition. Minor items were identified such as mechanical tube rubbing on the stringer tubes above the rear intermediate header and tube shield chafing at the rear economizer tube ladder hanger lugs. The bottom side was scaffolded for access and was inspected due to the scaffold required for the installation of four new IKs beneath the economizer. (See Figure 3 below)

8. Plan to build scaffolding to the bottom of the economizer for inspection to review the status of the component after operation with the new IKs that were installed during this outage.
9. Continue condition assessment work on HEP, headers and pressure part components.

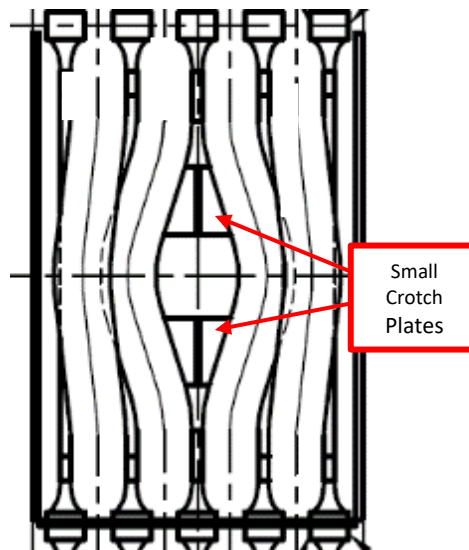
Figure 4. (Six Tube Panel – Four Bent Tubes - IR Opening)

- a. Original pipe sleeves have all burnt back, with some exposing the outer sootblower wallbox.
 - b. B&W recommends initiating a tube opening replacement program with the IR openings. Replace the two-tube bent openings with four-tube bent openings. The four-tube bent openings (Figure 4) result in much smaller crotch plates, thus an improved chance for survival. Plan to replace a level of IRs each outage for the next five years. Weld overlay could be included to limit sootblower damage repairs.

- a. Inspection and repair access from a swing stage would be limited to these areas based on existing cable drop locations.
5. Continue to install new IR panels with new pipe sleeves and crotch plates at the IR Sootblower openings in the furnace.

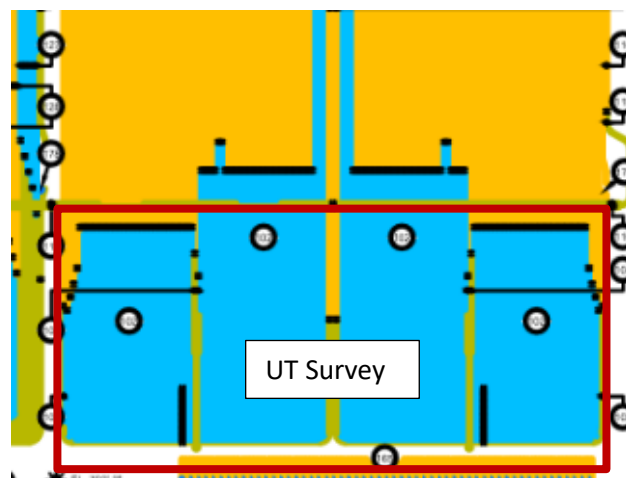
Figure 5. (UT the Lower Loops of the SH Division Panels)

6. Plan for UT surveys.
 - a. Furnace Waterwalls - This is based on visual inspections of fireside corrosion at the coolant slope transitions, which have been overlaid, but further data will help to create a database for remaining useful life of components that aren't overlaid.
 - i. A survey was completed by GECKO in 2021.
 - b. SH Division Panels - panels are experiencing coal ash corrosion in the lower 8' (below the horizontal alignment tube). We recommend performing a UT survey on both sides of all six (6) panels in 2021. UT all 160 tubes on both sides of each panel for a total of 1920 UT points (Figure 5.)

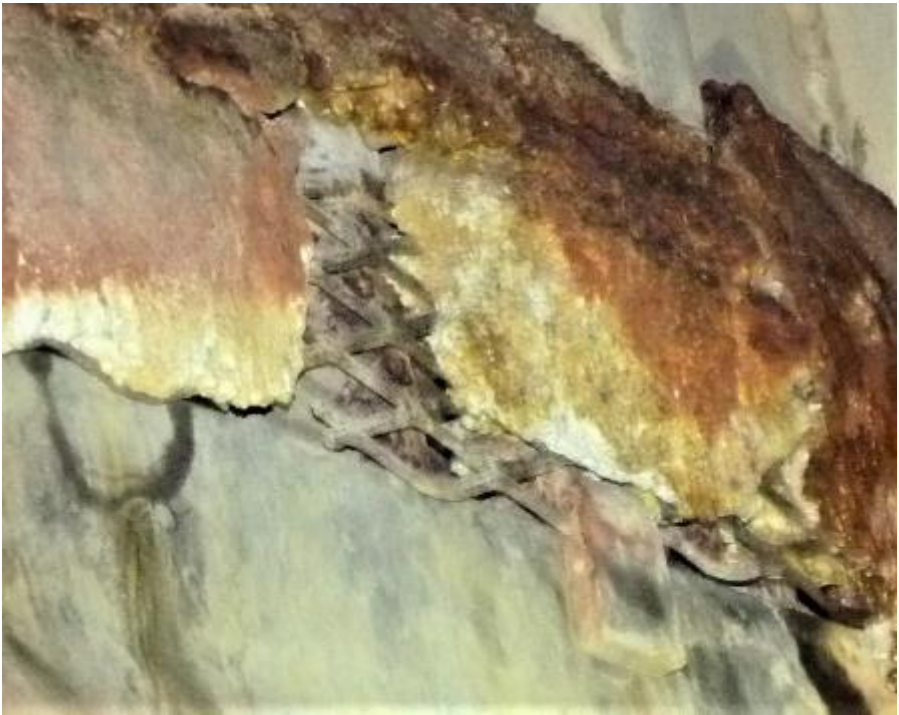
Date: 05/12/2023	Inspected by: B&W BC	Unit: 2	Item: BOTECON 1
Component Inspected: Bottom of the Economizer			
Condition Assessment: A small section of refractory Approx. 3' has broken off exposing the expanded metal beneath			
Recommendations: Repair the missing refractory			
Criticality: P3			
Risk if NOT Performed: This could allow erosion of the underlaying metal.			
EKPC Comments:			
Photos:

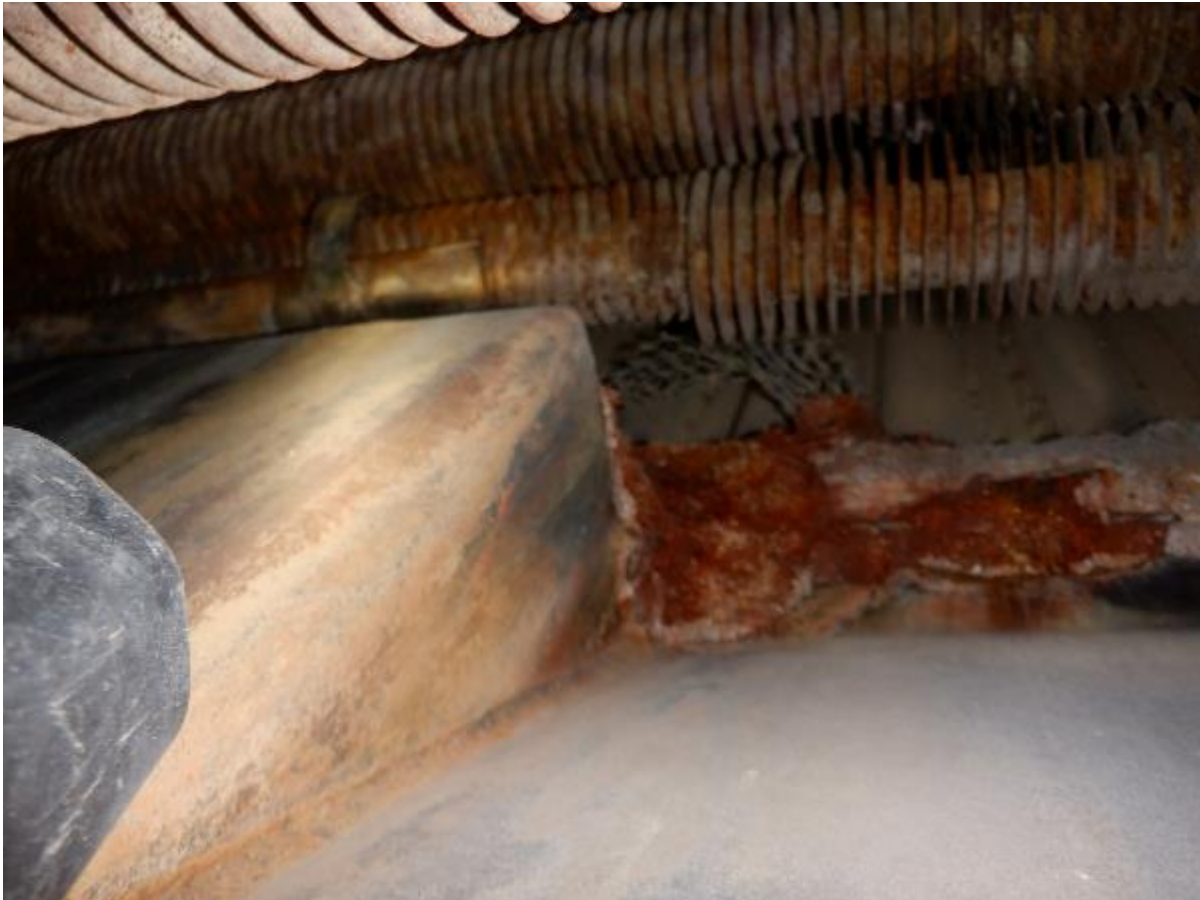
Date: 05/12/23	Inspected by: B&W ECC	Unit: 2	Item: BLTSHTOEC 3
Component Inspected: Bottom Economizer			
Condition Assessment: The bottom tube of the first and last elements have erosion of the fins in the middle of the tube above a support.			
Recommendations: This area has a tube shield but erosion is occurring past the shield, a longer shield should be installed.			
Criticality: P3			
Risk if NOT Performed: Fins will continue to erode and it is likely the tube is eroding between the fins.			
EKPC Comments:			
Photos:

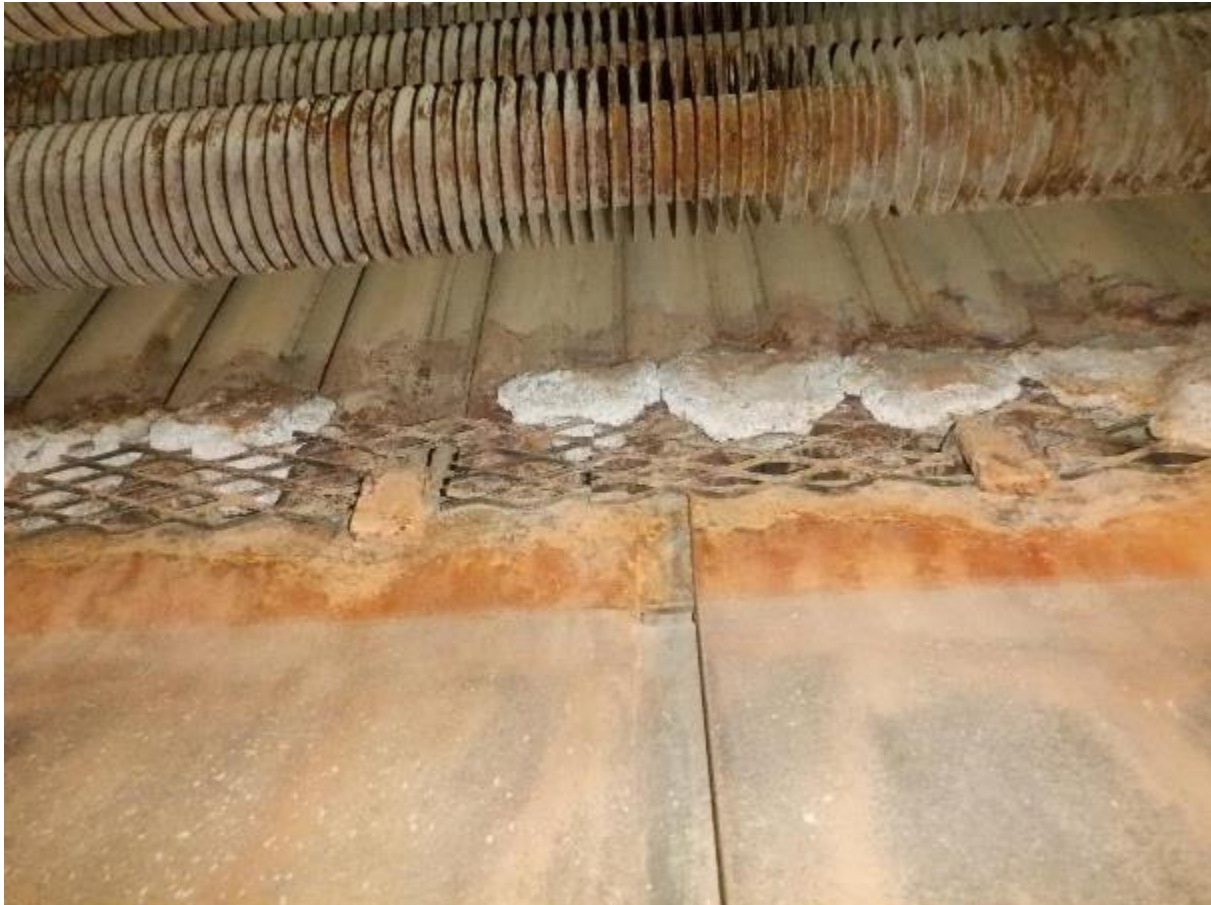
Date: 5/12/2023	Inspected by: B&W - CSH	Unit: 2	Item: BOTECON 3
Component Inspected: Bottom of the Economizer			
Condition Assessment: Above the header shield, the RHSV section of refractory missing near the midpoint of the wall.			
Recommendations: Replace missing refractory.			
Criticality: P2 Due to accessibility. Bottom of the economizer isn't scaffolded every year.			
Risk if NOT Performed: This allow flue gas to erode the backpass header.			
EKPC Comments:			
Photos:

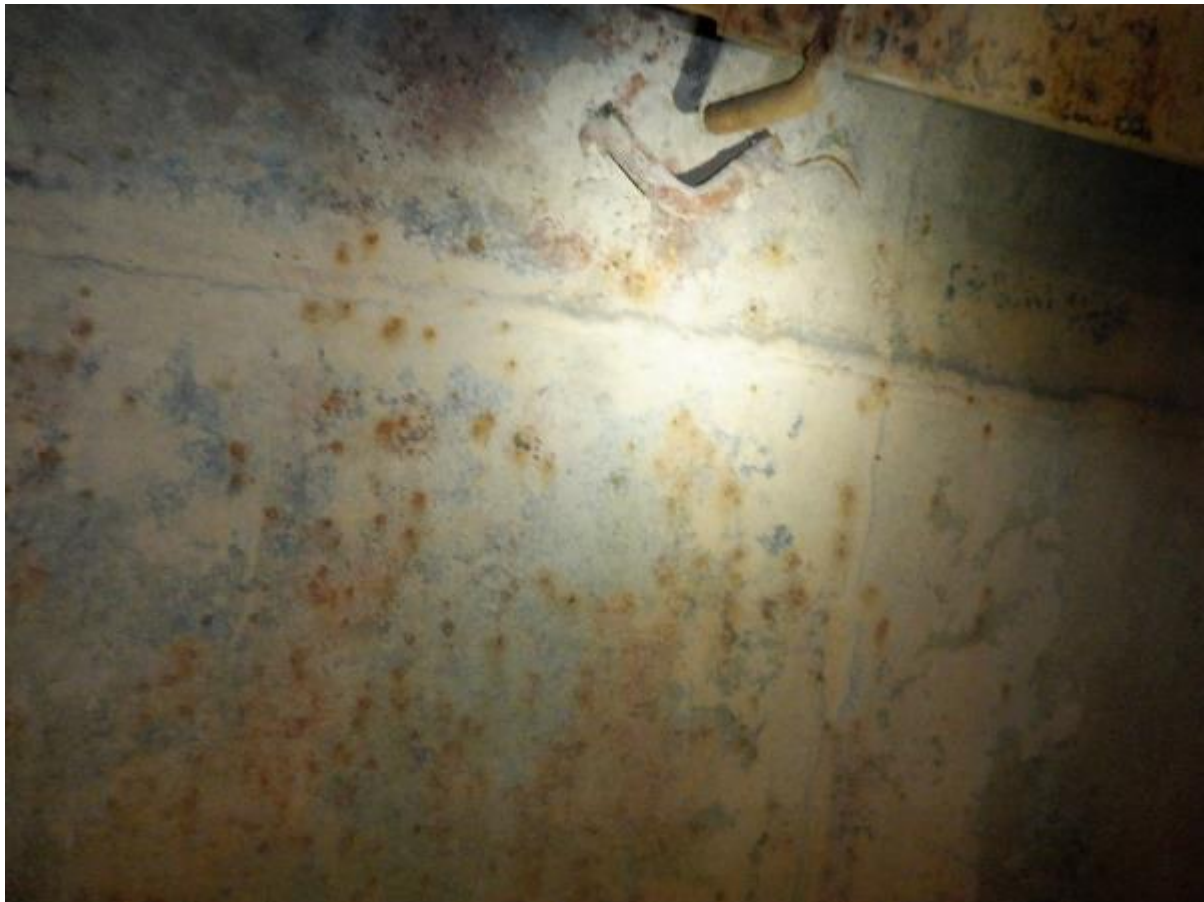
Date: 05/12/23	Inspected by: B&W ECC	Unit: 2	Item: BLTSHTOEC 4
Component Inspected: Bottom Economizer			
Condition Assessment: The 6 th retaining clip for the inner deflector shield from the front on the left side.			
Recommendations: Replace the clip			
Criticality: P3			
Risk if NOT Performed: Nothing of consequence.			
EKPC Comments:			
Photos:

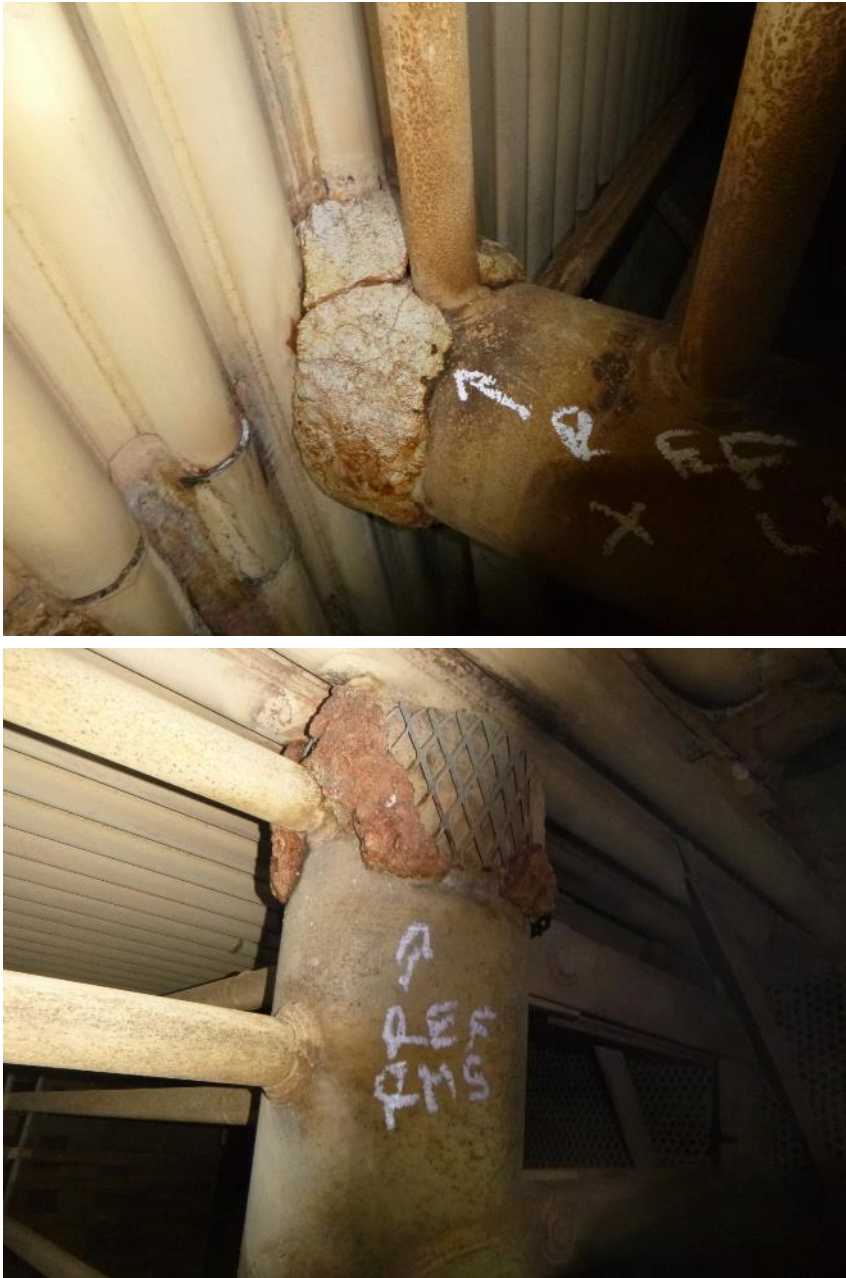
Date: 5/12/2023	Inspected by: B&W RJP	Unit: 2	Item: BLTSHTOC 1
Component Inspected: Bottom of LTSH & Top of Economizer (Front Crawl)			
Condition Assessment: The front crawl had broken or completely fallen off refractory on the left and right ends of the header.			
Recommendations: Replace refractory.			
Criticality: P3			
Risk if NOT Performed: Erosion will occur because there is no protective barrier to protect the header.			
EKP Comments:			
Photos:

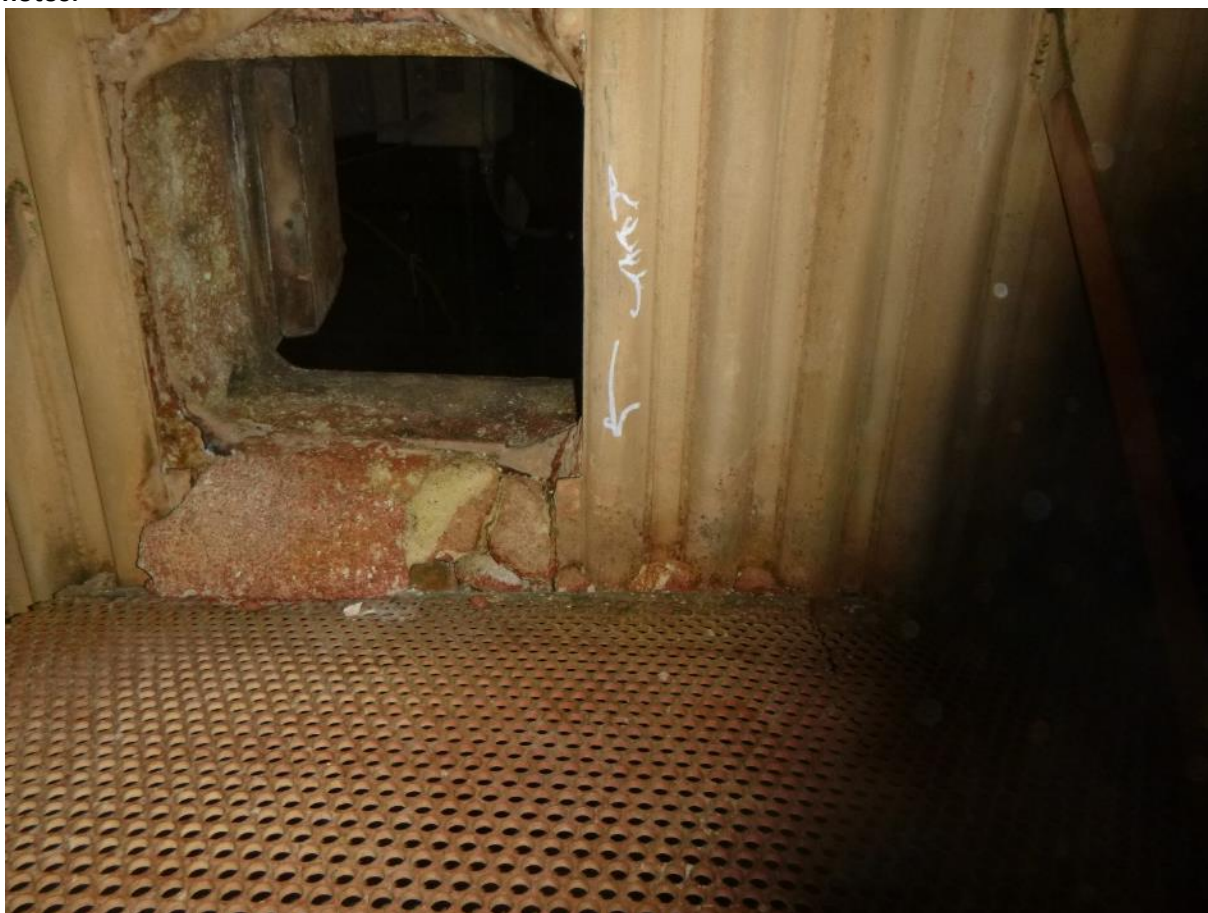
Date: 5/12/2023	Inspected by: B&W RJP	Unit: 2	Item: BLTSHTOC 2
Component Inspected: Bottom of LTSH & Top of Economizer (Rear Crawl)			
Condition Assessment: There were missing sections of refractory below the rear crawl access doors on the left and right side.			
Recommendations: Apply refractory to make a good seal on the casing to limit fly ash erosion on the convection pass.			
Criticality: P3			
Risk if NOT Performed: Fly ash may bypass the refractory and result in erosion to side walls or tubes.			
EKP Comments:

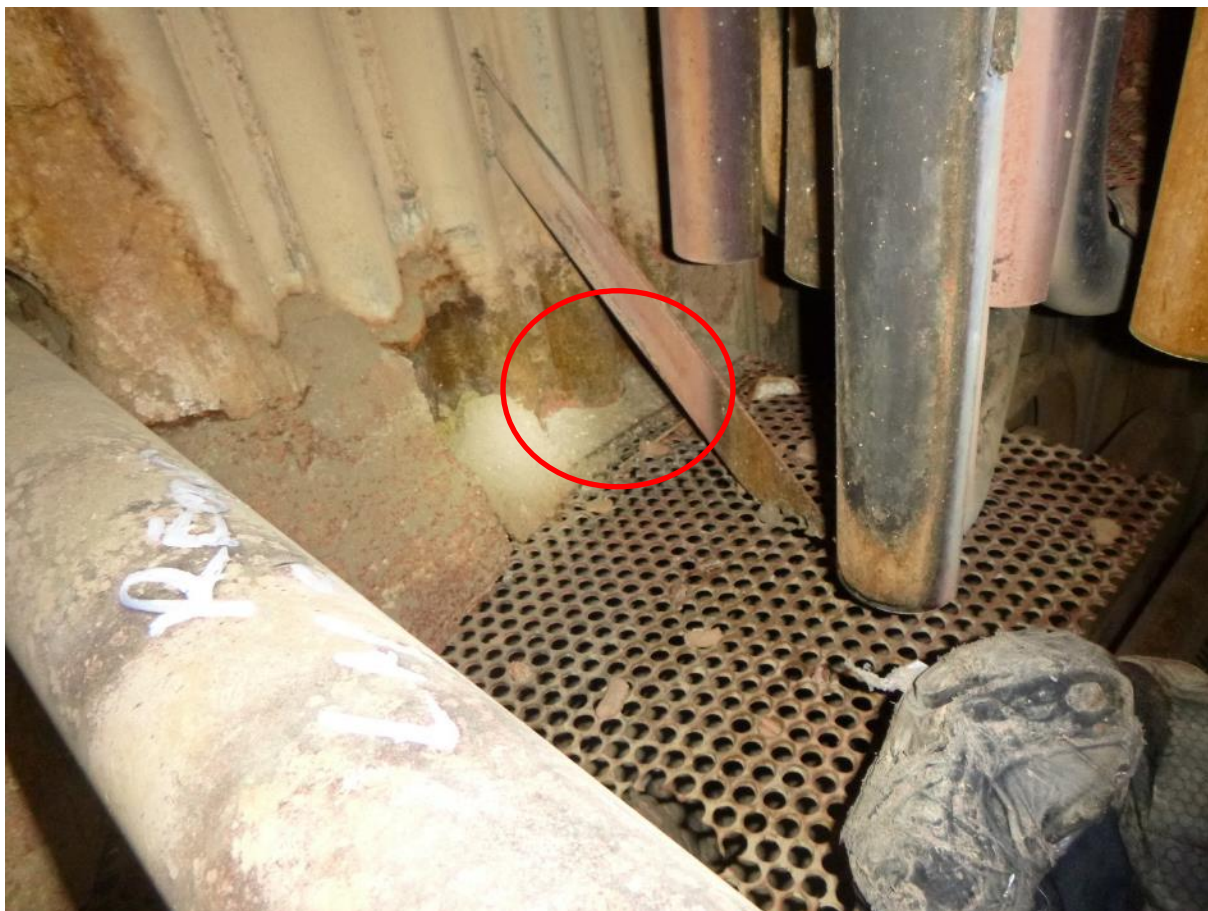
Date: 05/12/2023	Inspected by: B&W RJP	Unit: 2	Item: BLTSHTOC 3
Component Inspected: Bottom of LTSH & Top of Economizer (Rear Crawl)			
Condition Assessment: Damaged refractory was found on the left-hand side wall below sootblower 29 as well as a separated support.			
Recommendations: Replace refractory.			
Criticality: P3			
Risk if NOT Performed: The perforated plate will not be able to properly protective the side walls.			
EKP Comments:

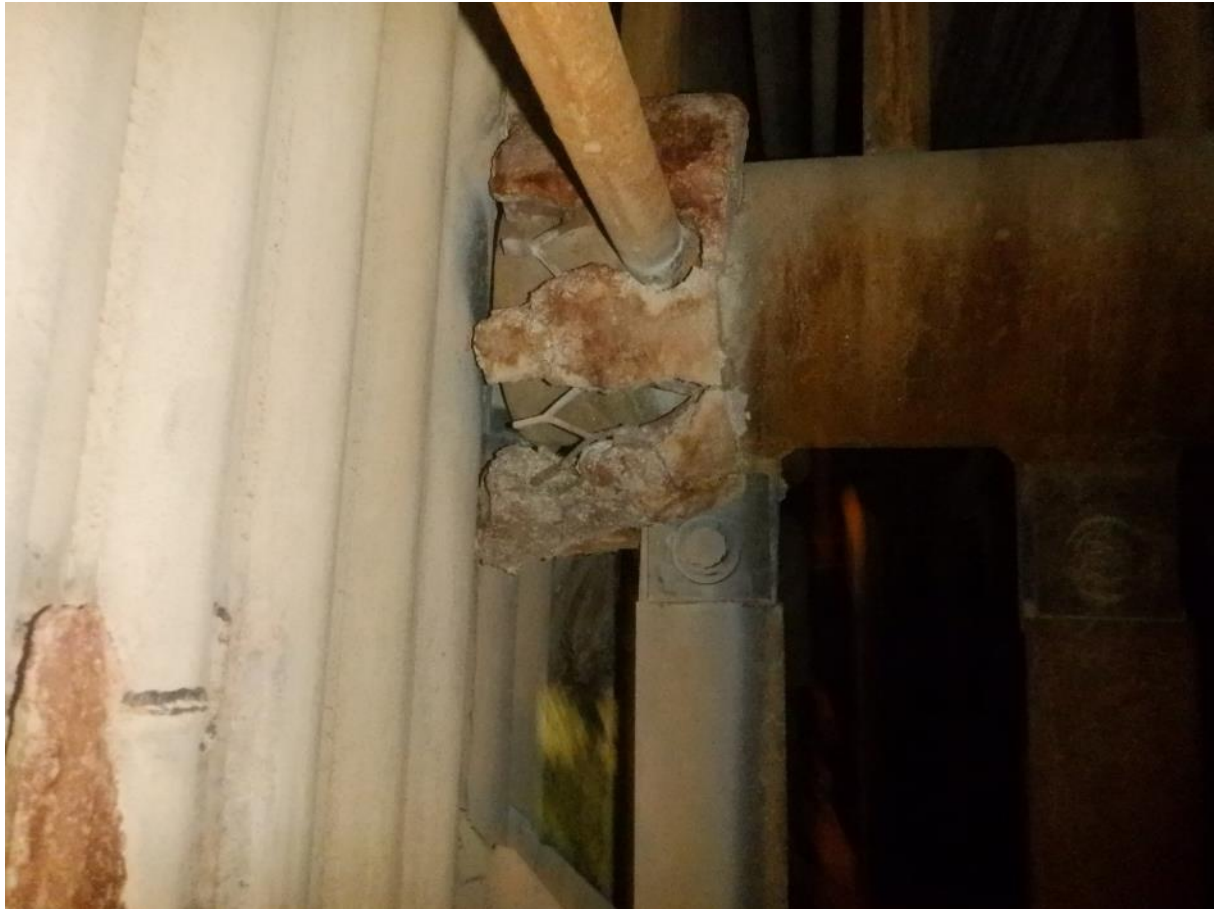
Date: 05/12/2023	Inspected by: B&W RJP	Unit: 2	Item: BLTSHTOC 4
Component Inspected: Bottom of LTSH & Top of Economizer (Middle Crawl)			
Condition Assessment: The middle crawl was missing refractory on the right-hand end of the header.			
Recommendations: Replace refractory.			
Criticality: P3			
Risk if NOT Performed: Erosion to the header may occur due to there being no protective barrier.			
EKP Comments:

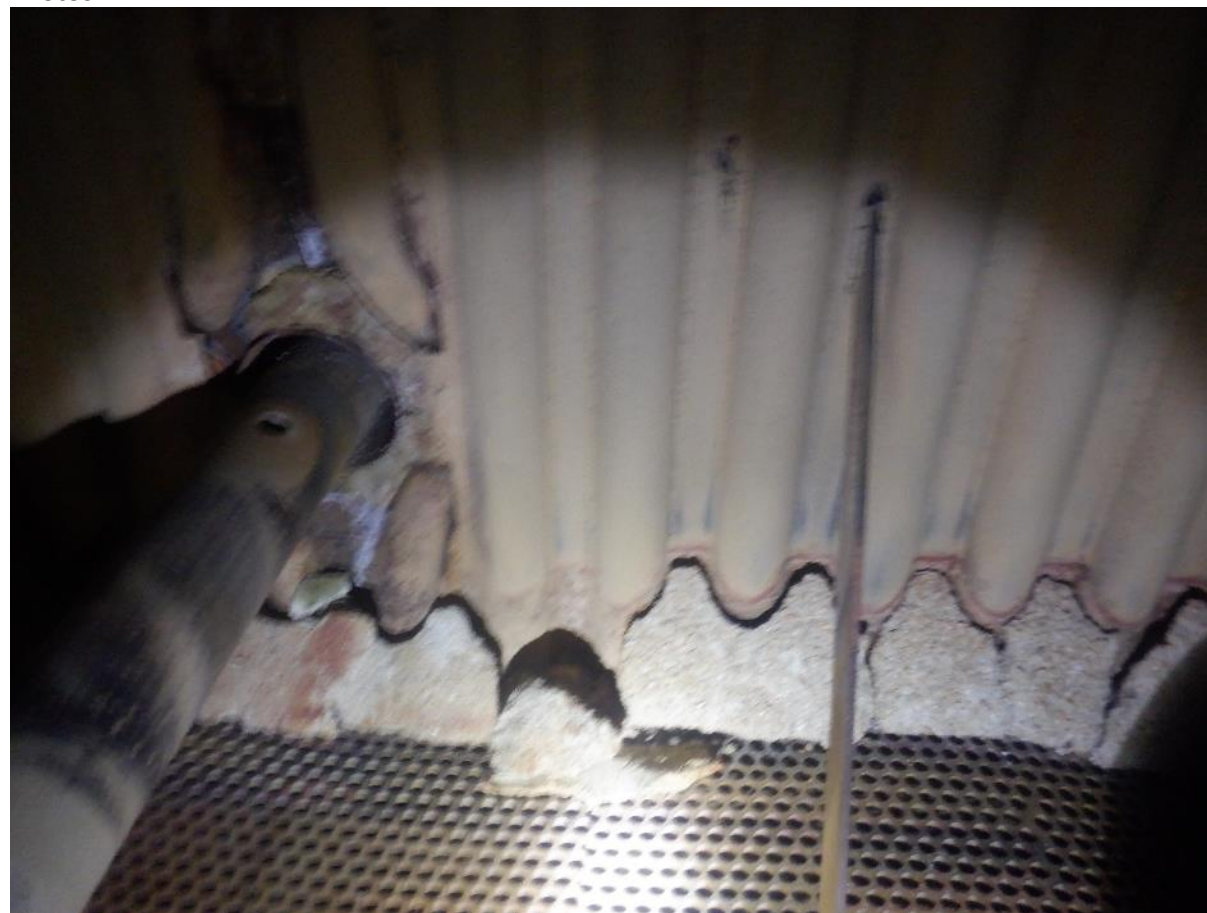
Date: 5/12/2023	Inspected by: B&W - CSH	Unit: 2	Item: BLTSHTOEC 5
Component Inspected: Bottom of LTSH & Top of Economizer			
Condition Assessment: Center & Rear Crawls – The refractory along the rear wall, LHSW and RHSW was loose and falling away from the walls.			
Recommendations: Remove and replace the refractory.			
Criticality: P3			
Risk if NOT Performed: Flyash can channel down rear wall causing erosion on the steam cooled wall tubes.			
EKP Comments:

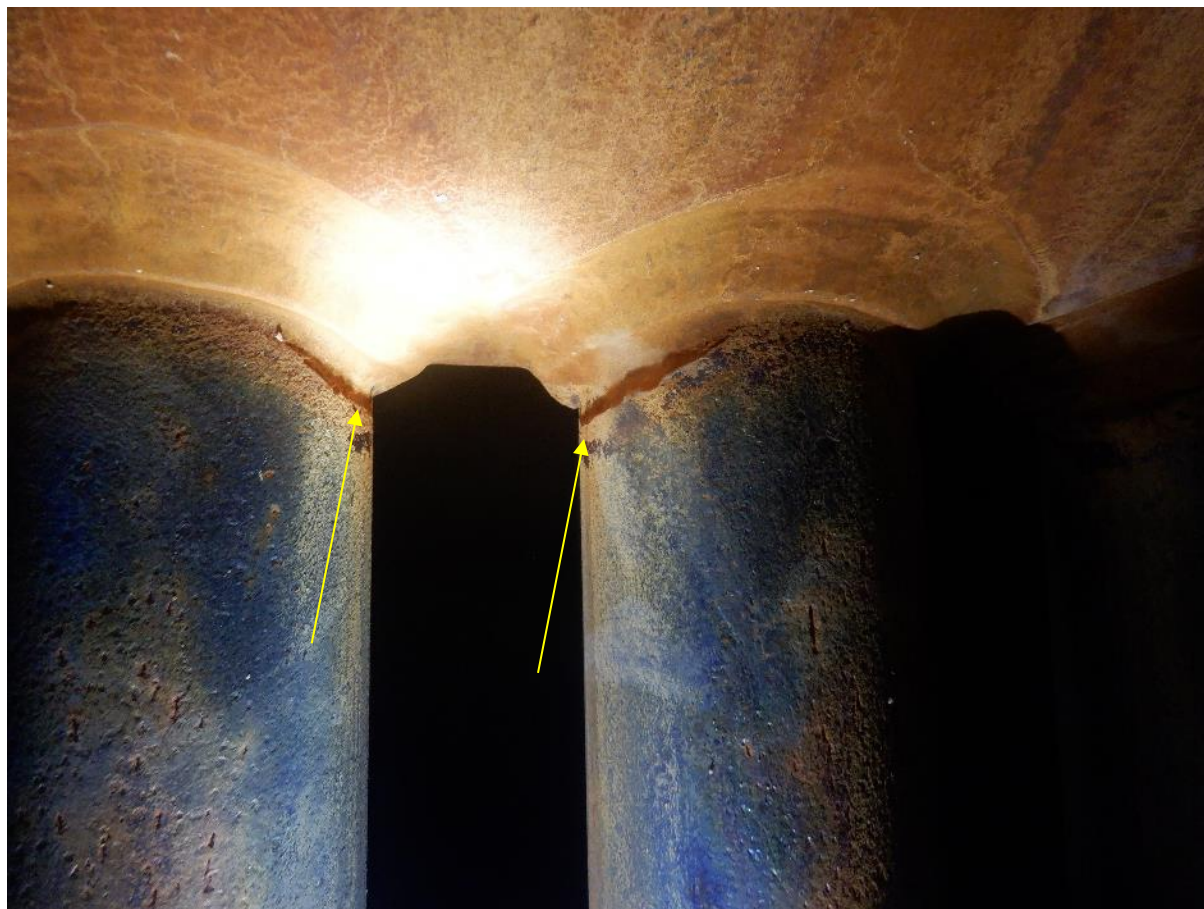
Date: 5/12/2023	Inspected by: B&W - CSH	Unit: 2	Item: BLTSHTOEC 6
Component Inspected: Top of the economizer.			
Condition Assessment: IK 29/30 Lane: There was minor to moderate sootblower erosion on the rear horizontal superheater inlet header nipples: 52 – 58, just below the weld to the header.			
Recommendations: Continue to monitor, if time allows install a shield or padweld. Inlet nipples are 2.50" OD s .300" MW, SA210-A1.			
Criticality: P3			
Risk if NOT Performed: Worse erosion to the header nipples.			
EKPC Comments:

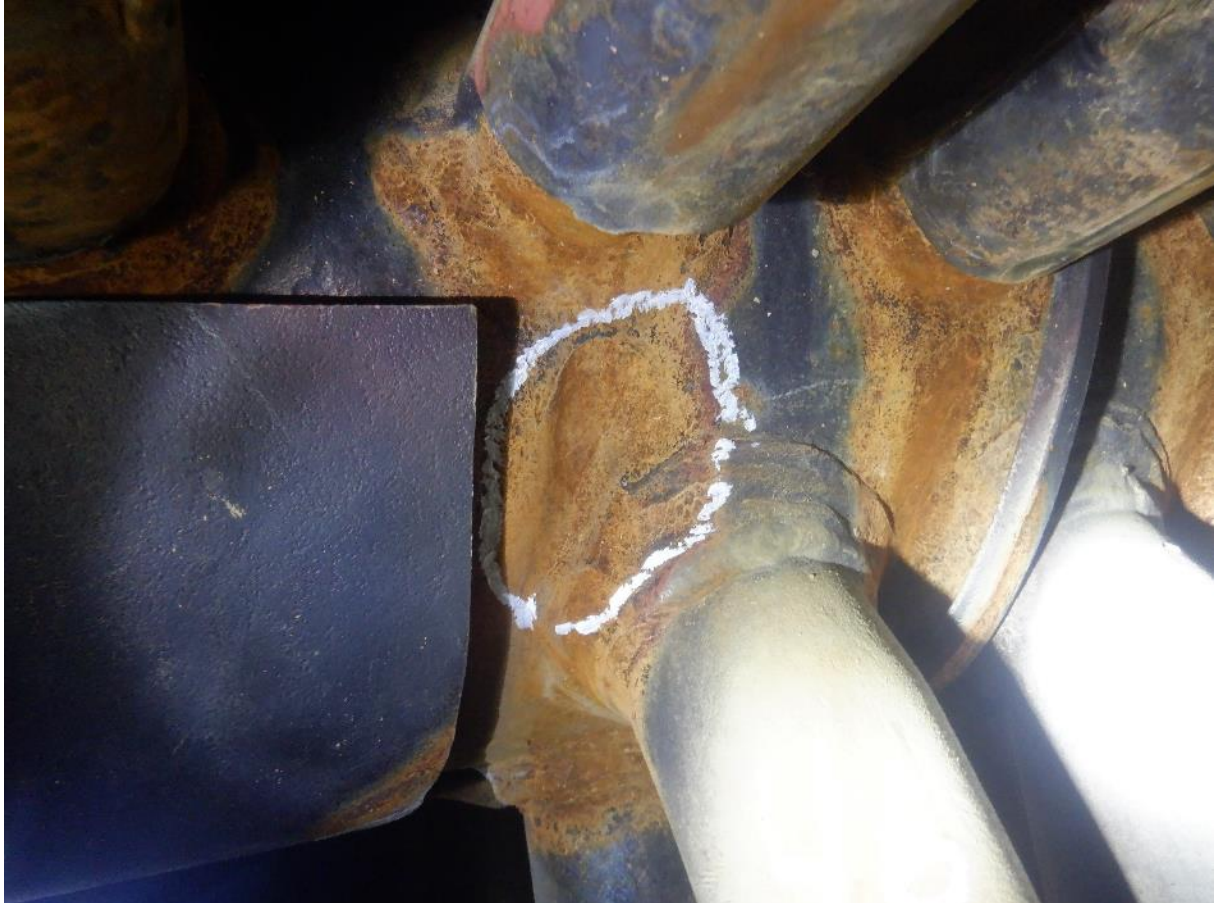
Date: 5/12/2023	Inspected by: B&W - CSH	Unit: 2	Item: BLTSHTOEC 7
Component Inspected: Top of the economizer.			
Condition Assessment: IK 29/30 Lane: There was a hole in the rear horizontal superheater inlet header shield, above the RHS access opening. There was minor erosion on the header at the LHS access opening.			
Recommendations: Patch the area with new metal. The header is 10.75" OD and the damaged area is about 2.5" wide and 6" long at the RHS and about 3" x 3" on the LHS access.			
Criticality: P3			
Risk if NOT Performed: Erosion to the header.			
EKPC Comments:			
Photos:

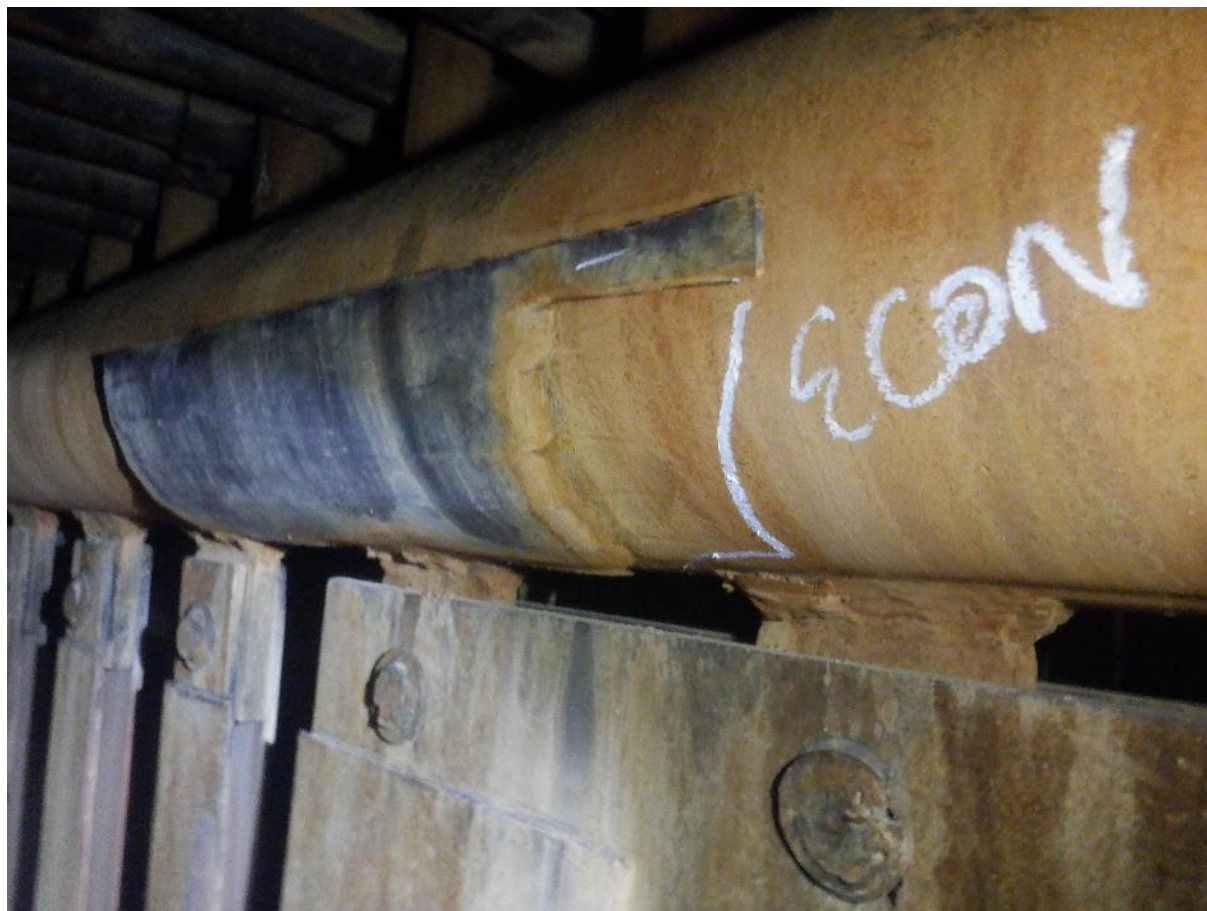
Date: 5/12/2023	Inspected by: B&W - CSH	Unit: 2	Item: BLTSHTOEC 9
Component Inspected: Top of the economizer.			
Condition Assessment: IK 30 Lane: There was minor erosion to the rear economizer intermediate header at the end of a damaged shield.			
Recommendations: Replace the economizer header shield or extend the existing by about 12". Economizer intermediate headers are 8.625" OD.			
Criticality: P3			
Risk if NOT Performed: Erosion to the unprotected header.			
EKPC Comments:

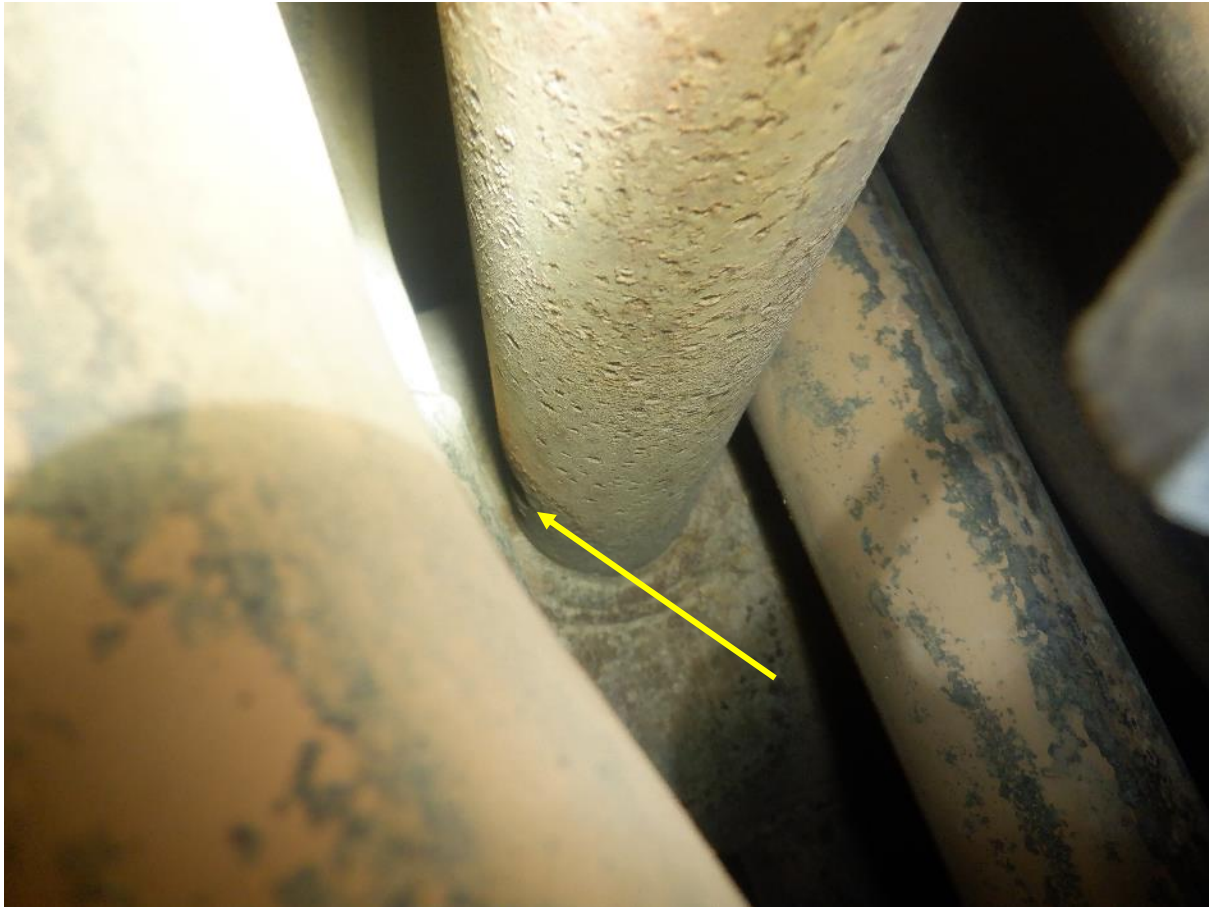
Date: 5/12/2023	Inspected by: B&W - CSH	Unit: 2	Item: BLTSHTOEC 10
Component Inspected: Top of the economizer.			
Condition Assessment: Rear Crawl: There was minor erosion to the 2 nd from the RHSW, rear economizer header nipple.			
Recommendations: Install a 6" long shield. Economizer header nipples are 1.75" OD.			
Criticality: P3			
Risk if NOT Performed: Erosion could further damage the tube.			
EKPC Comments:			
Photos:

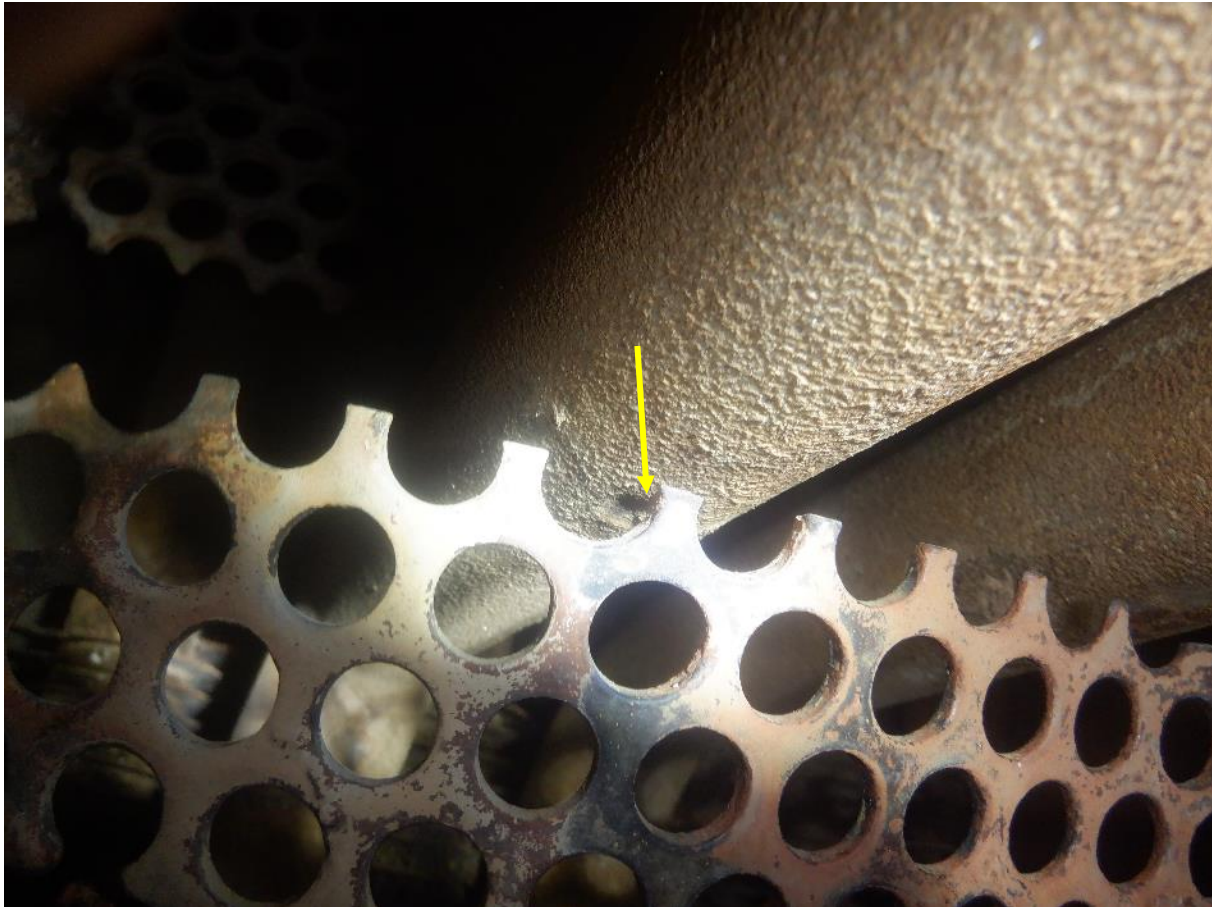
Date: 5/12/2023	Inspected by: B&W - CSH	Unit: 2	Item: BLTSHTOEC 11
Component Inspected: Top of the economizer.			
Condition Assessment: Center Crawl: There was minor erosion the vertical economizer tubes, just above the bend from the perforated baffle rubbing the tubes of assemblies 1 & 2.			
Recommendations: Cut the perforated plate about 1" away from the neighboring tubes.			
Criticality: P3			
Risk if NOT Performed: Erosion could further damage the tube.			
EKPC Comments:			
Photos:

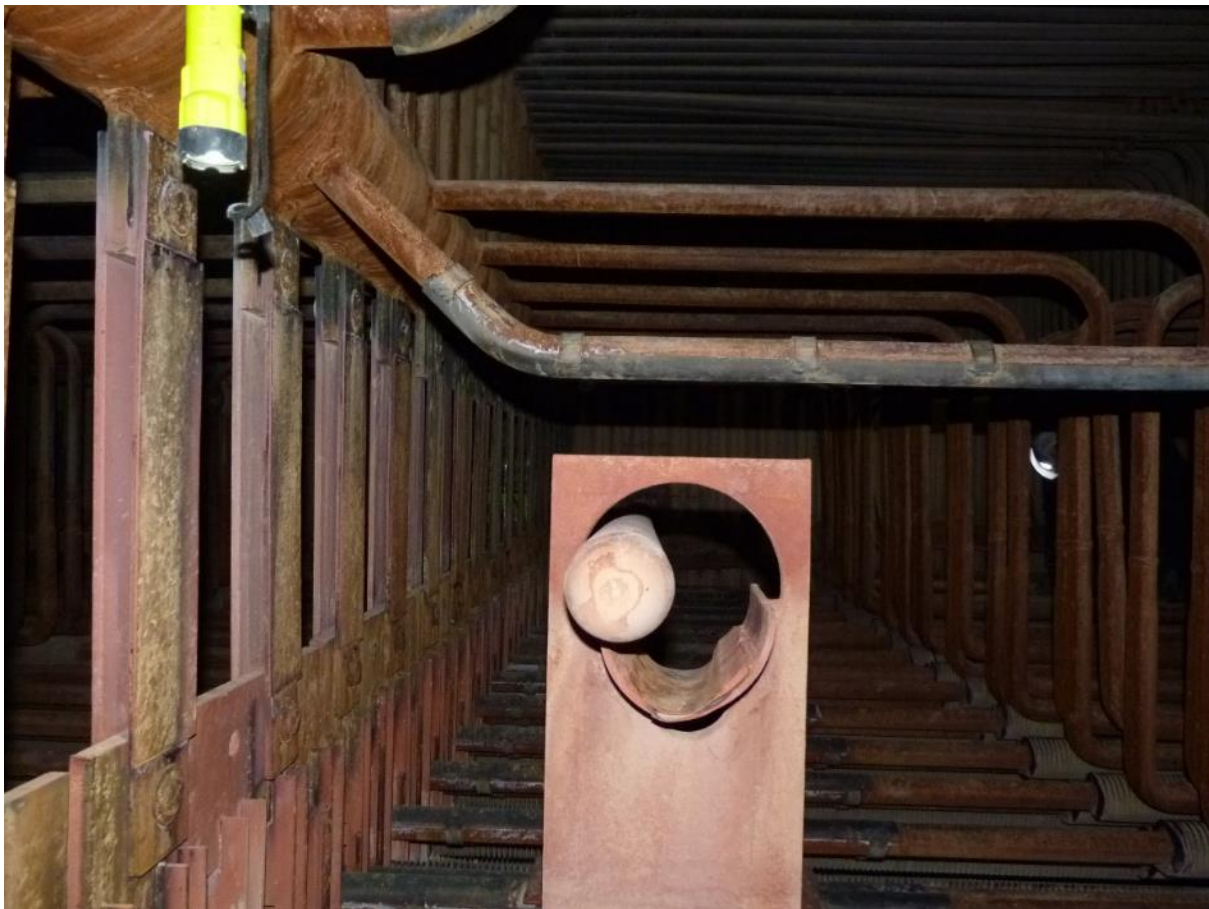
Date: 05/12/2023	Inspected by: B&W -BC	Unit: 2	Item: BLTSHTOC 12
Component Inspected: Top of Economizer			
Condition Assessment: Center Crawl: Soot blower/ IK 27 cradle is out of alignment.			
Recommendations: Realign soot blower cradle			
Criticality: P3			
Risk if NOT Performed: Shortening of soot blower life due to unnecessary wear.			
EKPC Comments:			
Photos:

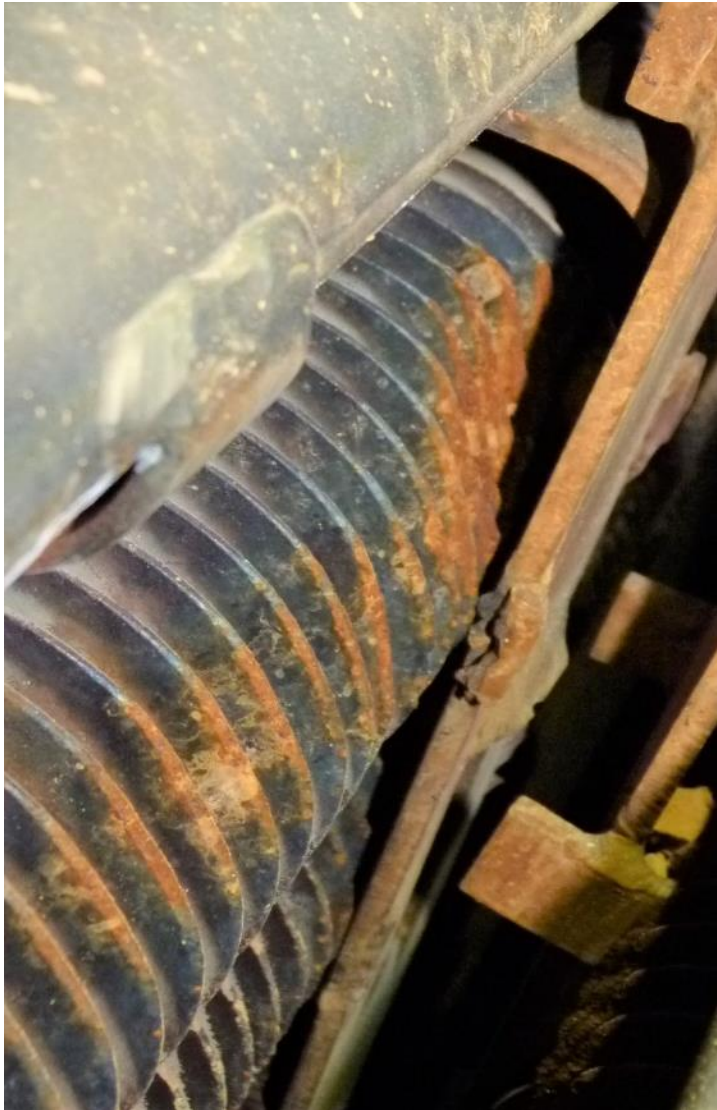
Date: 05/12/2023	Inspected by: B&W - BC	Unit: 2	Item: BLTSHTOC 13
Component Inspected: Top of the Economizer			
Condition Assessment: Center Crawl: Minor sootblower erosion was found in on the fins where ladder bars connect to the outlet headers			
Recommendations: Monitor in future outages to prevent economizer tube failure.			
Criticality: P3			
Risk if NOT Performed: Tube leak in the economizer			
EKPC Comments:			
Photos:

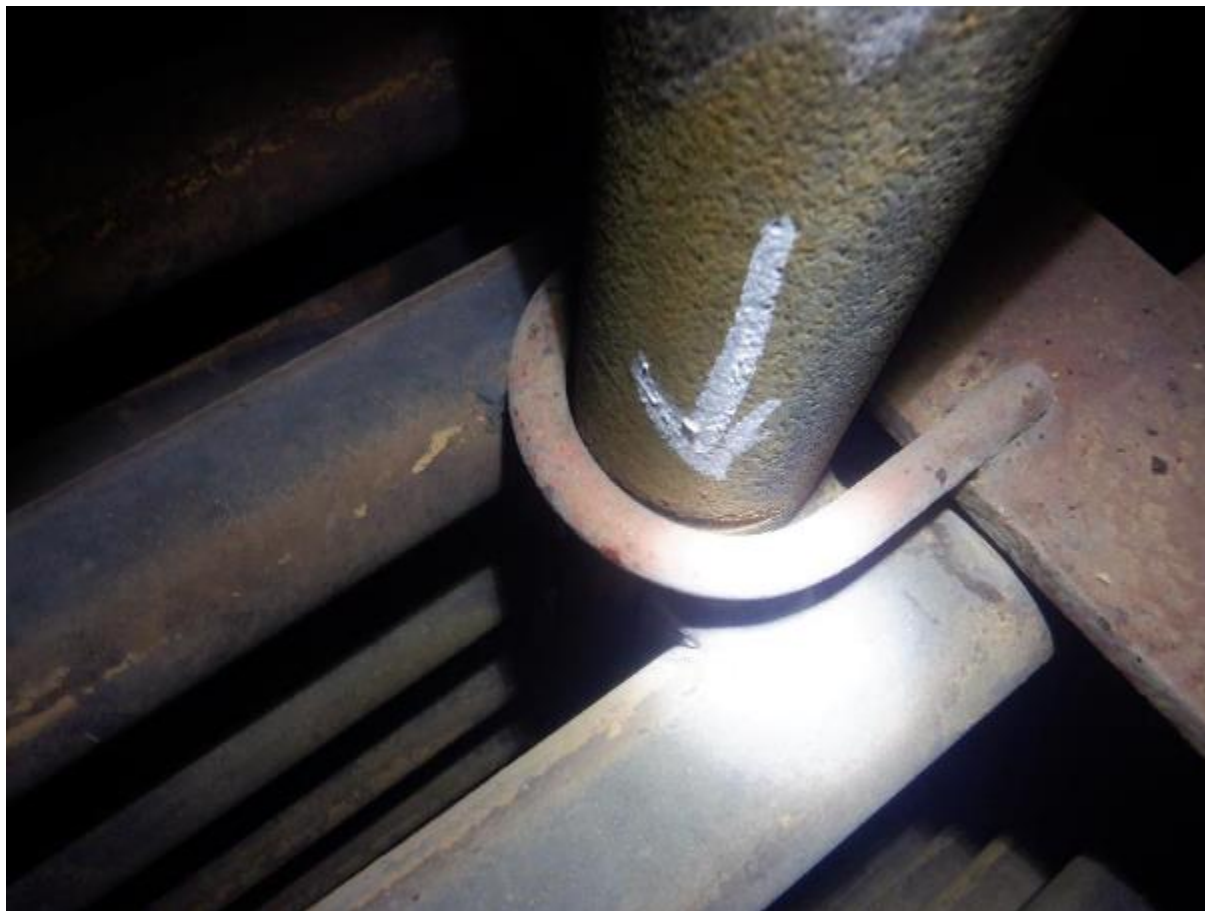
Date: 5/12/2023	Inspected by: B&W -CSH	Unit: 2	Item: TOPLTSH 1
Component Inspected: Top of LTSH Front Crawl			
Condition Assessment: There was minor-erosion on the front economizer stringer tubes at the alignment bar U straps at rows: 45 & 67			
Recommendations: Continue to monitor. If time allows - Cut off U strap, install a 4" long shield on aforementioned tubes and install a new U strap. Tube Material: SA210-A1, 2.00" OD, .220" MW			
Criticality: P3			
Risk if NOT Performed: Erosion could worsen causing a tube leak.			
EKP Comments:
