The Babcock & Wilcox Company

**Eastern Kentucky Power Cooperative
Spurlock Station, Unit #2**

U2 SPRING 2023 OUTAGE BOILER INSPECTION REPORT

B&W Project No.: BA9312817

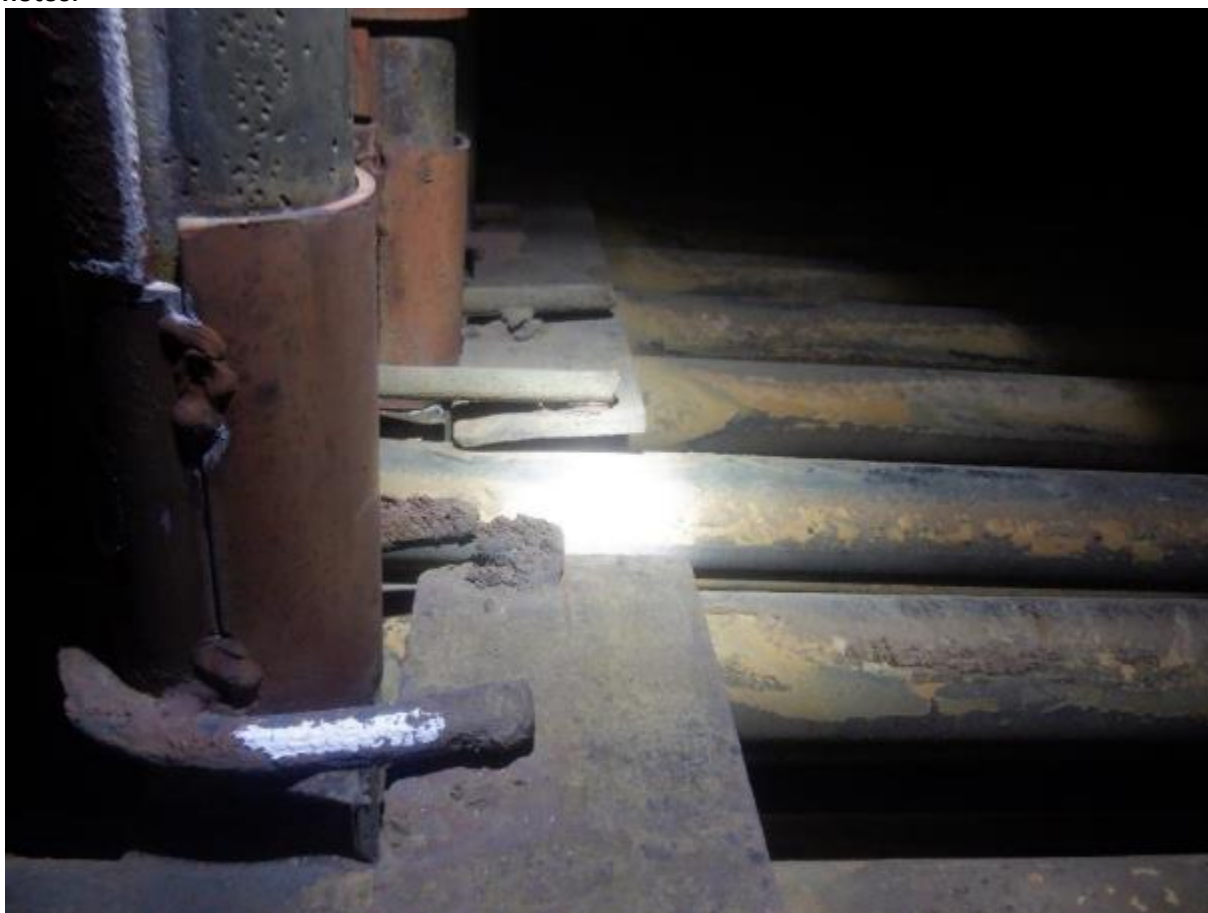
Date: 5/12/2023	Inspected by: B&W -CSH	Unit: 2	Item: TOPLTSH 2
Component Inspected: Top of LTSH Front Crawl			
Condition Assessment: The u strap was broken from the side to side alignment bar at front economizer support tube 65.			
Recommendations: Set the LTSH spacing at 4" on centers and re-weld the u strap to the alignment bar.			
Criticality: P3			
Risk if NOT Performed: Could allow the LTSH to become misaligned/have the incorrect side to side spacing.			
EKP Comments:

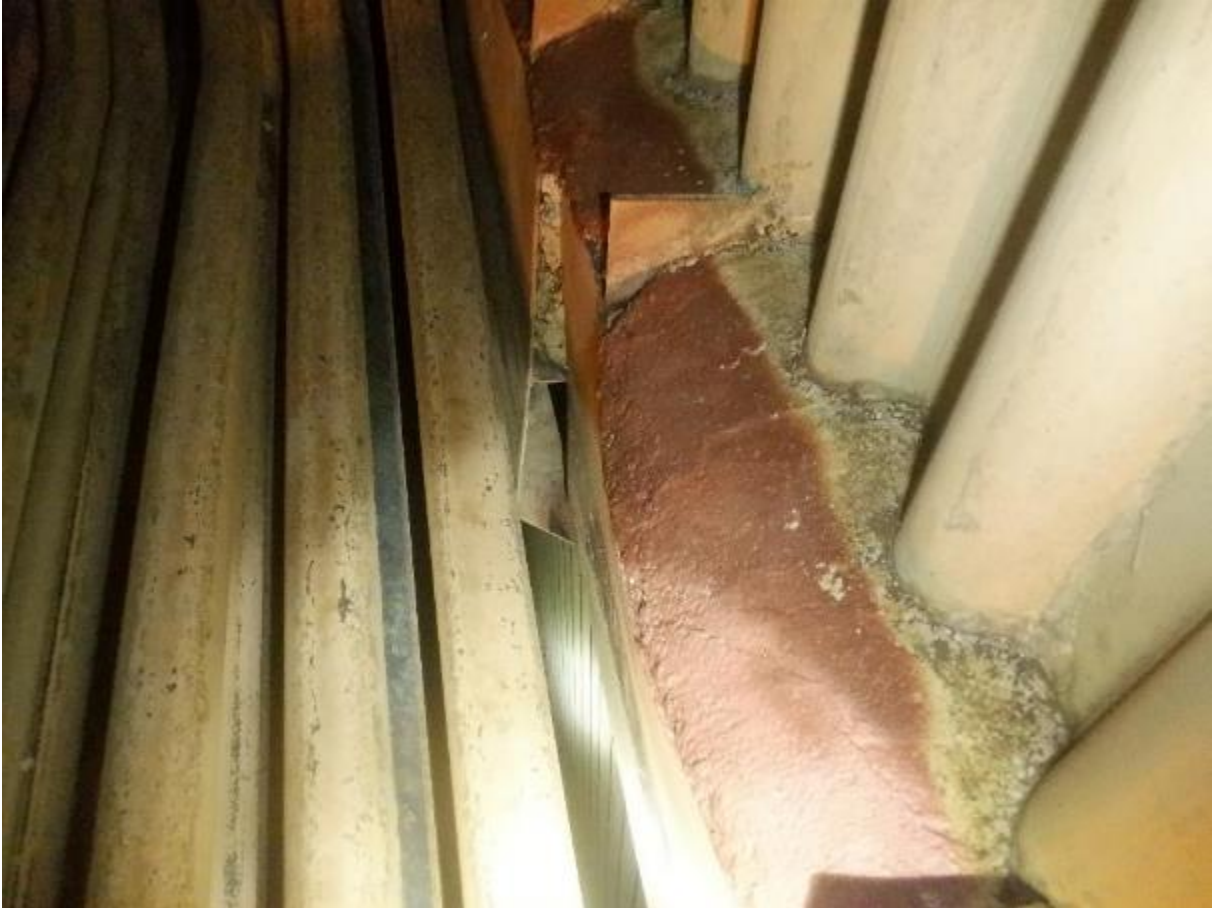
Date: 5/12/2023	Inspected by: B&W -CSH	Unit: 2	Item: TOPLTSH 3
Component Inspected: Top of LTSH (Center Crawl)			
Condition Assessment: The front most diverter plate was pulling away from the LHSW at the bottom.			
Recommendations: Remove the existing refractory and fasten the bottom of the diverter plate to the LHSW and pack with refractory.			
Criticality: P3			
Risk if NOT Performed: Flyash could channel through the tighter opening and cause erosion on the LTSH.			
EKP Comments:			
Photos:

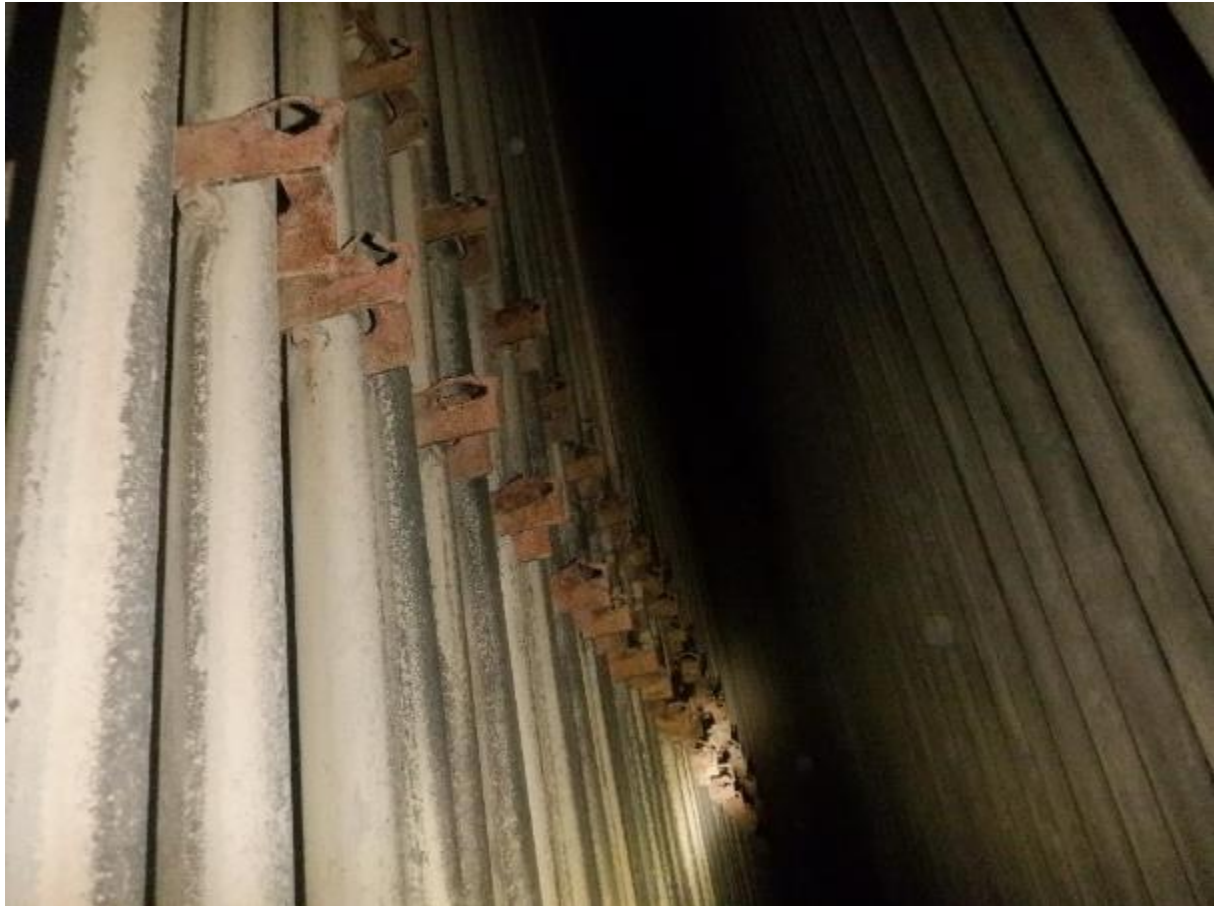
Date: 5/12/2023	Inspected by: B&W - CSH	Unit: 2	Item: RPENDSH 1
Component Inspected: Rear Pendant Superheater (LTSH)			
Condition Assessment: The front to rear alignment bars at the front of the LTSH, from the boiler center line to the RHSW were damaged throughout but were holding the tubes in place.			
Recommendations: Continue to monitor and prepare to have failed bars to replace in future outages.			
Criticality: P3			
Risk if NOT Performed: Tube alignment issues.			
EKP Comments:

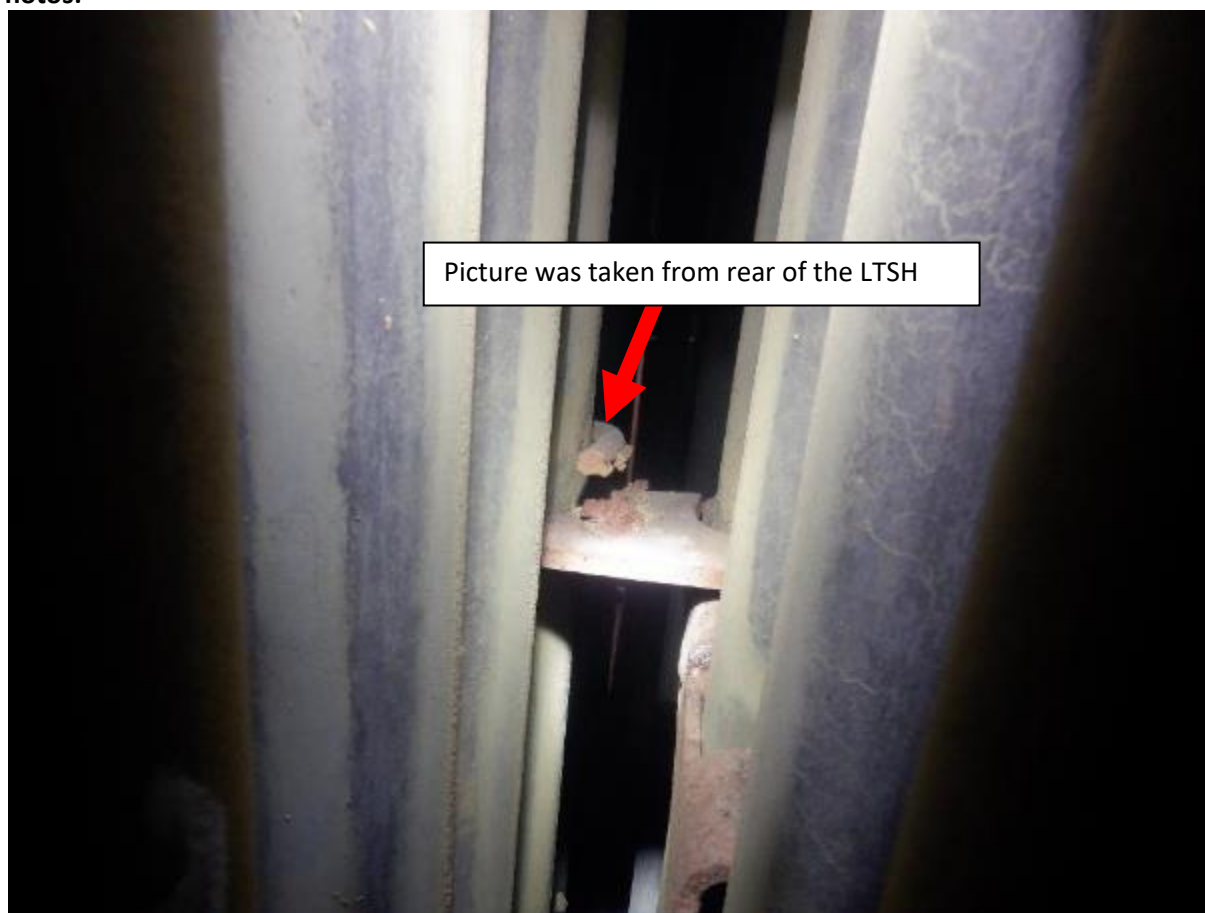
Date: 5/12/2023	Inspected by: B&W - CSH	Unit: 2	Item: RPENDSH 2
Component Inspected: Rear Pendant Superheater (LTSH)			
Condition Assessment: There were failed welds at the U strap to the alignment bar at the front of the LTSH assemblies: 73, 133, 142, 154 & 157.			
Recommendations: Install new U straps.			
Criticality: P3			
Risk if NOT Performed: If the alignment bars get loose by missing U straps, they could fall out of place and allow misalignment.			
EKP Comments:

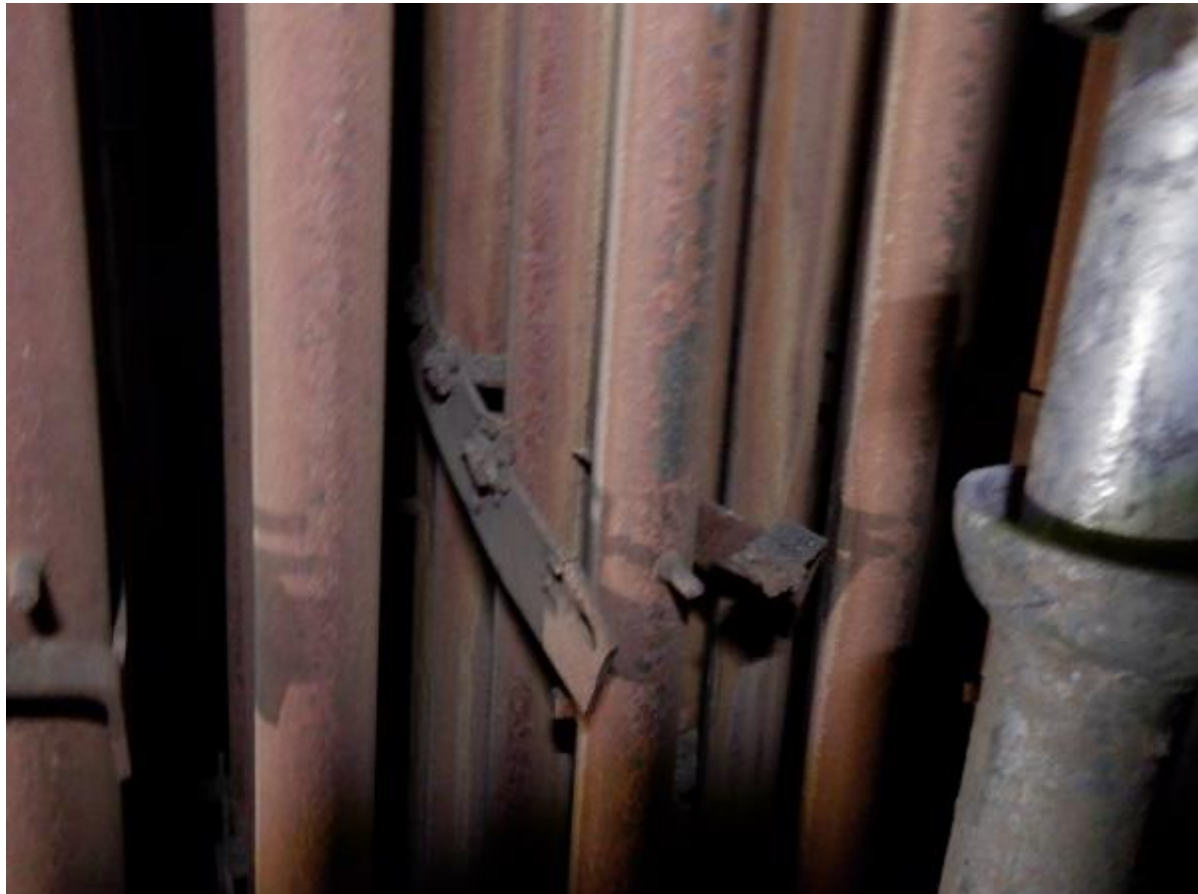
Date: 05/11/23	Inspected by: B&W	Unit: 2	Item: HTSHFSCW 1
Component Inspected: HTSH (Standing in loops)			
Condition Assessment:			
<p>Rear side of HTSH- The following alignment bars were broken at the front: Assemblies found warped and allowing the bar to slip over the support stud on the pendant: 32, 41, 45, 55, 61, 63, 65, 67, 68, 70, 73, 81, 86, 87, 91, 93, 97, 100, 101, 102, 103, 106, 122, 128, 129, 131, 133, 138, 139</p>			
<p>Front side of HTSH- Broken alignment bars were found at the front at the bottom elevation of assemblies 16, 30, 31, 34, 124,, 132, 140. At the second elevation of assemblies: 10, 16, 18, 24, 28, 30, 32, 42, 47, 50, 54, 58, 59, 64, 78, 80, 82, 84, 88, 98, 100, 104, 106, 108, 110, 112, 114, 118, 120, 128, 130, 135, 136, and 138.</p>			
Recommendations: Remove the damaged alignment bars and replace to correct position.			
Criticality: P3			
Risk if NOT Performed: Broken alignment bars could allow the HTSH tubes to shift.

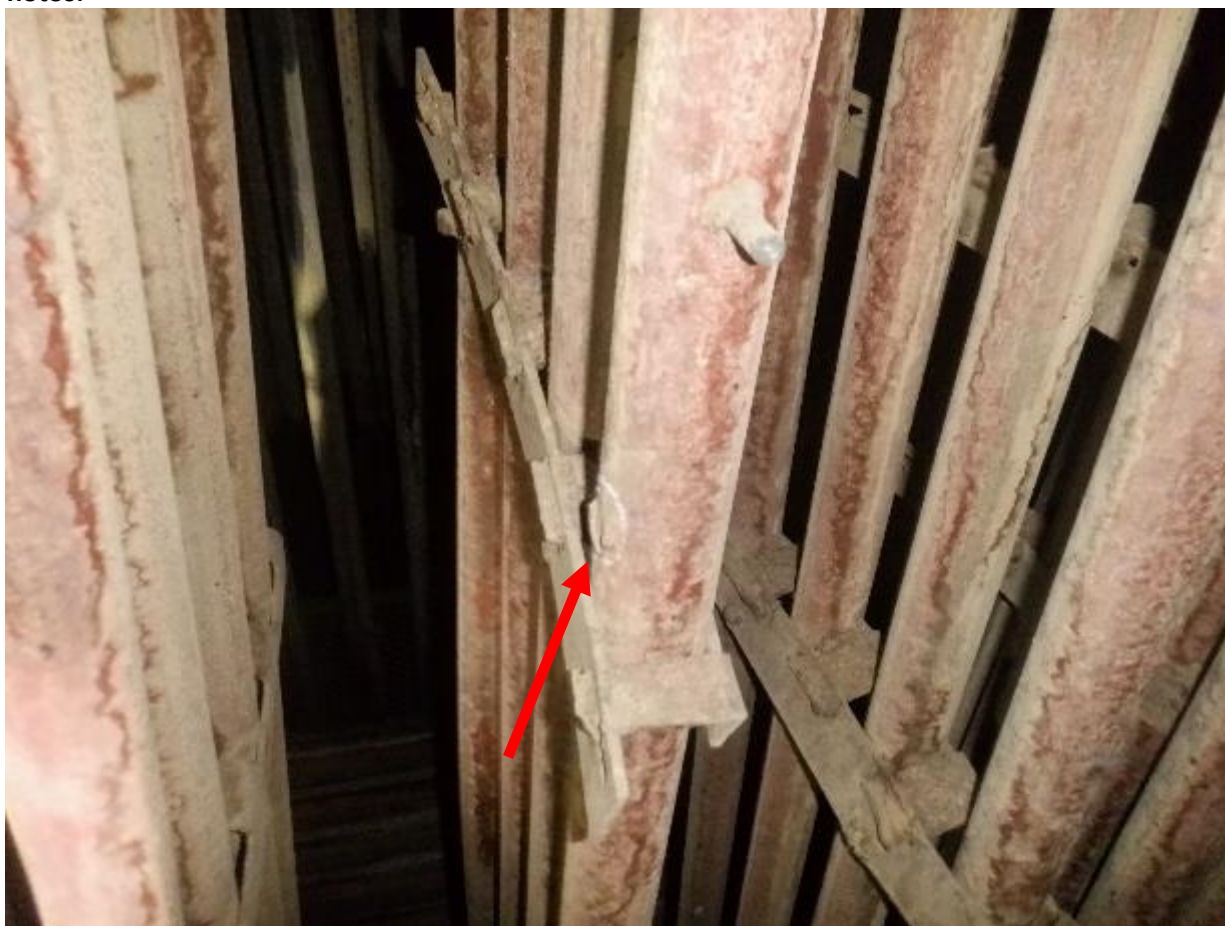
Date: 5/11/23	Inspected by: B&W ECC	Unit: 2	Item: HTSHFSCW 2
Component Inspected: HTSH (Standing in loops)			
Condition Assessment: Rear side of HTSH- The alignment bar support stud was missing on the leading edge of the rear loop of assembly 86, and 132.			
Recommendations: Put the alignment bar back into the correct position and weld a new support stud to the tube.			
Criticality: P3			
Risk if NOT Performed: The alignment bar could drop to the bends and chafe the tube. Misalignment could occur if the bar breaks.			
EKP Comments:

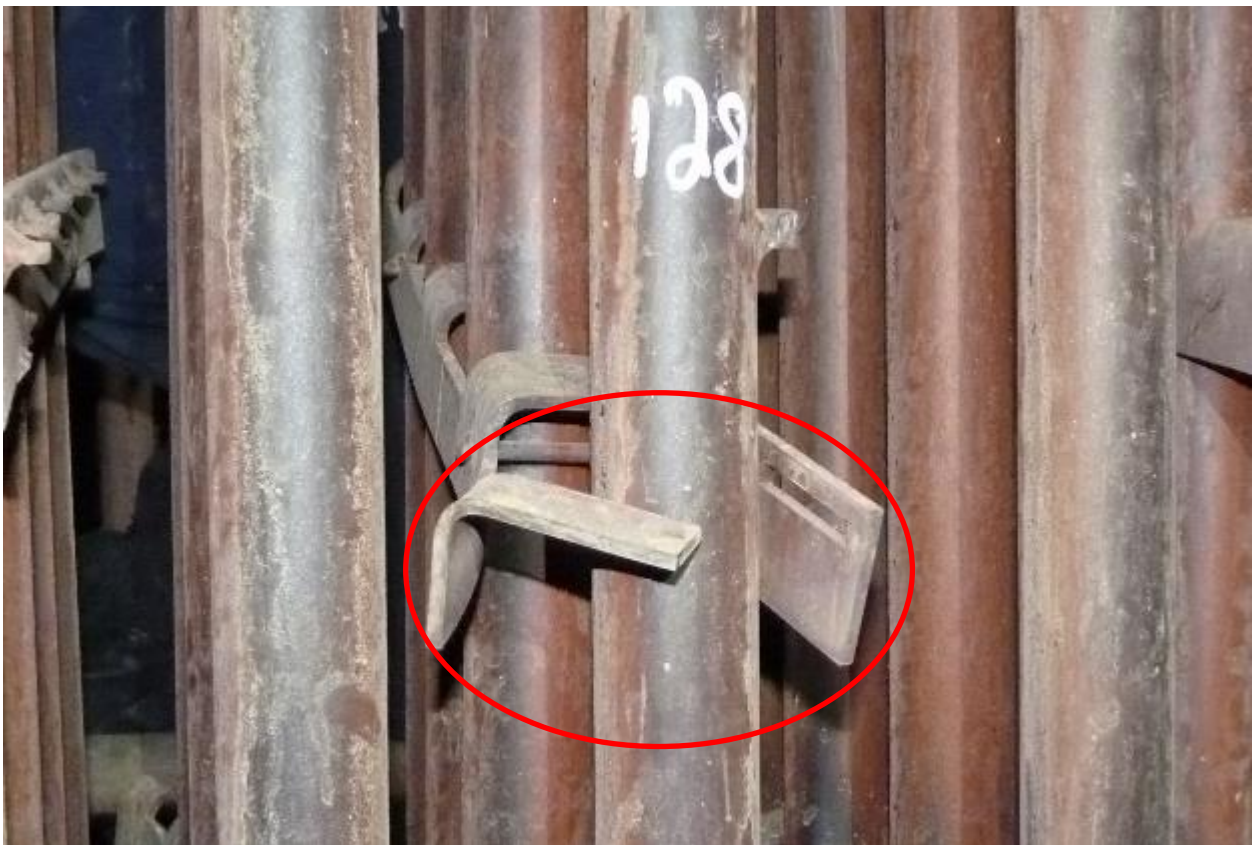
Date: 05/11/23	Inspected by: B&W ECC CSH	Unit: 2	Item: HTSHFSCW 3
Component Inspected: HTSH			
Condition Assessment: HTSH Front section-			
The HTSH tubes had broken alignment bars fallen from the second elevation of alignment bars: 8, 24, 30, 32, 50, 80, 82, 110 & 118.			
Recommendations: Remove fallen alignment bars and replace with new alignment bars for each pendant.			
Criticality: P3			
Risk if NOT Performed: Broken alignment bars could allow the HTSH tubes to become misaligned.			
EKP Comments:			
Photos:

Date: 05/11/2023	Inspected by: B&W BNC	Unit: 2	Item: HTSHFSCW 4
Component Inspected: HTSH & Front SCW Screen Tubes			
Condition Assessment: Rear of the HTSH – alignment bars where found to be in poor condition on elements: 86,100,120,128			
Recommendations: Replace the damaged alignment bars and install studs to prevent the bars from moving up the bank.			
Criticality: P3			
Risk if NOT Performed: Tubes and assemblies can become misaligned and experience a premature failure.			
EKP Comments:			
Photos:

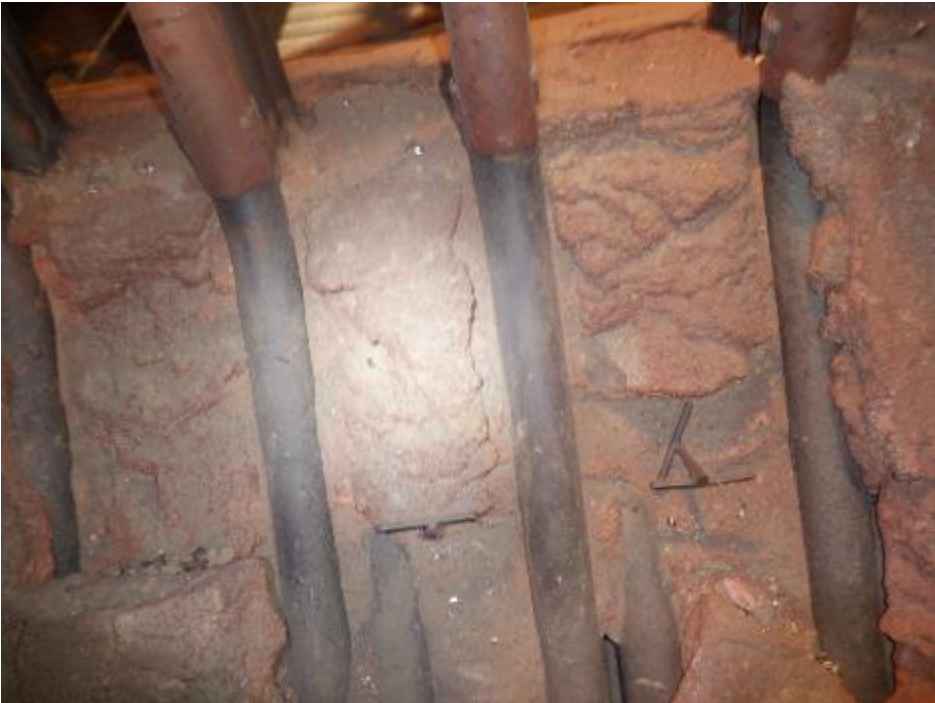
Date: 5/17/23	Inspected by: B&W ECC	Unit: 2	Item: RRHCORSCR 8
Component Inspected: WW Screen tubes			
Large sections of the refractory dam are missing at tube 60 and from tube 41 to 44.			
Recommendations: Replace the refractory. Install additional refractory ties to maintain the refractory.			
Criticality: P2			
Risk if NOT Performed: Tubes are subject to erosion and corrosion. Flue gas or tramp air can enter the space between the tubes and dead air space casing through the gaps between the tubes.			
EKP Comments:			
Photos:

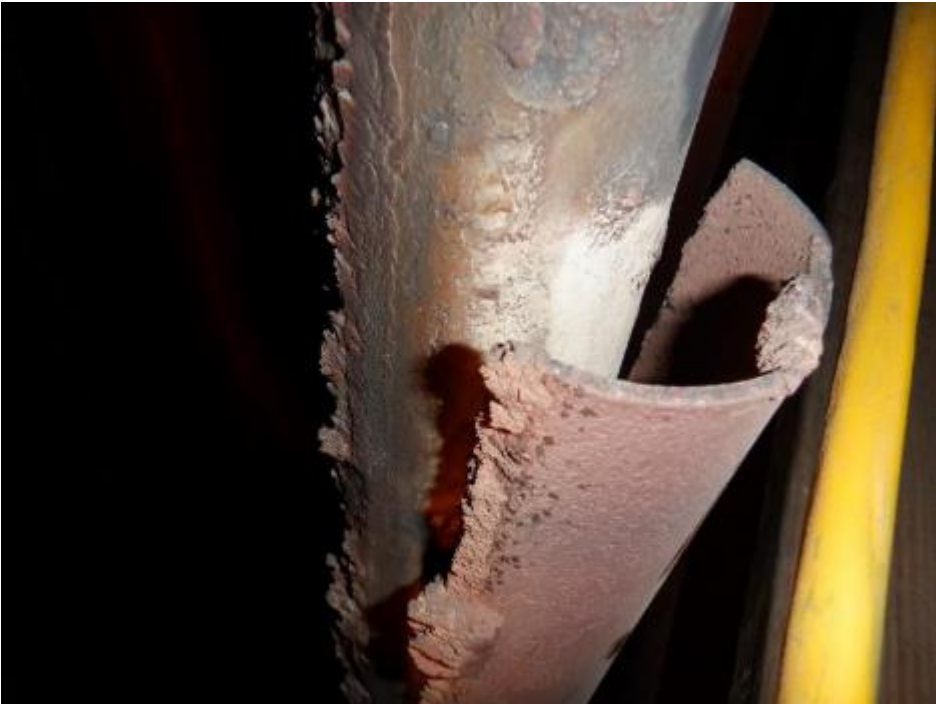
Date: 5/17/23	Inspected by: B&W ECC	Unit: 2	Item: RRHCORSCR 2
Component Inspected: Hanger Tubes			
Tube shield welds are broken on tubes: 1, 5, 8, 9, 10, 11, 12, 13, 14, 15, 16, 20, 22, 23, 24, 25, 26, 27, 29, 30, 31, 32, 40, 42, 43, 48, 50, 51, 55, 58, 57, 61, 26			
Recommendations: Replace the tube shield, tube OD is 2-3/8". At minimum pull the shield to the tube and weld.			
Criticality: P3			
Risk if NOT Performed: Eddies can form where the weld broke at the top of the shield pulled away from the tube which could cause accelerated corrosion. Gaps caused by mid-shield broken welds expose the tube to damage.			
EKP Comments:			
Photos:

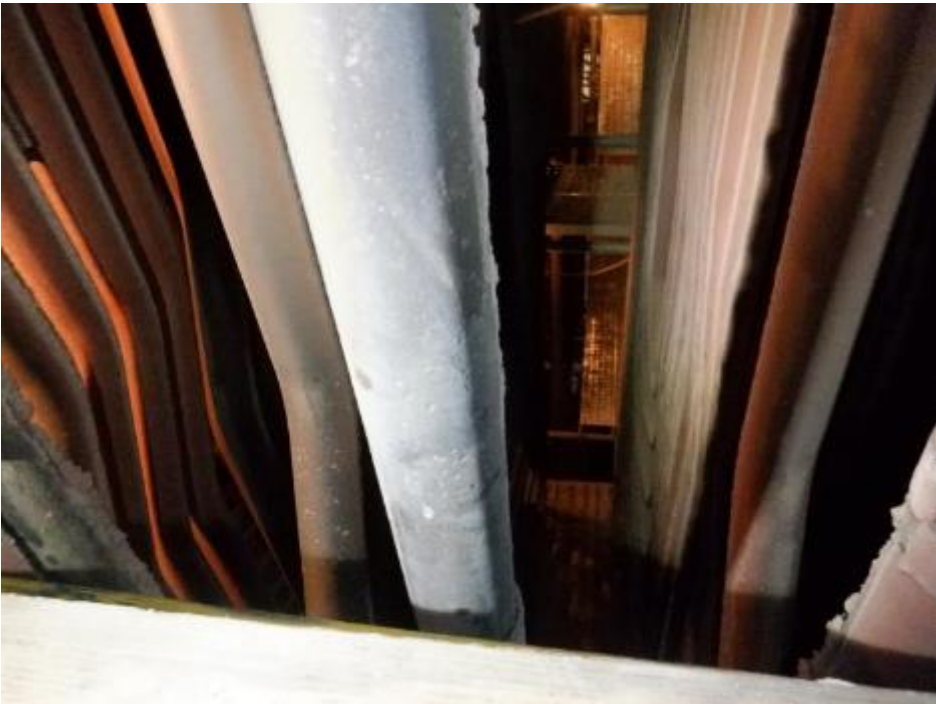
Date: 5/17/23	Inspected by: B&W ECC	Unit: 2	Item: RRHCORSCR 3
Component Inspected: Hanger Tubes			
Tube portion or the full shield is missing on tubes: 34, 35, 43, 46, 52, 53, 54, 60, 63, 65, 66			
Recommendations: Install new tube shields. Tube OD is 2-3/8"			
Criticality: P2			
Risk if NOT Performed: Tubes are subject to erosion and corrosion.			
EKP Comments:			
Photos:

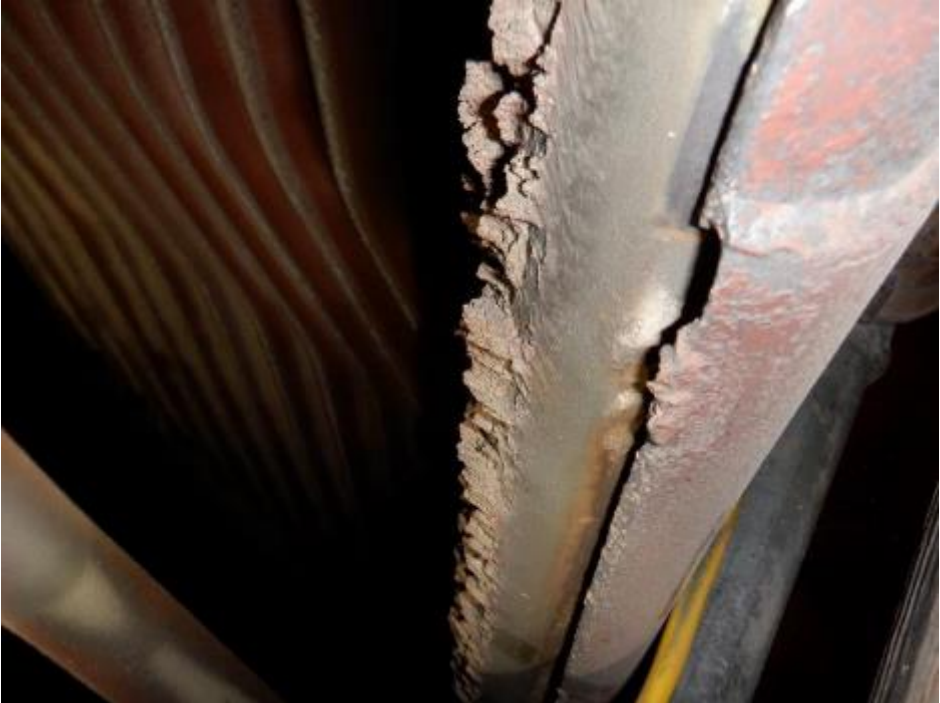
Date: 5/17/23	Inspected by: B&W ECC	Unit: 2	Item: RRHCORSCR 4
Component Inspected: Hanger Tubes			
Tube shield straps have corroded and broke from the shield: 23, 28, 40, 42, 48, 54, 56, 57, 63, 64			
Recommendations: Install new straps.			
Criticality: P3			
Risk if NOT Performed: Shields will pull from the tube creating a gap for ash and flue gas to cause erosion and corrosion.			
EKP Comments:			
Photos:

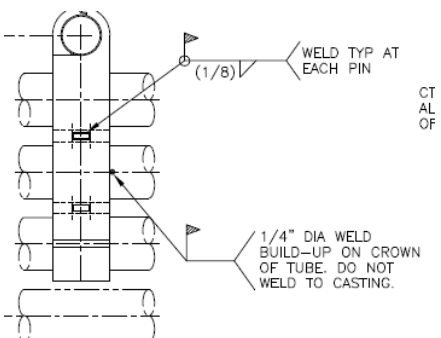
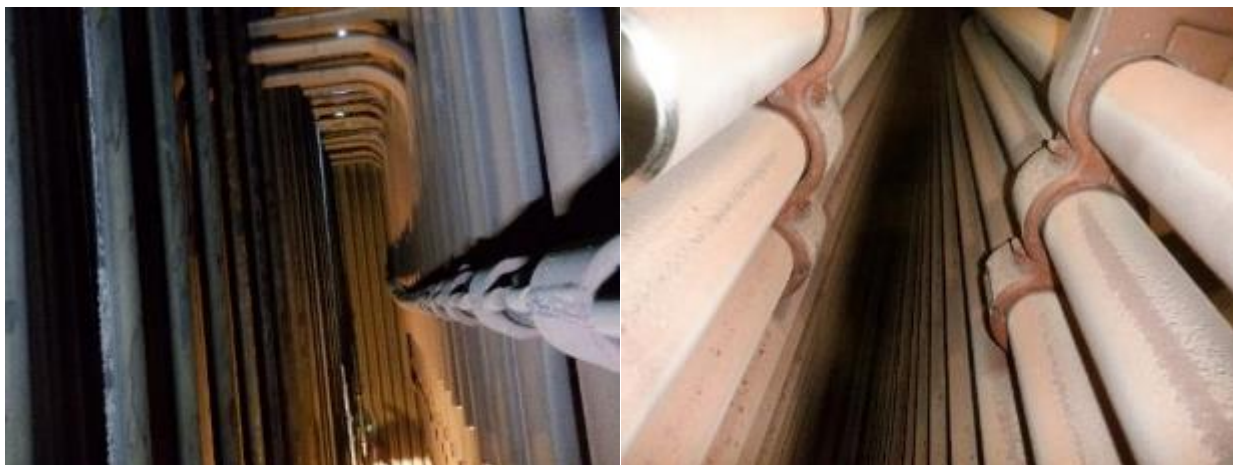
Date: 5/17/23	Inspected by: B&W ECC	Unit: 2	Item: RRHCORSCR 5
Component Inspected: RH Rear pendant			
<p>The water-cooled spacer tube is sloped down on the left side. The spacer casting slipped down the tubes because a sufficient weld on the tube to support the casting was not installed. Many of the castings simply slipped over the weld.</p>

Recommendations: Put a large weld bead under the casting to prevent it from slipping. Take care not to weld the casting to the tube.			
Criticality: P3			
Risk if NOT Performed: The castings could slip more.			
EKP Comments:			
Photos:

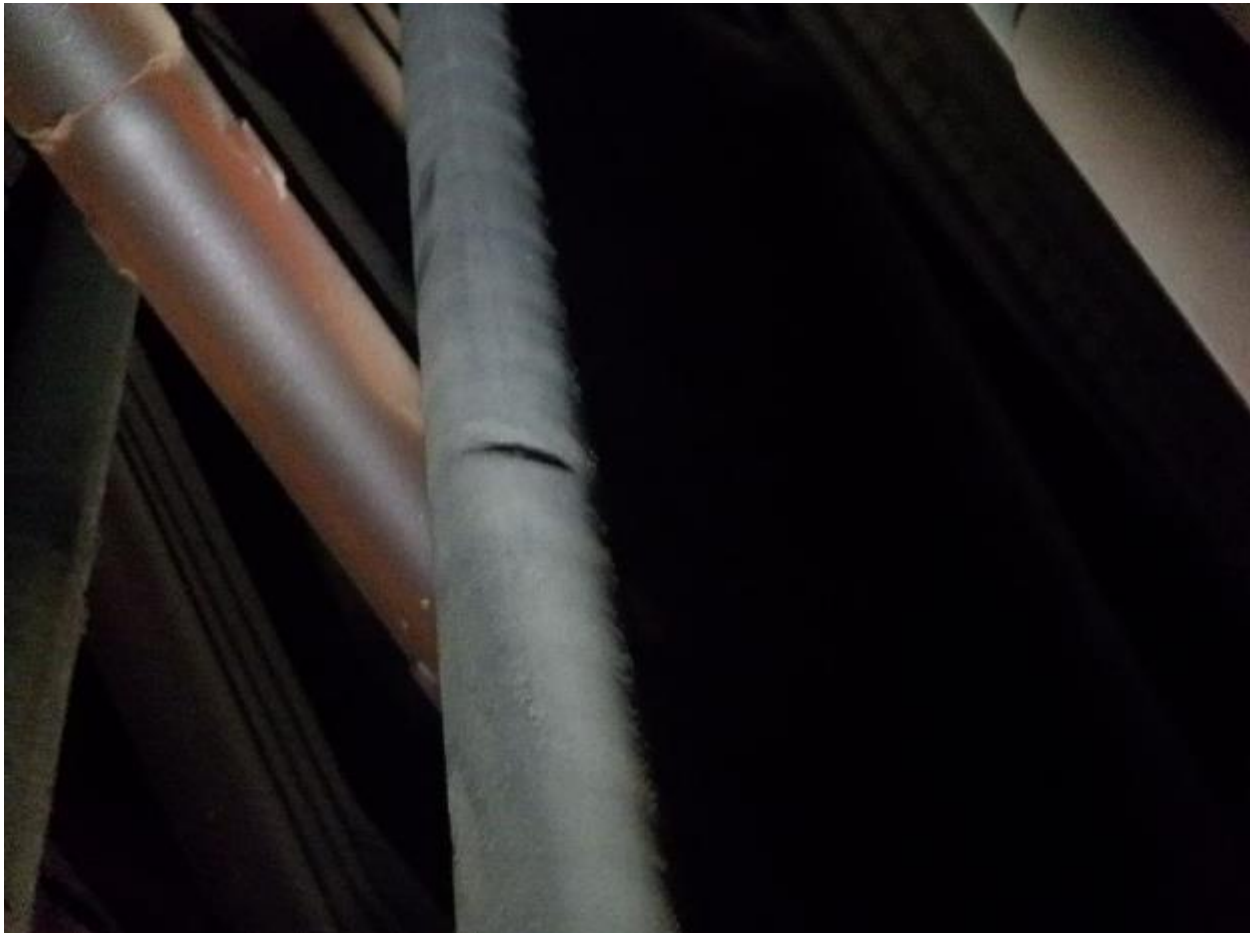
Date: 5/18/2023	Inspected by: B&W - CSH	Unit: 2	Item: RRHCORSCR 6
Component Inspected: RH Rear Pendants & Crossover, Rear WW Screen & Hanger Tubes			
Condition Assessment: Upper Crossover - Rear side of WW Hanger Tubes – There was sootblower erosion on the WW screen tubes 8, 9, 10, 14, 21, 24(UT-.293”), 26(UT-.299”), 29 (behind the ladder pole) at the IK 17 lane. The severity on all tubes could not be thoroughly inspected due to lack of accessibility. Tube #8 appeared to have the worst damage.			
Recommendations: Scaffold will be required for access to these repairs. Shield tubes 24, 26, & 29. Determine repairs (shields or padwelds) after a thorough inspection. Tubes are 2.25”OD x .320”MW, SA210A1.			
Criticality: P2			
Risk if NOT Performed: Erosion will continue and could lead to tube leaks.			
EKP Comments:			
Photos:

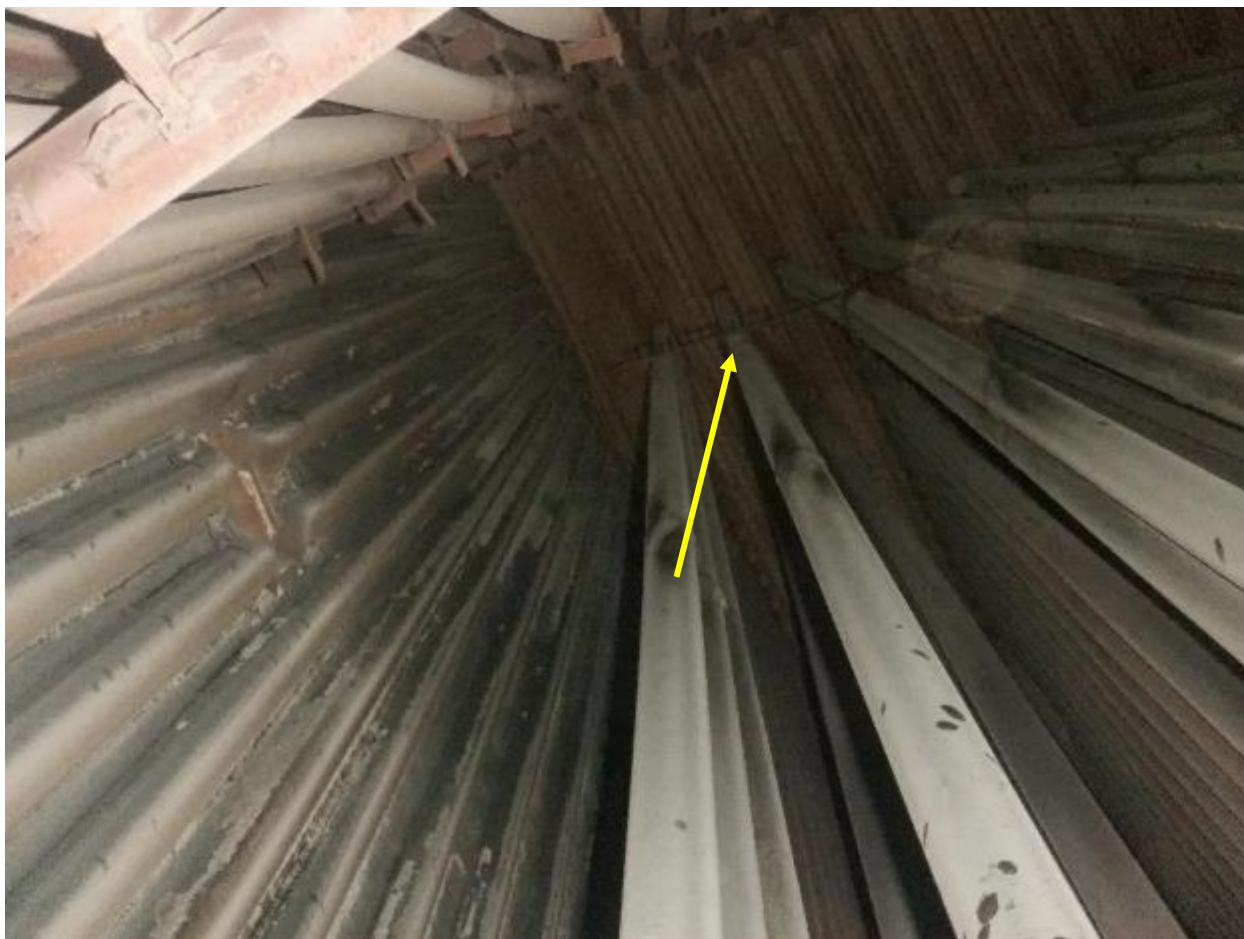
Date: 5/18/2023	Inspected by: B&W - CSH	Unit: 2	Item: RRHCORSCR 7
Component Inspected: RH Rear Pendants & Crossover, Rear WW Screen & Hanger Tubes			
Condition Assessment: WW Screen Tubes, Rear Side – The alignment bar U straps were broken or missing at tube 69.			
Recommendations: Install a new U strap. Scaffold will be required for access.			
Criticality: P3			
Risk if NOT Performed: Tube misalignment.			
EKP Comments:

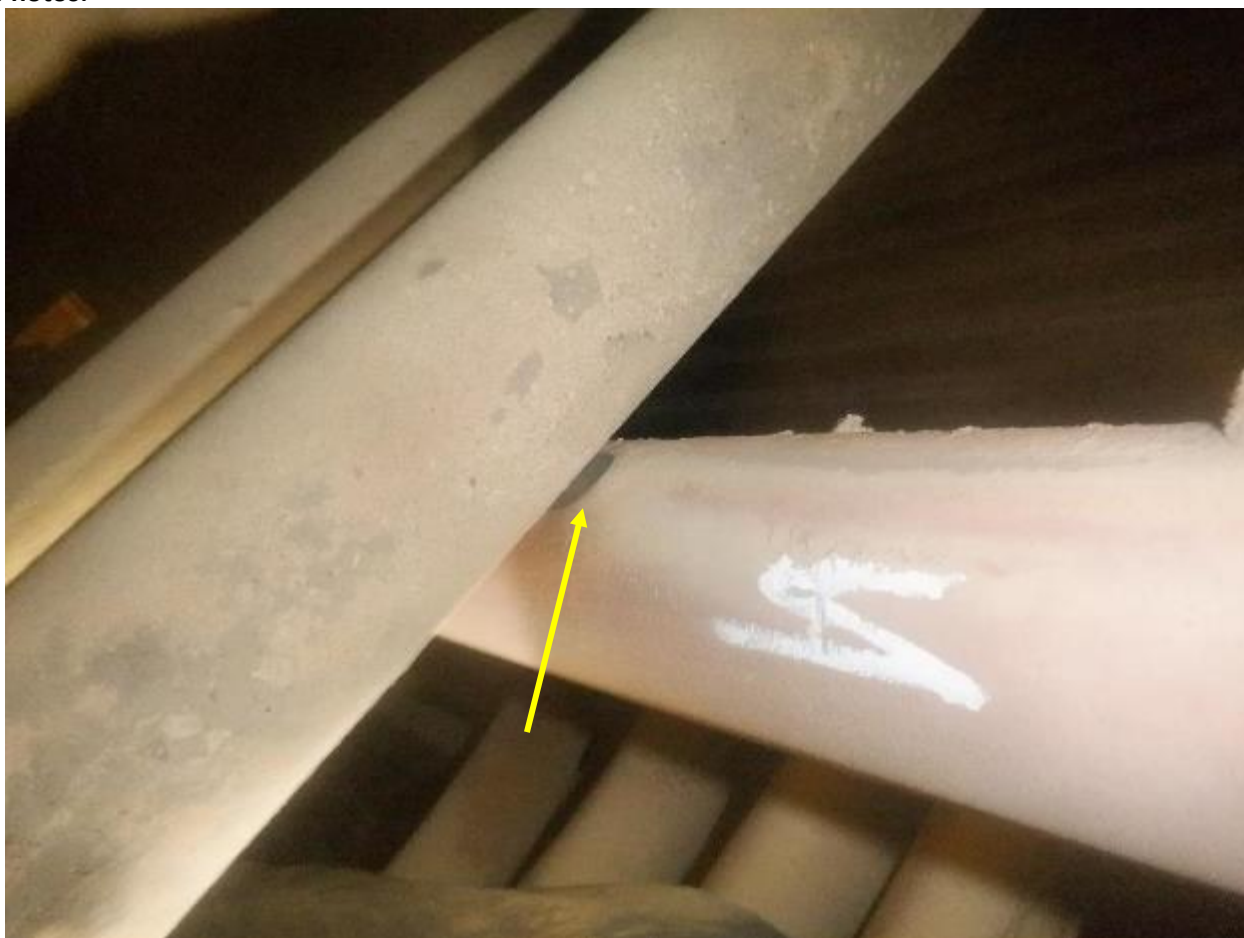
Date: 5/18/2023	Inspected by: B&W - CSH	Unit: 2	Item: RRHCORSCR 8
Component Inspected: RH Rear Pendants & Crossover, Rear WW Screen & Hanger Tubes			
Condition Assessment: Crossovers – There were multiple crossover tubes rubbing the following locations: Rear of RH Inlet at Middle Elevation: 1, 4, 6 Front of RH Outlet at Middle Elevation: 3, 6 (from the RHSW) Rear of RH Inlet at Upper Elevation: 20,			
Recommendations: Install 6" shields on each tube. If time allows reinstall the interlocking castings. The rubbing tubes are from tubes being out of the castings, causing misalignment. Front RH pendants are 2.5" OD. Rear RH pendants are 2.75" OD.			
Criticality: P3			
Risk if NOT Performed: Tube failures.			
EKP Comments:

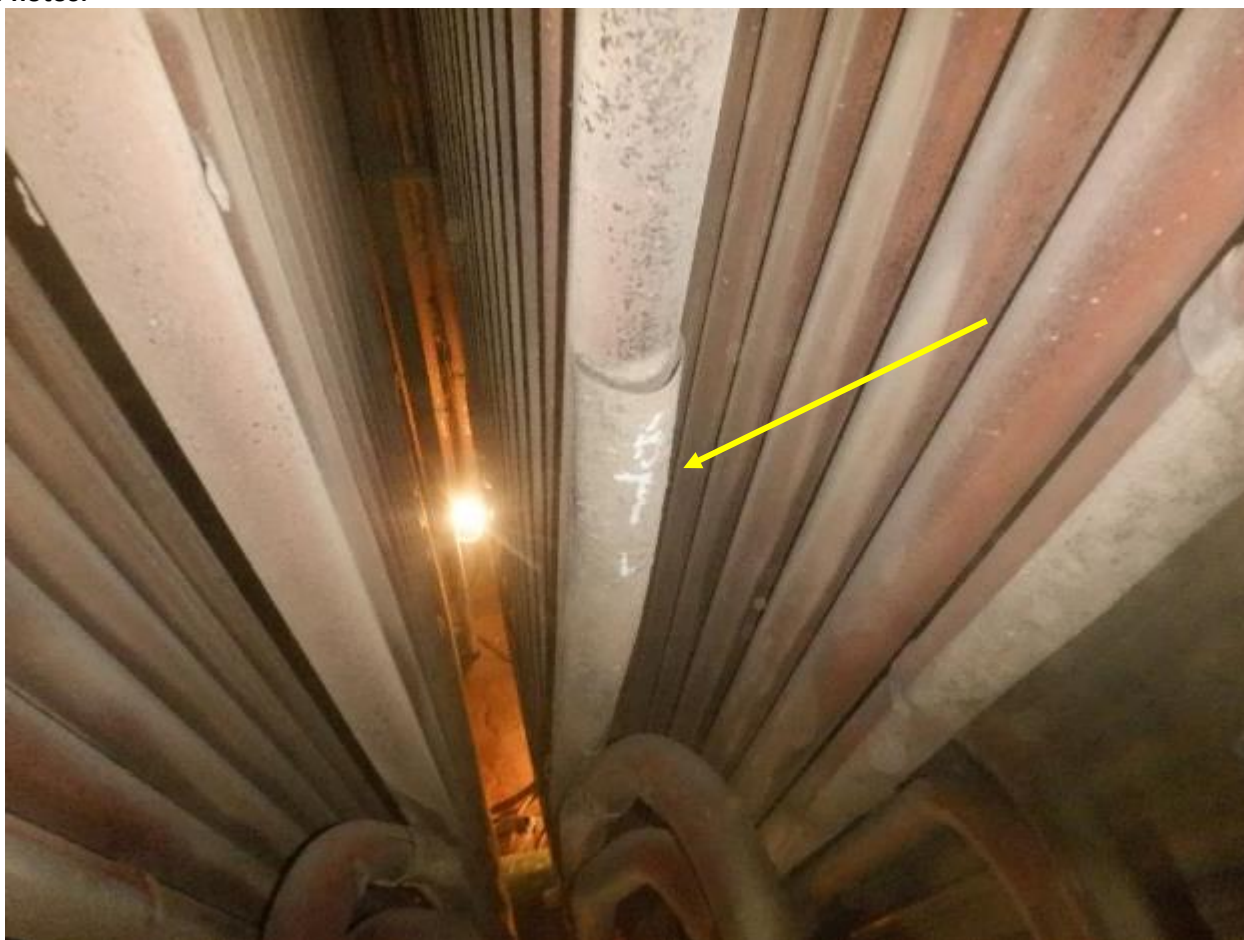
Date: 5/18/2023	Inspected by: B&W - CSH	Unit: 2	Item: RRHCORSCR 9
Component Inspected: RH Rear Pendants & Crossover, Rear WW Screen & Hanger Tubes			
Condition Assessment: Lower Crossovers – There were damaged tube shields at the leading edge of the rear pendant reheater assemblies: 21, 32, 33, 34, 37, 44, 53, 56, and 67.			
Recommendations: Replace shields.			
Criticality: P3			
Risk if NOT Performed: Tube failures.			
EKP Comments:

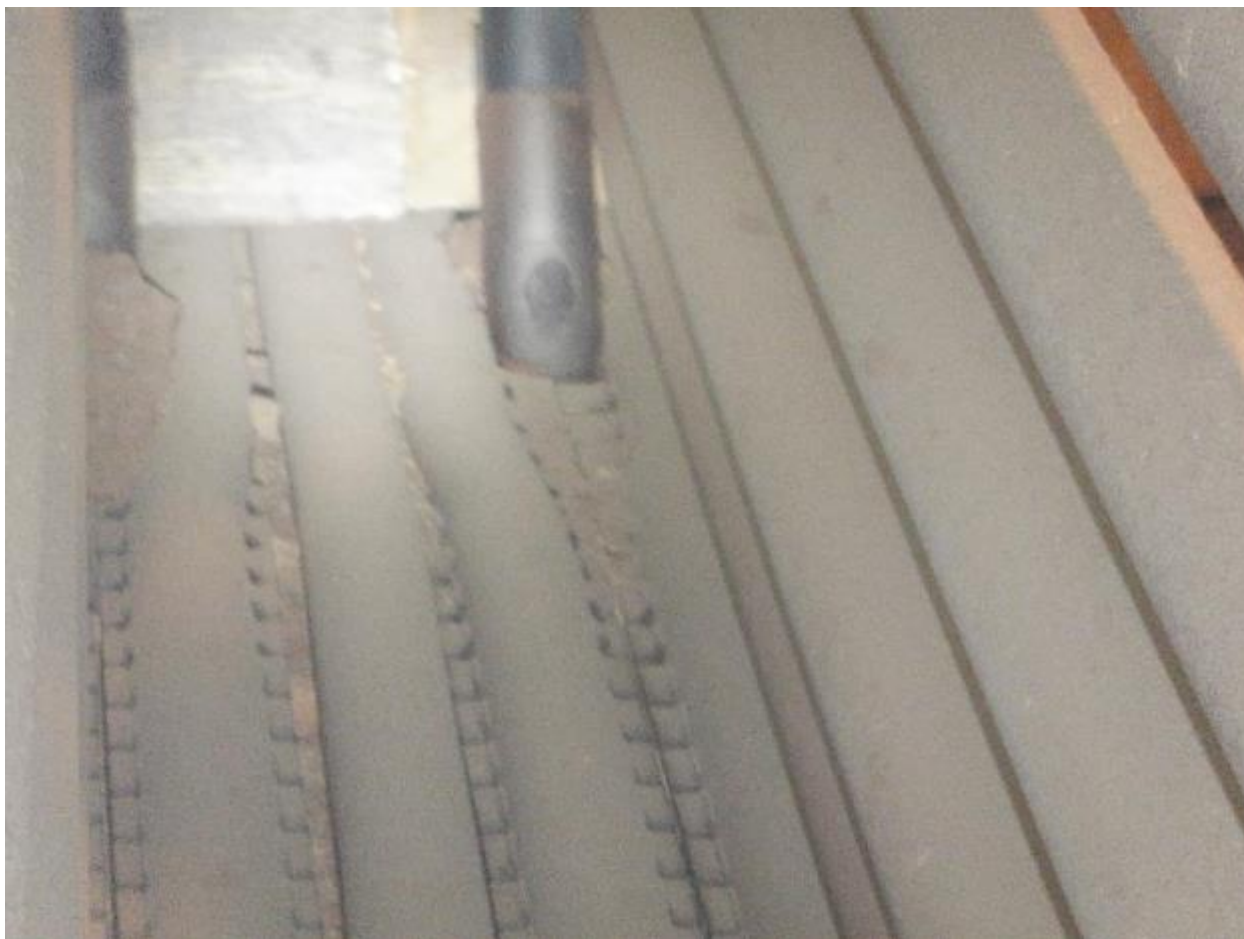
Date: 5/17/2023	Inspected by: B&W - CSH	Unit: 2	Item: RRHCORSCR 10
Component Inspected: RH Rear Pendants & Crossover, Rear WW Screen & Hanger Tubes			
Condition Assessment: Front side of WW Hanger Tubes – There were holes in shields above the arch penetrations at hanger tubes: 39, 51, 54, 56, 57, 59, 61.			
Recommendations: Replace the 18" shields. WW hanger tubes are 2.25" OD.			
Criticality: P2			
Risk if NOT Performed: Erosion will continue and could lead to tube leaks.			
EKP Comments:

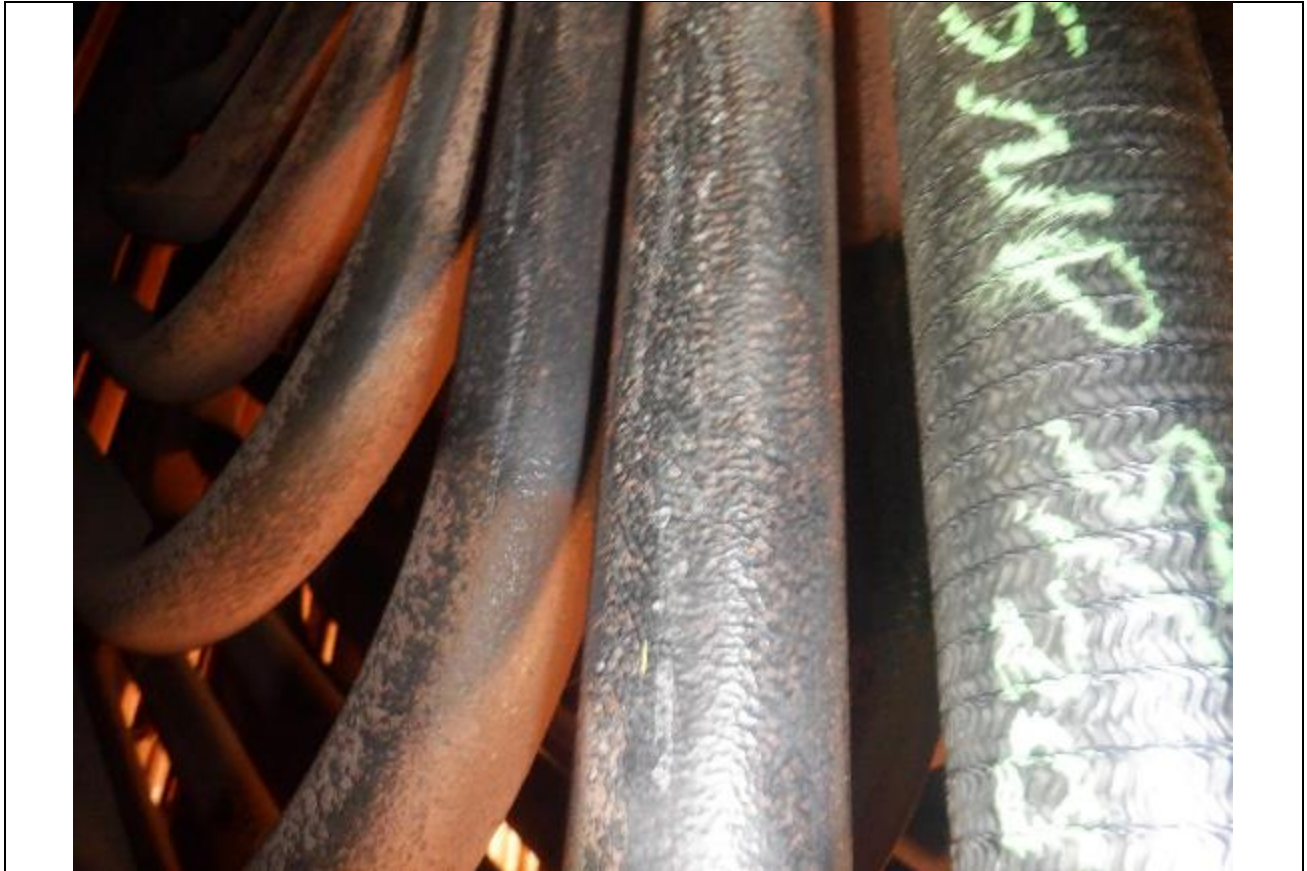
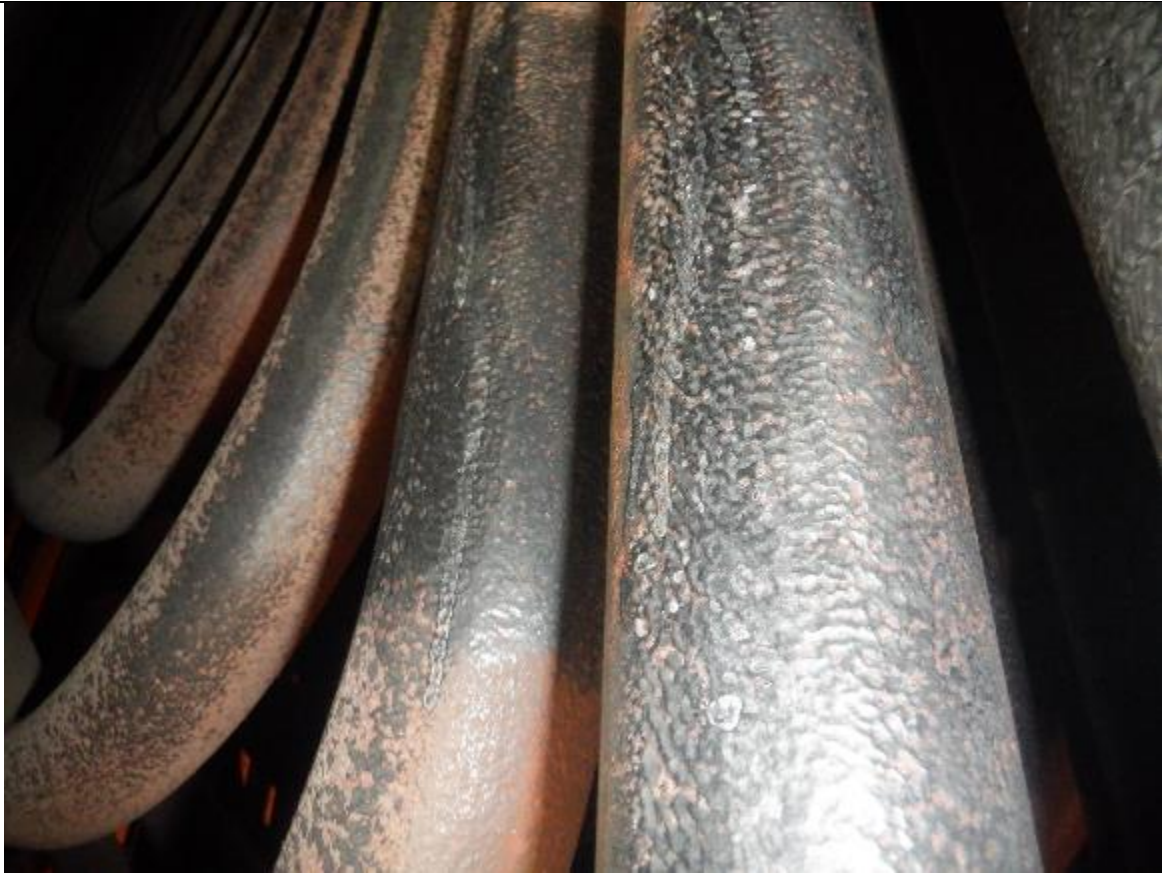
Date: 5/17/23	Inspected by: B&W	Unit: 2	Item: RRHCORSCR 8																																				
Component Inspected: RH Outlet																																							
<p>Condition Assessment: RH Outlet tubes 2 and 3 were measured for thickness during this outage on both sides of the tubes just above the bend. About a 1.5" x 10" area was scanned, and the lowest reading was saved. Moderate corrosion was identified on tubes 2 & 3 per the following table.</p>

Assembly	Tube(Left or Right side)	UTT	Priority	63	2L	.096	P1	64	3L	.114	P2	67	2L & 3L	.114, .105	P2	57	3L	.128	P3	60	2L	.126	P3	61	3L & 3R	.122, .12	P3	63	3L	.116	P3	64	3R	.126	P3
Assembly	Tube(Left or Right side)	UTT	Priority																																				
63	2L	.096	P1																																				
64	3L	.114	P2																																				
67	2L & 3L	.114, .105	P2																																				
57	3L	.128	P3																																				
60	2L	.126	P3																																				
61	3L & 3R	.122, .12	P3																																				
63	3L	.116	P3																																				
64	3R	.126	P3																																				
<p>Recommendations: Install 2"x 8" padwelds per the table above. RHO tubes are 2.5"OD x .165"MW, SA213TP304H. Continue to monitor this area in the future with continued UTT surveys.</p>																																							
Criticality: P1 – P3																																							
<p>Risk if NOT Performed: Tubes are subject to continued corrosion and wall loss which could lead to tube failures.</p>																																							
EKP Comments:																																							
<p>Photos:</p>
