The Babcock & Wilcox Company

**Eastern Kentucky Power Cooperative
Spurlock Station, Unit #2**

U2 SPRING 2023 OUTAGE BOILER INSPECTION REPORT

B&W Project No.: BA9312817

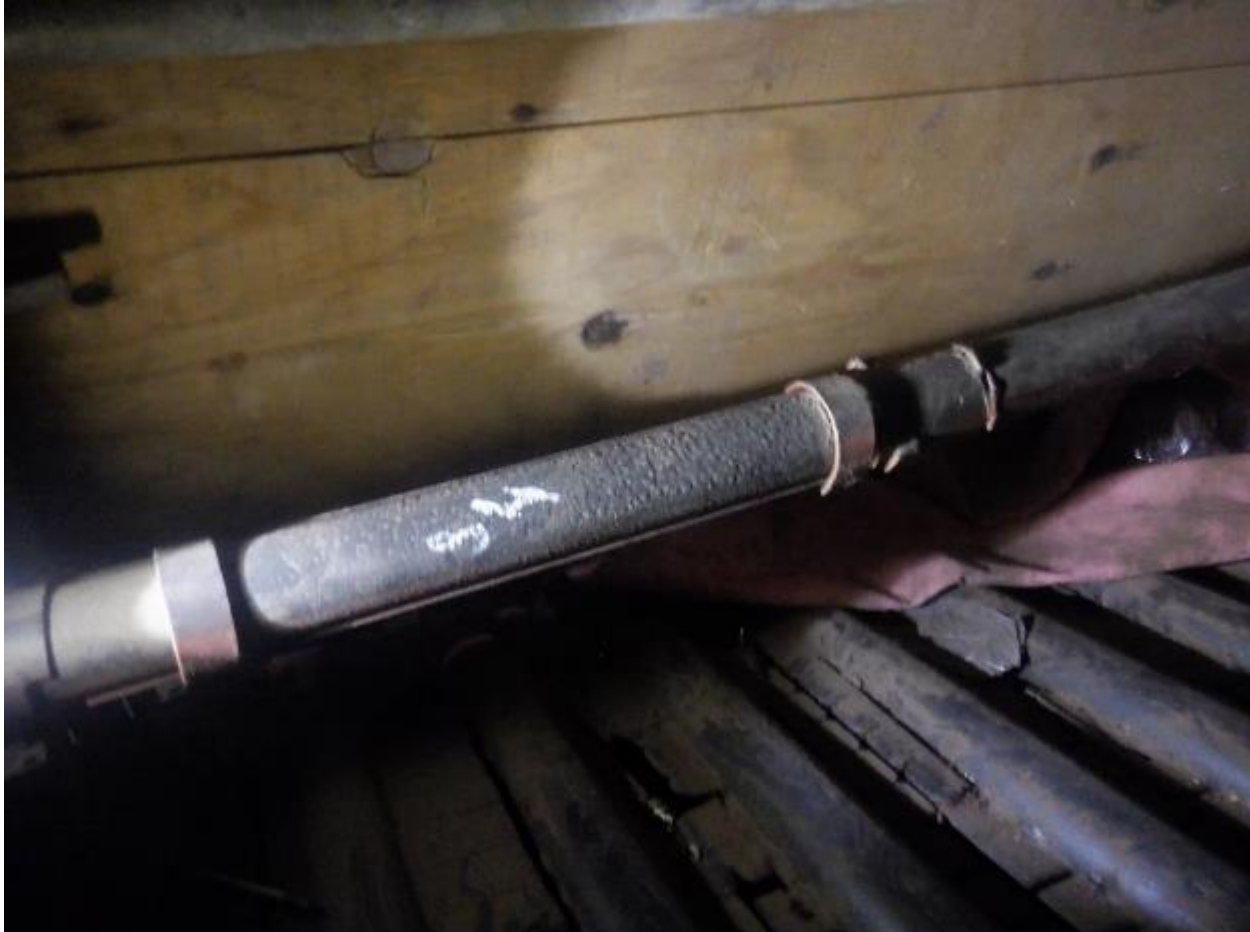
Date: 5/27/23	Inspected by: B&W	Unit: 2	Item: RRHCORSCR 2
Component Inspected: Upper Arch Beneath RHO			
Condition Assessment: Minor sootblower erosion was found on the WCS tube, above the arch penetration on the LHS.			
Recommendations: Install a 24" long shield. WCS tubes are 2.00"OD.			
Criticality: P3			
Risk if NOT Performed: Tubes are subject to continued erosion and wall loss which could lead to tube failures.			
EKP Comments:			
Photos:

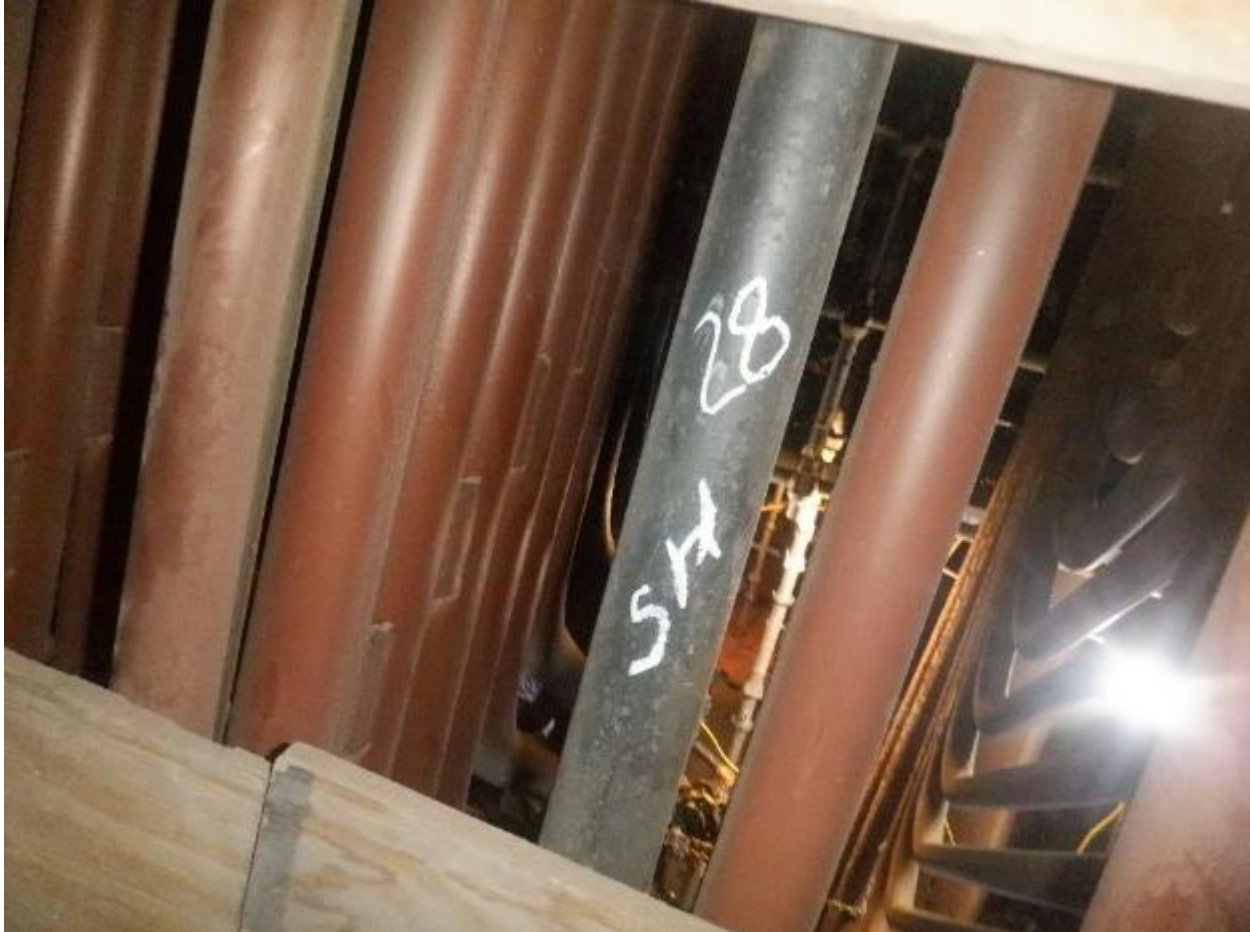
Date: 5/27/23	Inspected by: B&W	Unit: 2	Item: RRHCORSCR 3
Component Inspected: RW Hanger Tubes at the Upper Arch			
Condition Assessment: There were missing shields on the rear side of the RW hanger tubes, in the lower IK lane at tubes: 28, 37, 46, 54, 56, 59			
Recommendations: Install a 48" long shield. RW hanger tubes are 2.25"OD.			
Criticality: P3			
Risk if NOT Performed: Tubes are subject to continued erosion and wall loss which could lead to tube failures.			
EKP Comments:			
Photos:

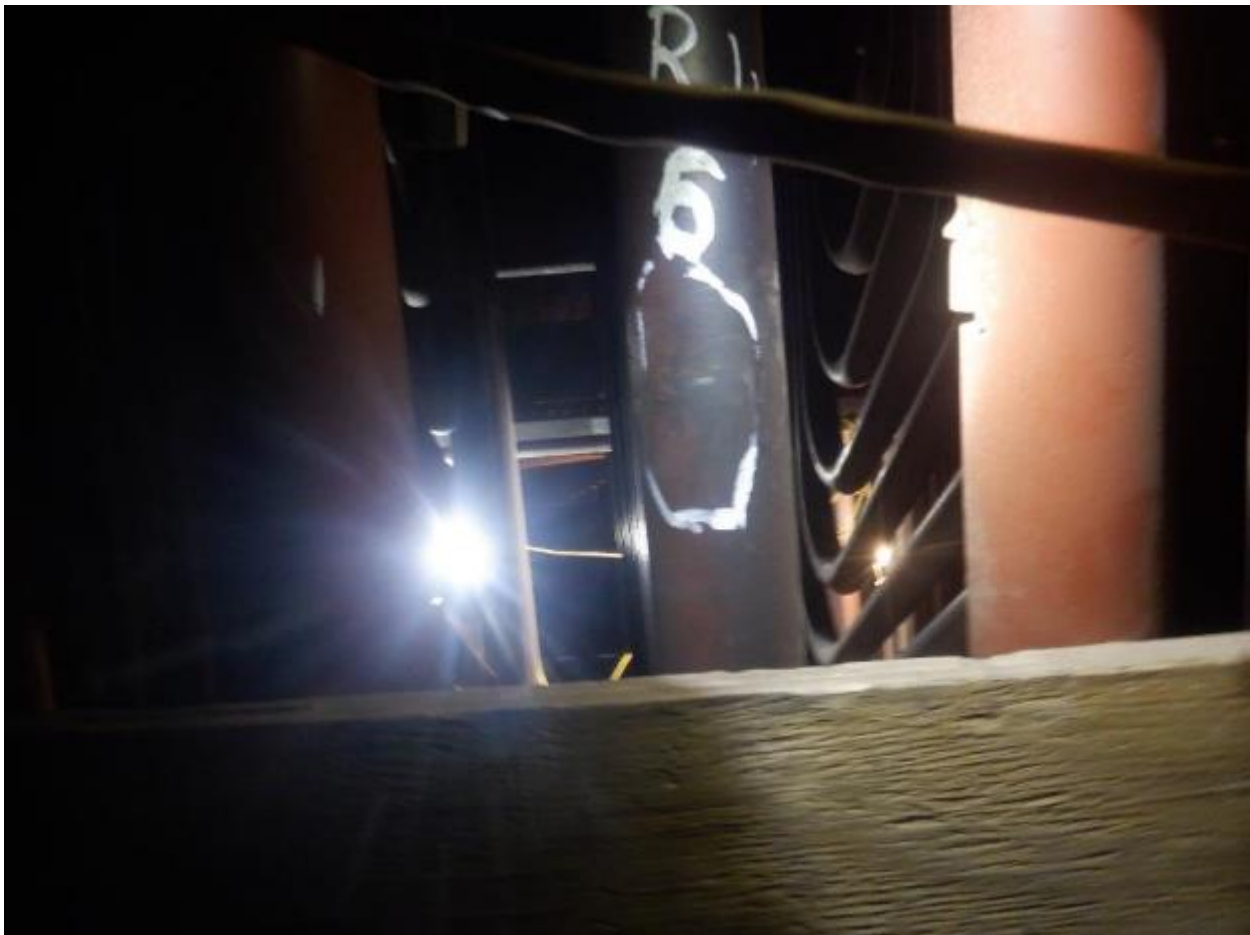
Date: 5/27/23	Inspected by: B&W	Unit: 2	Item: RRHCORSCR 4
Component Inspected: Rear of RH Inlet			
Condition Assessment: The rear of the rear tube of RH Inlet assembly 6 had minor erosion.			
Recommendations: Install a 24" long shield. RH Inlet tubes are 2.50"OD.			
Criticality: P3			
Risk if NOT Performed: Tubes are subject to continued erosion and wall loss which could lead to tube failures.			
EKP Comments:			
Photos:

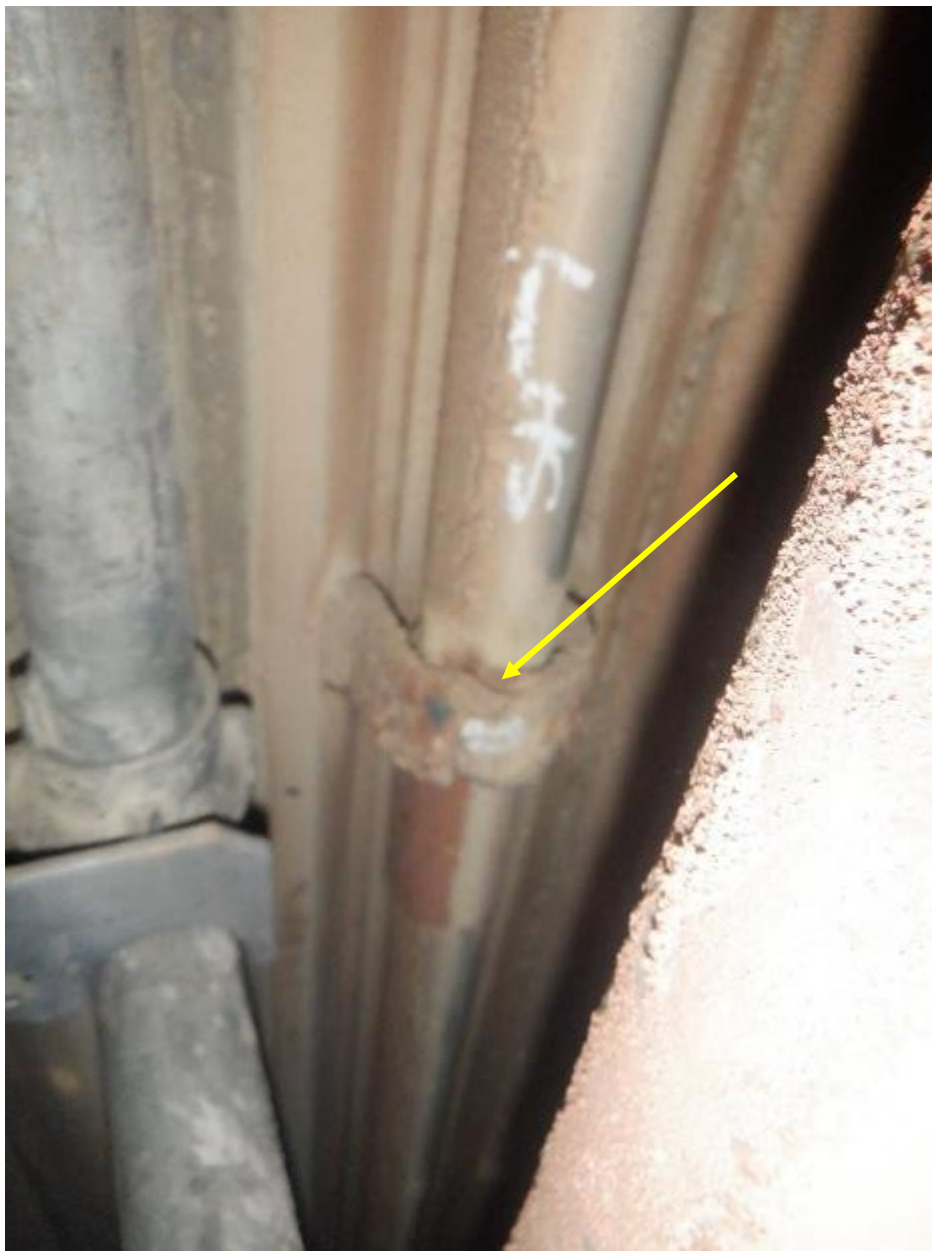
Date: 5/15/2023	Inspected by: B&W - CSH	Unit: 2	Item: RHFPEND 4
Component Inspected: RH Front Pendant & Between SH Pendant Platens			
Condition Assessment: Scaffold Level 7: The WCS U strap was overheated and cracked at the LHSW.			
Recommendations: Replace the U-strap.			
Criticality: P3			
Risk if NOT Performed: The strap could fail and allow the WCS tube to swing loose.			
EKP Comments:

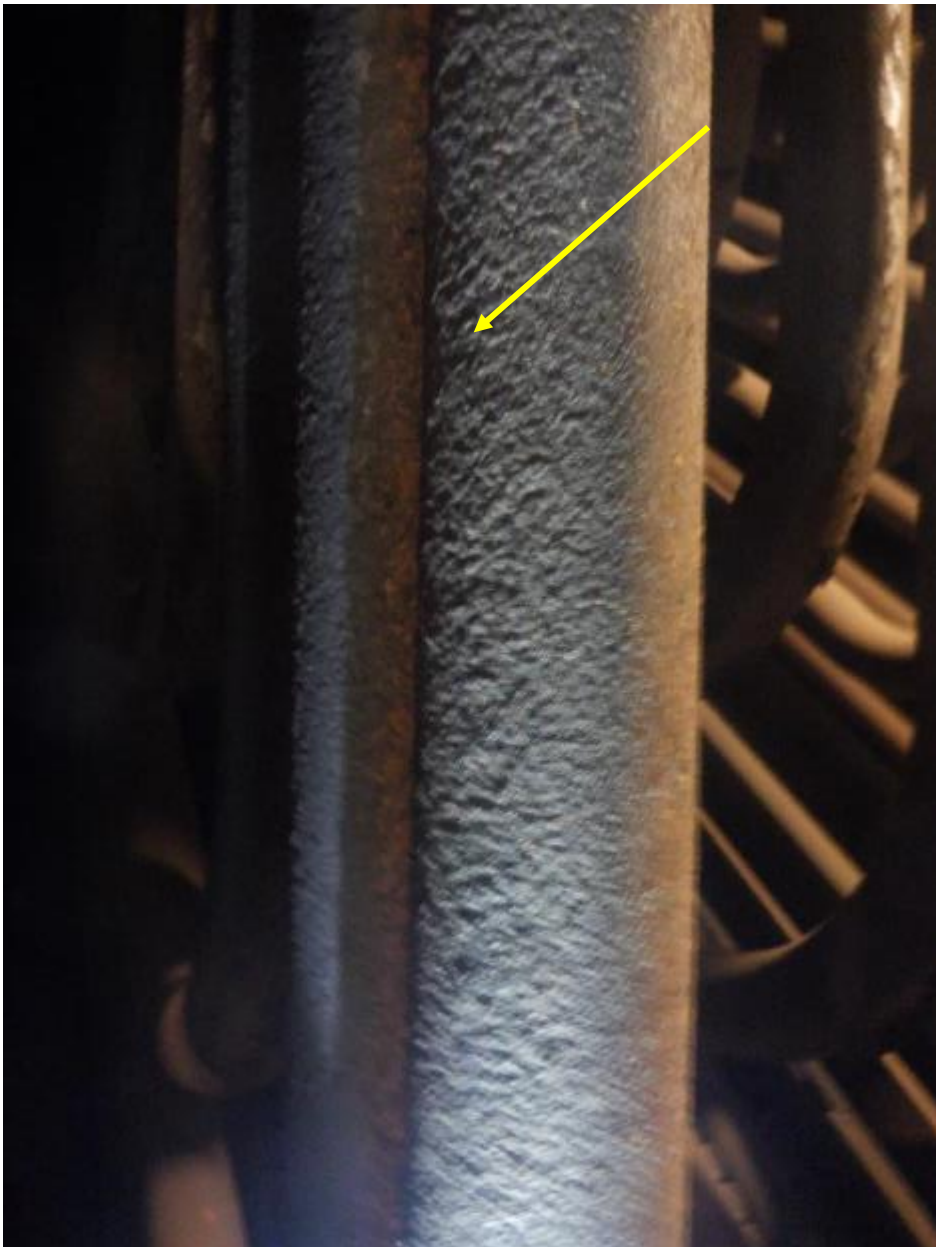
Date: 5/15/2023	Inspected by: B&W - CSH	Unit: 2	Item: RHPEND 8
Component Inspected: RH Front Pendant & Between SH Pendant Platens			
Condition Assessment: Scaffold Level 1: There was minor corrosion damage, likely carburization, on the leading edge of assemblies(UT): 24(.148), 26(.140), 28(.143) UT readings were performed at the worst appearing tubes. The damage appeared to be localized to the center of the boiler from the bottom bend up about three feet.			
Recommendations: Schedule at UT survey and monitor status during future outages.			
Criticality: P3			
Risk if NOT Performed: Tube failure if damage worsens.			
EKP Comments:			
Photos:

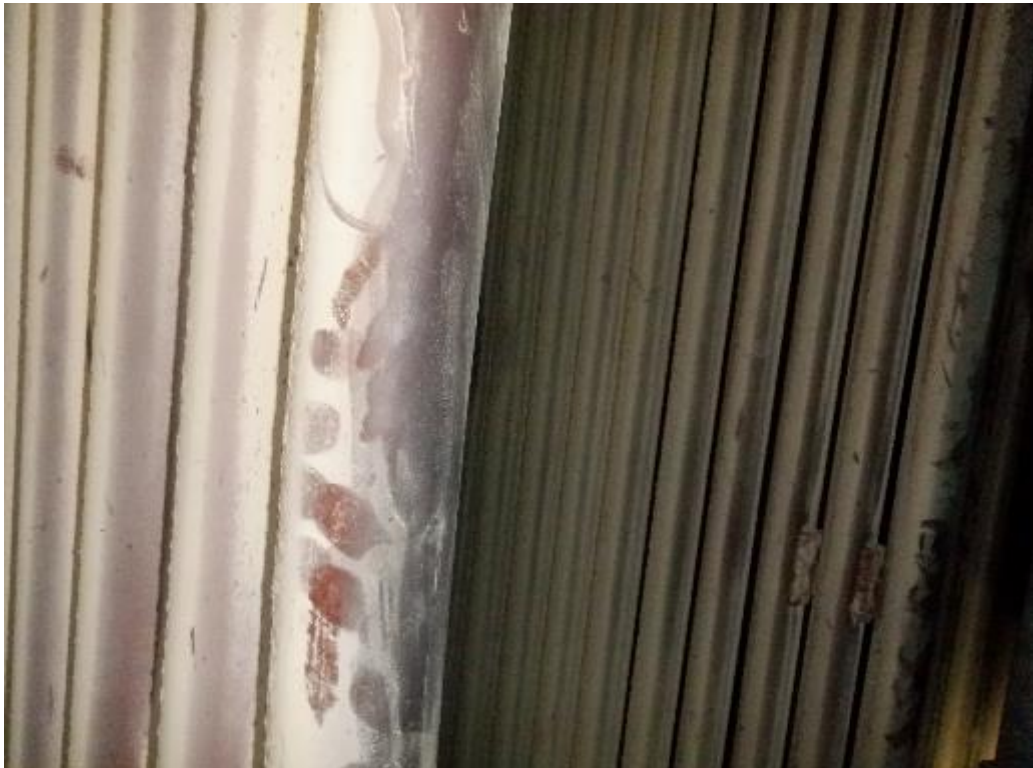
Date: 05/15/23	Inspected by: B&W ECC	Unit: 2	Item: SHPENDPL 1
Component Inspected: SH Pendant Platens & Between SH Division Panels			
Condition Assessment: Scaffold elevation 5 element 1 & 2: Mechanical damage to the training edge tube. The tube was likely bent during installation. Some tool marking are present in element 2 trailing edge tube. The tube is still in plan with the element.			
Recommendations: When installing sections make sure the elements are properly rigged to prevent damage.			
Criticality: Noted for future inspections			
Risk if NOT Performed:			
EKP Comments:			
Photos:

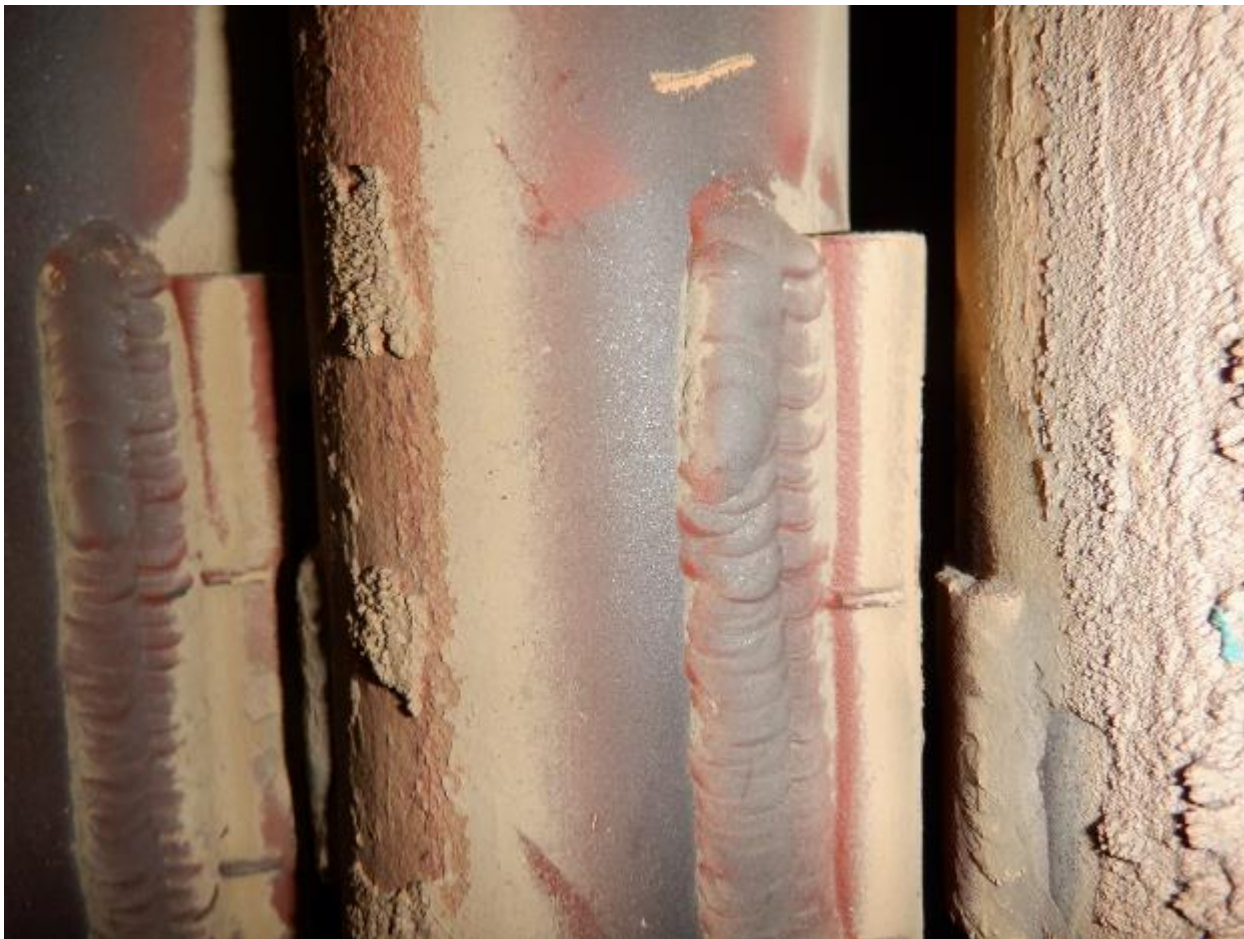
Date: 5/15/23	Inspected by: B&W ECC	Unit: 2	Item: SHPENDPL 2
Component Inspected: SH Pendant Platens & Between SH Division Panels			
Condition Assessment: Scaffold elevation 5: Missing slip spacers between tubes 33 and 34 on element 17.			
Recommendations: Replace slip spacer			
Criticality: P3			
Risk if NOT Performed: Tube could move out of plane with the element providing an area for slag to collect narrowing the side spacing and increasing gas velocity between the tubes.			
EKP Comments:

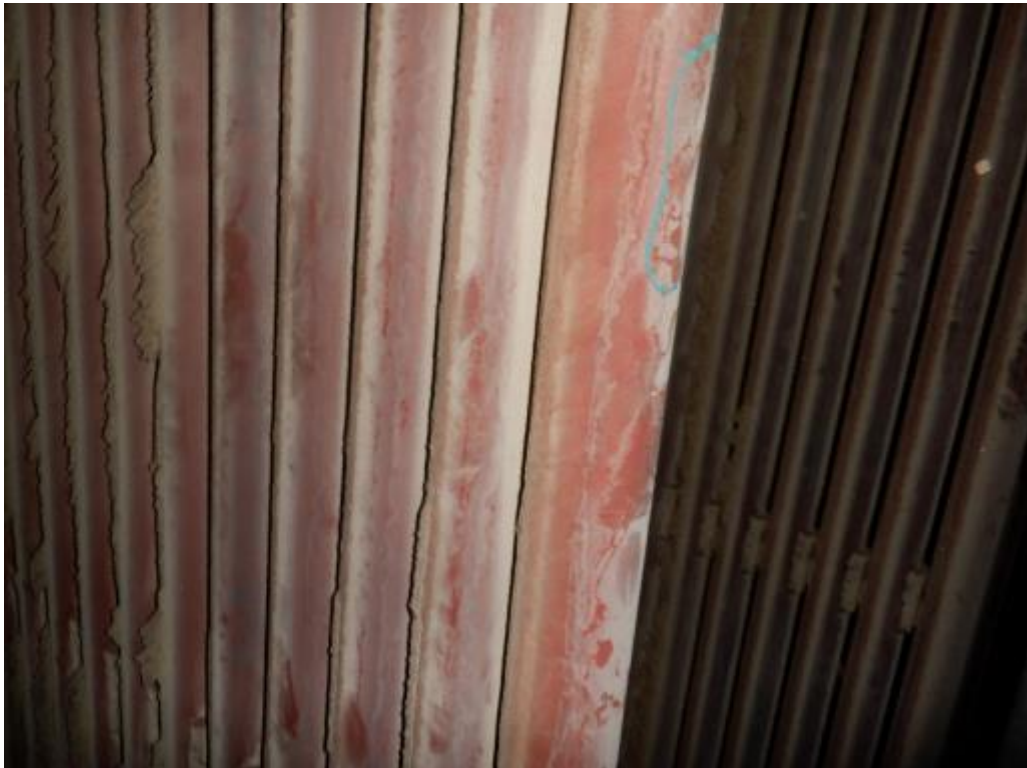
Date: 05/15/23	Inspected by: B&W ECC	Unit: 2	Item: SHPENDPL 3
Component Inspected: SH Pendant Platens & Between SH Division Panels			
Condition Assessment: Scaffold elevation 4 element 23: Mechanical damage to the training edge tube. The tube was likely bent during installation. Some tool marking are present on the trailing edge tube. The tube is still in plan with the element.			
Recommendations: When installing sections make sure the elements are properly rigged to prevent damage.			
Criticality: Noted for future inspections			
Risk if NOT Performed:			
EKP Comments:			
Photos:

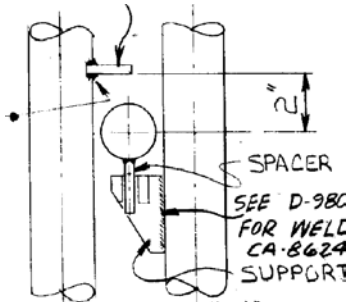
Date: 05/15/23	Inspected by: B&W ECC	Unit: 2	Item: SHPENDPL 6
Component Inspected: SH Pendant Platens & Between SH Division Panels			
Condition Assessment: Water cooled spacer tube: The spacer is very worn from contact with the element tube on tubes: 3, 6

Recommendations: Pad weld the water cooled spacer and shield tube 2 of the element. At minimum install a tube shield on the water cooled spacer tube.			
Criticality: P1			
Risk if NOT Performed: The water cooled spacer tube could fail as wear continues.			
EKP Comments:			
Photos:

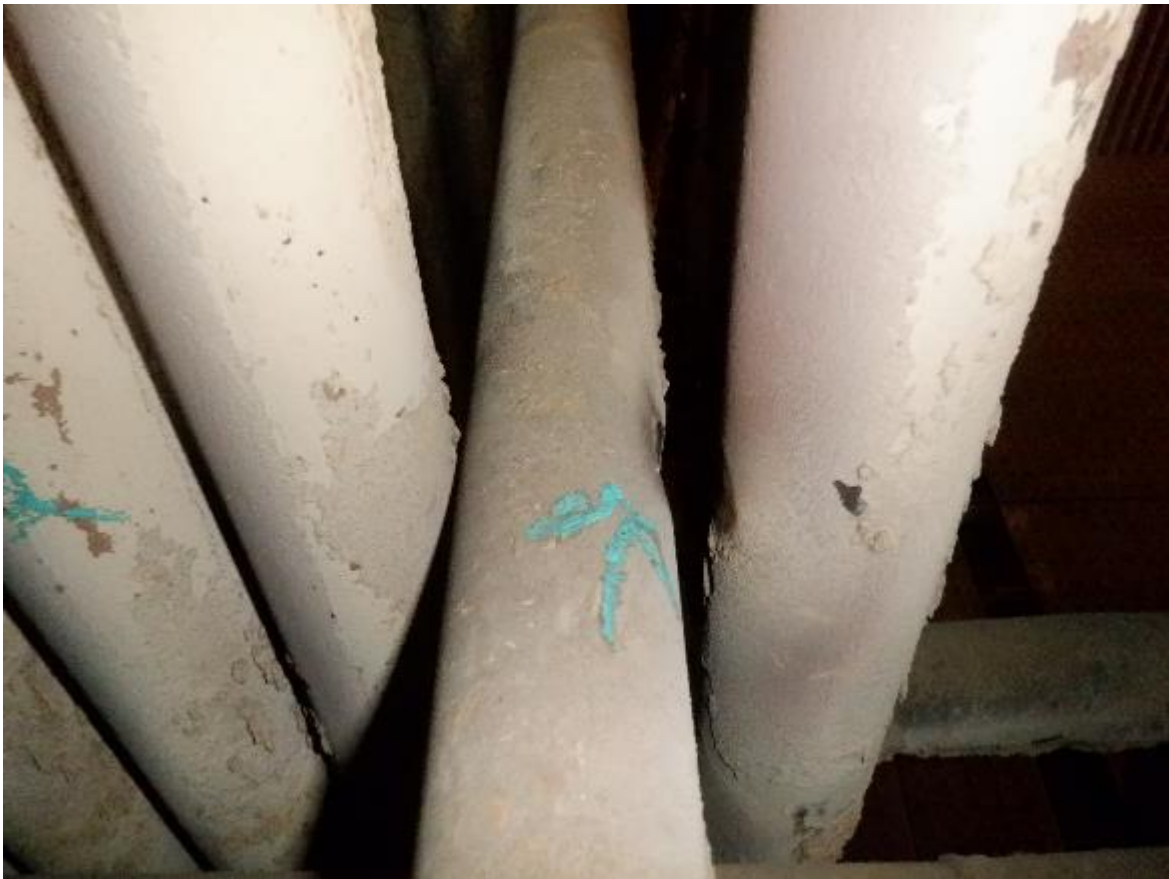
Date: 05/15/23	Inspected by: B&W ECC	Unit: 2	Item: SHPENDPL 7
Component Inspected: SH Pendant Platens & Between SH Division Panels			
Condition Assessment water cooled spacer tube: The spacer is worn from contact with the element tube on tubes: 17

Recommendations: Install a tube shield on the water cooled spacer.			
Criticality: P3			
Risk if NOT Performed: The water cooled spacer tube could fail as wear continues.			
EKP Comments:			
Photos:

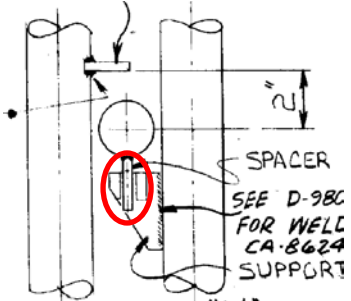
Date: 05/15/23	Inspected by: B&W	Unit: 2	Item: SHPENDPL 8
Component Inspected: SH Pendant Platens & Between SH Division Panels			
Condition Assessment: The clip on the water cooled spacer at elements 19 and 20 is enlarged allowing the spacer tube to move forward past the stop of the base.

Recommendations: Replace the clip on the spacer tube.			
Criticality: P3			
Risk if NOT Performed: The spacer tube can move forward and cause fretting with the first tube in the element.			
EKP Comments:			
Photos:

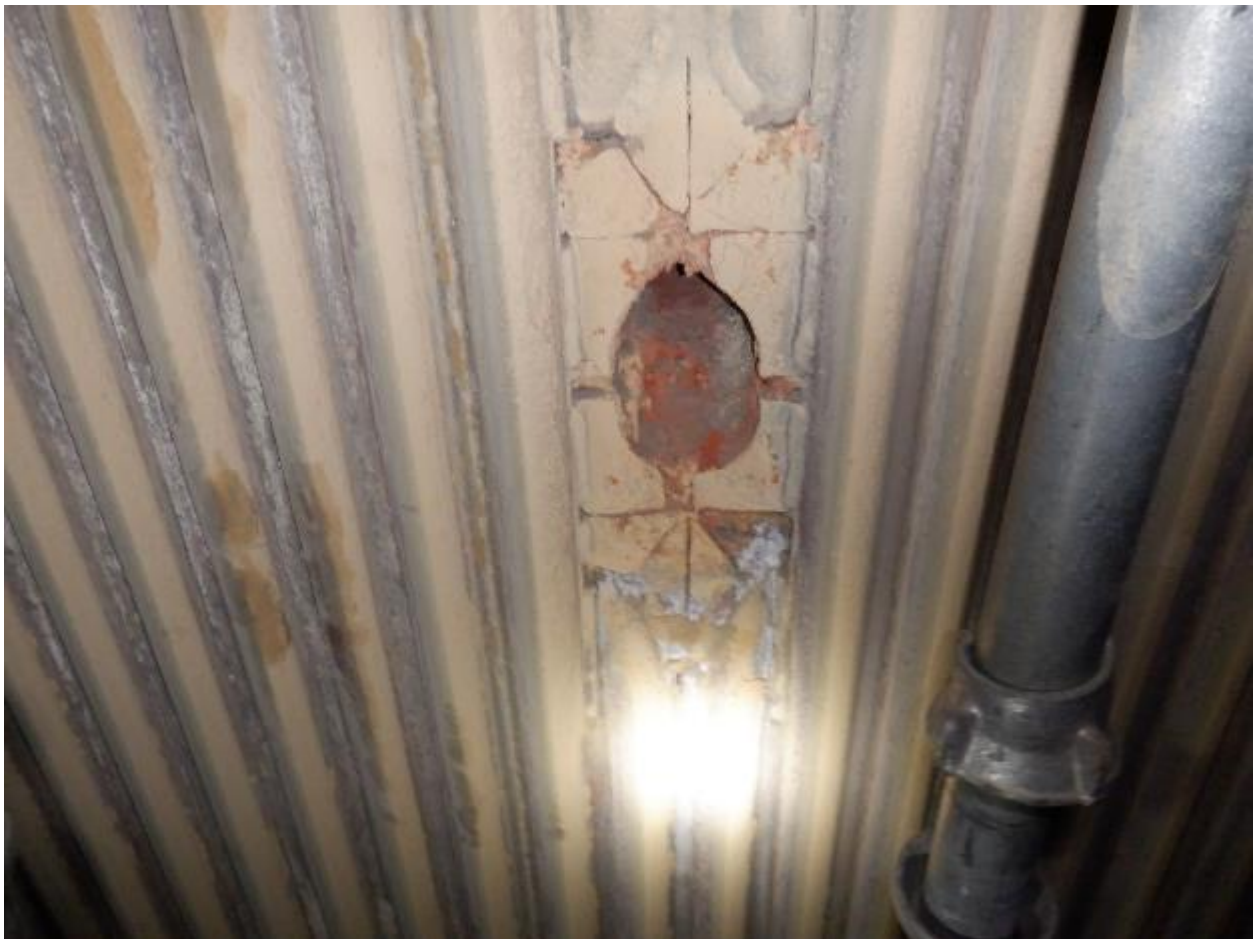
Date: 05/15/23	Inspected by: B&W ECC	Unit: 2	Item: SHPENDPL 12
Component Inspected: SH Pendant Platens & Between SH Division Panels			
Condition Assessment: The right side furnace pressure tap on scaffold elevation 6 between the division panel and pendent superheat is missing refractory box plate at 4 o'clock.			
Recommendations: Replace the refractory box plate.			
Criticality: P3			
Risk if NOT Performed: Damage to refractory.			
EKP Comments:

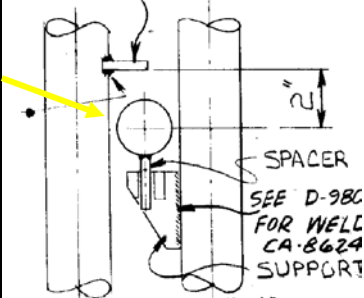
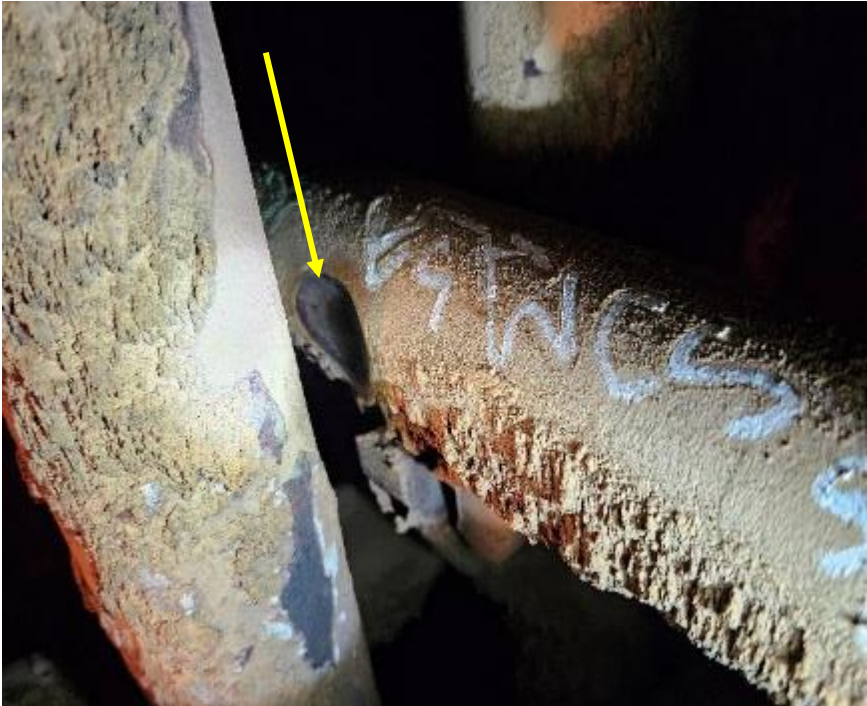
Date: 05/22/23	Inspected by: B&W - CSH	Unit: 2	Item: SHPENDPL 1
Component Inspected: SH Pendant Platens & Between SH Division Panels			
Condition Assessment: Water cooled spacer tube: The front side of the water-cooled spacer tube is severely worn from contact with the rear side of tube 1 of the pendant platens at the following assemblies.

Assembly	Repair	Priority	
3, 20, 21	Padweld WCS, shield front side of WCS & rear side pendant platen tube 1	P1	
15, 19	Shield front side of WCS & rear side pendant platen tube 1	P2	
Recommendations: Repair per the table above. WCS tube is 2.00"OD x .200"MW, SA210-A1. Pendant Platen Tube 1 is 2.250"OD x .260"MW, S30432.			
Criticality: P1 & P2			
Risk if NOT Performed: The water cooled spacer tube could fail as wear continues.			
EKP Comments:			
Photos: <div style="text-align: center;">

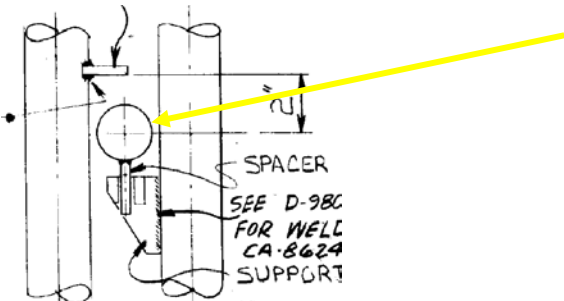
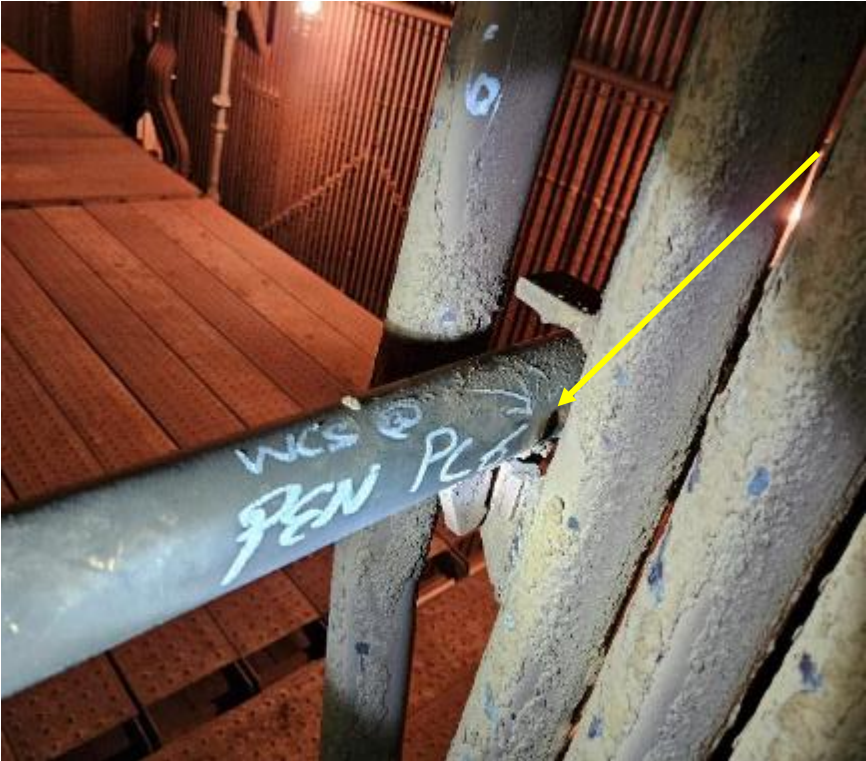
Date: 05/22/23	Inspected by: B&W - CSH	Unit: 2	Item: SHPENDPL 2
Component Inspected: SH Pendant Platens & Between SH Division Panels			
Condition Assessment water cooled spacer tube: The rear side of the water cooled spacer tube is moderately worn from contact with the front side of tube 2 of the pendant platens at the following assemblies.

Assembly	Repair	Priority	
6, 8, 10, 11, 14, 17	Padweld WCS, shield rear side of WCS & front side pendant platen tube 2	P2	
2, 4, 5, 7, 9, 16	Shield rear side of WCS & front side pendant platen tube 2	P3	
Recommendations: Repair per table above. WCS tube is 2.00"OD x .200"MW, SA210-A1. Pendant Platen Tube 2 is 2.125"OD x .240"MW, SA213TP347H.			
Criticality: P2 & P3			
Risk if NOT Performed: The water cooled spacer tube could fail as wear continues.			
EKP Comments:			
Photos:

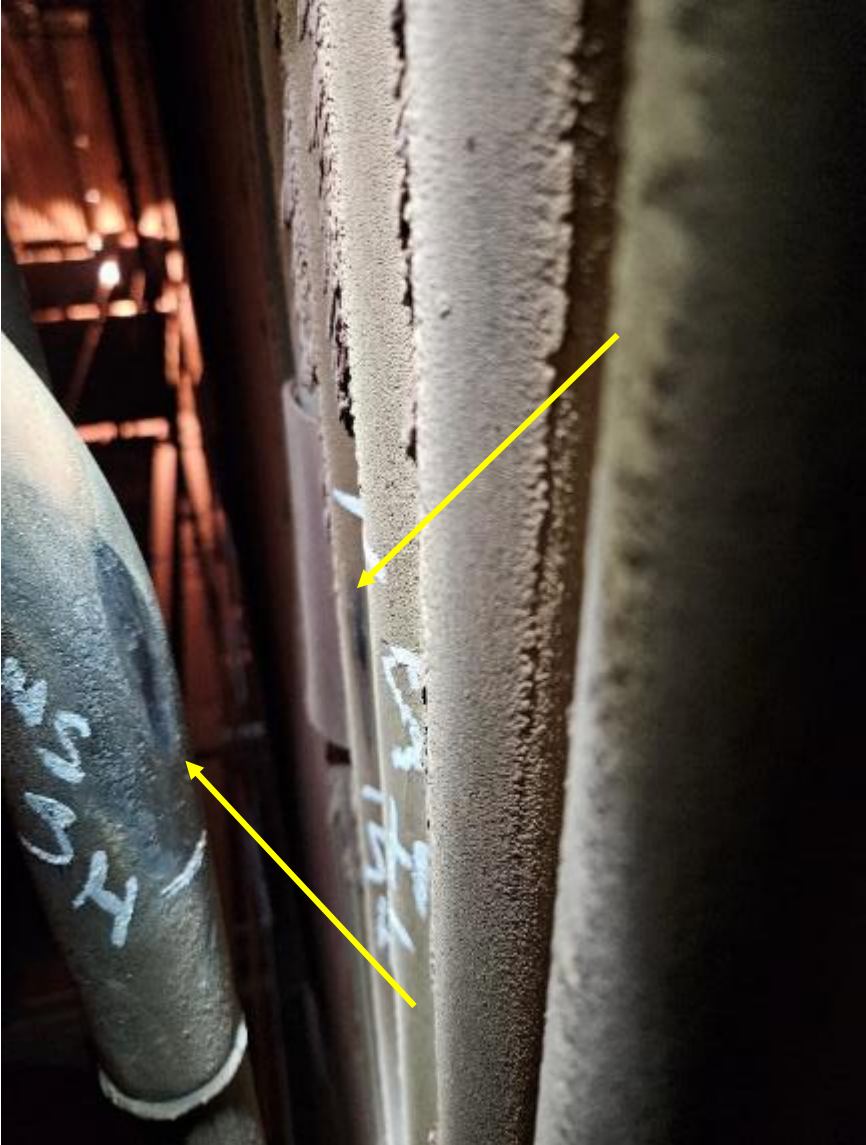
Date: 05/23/23	Inspected by: B&W - CSH	Unit: 2	Item: SHPENDPL 3
Component Inspected: SH Pendant Platens & Between SH Division Panels			
Condition Assessment water cooled spacer tube: The WCS tube bends have rubbed against the LHSW & RHSW tubes.			
Recommendations: Install a 24" shield on the WCS tube at each SW. Install two (2) shields on the LHSW tubes and one (1) shield on the RHSW tube, adjacent to the WCS. SW tubes are 2" OD. The WCS is 2" OD.			
Criticality: P2			
Risk if NOT Performed: The water-cooled spacer or side wall tubes could fail as wear continues.			
EKP Comments:			
Photos:

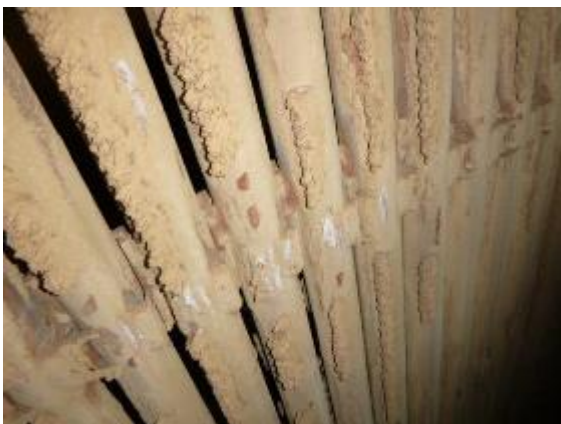
Date: 05/15/2023	Inspected by: B&W RJP	Unit: 2	Item: SHDIVPAN 1
Component Inspected: SH Division Panels			
Condition Assessment: Flex ties were damaged or missing in the following area:			
<p><u>Landing #6</u> -Front Panel #4, Right-hand side, Pendants 2 & 5.</p> <p><u>Landing #4</u> -Front Panel #6, Right-hand side, Pendant 1. -Rear Panel #6, Right-hand side, Pendants 8-11.</p> <p><u>Landing #3</u> -Rear Panel #6, Right-hand side, Pendant 78. -Front Panel #6, Left-hand side, Pendant 4. -Rear Panel #5, Right-hand side, Pendant 77 & 79. -Rear Panel #5, Left-hand side, Pendant 77 & 78. -Rear Panel #4, Right-hand side, Pendant 27. -Front Panel #4, Right-hand side, Pendant 48 & 68.</p> <p><u>Landing #2</u> -Rear Panel #3, Right-hand side, Pendants 53, 65, 67.</p> <p><u>Landing #1</u> Rear Panel #6, Right-hand side, Pendant 80. Rear Panel #6, Left-hand side, Pendant 1 & 3. Rear Panel #5, Right-hand side, Pendant 70 & 76. Rear Panel #5, Left-hand side, Pendant 2, 74, 76. Rear Panel #4, Right-hand side, Pendants 70, 74, 76, 78, 79. Front Panel #4, Right hand side, Pendant 68. Rear Panel #4, Left hand side, Pendants 62, 64, 71, 72, 74, 75, 76, 78, 79. Front Panel #4, Left hand side, Pendants 1, 4, 68.</p>

Recommendations: Flex ties should be ground off and replaced.			
Criticality: P3			
Risk if NOT Performed: Pendants in the panel will veer out of alignment without ties supporting its placement.			
EKP Comments:			
<p>Photos:</p>

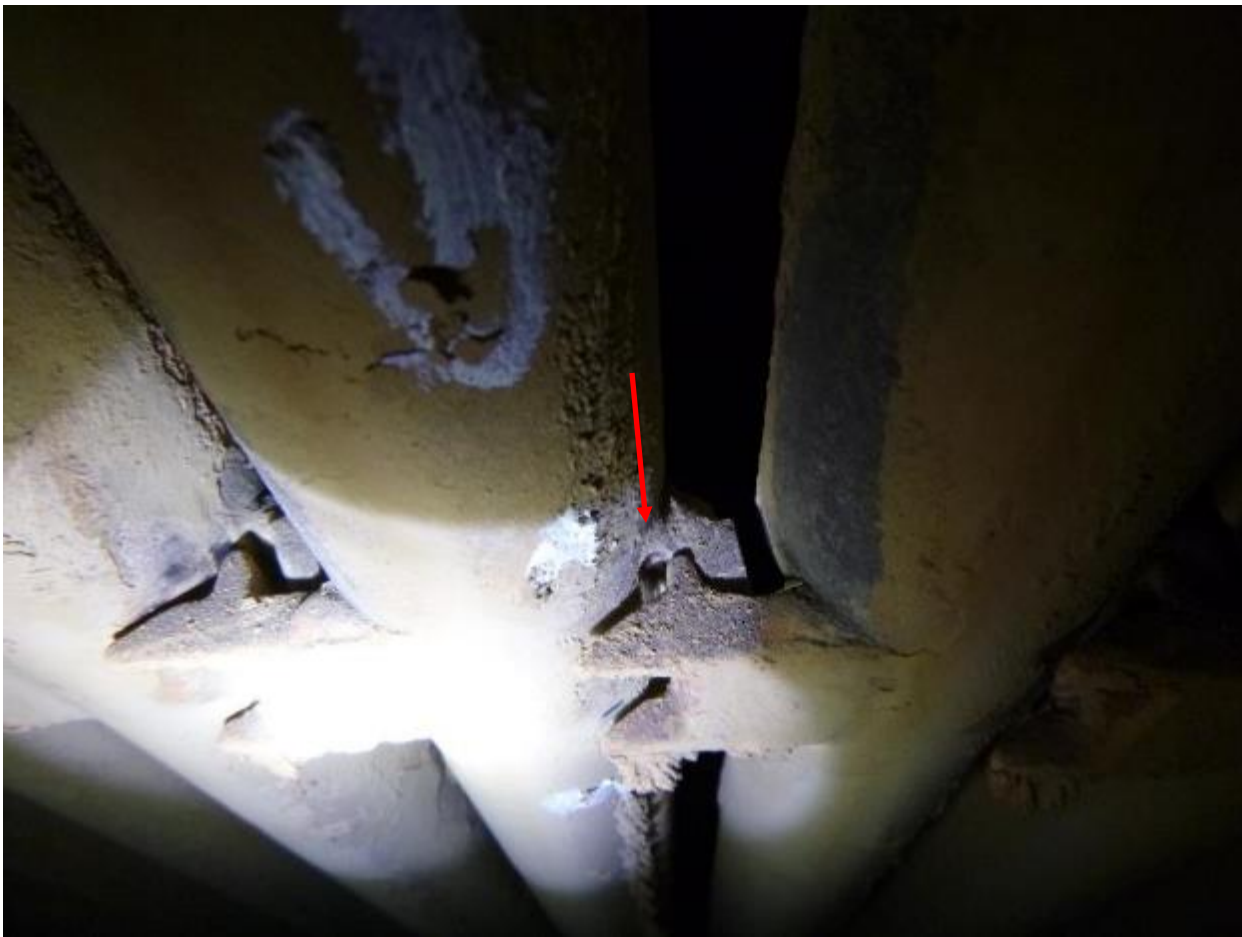
Date: 05/15/2023	Inspected by: B&W RJP	Unit: 2	Item: SHDIVPAN 2
Component Inspected: SH Division Panels, Landing 4, Front Panel #6			
Condition Assessment: Minor to moderate wear was found at the weld of the flex tie on the left-hand side on Pendant 48.			
Recommendations: Monitor condition for future outages.			
Criticality: P3			
Risk if NOT Performed: Wear may result into a damaged clip or pad weld.			
EKP Comments:

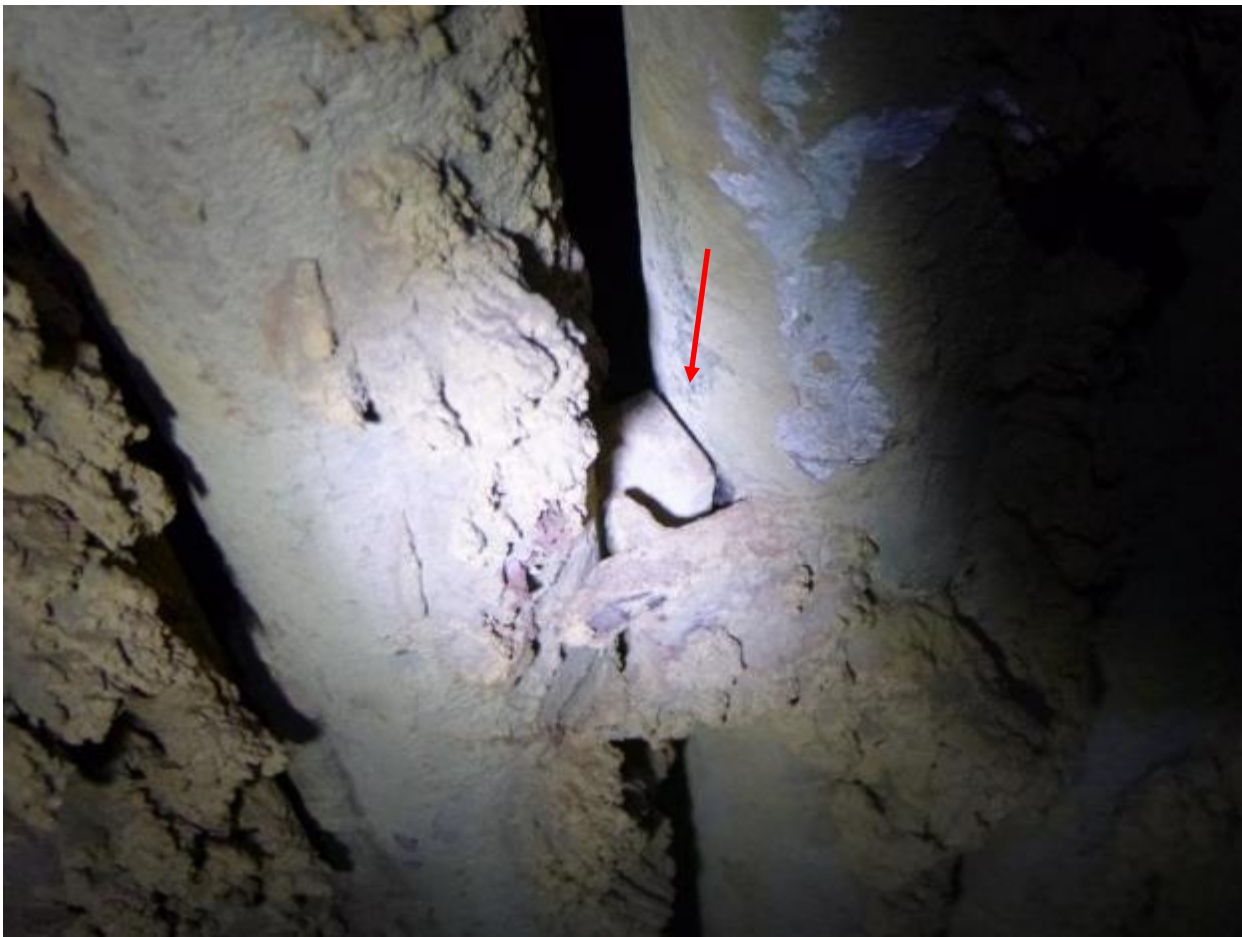
Date: 05/15/12023	Inspected by: B&W RJP	Unit: 2	Item: SHDIVPAN 3
Component Inspected: SH Division Panels, Landing #3, Front Panel #5			
Condition Assessment: Moderate to heavy wear from the flex tie rubbing on the left-hand side of Pendant 4.			
Recommendations: Pad weld wear and replace flex ties.			
Criticality: P1			
Risk if NOT Performed: Further material loss will occur and potentially result in a dutchman replacement.			
EKP Comments:

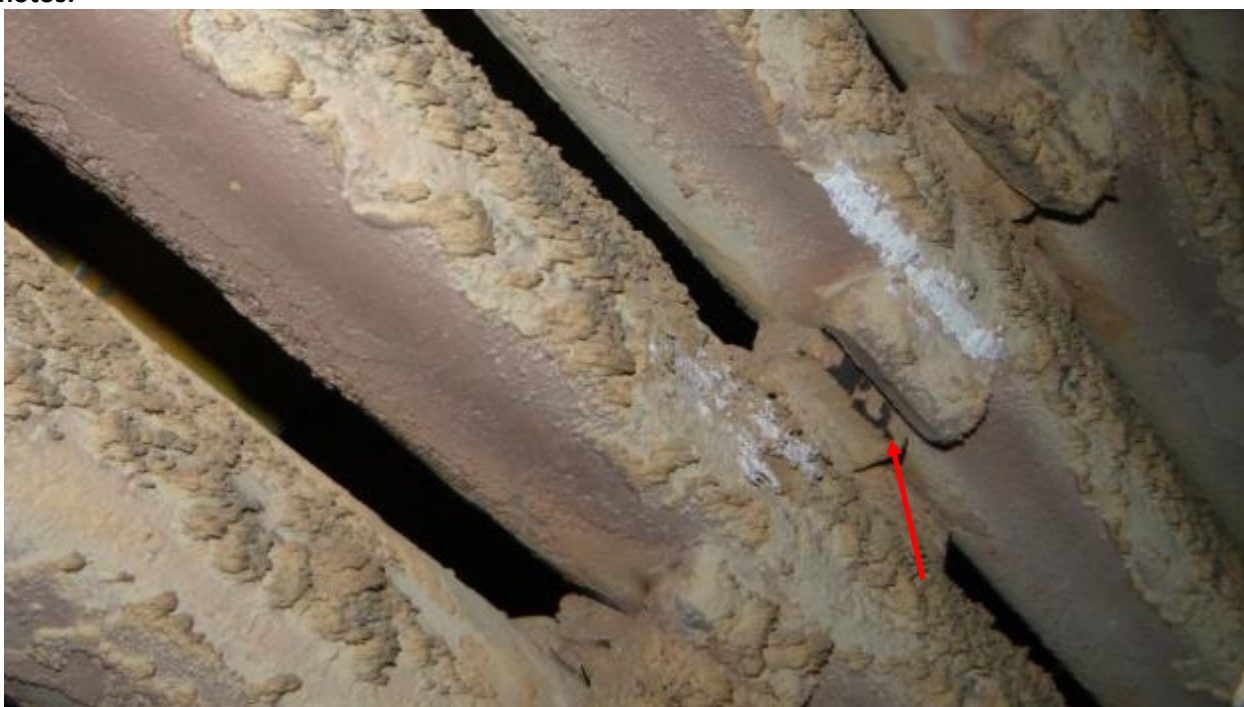
Date: 05/15/2023	Inspected by: B&W RJP	Unit: 2	Item: SHDIVPAN 4
Component Inspected: SH Division Panels			
Condition Assessment: Landing #3, Front Panel #5 There was minor to moderate rubbing on the left-hand side of pendant 73 from the flex tie. Landing #6, Rear Panel #6 There was minor to moderate rubbing on pendants Tube 74 and 75 from the flex tie.			
Recommendations: Remove clip and UT for material loss. May result in pad weld.			
Criticality: P2			
Risk if NOT Performed: Further material loss could result in dutchmen if issue persists.			
EKP Comments:

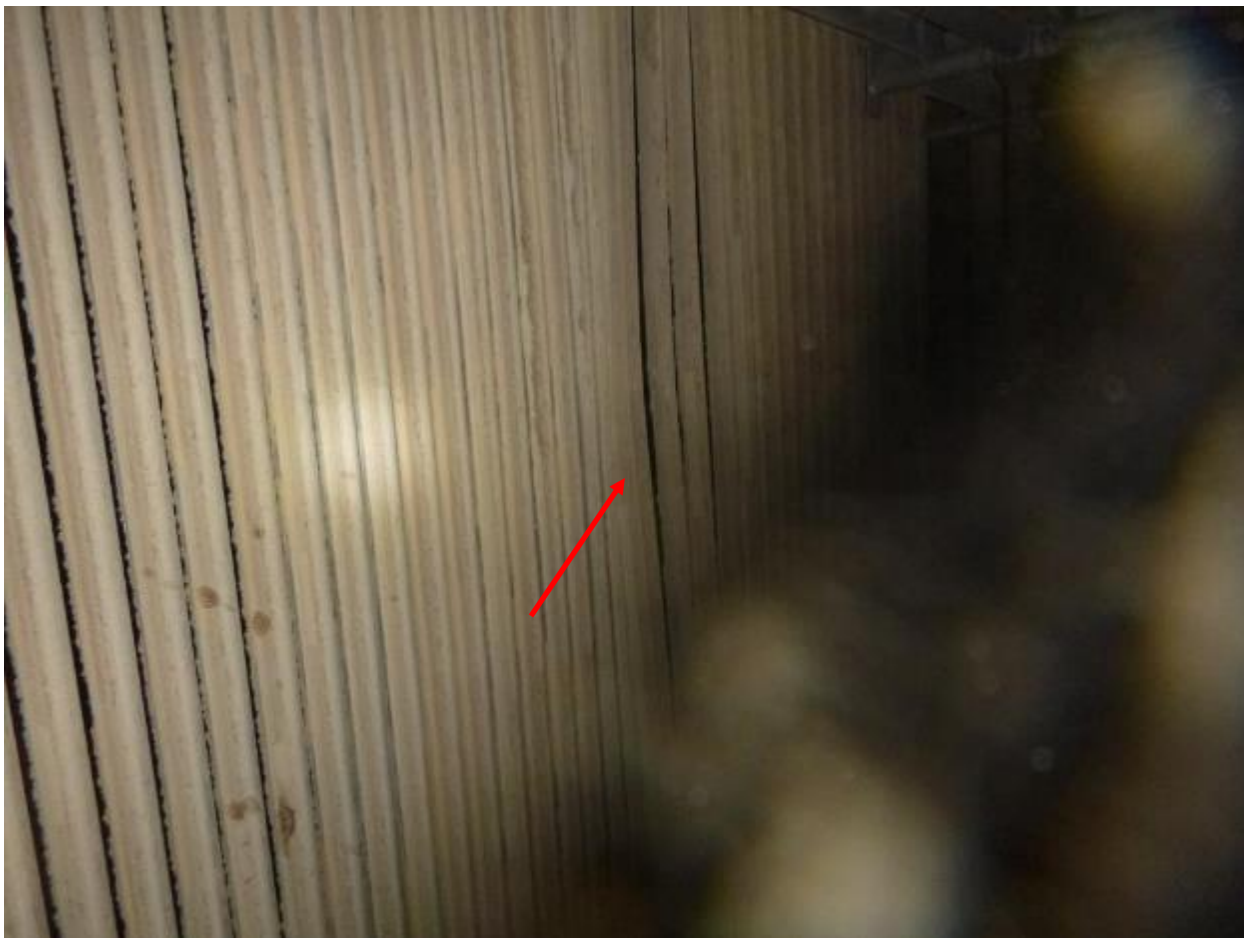
Date: 05/15/2023	Inspected by: B&W RJP	Unit: 2	Item: SHDIVPAN 5
Component Inspected: SH Division Panels, Landing #3, Rear Panel #6			
Condition Assessment: There was moderate bowing at pendants 60-65.			
Recommendations: Monitor condition for future outages.			
Criticality: P3			
Risk if NOT Performed: Pendants may continue bow.			
EKP Comments:

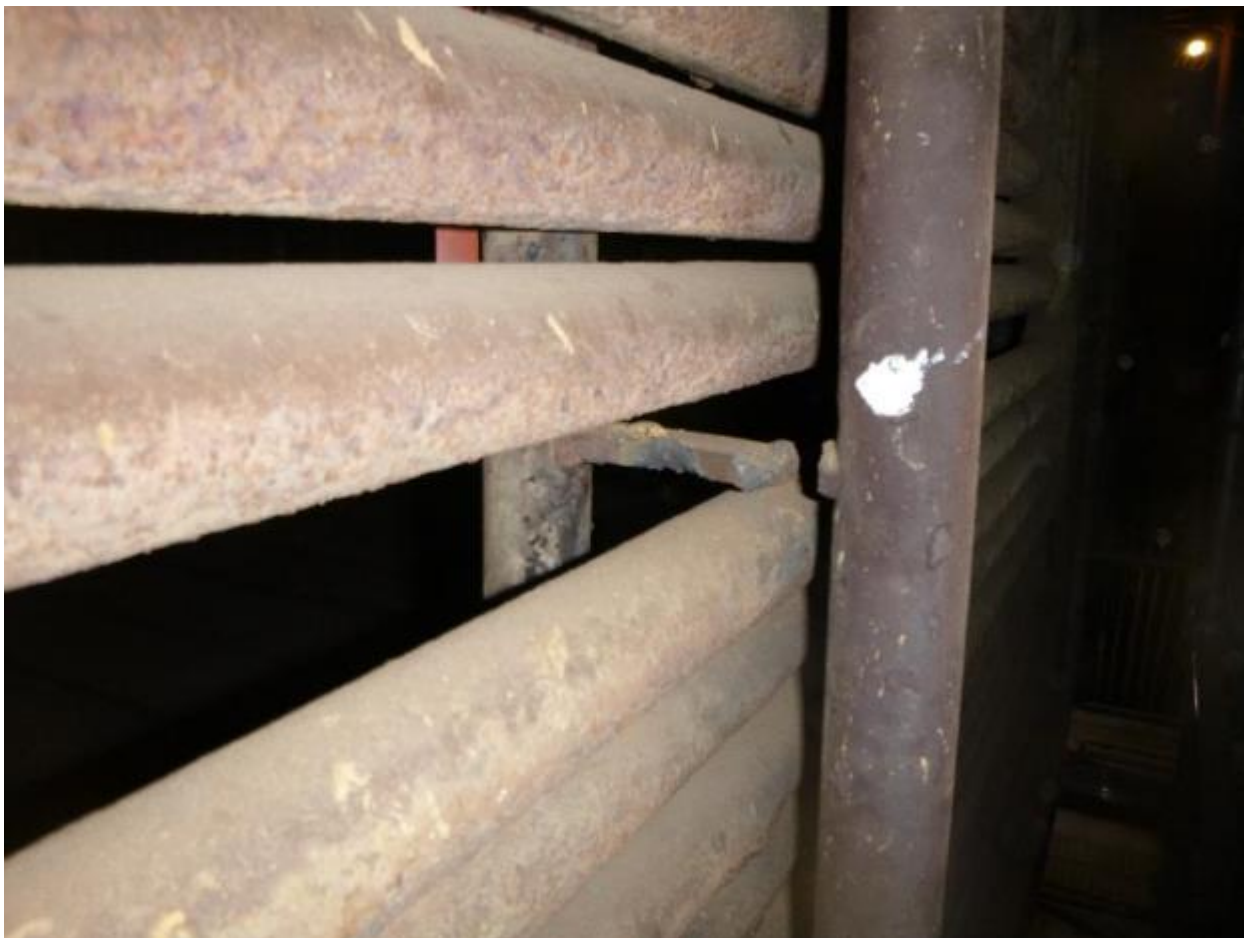
Date: 05/15/2023	Inspected by: B&W RJP	Unit: 2	Item: SHDIVPAN 7
Component Inspected: SH Division Panels, Landing #1, Rear Panel #4			
Condition Assessment: There was a broken alignment lug at the center of the panel.			
Recommendations: Repair weld the broken lug.			
Criticality: P3			
Risk if NOT Performed: Tube misalignment.			
EKP Comments:
