The Babcock & Wilcox Company

**Eastern Kentucky Power Cooperative
Spurlock Station, Unit #2**

U2 SPRING 2023 OUTAGE BOILER INSPECTION REPORT

B&W Project No.: BA9312817

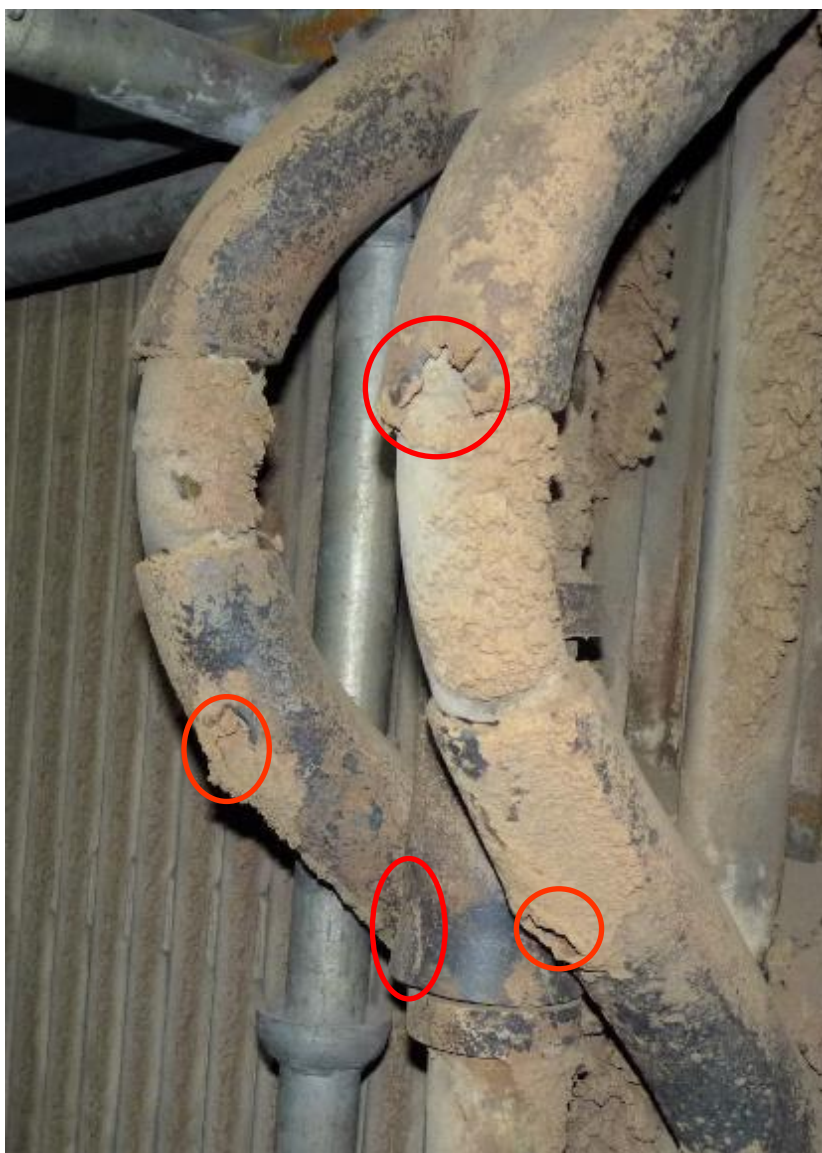
Date: 05/15/2023	Inspected by: B&W BC	Unit: 2	Item: SHDIVPAN 9
Component Inspected: SH Division Panels			
Condition Assessment: Scaffold Level 2: The lower bumper wear sleeves have cracked in multiple locations			
Recommendations: V out the crack with a burr bit, weld the crack and grind the sleeve face flush.			
NOTE: Material of sleeve is unknown. Prior to welding determine material so a proper weld procedure can be used to prevent damage/cracking of the sleeve.			
Criticality: P3			
Risk if NOT Performed: Crack could grow, the sleeve could fail, and the tube could be left unprotected/susceptible to mechanical erosion.			
EKP Comments:

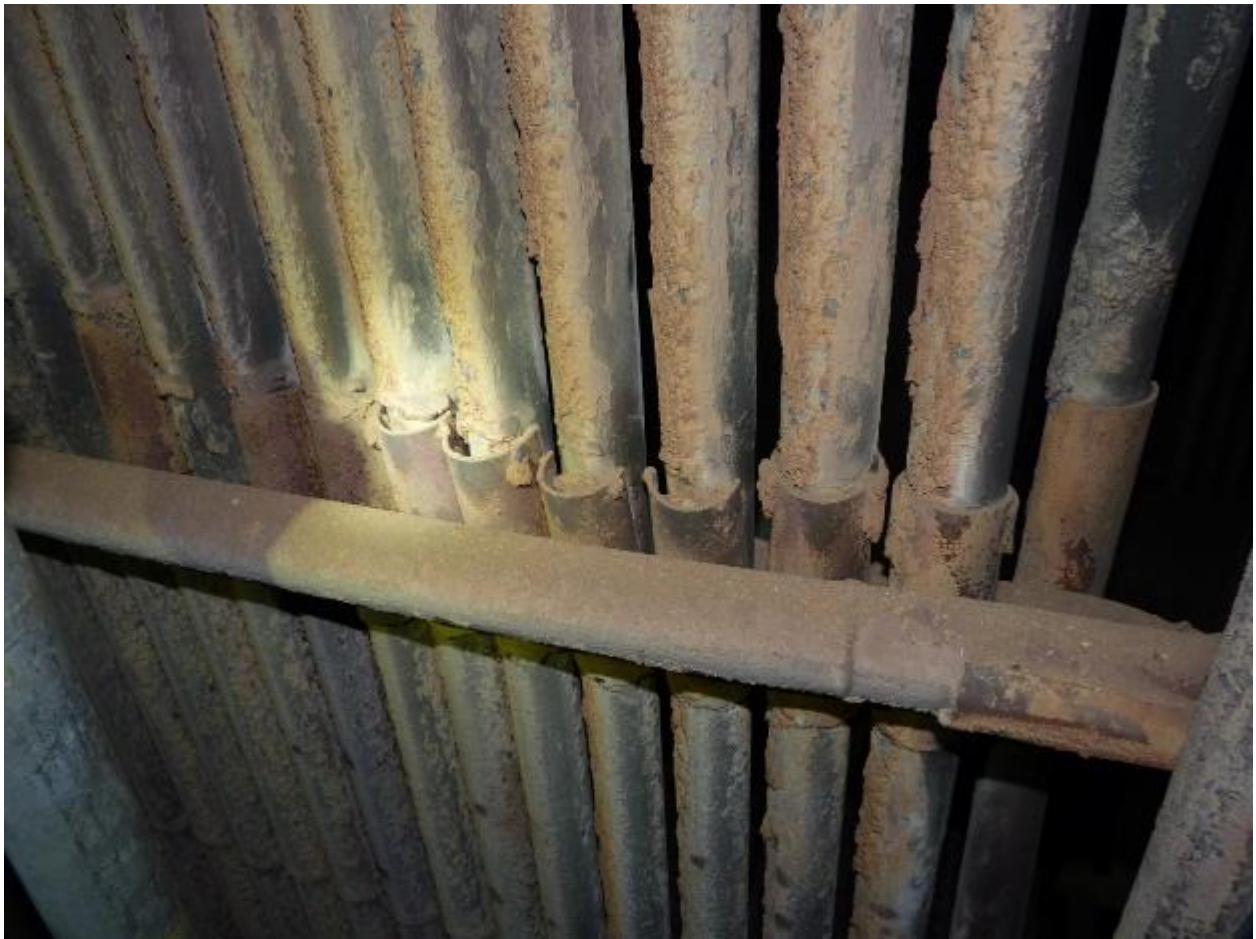
Date: 05/15/2023	Inspected by: B&W BC	Unit: 2	Item: SHDIVPAN 10
Component Inspected: SH Division Panels			
Condition Assessment: Scaffold Level 2: Loose tube shields on the RHS of the Rear tube panel on tubes 72-80. It is possible the shield has fallen from the spacer tube elevation.			
Recommendations: Remove the shield or Repair tube shields			
Criticality: P3			
Risk if NOT Performed: Shield could rub into neighboring tubes.			
EKP Comments:

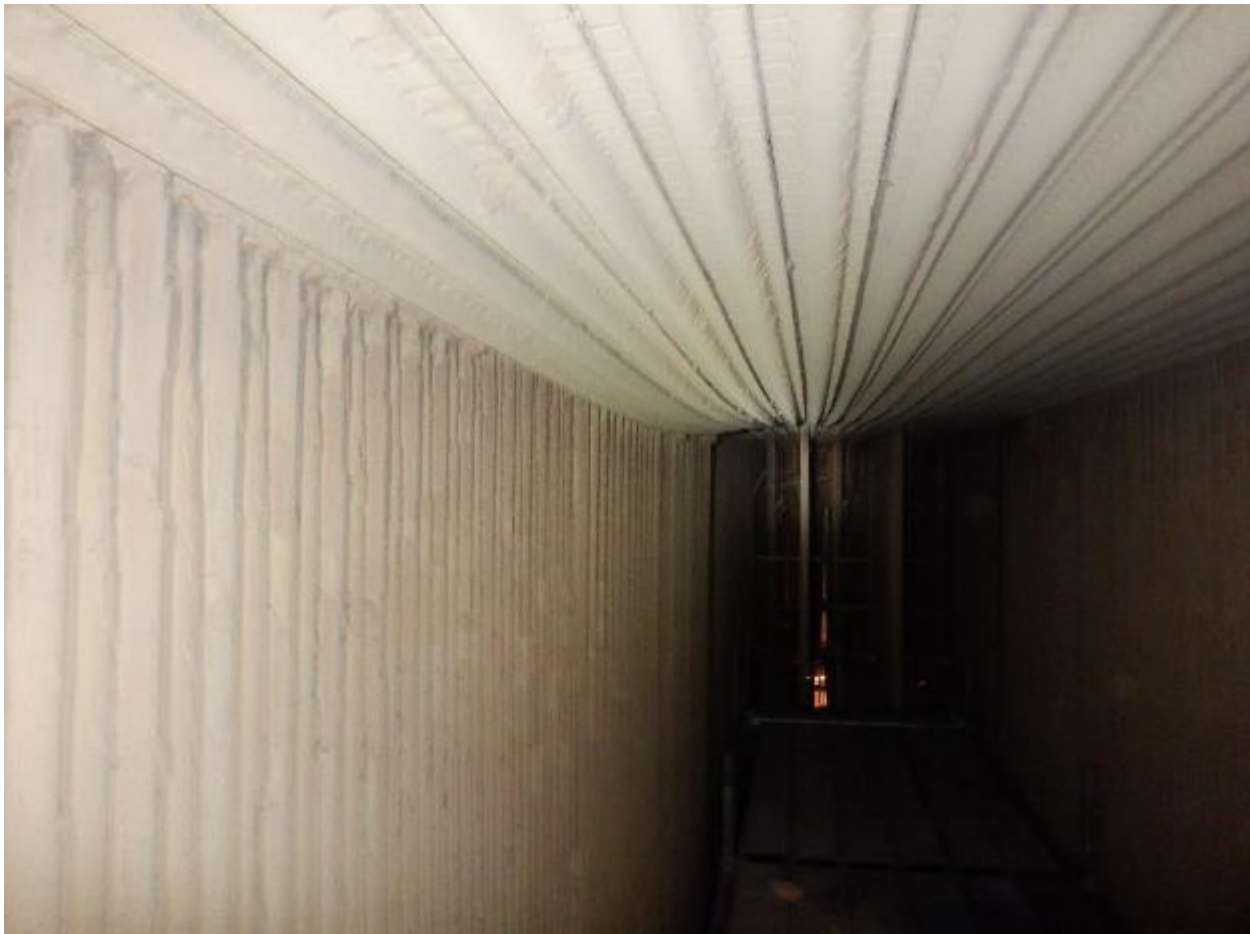
Date: 5/15/2023	Inspected by: B&W - CSH	Unit: 2	Item: RADRHT 1
Component Inspected: Radiant Reheater & Upper Furnace/Dance Floor			
Condition Assessment: Scaffold Level 7: A. The first 10 roof tubes from the LHSW were sagging down approximately 12". B. The first 6 roof tubes from the RHSW were sagging down approximately 4". C. The first 2 tubes on the LHS of division panel 3 were sagging down approximately 2". D. The first tube on the LHS of division panel 4 was sagging down approximately 2". All areas listed above were sagging down from the FW to the front of the SH Pendant Platens.			
Recommendations: Continue to monitor.			
Criticality: Information only.			
Risk if NOT Performed:			
EKP Comments:			
Photos:

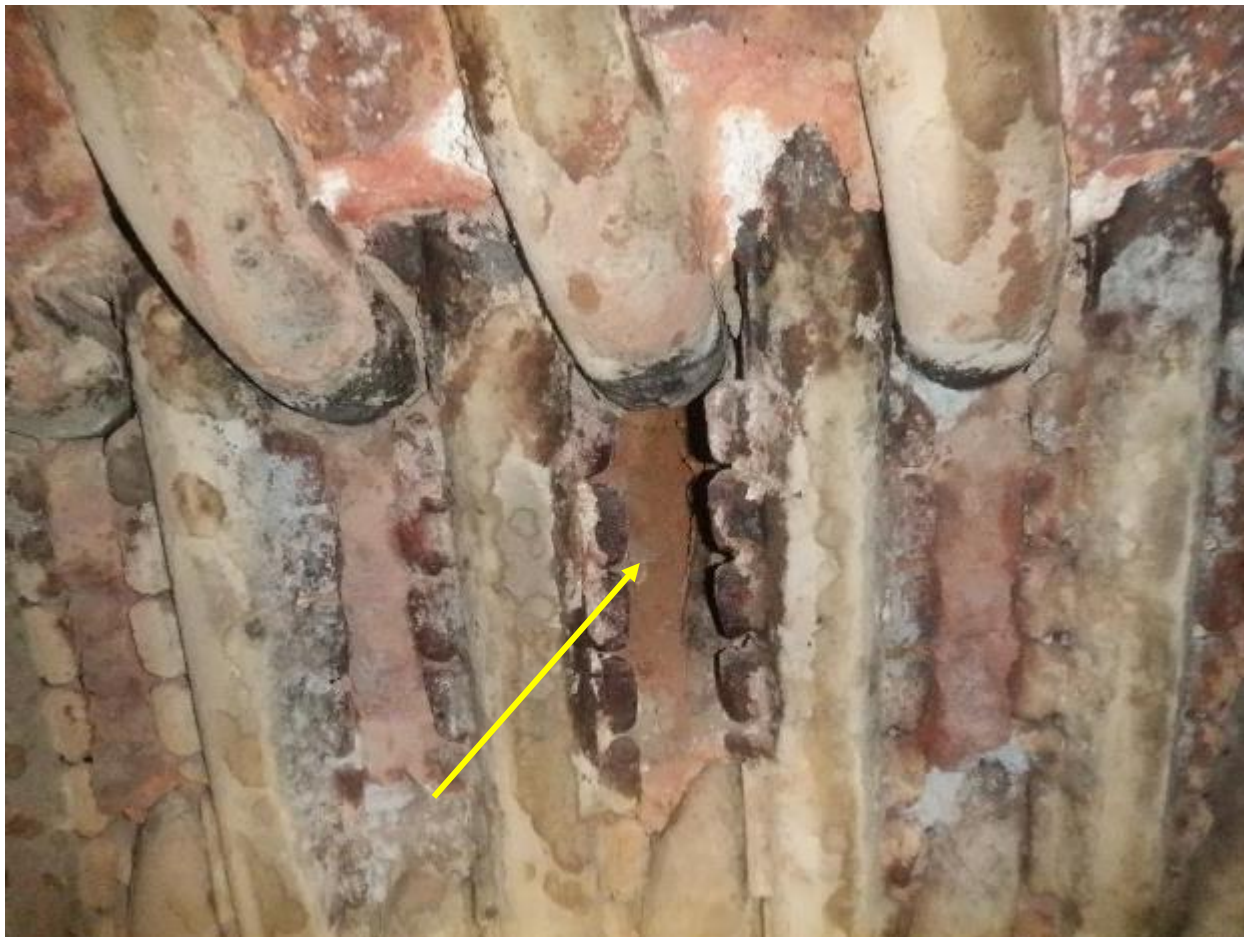
Date: 5/15/2023	Inspected by: B&W -CSH	Unit: 2	Item: RADRHT 2
Component Inspected: Radiant Reheater & Upper Furnace/Dance Floor			
Condition Assessment: Scaffold Dancefloor Level -: There was minor refractory damage at the radiant reheat inlet penetrations. There were portions missing at the FW and LHSW.			
Recommendations: Remove loose refractory and install new at the one location.			
Criticality: P3			
Risk if NOT Performed: The wall seal will continue to deteriorate.			
EKP Comments:

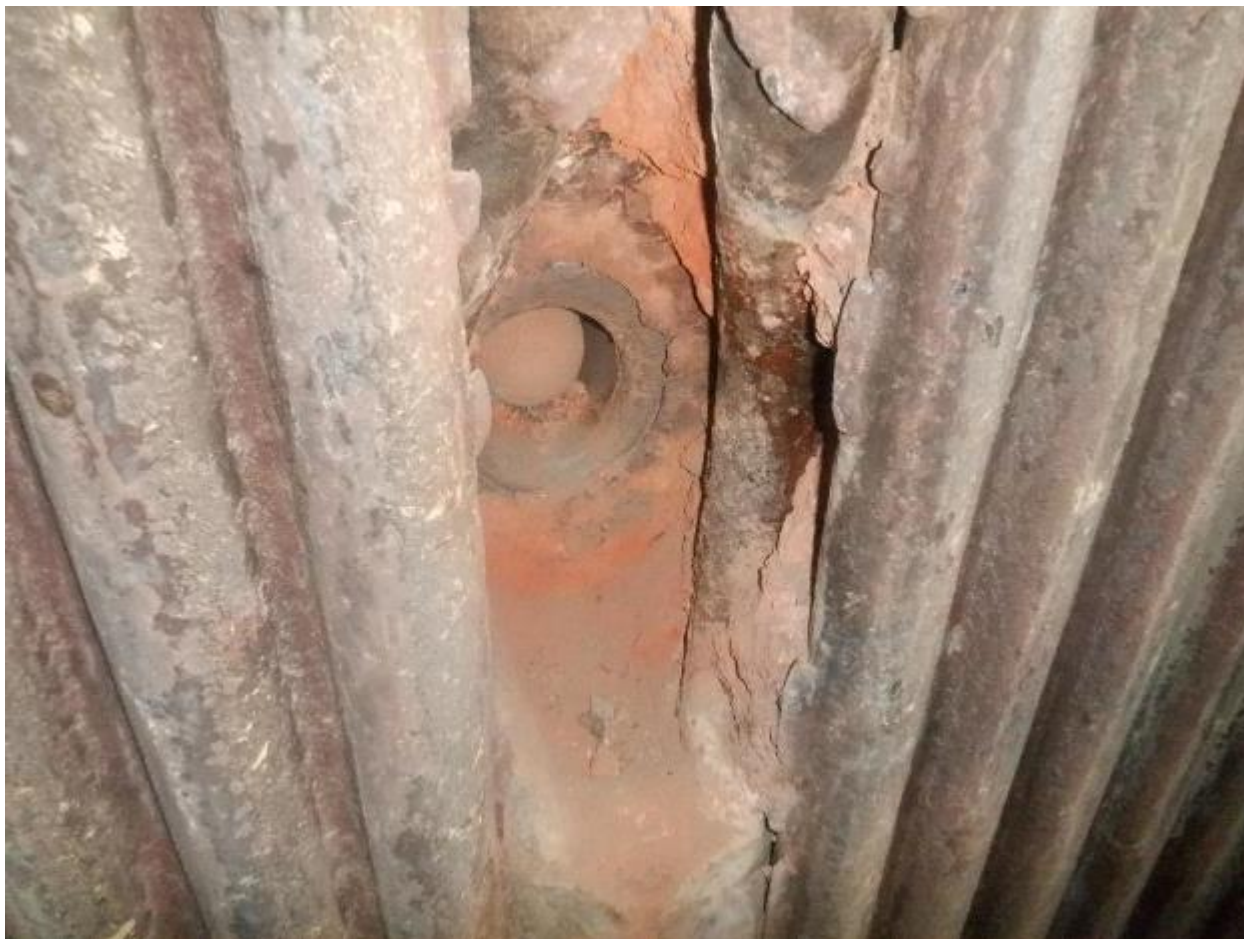
Date: 5/16/2023	Inspected by: B&W	Unit: 2	Item: WW 1
Component Inspected: Water Walls			
Condition Assessment: There was damaged refractory at most IR openings. LHSW: 1-5, 23-27, 45-49, 67, 69 – 71, 89 - 93 RW: 6-11, 28-33, 50-55, 72-77, 95-99 RHSW: 12-16, 34-38, 56-60, 78-80, 82, 101-104 FW: 17-22, 39-40, 42-44, 61-66, 83-84, 86-87, 105-110			
Recommendations: Apply refractory.			
Criticality: P3			
Risk if NOT Performed: If the wallboxes are missing refractory, slag will build further back into the wall boxes and slag covered wall boxes limit the operation of the IR's. Therefore, limiting the cleaning of the waterwall tubes.			
EKP Comments:

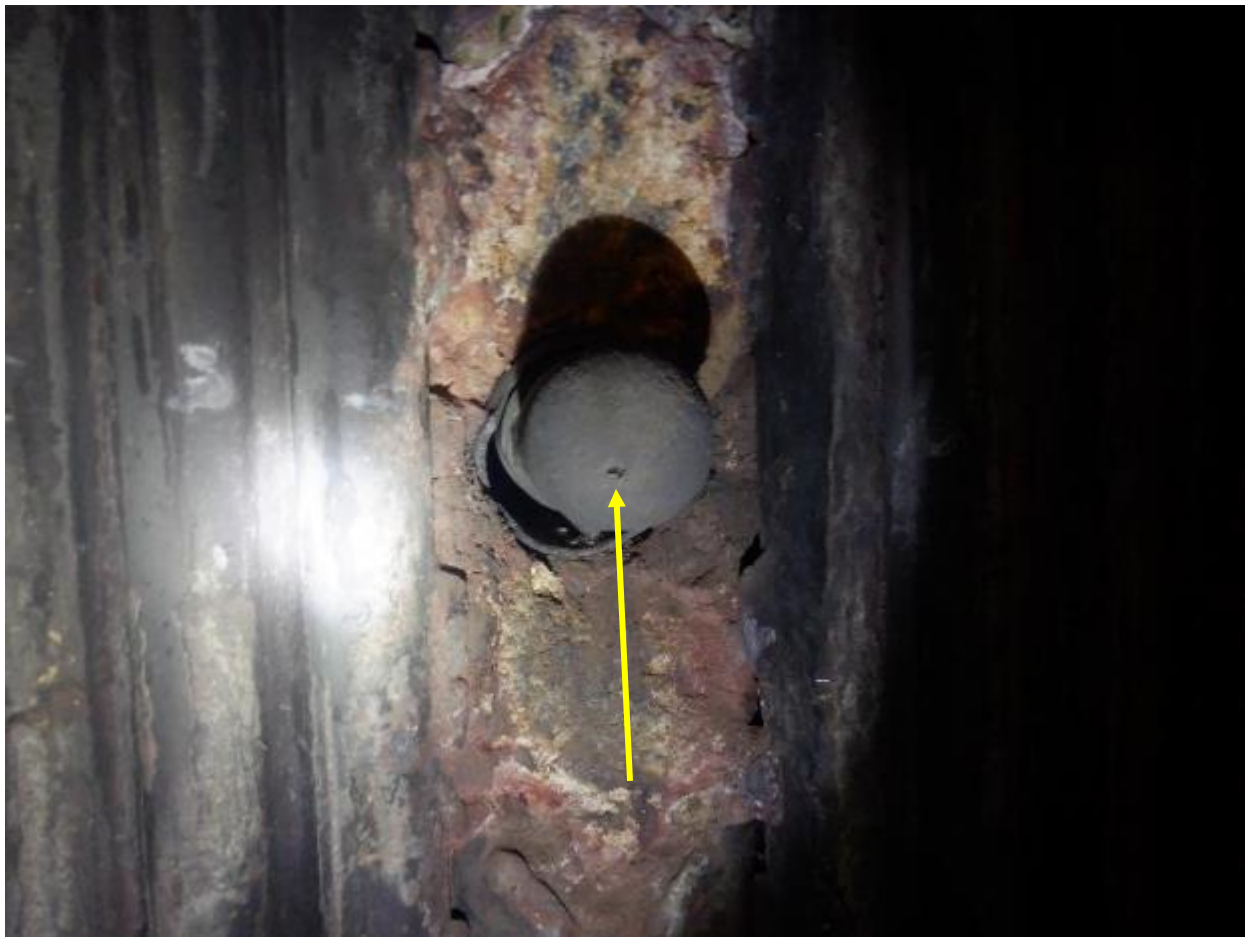
Date: 5/16/2023	Inspected by: B&W	Unit: 2	Item: WW 3
Component Inspected: Water Walls			
Condition Assessment: LHSW Scaffold Level 6: There was a hole in the nozzle at IR 46.			
Recommendations: Replace the IR nozzle.			
Criticality: P3			
Risk if NOT Performed: IF the nozzle tip fails, slag will build up because the IR cannot effectively clean the wall because it is blowing straight into the furnace.			
EKP Comments:

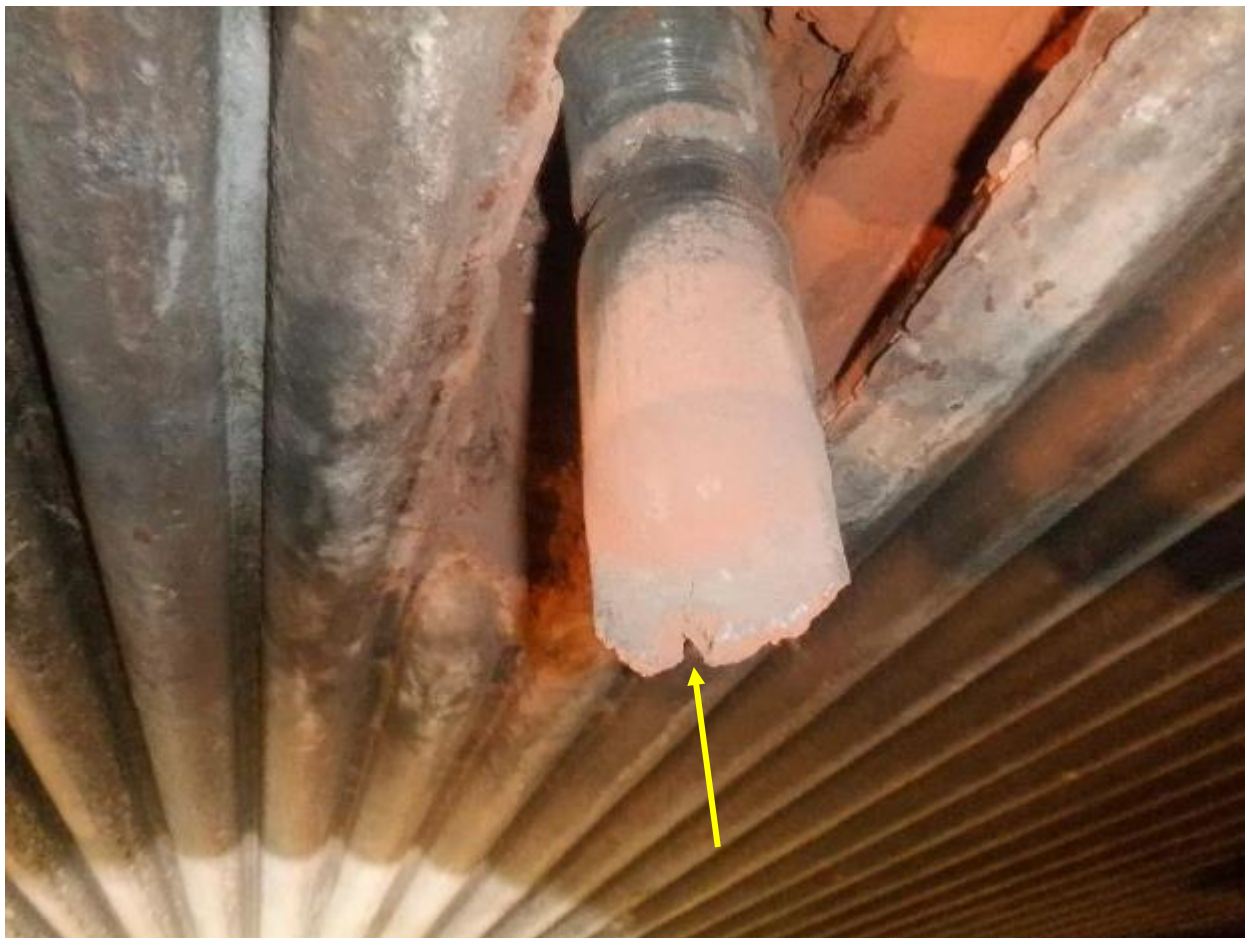
Date: 5/16/2023	Inspected by: B&W	Unit: 2	Item: WW 5
Component Inspected: Water Walls			
Condition Assessment: RW and RHSW Scaffold Level 7: The slag buster points were cracked at IR 30 (RW) and IR 36 (RHSW).			
Recommendations: Replace the IR nozzle.			
Criticality: P3			
Risk if NOT Performed: If the cracked protrudes and the nozzle tip fails, slag will build up because the IR cannot effectively clean the wall because it is blowing straight into the furnace.			
EKP Comments:

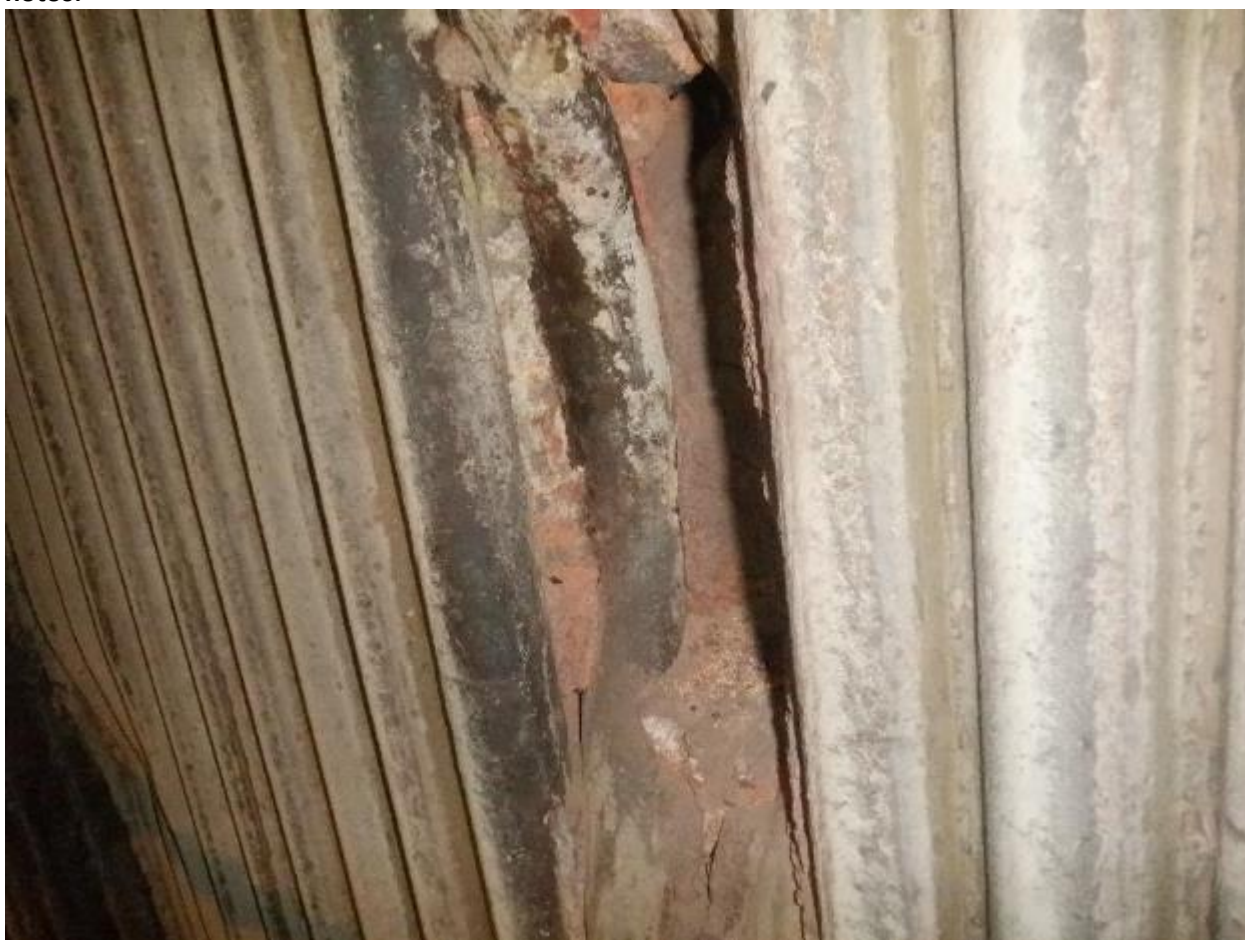
Date: 5/16/2023	Inspected by: B&W	Unit: 2	Item: WW 7
Component Inspected: Water Walls			
Condition Assessment: There was minor refractory damage at the following observation door locations.			
Wall	Location	Scaffold Elevation	
LHSW	At FW and RW corners	7	
FW	At RHSW corner	10	
RW	At RHSW and LHSW corners	10	
RW	At RHSW corner	13	
Recommendations: Replace the refractory.			
Criticality: P3			
Risk if NOT Performed: Refractory will continue to deteriorate and could overheat the wallbox.			
EKP Comments:

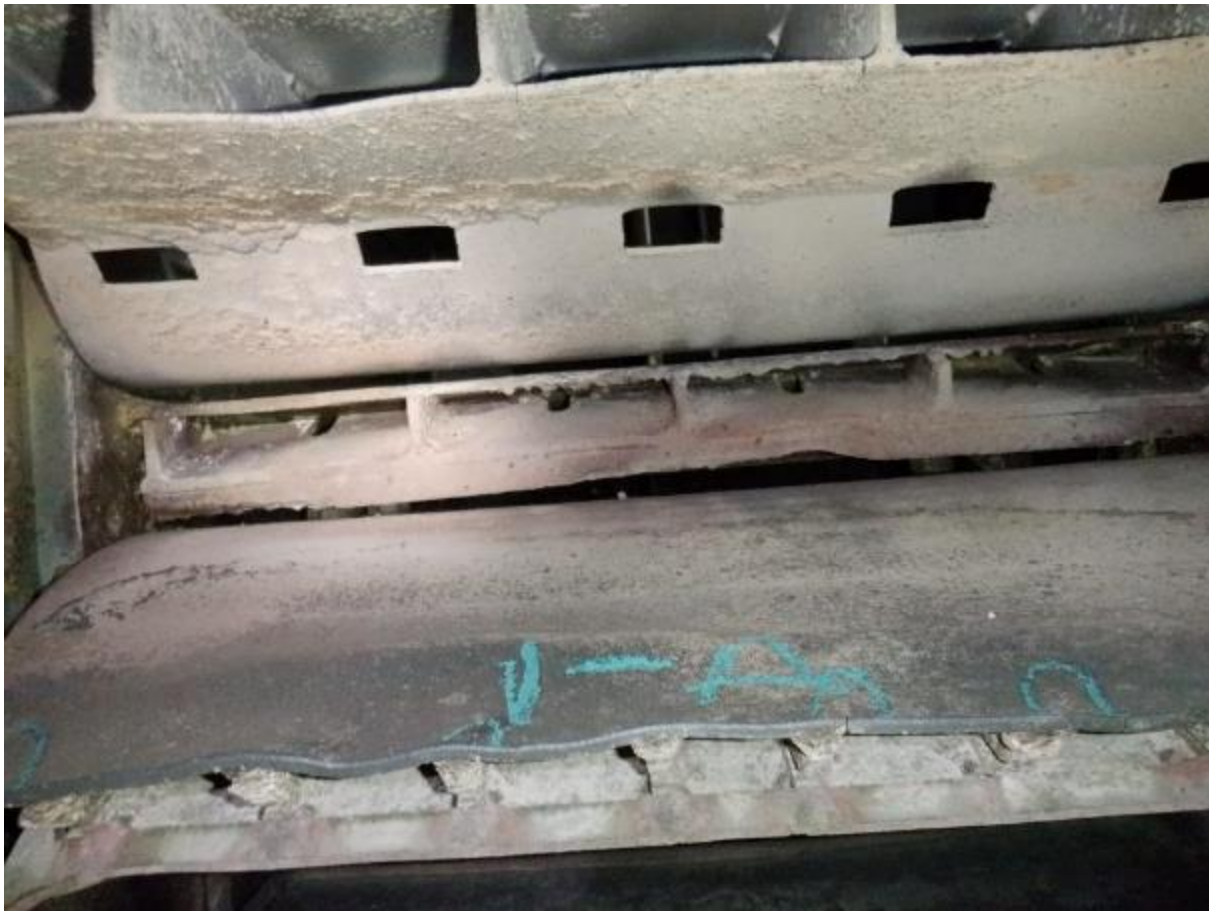
Date: 5/19/23	Inspected by: B&W	Unit: 2	Item: Burner 1
Component Inspected: Burner 1 A			
Condition Assessment: Distortion on the upper seal plate.			
Recommendations: Monitor			
Criticality: P3			
Risk if NOT Performed: Sec air bypassing the burner.			
EKP Comments:

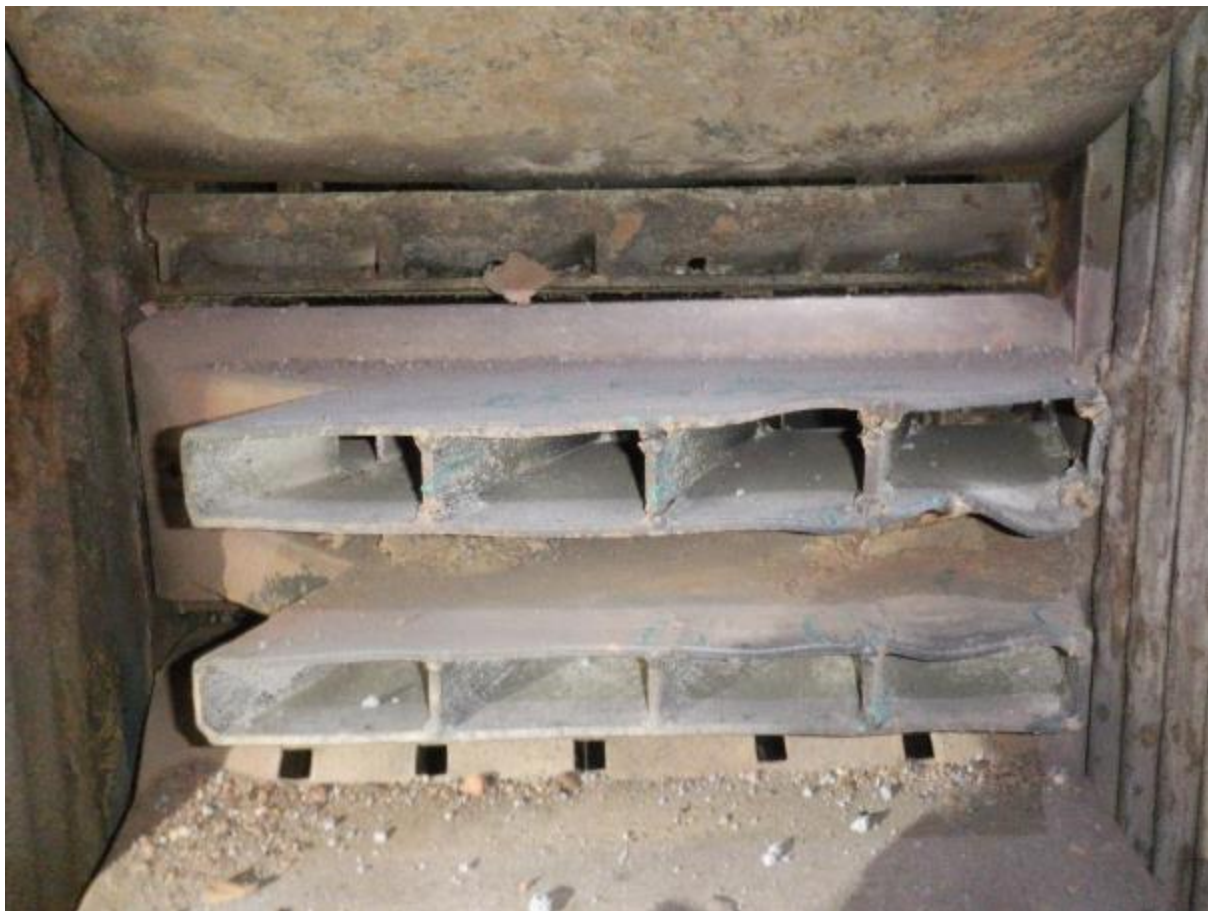
Date: 5/19/2023	Inspected by: B&W	Unit: 2	Item: Burner 2
Component Inspected: CPS Lower and Lower All elevations			
Condition Assessment: The right corners of the top and bottom nozzles are distorted.			
Recommendations: Monitor			
Criticality: P3			
Risk if NOT Performed: Further distortion			
EKP Comments:

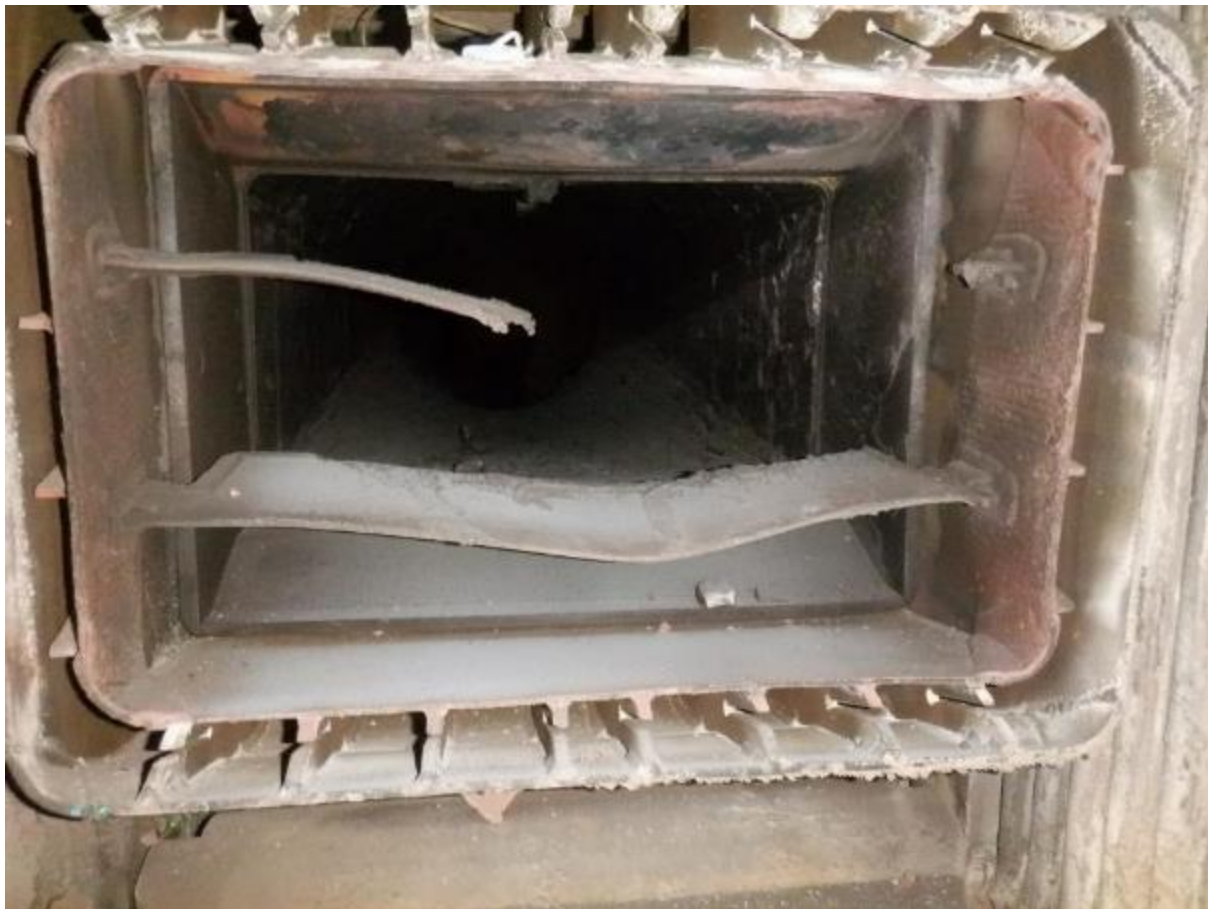
Date: 5/19/2023	Inspected by: B&W	Unit: 2	Item: Burner 3
Component Inspected: 1B Burner			
Condition Assessment: Burner splitter plates are damaged.			
Recommendations: Replace the burner tip			
Criticality: P2			
Risk if NOT Performed: Coal stream will not be distributed properly and combustion performance will degrade.			
EKP Comments:

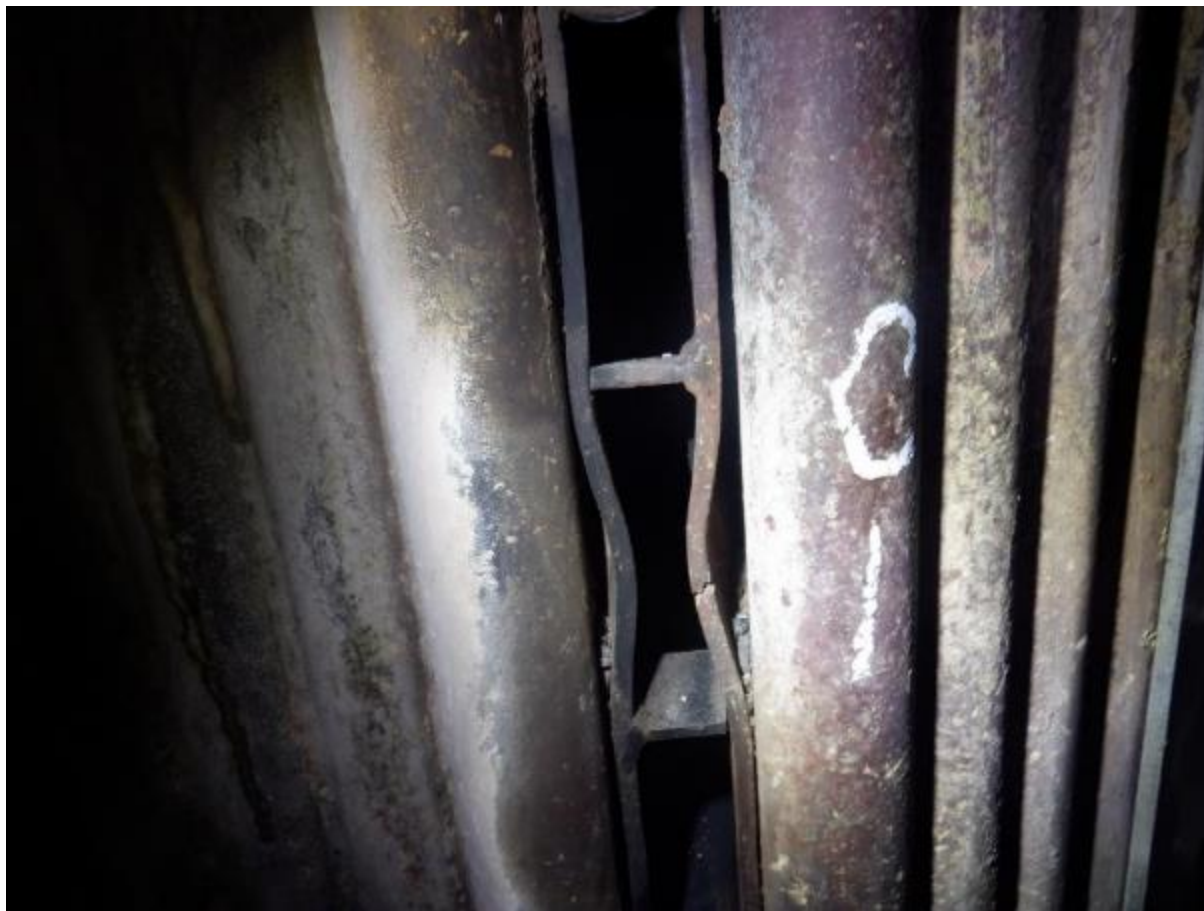
Date: 5/19/2023	Inspected by: B&W	Unit: 2	Item: Burner 4
Component Inspected: 1C& 1E Ignitor			
Condition Assessment: Deformation in the ignitor housing			
Recommendations: Repair the cracks and check the width to ensure the spark rod can insert.			
Criticality: P3			
Risk if NOT Performed: Deformation may worsen and compromise ignitor reliability.			
EKP Comments:

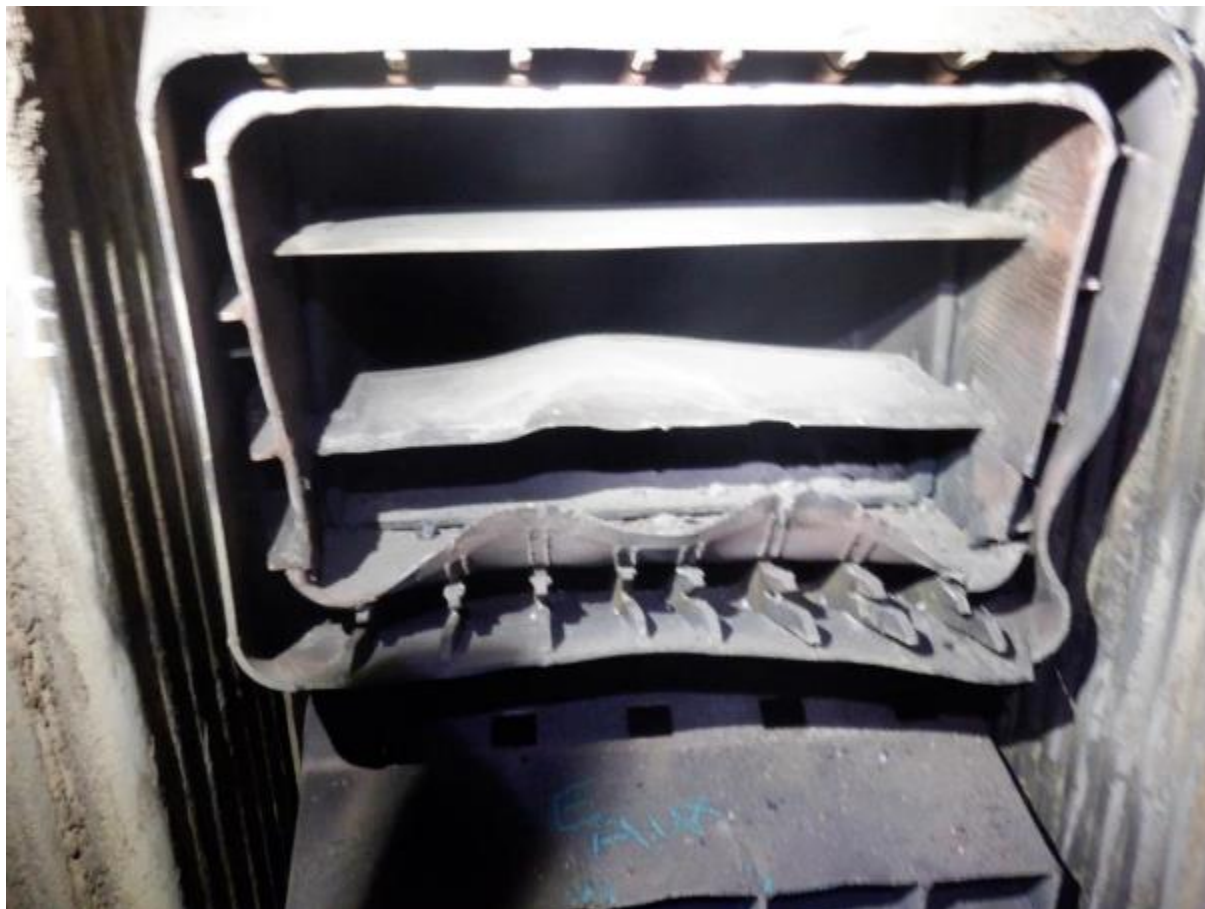
Date: 5/19/2023	Inspected by: B&W	Unit: 2	Item: Burner 5
Component Inspected: 1E Burner			
Condition Assessment: The lower portion of the burner is warped up into the burner.			
Recommendations: Replace the burner tip. If not replacing, replace splitter plates and straighten the bottom of the tip and weld to the stiffeners on the bottom of the plate.			
Criticality: P2			
Risk if NOT Performed: The distortion reduces the coal free flow area and opens the air anulus both changing the combustion characteristics of the burner.			
EKP Comments:

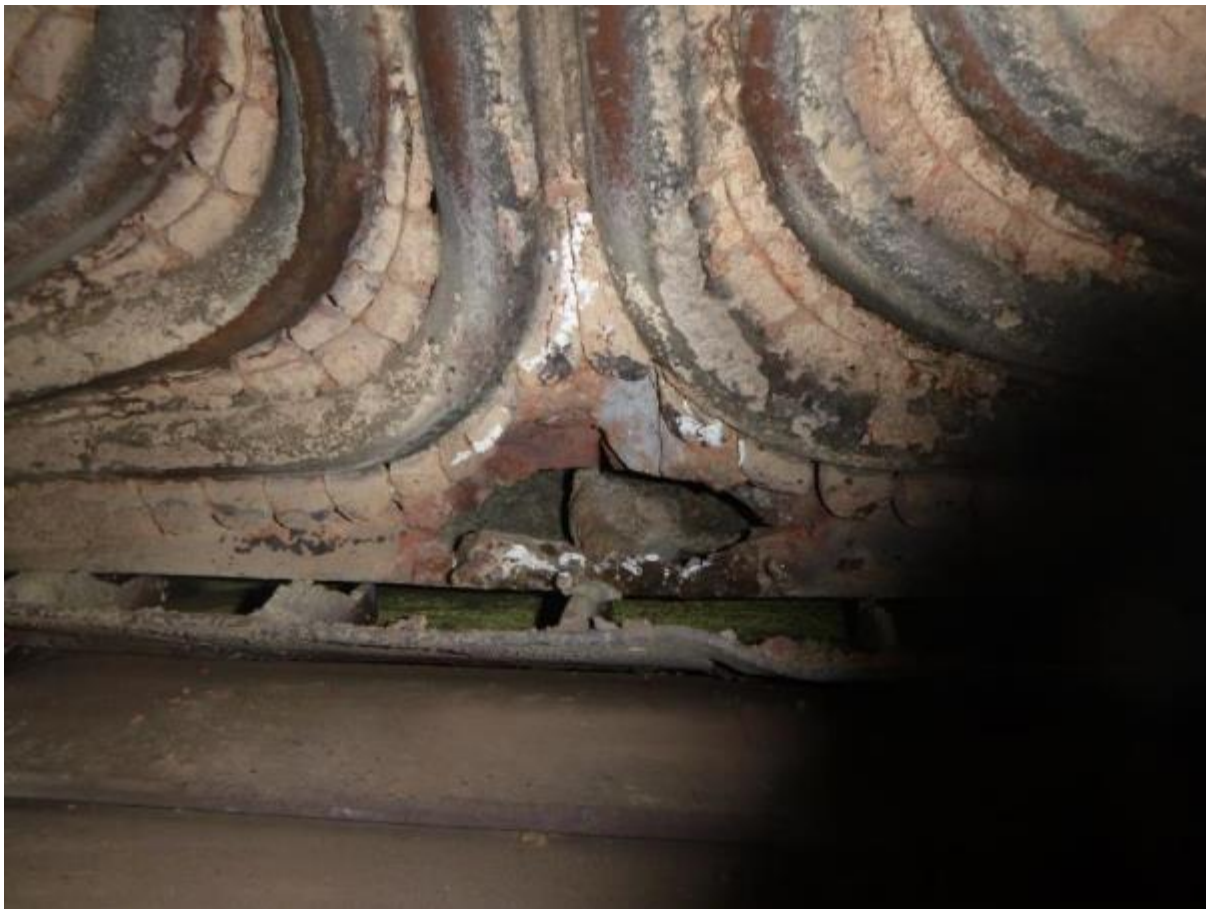
Date: 05/19/2023	Inspected by: B&W RJP	Unit: 2	Item: BURNERS 6
Component Inspected: Corner 2 Burners			
Condition Assessment: Above 2CCOFA Elevation Y refractory was missing and a hole in the upper crotch plate.			
Recommendations: Install new crotch plate and refractory.			
Criticality: P3			
Risk if NOT Performed: Potential for continued damage and windbox to furnace leakage.			
EKP Comments:

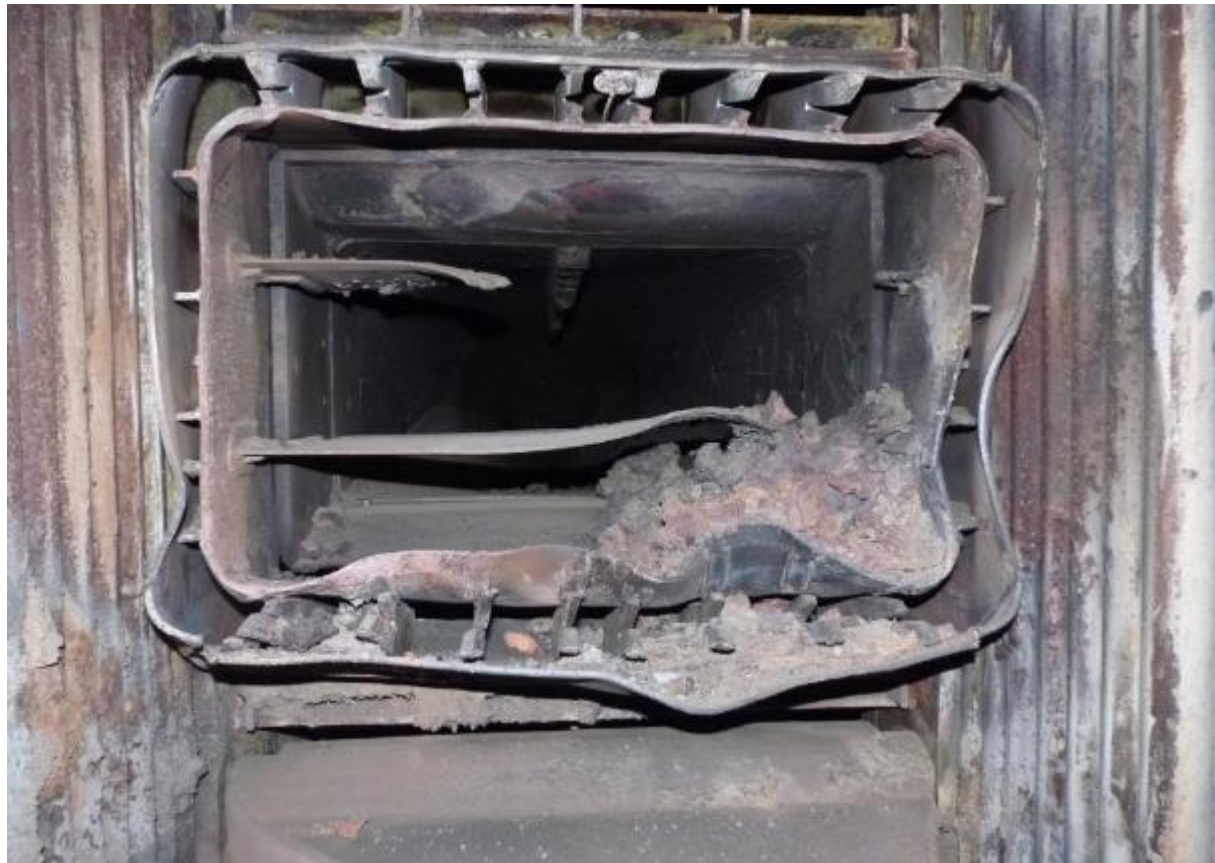
Date: 5/15/2023	Inspected by: BC	Unit: 2	Item: Burner 8
Component Inspected: B3			
Condition Assessment: Splitter plates were found missing and debris has collected in the burner opening			
Recommendations: Replace the burner tip. If not replacing, replace splitter plates and straighten the bottom of the tip and weld to the stiffeners on the bottom of the plate.			
Criticality: P2			
Risk if NOT Performed: Burner fires.			
EKP Comments:

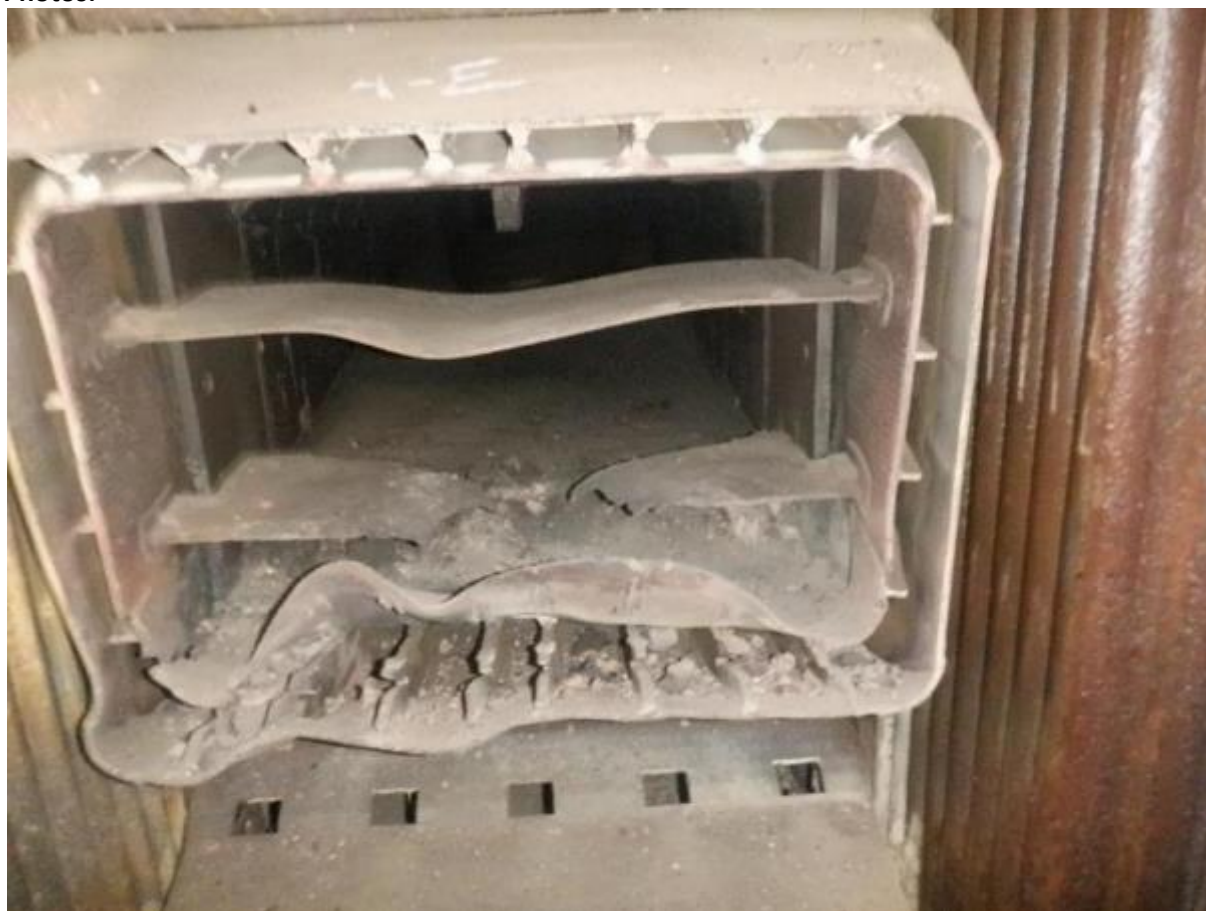
Date: 5/19/2023	Inspected by: B&W	Unit: 2	Item: BURNERS 9
Component Inspected: Burners – Corner 4			
Condition Assessment: 4E burner was severely warped at the bottom and the bottom splitter plate was missing a large portion.			
Recommendations: Replace the burner. If not replacing, replace splitter plates and straighten the bottom of the tip and weld to the stiffeners on the bottom of the plate.			
Criticality: P2			
Risk if NOT Performed: Burner fire.			
EKP Comments:

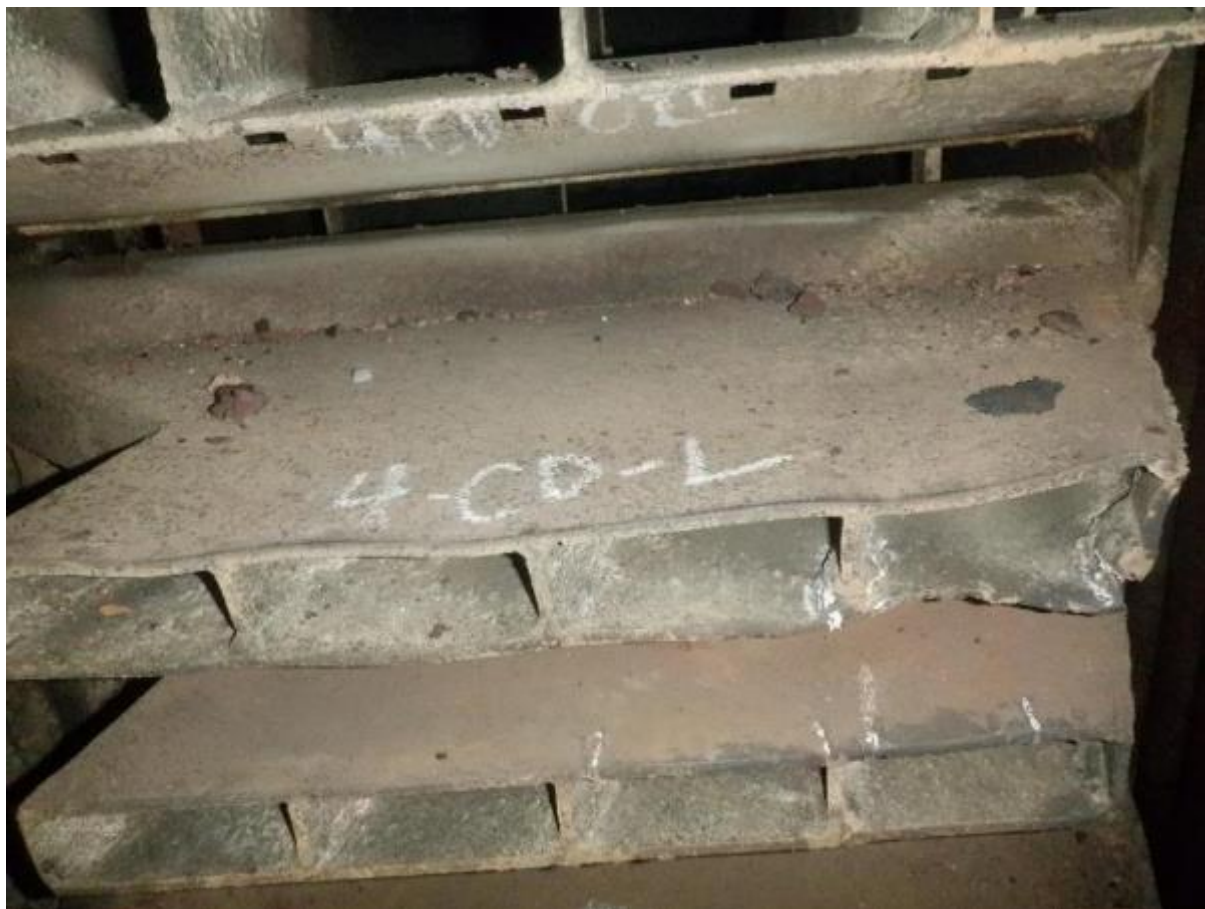
Date: 5/19/2023	Inspected by: B&W -CSH	Unit: 2	Item: BURNERS 10
Component Inspected: Burners – Corner 4			
Condition Assessment: There were cracks in most of the CFS, SOFA, existing burner parts. See the following sheet for locations and sizes of weld repairs.			
Recommendations: Weld the cracks. New plates may be required to straighten the tips.			
Criticality: P2			
Risk if NOT Performed: Burner parts will fail prematurely.			
EKP Comments:

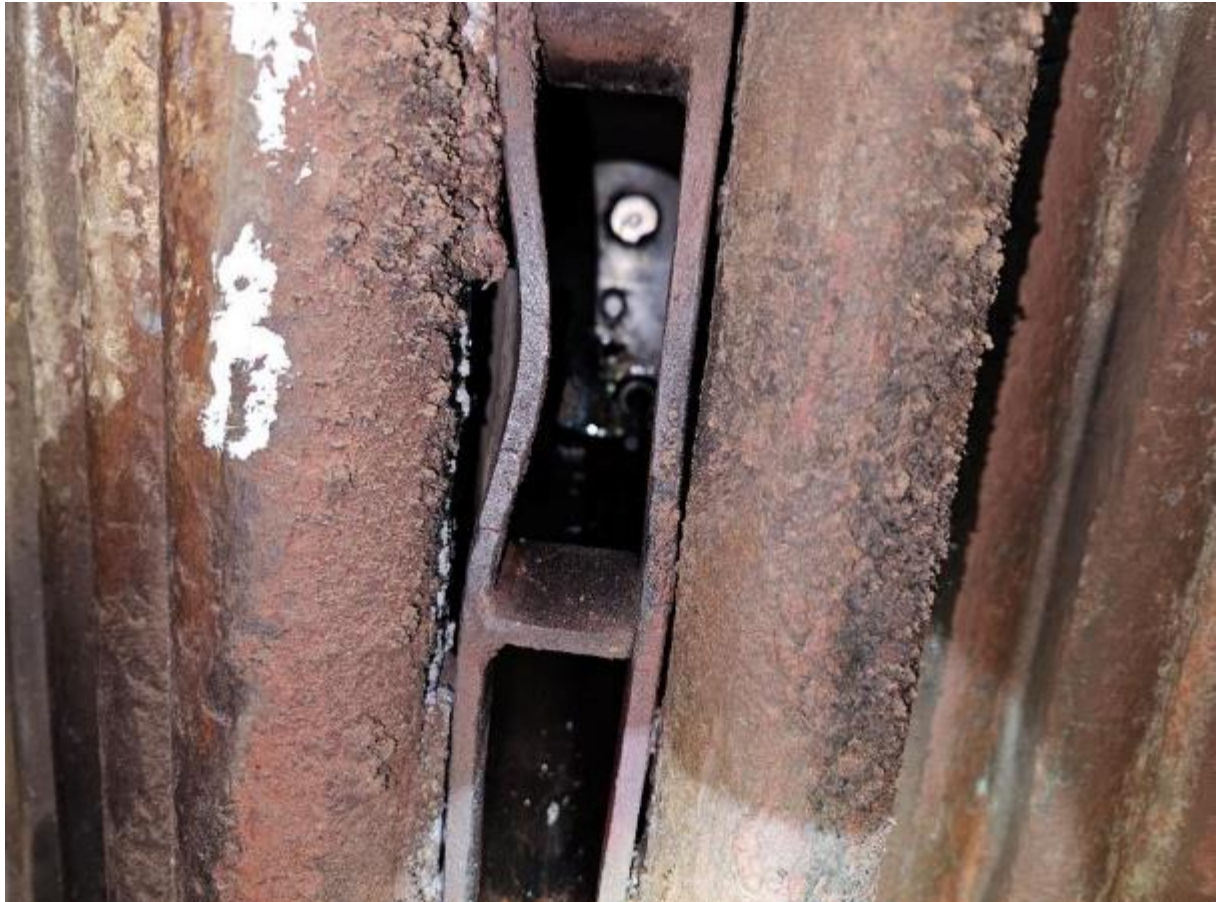
Date: 5/19/2023	Inspected by: B&W	Unit: 2	Item: BURNERS 11
Component Inspected: 4B Ignitor			
Condition Assessment: Fuel oil was dripping from the main ignitor.			
Recommendations: Verify LOTO and that investigate if oil is leaking by.			
Criticality: P3			
Risk if NOT Performed: Fuel oil leaking into the furnace.			
EKP Comments:			
Photos:
