The Babcock & Wilcox Company

**Eastern Kentucky Power Cooperative
Spurlock Station, Unit #2**

U2 SPRING 2023 OUTAGE BOILER INSPECTION REPORT

B&W Project No.: BA9312817

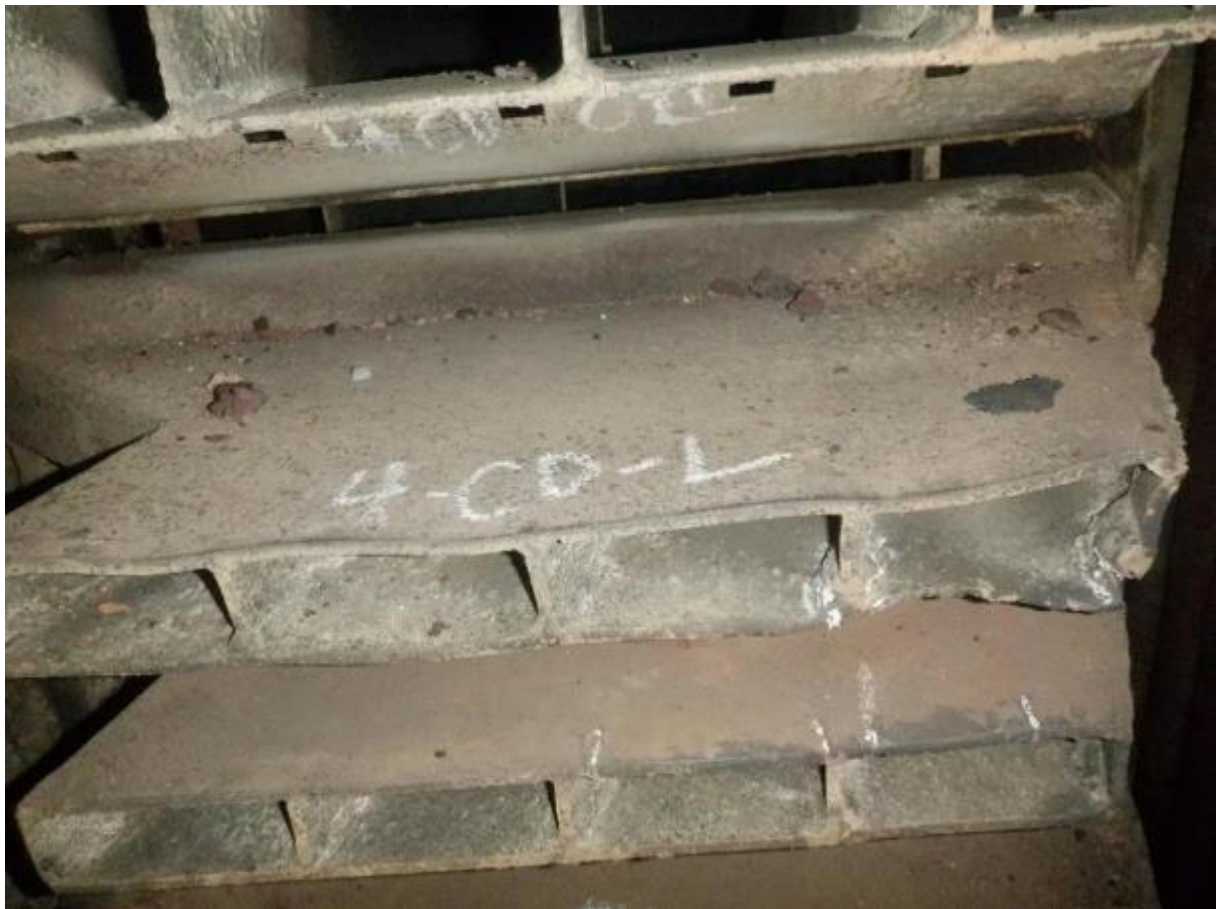
Date: 5/19/2023	Inspected by: B&W -CSH	Unit: 2	Item: BURNERS 13
Component Inspected: Burners – All Corners			
Condition Assessment: There were cracks in most of the CFS, SOFA, existing burner parts. See the following sheet for locations and sizes of weld repairs.			
Recommendations: Weld the cracks. New plates may be required to straighten the tips.			
Criticality: P2			
Risk if NOT Performed: Burner parts will fail prematurely.			
EKP Comments:

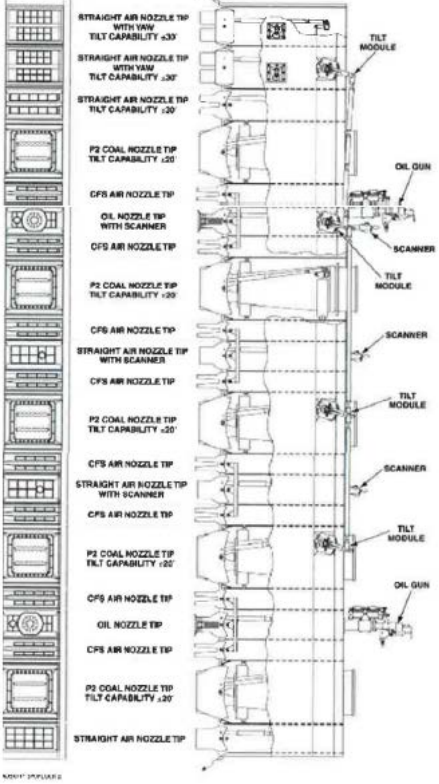
Date		5/19/2023										
Corner		1										
			Crack Length (inches)									
			0.25	0.5	0.75	1	2	3	4	5	6

STRAIGHT AIR NOZZLE TIP WITH 1/4" TILT CAPABILITY ±30°	Y		3						2		
	STRAIGHT AIR NOZZLE TIP WITH 1/4" TILT CAPABILITY ±30°	X	13	3		3						
	STRAIGHT AIR NOZZLE TIP WITH 1/4" TILT CAPABILITY ±30°	AA	13	2		1	1					
	P2 COAL NOZZLE TIP TILT CAPABILITY ±20°	A				9		2				
	CFS AIR NOZZLE TIP	AB		2		5	1				2	
	OIL NOZZLE TIP WITH SCANNER	AB		3			1					
	CFS AIR NOZZLE TIP	AB	2				6		2			
	B1 COAL NOZZLE	B		1							2	
	CFS AIR NOZZLE TIP - UPPER	BC					8		1	1		
	STRAIGHT AIR NOZZLE TIP WITH SCANNER	BC	6	1			1					
	CFS AIR NOZZLE TIP - LOWER	BC	6			1	1					
	C1 COAL NOZZLE	C	REPLACED 2023 OUTAGE									
	CFS AIR NOZZLE TIP - UPPER	CD	2			1						
	STRAIGHT AIR NOZZLE TIP	CD		4								
	CFS AIR NOZZLE TIP - LOWER	CD		2			1	7				
	D1 COAL NOZZLE	D						1		1		
	CFS AIR NOZZLE TIP - UPPER	DE				2						
	OIL NOZZLE TIP	DE

CFS AIR NOZZLE TIP - LOWER	DE										
	E1 COAL NOZZLE	E										
	STRAIGHT AIR NOZZLE TIP	EE		5			6					
Lower plate									1			
Total Cracks			42	26	0	22	26	10	3	4	4	
Linear Inches Crack			10.5	13	0	22	52	30	12	20	24	183.5

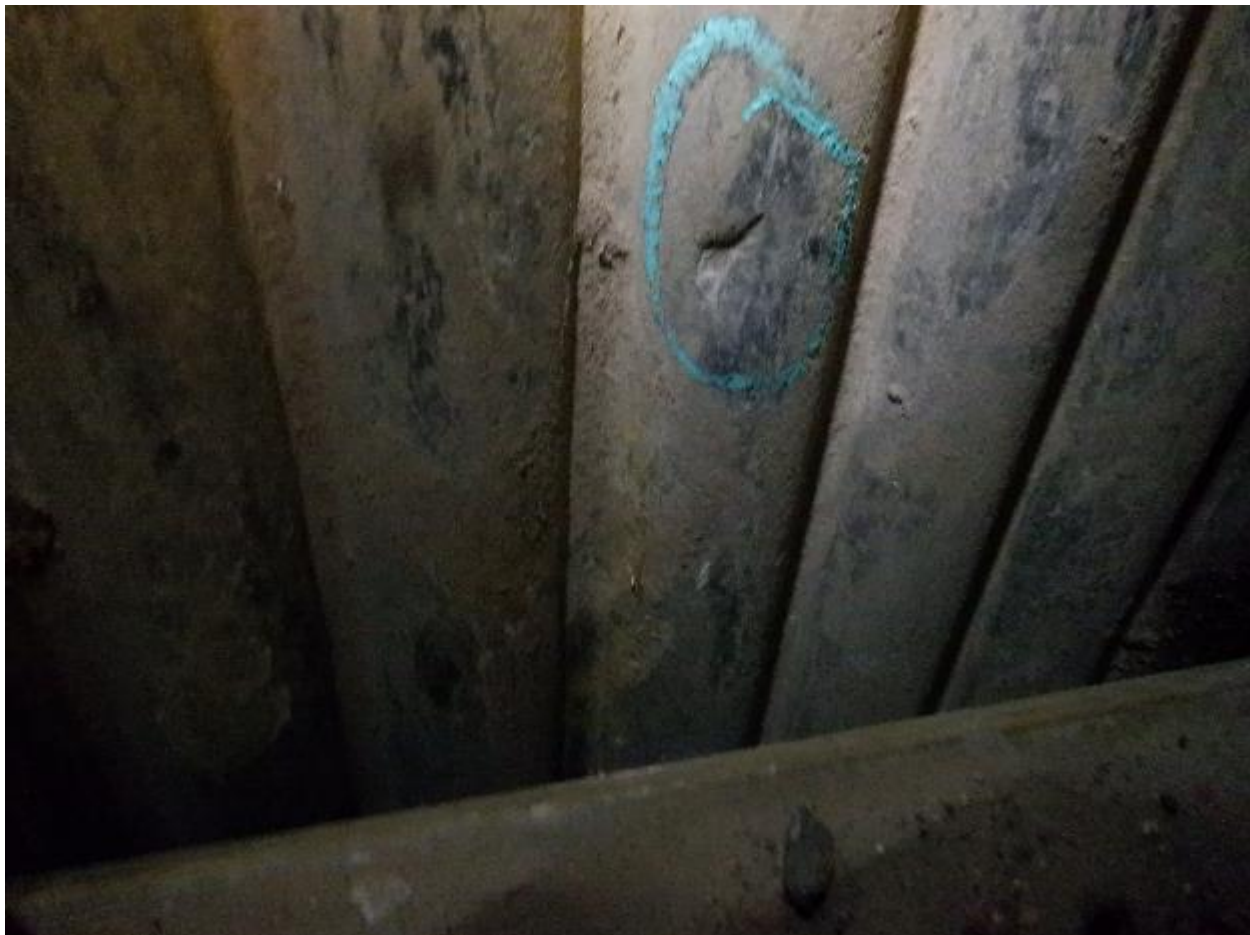
Date: 5/16/23	Inspected by: B&W ECC	Unit: 2	Item: CSLOPES 2																							
Component Inspected: Coutant Slopes																										
Condition Assessment: Rear Slope – Minor Gouges were discovered throughout and the worst are listed below:

Tube #	Height from Nose of Slope	Priority	88	30"	2	140	30"	3	125	24"	3	128	24"	3	140	30"	3	167	5'	3	276	10'	2	
Tube #	Height from Nose of Slope	Priority																								
88	30"	2																								
140	30"	3																								
125	24"	3																								
128	24"	3																								
140	30"	3																								
167	5'	3																								
276	10'	2																								
Recommendations: Grind smooth and install light pad welds over gouges. Slope tubes are 2.00" OD x .220" MW SA210-A1																										
Criticality: Per list above																										
Risk if NOT Performed: Tube leaks if erosion or another gouge occurs at the existing thinner locations.																										
EKP Comments:																										
Photos:

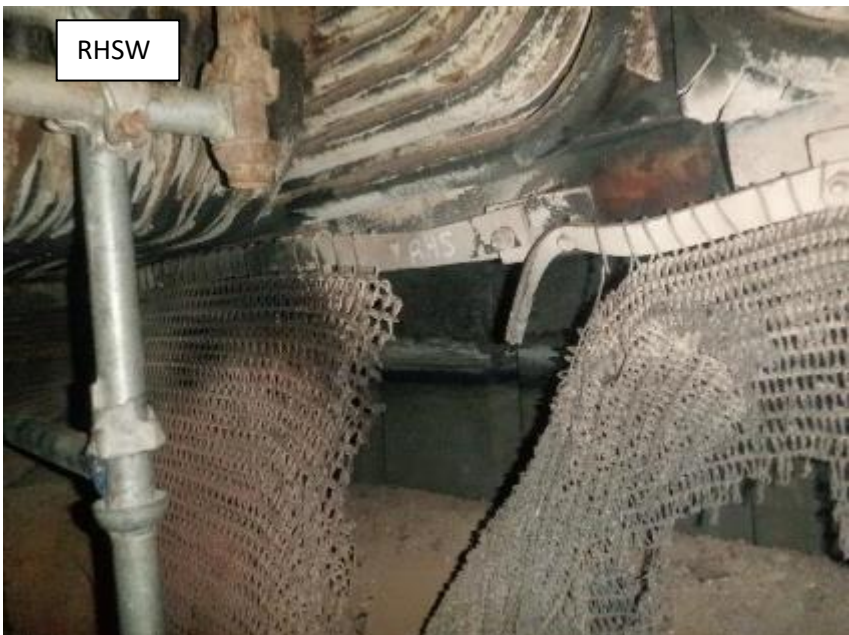
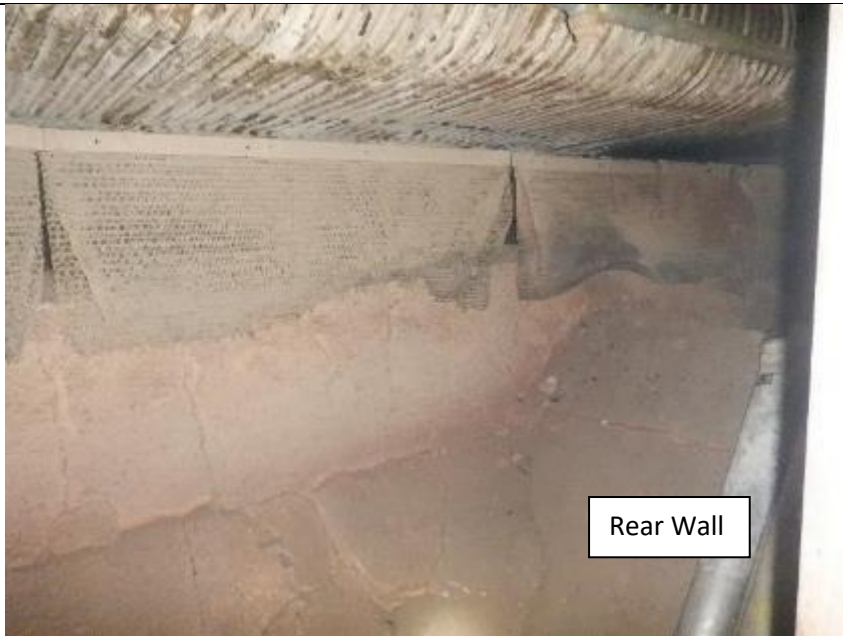
Date: 5/16/2023	Inspected by: B&W	Unit: 2	Item: ASHHOP 1
Component Inspected: Ash Hopper and Throat Tubes from Dance Floor			
Condition Assessment: There was minor damage to the drip screens at the LHSW, the front and rear slopes. The drip screens at the RHSW were damaged with about ½ of the drip screens missing. The drip screens have been overheated.			
Recommendations: Replace the two (2) drip screens and continue to monitor the others.			
Criticality: P3			
Risk if NOT Performed: Seal skirt and trough are left open for ash to enter.			
EKP Comments:			
Photos:

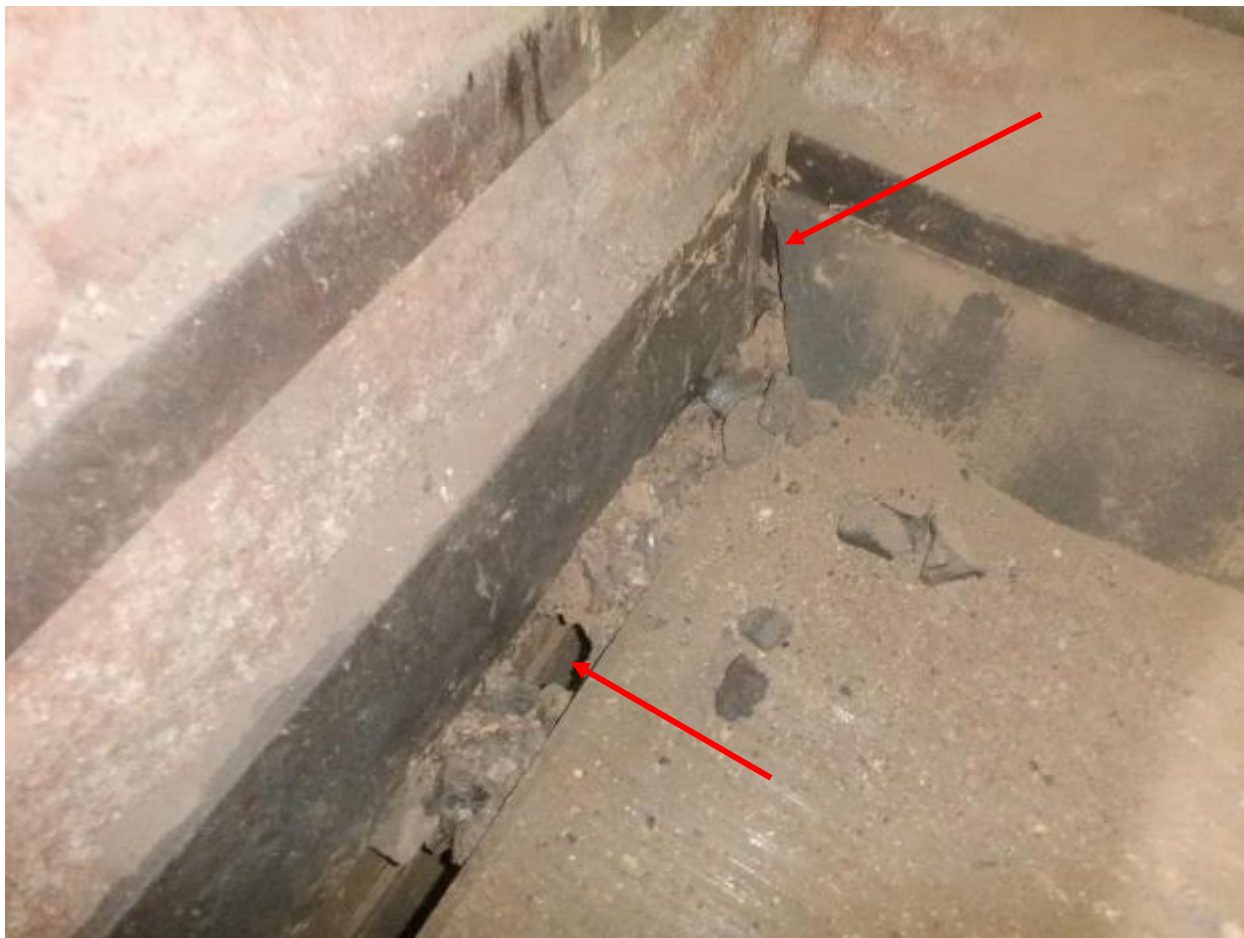
Date: 5/16/2023	Inspected by: B&W	Unit: 2	Item: ASHHOP 3
Component Inspected: Ash Hopper and Throat Tubes from Dance Floor			
Condition Assessment: The knife gates at hoppers A and D weren't fully closed.			
Recommendations: Stroke dampers and rebuild the seal above the gates on D hopper.			
Criticality: P3			
Risk if NOT Performed: If the knife gate is open while the unit is online, ash can go through the opening.			
EKP Comments:

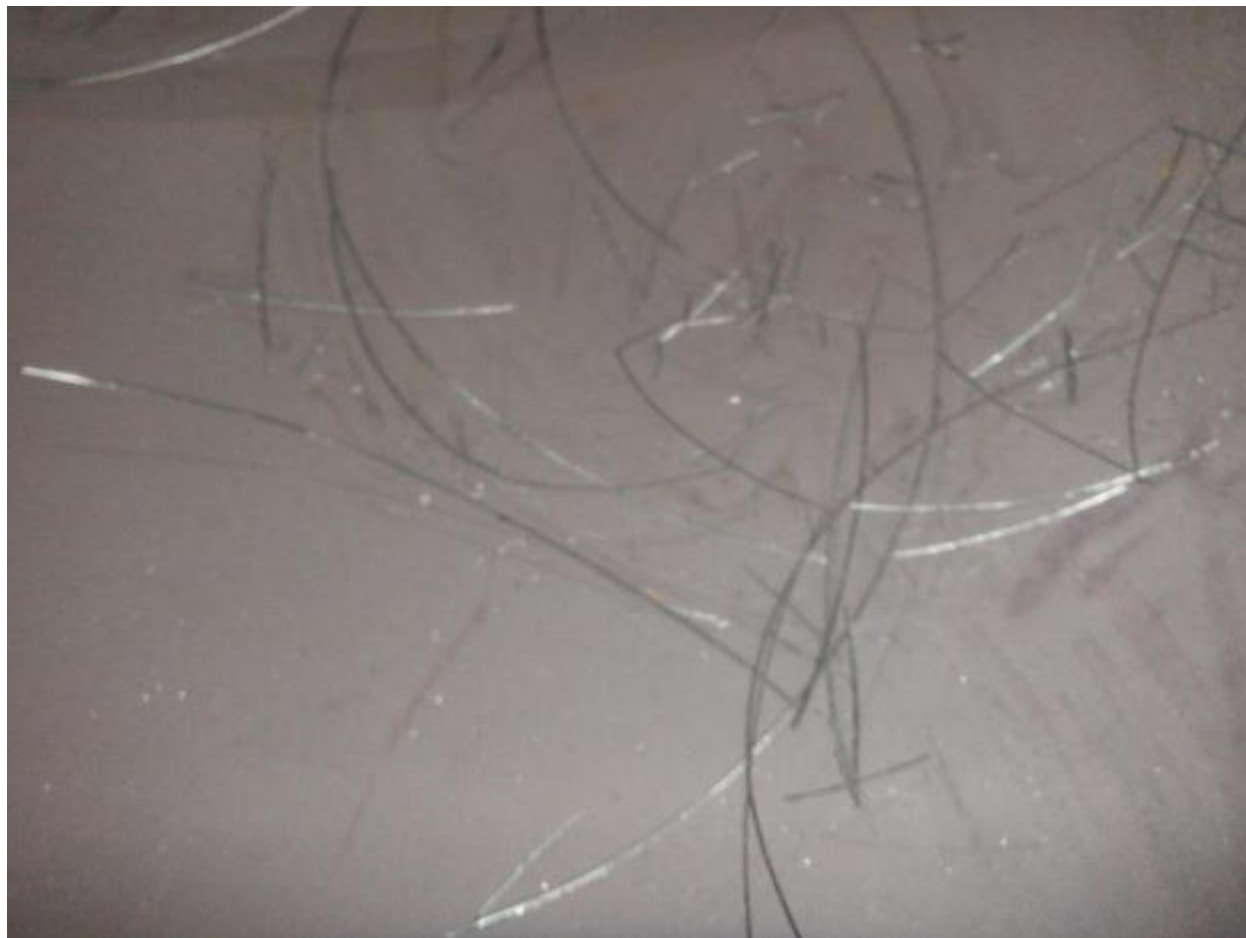
Date: 10/8/2021	Inspected by: B&W	Unit: 2	Item: FWWINHDR 2
Component Inspected: Front Waterwall Inlet Header (Mud Drum)			
Condition Assessment: There were pieces of door gasket in the header on each end.			
Recommendations: Remove the gasket material.			
Criticality: P2			
Risk if NOT Performed: The gasket material will plate out inside a furnace tube.			
EKP Comments:

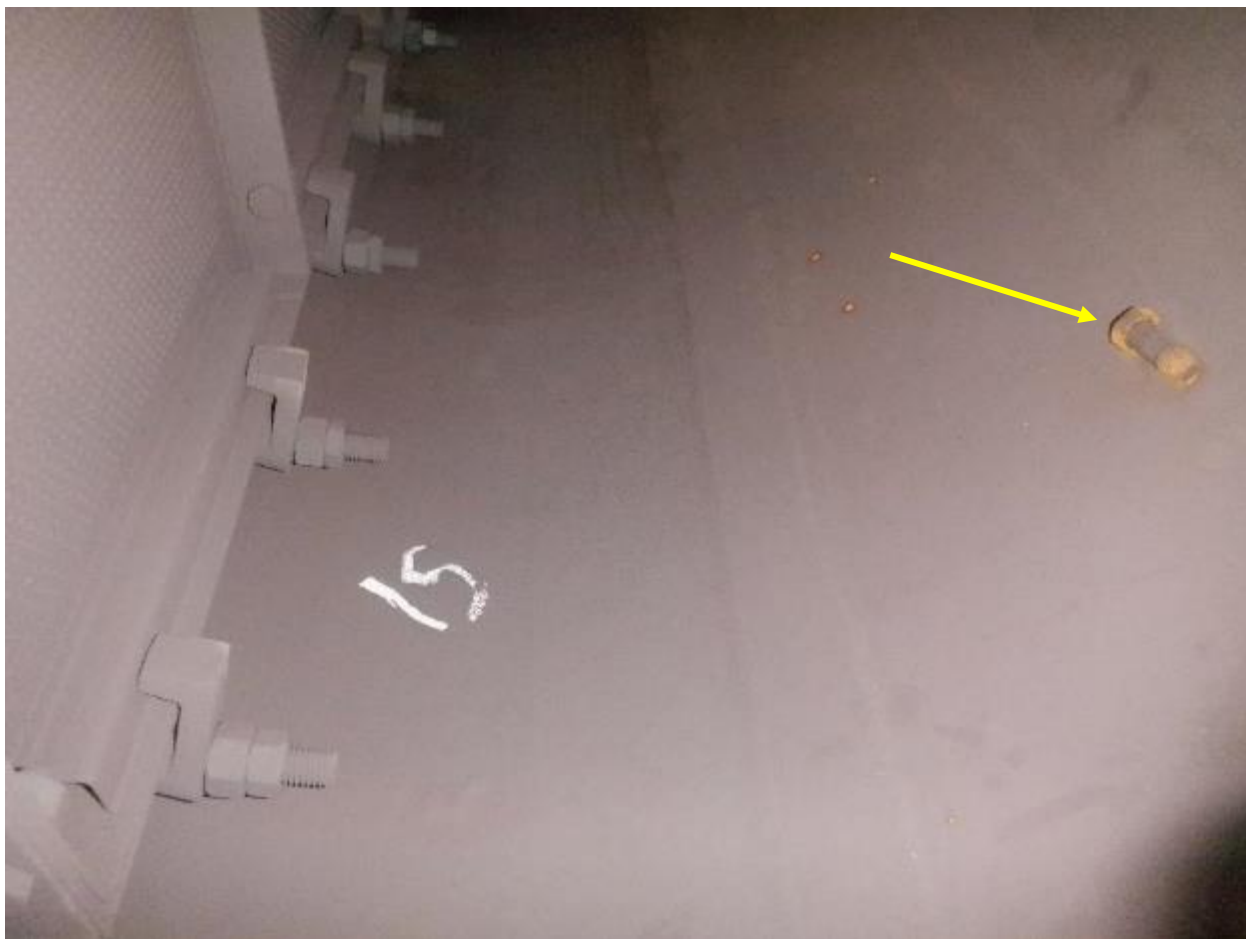
Date: 5/25/2023	Inspected by: B&W	Unit: 2	Item: FWWINHDR 3
Component Inspected: Front Waterwall Inlet Header (Mud Drum)			
Condition Assessment: There was a loose cap screw in the drum. No missing hardware was identified in either waterwall inlet headers.			
Recommendations: Information only, the cap screw was removed.			
Criticality: INFO			
Risk if NOT Performed: None at this time.			
EKP Comments:

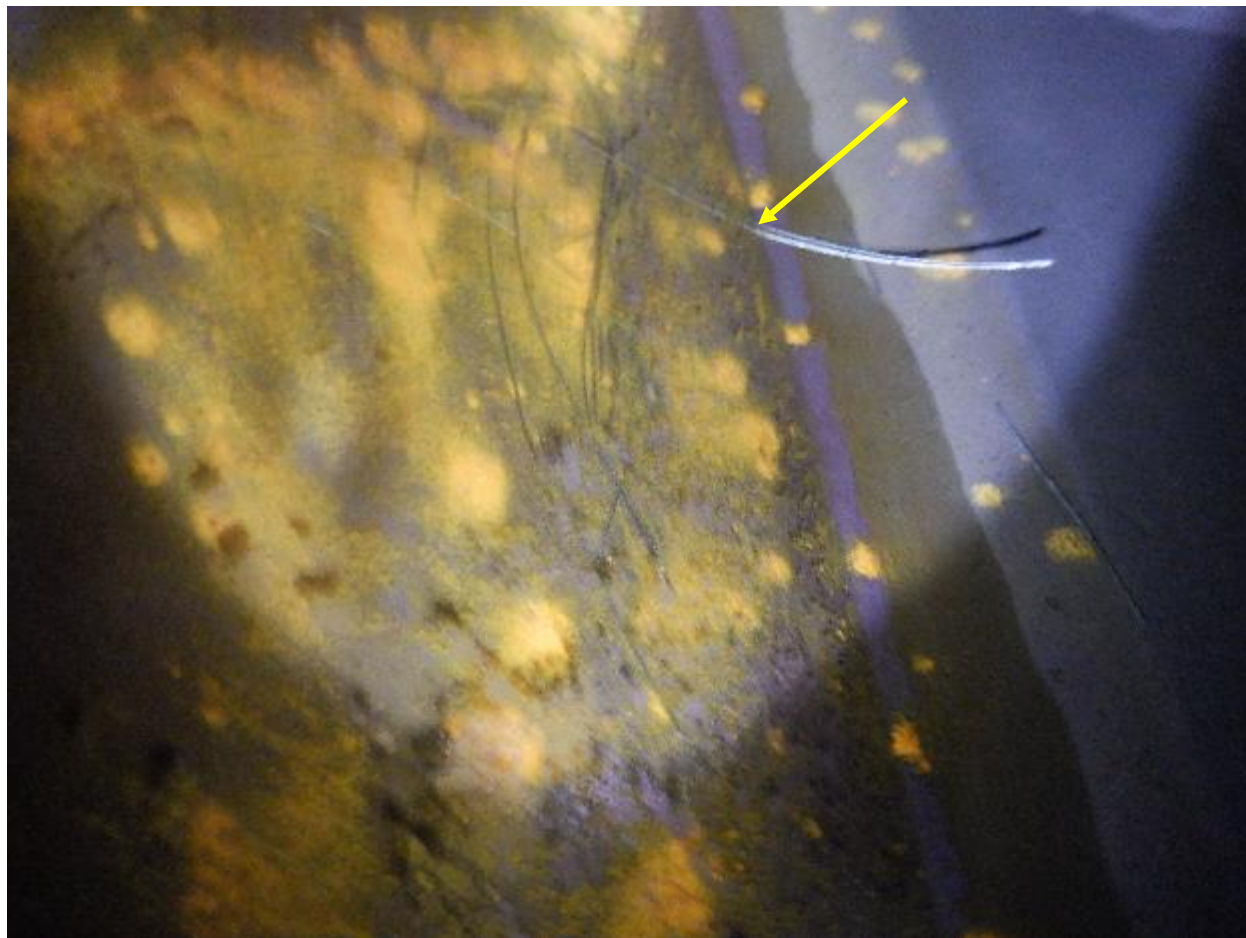
Date: 5/25/2023	Inspected by: B&W	Unit: 2	Item: RWWINHDR 3
Component Inspected: Rear Waterwall Inlet Header (Mud Drum)			
Condition Assessment: There were pieces of door gasket in the header on each end.			
Recommendations: Remove the gasket material.			
Criticality: P2			
Risk if NOT Performed: The gasket material will plate out inside a furnace tube.			
EKP Comments:

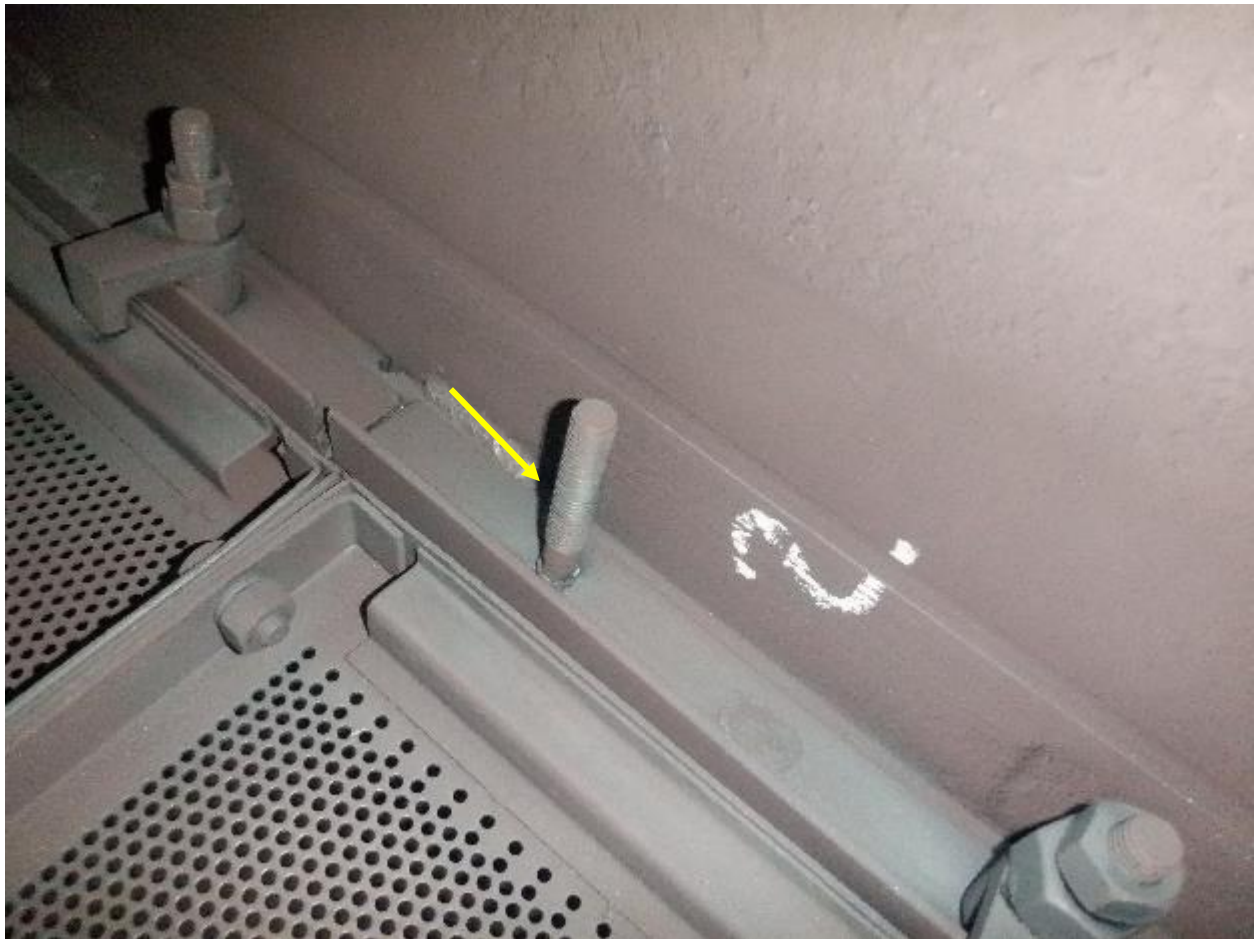
Date: 5/25/2023	Inspected by: B&W	Unit: 2	Item: RWWINHDR 5
Component Inspected: Rear Water-wall Inlet Header (Mud Drum)			
Condition Assessment: There was a missing claw at the top of screen 2.			
Recommendations: Replace the claw, the claw nut, and the lock nut. The stud may also need to be replaced.			
Criticality: P3			
Risk if NOT Performed: Screen could work loose.			
EKP Comments:

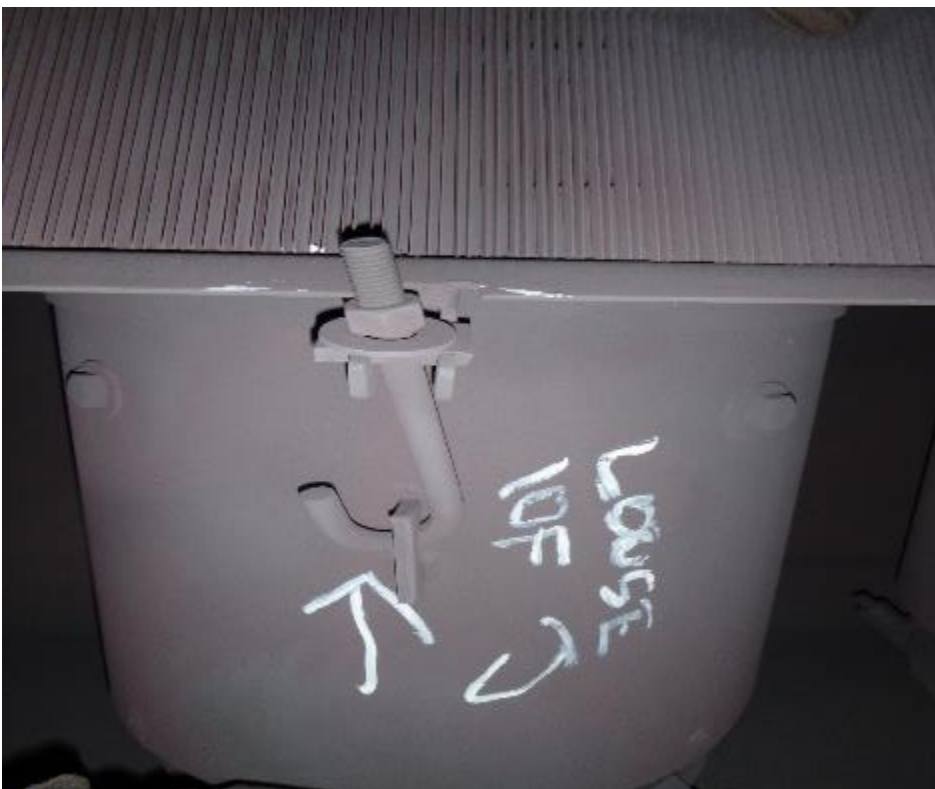
Date: 5/16/2023	Inspected by: B&W	Unit: 2	Item: STMDRUM 2
Component Inspected: Steam Drum			
Condition Assessment: The J-hook holding the secondary scrubbers to the separator was loose on the front side or back side on the following: Backside of rear turbo separator: 4, 9 Backside of front turbo separator: 8, Front side of rear turbo separator: 10, 11, 12 Front side of front separator: 10			
Recommendations: Tighten nut on J-hook.			
Criticality: P3			
Risk if NOT Performed: Eventually the secondary scrubber may come loose and not have a proper seal.			
EKP Comments:			
Photos:

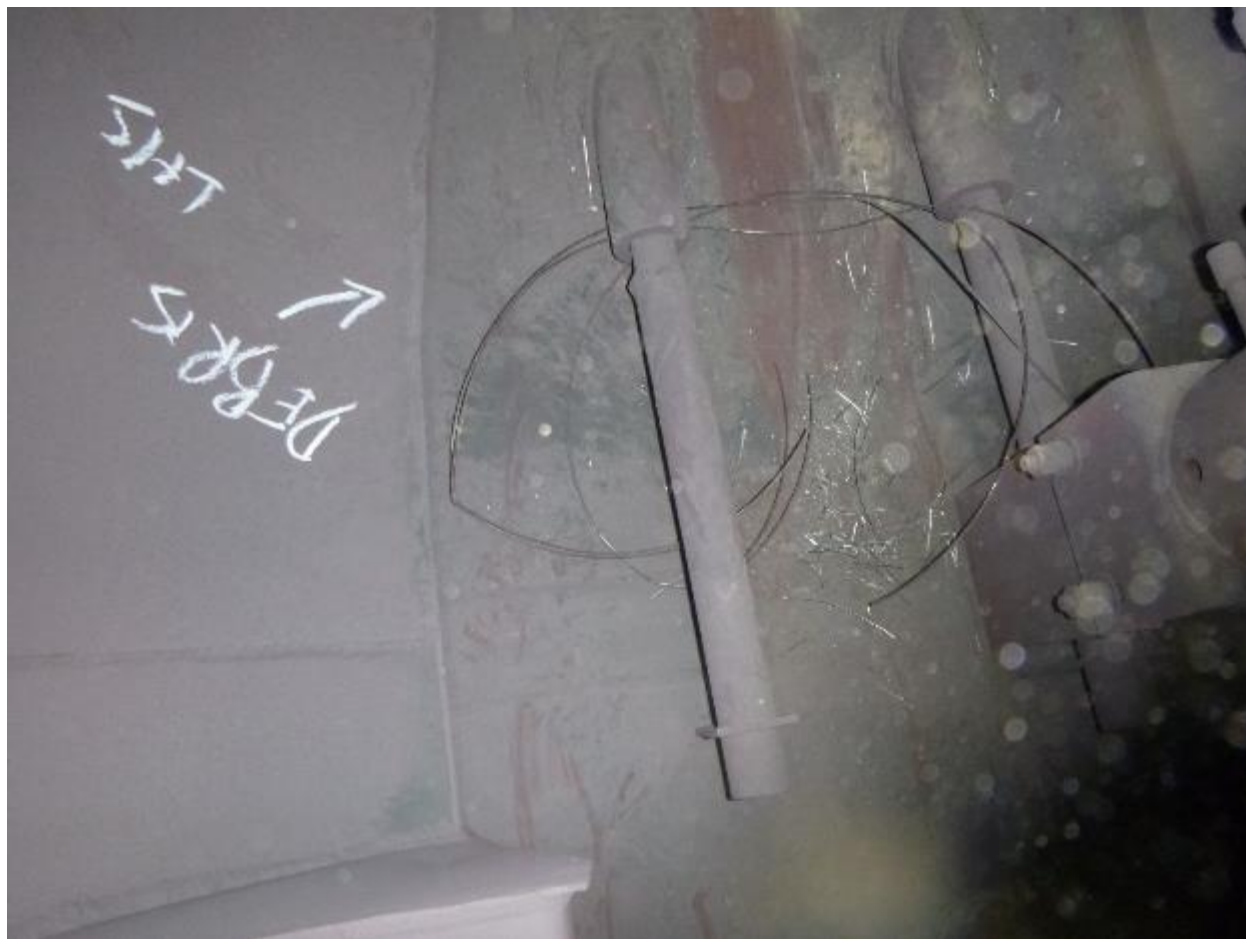
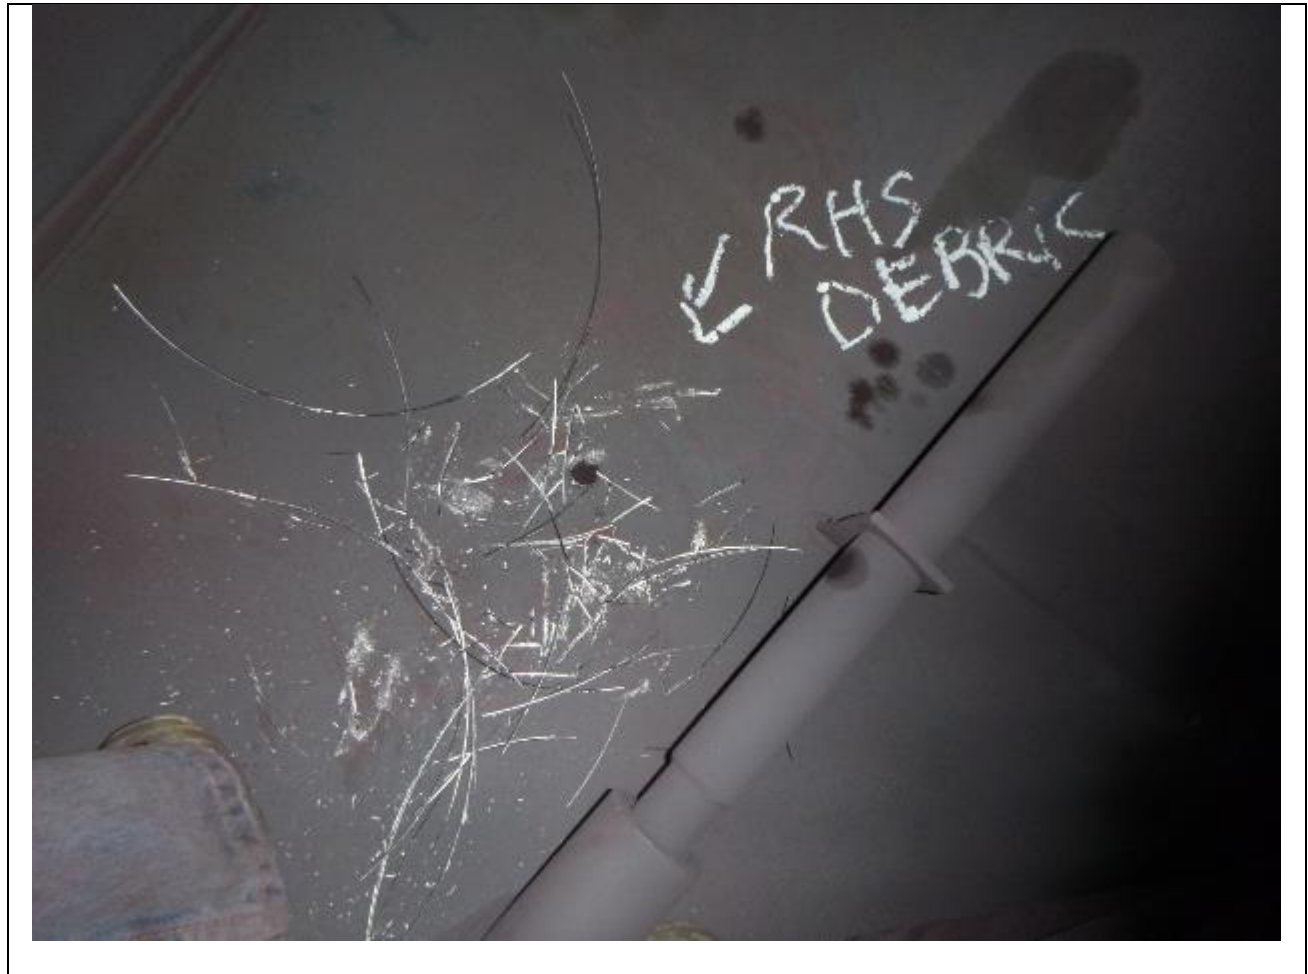
Date: 5/16/2023	Inspected by: B&W RJP	Unit: 2	Item: STMDRUM 4
Component Inspected: Steam Drum			
Condition Assessment: There was gasket material in the drum at the both ends.			
Recommendations: Hand pick gasket material from drum. Replace gaskets on both heads.			
Criticality: P1			
Risk if NOT Performed: Gasket material may cause a disruption in the water circuit should it enter the downcomers.			
EKP Comments:

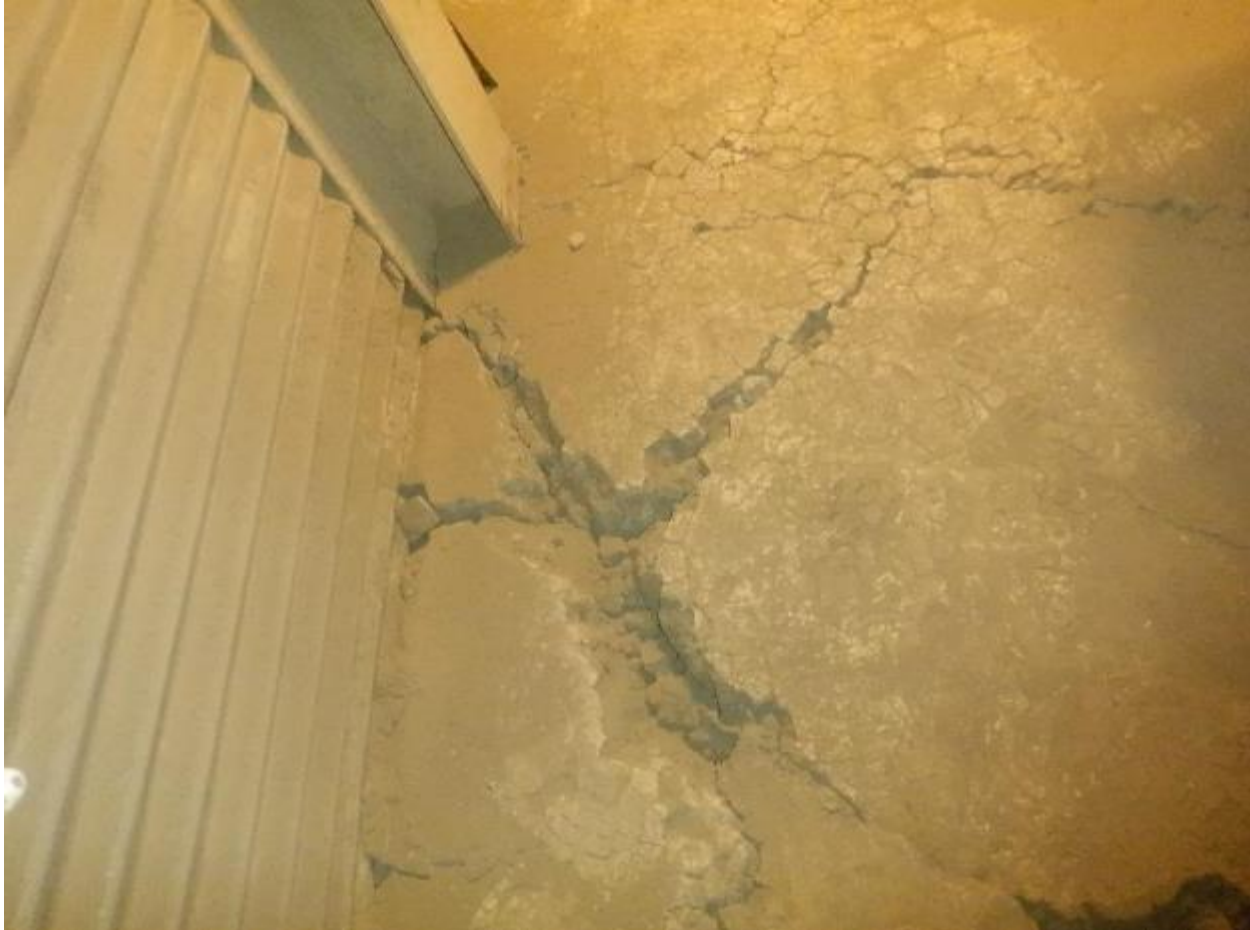
Date: 5/17/2023	Inspected by: B&W - CSH	Unit: 2	Item: PENT 1
Component Inspected: Penthouse			
Condition Assessment: The refractory around the perimeter of the unit was cracked and damaged. The most damage can be found at the corners of the unit.			
Recommendations: Continue to monitor and patch when necessary during future outages.			
Criticality: INFO			
Risk if NOT Performed: NA			
EKP Comments:			
Photos:

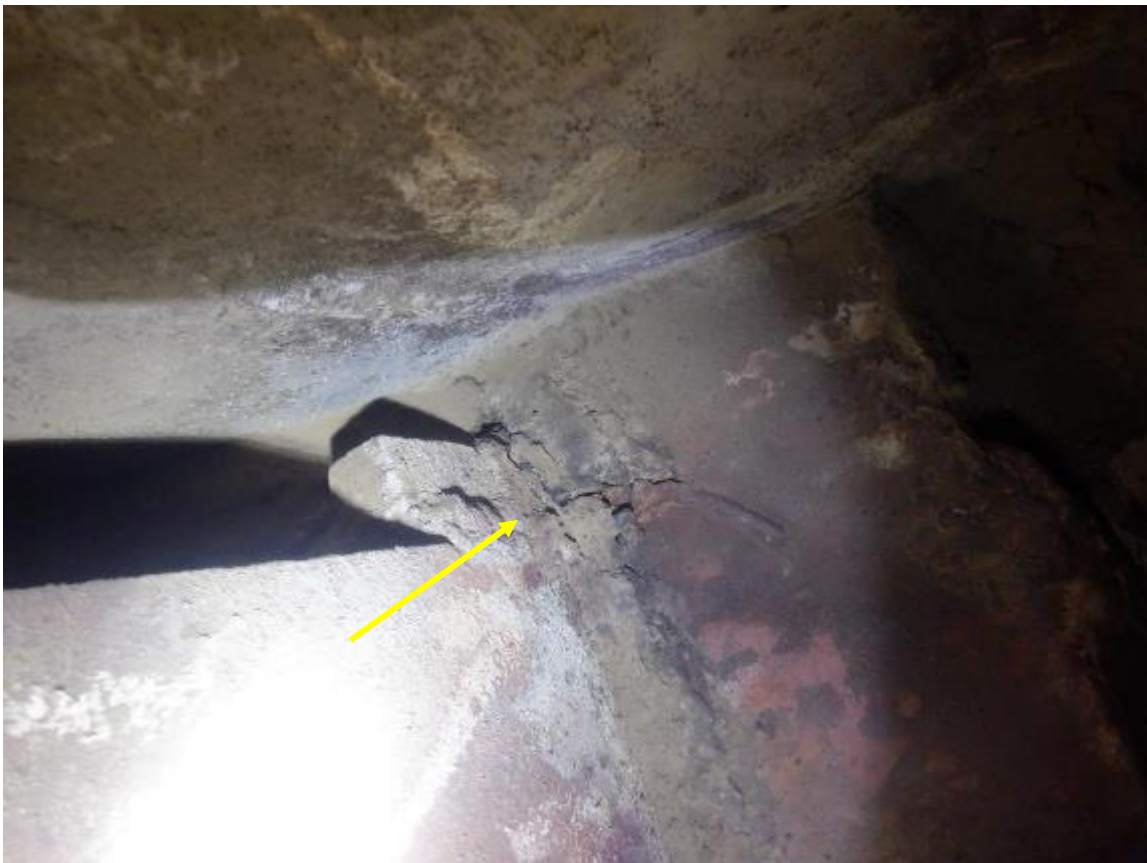
Date: 5/17/2023	Inspected by: B&W - CSH	Unit: 2	Item: PENT 2
Component Inspected: Penthouse			
Condition Assessment: There are numerous casing cracks (some large, some small) scattered throughout the Penthouse. The locations are as follows: <ul style="list-style-type: none"> • LHSW near rear waterwall hanger tubes – one (1) large hole and one small crack • RHSW near rear waterwall hanger tubes – three (3) small cracks • Near LHSW, RHSW and at quarter points across the boiler in front of the waterwall upper rear header enclosure – ripped and cracks in casing • LHS of Pendant Platen assembly 21 – small hole • RHS of Pendant Platen assembly 20 – small hole • Front of Pendant Reheat Inlet Header near LHSW – crack • Front of RH Inlet Header at assemblies 31/32 – Medium crack • Floor casing in front of waterwall upper rear header about 12' from LHSW – large rip • LHSW on the front side of the SH pendant platen inlet tubes – small hole

Recommendations: Grind off old weld, cut out small section of casing, lap with 3/16" thick CS plate and seal weld the patch to the existing casing.			
Criticality: P3			
Risk if NOT Performed: Ash continues to lay out in Penthouse and tramp air is sucked into boiler.			
EKP Comments:			
Photos:

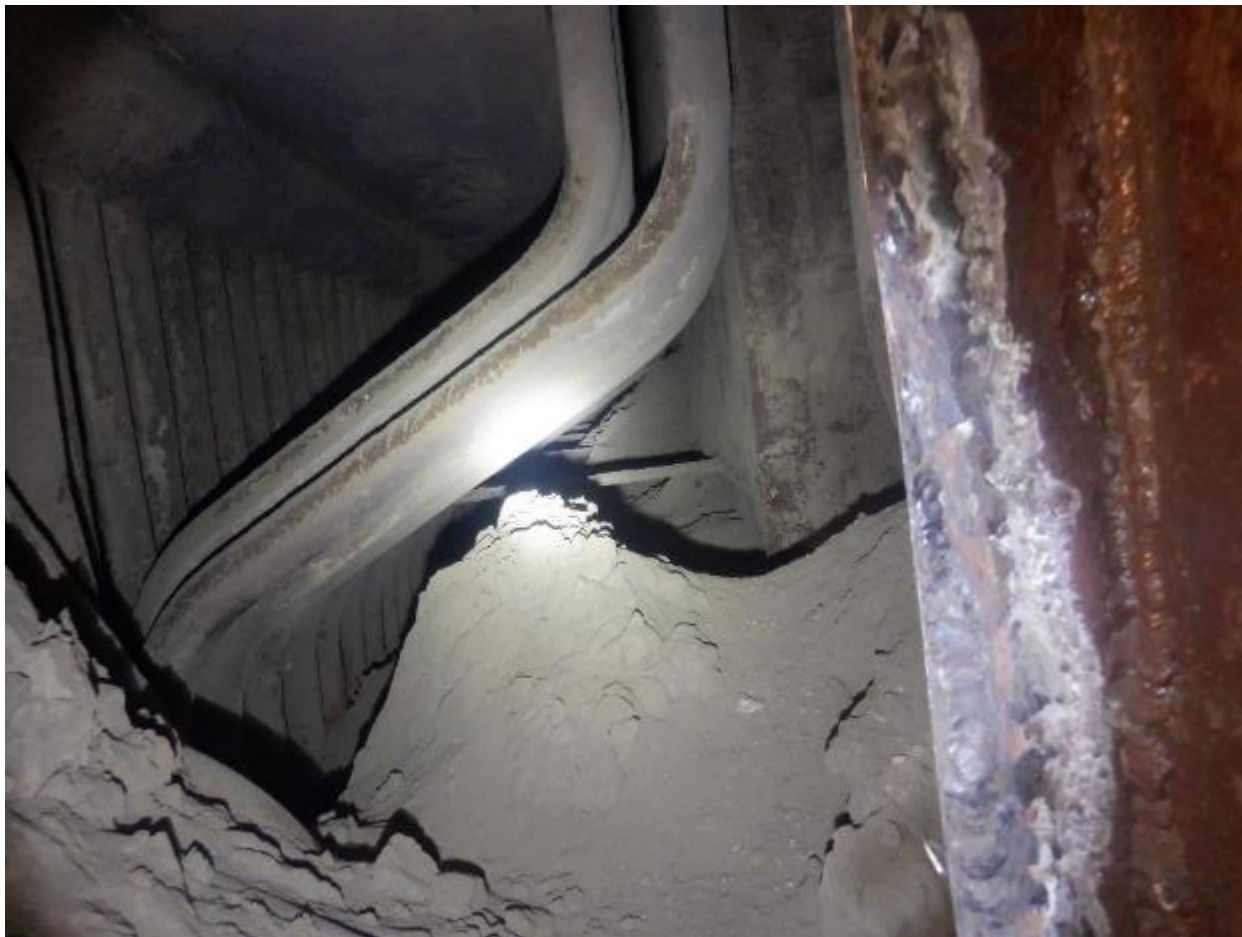
Date: 5/17/2023	Inspected by: B&W - CSH	Unit: 2	Item: PENT 3
Component Inspected: Penthouse			
Condition Assessment: The radiant RH enclosure was open, and cleaning was in progress. There were mounds of ash at the FW and each sidewall, indicating roof penetration leaks.			
Recommendations: Clean the space, and pack refractory around the tube penetrations.			
Criticality: P3			
Risk if NOT Performed: Ash will continue to accumulate.			
EKP Comments:

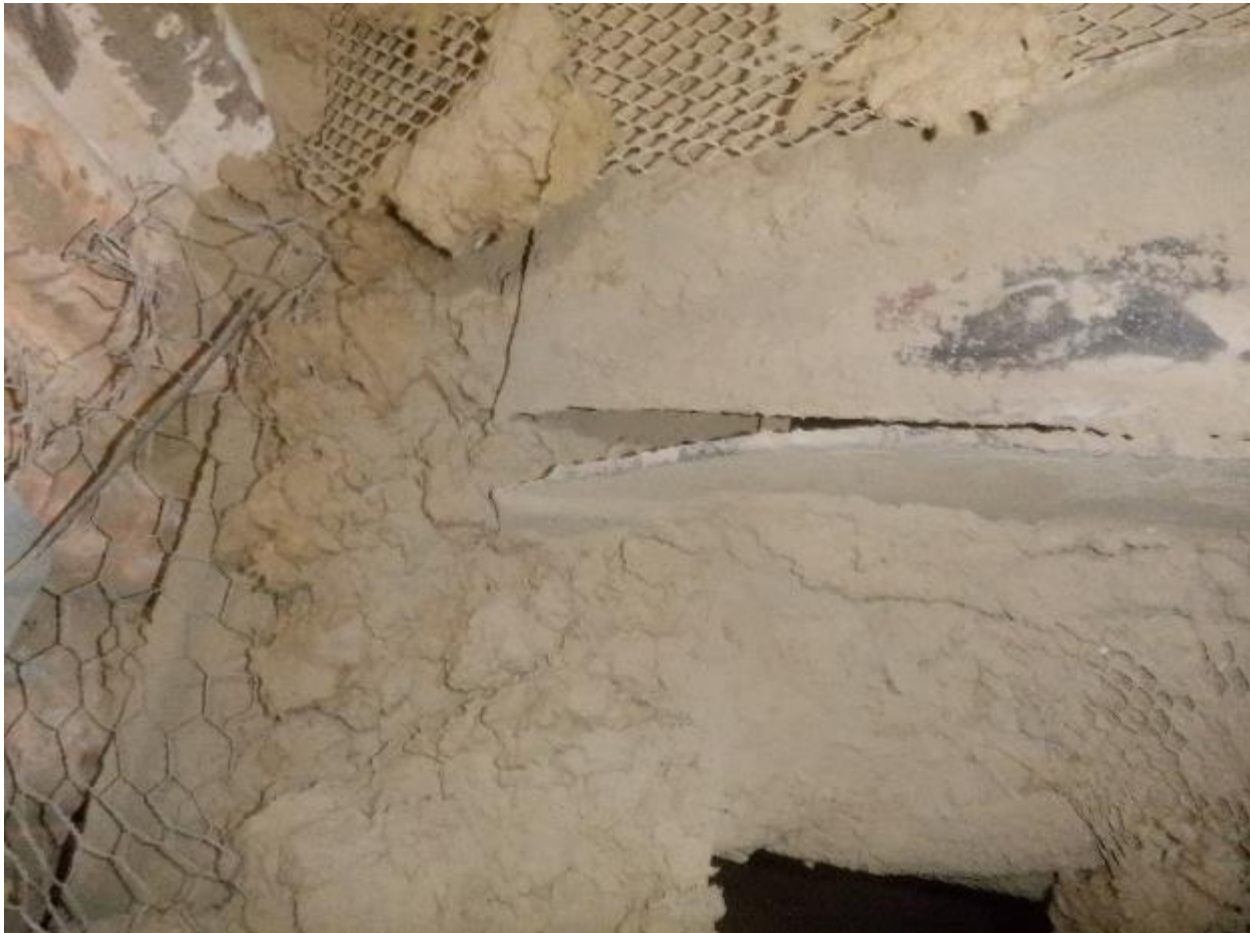
Date: 05/17/23	Inspected by: B&W ECC	Unit: 2	Item: PENT 4
Component Inspected: Penthouse			
Condition Assessment: Rear water wall screen tube header left side of unit Large split in the weld on the casing around the header support.			
Recommendations: Pull caking together and weld the seam.			
Criticality: P3			
Risk if NOT Performed: The crack will continue to propagate.			
EKP Comments:			
Photos:

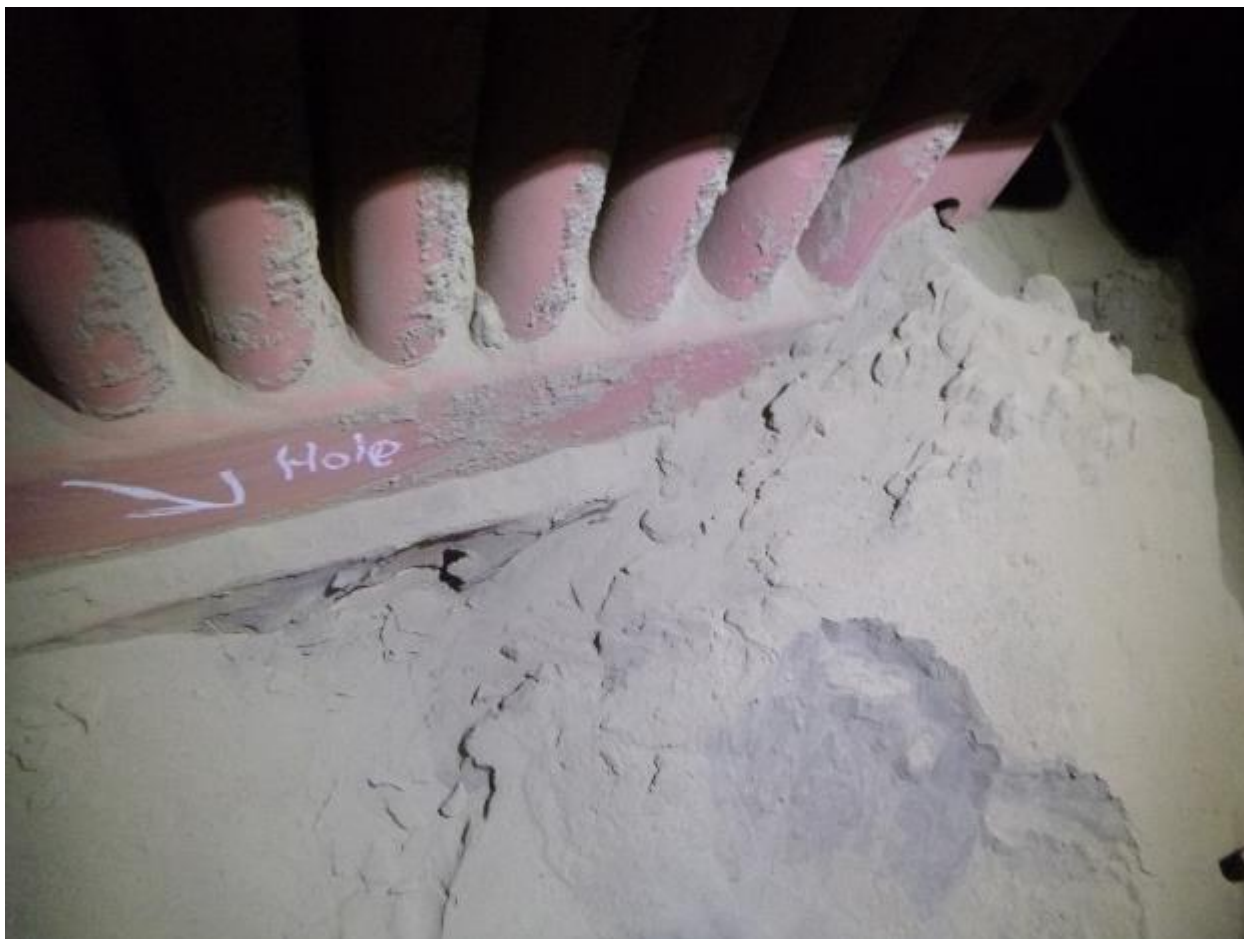
Date: 5/17/2023	Inspected by: B&W RJP	Unit: 2	Item: PENT 5
Component Inspected: Penthouse			
Condition Assessment: The front left-hand side of assembly 7 on the SH Pendant Platen had a hole in the casing.			
Recommendations: Grind out casing hole and repair with seal weld.			
Criticality: P3			
Risk if NOT Performed: Air in leakage to the furnace and flue gas leak to the penthouse.			
EKP Comments:

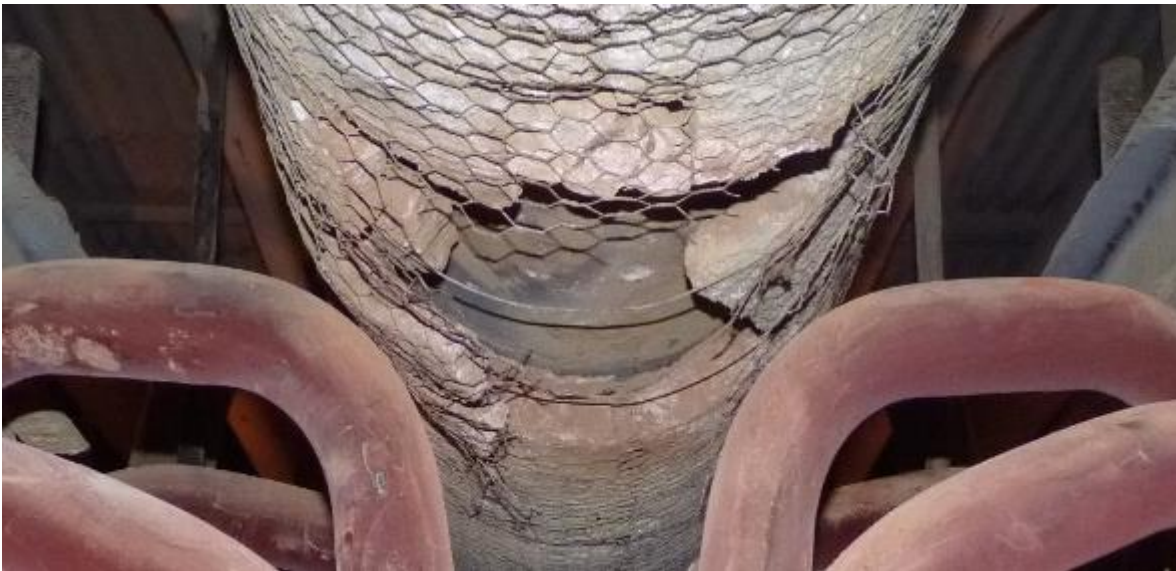
Date: 5/17/2023	Inspected by: B&W BC	Unit: 2	Item: SHDIVPAN 6
Component Inspected: Penthouse Intermediate SH outlet piping			
Condition Assessment: Missing section of insulation			
Recommendations: Replace missing insulation and support materials			
Criticality: P3			
Risk if NOT Performed: No significant ramification.			
EKP Comments:			
Photos:

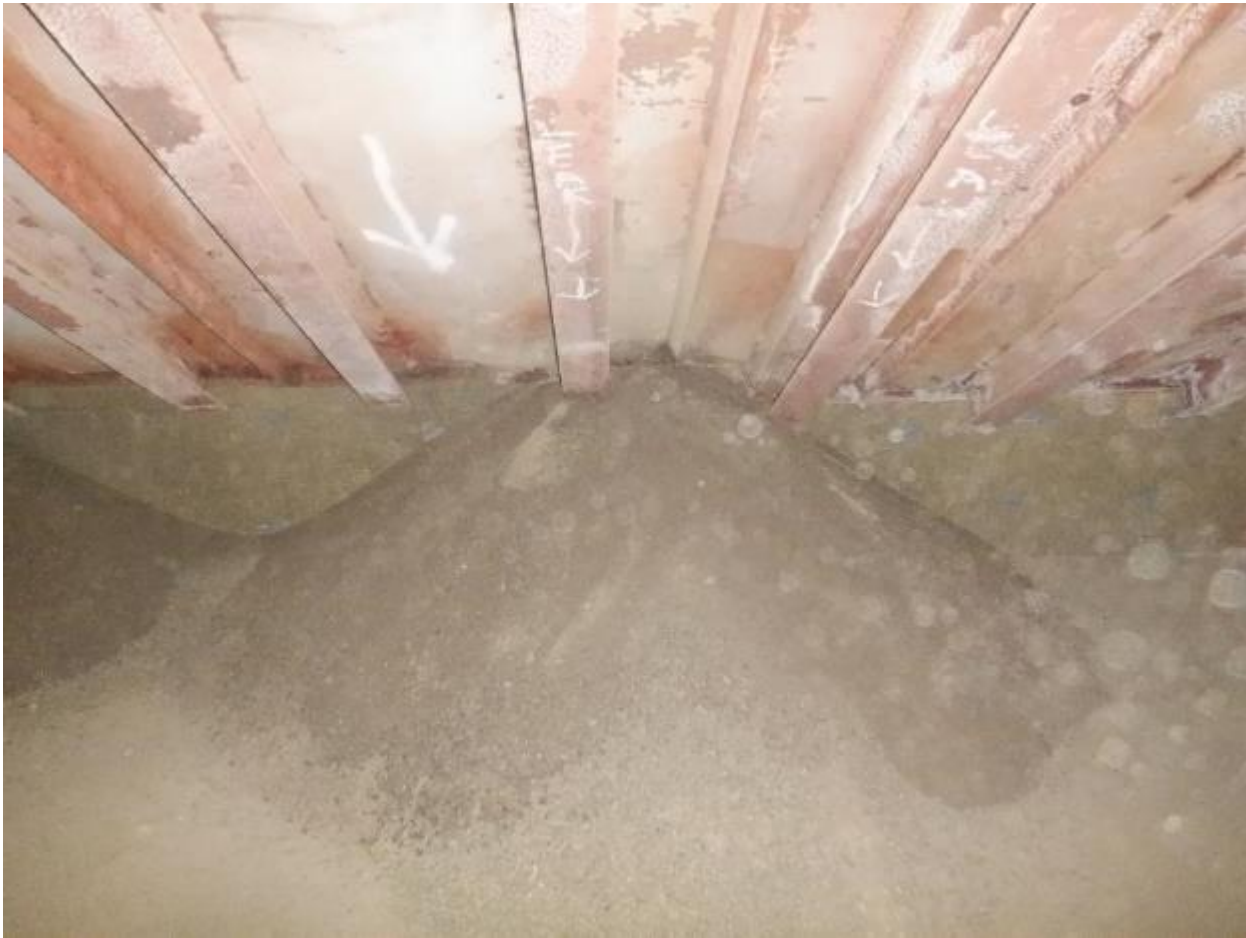
Date: 5/11/2023	Inspected by: B&W	Unit: 2	Item: UPPERDAIR 1
Component Inspected: Upper Dead Air Space			
Condition Assessment: 13 th Floor Upper Dead Air Space – There are areas on the arch casing where the casing has overheated and failed. Most notably at the bottom of the slope between the I-beam supports running front to back #9-10, 13-14 and 16-17 and at the end of 20 (from LHSW). The top of the slope at the expansion bend near beam #17 also has damaged casing.			
Recommendations: Patch casing tears with 3/16" CS plate. Vacuum out fly ash.			
Criticality: P3			
Risk if NOT Performed: Casing continues to fail and heat damages structural members. This is a source of air in leakage and ash and flue gas entering the dead air space when the boiler goes positive.			
EKP Comments:			
Photos:
