The Babcock & Wilcox Company

**Eastern Kentucky Power Cooperative
Spurlock Station, Unit #2**

U2 SPRING 2023 OUTAGE BOILER INSPECTION REPORT

B&W Project No.: BA9312817

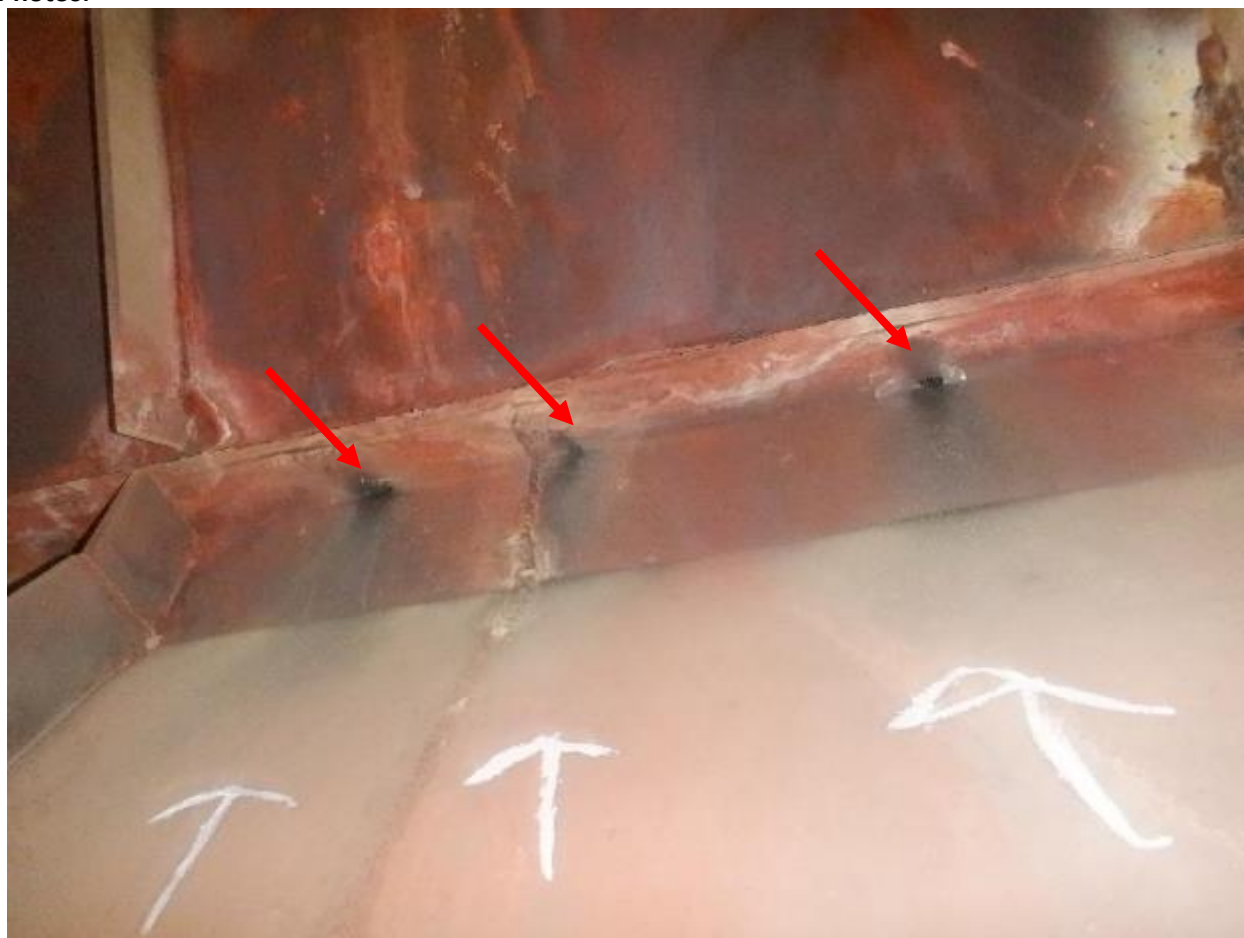
Date: 5/11/2023	Inspected by: B&W	Unit: 2	Item: UPPERDAIR 2
Component Inspected: Upper Dead Air Space			
Condition Assessment: 12 th Floor Upper Dead Air Space – Holes and casing tears were found in the upper portion of the dead air space (towards the tip of the nose) in the casing sections: 9, 11, 14, and 16.			
Recommendations: Weld repair or patch casing tears with 3/16" CS plate.			
Criticality: P3			
Risk if NOT Performed: Cracks and holes in the dead air space casing allow for ash and hot gases to enter the dead air space when the boiler goes positive and for air in leakage during normal operation.			
EKP Comments:

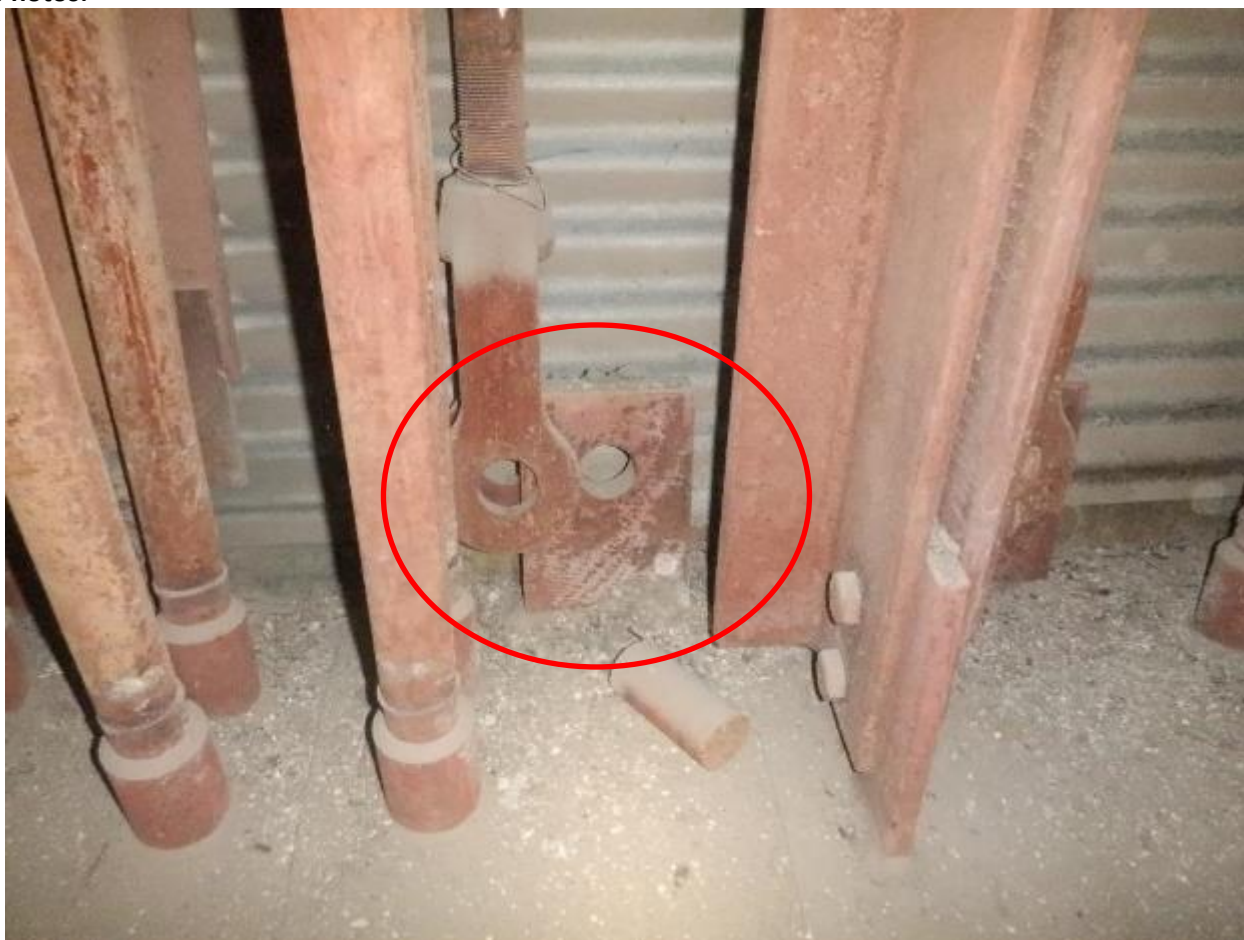
Date: 5/11/23	Inspected by: B&W CSH	Unit: 2	Item: LOWERDAIR 1
Component Inspected: Lower Dead Air Spaces			
Condition Assessment: Rear Lower Dead Air Space: The 13 th lower waterwall inlet header hanger was missing a support pin.			
Recommendations: Replace pin and secure.			
Criticality: P2			
Risk if NOT Performed: Extra stress on header, tubes, and surrounding hangers.			
EKP Comments:

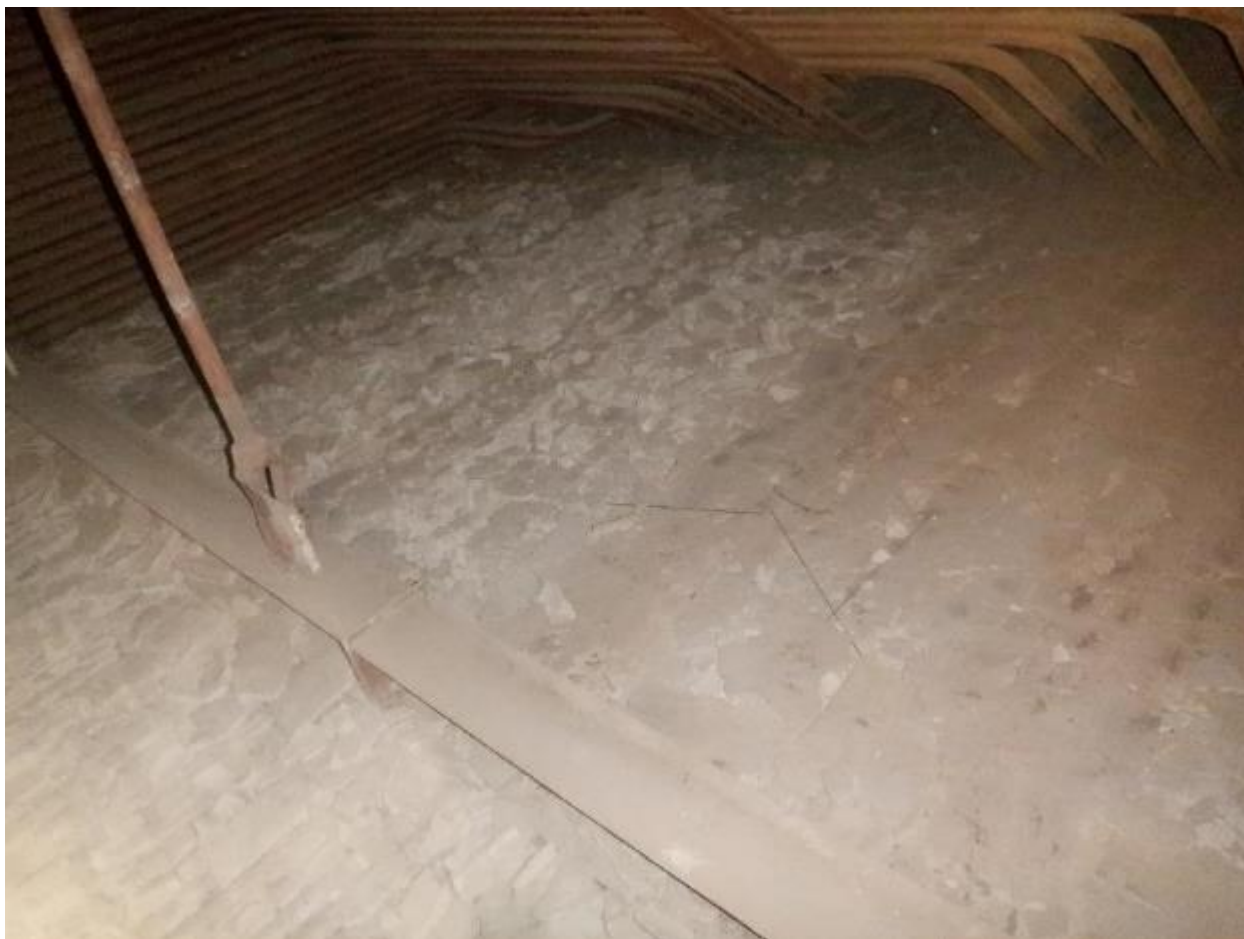
Date: 5/11/23	Inspected by: B&W CSH BC	Unit: 2	Item: LOWERDAIR 3
Component Inspected: Lower Dead Air Spaces			
Condition Assessment: Front and Rear Lower Dead Air Spaces: The refractory along the floor in each lower dead air space is beginning to break up.			
Recommendations: Patch the refractory and continue to monitor.			
Criticality: P3			
Risk if NOT Performed: Refractory seals the vestibule floor.			
EKP Comments:

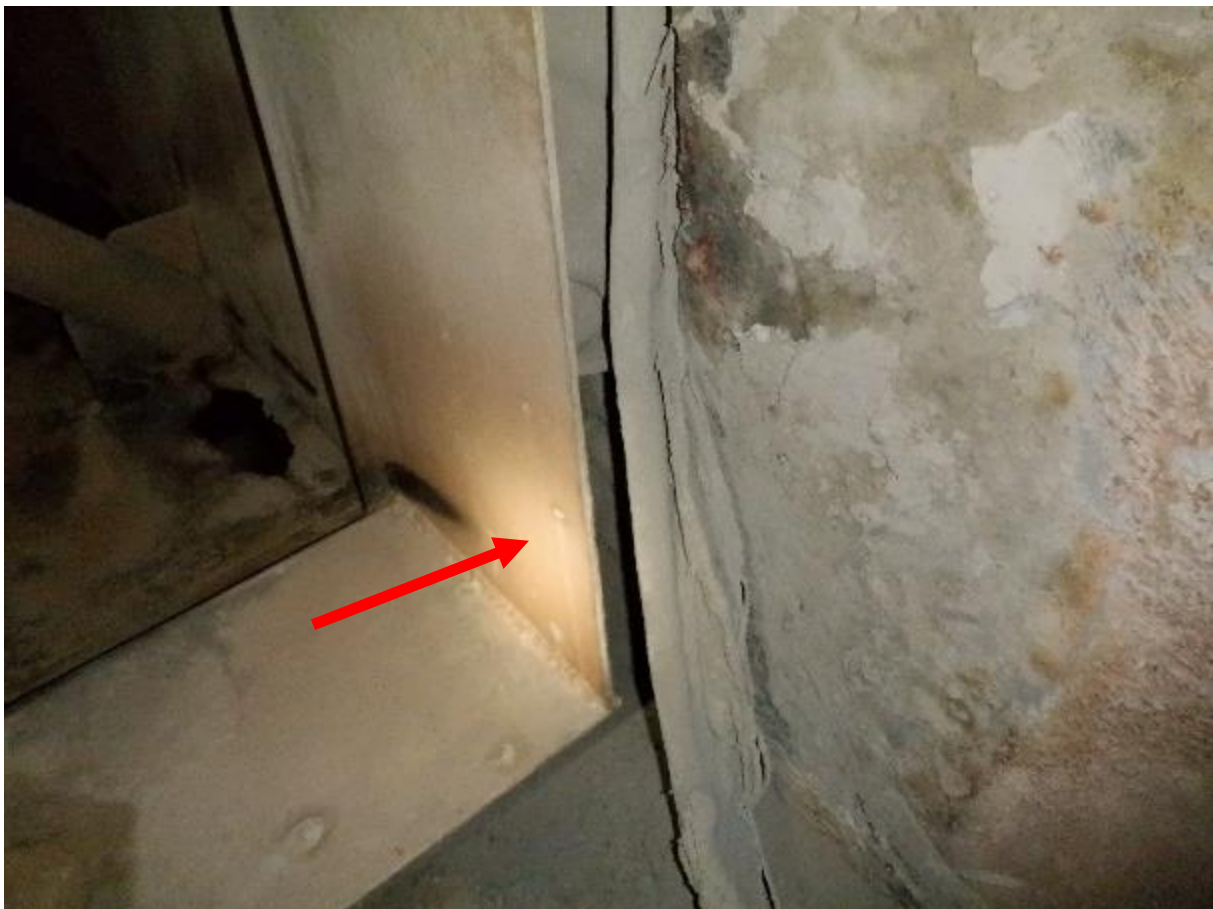
Date: 05/12/23	Inspected by: B&W	Unit: 2	Item: ECONHOP 1
Component Inspected: Economizer Outlet Flue and Hoppers			
Condition Assessment: A & B Side: The inner layer of the expansion joint has torn away where it crimps into the joint near the lower corner. A Side: Right side B Side: Left and right side			
Recommendations: Remove the expansion joint shield to better inspect the condition of the joint.			
Criticality: P3			
Risk if NOT Performed: Over time more of the inner could tear eventually separating from the frame.			
EKP Comments:

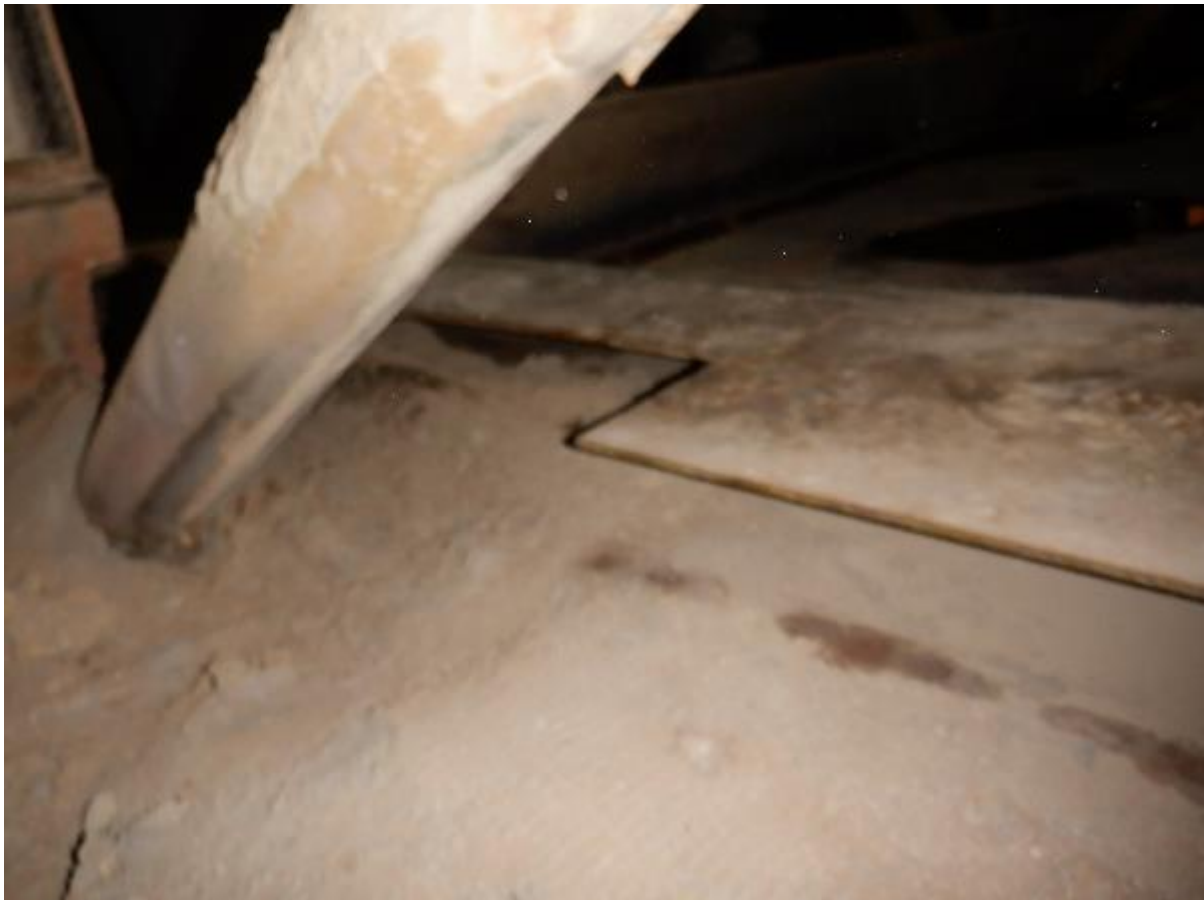
Date: 05/12/23	Inspected by: B&W ECC	Unit: 2	Item: ECONHOP 2
Component Inspected: Economizer Outlet and Hoppers			
Condition Assessment: A & B side: The expansion joint is packed with ash. The buckling on the flue side walls on side B could be a result of the expansion joint locking up.			
Recommendations: Remove the deflector shield and thoroughly clean the ash form the expansion joint. When re-installing the deflector shield add a vertical section extending to 1" of the flue floor to limit the amount of ash entering the expansion joint.			
Criticality: P2			
Risk if NOT Performed: The expansion will not allow the proper expansion and the fluework will deform.			
EKPC Comments:			
Photos:

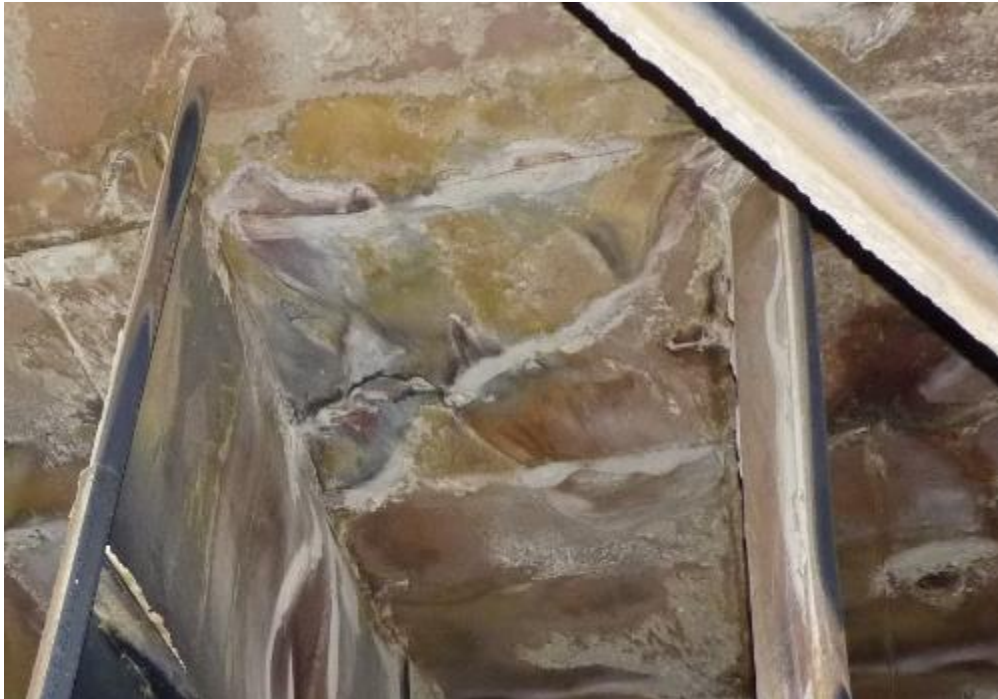
Date: 05/12/2023	Inspected by: B&W BC	Unit: 2	Item: ECONHOP 3
Component Inspected: Economizer Outlet Flue			
Condition Assessment: The casing is cracked at the top of the duct between the turning vanes.			
Recommendations: Strip the insulation and lagging to access the flue and make needed repairs.			
Criticality: P2			
Risk if NOT Performed: Air in leakage			
EKPC Comments:			
Photos:

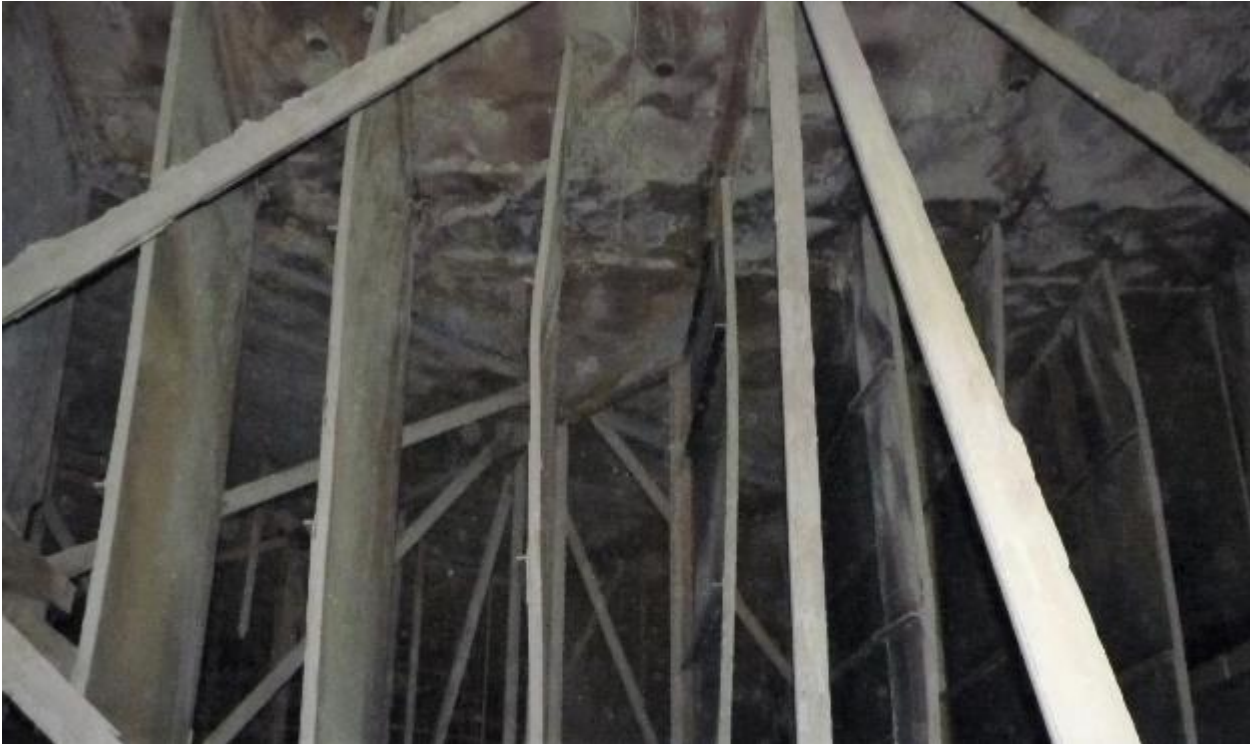
Date: 05/12/2023	Inspected by: B&W BC	Unit: 2	Item: ECONHOP 5
Component Inspected: Economizer Outlet Flue			
Condition Assessment: Vertical turning vanes on the right flue are buckled.			
Recommendations: Stiffen the vanes with angle on the leading edge.			
Criticality: P3			
Risk if NOT Performed: Vanes could continue to buckle eventually failing.			
EKPC Comments:			
Photos:

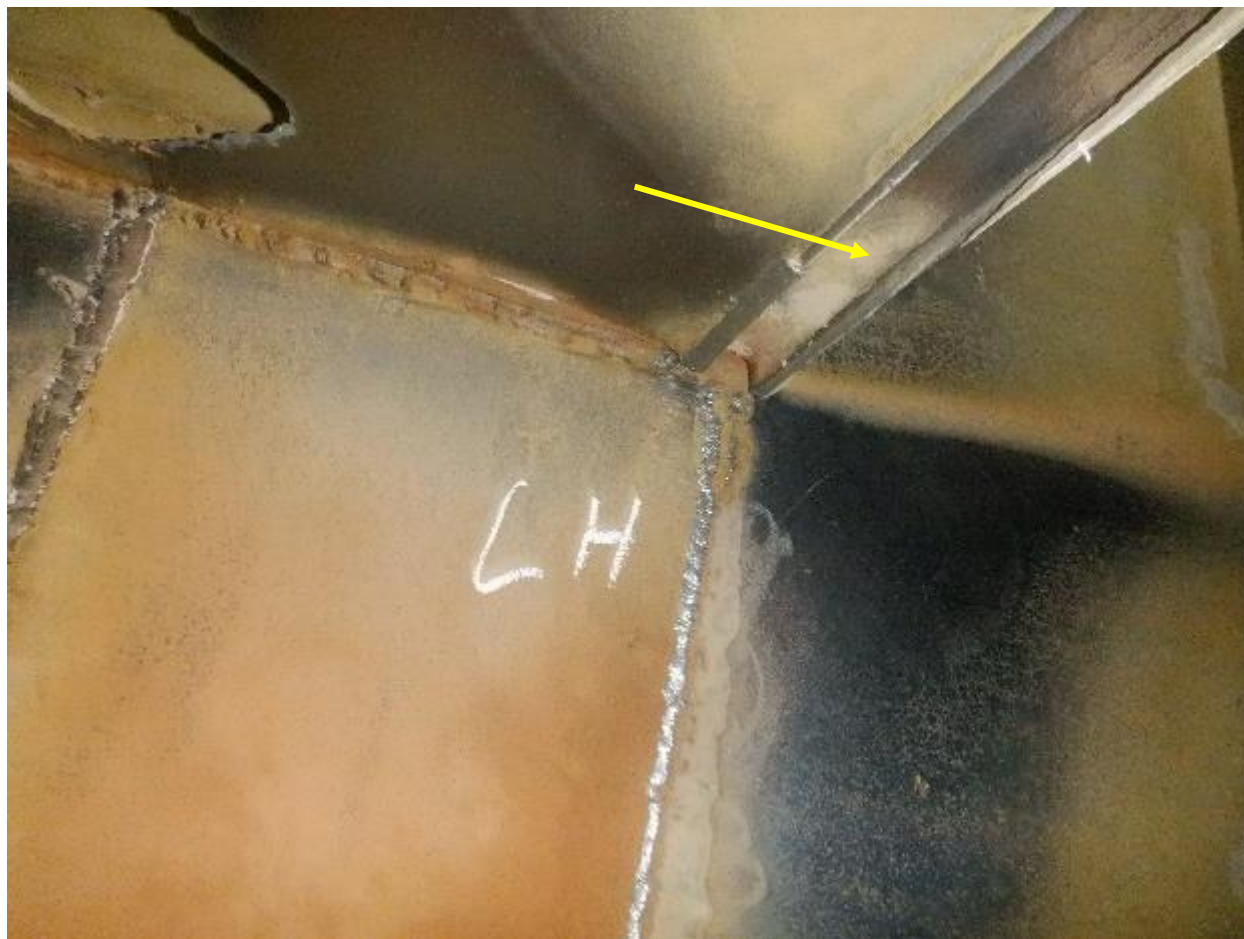
Date: 5/23/2023	Inspected by: B&W	Unit: 2	Item: ESPDUCTS 1
Component Inspected: 2AB ESP Inlet Duct			
Condition Assessment: The underside of the pipe stiffener of the lowest horizontal turning vane at the LHSW and RHSW was eroded.			
Recommendations: Seal weld an angle patch over the pipe stiffener.			
Criticality: P3			
Risk if NOT Performed: Erosion will continue and could cause a hole in the casing.			
EKP Comments:

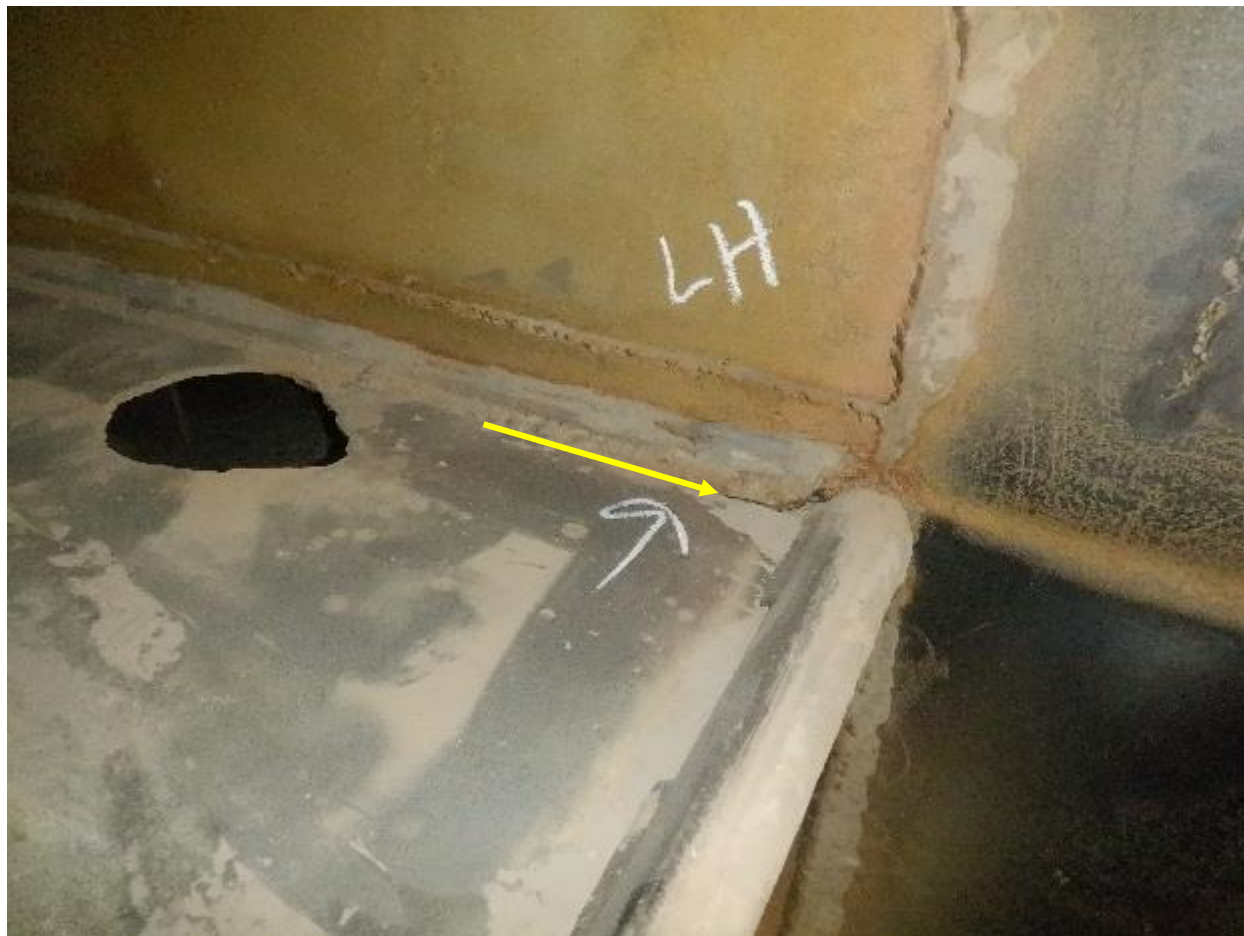
Date: 5/23/2023	Inspected by: B&W	Unit: 2	Item: ESPDUCTS 2
Component Inspected: 2AB ESP Inlet Duct			
Condition Assessment: The lowest turning vane had a failed weld at the LHSW.			
Recommendations: Reweld the failed weld.			
Criticality: P3			
Risk if NOT Performed: Turning vane could pull from the weld and wall.			
EKP Comments:

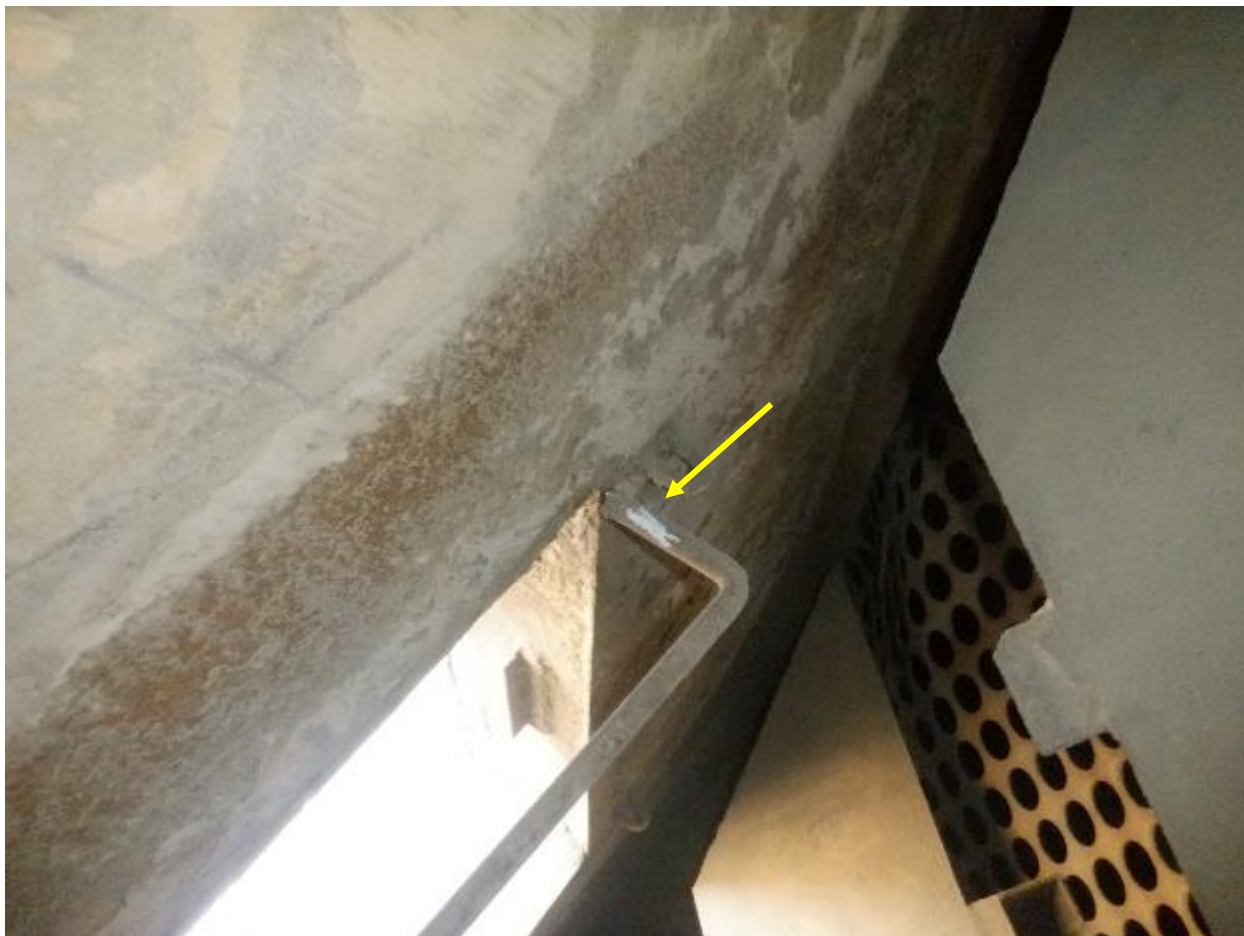
Date: 5/23/2023	Inspected by: B&W	Unit: 2	Item: ESPDUCTS 5
Component Inspected: 2AB ESP Inlet Duct			
Condition Assessment: The hand grab, inside the flue, above the access door, had a failed weld.			
Recommendations: Re-weld the hand grab to the casing.			
Criticality: P3			
Risk if NOT Performed: The hand grab could break off while in use and hurt someone.;			
EKP Comments:

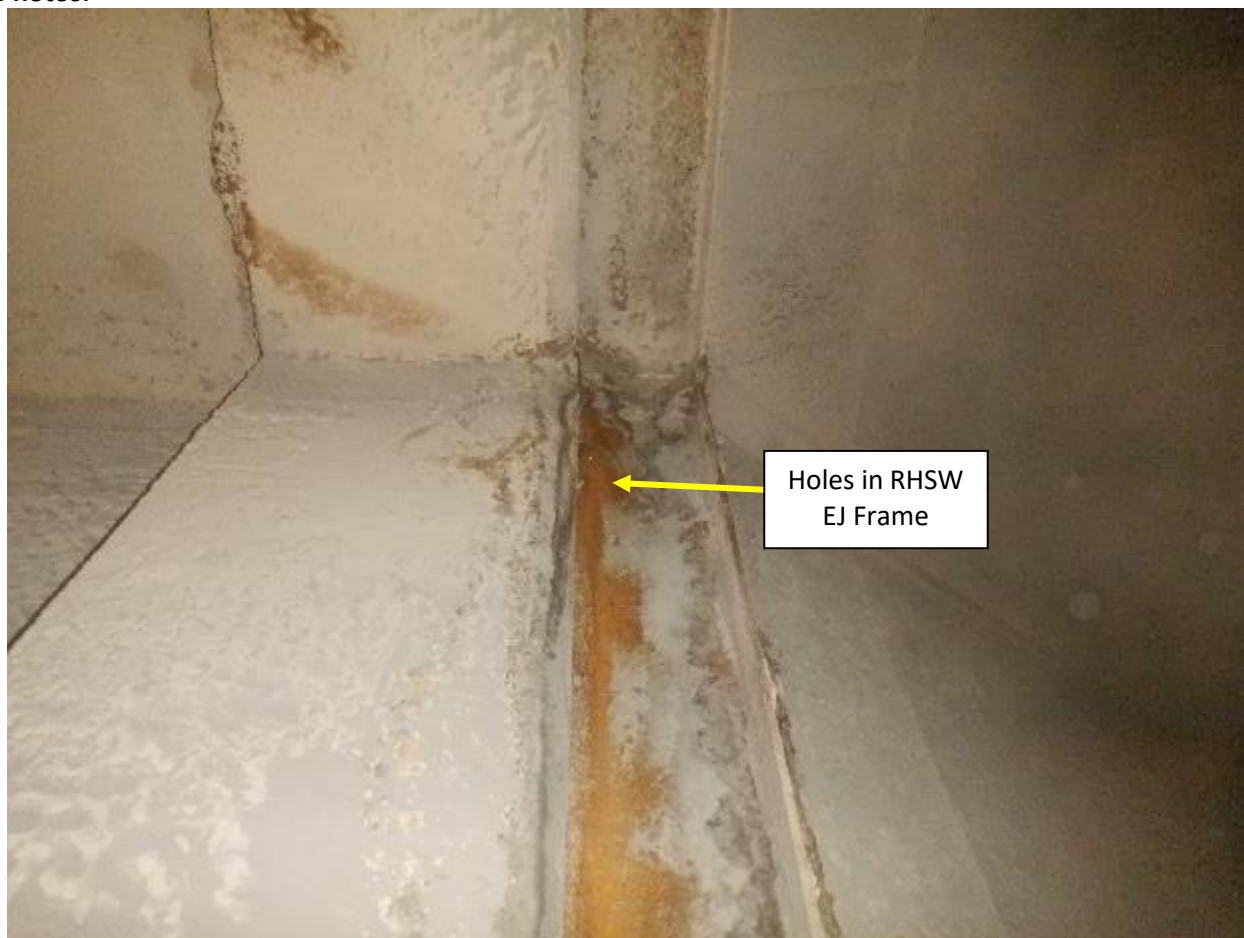
Date: 5/23/2023	Inspected by: B&W	Unit: 2	Item: ESPDUCTS 9
Component Inspected: 2AA ESP Outlet Duct			
Condition Assessment: There appeared to be multiple casing leaks in the expansion joint frame at the following locations – multiple holes in the RHSW near the roof, (1) in the roof near the LHSW, (1) in the roof at the $\frac{3}{4}$ point, and (1) in the roof at the $\frac{1}{4}$ point in the expansion joint frame.			
Recommendations: Seal weld patches over the frame and plan to replace the frame when the expansion joint requires replacement.			
Criticality: P3			
Risk if NOT Performed: Air in-leakage and the leaks will worsen.			
EKP Comments:

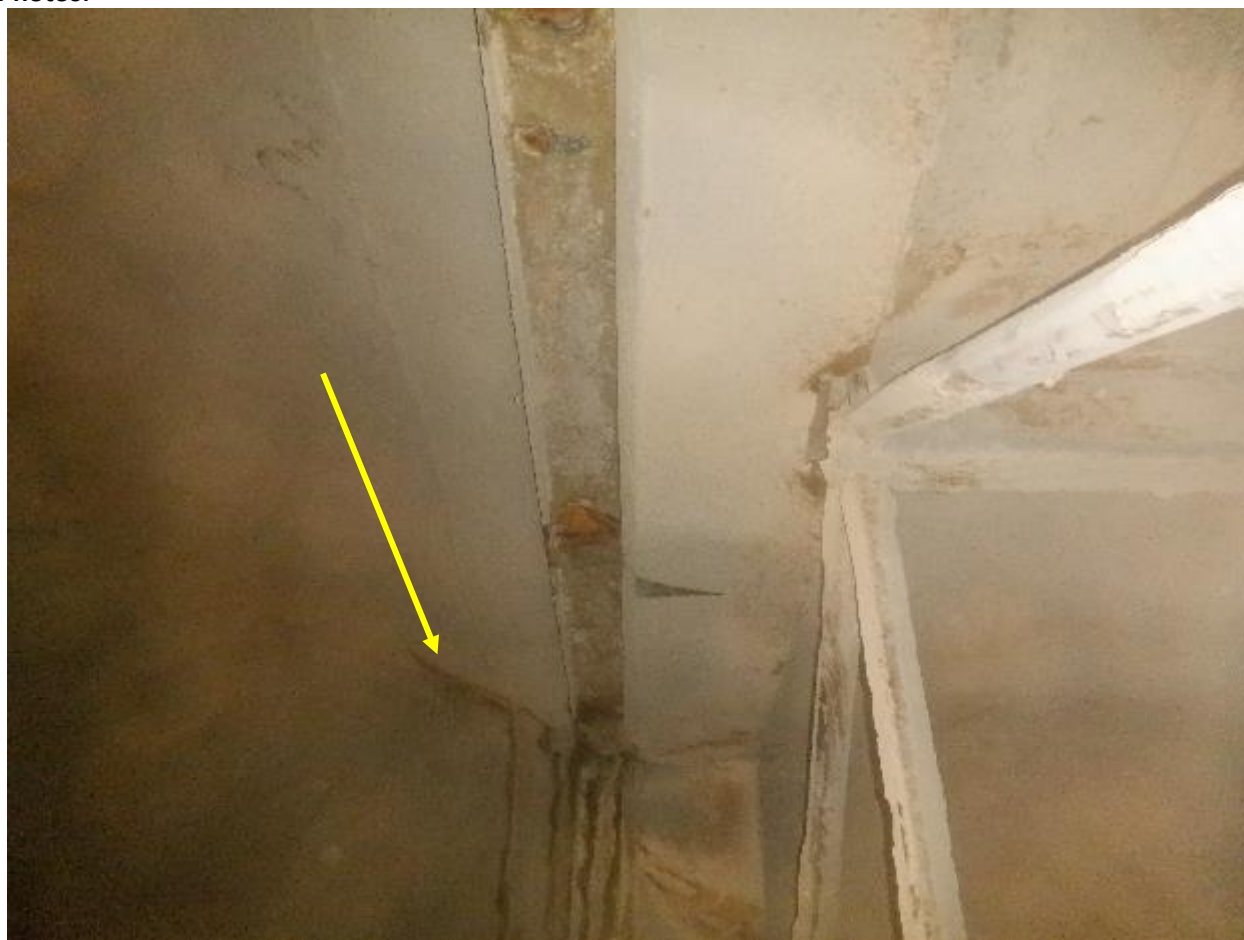
Date: 5/23/2023	Inspected by: B&W	Unit: 2	Item: ESPDUCTS 10
Component Inspected: 2AA ESP Outlet Duct			
Condition Assessment: There appeared to be a leak in the roof, sloped transition casing near the LHSW, just upstream of the expansion joint.			
Recommendations: Remove the lagging and insulation from the exterior and repair the casing with seal welded 3/16" carbon steel patches. Rework the lagging and insulation at the top of the ESP to flue transition to prevent water from going underneath the lagging.			
Criticality: P3			
Risk if NOT Performed: Gas distribution problems.			
EKP Comments:

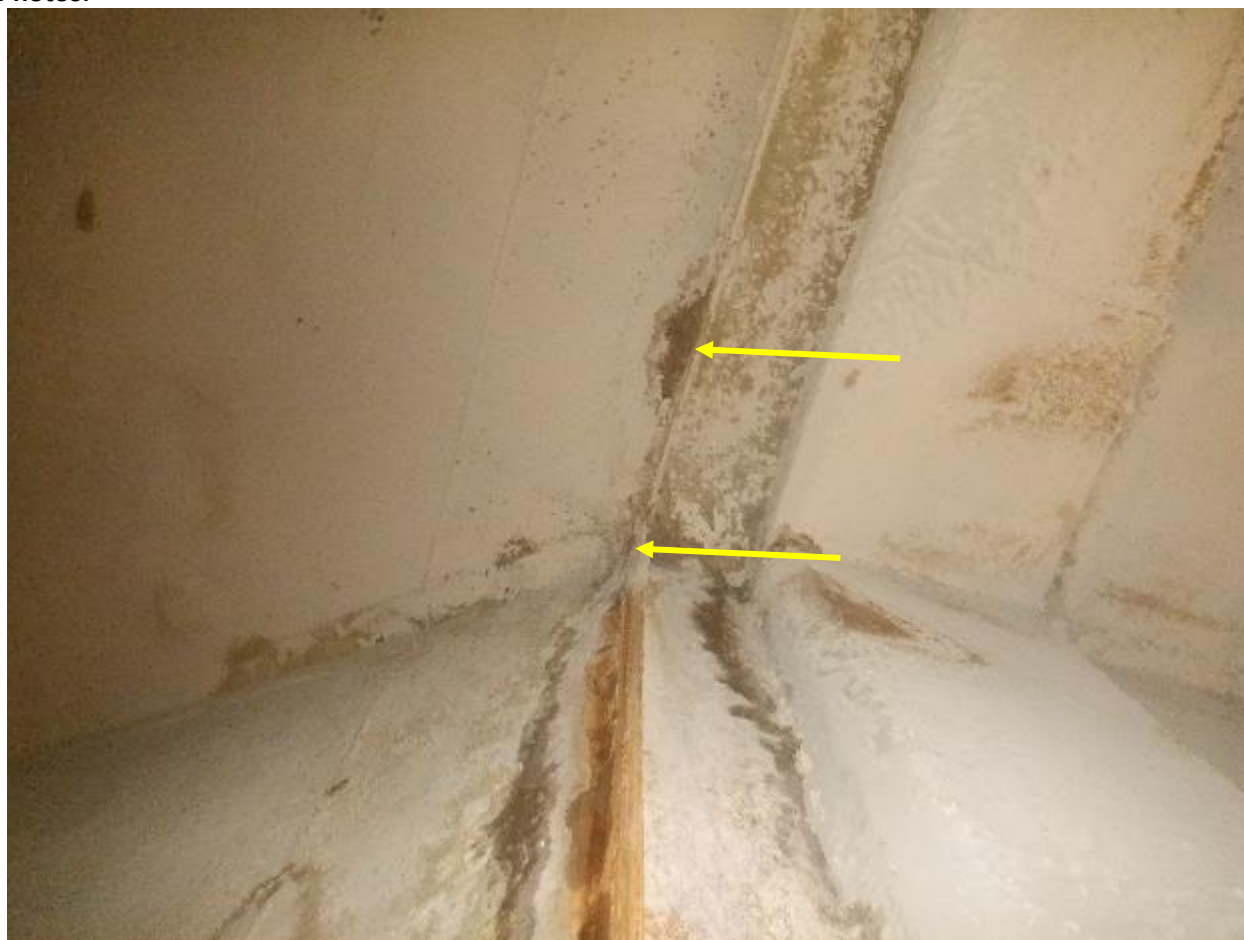
Date: 5/23/2023	Inspected by: B&W	Unit: 2	Item: ESPDUCTS 11
Component Inspected: 2AB ESP Outlet Duct			
Condition Assessment: There appeared to be multiple casing leaks in the expansion joint frame at the following locations – (2) in the roof near the LHSW, (1) in the roof at the RHSW, and (1) in the roof at the center of the expansion joint frame.			
Recommendations: Seal weld patches over the frame and plan to replace the frame when the expansion joint requires replacement.			
Criticality: P3			
Risk if NOT Performed: Air in-leakage and the leaks will worsen.			
EKP Comments:

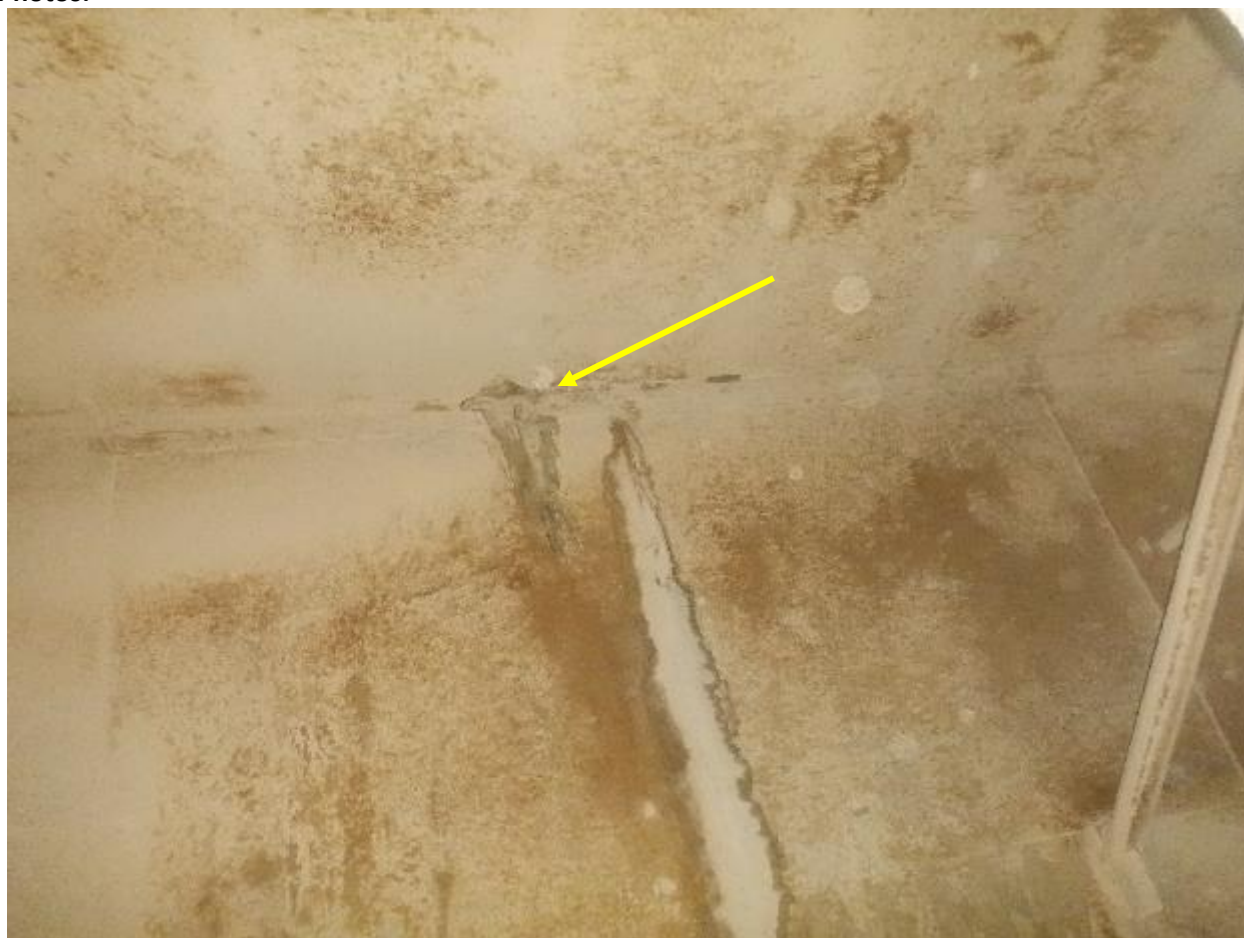
Date: 5/23/2023	Inspected by: B&W	Unit: 2	Item: ESPDUCTS 13
Component Inspected: 2AB ESP Outlet Duct			
Condition Assessment: There was a casing leak in the roof at the LHSW of the outlet flue.			
Recommendations: Remove the lagging and insulation from the exterior and repair the casing with seal welded 3/16" carbon steel patches. Rework the lagging and insulation at the top of the ESP to flue transition to prevent water from going underneath the lagging.			
Criticality: P3			
Risk if NOT Performed: Allows in-leakage and the hole will worsen.			
EKP Comments:

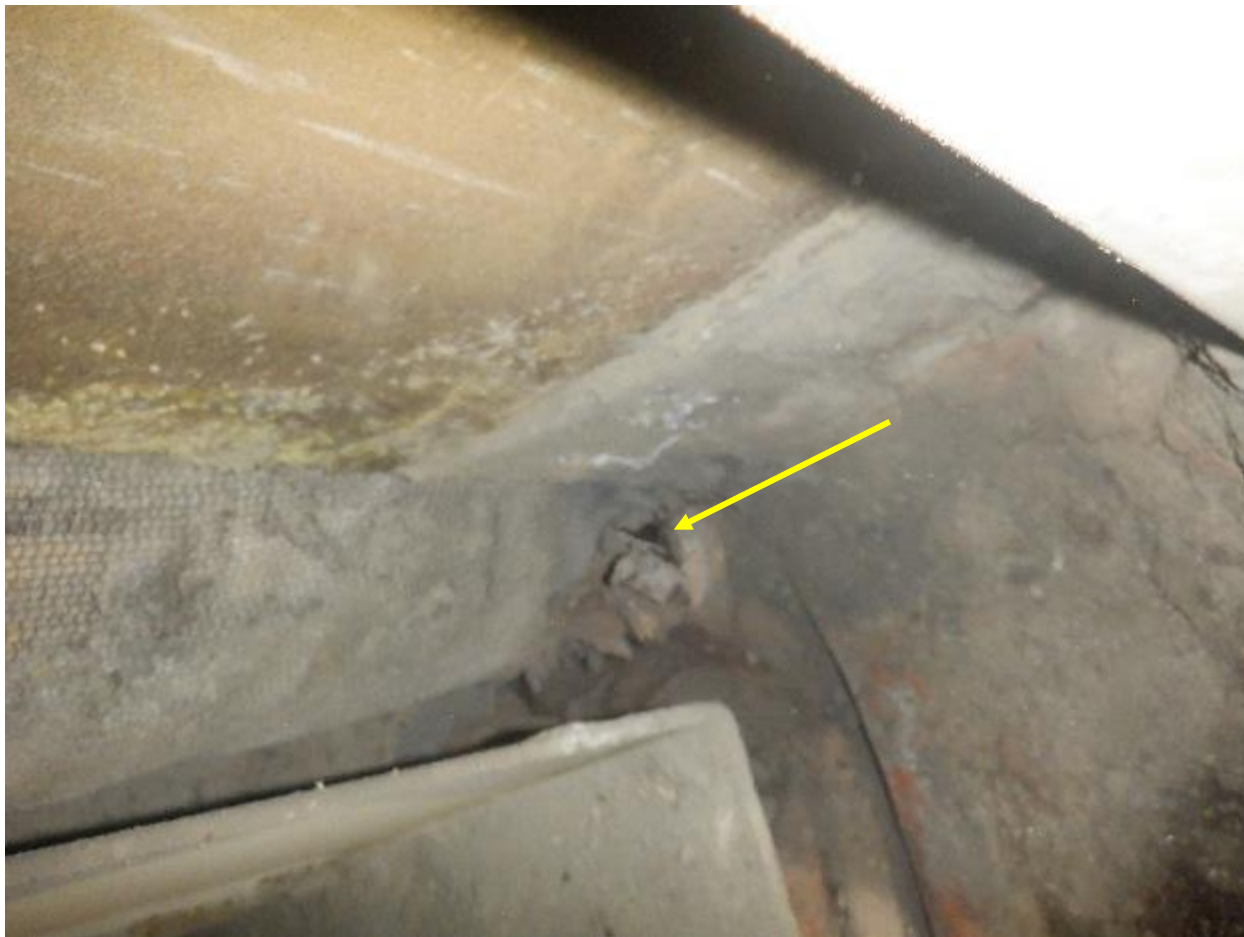
Date: 5/23/2023	Inspected by: B&W	Unit: 2	Item: ESPDUCTS 14
Component Inspected: 2BB ESP Inlet Duct			
Condition Assessment: The acid sleeve of the expansion joint was damaged, and the pillow has begun to show.			
Recommendations: Continue to monitor.			
Criticality: P3			
Risk if NOT Performed: Expansion joint will be prone to damage due to portions of acid sleeve missing.			
EKP Comments:

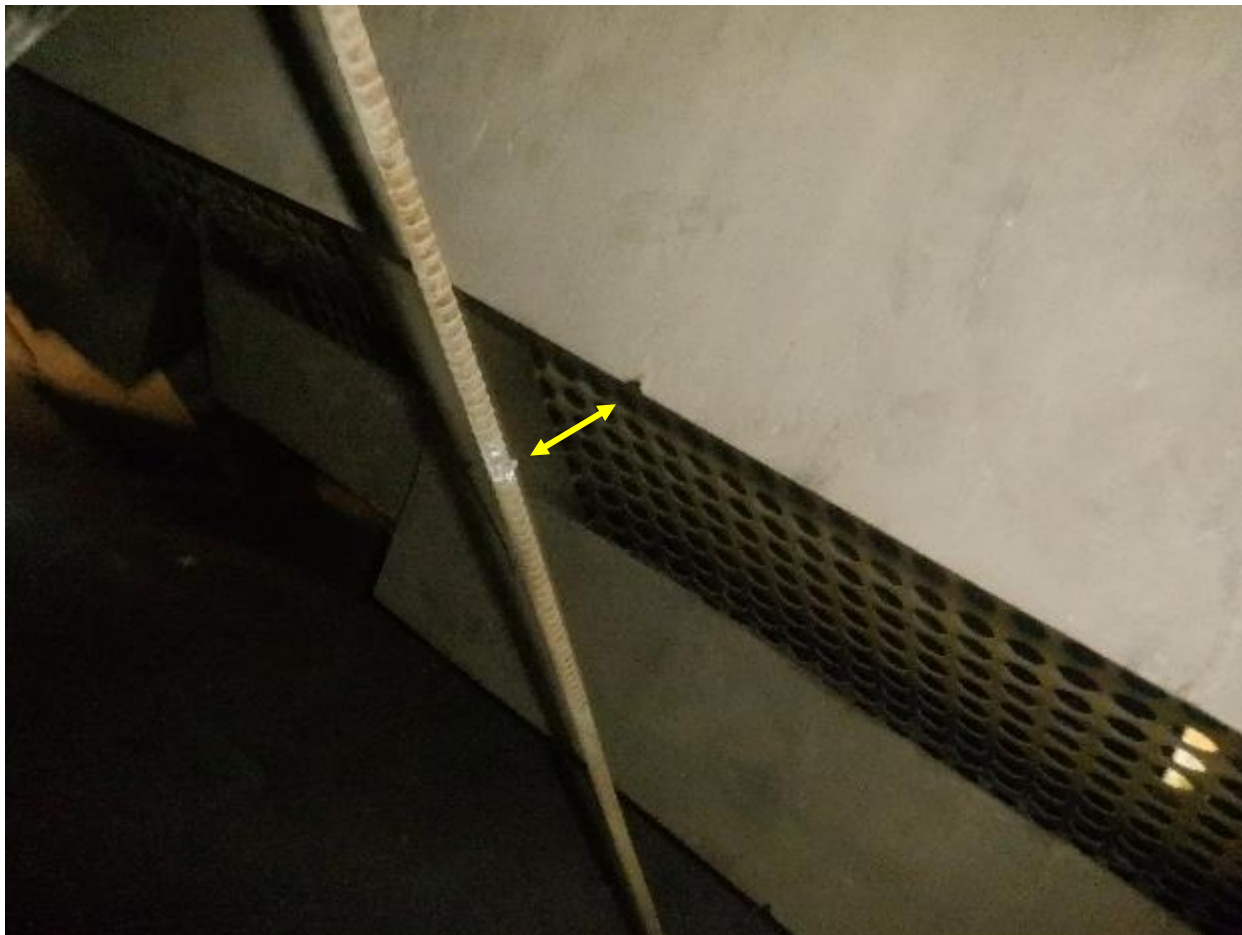
Date: 5/23/2023	Inspected by: B&W	Unit: 2	Item: ESPDUCTS 15
Component Inspected: 2BB ESP Inlet Duct			
Condition Assessment: There were three (3) failed welds on the 2nd perforated screen to rebar stiffeners.			
Recommendations: Re-weld the (3) failed welds.			
Criticality: P3			
Risk if NOT Performed: The perforated plates could sag and allow ash to bypass the plates. This would be detrimental to the ESP efficiency.			
EKP Comments:

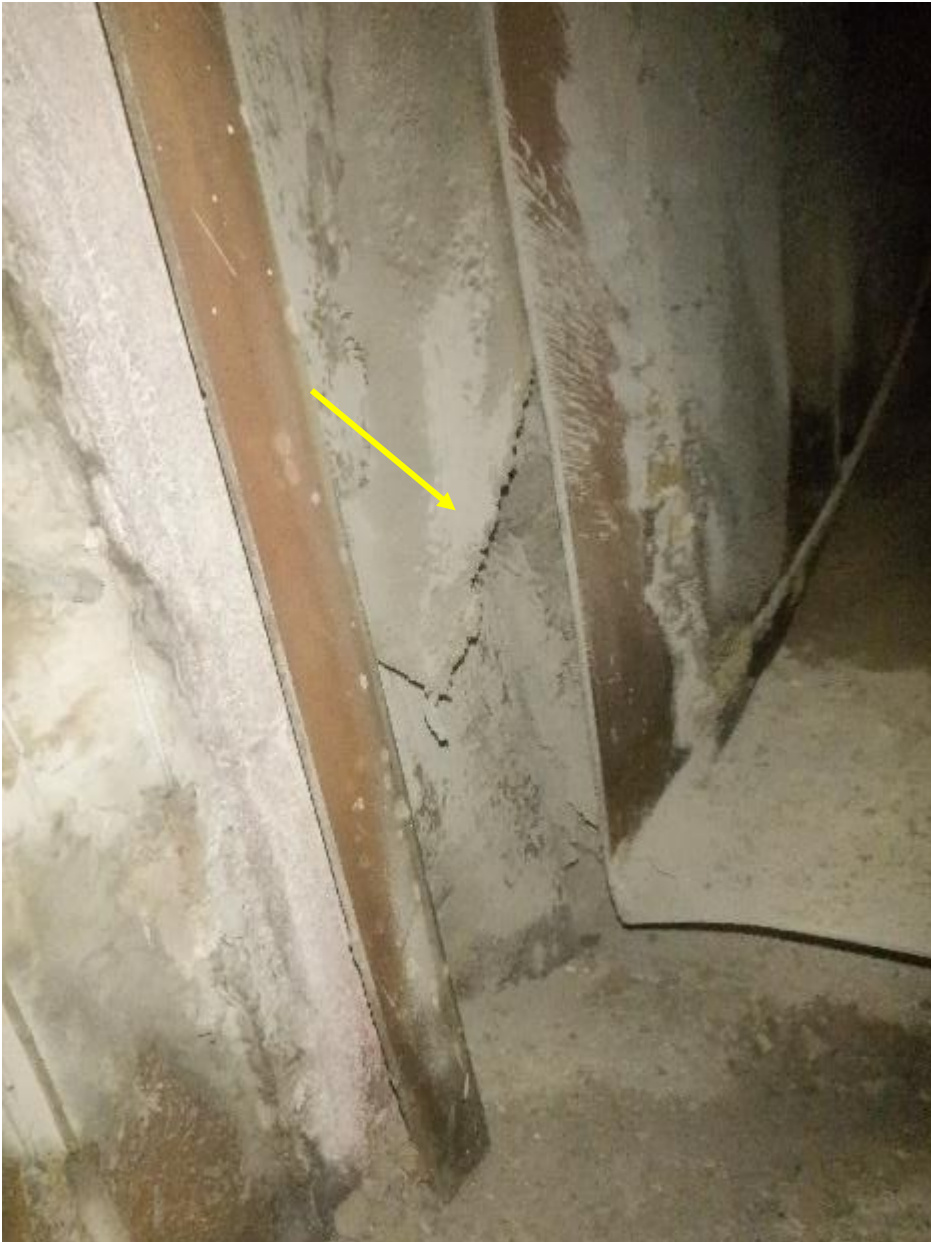
Date: 5/23/2023	Inspected by: B&W	Unit: 2	Item: ESPDUCTS 16
Component Inspected: 2BA ESP Inlet Duct			
Condition Assessment: The acid sleeve was torn on the expansion joint found just downstream of the ESP outlet transition slope.			
Recommendations: Patch the expansion acid sleeve.			
Criticality: P3			
Risk if NOT Performed: The joint will continue to deteriorate; the leaks will occur, and air-in leakage will rise.			
EKP Comments:			
Photos:

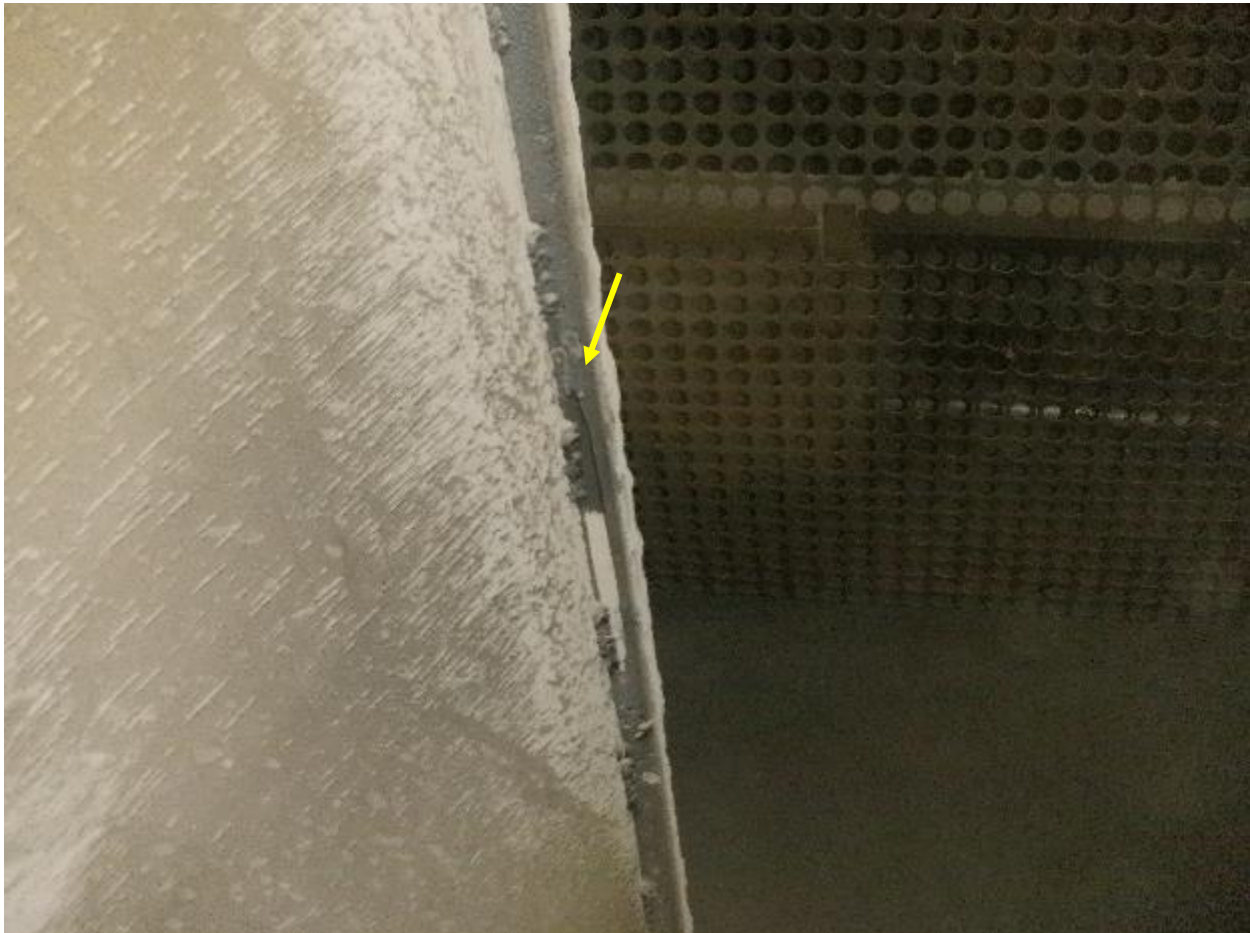
Date: 5/23/2023	Inspected by: B&W	Unit: 2	Item: ESPDUCTS 17
Component Inspected: 2BA ESP Inlet Duct			
Condition Assessment: There was a hole in the leading edge of the trailing pipe stiffeners of the two (2) vertical turning vanes.			
Recommendations: Weld 2"x2"x24" angles over the holes.			
Criticality: P3			
Risk if NOT Performed: Tramp air will be sucked in and the leak will worsen.			
EKP Comments:			
Photos:
