The Babcock & Wilcox Company

**Eastern Kentucky Power Cooperative
Spurlock Station, Unit #2**

U2 SPRING 2023 OUTAGE BOILER INSPECTION REPORT

B&W Project No.: BA9312817

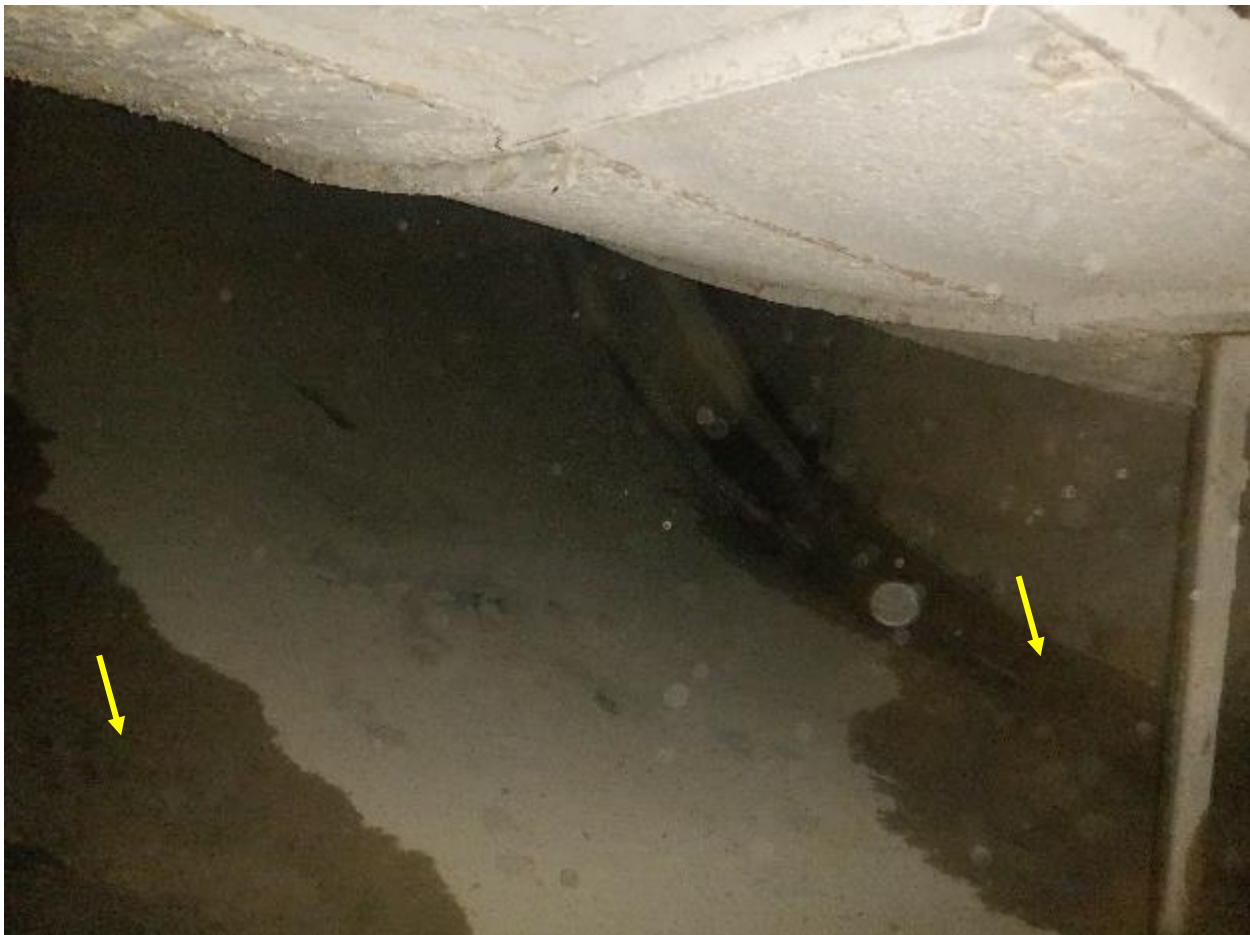
Date: 5/23/2023	Inspected by: B&W	Unit: 2	Item: ESPDUCTS 18
Component Inspected: 2BA ESP Inlet Duct			
Condition Assessment: There were two (2) areas on the FW, coming from the Economizer outlet flue, with large amounts of water running down the flue.			
Recommendations: Investigate where the water came from.			
Criticality: P3			
Risk if NOT Performed: If this is from a leak, air in-leakage and the leak will worsen.			
EKP Comments:			
Photos:

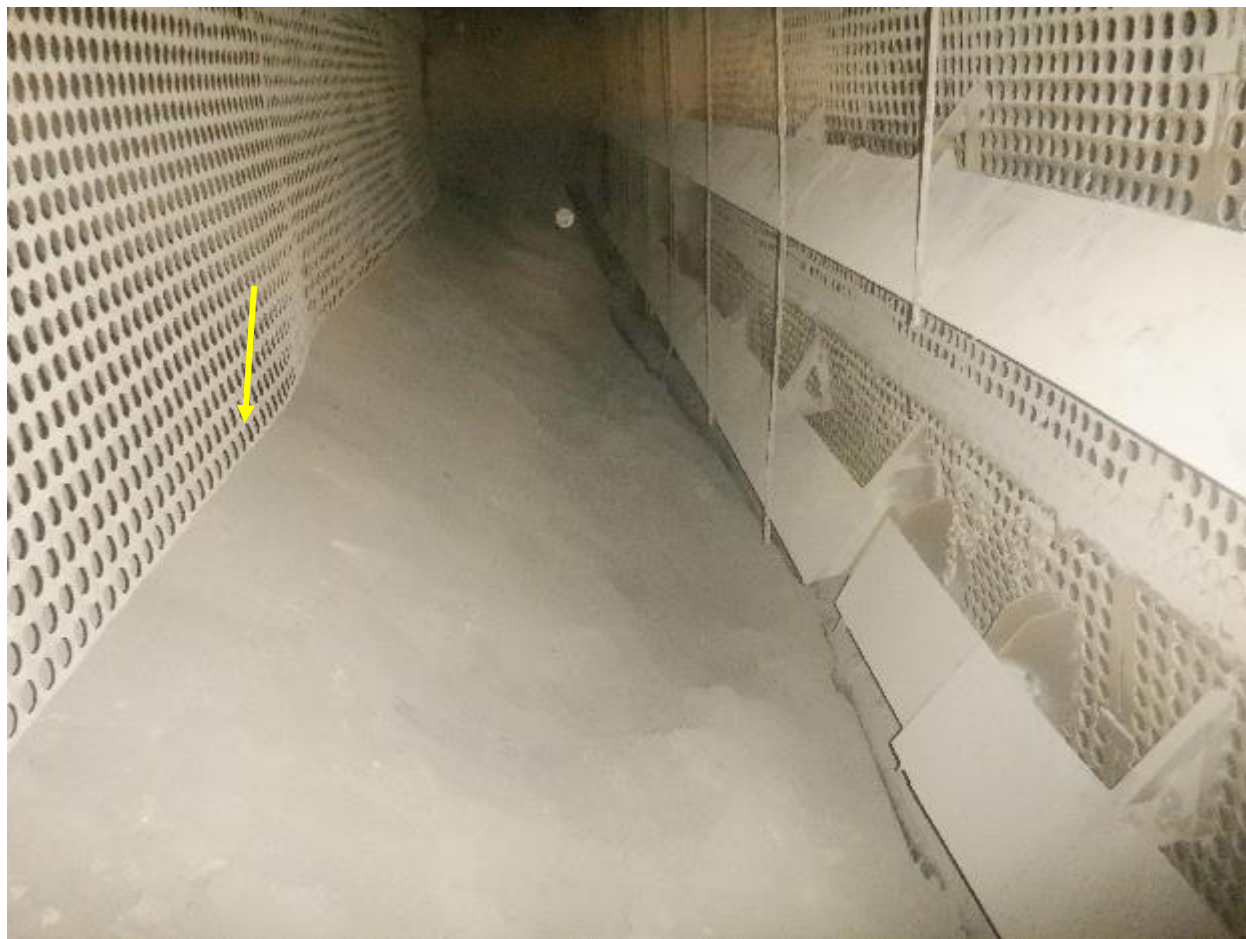
Date: 5/23/2023	Inspected by: B&W	Unit: 2	Item: ESPDUCTS 19
Component Inspected: 2BA ESP Inlet Duct			
Condition Assessment: The leading edge perforated screen didn't have any anchors at the bottom.			
Recommendations: Push the screen towards the slope and Install the bent hold down plates.			
Criticality: P3			
Risk if NOT Performed: The screen can move excessively and could swing free which could allow ash to bypass the screen.			
EKP Comments:

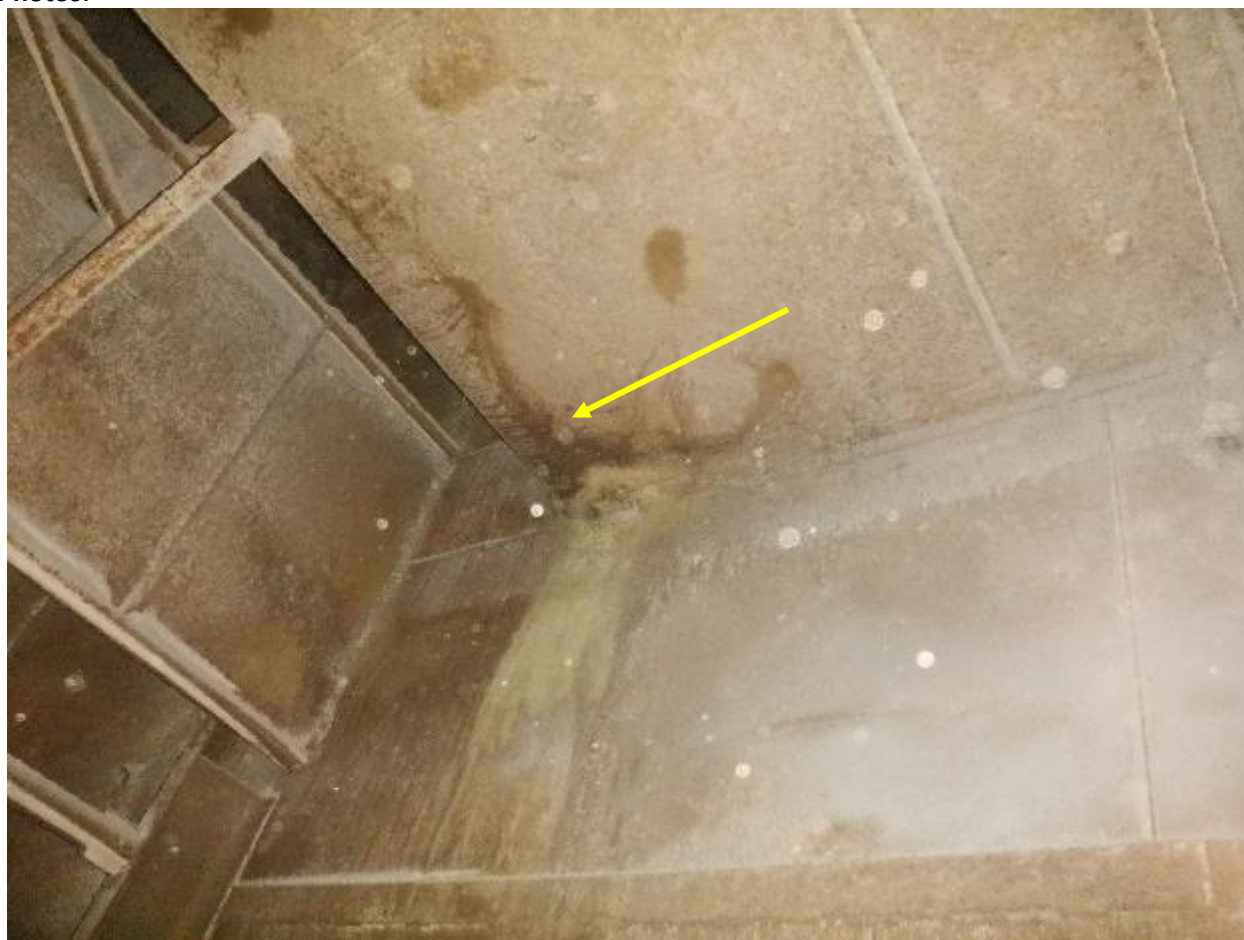
Date: 5/23/2023	Inspected by: B&W	Unit: 2	Item: ESPDUCTS 20
Component Inspected: 2BA ESP Outlet Duct			
Condition Assessment: There was a casing leak in the roof, RHSV, above the SCR bypass dampers.			
Recommendations: Remove the lagging and insulation from the exterior and repair the casing with seal welded 3/16" carbon steel patches. Rework the lagging and insulation at the top of the ESP to flue transition to prevent water from going underneath the lagging.			
Criticality: P3			
Risk if NOT Performed: Allows in-leakage and the hole will worsen.			
EKP Comments:

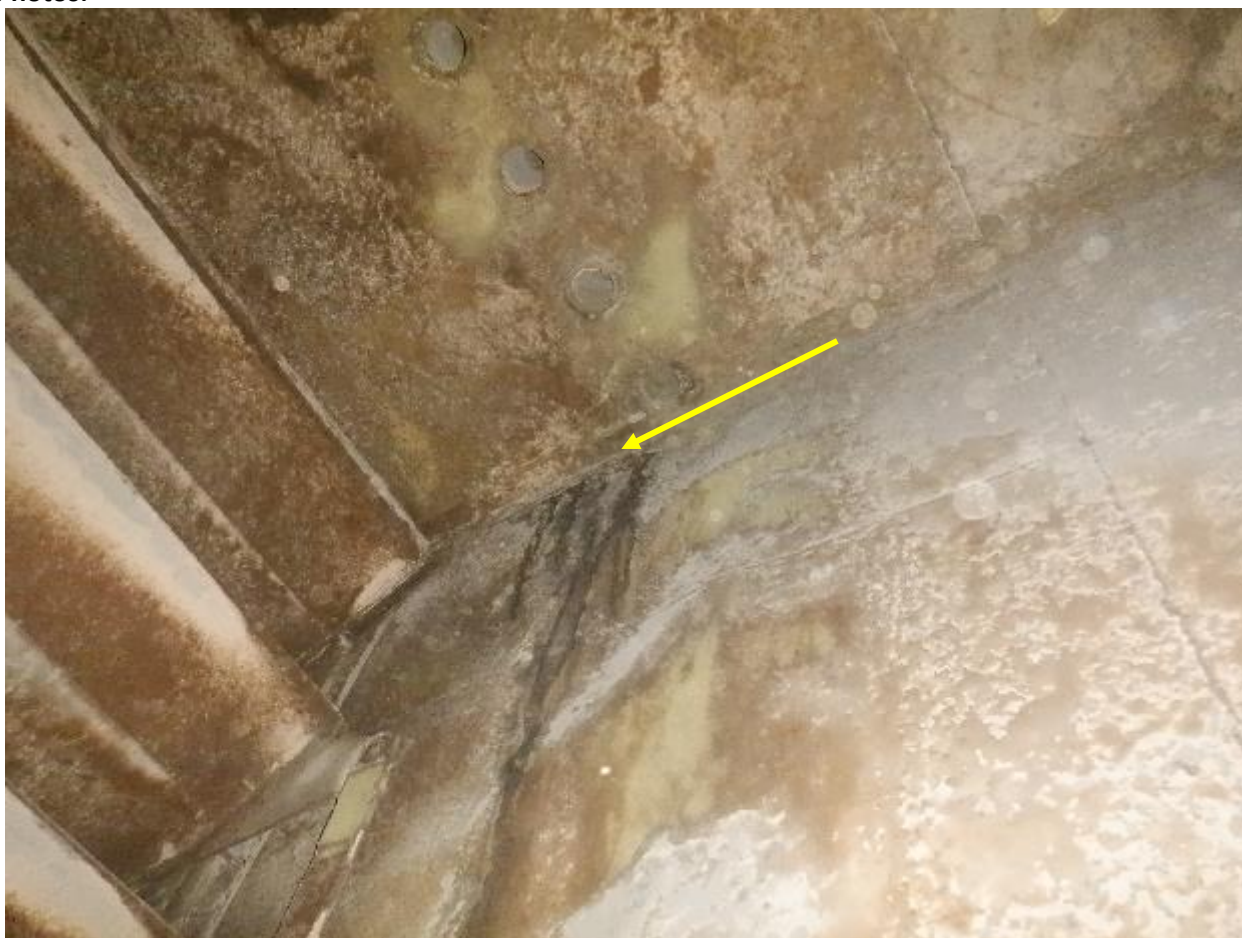
Date: 5/23/2023	Inspected by: B&W	Unit: 2	Item: ESPDUCTS 21
Component Inspected: 2BA ESP Outlet Duct			
Condition Assessment: There was a casing leak in the roof, at the RHSW, upstream of the outlet dampers.			
Recommendations: Remove the lagging and insulation from the exterior and repair the casing with seal welded 3/16" carbon steel patches. Rework the lagging and insulation at the top of the ESP to flue transition to prevent water from going underneath the lagging.			
Criticality: P3			
Risk if NOT Performed: Allows in-leakage and the hole will worsen.			
EKP Comments:

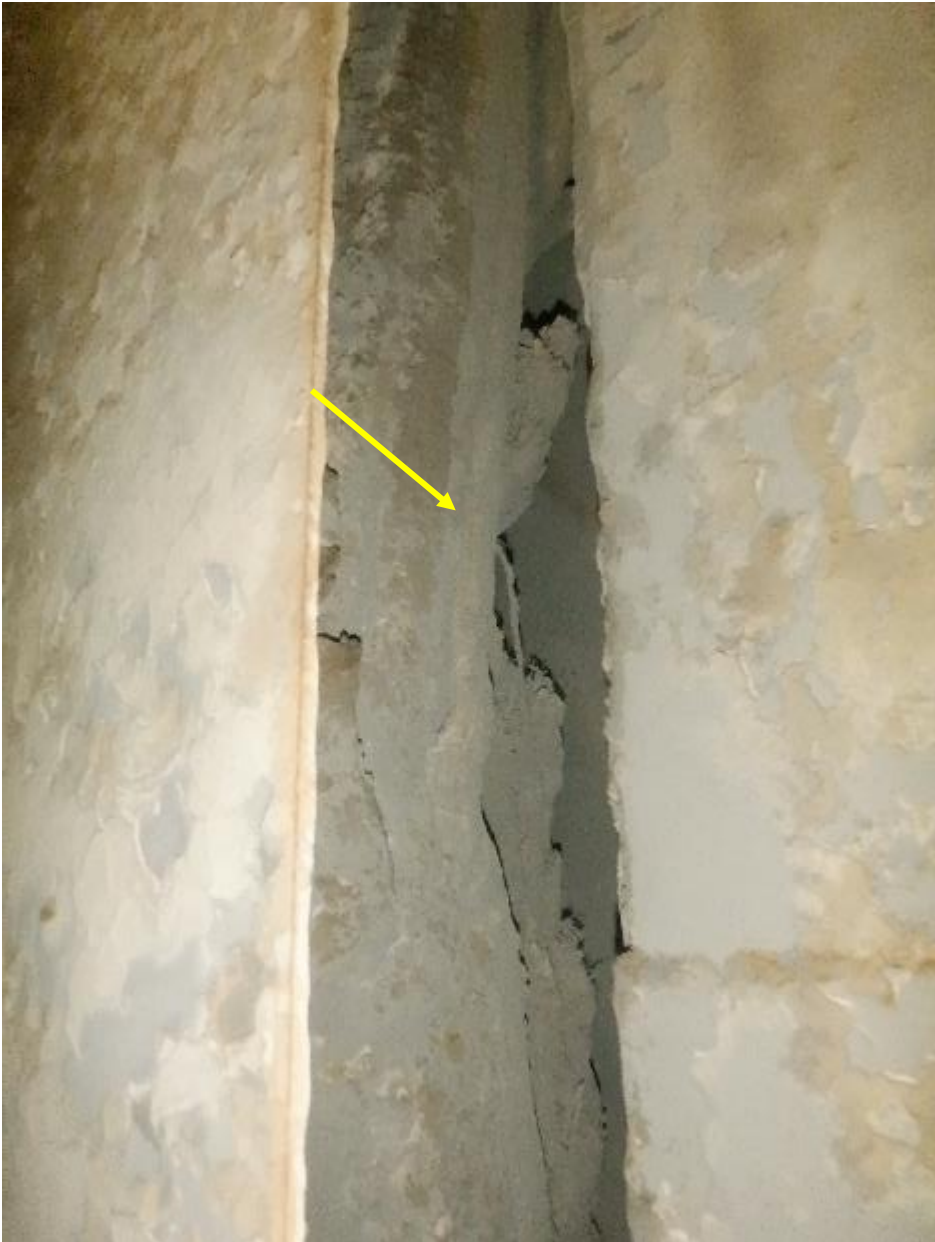
Date: 5/23/2023	Inspected by: B&W	Unit: 2	Item: ESPDUCTS 22
Component Inspected: 2BA ESP Outlet Duct			
Condition Assessment: The acid sleeve was torn on the expansion joint found just downstream of the ESP outlet transition slope.			
Recommendations: Patch the expansion acid sleeve.			
Criticality: P3			
Risk if NOT Performed: The joint will continue to deteriorate; the leaks will occur, and air-in leakage will rise.			
EKP Comments:			
Photos:

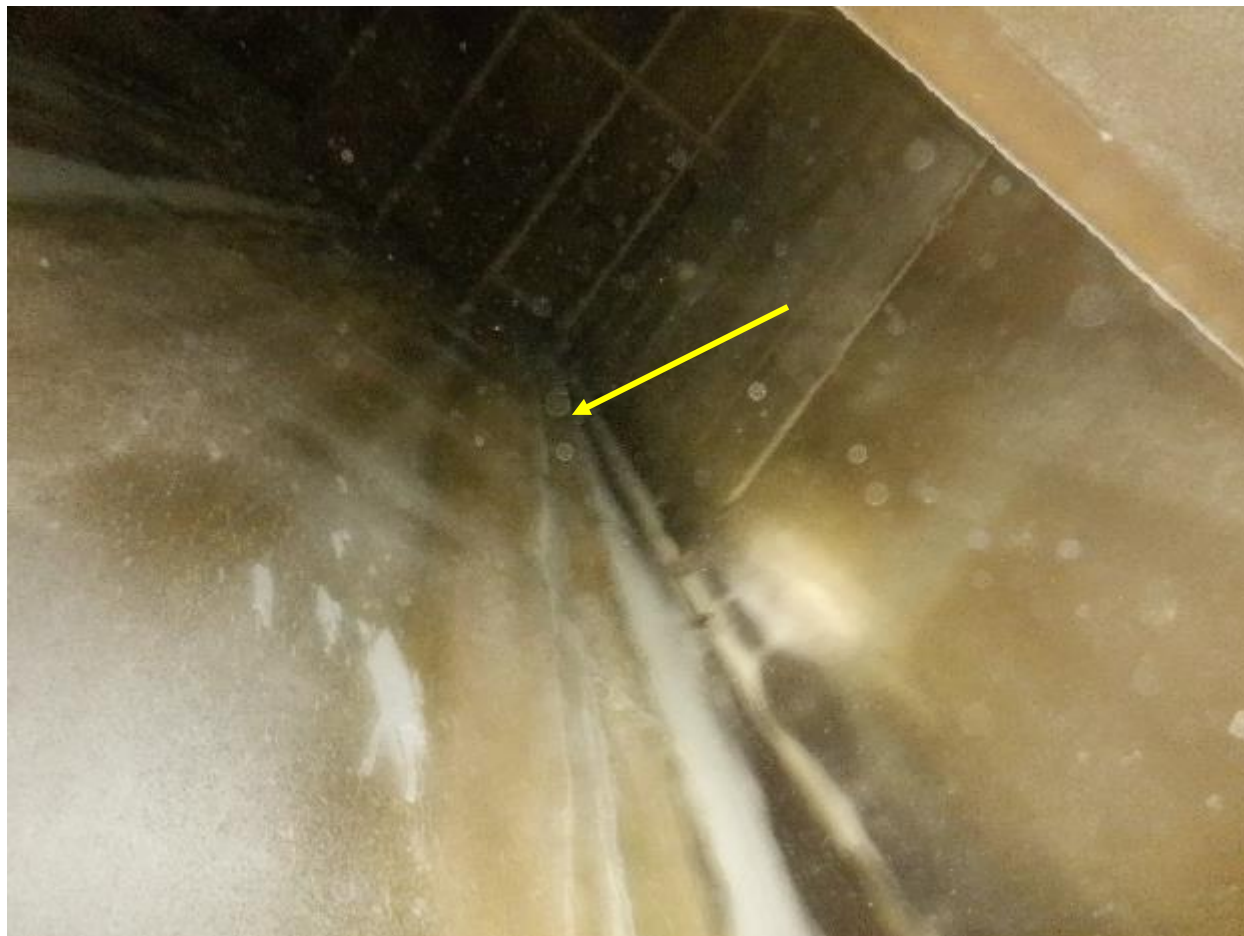
Date: 5/23/2023	Inspected by: B&W	Unit: 2	Item: ESPDUCTS 23
Component Inspected: 2BB ESP Outlet Duct			
Condition Assessment: There appeared to be a casing above the SCR bypass dampers, along the RW.			
Recommendations: Inspect the vertical flue from the ESP outlet to the SCR Inlet for leaks.			
Criticality: P3			
Risk if NOT Performed: Allows in-leakage and the hole will worsen.			
EKP Comments:

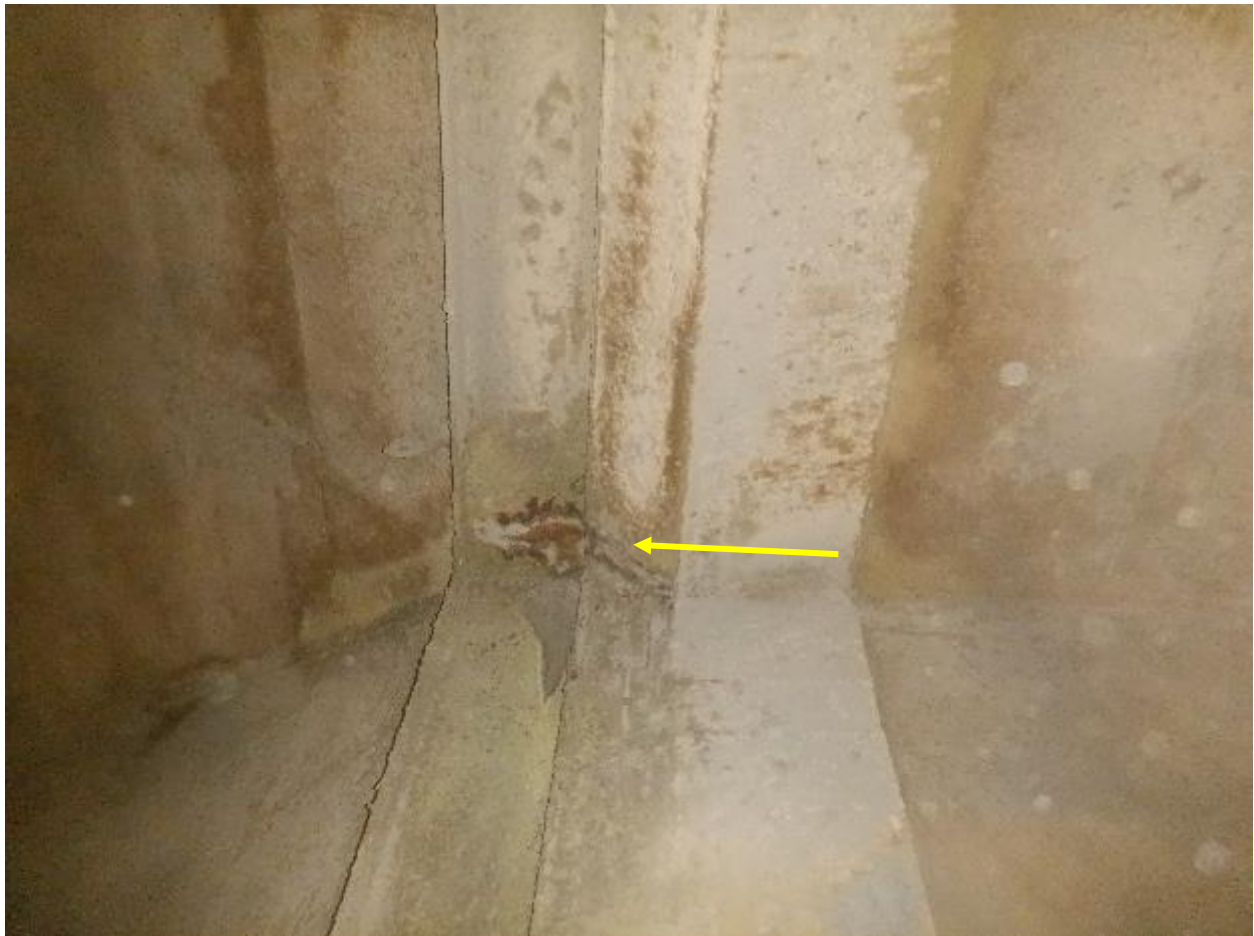
Date: 5/23/2023	Inspected by: B&W	Unit: 2	Item: ESPDUCTS 24
Component Inspected: 2BB ESP Outlet Duct			
Condition Assessment: There appeared to be a casing leak in the expansion joint frame at the roof and LHSW.			
Recommendations: Seal weld patches over the frame and plan to replace the frame when the expansion joint requires replacement.			
Criticality: P3			
Risk if NOT Performed: Air in-leakage and the leaks will worsen.			
EKP Comments:

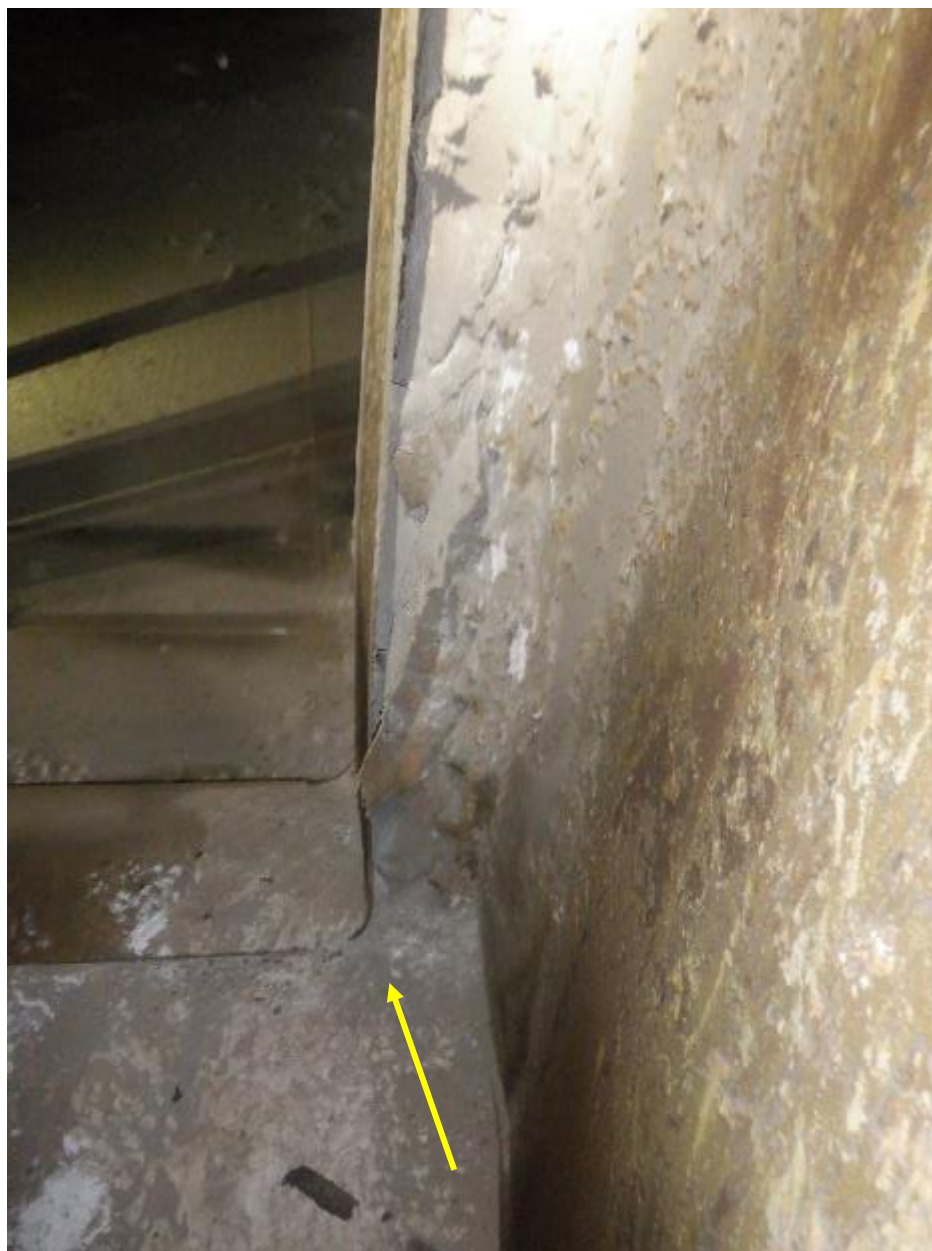
Date: 5/13/2023	Inspected by: B&W - CSH	Unit: 2	Item: SCR 1
Component Inspected: 2A & 2B SCR Outlet			
Condition Assessment: Both expansion joints in the SCR Outlet had minor ash and DSI buildup.			
Recommendations: Clear ash and DSI from the joints.			
Criticality: P3			
Risk if NOT Performed: Fabric corrosion and joint binding.			
EKP Comments:

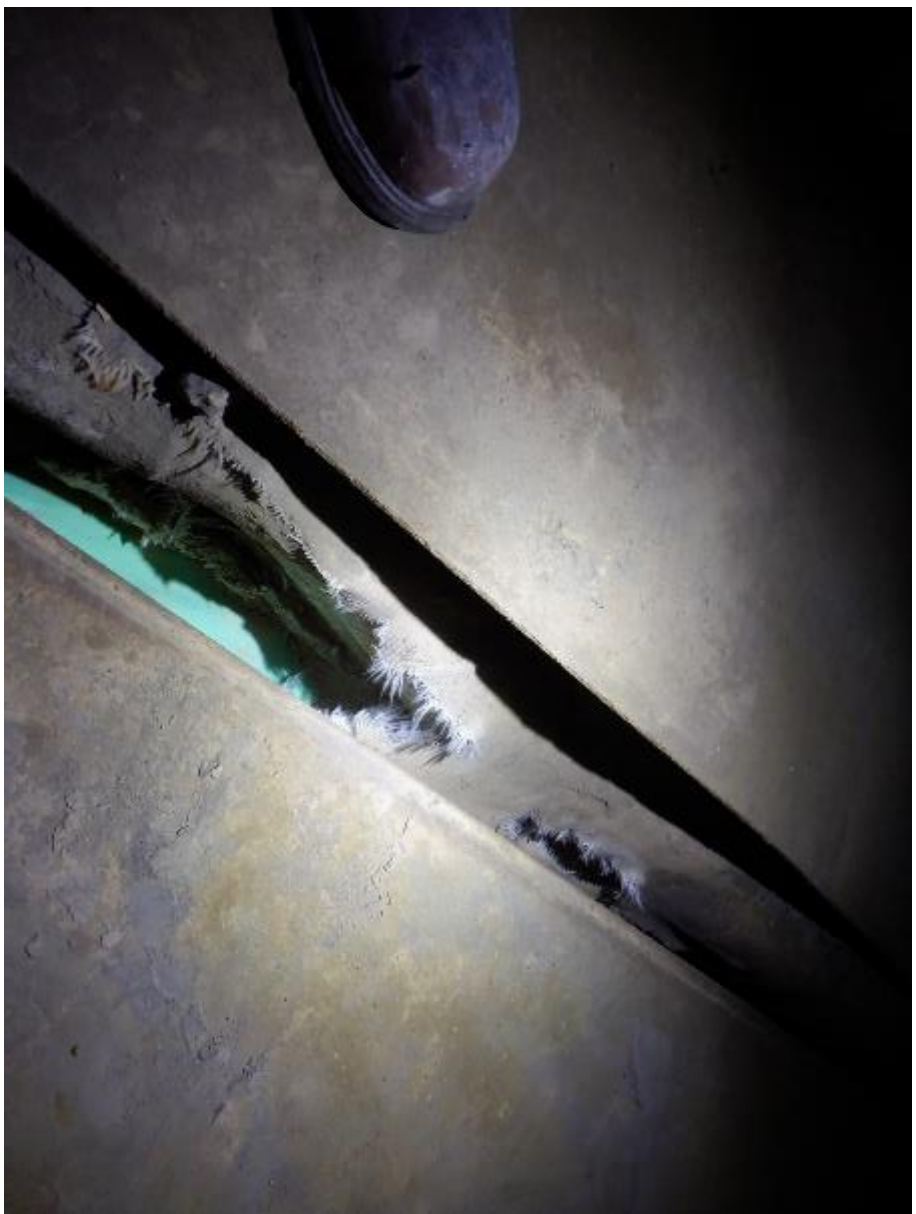
Date: 5/18/23	Inspected by: B&W ECC	Unit: 2	Item: SCR 2
Component Inspected: 2A & 2B SCR Inlet			
Condition Assessment: The expansion joint pillow was discovered with tears and holes, exposing inner fabric. The outer layer is exposed on the left side.			
Recommendations: Patch or replace the expansion joint.			
Criticality: RHS P3 LHS P2			
Risk if NOT Performed: Holes/Tears can occur through the inner fabric, exposing the inside of the outer layer, and eventually causing the expansion joint to fail.			
EKP Comments:			
Photos:

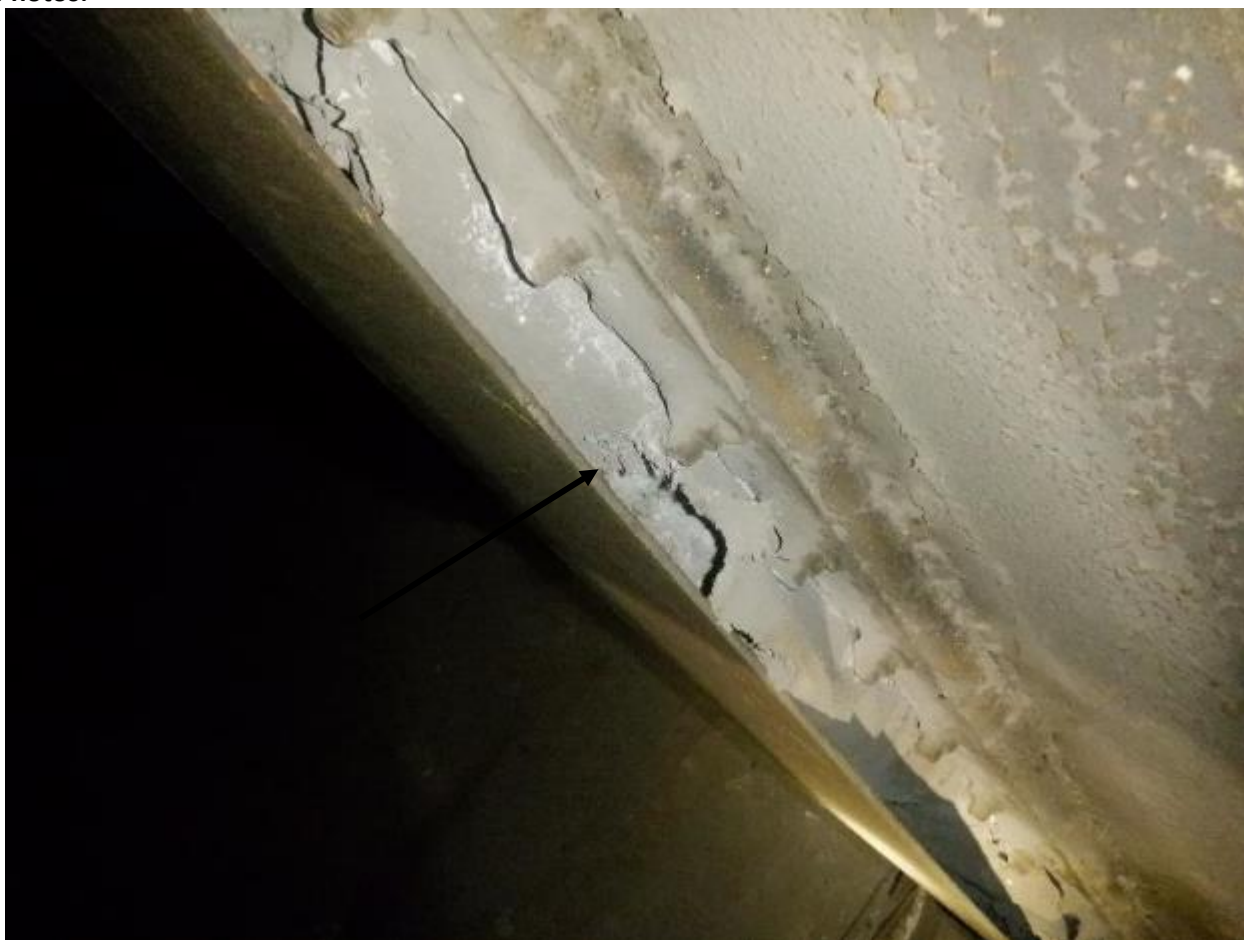
Date: 5/13/2023	Inspected by: B&W - CSH	Unit: 2	Item: SCR 4
Component Inspected: 2A & 2B SCR Outlet			
Condition Assessment: The expansion joint pillow of the joints upstream of the APH inlets, were discovered with tears and holes, exposing inner fabric at the top of the RHS on 2A and near the floor and the entire RHS on 2B.			
Recommendations: Continue to monitor.			
Criticality: P3			
Risk if NOT Performed: Holes/Tears can occur through the inner fabric, exposing the inside of the outer layer, and eventually causing the expansion joint to fail.			
EKP Comments:

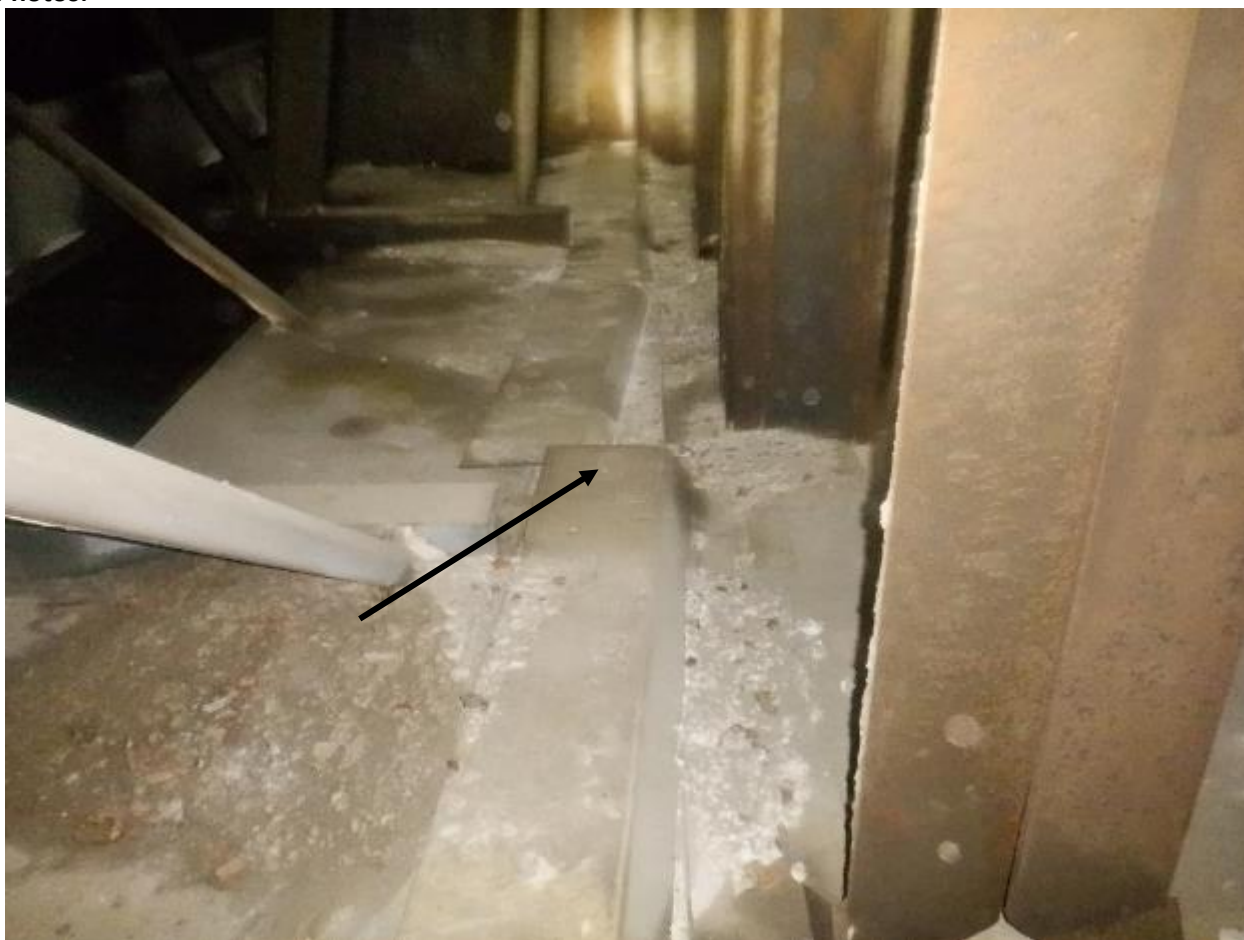
Date: 5/13/2023	Inspected by: B&W - CSH	Unit: 2	Item: SCR 5
Component Inspected: 2A SCR Outlet			
Condition Assessment: The expansion joint dust cover was loose on the floor of the casing on the joint upstream of the APH inlets.			
Recommendations: Clean the debris from the expansion joint and tack weld the dust cover to the flue, over the expansion joint.			
Criticality: P3			
Risk if NOT Performed: Excessive debris build up on the joint/at the loose covers.			
EKP Comments:

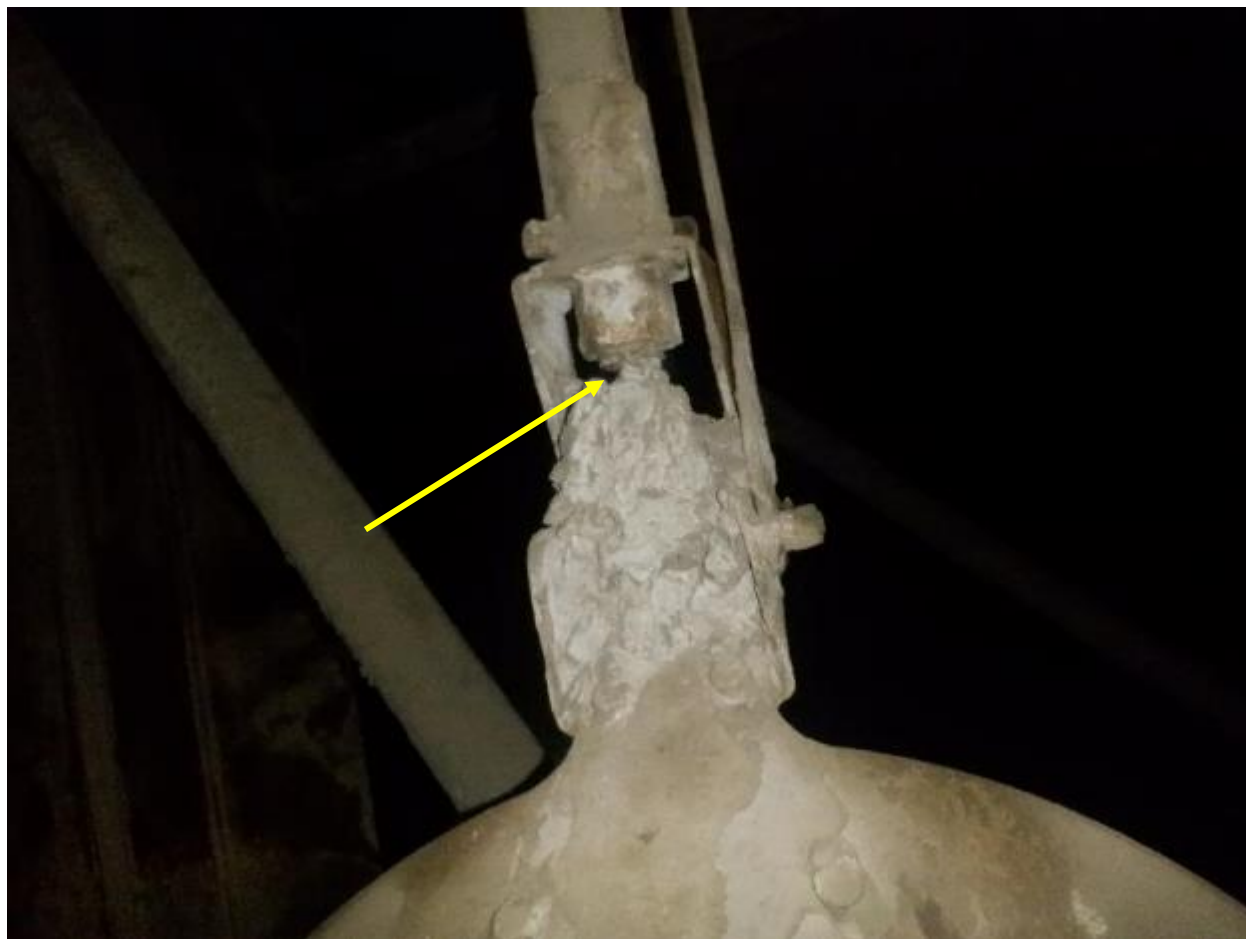
Date: 5/13/2023	Inspected by: B&W – CSH	Unit: 2	Item: SCR 6
Component Inspected: 2A & 2B SCR Outlet			
Condition Assessment: Column 1 - upper and lower and column 5 - lower DSI nozzles were plugged in 2A flue. Column 1 – upper and column 4 – upper and lower nozzles were plugged.			
Recommendations: Clean the nozzles and splash plates.			
Criticality: P3			
Risk if NOT Performed: Portions of the flue gas will go untreated due to the plugged nozzles.			
EKP Comments:

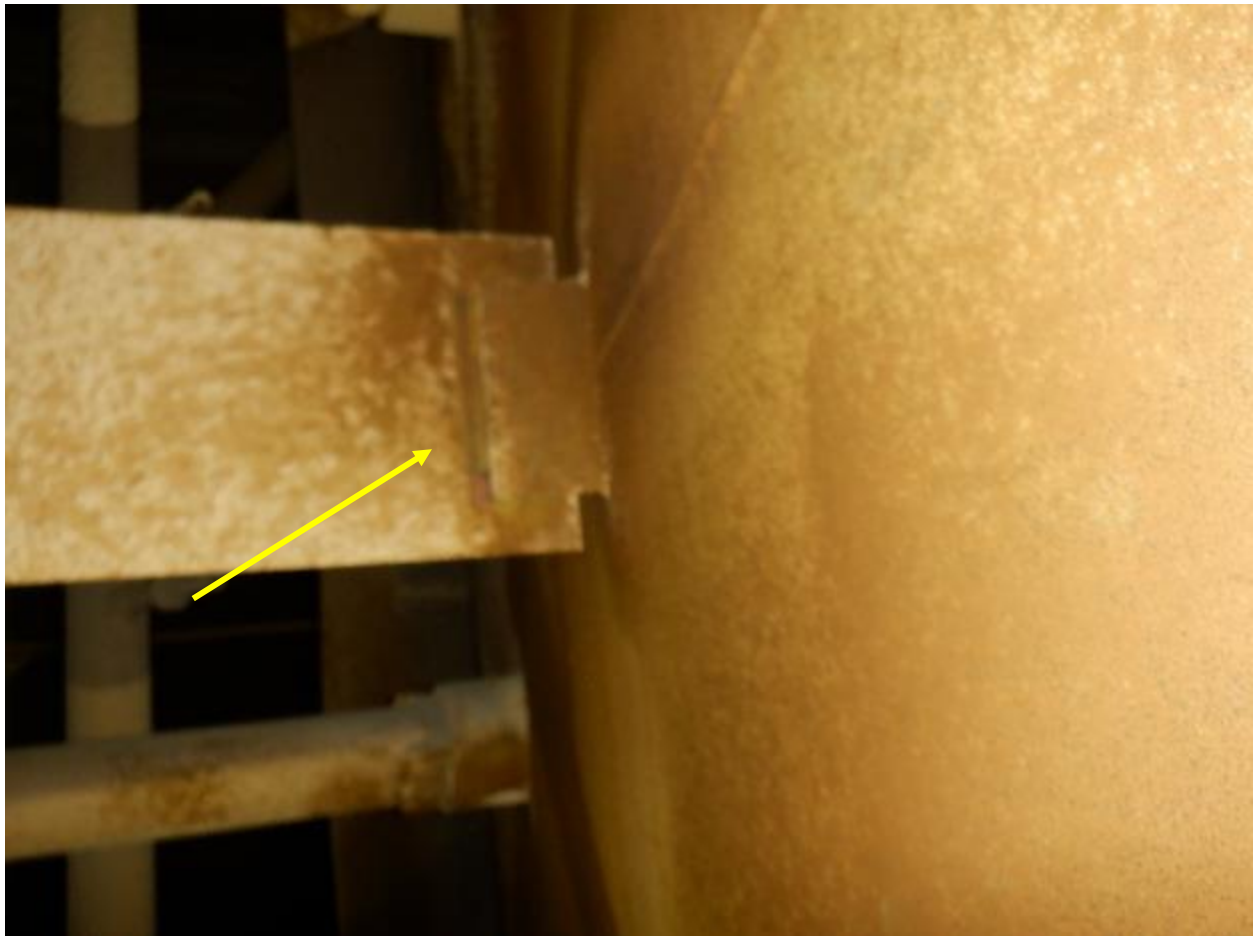
Date: 5/18/23	Inspected by: B&W ECC	Unit: 2	Item: SCR 7
Component Inspected: 2B SCR Inlet			
Condition Assessment: The lower two deflector panels are on the wrong side of the left-side stops.			
Recommendations:			
Criticality: P3			
Risk if NOT Performed: Portions of the flue gas will go untreated due to the plugged nozzles.			
EKP Comments:

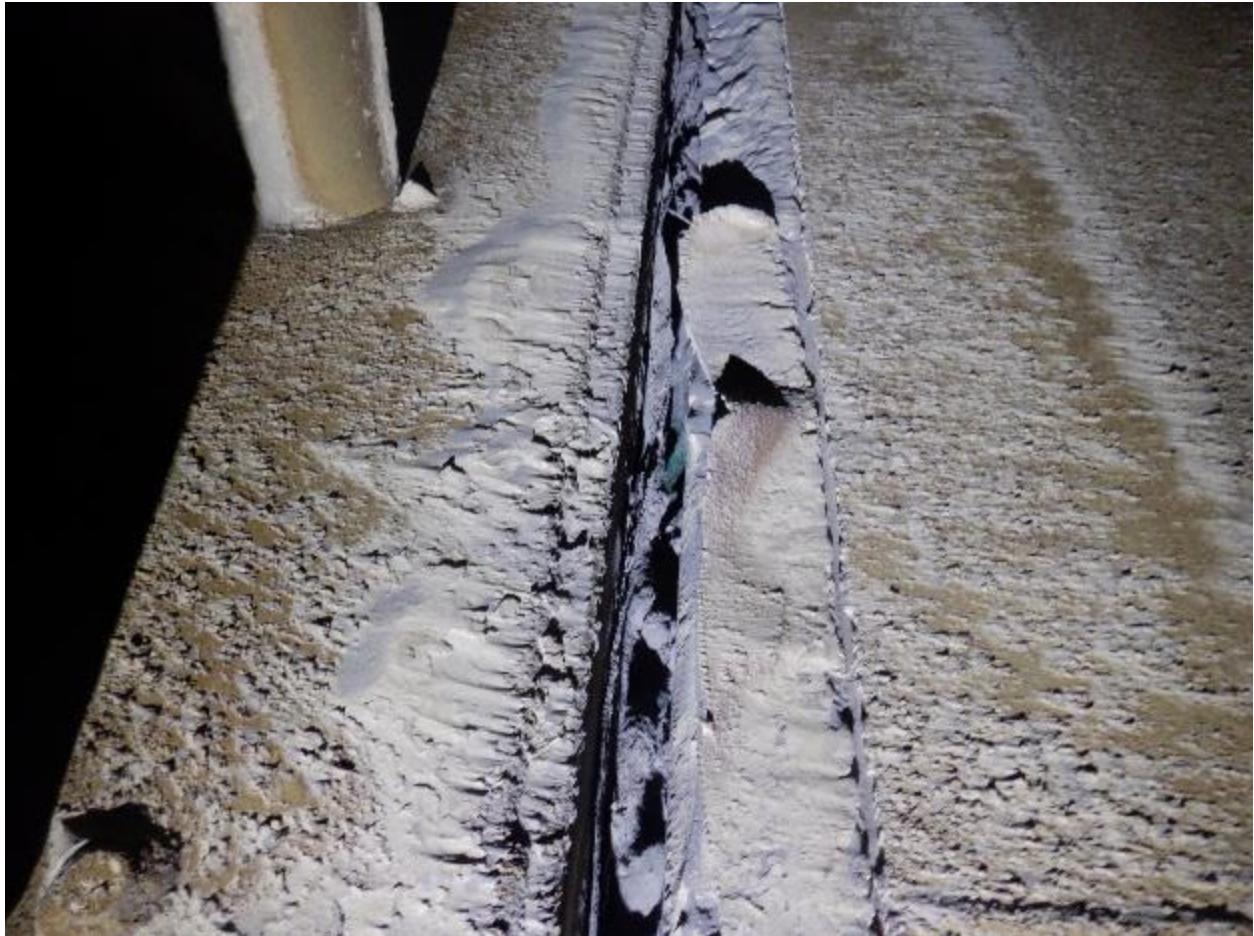
Date: 5/18/23	Inspected by: B&W	Unit: 2	Item: SCR 8
Component Inspected: 2A & 2B SCR Inlet			
Condition Assessment: Both expansion joints in the SCR inlet had minor ash buildup.			
Recommendations: Clear ash from the joints.			
Criticality: P3			
Risk if NOT Performed: Fabric corrosion and joint binding.			
EKP Comments:

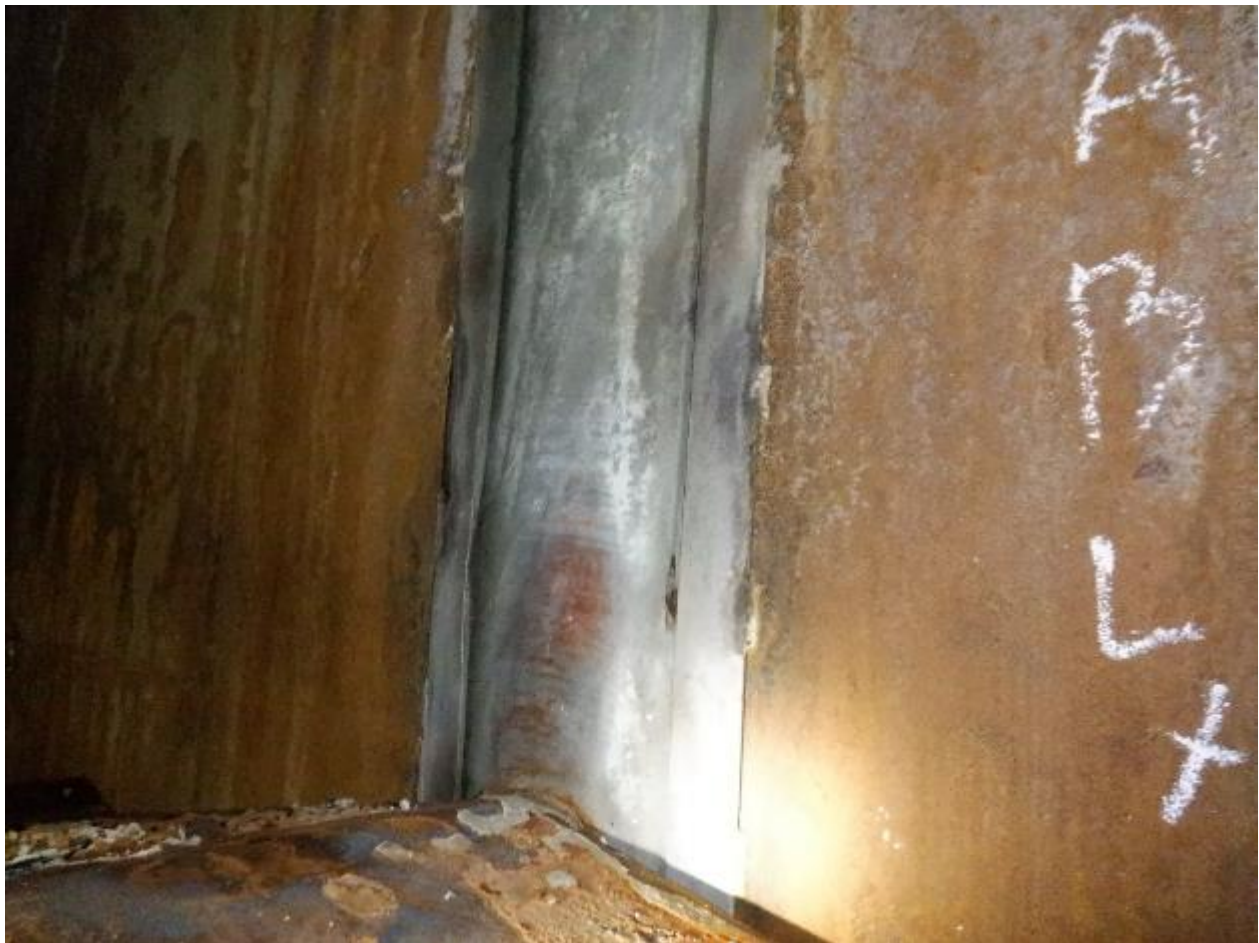
Date: 05/13/23	Inspected by: B&W ECC	Unit: 2	Item: APHGASIO 1
Component Inspected: Air Preheater Gas Outlet			
Condition Assessment: Gas crossover – Several holes have eroded into the gas outlet crossover damper frame.			
Recommendations: Weld repair the holes.			
Criticality: P3			
Risk if NOT Performed: Erosion will continue and the holes enlarge.			
EKP Comments:

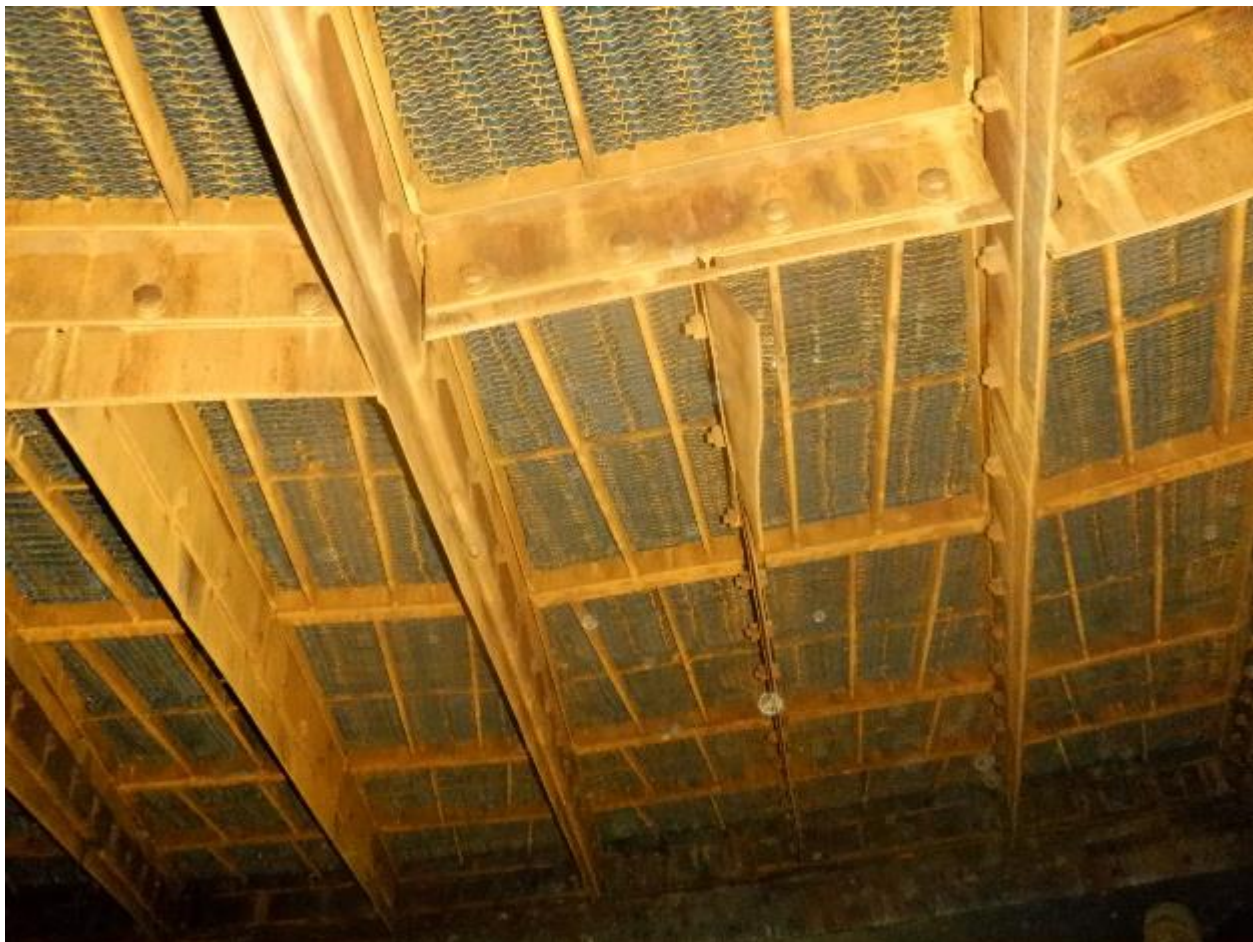
Date: 05/13/23	Inspected by: B&W ECC	Unit: 2	Item: APHGASIO 2
Component Inspected: Air Preheater Gas Outlet			
Condition Assessment: AH A Gas Outlet: Missing and one bent radial seal section.			
Recommendations: Replace the sections of seal.			
Criticality: P3			
Risk if NOT Performed: Minor increase in air heater leakage.			
EKP Comments:

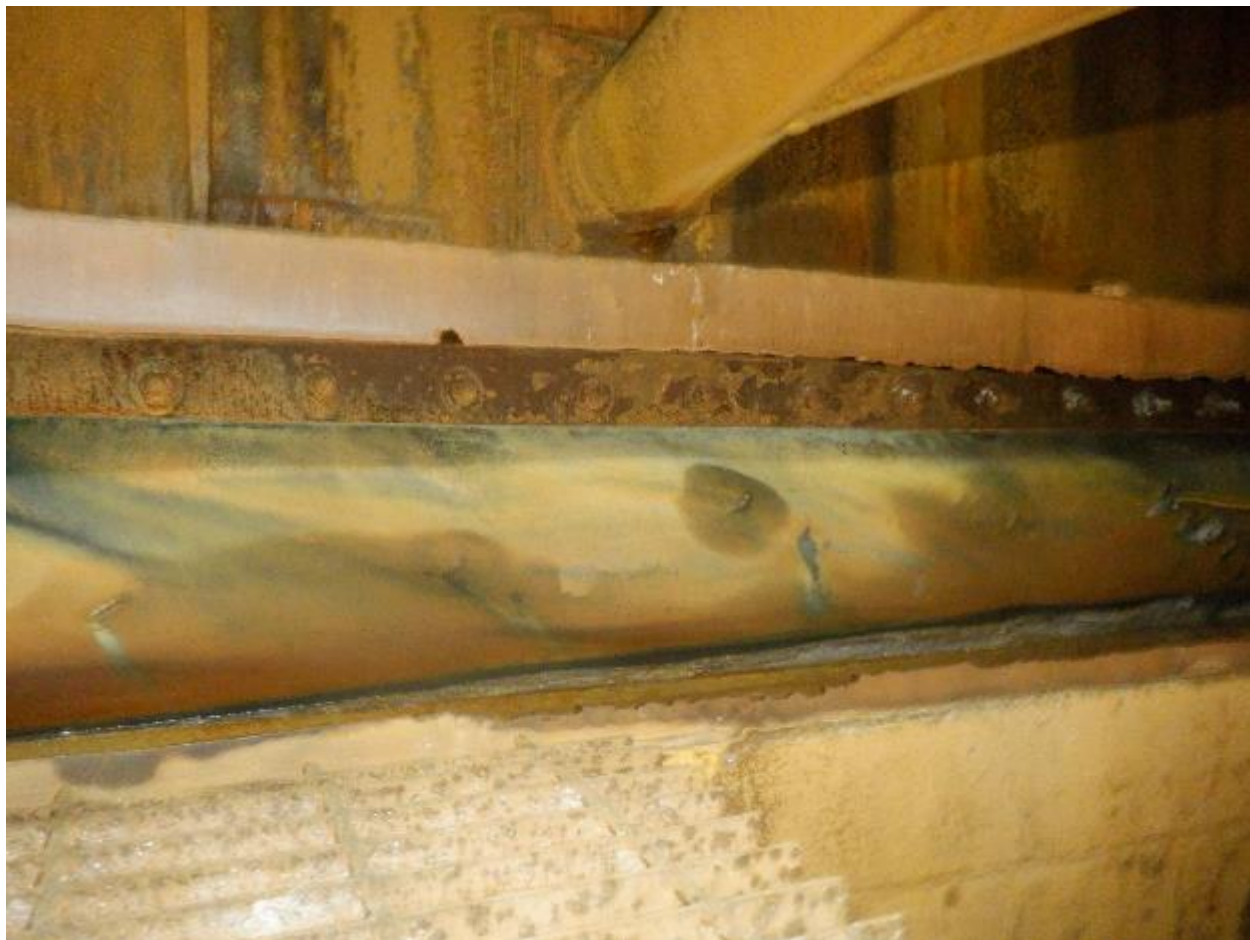
Date: 05/13/23	Inspected by: B&W ECC	Unit: 2	Item: APHGASIO 3
Component Inspected: Air Preheater Gas Outlet			
Condition Assessment: Air heater A Gas outlet: The front of the expansion joint as many small holes.			
Recommendations: Patch the holes.			
Criticality: P3			
Risk if NOT Performed: Holes can enlarge over time and increase air in leakage.			
EKP Comments:

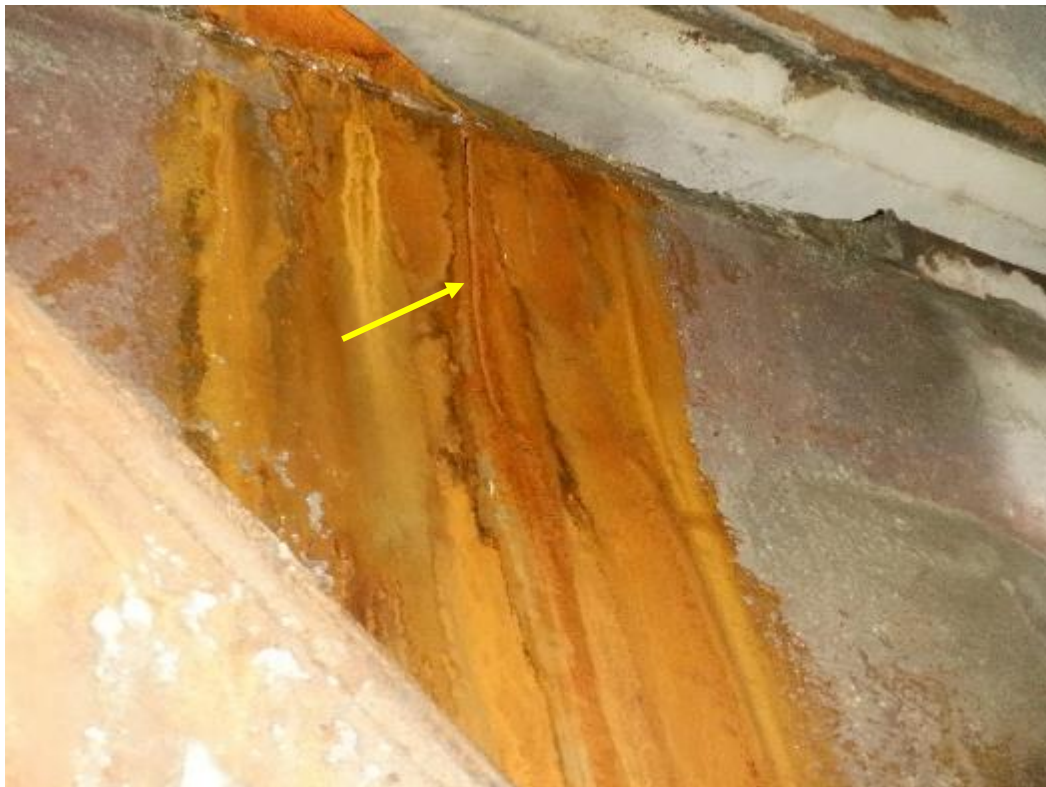
Date: 05/13/23	Inspected by: B&W ECC	Unit: 2	Item: APHGASIO 4
Component Inspected: Air Preheater Gas Outlet			
Condition Assessment: 2A Outlet Inlet – The rear wall of the flue has an indication near the left rear corner.			
Recommendations: PT the indication to determine its extent. Grind out and weld repair as needed.			
Criticality: P3			
Risk if NOT Performed: Slight air in leakage.			
EKP Comments:
