The Babcock & Wilcox Company

**Eastern Kentucky Power Cooperative
Spurlock Station, Unit #2**

U2 SPRING 2023 OUTAGE BOILER INSPECTION REPORT

B&W Project No.: BA9312817

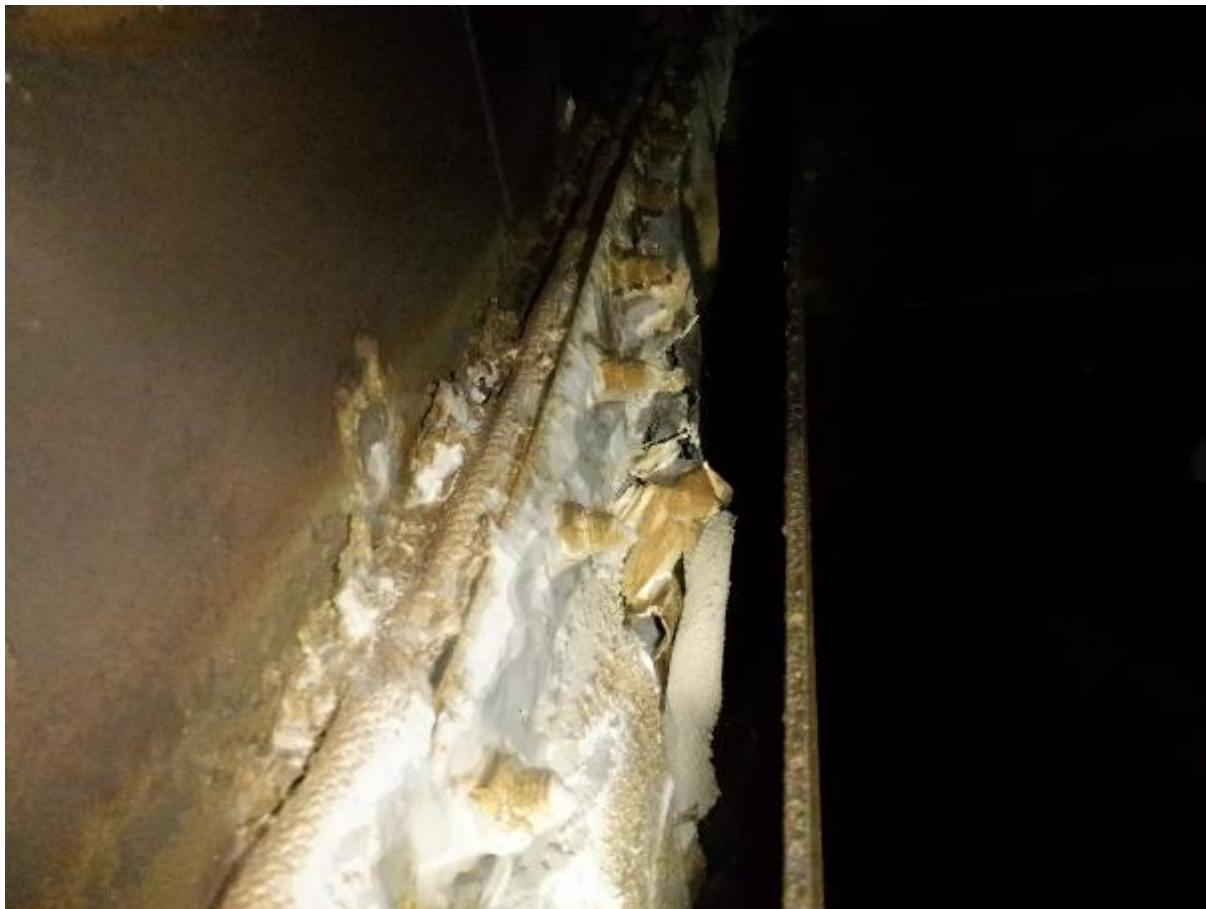
Date: 05/13/23	Inspected by: B&W ECC	Unit: 2	Item: APHGASIO 5
Component Inspected: 2A & 2B Air Preheater Gas Inlet			
Condition Assessment: The inner fabric of the expansion going is torn.			
Recommendations: Repair the expansion joint			
Criticality: P3			
Risk if NOT Performed: Damage will continue and damage could start to occur in the outer layer of the expansion joint.			
EKP Comments:

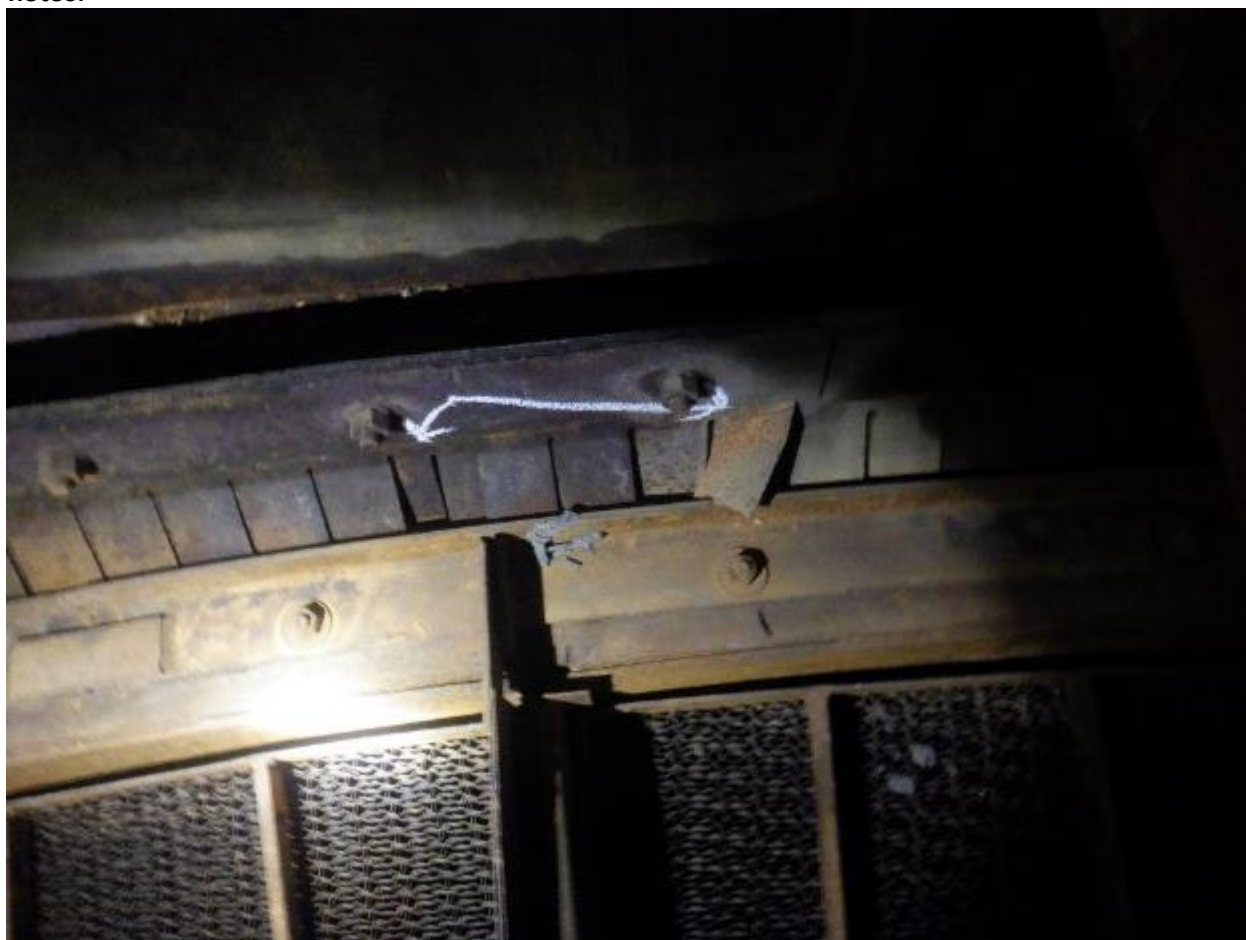
Date: 5/13/2023	Inspected by: B&W - CSH	Unit: 2	Item: APHGASIO 6
Component Inspected: Air Preheater Gas Inlet/Outlet			
Condition Assessment: 2A Gas Inlet – There were six (6) excessive gaps marked along the rear of the APH where the circumferential seals were missing/damaged.			
Recommendations: Replace the damaged seals.			
Criticality: P3			
Risk if NOT Performed: A poor seal will allow gas to bypass the air heater baskets and cause the APH to be less efficient.			
EKP Comments:

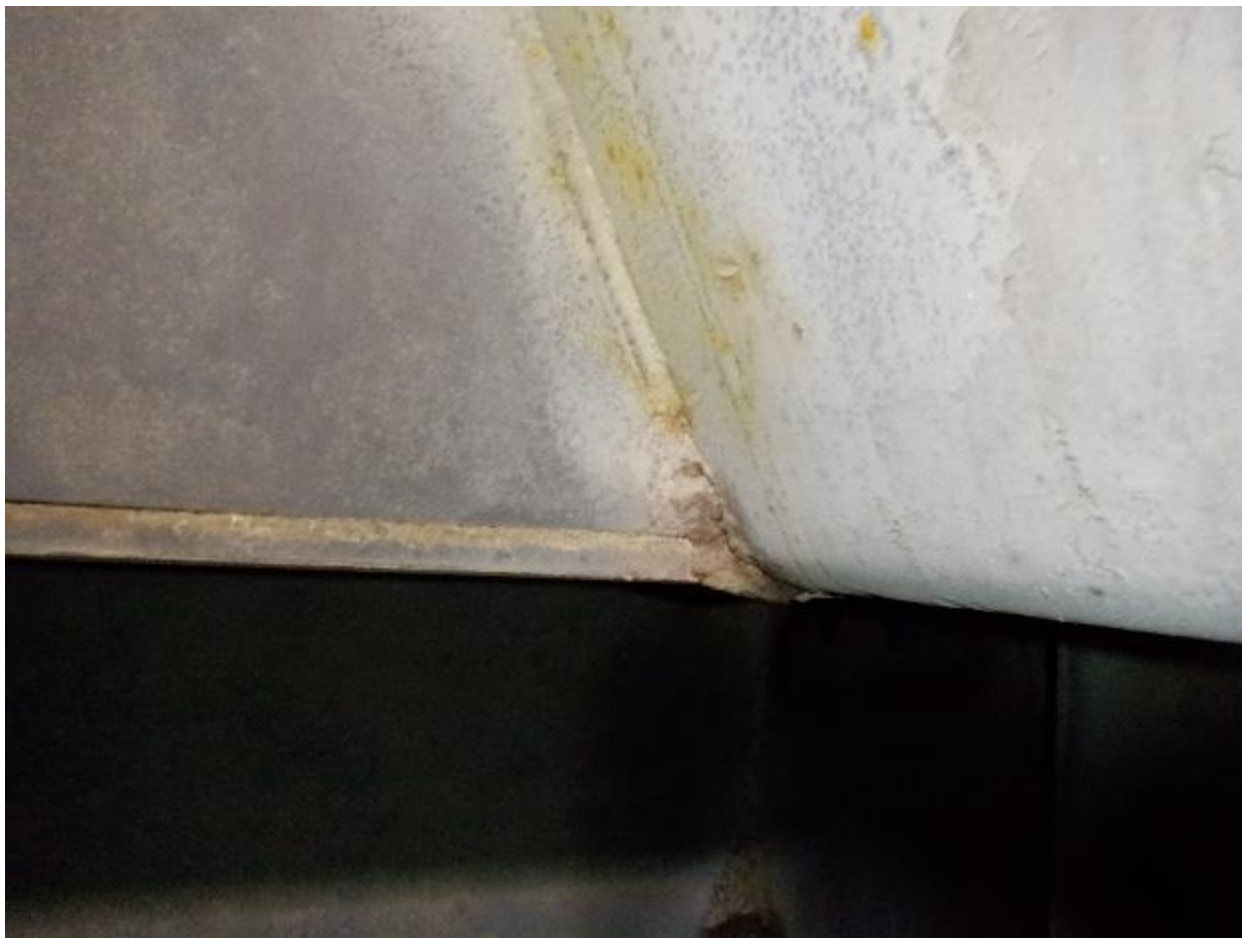
Date: 05/13/23	Inspected by: B&W ECC	Unit: 2	Item: APHAIRIO 1
Component Inspected: Air Preheater Sec Air Outlet			
Condition Assessment: 2B – The front left lower corner of the casing has an indication.			
Recommendations: PT in the indication and grind out and reweld as needed.			
Criticality: P3			
Risk if NOT Performed: The indication could propagate.			
EKP Comments:

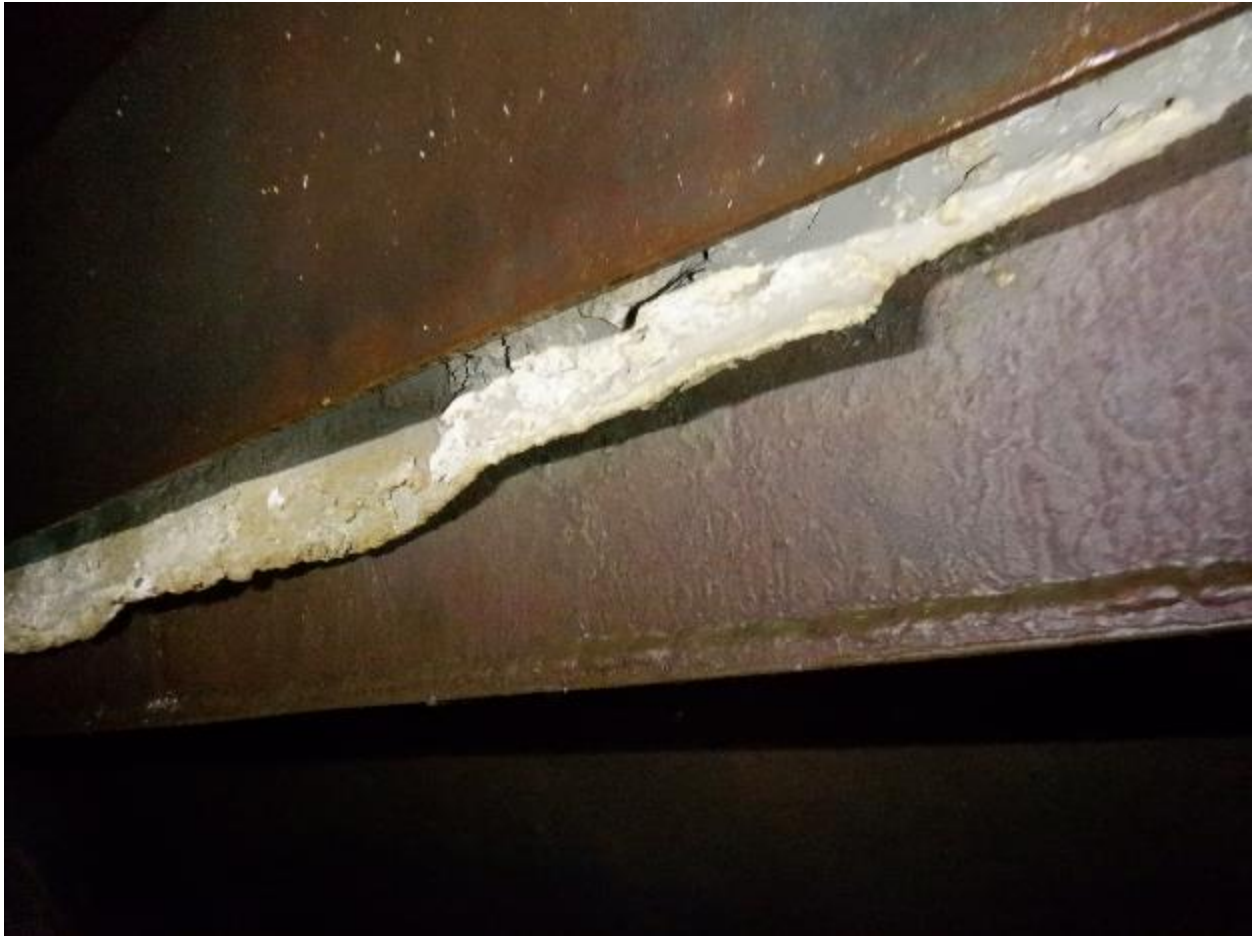
Date: 05/13/23	Inspected by: B&W ECC	Unit: 2	Item: APHAIRIO 2
Component Inspected: Air Preheater Sec Air Outlet			
Condition Assessment: 2B Secondary Air Out – The expansion joint inner fabric is ripped around the perimeter.			
Recommendations: Repair the expansion joint.			
Criticality: P3			
Risk if NOT Performed: The damage could continue and form a hole in the outer layer of the joint.			
EKP Comments:

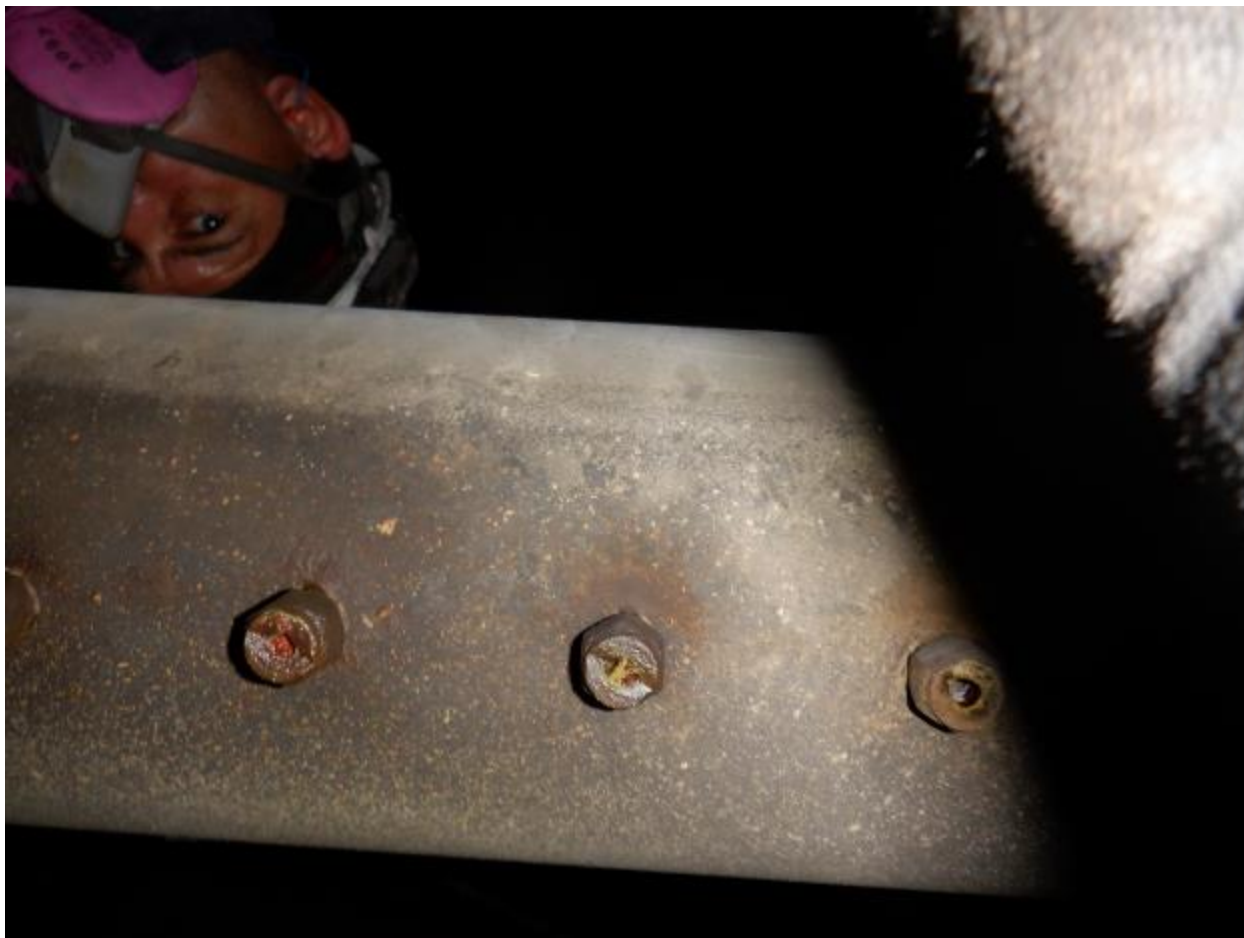
Date: 05/13/23	Inspected by: B&W ECC	Unit: 2	Item: APHAIRIO 3
Component Inspected: Air Preheater Air Outlet			
Condition Assessment: AH B Secondary Air Outlet: Many of the deluge header nozzles are plugged.			
Recommendations: Clean nozzles			
Criticality: P3			
Risk if NOT Performed: Uneven distribution of water when the deluge system is used.			
EKP Comments:

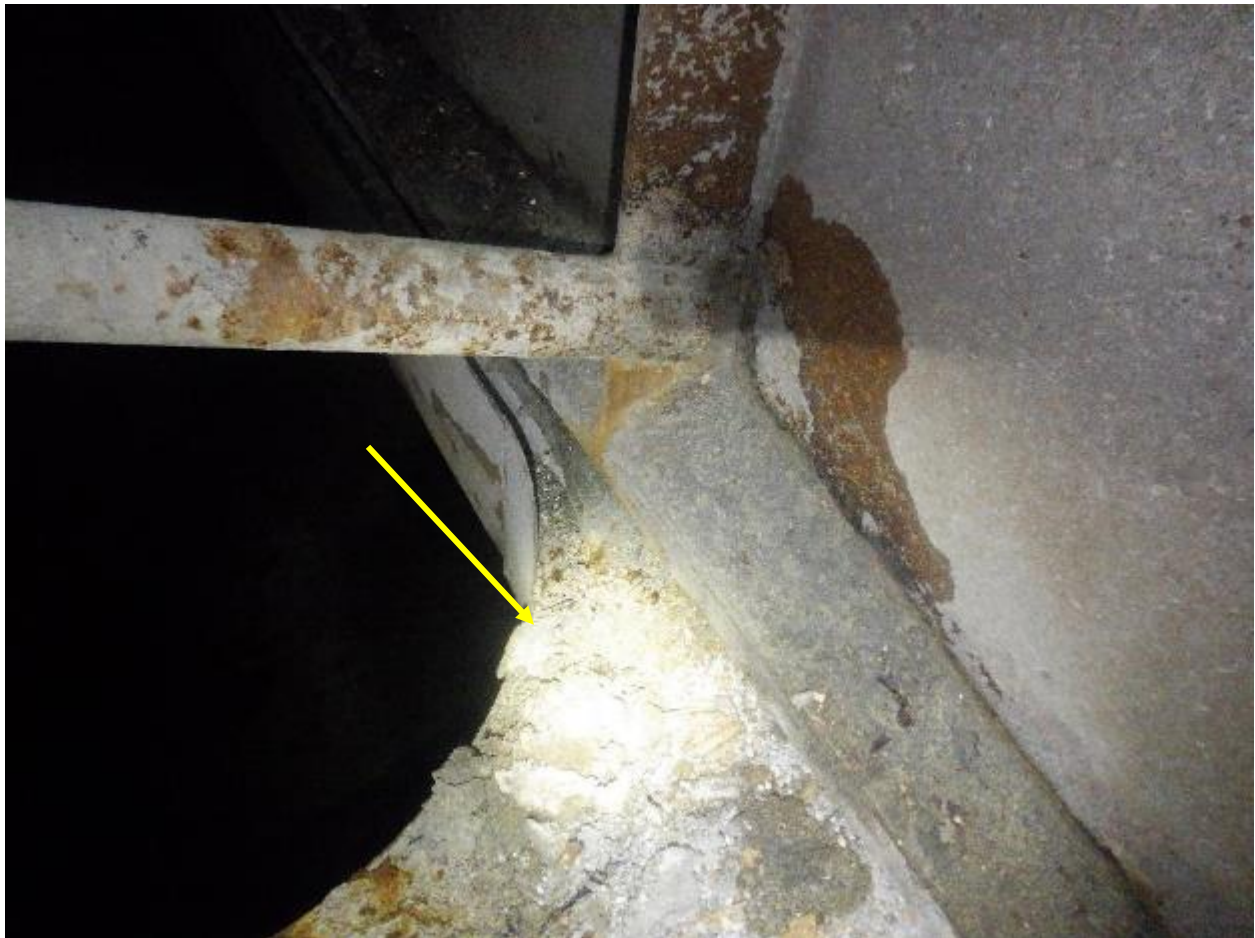
Date: 5/13/2023	Inspected by: B&W - CSH	Unit: 2	Item: APHAIRIO 4
Component Inspected: Air Preheater Air Inlet/Outlet			
Condition Assessment: 2A & 2B Secondary Air Inlet – There were debris in the expansion joints beneath the APH baskets.			
Recommendations: Remove the debris and install a cover over the existing shield to prevent debris falling into the existing cover.			
Criticality: P3			
Risk if NOT Performed: Debris can prevent the joint from being able to move properly and the metal from the baskets could penetrate the joint.			
EKP Comments:

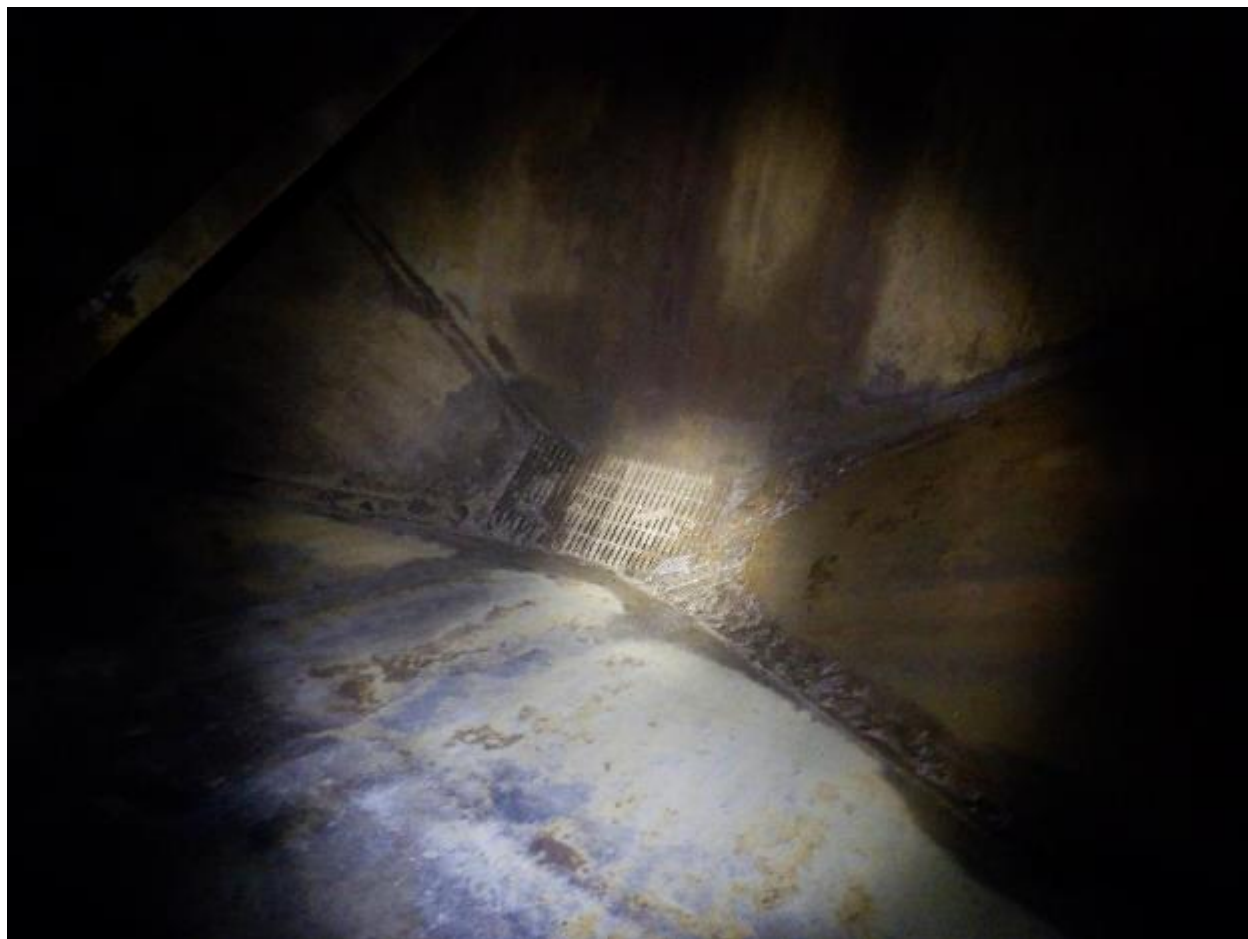
Date: 5/13/2023	Inspected by: B&W - CSH	Unit: 2	Item: APHAIRIO 5
Component Inspected: Air Preheater Air Inlet/Outlet			
Condition Assessment: 2B Secondary Air Inlet – There were debris in the hoppers beneath the APHs, downstream of the SCAHs.			
Recommendations: Remove the debris.			
Criticality: P3			
Risk if NOT Performed: Hoppers/drains could get plugged.			
EKP Comments:

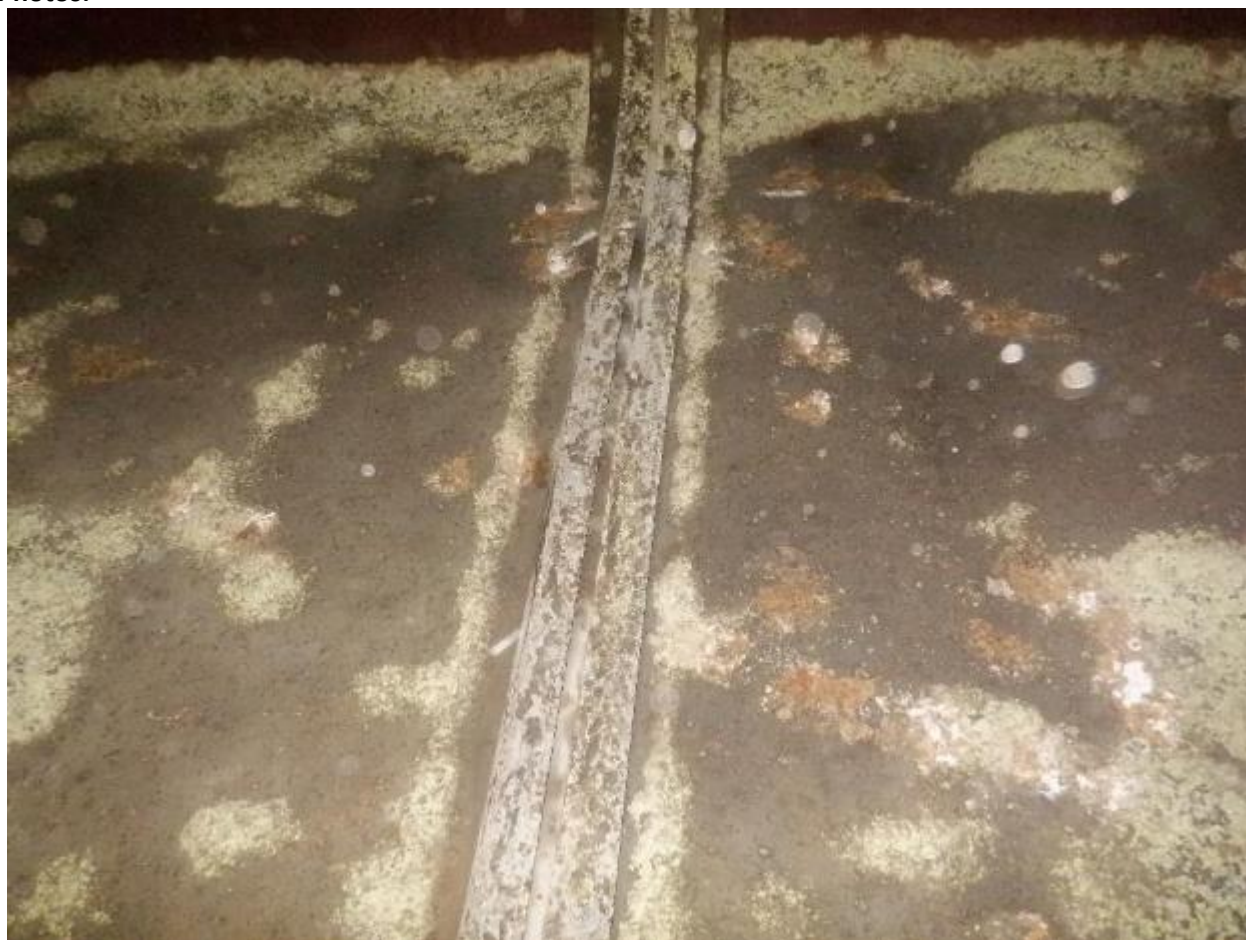
Date: 5/13/2023	Inspected by: B&W - CSH	Unit: 2	Item: APHAIRIO 7
Component Inspected: 2A & 2B Air Preheater Air Outlet			
Condition Assessment: 2A & 2B Secondary Air Outlet - There was debris in the crossover duct and the metallic expansion joint.			
Recommendations: Remove the debris.			
Criticality: P2			
Risk if NOT Performed: Debris prevent the joint from being able to move as designed and could cause the joint to fail.			
EKP Comments:

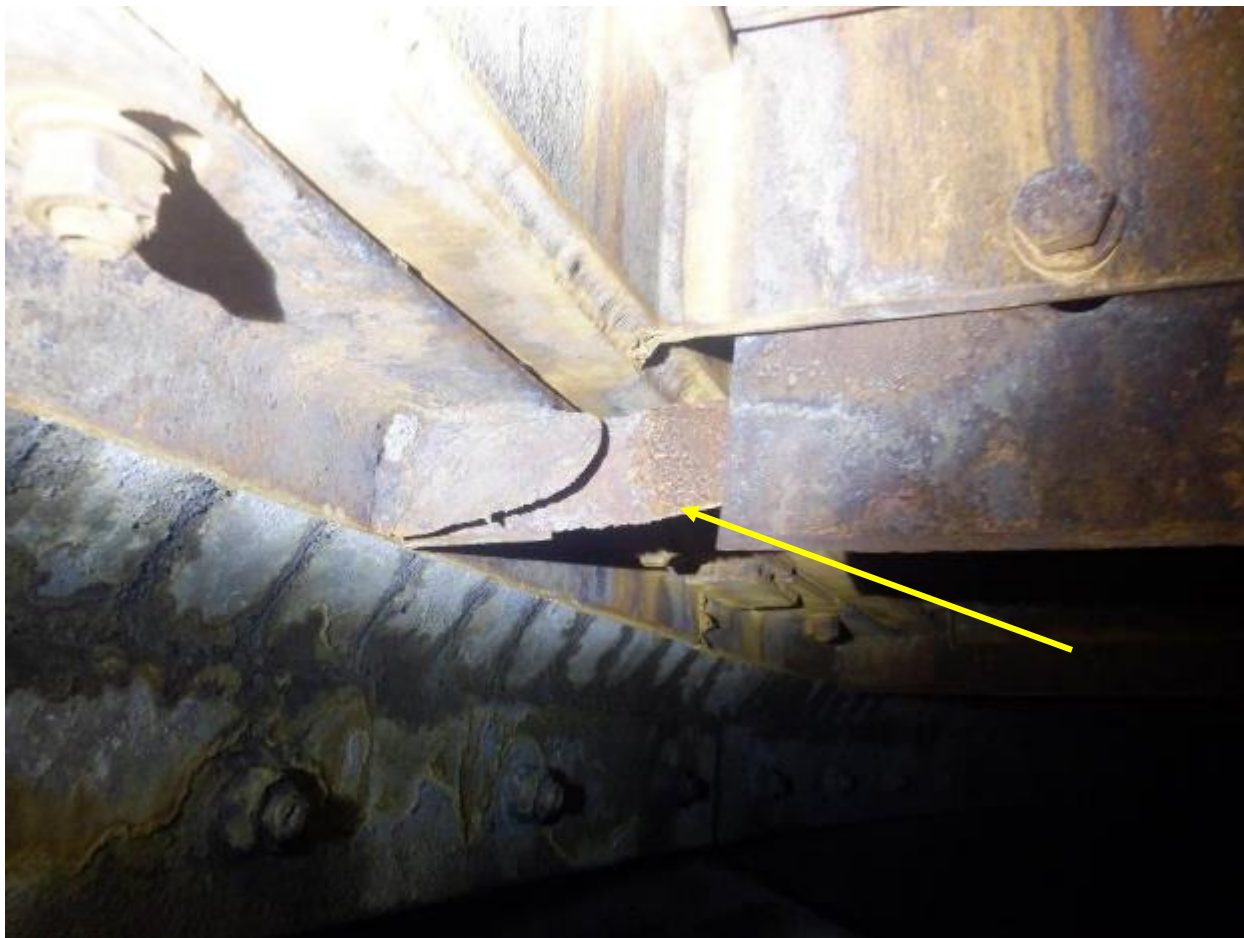
Date: 5/13/2023	Inspected by: B&W - CSH	Unit: 2	Item: APHAIRIO 8
Component Inspected: Air Preheater Air Inlet/Outlet			
Condition Assessment: 2B Secondary Air Inlet – There was minor corrosion on the outboard radial seals.			
Recommendations: Replace the section of seals.			
Criticality: P3			
Risk if NOT Performed: Air can short circuit the heater.			
EKP Comments:

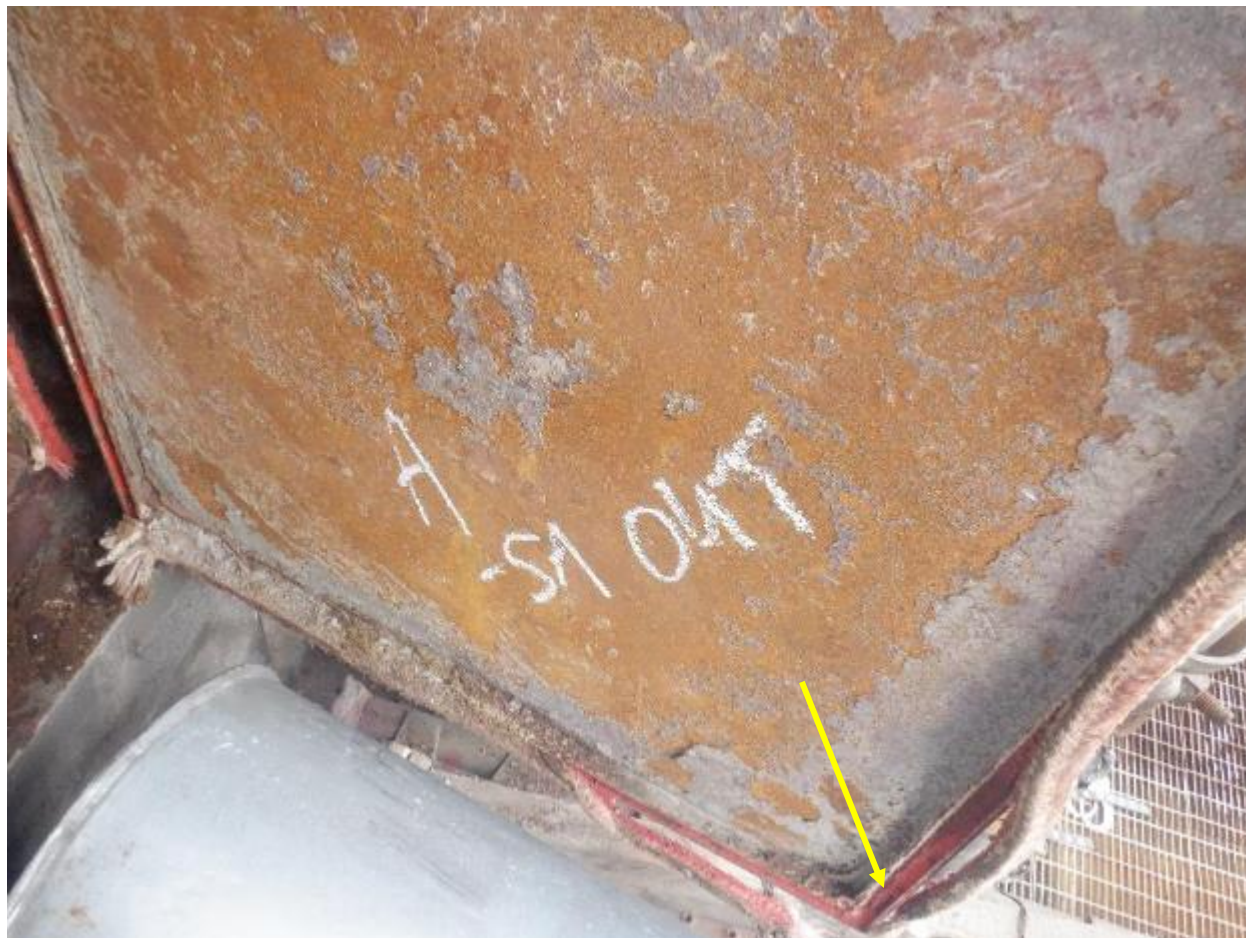
Date: 5/13/2023	Inspected by: B&W - CSH	Unit: 2	Item: APHAIRIO 9
Component Inspected: Air Preheater Air Inlet/Outlet			
Condition Assessment: 2B Secondary Air Outlet – The access door’s gasket was loose.			
Recommendations: Replace the gasket or securely fasten it in place			
Criticality: P3			
Risk if NOT Performed: Air can short circuit the heater.			
EKP Comments:

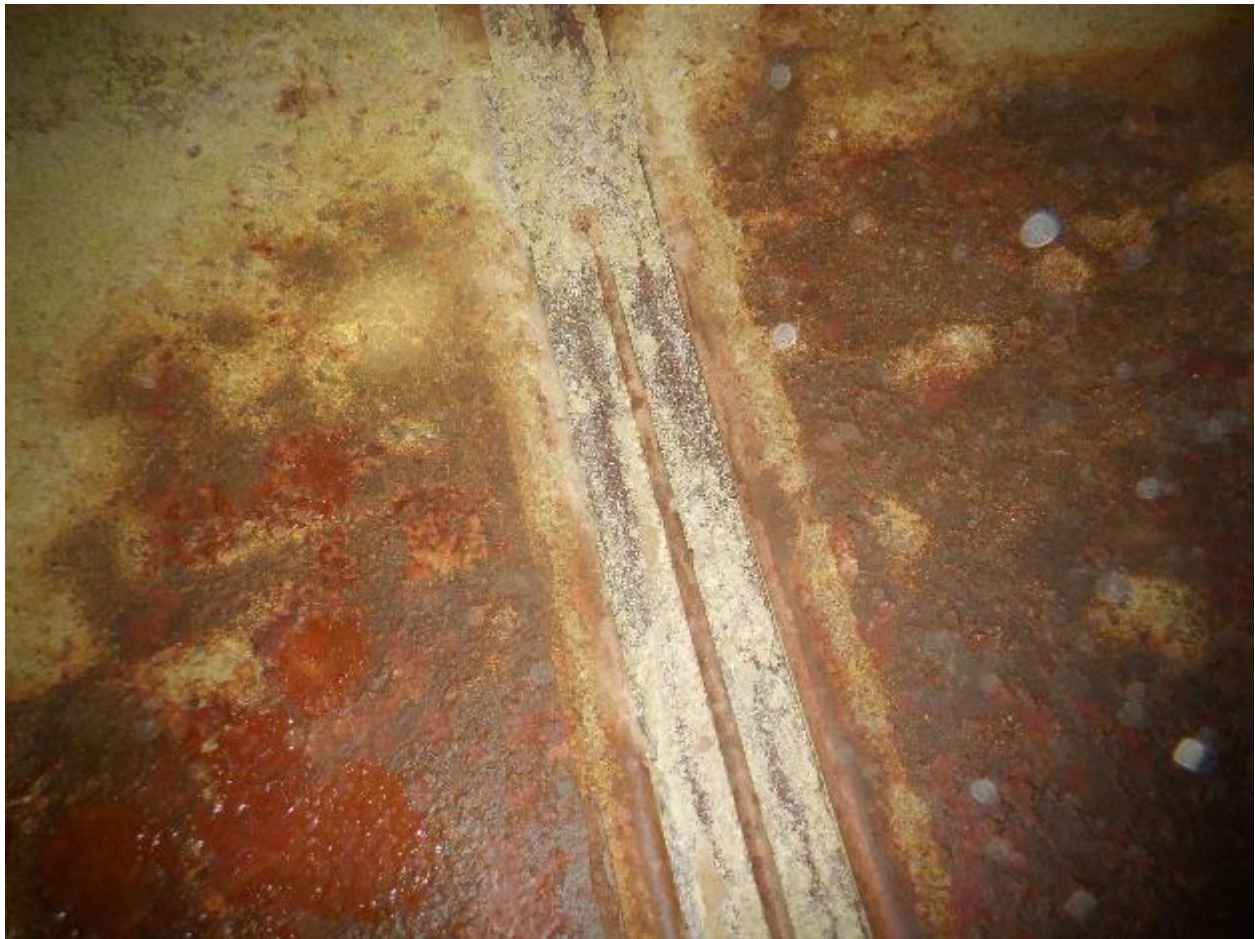
Date: 10/6/2021	Inspected by: B&W	Unit: 2	Item: APHAIRIO 6
Component Inspected: 2A & 2B Air Preheater Air Outlet			
Condition Assessment: 2A & 2B Secondary Air Outlet - There was debris in the crossover duct metallic expansion joint.			
Recommendations: Remove the debris in the expansion joint.			
Criticality: P2			
Risk if NOT Performed: Debris prevent the joint from being able to move as designed and could cause the joint to fail.			
EKP Comments:

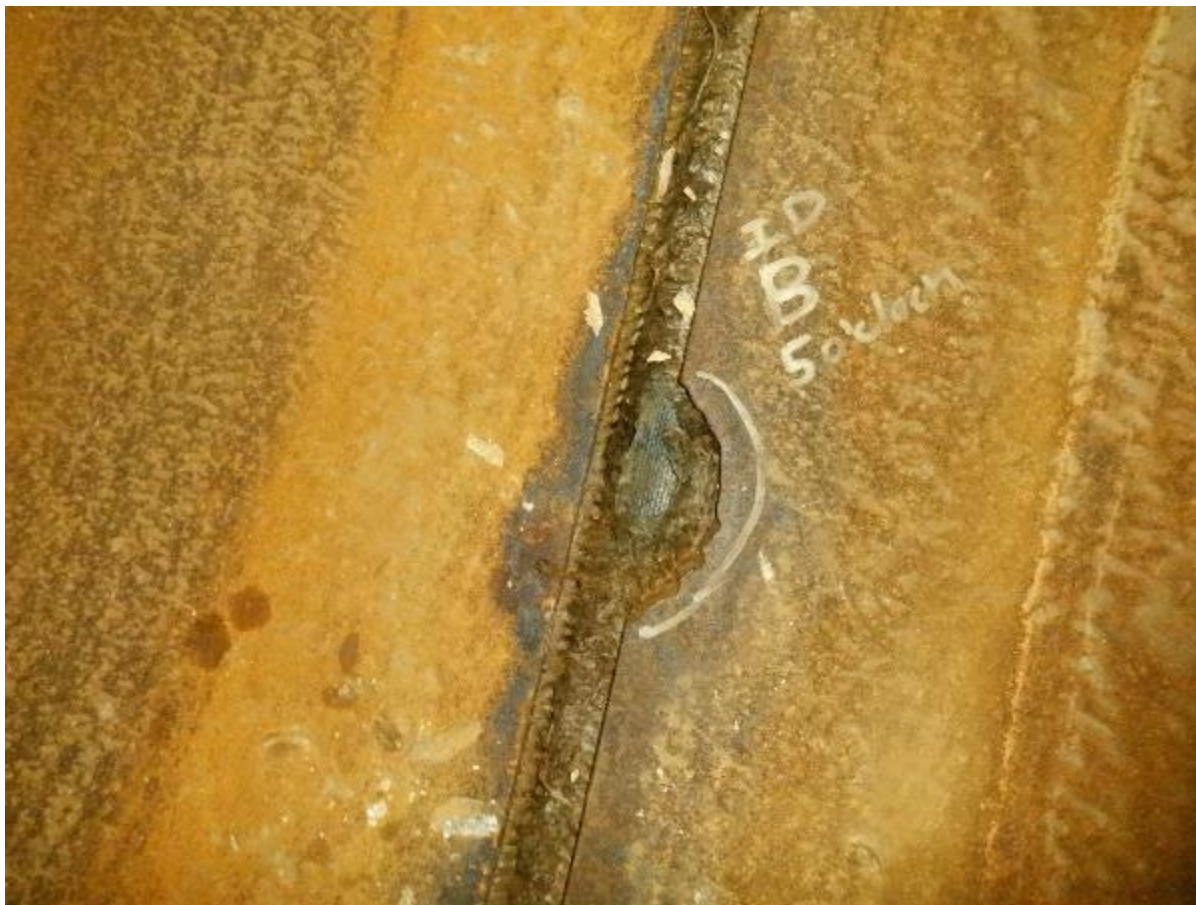
Date: 05/13/23	Inspected by: B&W ECC	Unit: 2	Item: IDFANS 1
Component Inspected: 2B ID Fan			
Condition Assessment: The ID Fan inlet expansion joint is starting to fray. At the 5 o'clock position the fabric has a hole exposing the rubber portion of the joint. A small section of the flue is missing at this location.			
Recommendations: Cover the rubber section of the joint and patch the missing section of flue.			
Criticality: P3			
Risk if NOT Performed: A hole may form in the expansion joint resulting in air leakage.			
EKP Comments:

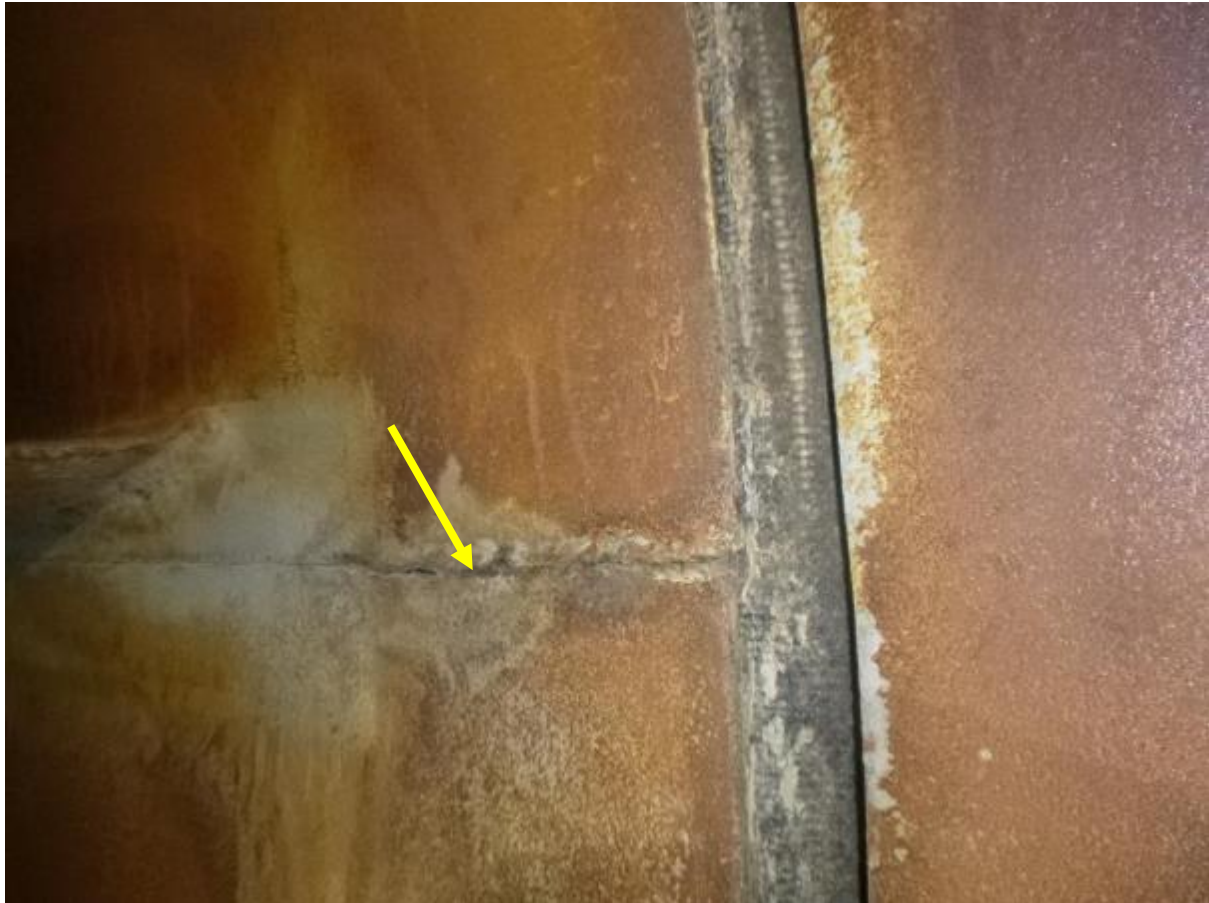
Date: 10/7/2021	Inspected by: B&W	Unit: 2	Item: IDFANS 2
Component Inspected: 2B ID Fan Outlet			
Condition Assessment: There was a broken weld on the fan outlet casing section of the 2B ID Fan.			
Recommendations: Reweld.			
Criticality: P3			
Risk if NOT Performed: Separation of the casing sections could lead to expansion joint failure and flue gas leaks.			
EKP Comments:			
Photos:

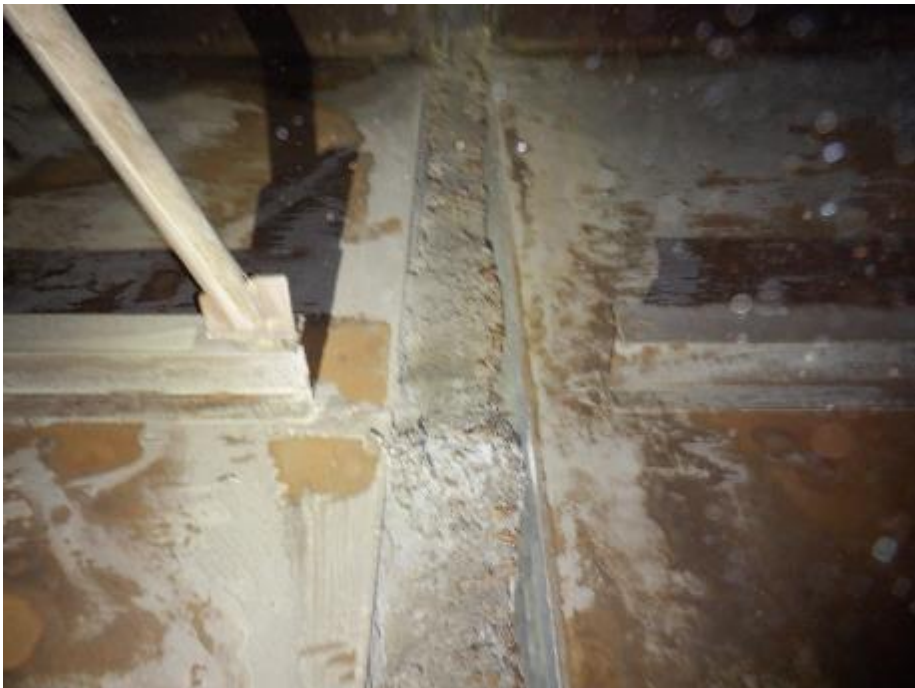
Date: 5/18/23	Inspected by: B&W ECC	Unit: 2	Item: ID Outlets 1
Component Inspected: 2A & 2B ID Discharge Flue			
Condition Assessment: All four (4) expansion joints in each side had minor debris in them and the first joint in B side contained water.			
Recommendations: Clean out all eight (8) of the expansion joints.			
Criticality: P3			
Risk if NOT Performed: Debris puts extra weight in the joint and could cause the joint to fail or not be able to flex.			
EKP Comments:			
Photos:

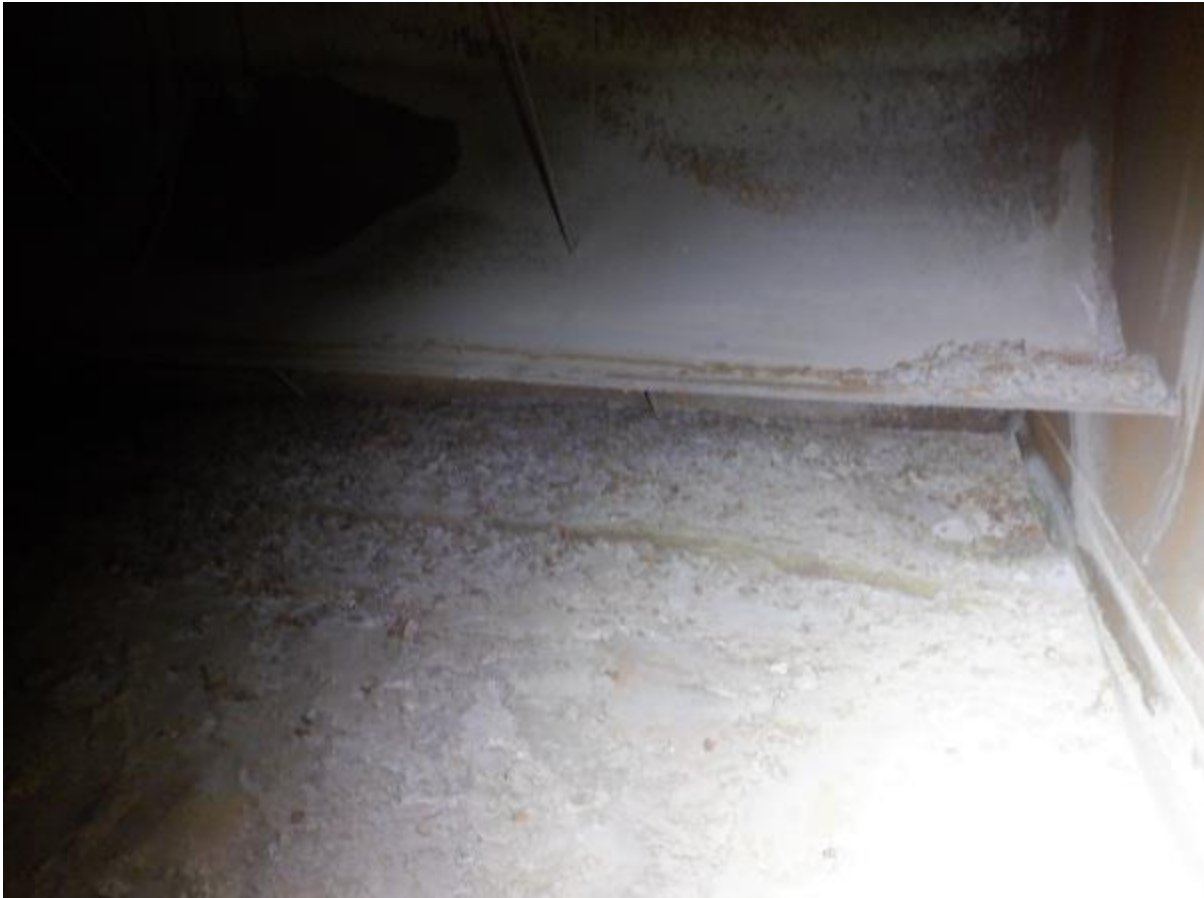
Date: 5/18/23	Inspected by: B&W ECC	Unit: 2	Item: ID Outlets 2
Component Inspected: 2A & 2B ID Fan Discharge			
Condition Assessment: At the end of the flue, at the takeoff underneath the turning vanes, there was a small accumulation of ash.			
Recommendations: Remove the ash by vacuuming.			
Criticality: P3			
Risk if NOT Performed: If ash continues to build it could overload the flue.			
EKP Comments:			
Photos:

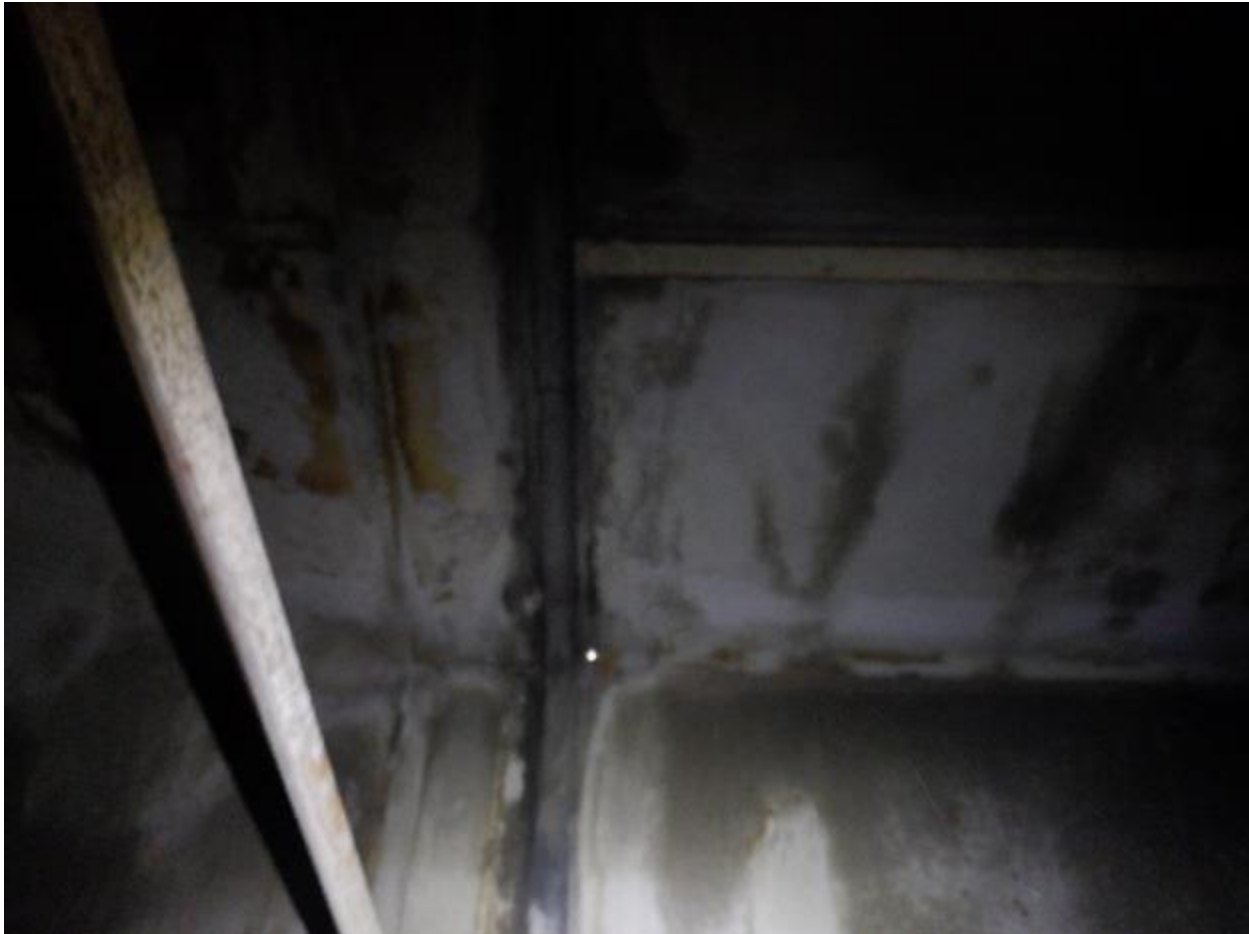
Date: 5/18/23	Inspected by: B&W ECC	Unit: 2	Item: ID Outlets 3
Component Inspected: 2B ID Fan Discharge			
Condition Assessment: Just downstream of the first expansion joint from the ID fan the flue has a small hole in the upper left corner of the flue.			
Recommendations: Strip the insulation and lagging to access from the outside and patch the hole, or scaffold from the inside to access the area and patch the hole.			
Criticality: P2			
Risk if NOT Performed: Flue gas leak to ambient.			
EKP Comments:			
Photos:

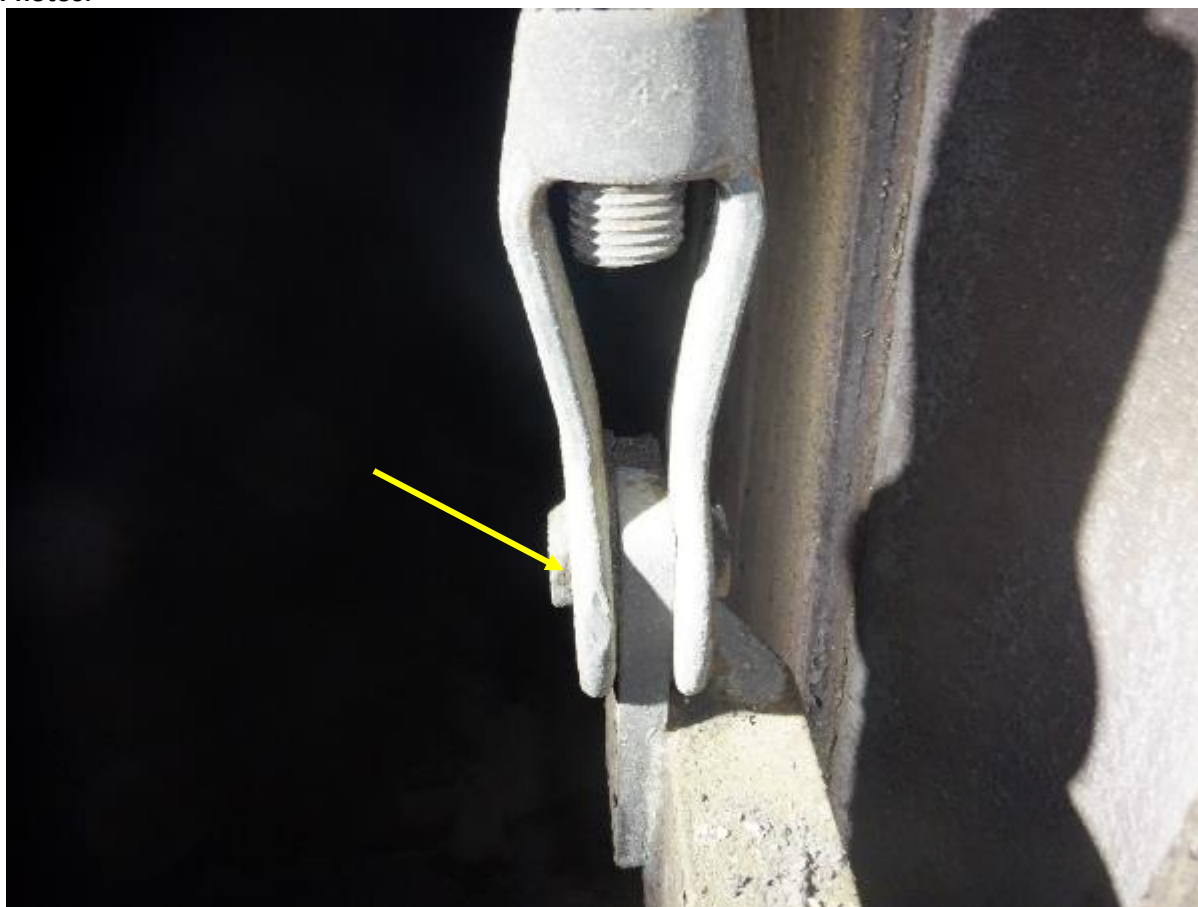
Date: 5/18/23	Inspected by: B&W ECC	Unit: 2	Item: ID Outlets 4
Component Inspected: 2A ID Fan Discharge			
Condition Assessment: The lower hanger attachment pin on the third expansion joint hanger is missing a cotter pin.			
Recommendations: Install a cotter pin.			
Criticality: P3			
Risk if NOT Performed: As long as the pin remains loaded nothing will happen. If the pin unloads the pin could shift and fall out of the clevis.			
EKP Comments:

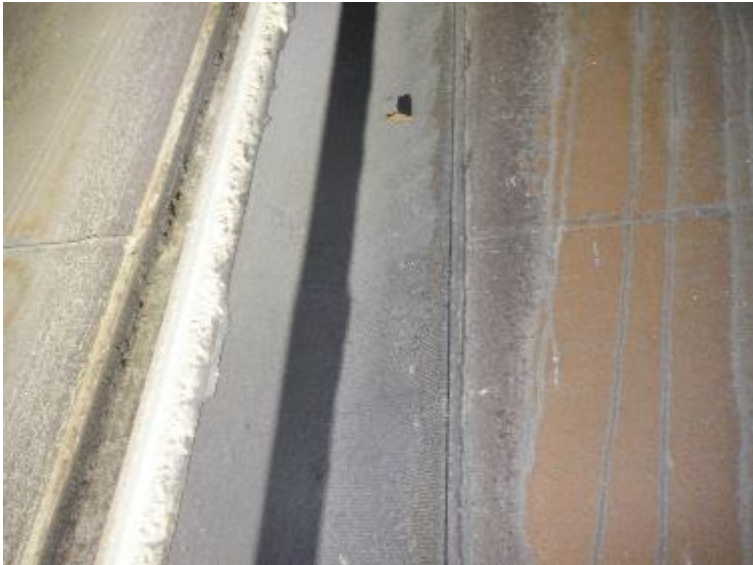
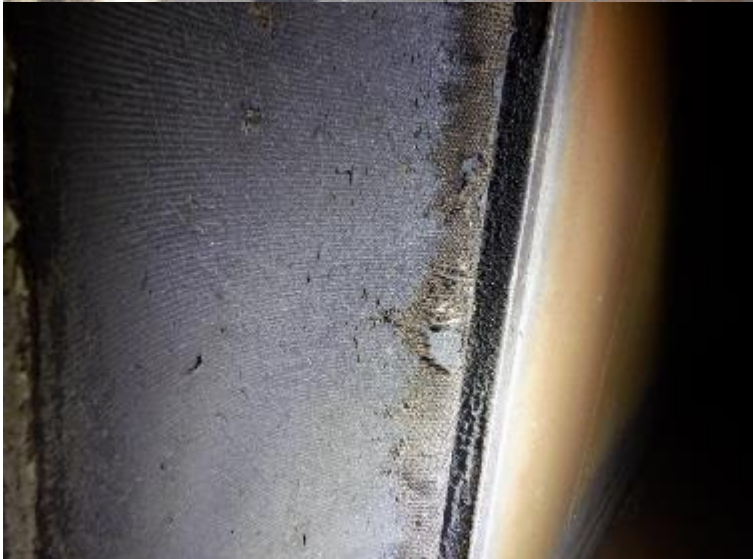
Date: 5/18/23	Inspected by: B&W ECC	Unit: 2	Item: ID Outlets 5
Component Inspected: 2ID A Outlet			
Condition Assessment: The left side of the first expansion joint has many small cuts and the fabric is frayed.			
Recommendations: Installing a deflector on the left side wall of the flue will help preserve the expansion joint.			
Criticality: P3			
Risk if NOT Performed: The small cuts could grow. Given the trajectory of the flue gas the left side will wear more over time without protection.			
EKP Comments:			
Photos: <div style="display: flex; flex-direction: column; align-items: center;">
