The Babcock & Wilcox Company

**Eastern Kentucky Power Cooperative
Spurlock Station, Unit #2**

U2 SPRING 2023 OUTAGE BOILER INSPECTION REPORT

B&W Project No.: BA9312817

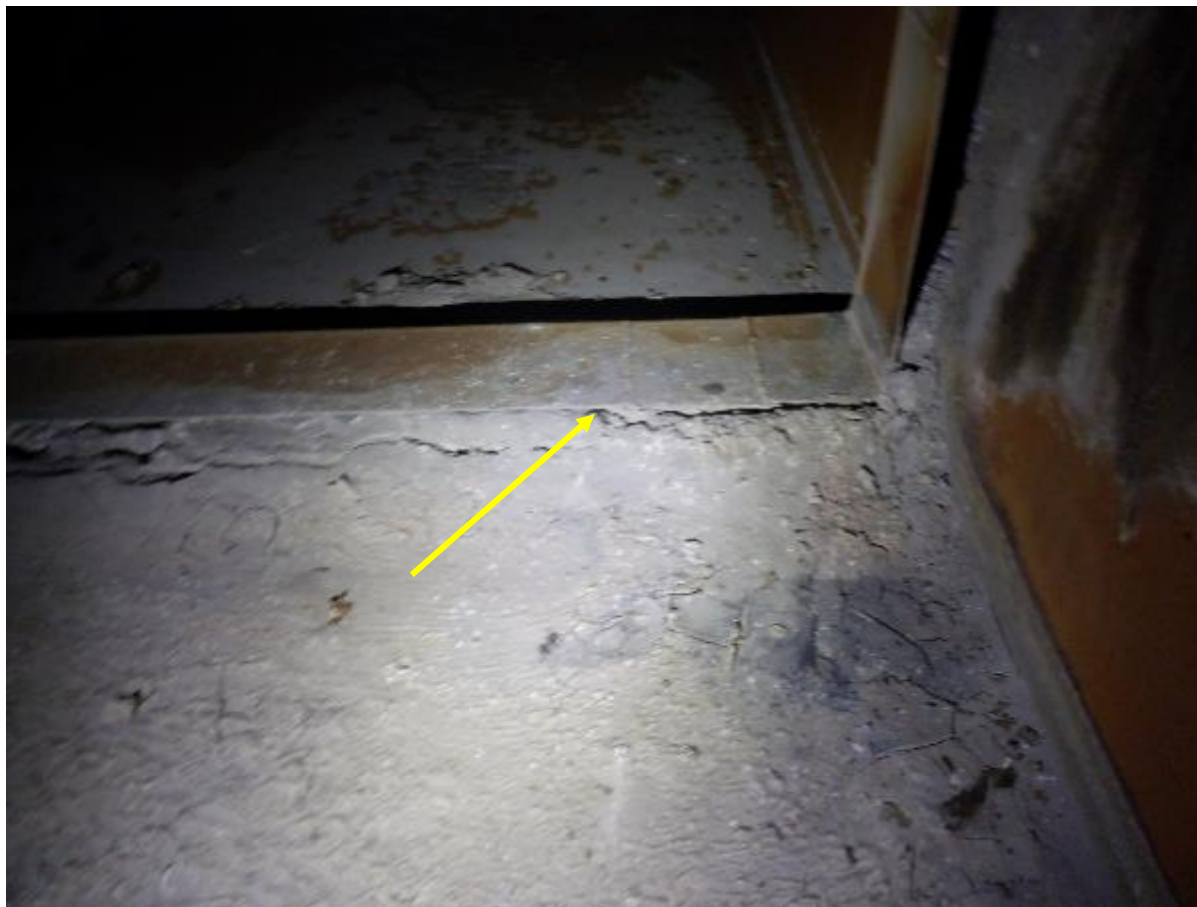
Date: 5/18/23	Inspected by: B&W ECC	Unit: 2	Item: ID Outlets 6
Component Inspected: U2 Upper ID Fan Discharge to Absorber Inlet Flue			
Condition Assessment: A & B Sides - There was minor ash/debris accumulation in the two (2) expansion joints on each side.			
Recommendations: Remove the ash and debris from the joint.			
Criticality: P3			
Risk if NOT Performed: If more debris accumulates, it could hinder the joints movement and cause it to fail.			
EKP Comments:

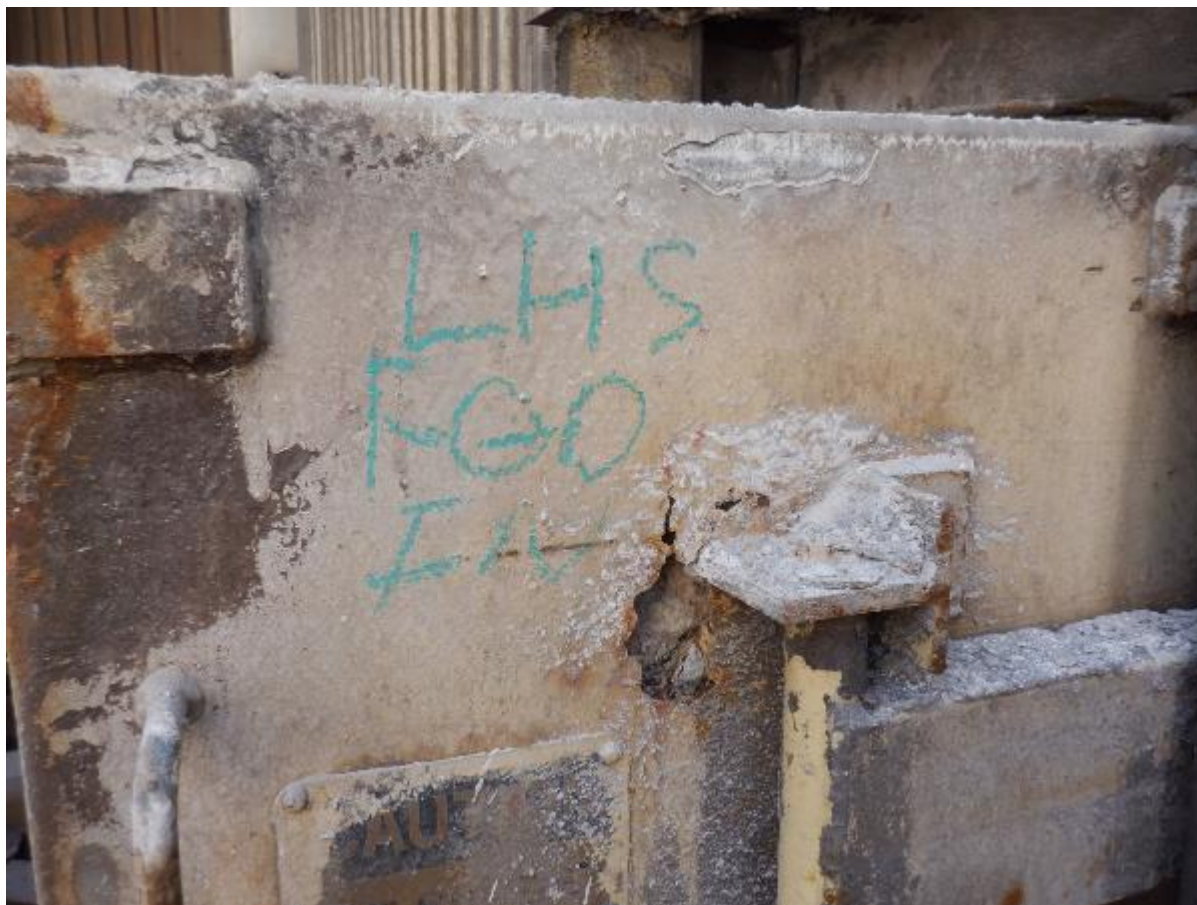
Date: 5/18/23	Inspected by: B&W	Unit: 2	Item: ID Outlets 7
Component Inspected: U2 Upper ID Fan Discharge to Absorber Inlet Flue B side (left)			
Condition Assessment: The access door is severely corroded and has a hole in the skin.			
Recommendations: Patch skin or replace the door.			
Criticality: P3			
Risk if NOT Performed: Loss of structural integrity may make it difficult to maintain a seal on the door..			
EKP Comments:

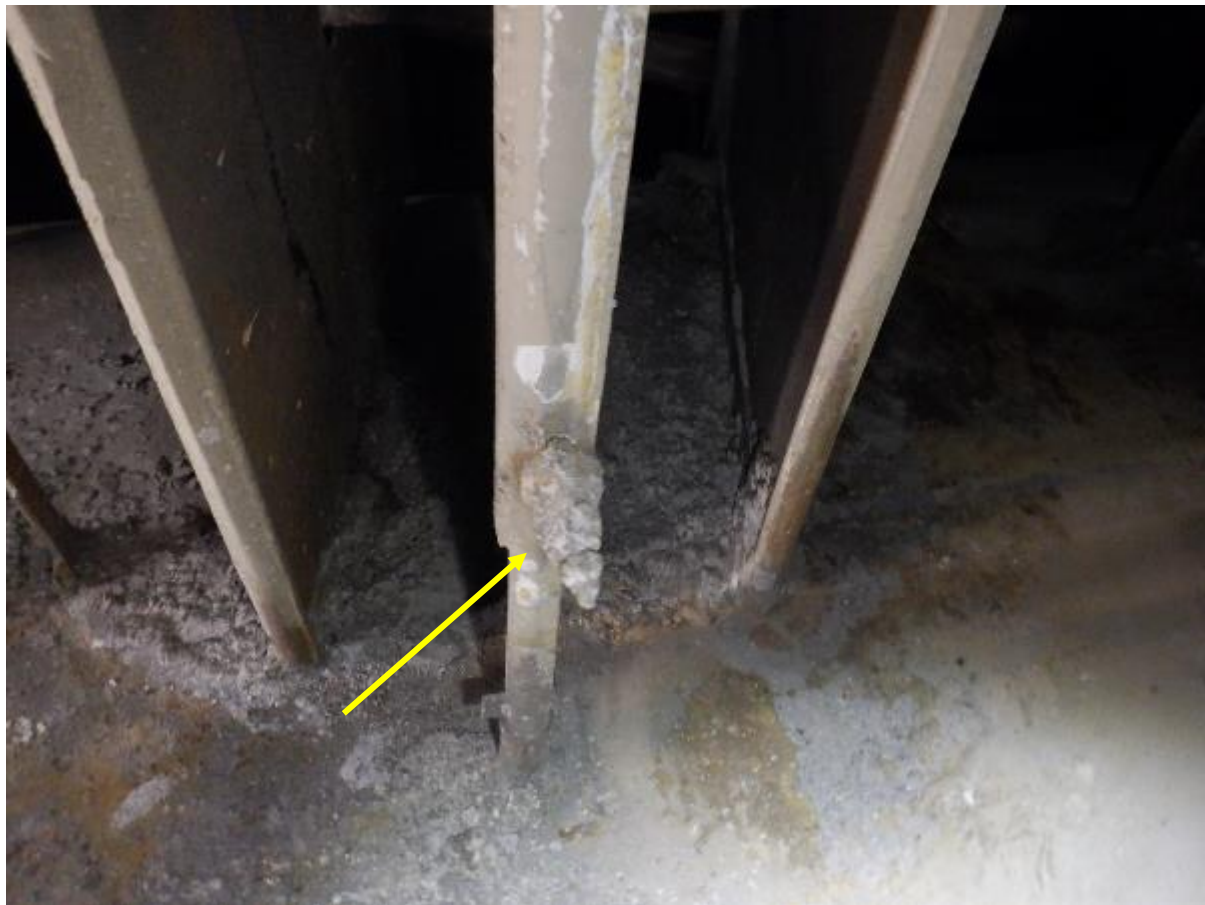
Date: 5/18/23	Inspected by: B&W	Unit: 2	Item: ID Outlets 8
Component Inspected: U2 Absorber Inlet			
Condition Assessment: The absorber quench water nozzles were all plugged with ash.			
Recommendations: Clear the nozzle of ash and verify proper flow.			
Criticality: P2			
Risk if NOT Performed: If nozzles are plugged, could prohibit the quench system from working.			
EKP Comments:

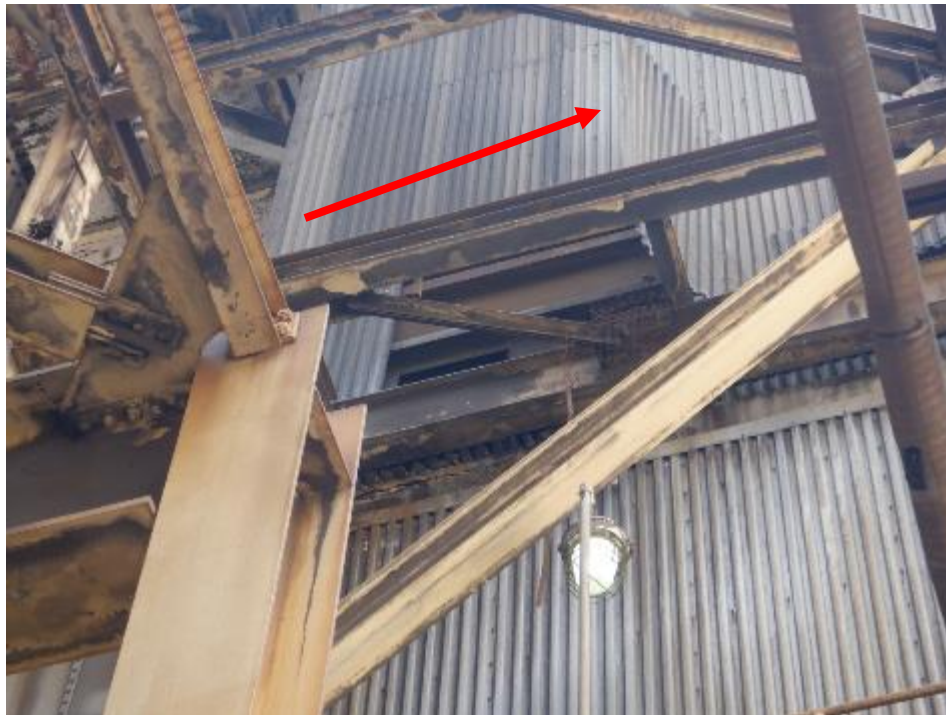
Date: 5/18/23	Inspected by: B&W	Unit: 2	Item: ID Outlets 9
Component Inspected: U2 Mid ID Fan Discharge to Absorber Inlet Flue B side (left)			
Condition Assessment: The old flue work above the upper section of flue has loose lagging.			
Recommendations: Remove the lagging.			
Criticality: P1			
Risk if NOT Performed: The lagging could fall.			
EKP Comments:

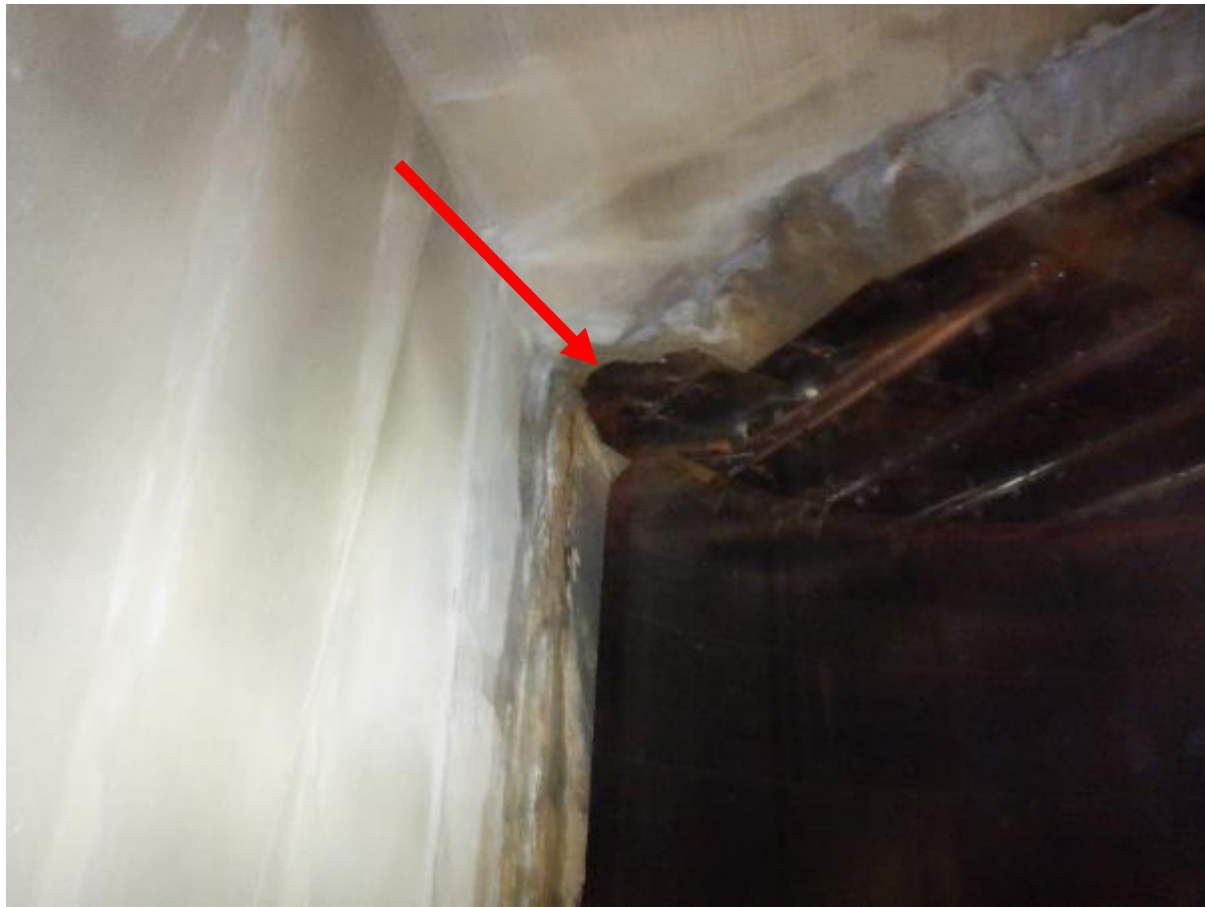
Date: 5/18/23	Inspected by: B&W ECC	Unit: 2	Item: ID Outlets 10
Component Inspected: U2 Absorber Inlet			
Condition Assessment: The corners of the upper deflector hood are missing.			
Recommendations: Replace the corners of the deflector hood.			
Criticality: P3			
Risk if NOT Performed: Ash accumulation in the upper corner and disrupted gas distribution.			
EKP Comments:

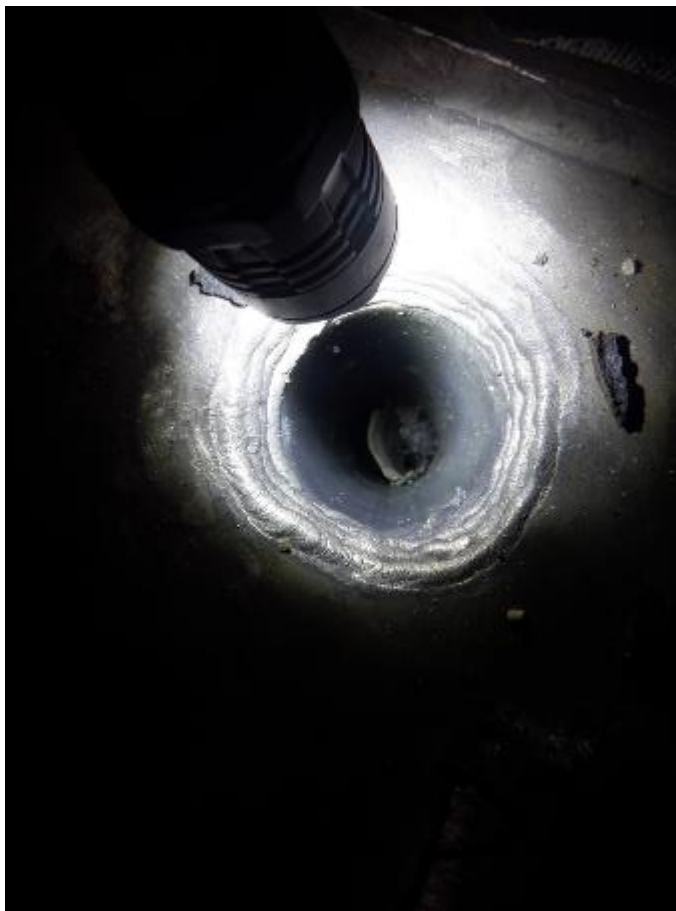
Date: 5/18/23	Inspected by: B&W ECC	Unit: 2	Item: ID Outlets 10
Component Inspected: U2 WESP to Stack Flue			
Condition Assessment: The drains upstream from the stack expansion joint contain debris.			
Recommendations: Clear all the drains prior to start-up			
Criticality: P3			
Risk if NOT Performed: Water will not be able to drain from the flue.			
EKP Comments:

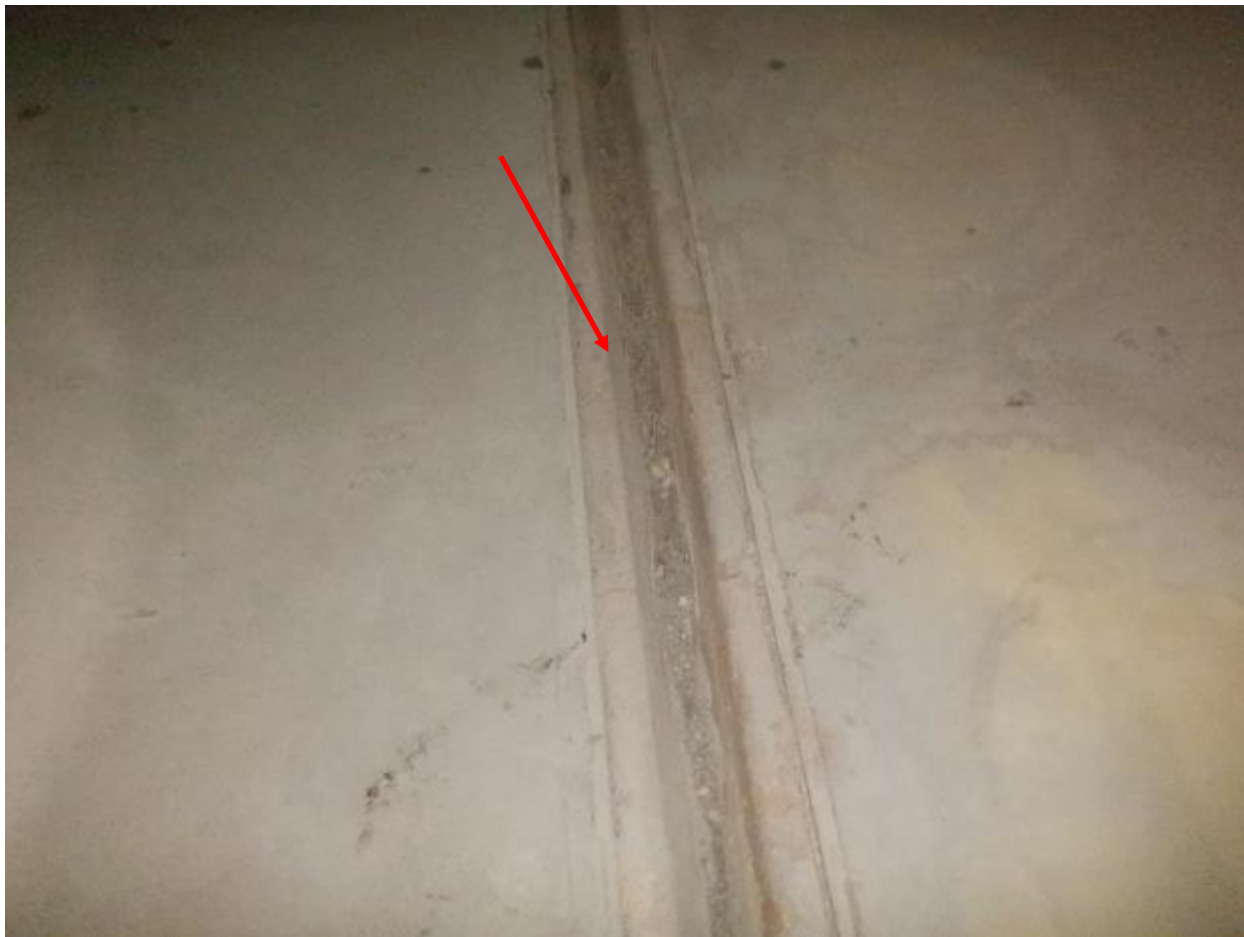
Date: 5/18/2023	Inspected by: B&W - CSH	Unit: 2	Item: FDFANS 1
Component Inspected: FD Fans			
Condition Assessment: 2A Discharge – The expansion joint at the crossover duct had debris in it.			
Recommendations: Clean out the expansion joint.			
Criticality: P3			
Risk if NOT Performed: Duct will not be able to flex and could cause the joint to fail.			
EKP Comments:

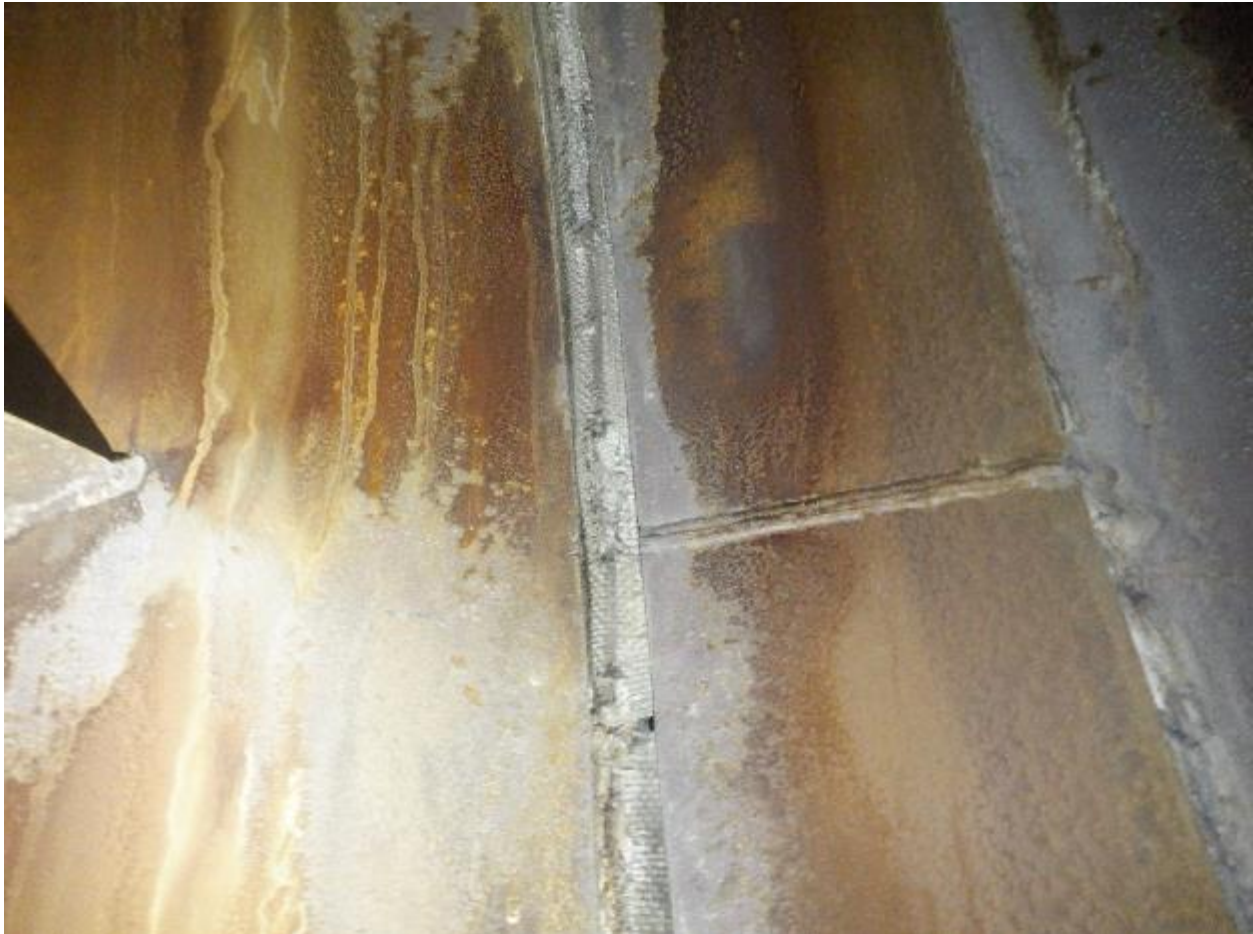
Date: 5/18/2023	Inspected by: B&W - ECC	Unit: 2	Item: FDFANS 3
Component Inspected: FD B Outlet			
Condition Assessment: The expansion joint fabric is frayed.			
Recommendations: Replace the expansion joint			
Criticality: P3			
Risk if NOT Performed: Damage will eventually wear through to the outer layer.			
EKP Comments:

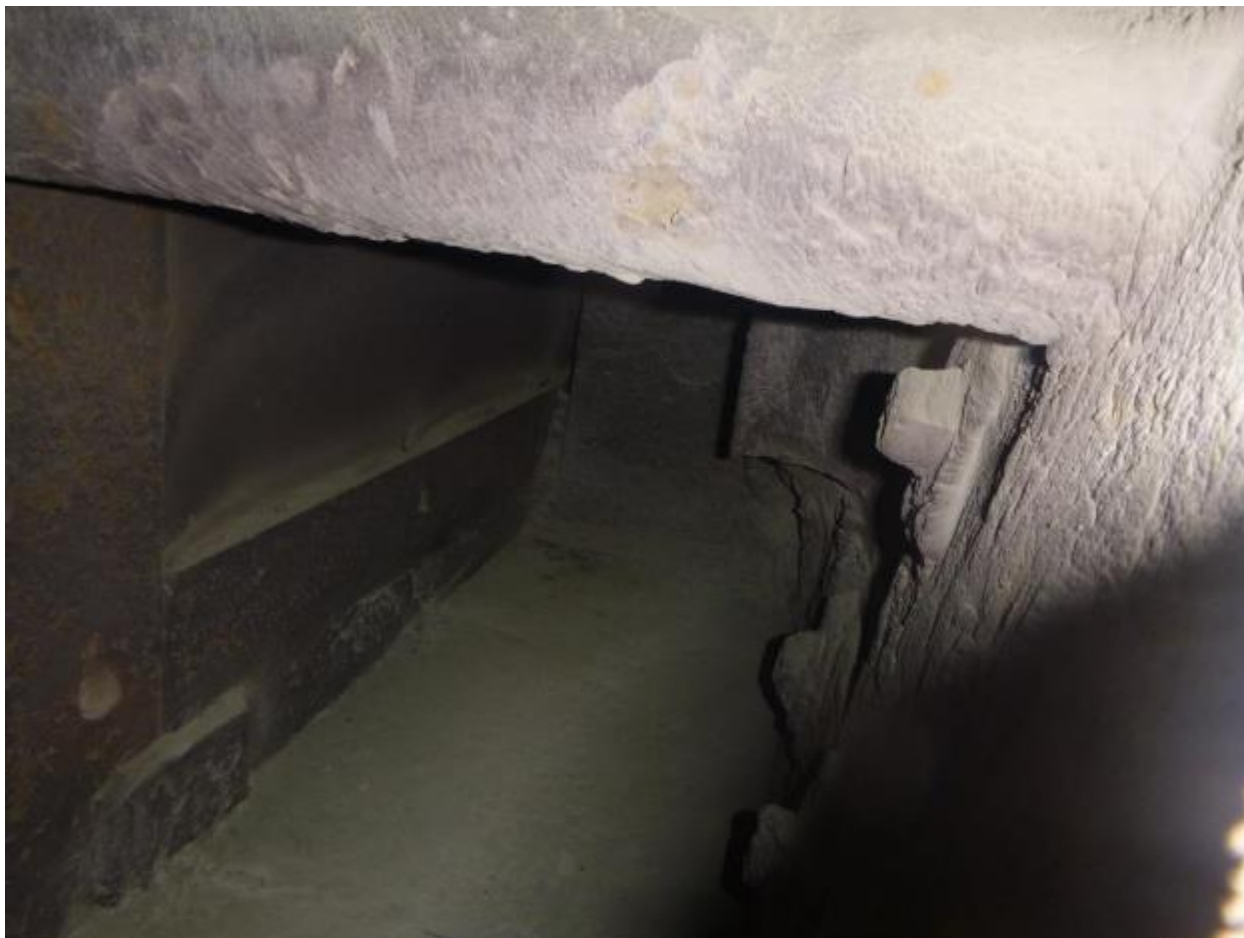
Date: 05/22/2023	Inspected by: B&W	Unit: 2	Item: PAFANS 1
Component Inspected: PA Fans – 2A & 2B			
Condition Assessment: Both side of the inlet boxes for the PA Fans had debris in the bottom.			
Recommendations: Remove the debris.			
Criticality: P3			
Risk if NOT Performed: Debris could possibly get pulled into the inlet vanes.			
EKP Comments:

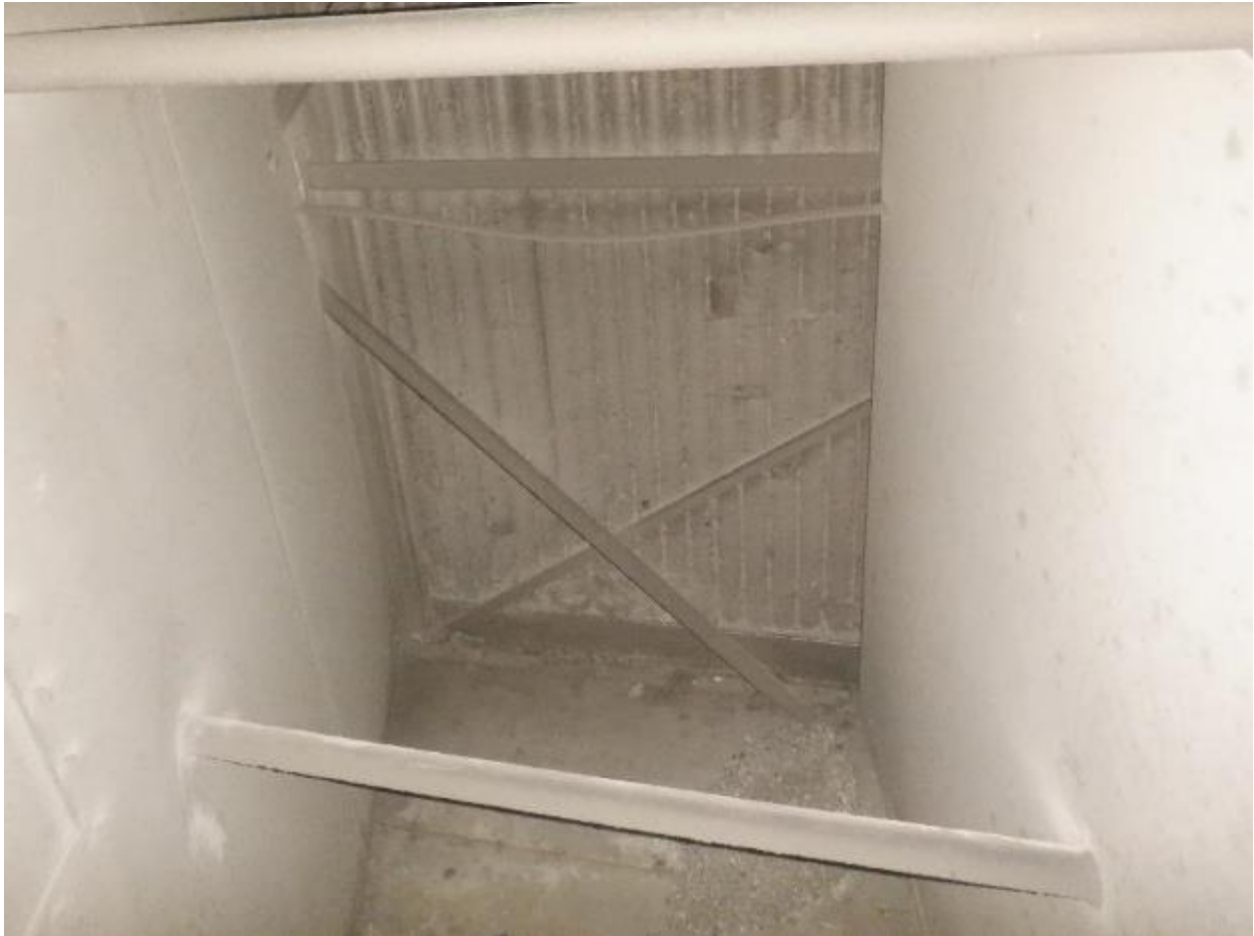
Date: 5/18/2023	Inspected by: B&W -CSH	Unit: 2	Item: STMCOIL 1
Component Inspected: 2A & 2B Steam Coil Air Heater			
Condition Assessment: The leading edge of the steam coils were clean with minor pluggage.			
Recommendations: Continue to monitor.			
Criticality: Information only.			
Risk if NOT Performed: None.			
EKP Comments:

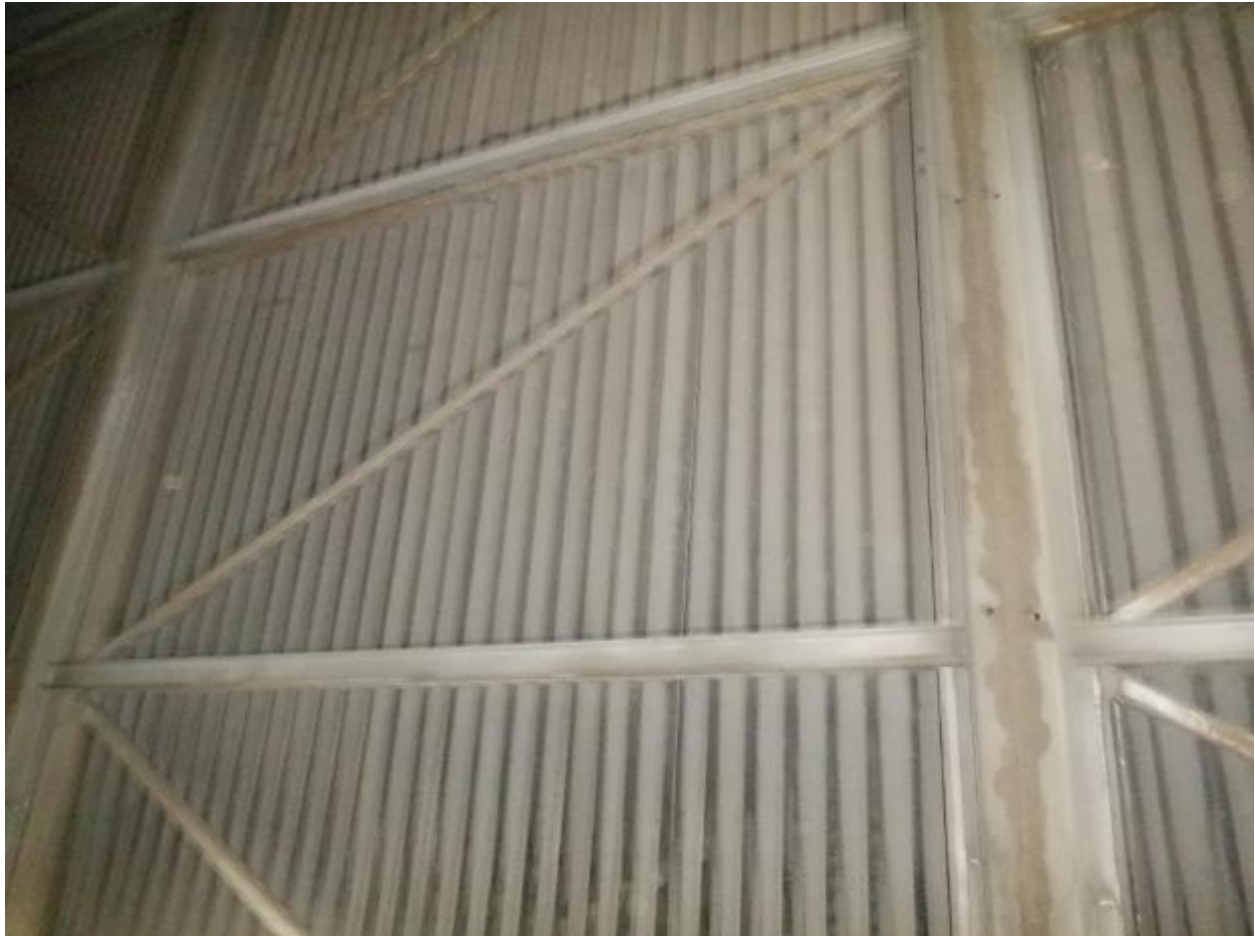
Date: 5/13/2023	Inspected by: B&W - CSH	Unit: 2	Item: STMCOIL 2
Component Inspected: Steam Coil Air Heater – 2B Side			
Condition Assessment: 2A & 2B steam coil trailing edge was in good condition.			
Recommendations: Continue to monitor.			
Criticality: Information only.			
Risk if NOT Performed: None at this time.			
EKP Comments:

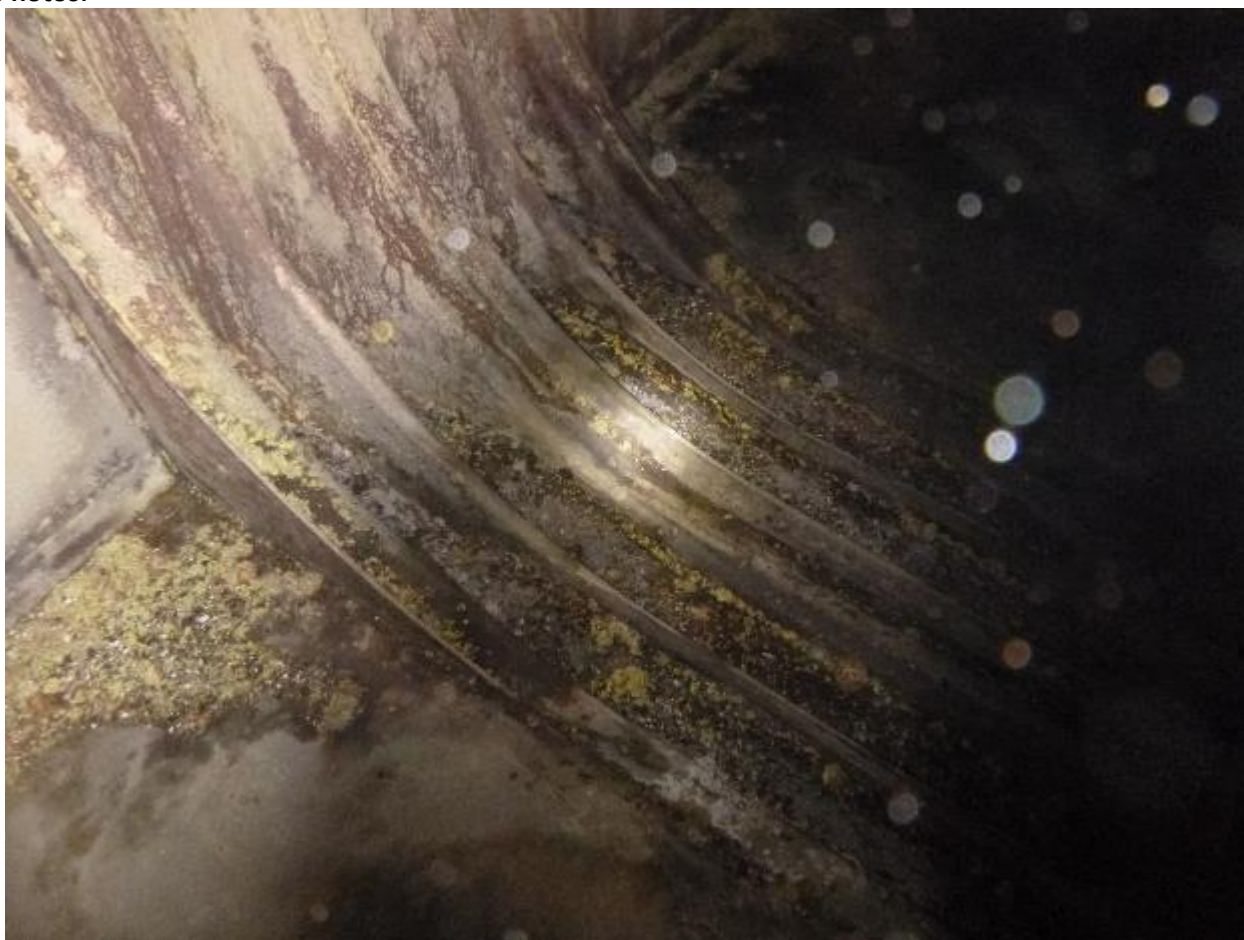
Date: 05/13/23	Inspected by: B&W ECC	Unit: 2	Item: SADUCT 1
Component Inspected: Secondary Air Duct			
Condition Assessment: SA A & B Sides: There were debris found in A side at the last three (3) expansion joints closest to the APH. Debris were in all expansion joints in B side.			
Recommendations: Remove the debris from the expansion joints of the ducts.			
Criticality: P3			
Risk if NOT Performed: The expansion joints won't be able to expand, and contract as designed and could cause damage to the duct or joint.			
EKP Comments:

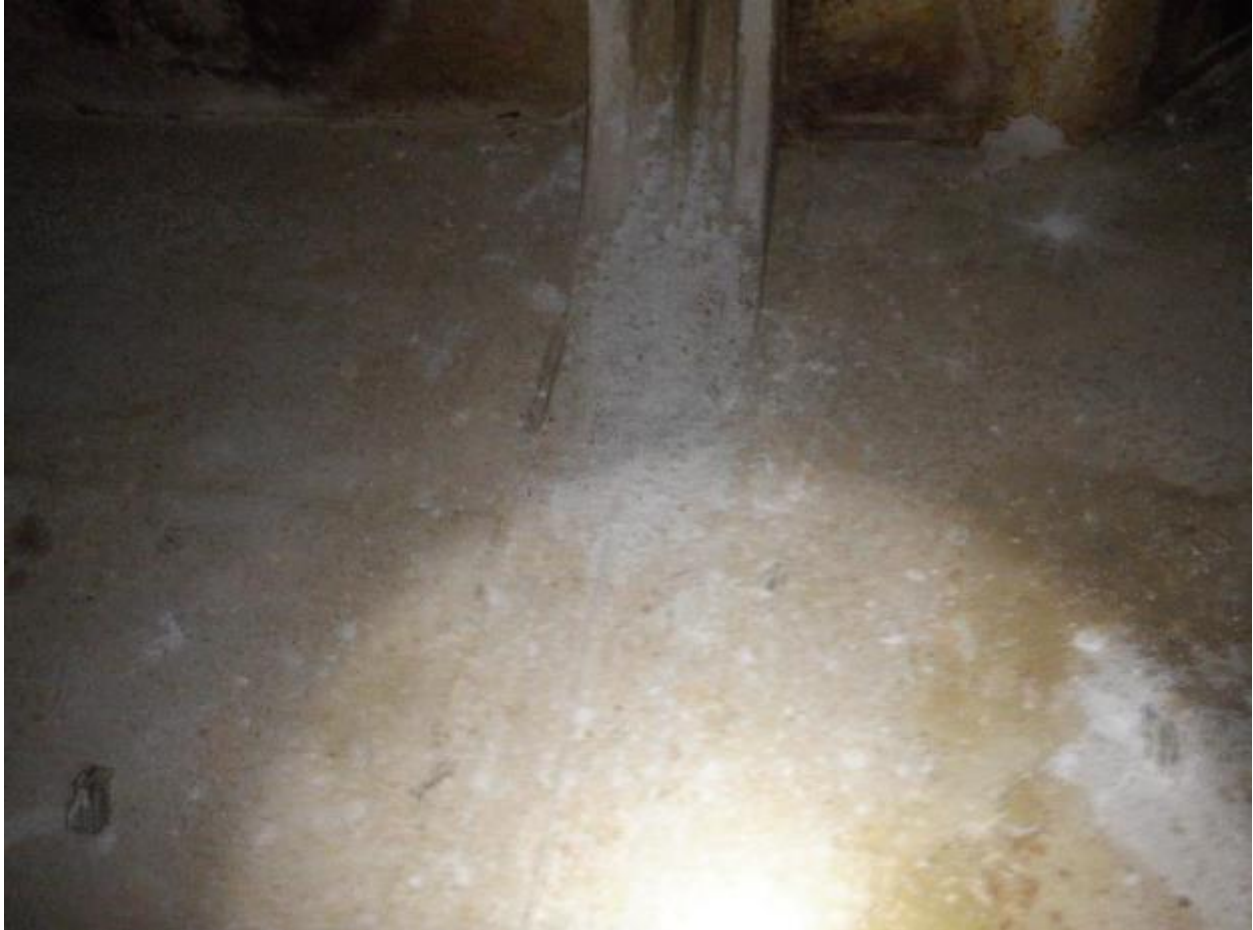
Date: 5/18/2023	Inspected by: B&W - CSH	Unit: 2	Item: PADUCTS 1
Component Inspected: Primary Air Ducts			
Condition Assessment: There were small piles of debris in the upper portion of the PA and expansion joints 1, 2, and 3 from the APH had debris in them.			
Recommendations: Vacuum out the upper portion of the duct and expansion joints.			
Criticality: P3			
Risk if NOT Performed: Expansion joints will not be able to move as designed and this could lead to expansion joint or duct failure/damage.			
EKP Comments:			
Photos:

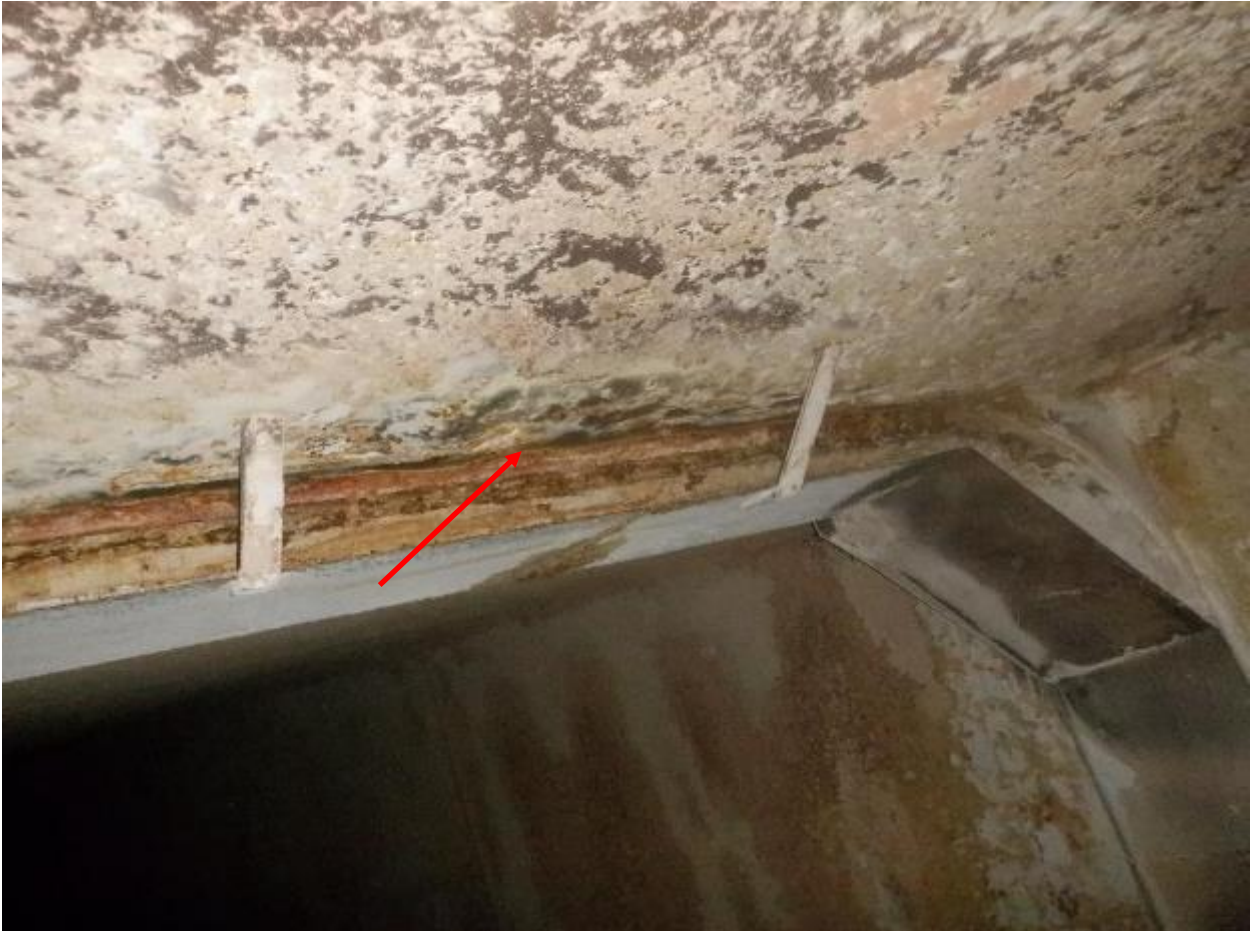
Date: 5/18/2023	Inspected by: B&W - CSH	Unit: 2	Item: PADUCTS 2
Component Inspected: Primary Air Ducts			
Condition Assessment: There appeared to be a casing leak at the roof beside the seventh expansion joint from the APH.			
Recommendations: Clean the area and inspect the casing/expansion joint for the leak.			
Criticality: P3			
Risk if NOT Performed: Expansion joint or duct will allow air to escape.			
EKP Comments:			
Photos:

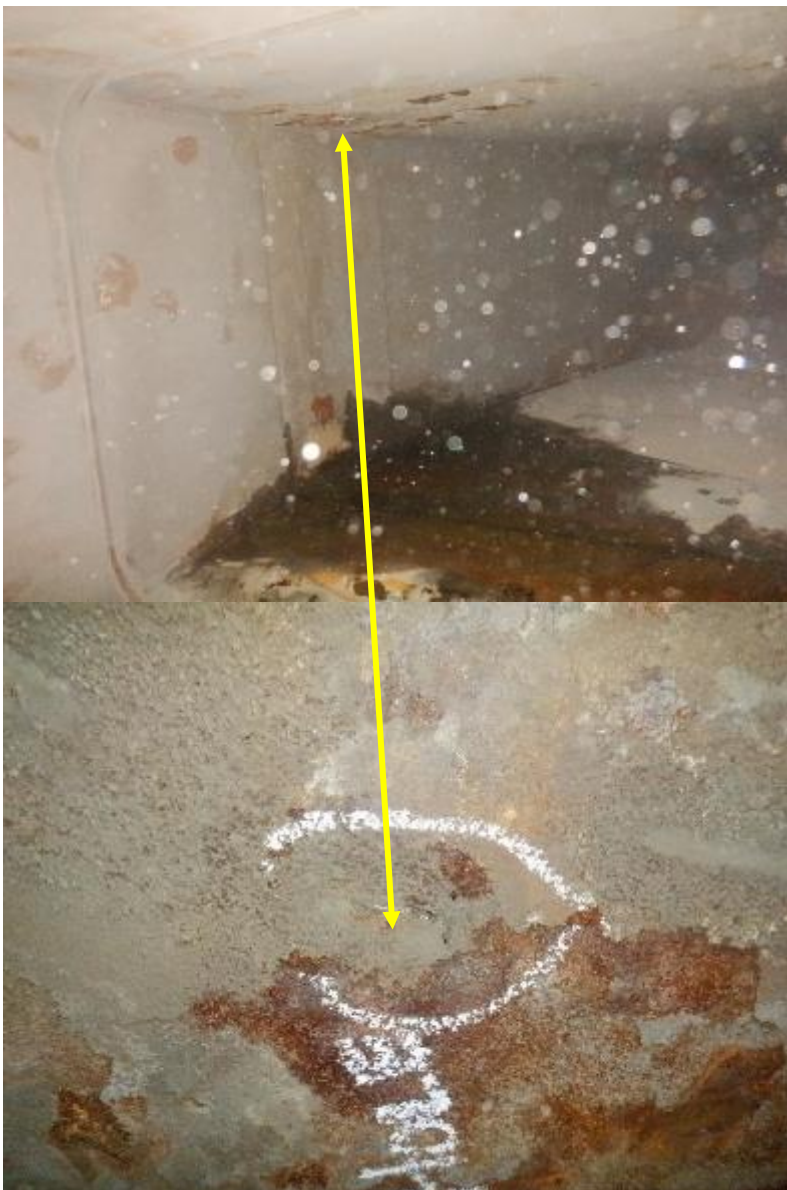
Date: 5/18/2023	Inspected by: B&W - CSH	Unit: 2	Item: TADUCTS 1
Component Inspected: Tempering/Cold Air Ducts (5 th Floor)			
Condition Assessment: About 8' upstream of the E mill take off, there were two holes in the casing roof. This is near the bend of the duct. The leak has allowed water to accumulate in the duct. This is on the exterior side of the boiler house, near the building penetration.			
Recommendations: Seal weld a 6" x 6" x 3/16" thick, carbon steel patch over the holes. It would be better to weld the patch from the exterior of the duct.			
Criticality: P3			
Risk if NOT Performed: Water will continue to enter the duct and the leak will worsen.			
EKP Comments:			
Photos:

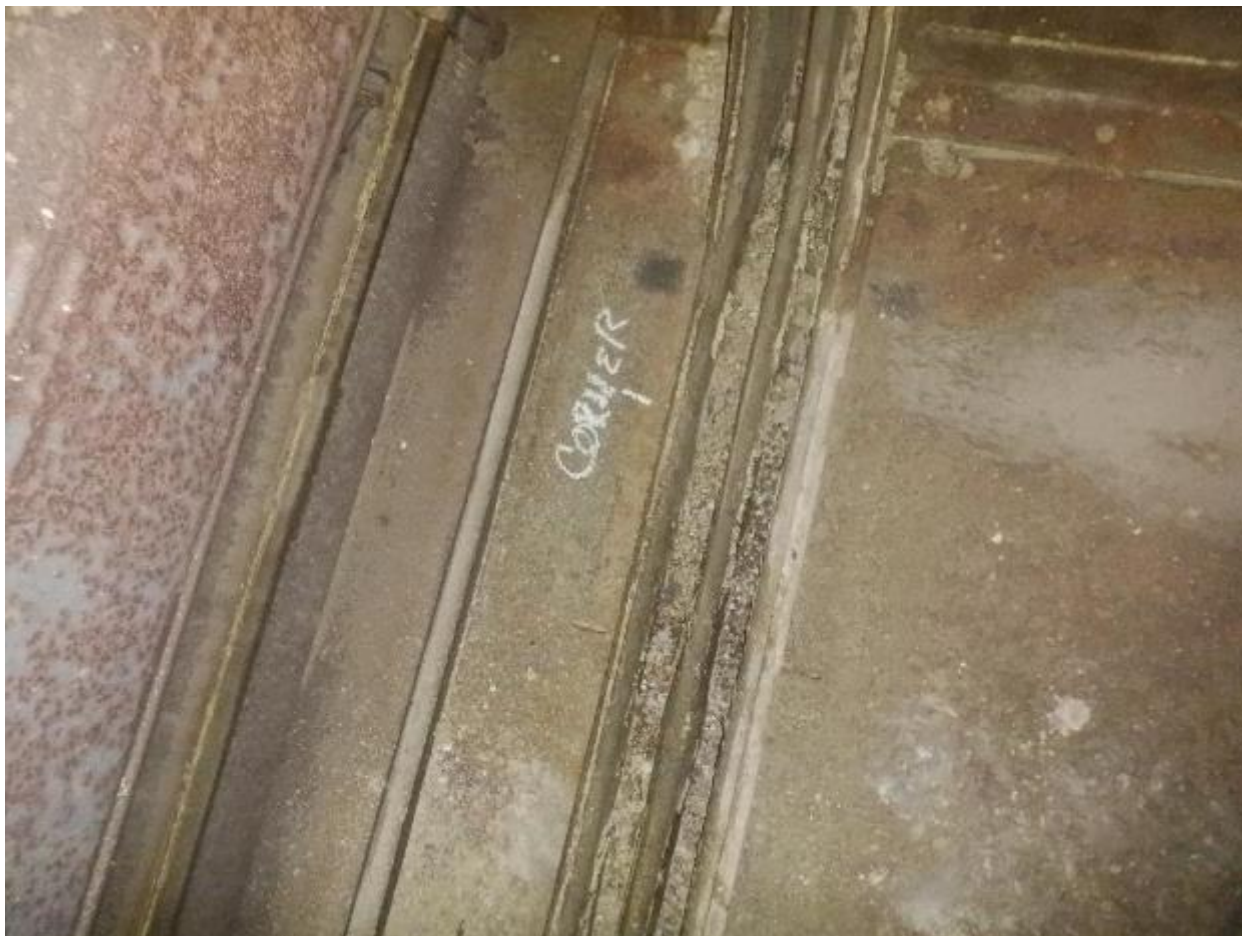
Date: 5/18/2023	Inspected by: B&W - CSH	Unit: 2	Item: WINDBOX 1
Component Inspected: Windbox and Connecting Ducts			
Condition Assessment: A & B side – All windbox expansion joints, at the corners beside the burners, had ash accumulation in the folds.			
Recommendations: Vacuum out ash and install a light insulation or kaowool into the expansion joints folds to prevent ash accumulation.			
Criticality: P3			
Risk if NOT Performed: Ductwork not able to grow/move appropriately which could cause joint failure.			
EKP Comments:

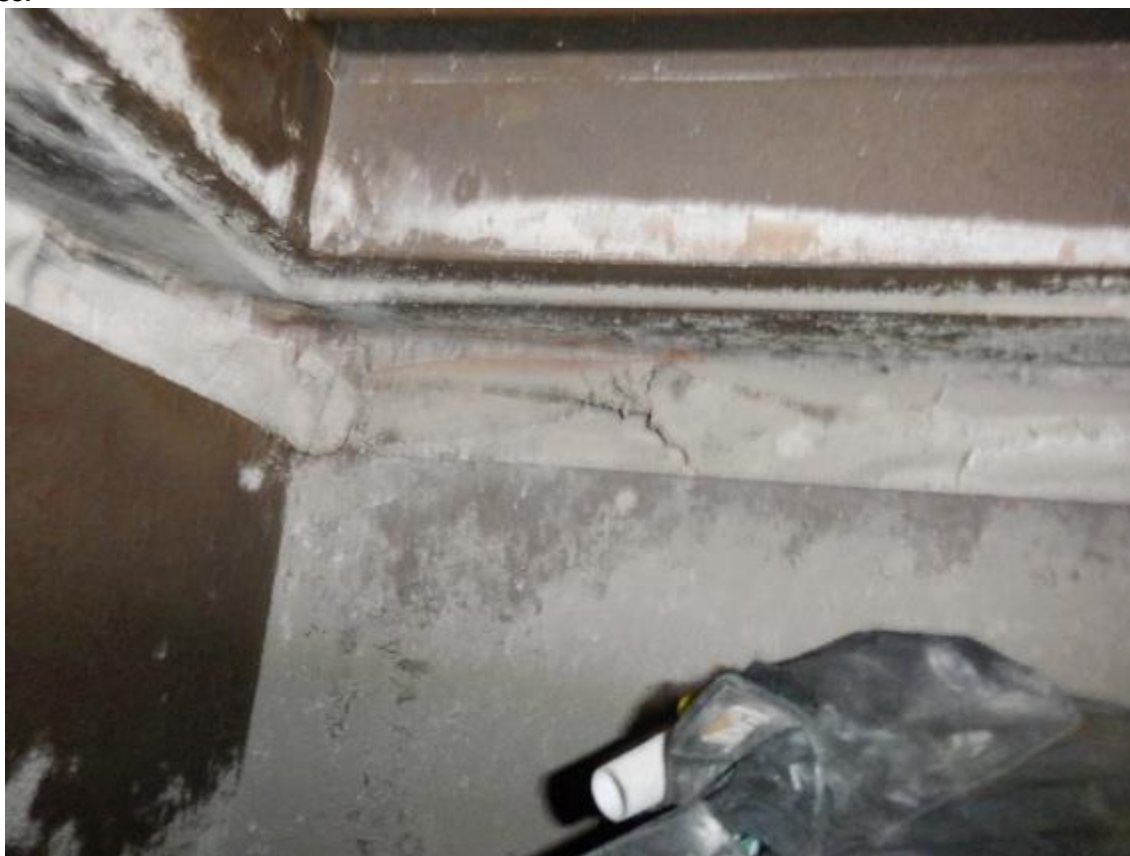
Date: 05/13/23	Inspected by: B&W	Unit: 2	Item: SOFA 1
Component Inspected: SOFA Inlet Ducts (Upper)			
Condition Assessment: Holes and tears were identified in the inner fabric of the left rear, right front, and right rear SOFA duct expansion joints.			
Recommendations: Patch the fabric and continue to monitor the exterior for holes and/or tears.			
Criticality: P3			
Risk if NOT Performed: Damage to the expansion joint may continue and eventually impact the outer portion allowing hot air to escape or causing the joint to function improperly.			
EKP Comments:

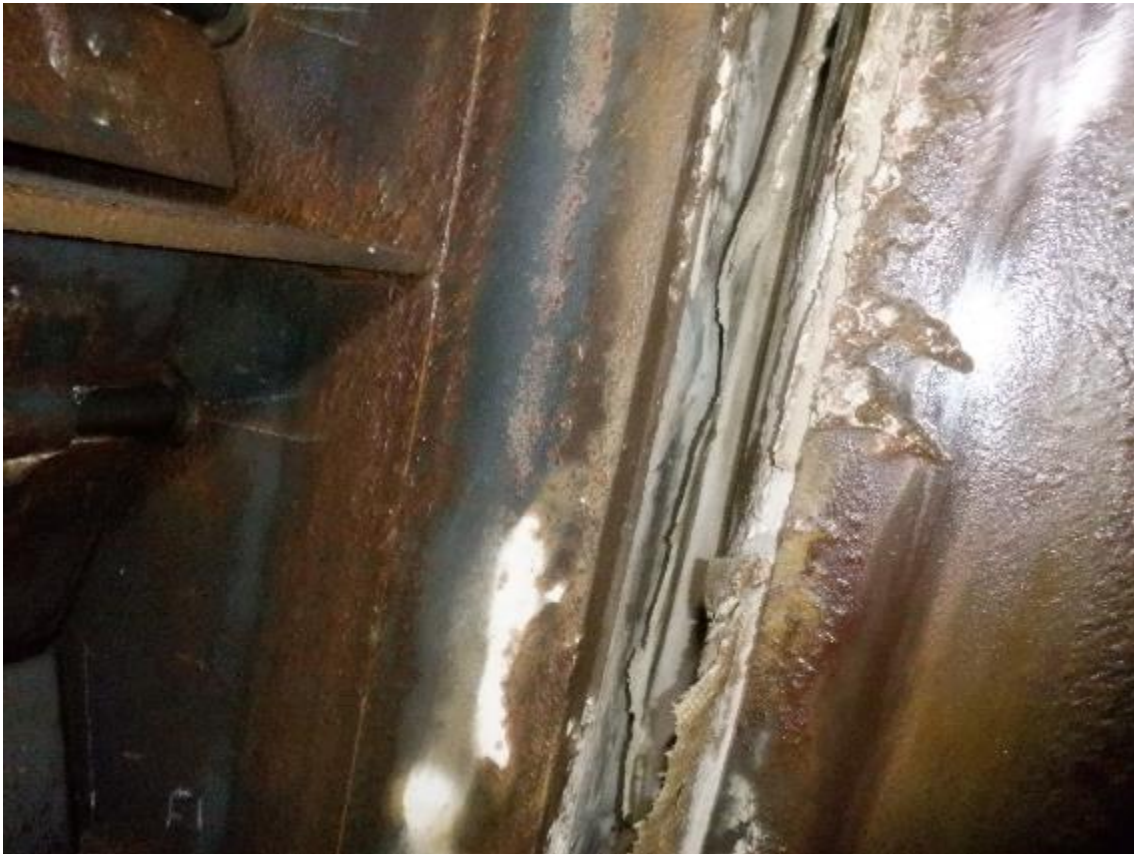
Date: 05/13/23	Inspected by: B&W	Unit: 2	Item: SOFA 2
Component Inspected: SOFA Inlet Ducts (Lower)			
Condition Assessment: Holes and tears were identified in the inner fabric of the left rear, left front, and right rear SOFA duct expansion joints.			
Recommendations: Patch the fabric and continue to monitor the exterior for holes and/or tears.			
Criticality: P3			
Risk if NOT Performed: Damage to the expansion joint may continue and eventually impact the outer portion allowing hot air to escape or causing the joint to function improperly.			
EKP Comments:			
Photos:

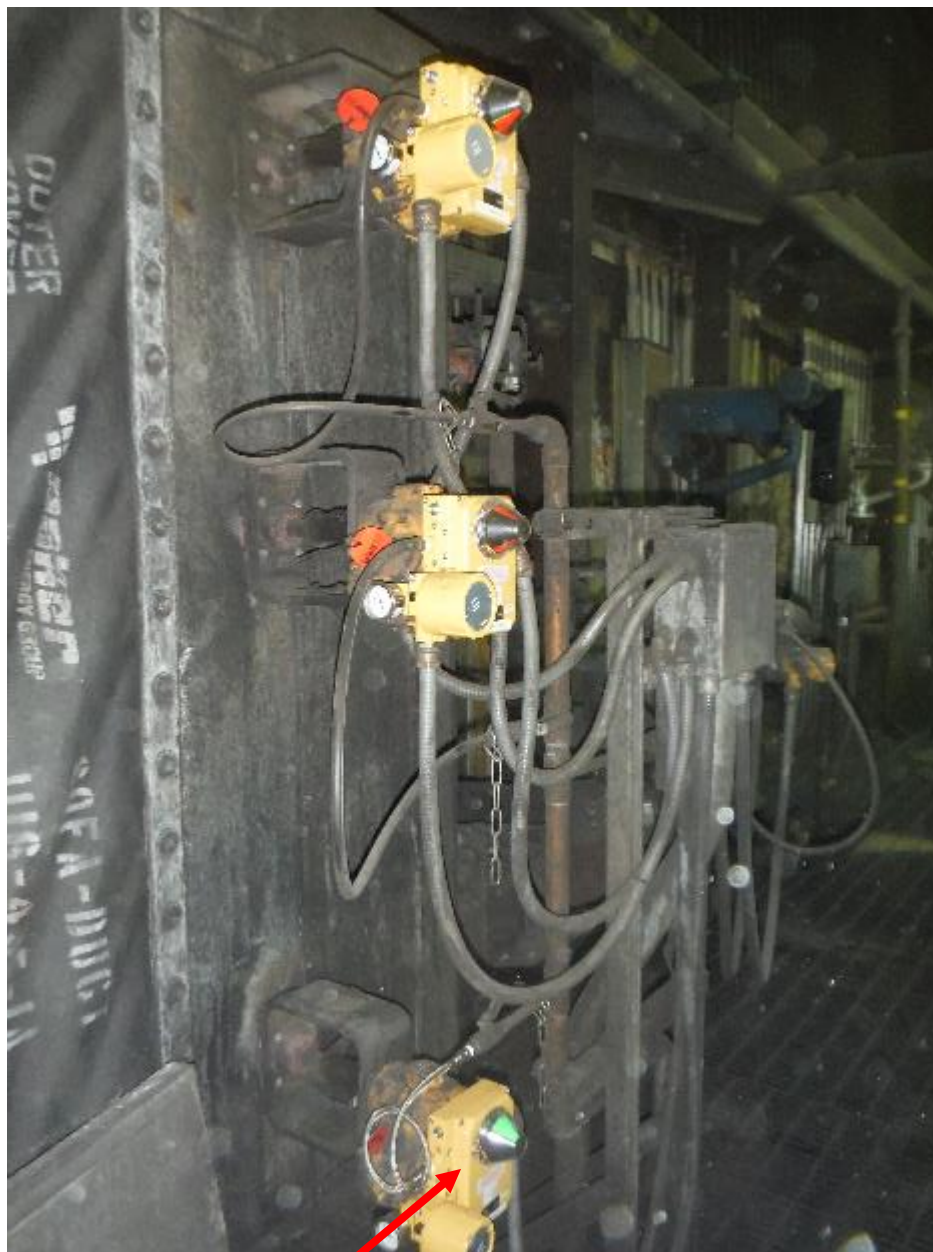
Date: 05/13/23	Inspected by: B&W	Unit: 2	Item: SOFA 3
Component Inspected: SOFA Inlet Ducts			
Condition Assessment: Upper SOFA Indicators – Sofa lower dampers 3C, 2C, and 1C were showing open but the actual damper was closed.			
Recommendations: Flip the indicator 90 degrees to show the proper orientation locally.			
Criticality: P3			
Risk if NOT Performed: The local indication is inaccurate of how far the damper is opened.			
EKP Comments:
