The Babcock & Wilcox Company

**Eastern Kentucky Power Cooperative
Spurlock Station, Unit #2**

U2 SPRING 2023 OUTAGE BOILER INSPECTION REPORT

B&W Project No.: BA9312817

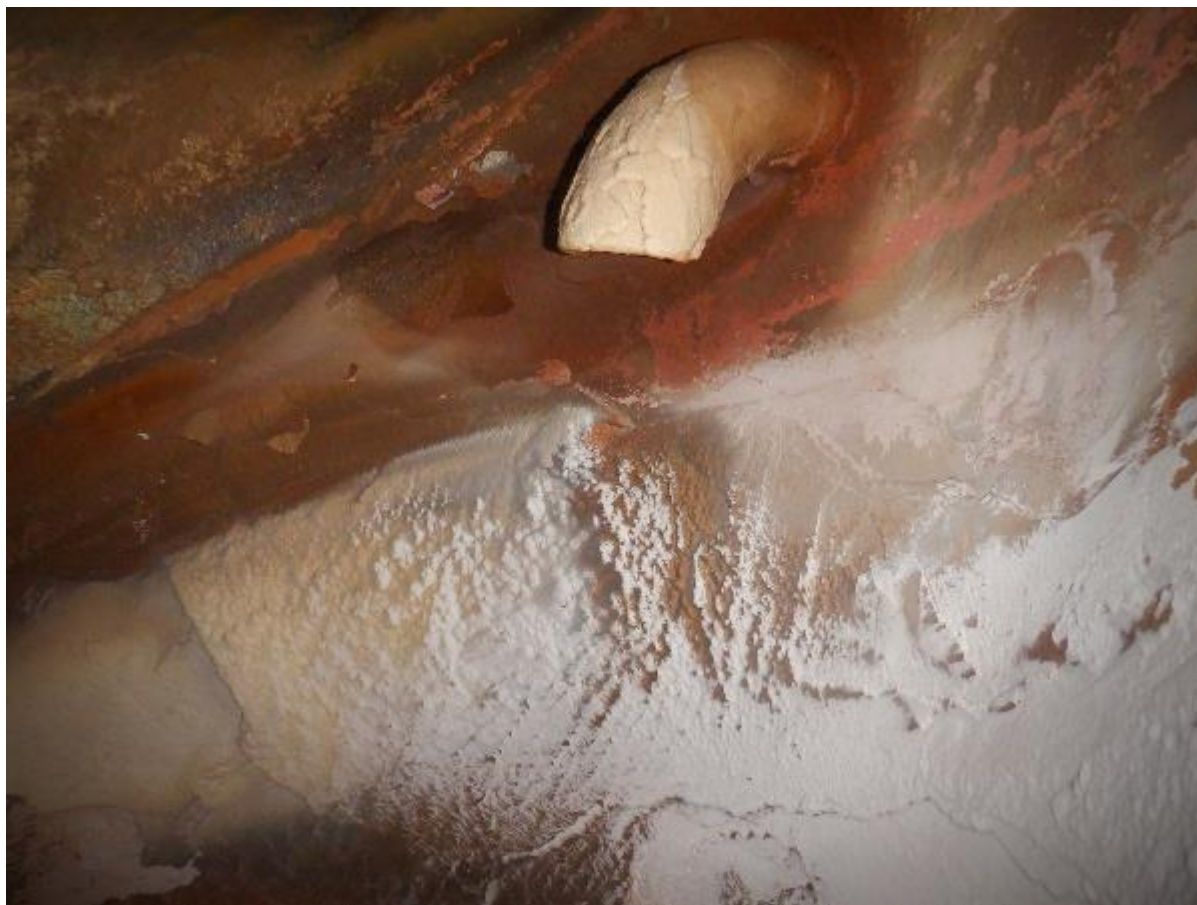
Date: 5/25/2023	Inspected by: B&W	Unit: 2	Item: BTank 1
Component Inspected: Blowdown Tank			
Condition Assessment: There was minor scale accumulation throughout the tank. All the pipes in the tank were clear. The worst area was inside the vent.			
Recommendations: Remove the scale from the line and tank.			
Criticality: P3			
Risk if NOT Performed: Scale will continue to accumulate.			
EKP Comments:

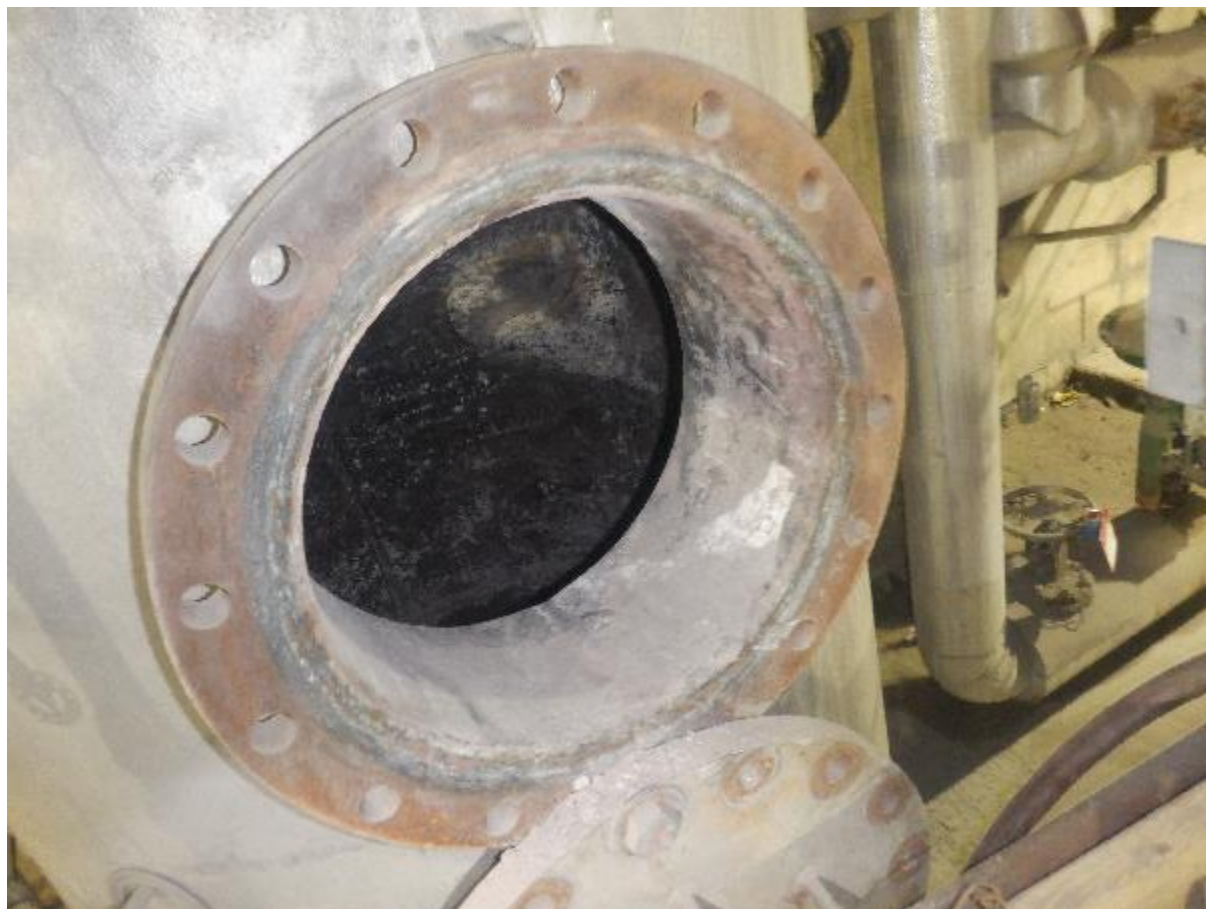
Date: 5/25/2023	Inspected by: B&W	Unit: 2	Item: BTank 2
Component Inspected: Blowdown Tank			
Condition Assessment: There was minor scale accumulation at the top of the door opening around the gasket.			
Recommendations: Remove the scale from the entrance and replace the door gasket.			
Criticality: P3			
Risk if NOT Performed: Door could leak when returned to service.			
EKP Comments:

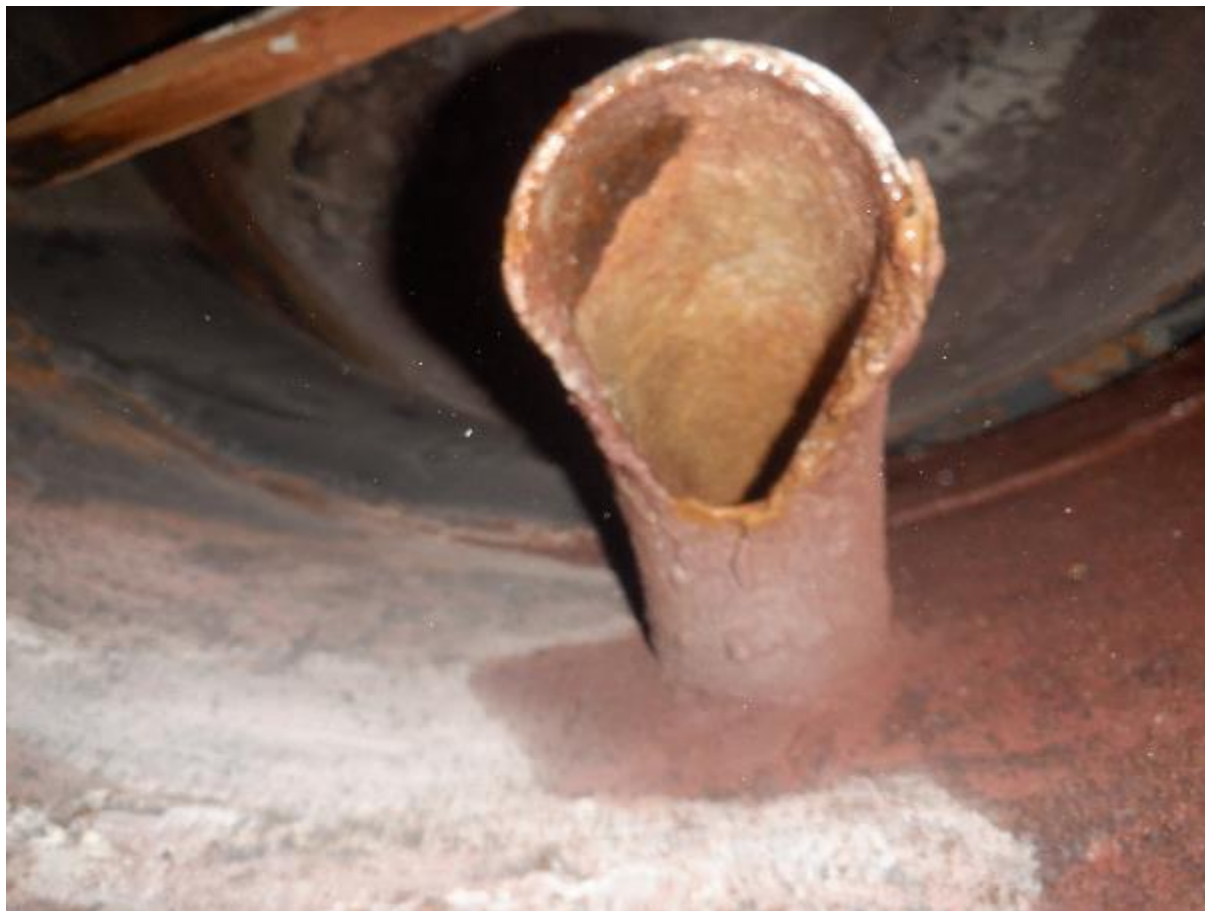
Date: 5/25/2023	Inspected by: B&W	Unit: 2	Item: BTank 3
Component Inspected: Blowdown Tank			
Condition Assessment: The service water inlet pipe elbow was corroded at the end of the pipe.			
Recommendations: Continue to monitor.			
Criticality: P3			
Risk if NOT Performed: Elbow will deteriorate.			
EKP Comments:

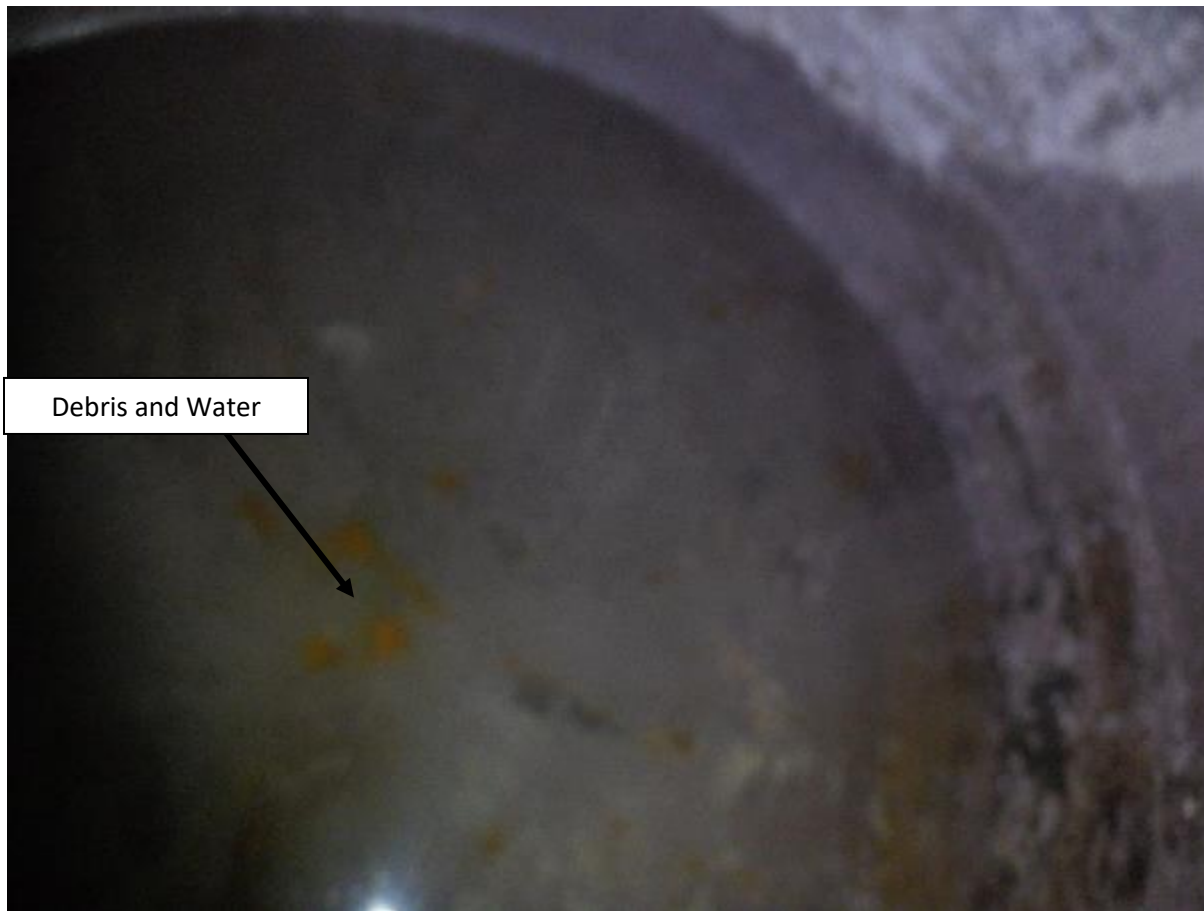
Date: 5/25/2023	Inspected by: B&W	Unit: 2	Item: BTank 4
Component Inspected: Blowdown Tank			
Condition Assessment: There was a small amount of water and debris at the bottom of the tank.			
Recommendations: Remove the debris from the tank.			
Criticality: P3			
Risk if NOT Performed: Debris will continue to accumulate.			
EKP Comments:
