## ENGINEERED PUMP SERVICES, INC.

# INSPECTION REPORT

<b>CUSTOMER</b>	: East Kentucky Power Cooperative	<b>REPORT DATE</b>	: 01/17/22
<b>PLANT NAME</b>	: Spurlock Station	<b>REPORT NO.</b>	: 56731-IR1
<b>CITY/STATE</b>	: Maysville, KY	<b>CUST. ORDER</b>	: TBD
<b>EQUIPMENT</b>	: 12x12x14 HDB-6	<b>COPY</b>	: Tony Ring
<b>SERVICE</b>	: Boiler Feed		
<b>MANF.</b>	: Byron-Jackson	<b>FILE</b>	: 56731
<b>SERIAL NO.</b>	: Unit 2A	<b>PAGE</b>	: 1 of 4

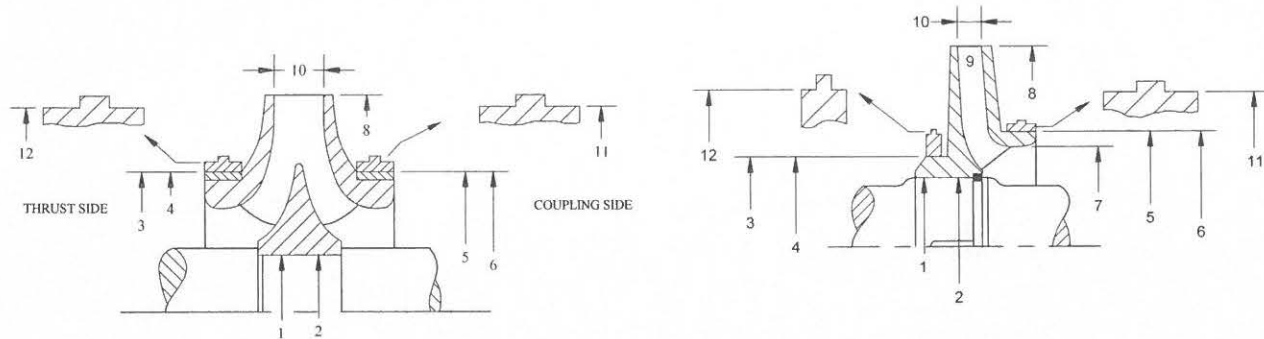
6	CASING RING BORE	9.001	9.002	N/A	N/A	8.502	8.503	8.501	8.502	8.502	8.503	8.501	8.502	8.501	8.503	7.250	7.251
	RUNNING CLEARANCE	0.015	0.018	N/A	N/A	0.018	0.020	0.017	0.020	0.017	0.020	0.018	0.020	0.018	0.021	0.015	0.017
7	IMP. EYE DIA./ROTATION (*)	7.86	Dual	N/A	N/A	7.26	CCW	7.25	CCW	7.25	CW	7.26	CW	7.25	CW	6.49	CW
8	IMP. MAJOR DIA. / VANE DIA.	11.74	Full	N/A	N/A	13.85	Full	13.86	Full	13.87	Full	13.87	Full	13.86	Full	10.15	Full
9	# OF VANES / B-VANE LENGTH	3	0.28	N/A	N/A	5	0.24	5	0.24	5	0.25	5	0.25	5	0.26	11.00	0.66
10	DISCHARGE PASSAGE WIDTH	1.83		N/A		1.36		1.35		1.34		1.36		1.36		0.47	
11	CASING RING FIT TURN	9.749	9.752	N/A	N/A	9.499	9.500	9.499	9.500	9.499	9.500	9.499	9.499	9.498	9.501	9.498	9.502
	CASING RING FIT BORE	9.752	9.753	N/A	N/A	9.501	9.502	9.502	9.503	9.501	9.502	9.502	9.503	9.502	9.503	9.502	9.503
	FIT CLEARANCE	0.000	0.004	N/A	N/A	0.001	0.003	0.002	0.004	0.001	0.003	0.003	0.004	0.001	0.005	0.000	0.005

12	STAGE PIECE FIT TURN	9.746	9.754	9.499	9.500	9.498	9.499	9.498	9.499	9.498	9.499	9.499	9.500	9.499	9.499	9.498	9.499
	STAGE PIECE FIT BORE	9.752	9.753	9.501	9.502	9.501	9.502	9.502	9.503	9.501	9.502	9.502	9.503	9.502	9.503	9.502	9.503
	FIT CLEARANCE	(0.002)	0.007	0.001	0.003	0.002	0.004	0.003	0.005	0.002	0.004	0.002	0.004	0.003	0.004	0.003	0.005
13	IMP. HUB RING HARDNESS (Rc)	40 Rc		35 Rc		40 Rc		40 Rc		40 Rc		40 Rc		40 Rc		40 Rc	
14	STAGE PIECE HARDNESS (Rc)	55 Rc		55 Rc		55 Rc		55 Rc		55 Rc		55 Rc		55 Rc		55 Rc	
15	IMP. EYE RING HARDNESS (Rc)	40 Rc		N/A		40 Rc		40 Rc		40 Rc		40 Rc		40 Rc		40 Rc	
16	CASING RING HARDNESS (Rc)	55 Rc		N/A		55 Rc		55 Rc		55 Rc		55 Rc		55 Rc		55 Rc

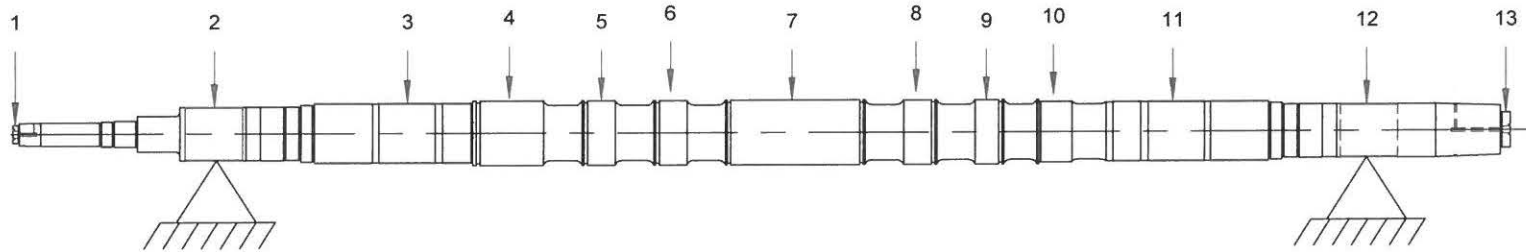
1	2	3	4	5	6	7	8	9	10	11	12	13
0°	0.0000	0.0000	0.0000	0.0000	0.0000	0.0000	0.0000	0.0000	0.0000	0.0000	0.0000	0.0000	0.0000
90°	0.0000	0.0000	0.0000	0.0000	0.0000	0.0000	-0.0005	0.0000	0.0000	-0.0005	0.0000	0.0000	0.0000
180°	0.0000	0.0000	0.0000	0.0000	0.0000	0.0000	-0.0005	0.0000	0.0000	0.0000	0.0000	0.0000	0.0000
270°	0.0000	0.0000	0.0000	0.0000	0.0000	0.0000	0.0000	0.0000	0.0000	0.0000	0.0000	0.0000	0.0000
Diameter	2.499 - 2.500	5.250	5.485	5.504	5.509 - 5.510	5.514 - 5.515	5.519	5.519 - 5.520	5.504	5.499 - 5.500	5.485	5.250 - 5.251	3.471 Minor
