INSPECTION REPORT

CUSTOMER	: East Kentucky Power Cooperative	REPORT DATE	: 12/17/21
PLANT NAME	: Spurlock Generating Station	REPORT NO.	: 56743-IR1
CITY/STATE	: Maysville, Kentucky	CUST. ORDER	: TBD
EQUIPMENT	: 29" APKD - 4	COPY	: Anthony Ring
SERVICE	: Condensate Water	FILE	: 56743
MANF.	: Ingersoll-Rand	PAGE	: 1 of 4 Pages
SERIAL NO.	: Unit #2

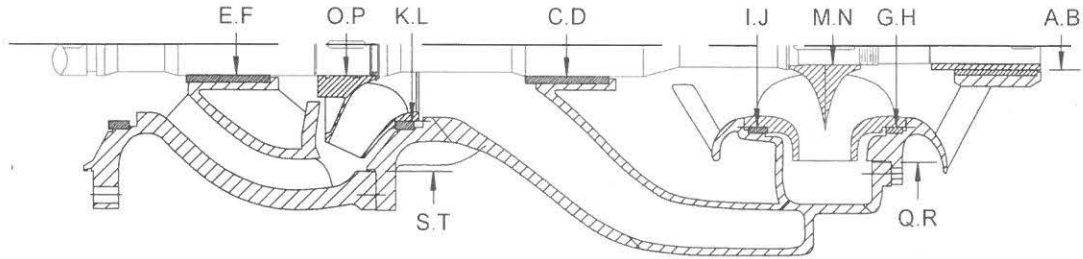
RUNNING CLR.		STAGE 1	STAGE 2	STAGE 3	STAGE 4				
A	BEARING BORE	2.507	2.511						
B	SLEEVE TURN	2.490	2.500						
	CLR.	0.007	0.021						
C	BEARING BORE	4.780	4.790						
D	SLEEVE TURN	4.742	4.750						
	CLR.	0.030	0.048						
E	BEARING BORE			4.770	4.773	4.773	4.780	4.768	4.775
F	SLEEVE TURN			4.742	4.750	4.742	4.750	4.742	4.750
	CLR.			0.020	0.031	0.023	0.038	0.018	0.033
G	RING BORE	10.504	10.506						
H	IMPELLER TURN	10.481	10.483						
	CLR.	0.021	0.025						
I	RING BORE	10.503	10.506						
J	IMPELLER TURN	10.482	10.483						
	CLR.	0.020	0.024						
K	RING BORE			10.503	10.507	10.505	10.507	10.504	10.505
L	IMPELLER TURN			10.482	10.485	10.483	10.485	10.482	10.483
	CLR.			0.018	0.025	0.020	0.024	0.021	0.023
FITS									
M	IMPELLER BORE	2.125	2.127						
N	SHAFT TURN	2.123	2.124						
	FIT	0.001	0.004						
O	IMPELLER BORE			4.253	4.254	4.253	4.254	4.253	4.255
P	SHAFT TURN			4.249	4.249	4.249	4.249	4.249	4.250

FIT			0.004	0.005	0.004	0.005	0.003	0.006
Q	CASING BORE	15.002	15.003						
R	SUC. BELL TURN	15.003	15.004						
	FIT	-0.002	0.000						
S	CASING BORE			17.002	17.003	17.003	17.004	17.003	17.004
T	CASING TURN			16.998	16.999	16.999	16.999	16.998	16.999
	FIT			0.003	0.005	0.004	0.005	0.004	0.006

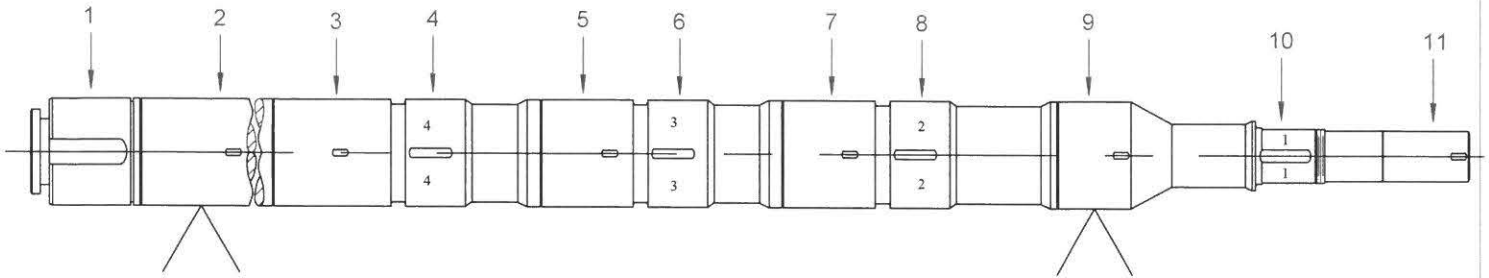
1	2	3	4	5	6	7	8	9	10	11
0	.0000	.0000	.0000	.0000	.0000	.0000	.0000	.0000	.0000	.0000	.0000
90	-.0020	-.0020	-.0010	-.0010	-.0010	-.0005	-.0005	.0000	+.0020	+.0010	+.0010
180	-.0020	-.0030	-.0010	-.0010	-.0010	-.0005	.0000	+.0010	+.0020	-.0020	-.0020
270	-.0005	-.0010	.0000	-.0010	.0000	-.0005	.0000	+.0010	+.0015	-.0020	-.0030

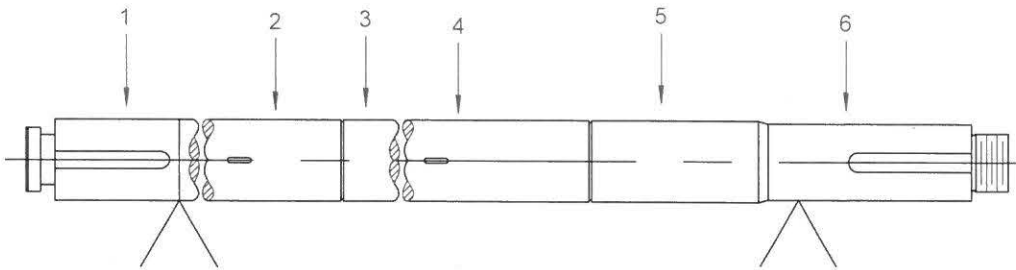
1	2	3	4	5	6
0	.0000	.0000	.0000	.0000	.0000	.0000
90	.0000	-.0010	-.0010	-.0030	-.0010	+.0020
180	.0000	.0000	+.0005	-.0020	-.0010	+.0020
270	-.0010	+.0010	+.0010	.0000	.0000	.0000
