1.1 The Accident .....	1
1.1.1 Area Layout.....	2
1.1.2 Service Line and Tee Replacement at Palmer Building 2 .....	5
1.1.3 Natural Gas Leak and Explosion .....	8

Pipeline Investigation Report

Report Number PIR-25-01

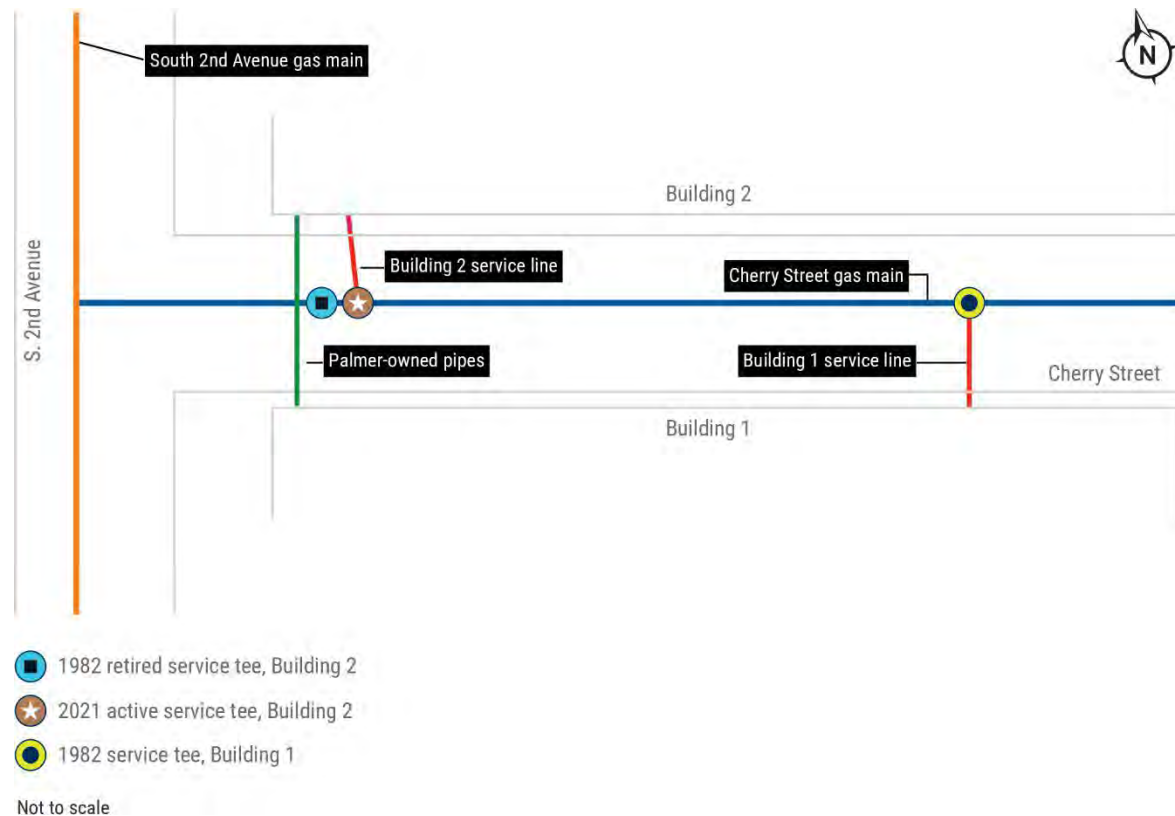
Two years before this accident, on February 16, 2021, a UGI crew conducted a routine inspection of the Building 2 gas meter, which at the time was in the basement.<sup>7</sup> The crew detected gas inside the basement of Building 2 and at the service curb valve outside the building. UGI recorded this as a “grade C” leak, which required immediate attention or repair, and began a project to replace the service line and service tee from the Cherry Street gas main to Building 2 and to move the meter outdoors as required by UGI procedures. The service tee joined the service line to the main. The alignment of the private pipes and natural gas distribution system assets after the replacement project is shown in figure 4.

**Figure 4.** Natural gas distribution system and Palmer-owned pipes.

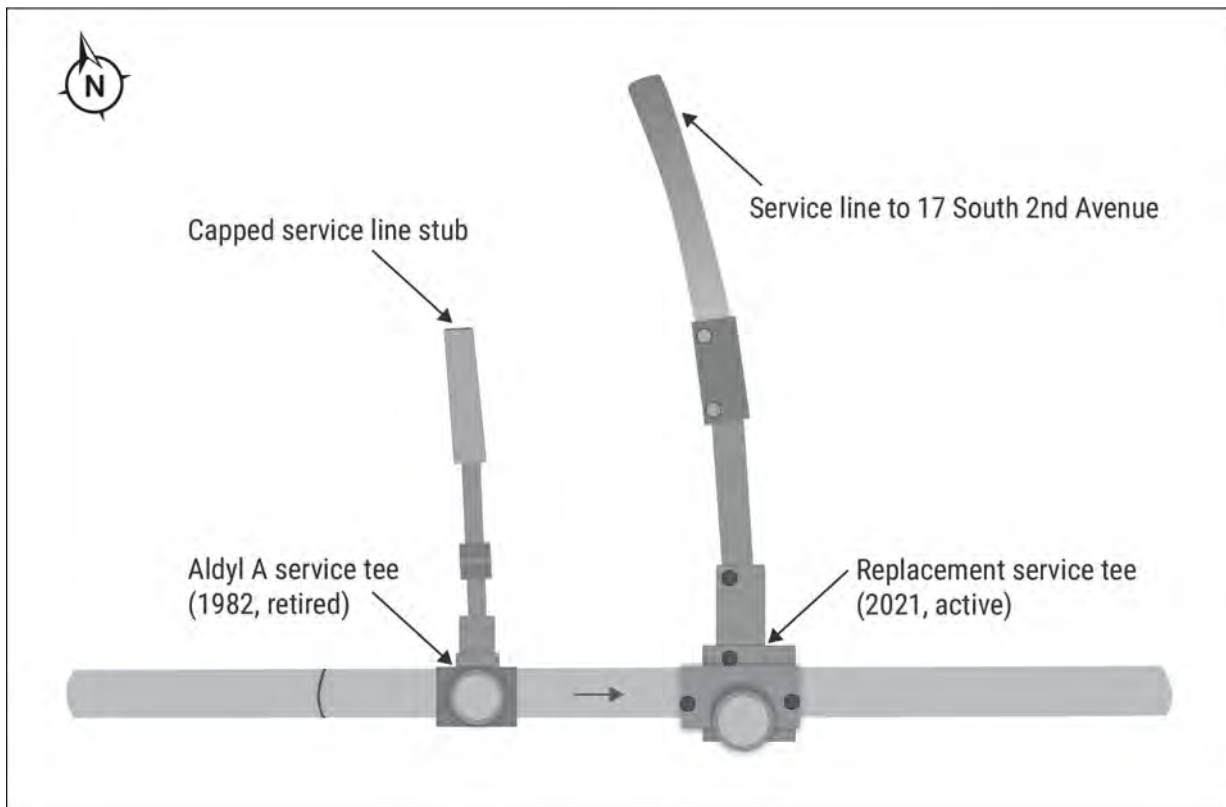
The crew continued the excavation and completed the retirement of the original service line and tee and installation of the new service line and tee to the east of the old ones.<sup>10</sup> (See section 1.5.1 for a description of the typical process.) (See figure 5.) Upon completion of the project, the 1982 service line stub and tee remained attached to the gas main and exposed internally to full gas system pressure. UGI's standard and common industry practice for replacement of a service line and tee is to cap the tee and leave the tee attached to the main, exposed to full gas system pressure, and to install a new tee and service line nearby.

**Figure 5.** Cherry Street gas main and Building 2 service tees, viewed from above.

A review of PA One Call records indicated that no further work exposed the original service tee after February 16, 2021.

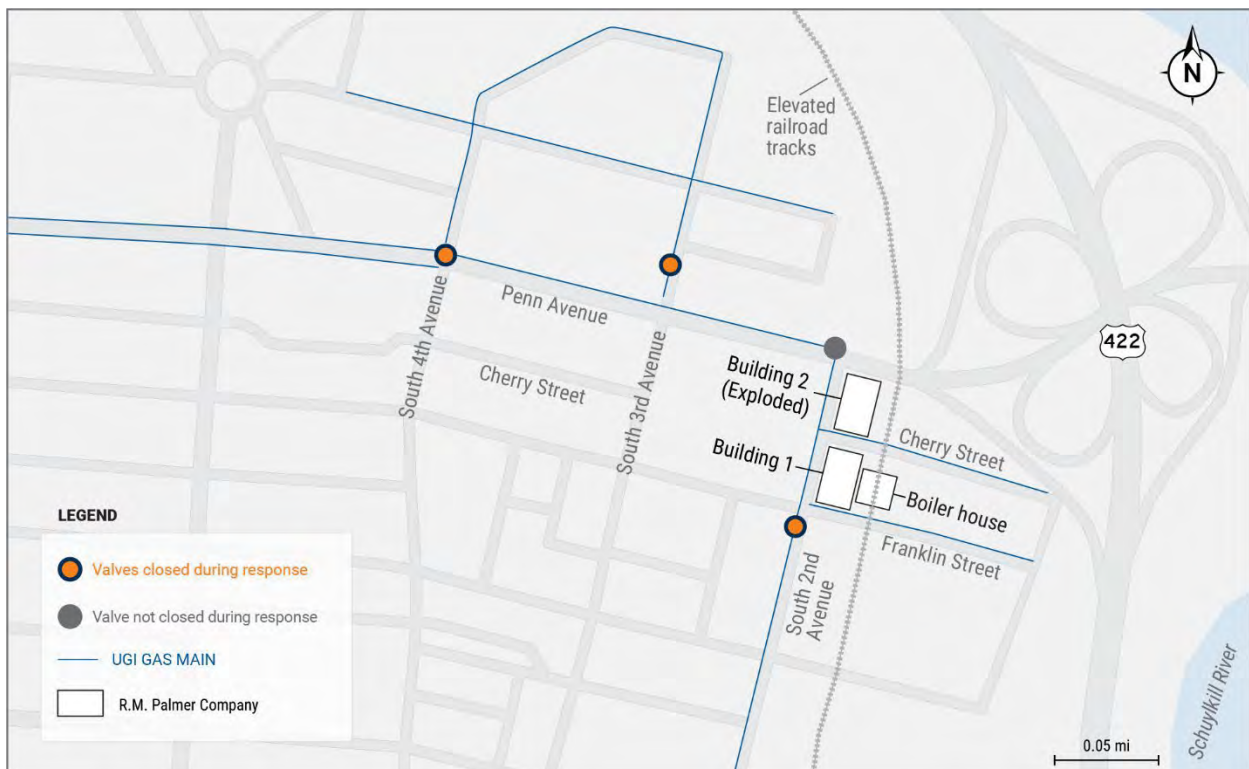
The UGI mechanic closed the first valve, at South 2nd Avenue and Franklin Street, about 5:30 p.m. (Figure 6 shows the locations of the valves UGI closed or attempted to close in response to the accident.) He recalled that when he went to the second valve at South 2nd Avenue and Penn Avenue, the valve identification number that he had received did not match the valve itself. A UGI representative later stated that the South 2nd Avenue and Penn Avenue valve was inaccessible and paved over and that consequently this valve was not closed during the response.<sup>22</sup> The UGI representative stated later that personnel tried to verify the gas valve's identification numbers and were unable to do so. At the time, they were not viewing the paved-over gas valve but instead a water valve that, for an undetermined reason, had a gas valve cover. UGI had designated this valve, and all the other valves it closed or

UGI added that upon encountering this issue, the UGI mechanic used geographic information system (GIS)–based maps and records to identify the next-closest valve needed to isolate the main segment; this valve was located at South 3rd Avenue and Penn Avenue. The UGI mechanic subsequently closed the South 3rd Avenue and Penn Avenue valve about 5:50 p.m., shutting off gas flowing north to south. He then moved to the final valve at South 4th Avenue and Penn Avenue that, when closed, shut off gas flowing west to east and completed the isolation of the gas system in the affected area.

**Figure 6.** Underground gas main valves involved in response to the March 24 incident.

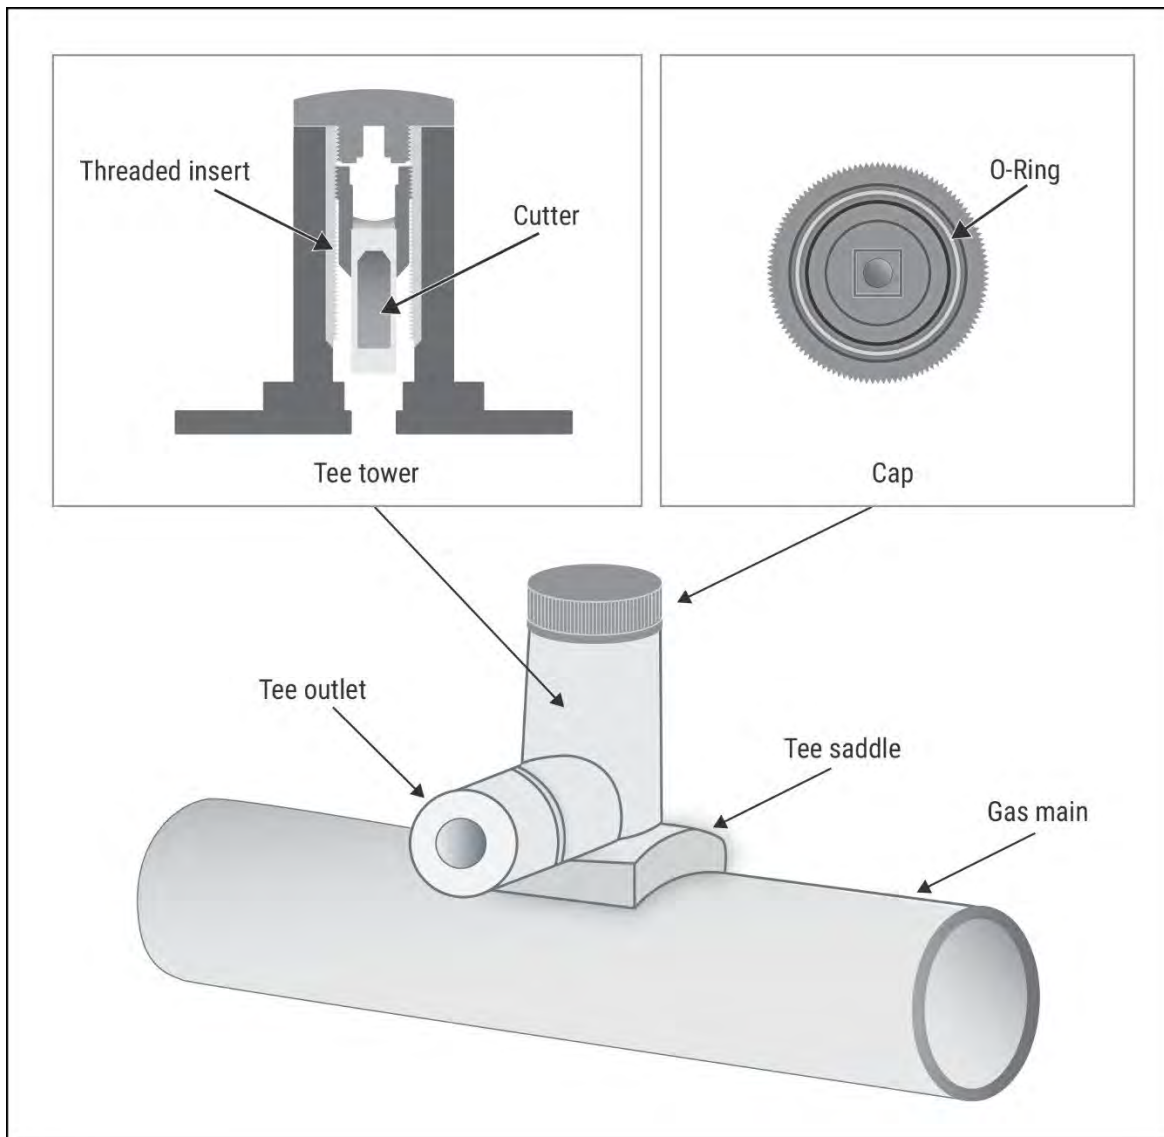
These tees were designed to perform three functions: (1) form a leak-free connection with the gas main, (2) form a leak-free connection to downstream service line piping, and (3) perforate the gas main to allow gas to enter the service line. The first function was accomplished by saddle fusing the tee to the gas main.<sup>27</sup> To complete the second function, service line piping and fittings were attached to the tee's outlet. Once a leak-free connection was established, the third function was accomplished using a cutter that was housed in the tower of the service tee. To complete this function, the cutter was lowered using a wrench until its tip cut a circular hole in the top of the gas main. The cutter was next raised to clear the cut hole and allow gas to enter the service line. The tee was then sealed by installing a threaded cap with rubber O-ring on top of the tee's tower. (See figure 7.)

**Figure 7.** Aldyl A service tee and its components.

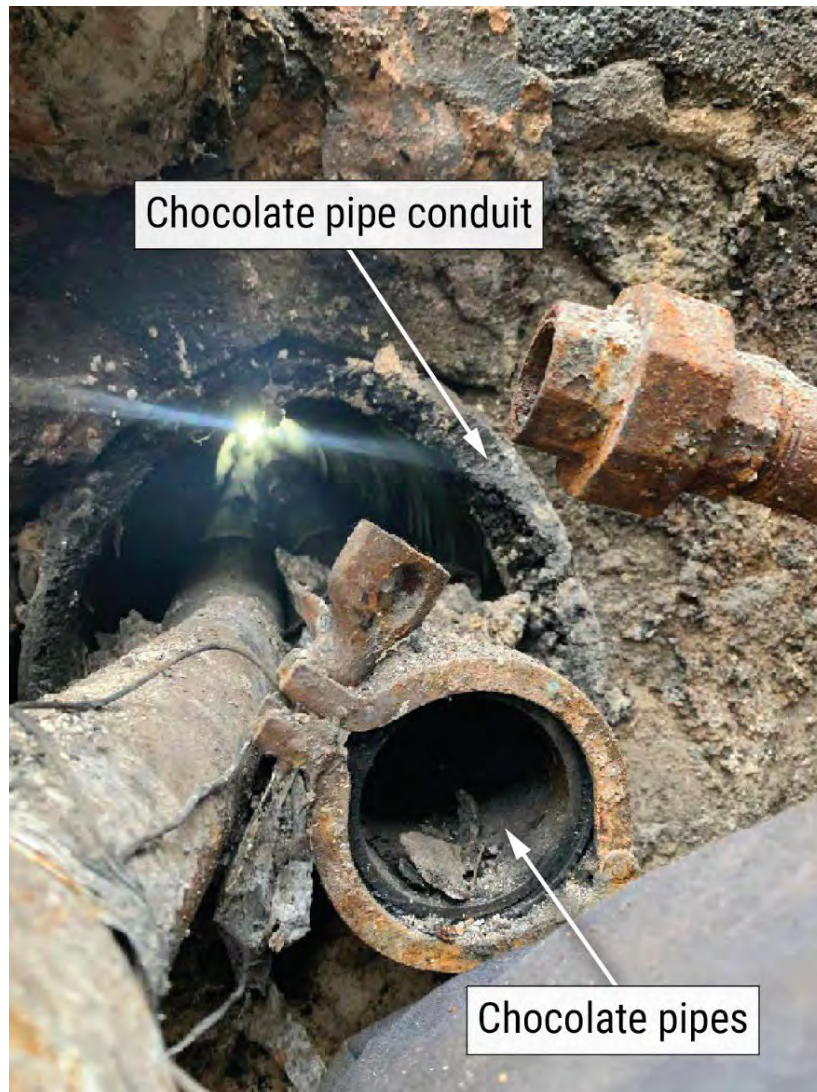
Also on April 26, the Pennsylvania State Police deputy fire marshal visually inspected what remained of the Building 2 basement. Investigators in the basement of Building 1 pointed a flashlight through the chocolate pipe conduits toward the Building 2 basement to see whether air flow through the conduits could have been obstructed by insulation or other material. The deputy fire marshal observed light through the conduits. (See figure 12.)

**Figure 12.** A view of one of the chocolate pipe conduits from the Building 2 basement.

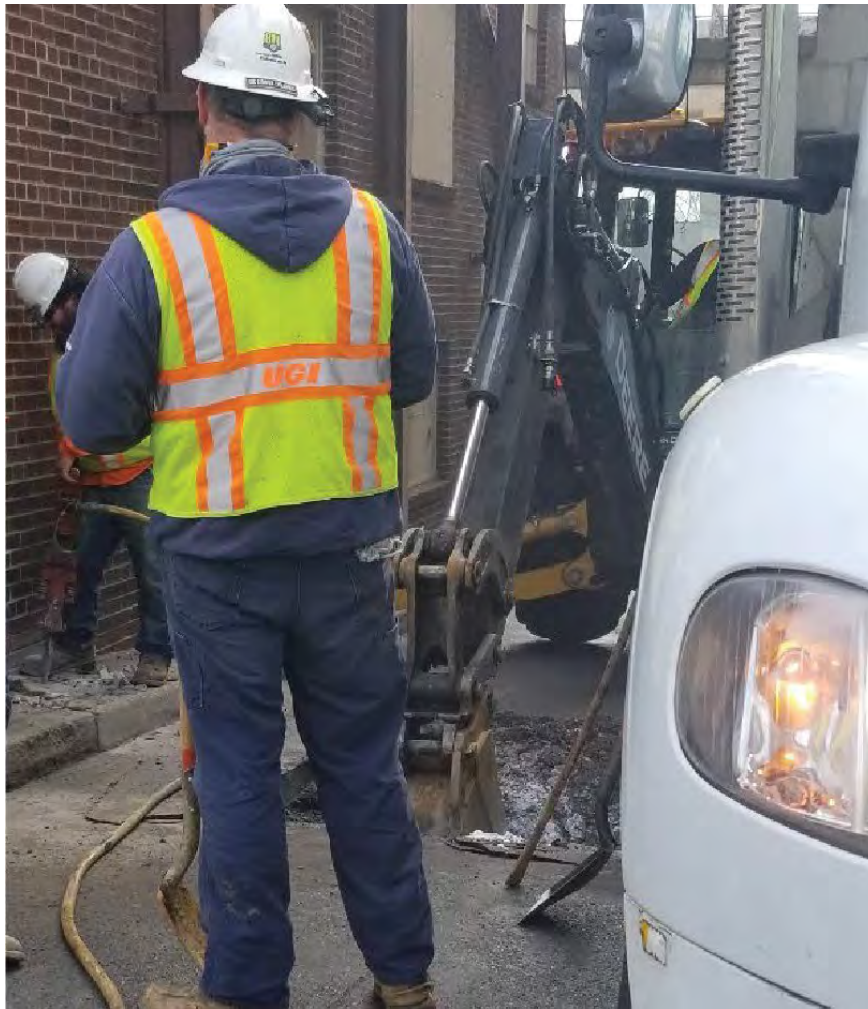
(See figure 18.) The NTSB reviewed the photograph to estimate the extent and location of excavation with mechanized equipment, and the photographic study showed that the excavation took place around the same location as the crack in the steam pipe. (See section 1.6.2.5.) The study showed that the west edge of the excavation was located within about 1 foot of the location of the steam pipe and that the excavation extended south of the location of the crack. The study was unable to determine the depth of the excavation.

**Figure 18.** UGI crew during service line replacement project, 2021. (Photo courtesy Palmer.)
