Kentucky Power Company
KPSC Case No. 2026-00001
Commission Staff's First Set of Data Requests
Dated March 19, 2026

**AMERICAN ELECTRIC POWER SERVICE CORPORATION
OHIO POWER COMPANY
MITCHELL PLANT, UNIT NO. 1
MOUNDSVILLE, WEST VIRGINIA**

**Report
for
Inspection of 370'-0" High
Reinforced Concrete Cooling Tower**

American Electric Power Service Corporation
Ohio Power Company
Service Order B-6858
March 12, 1990

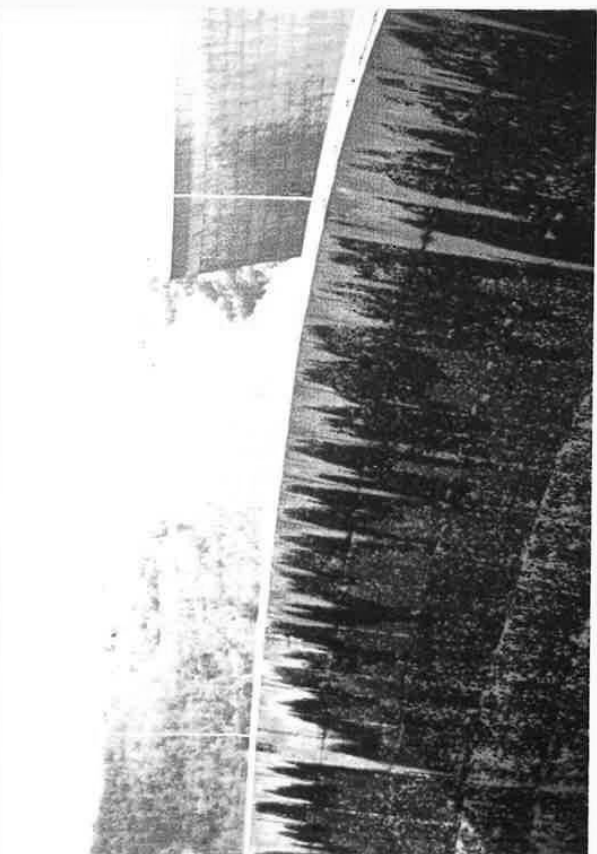
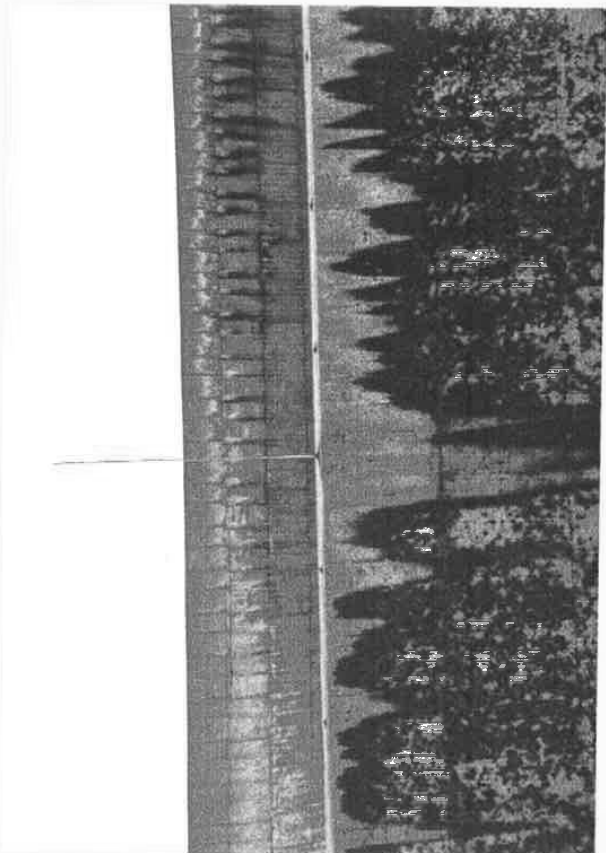
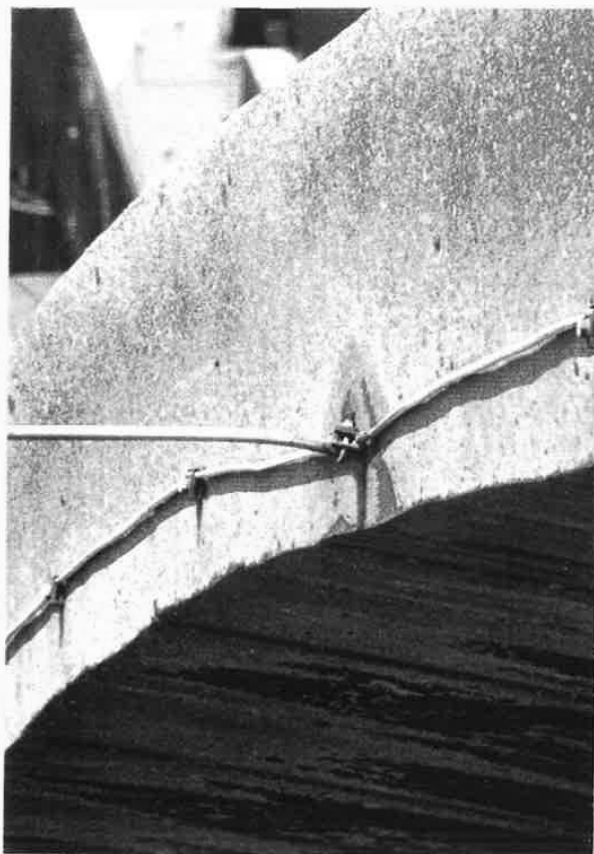
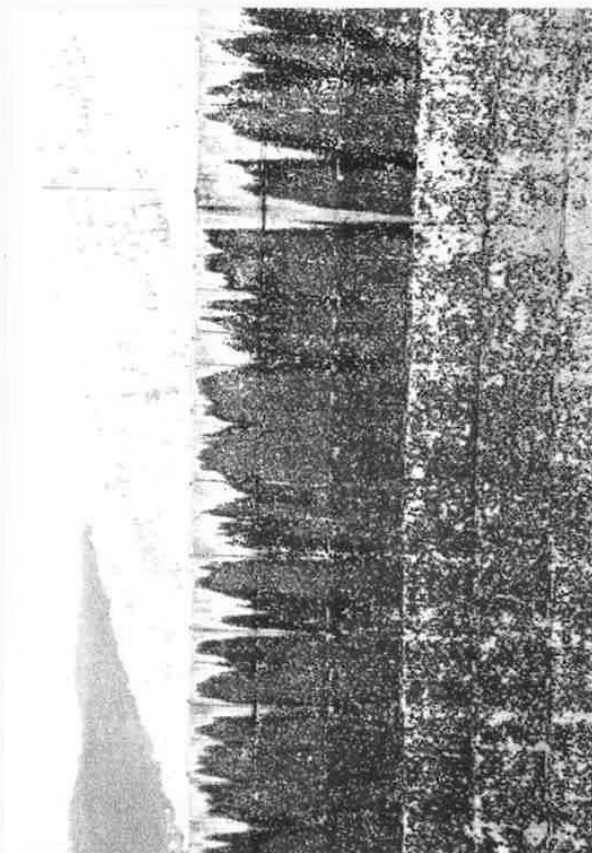
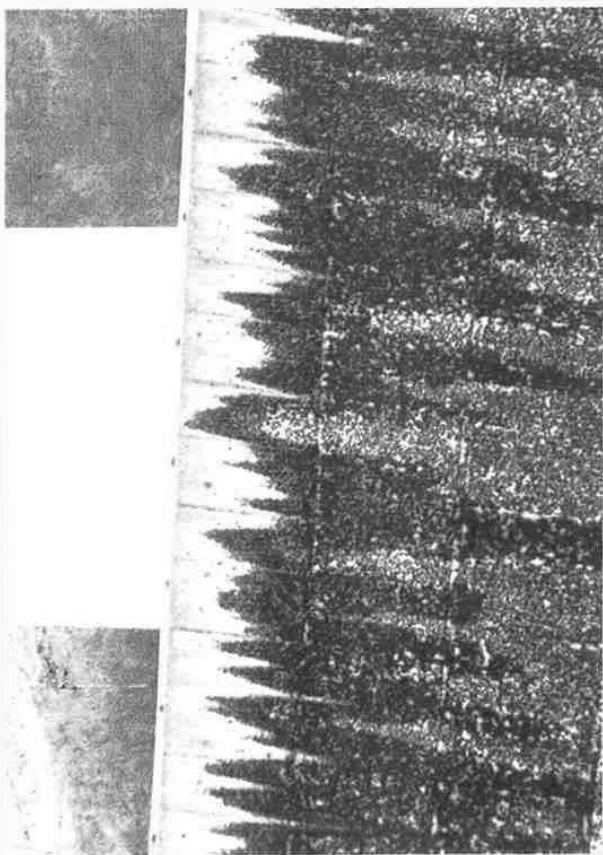
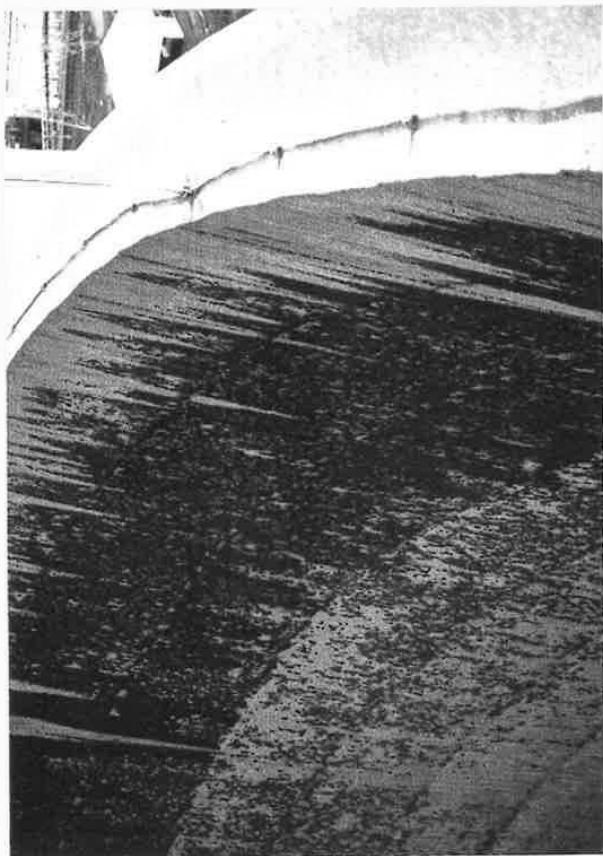
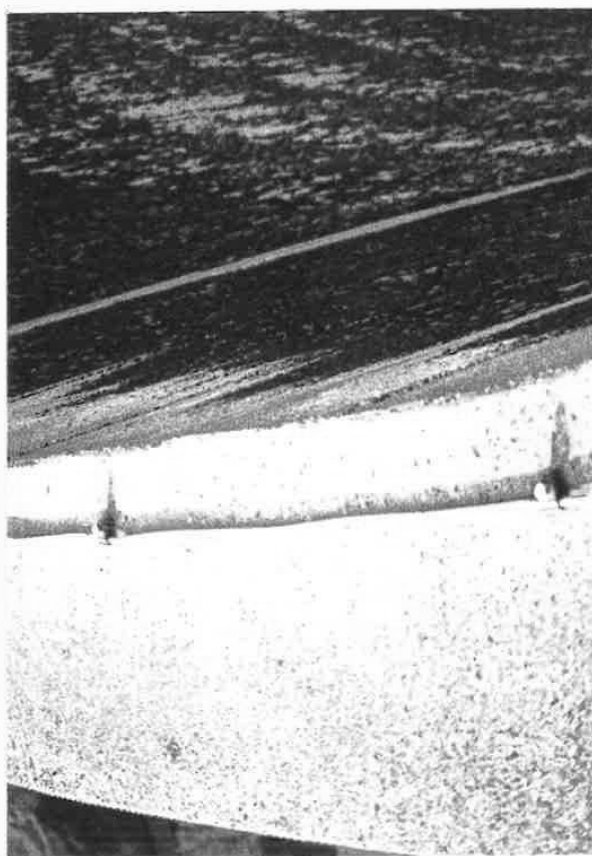
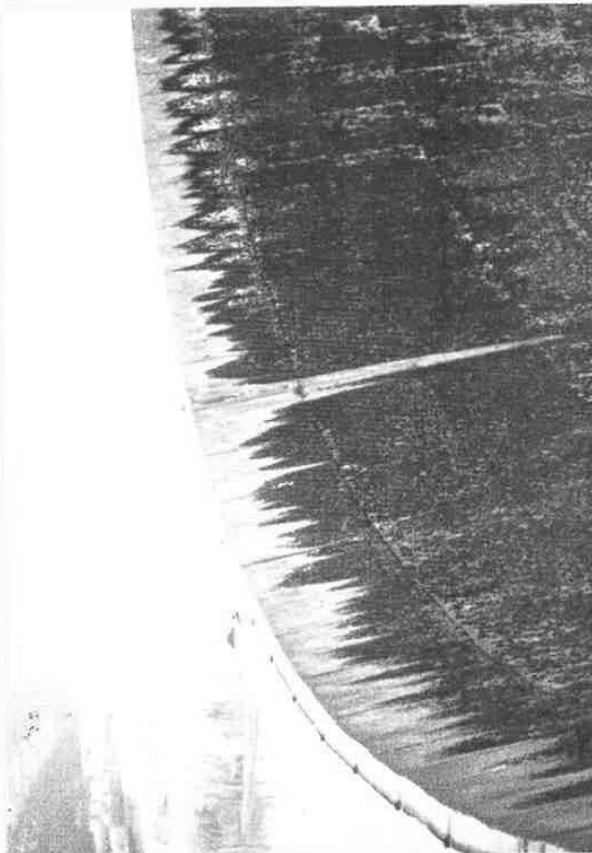
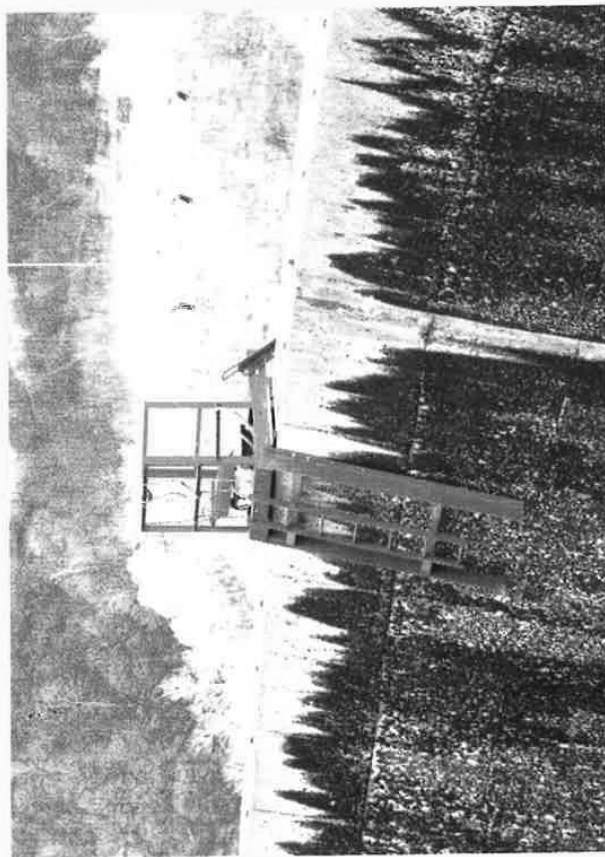
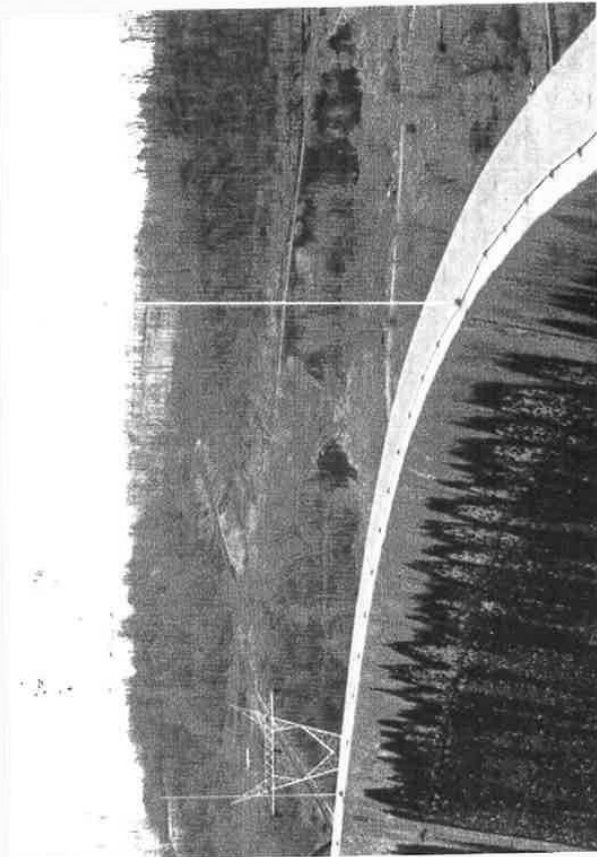
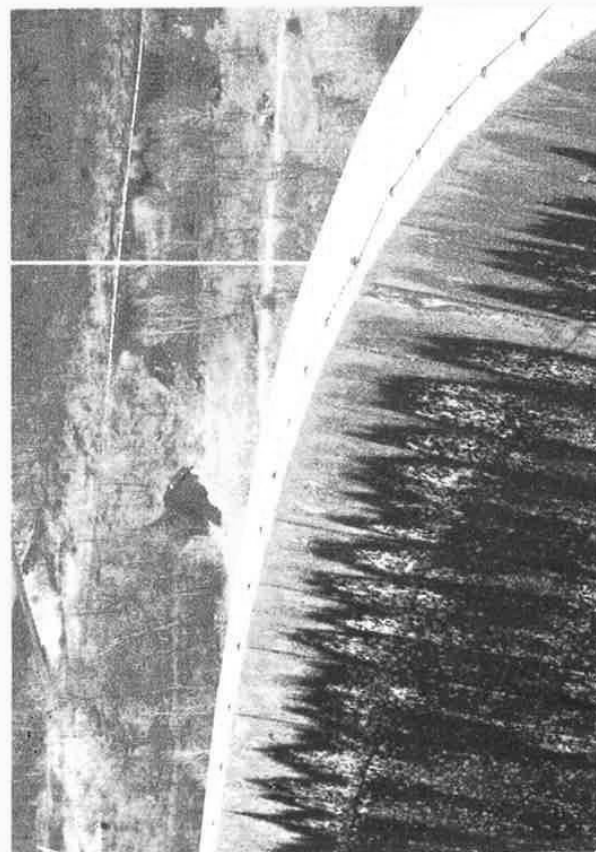
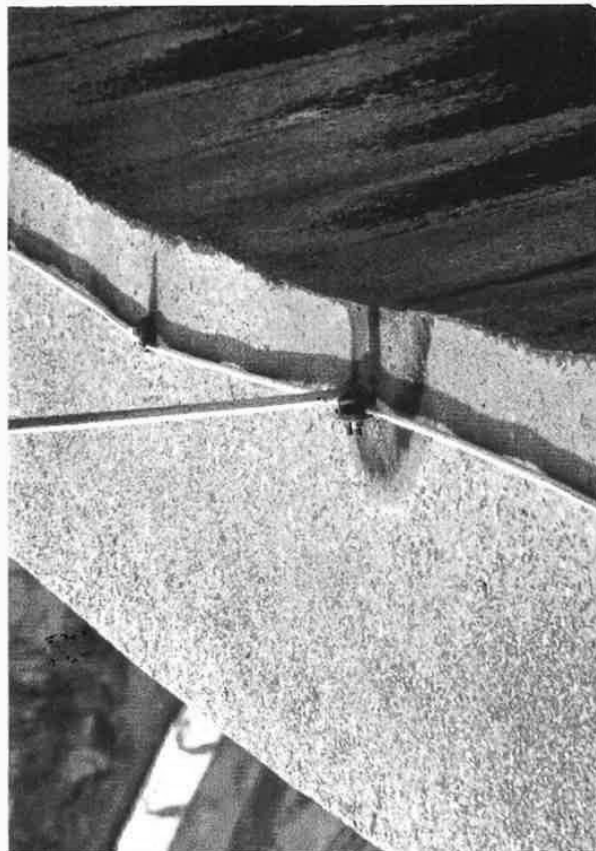
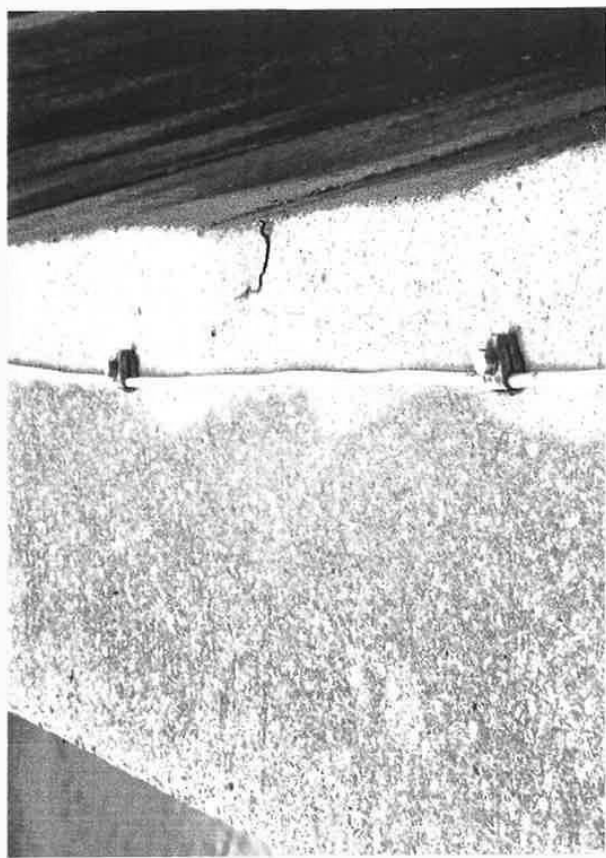
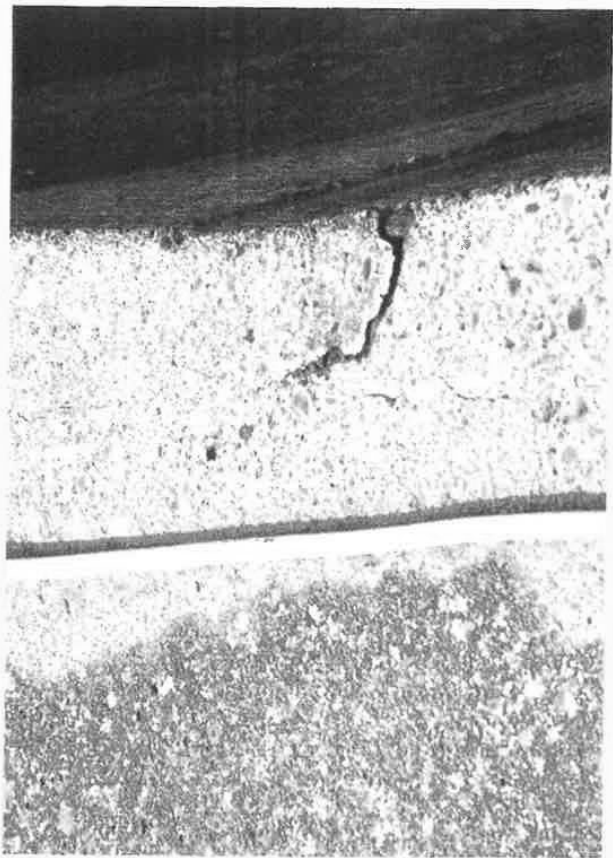
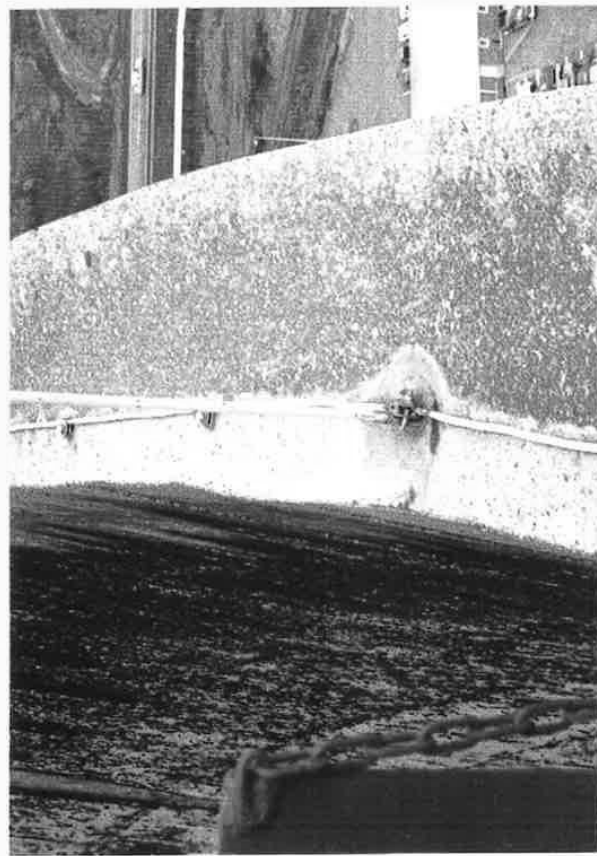
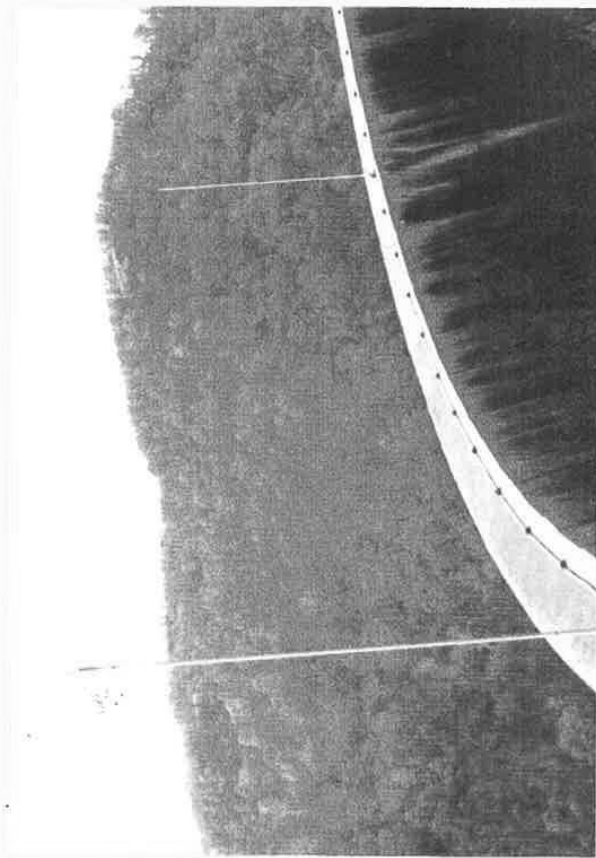
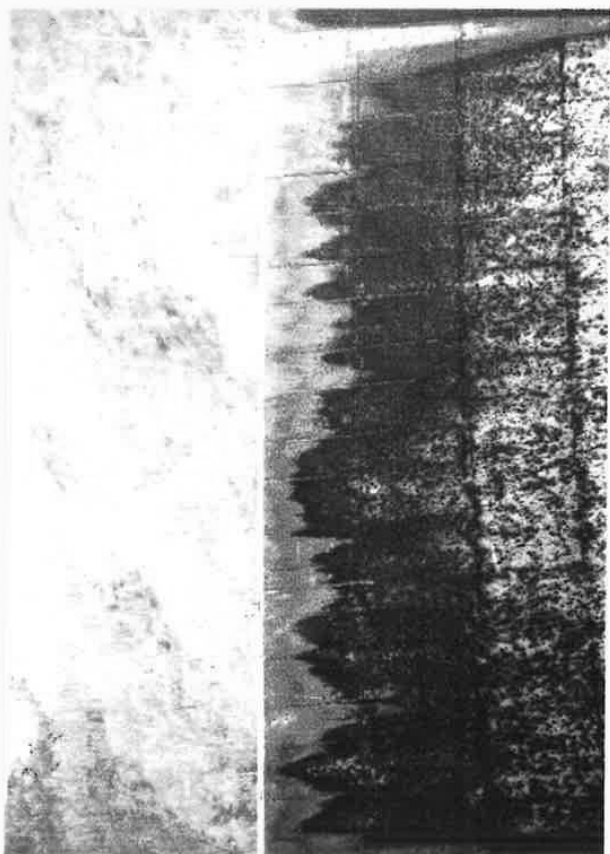
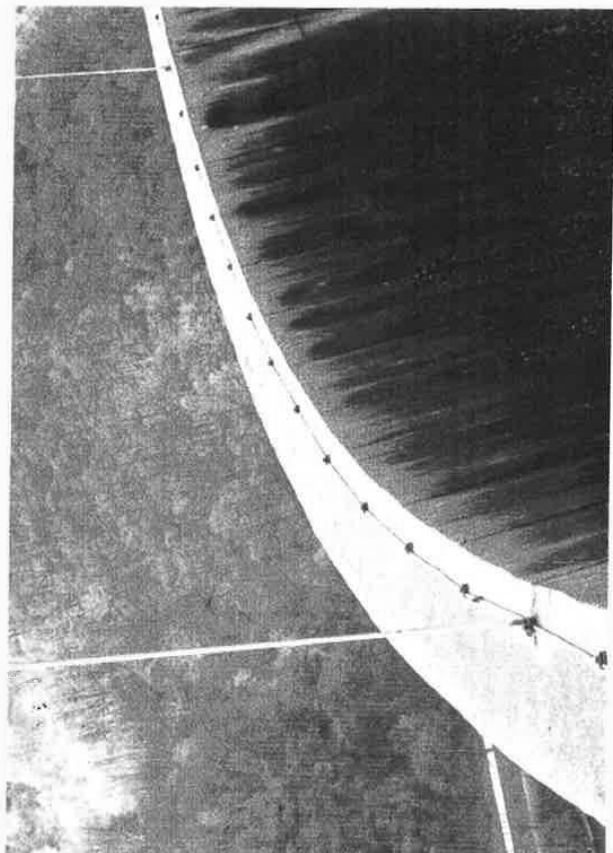
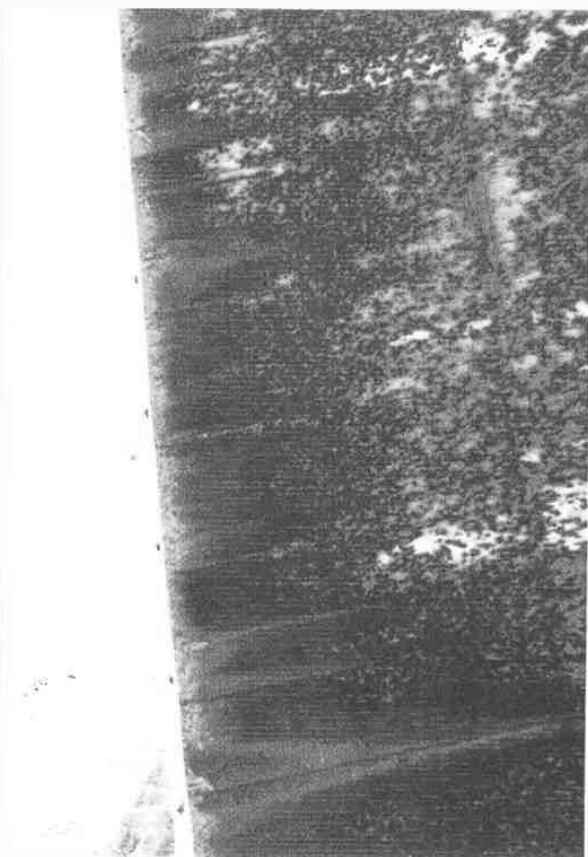
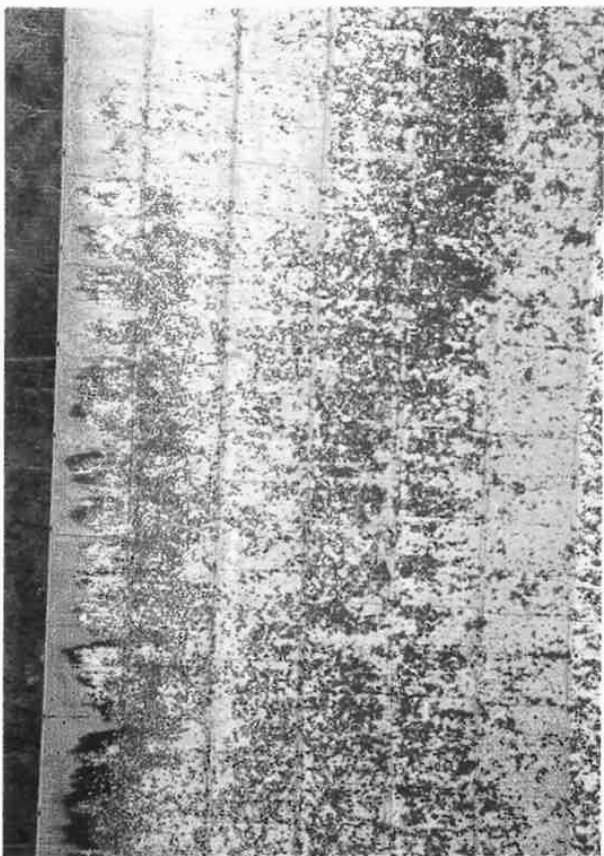
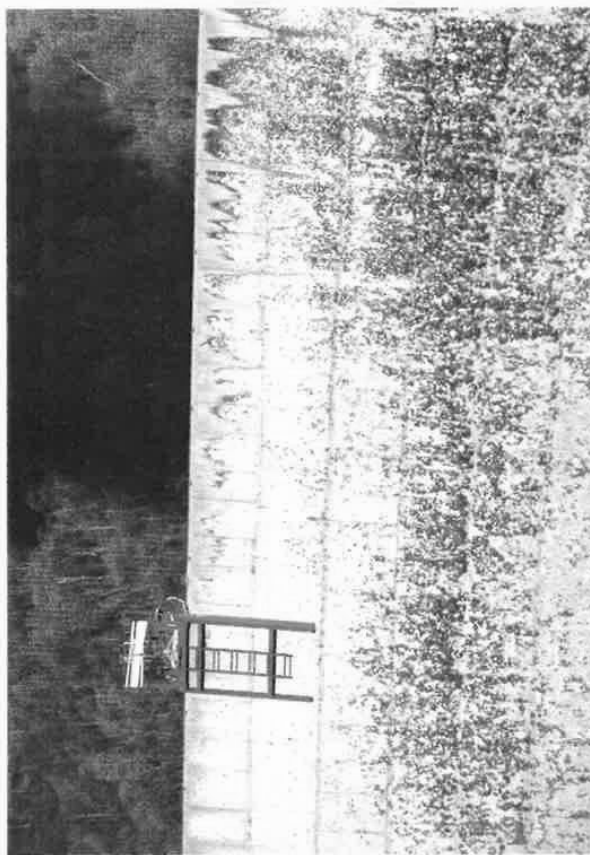
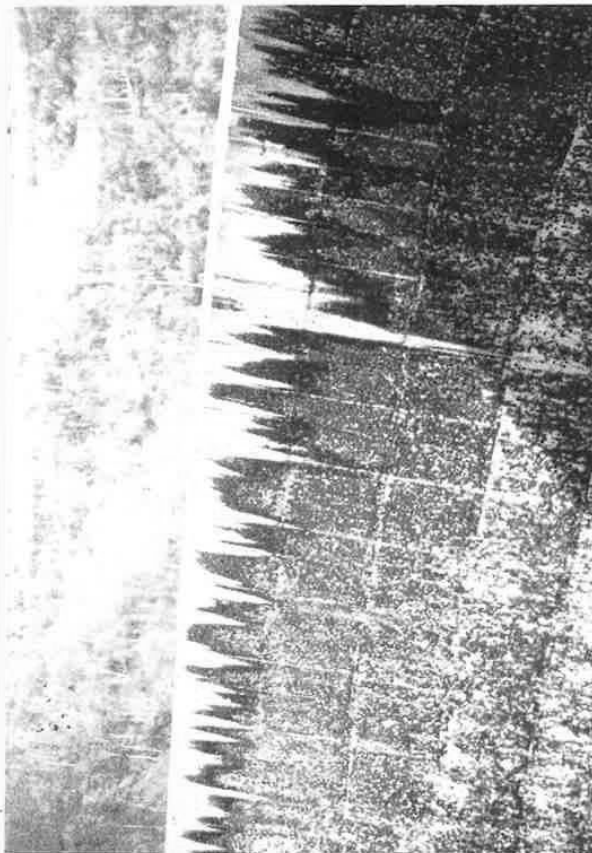
Photographs no. 1 - 22 were taken at the top of the shell and give views of the uppermost five (5) lifts of the tower plus the cornice beam and lightning protection system. As seen in the photographs, the lightning protection air terminals and encircling cable appear to be continuous. However, more information relative to the initial installation/design is required to provide statement as to grounding capabilities. Note the extent of algae growth for this portion of the shell. One (1) spall in the top of the cornice was noted as shown in Photographs no. 13 and 14.

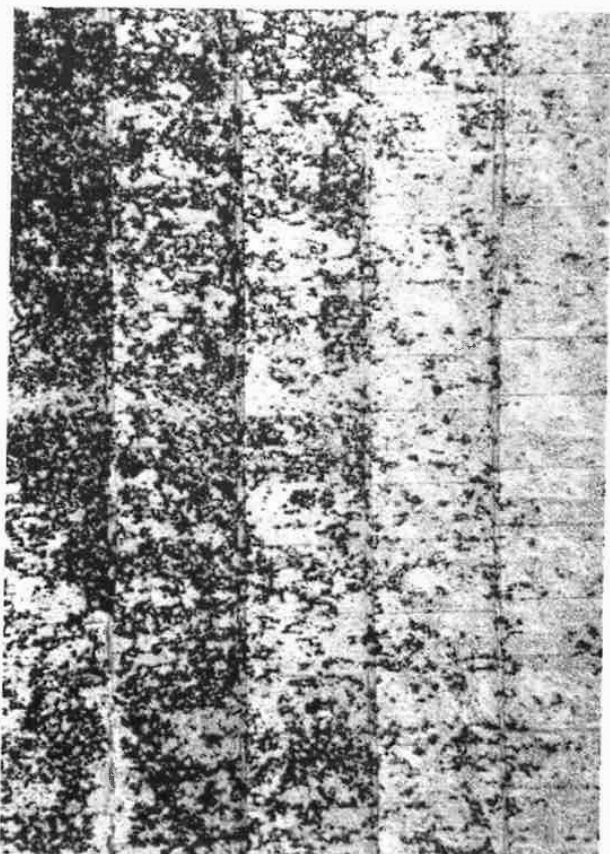
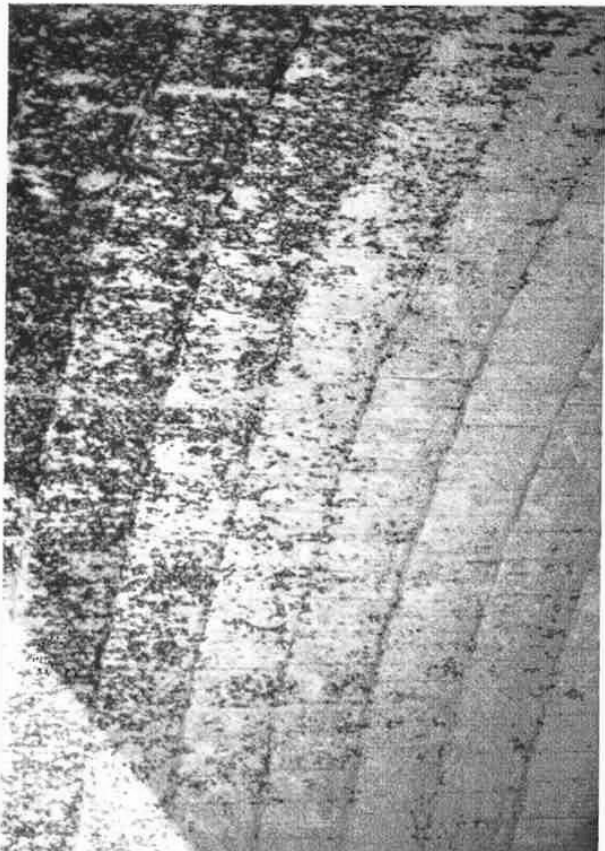
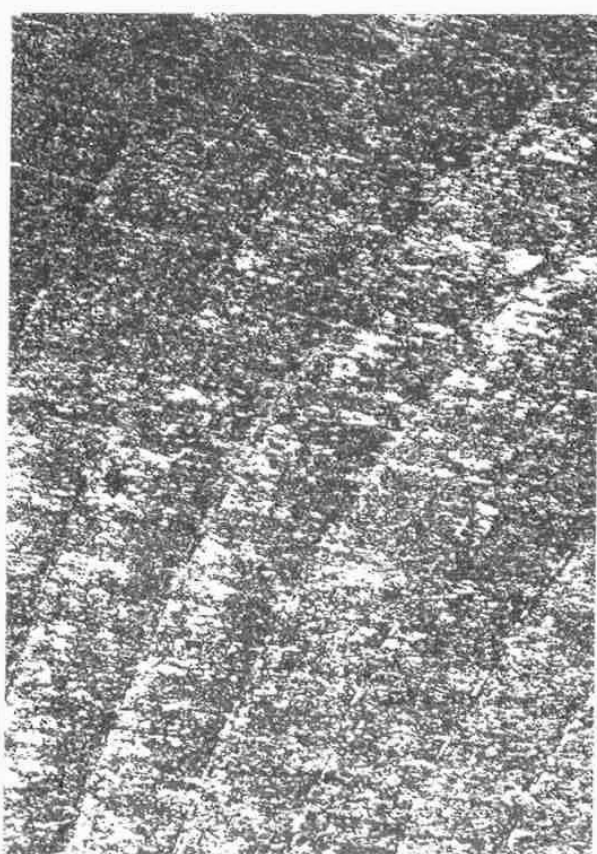
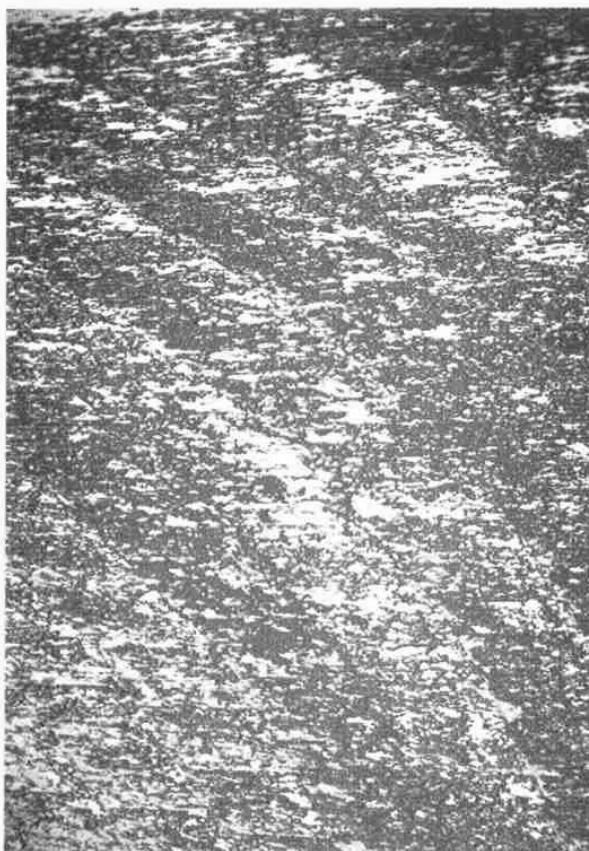
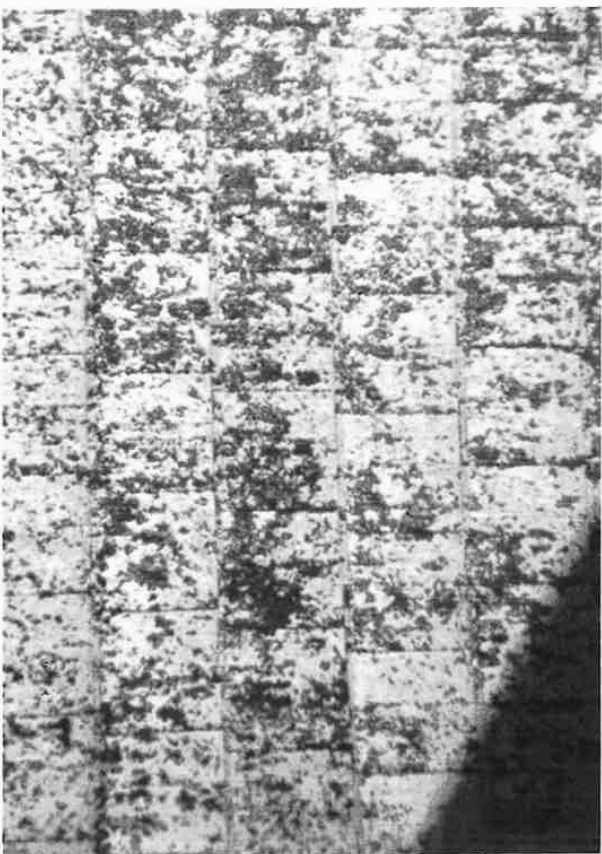
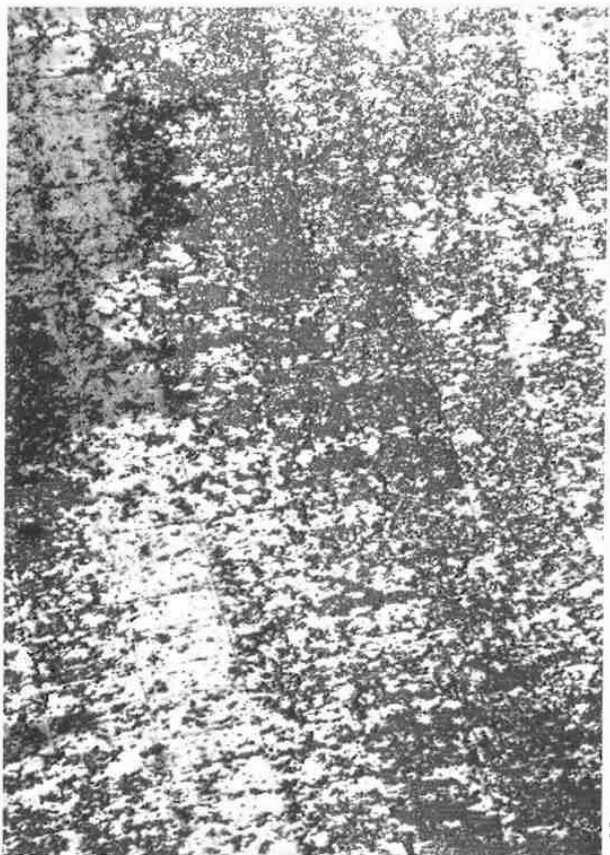
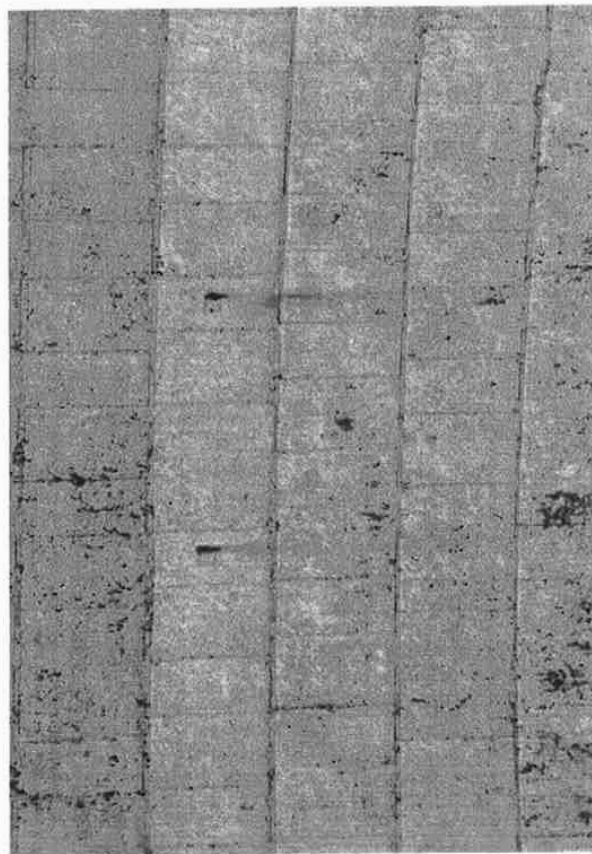
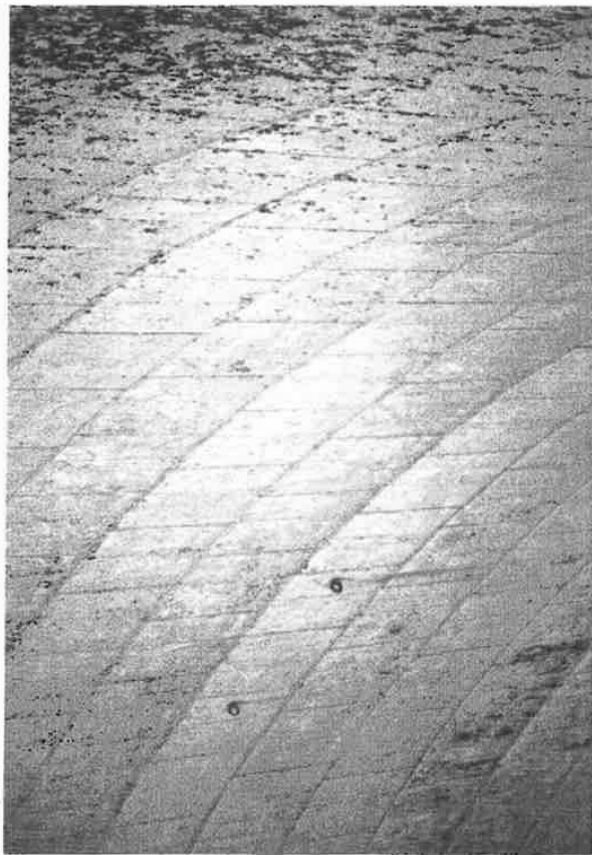
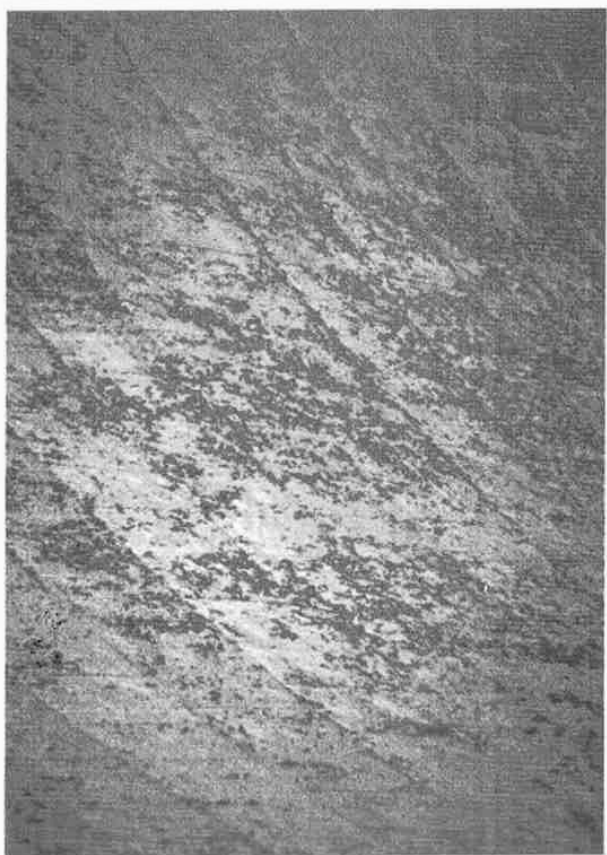
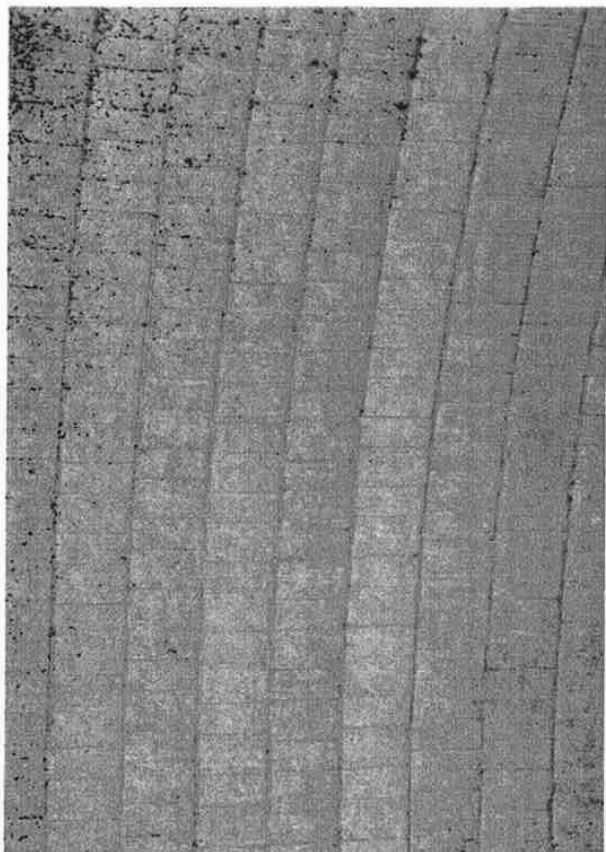
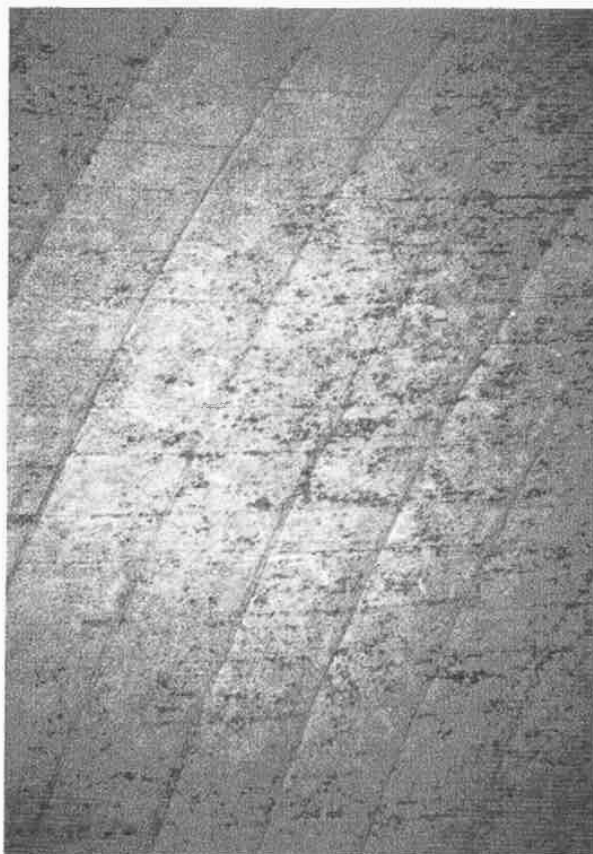
Photographs no. 23 - 27, also taken from the top of the shell, provide documentation from lifts no. 5 - 16. Again note the extent of algae growth, photographs no. 36 and 37 at radials 209 and 210 give close up views of this growth. Photographs no. 29 and 30 show existing construction embedments and were secured to provide information as to relative rust staining from continuously exposed carbon steel. Although difficult to see in Photograph no. 32, a total of eight (8) rock pockets were noted at the bottom of lifts no. 7, 9, 10 and 12 in the relative west quadrant.

<u>Photograph No.</u>	<u>Location</u>
31	Lifts 5 - 12, Southeast
32	Lifts 6 - 14, West
33	Lifts 10 - 16, Northwest
34	Below Lift 12, Southeast
35	Below Lift 12, West
36	Algae Close Up, Radial 209
37	Algae Close Up, Radial 210
38	Bottom, North
39	Bottom, Northeast
40	Bottom, South
41	Bottom, Southwest
42	Bottom, Southwest
43	Bottom, West

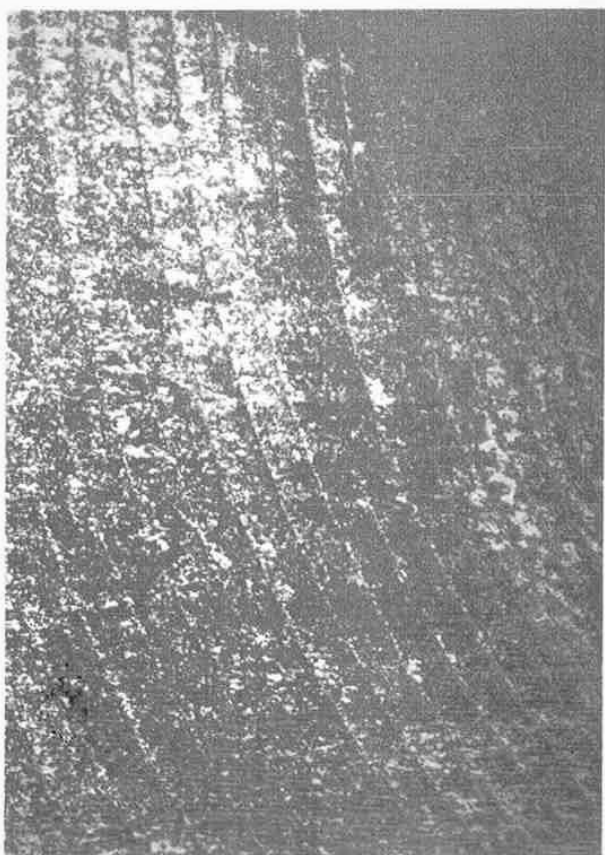
Photographs no. 38 - 43 show the X-brace supports and bottom of the shell. These photographs were taken from the cornice and no defects were noted from that vantage point.

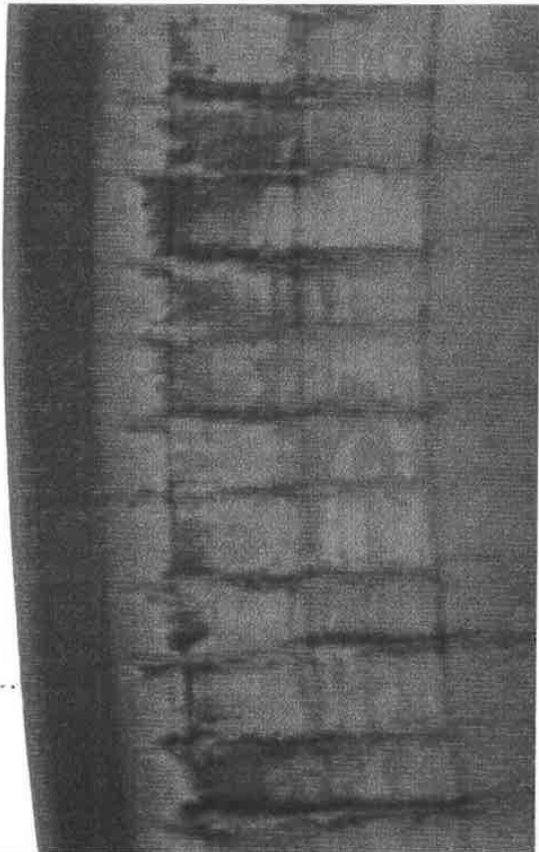
48

Photographs no. 47 - 50 show the condition at the top four (4) construction lifts. The staining for most of this area appears to stem from condensation of the exiting plume while the unit is in operation, however, the east face (photograph no. 50) exhibits weeping at the bottom of lift no. 1 and resultant efflorescence deposits.

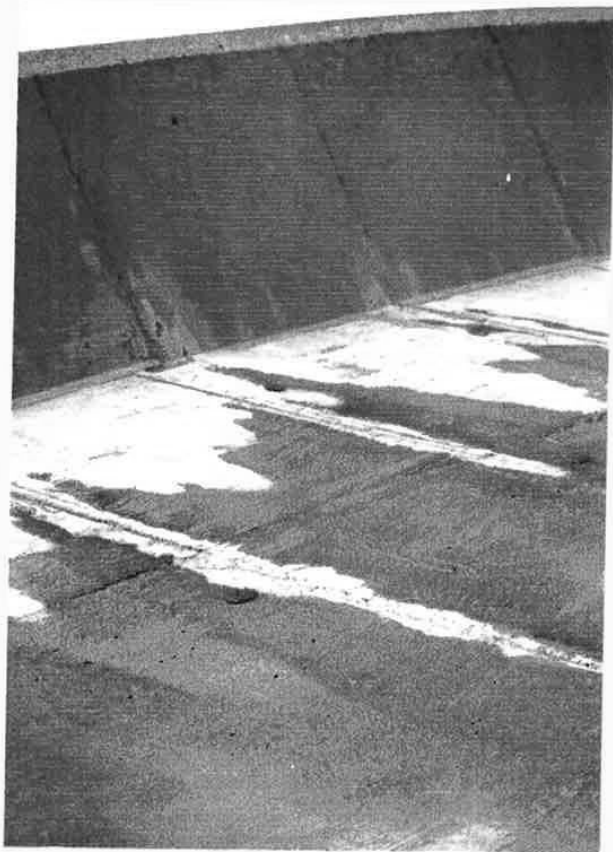
52

Photographs no. 51 - 69 document the present condition of lifts 1 - 5. Defects noted range from loosened wall tie plugs as seen in photograph no. 52, several cracks of which either stem from wall tie plugs or correlate to construction joints as seen in photographs no. 56, 57, 58, 64, 65, 68 and 69. Several open lift joints and resultant efflorescence are visible in the remainder of this set of photographs.

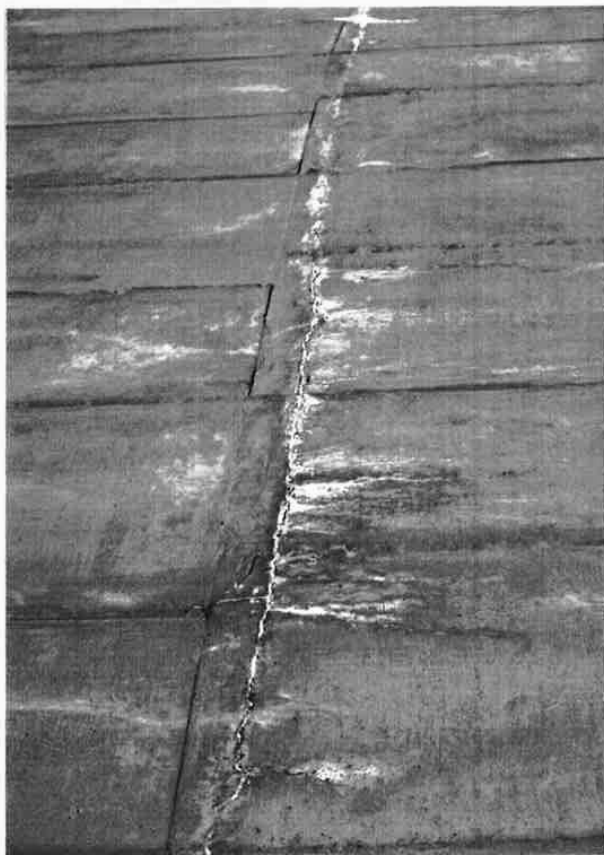
71

Lifts no. 6 - 11 exhibit additional joint weepage and some cracking such as vertical or along construction joints and pop-outs from wall tie areas as seen in photographs no. 70 - 84. It appears that during construction of the shell after the forms were raised, the entire exterior surface was finished in a manner such as sacking. Note debonding of the sacking as shown in photograph no. 83.

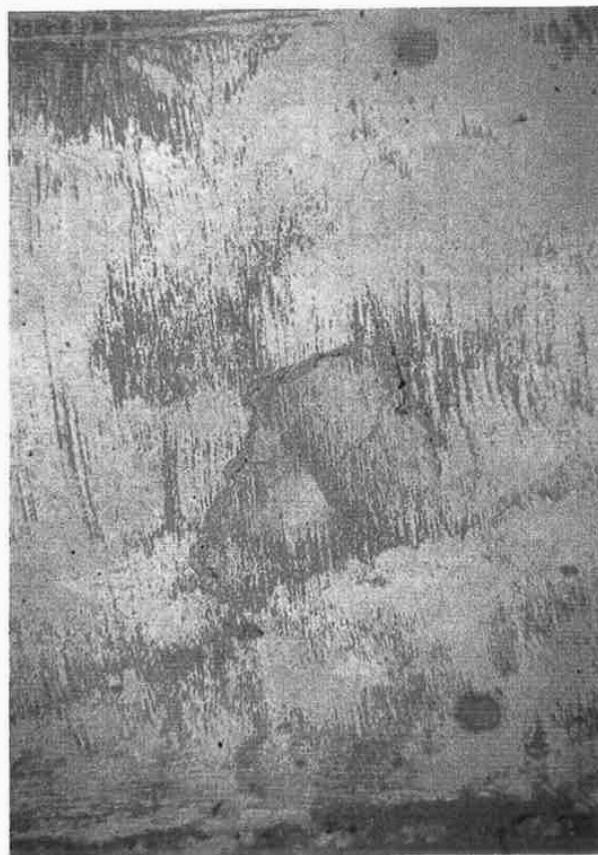
Photographs no. 121 - 149 include lifts no. 25 - 33 and noted conditions are as follows: cracking was observed in these areas from all four (4) drop zones; photograph no. 122 shows the beginning of spalled area; photograph no. 150 shows a spalled area with rust stain stemming from the exposed aggregate; a notable leaking joint with efflorescence stain and exposed aggregate can be seen in photographs no. 129 and 130; a diagonal leaking cold joint with rock pocket is seen in photograph no. 137; photograph no. 138 is a leaking joint with rock pockets and moss growth apparently stemming from silt accumulation within the joint.

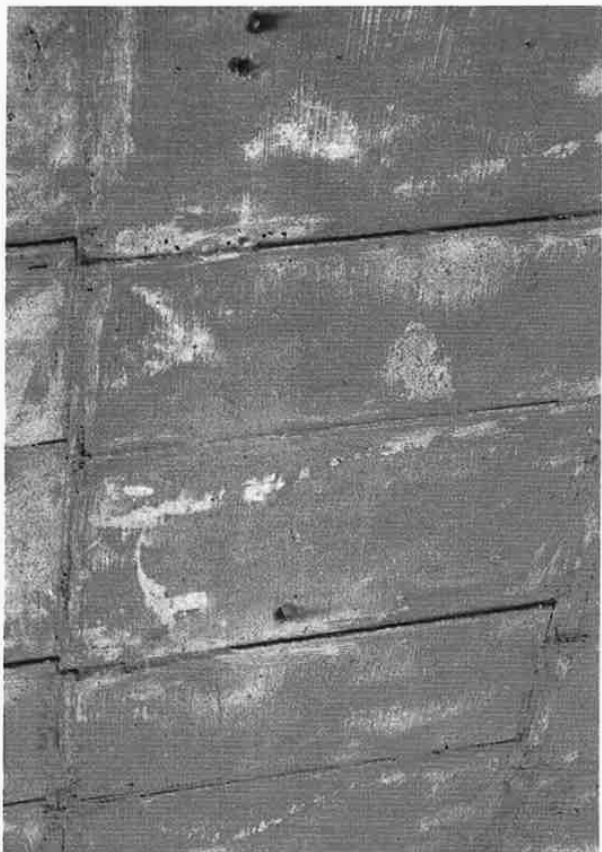
Lifts no. 34 - 43 exhibit the same typical defects with severity similar to the proceeding lifts as stated above. Photographs no. 150 - 185 document these typical defects such as: weeping joints and resultant efflorescence deposits, moss formation, open joints/rock pockets, rust stemming from aggregate or construction wall ties and spalls. Photograph no. 160 is an example of rusting aggregate as opposed to a wall tie, note the spalling area in the top center of the photograph. The rust bleeding from this area appears to be from aggregate, not a wall tie, because of the close proximity of the wall tie plug to its immediate left. Suspected patched rock pocket areas can be seen in photographs no. 154, 170, 179 and 185 in which it appears that portions of a patch has spalled off exposing an open joint/rock pocket.

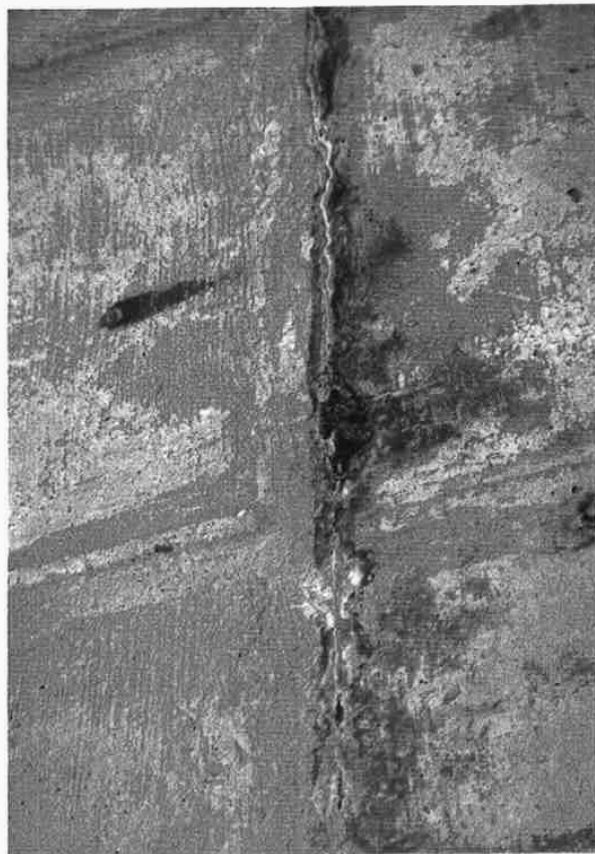
204

Lifts no. 53 - 60, shown in photographs no. 203 - 226, exhibit an increase in moss formation at the open joints/rock pockets. Also observed was additional signs of apparent silt accumulation within the open construction joints.
