Kentucky Power Company
KPSC Case No. 2026-00001
Commission Staff's First Set of Data Requests
Dated March 19, 2026

**AMERICAN ELECTRIC POWER SERVICE CORPORATION
OHIO POWER COMPANY
MITCHELL PLANT, UNIT NO. 1
MOUNDSVILLE, WEST VIRGINIA**

**Report
for
Inspection of 370'-0" High
Reinforced Concrete Cooling Tower**

American Electric Power Service Corporation
Ohio Power Company
Service Order B-6858
March 12, 1990

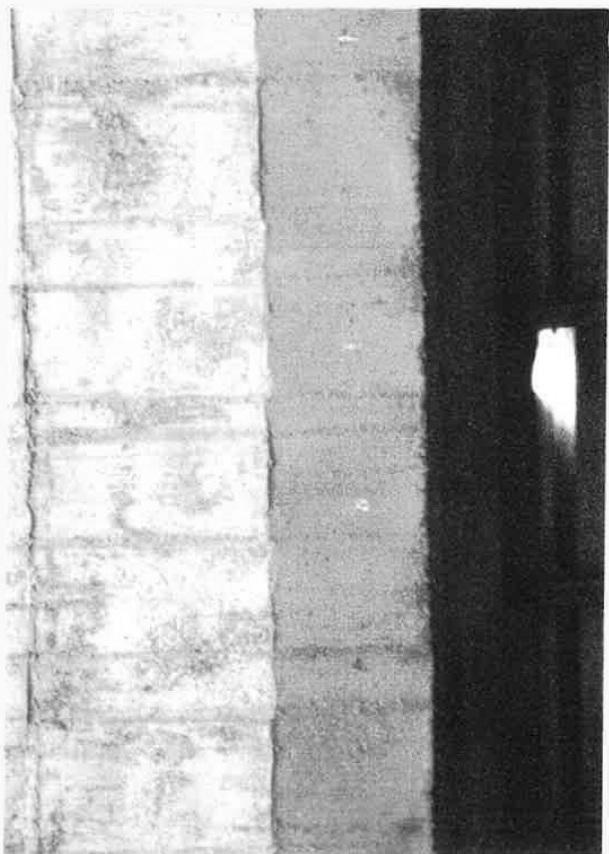
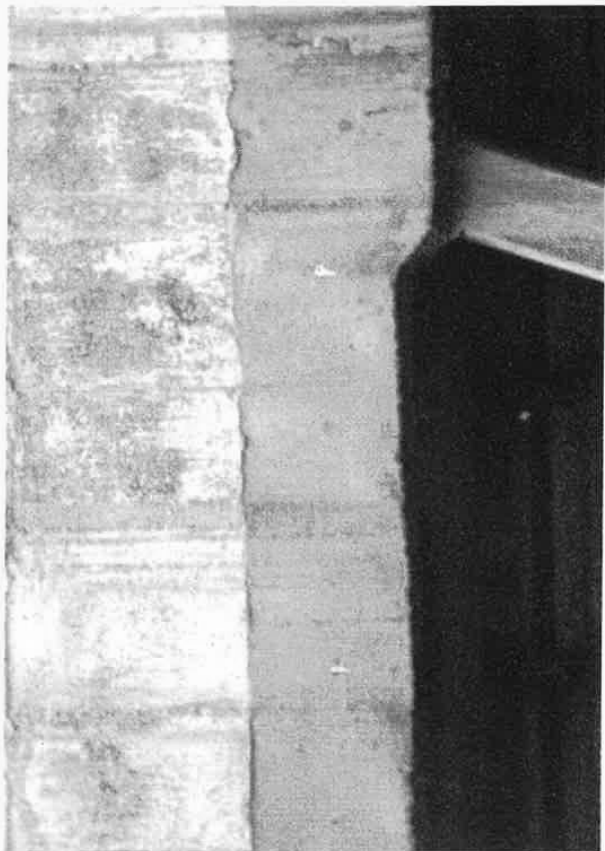
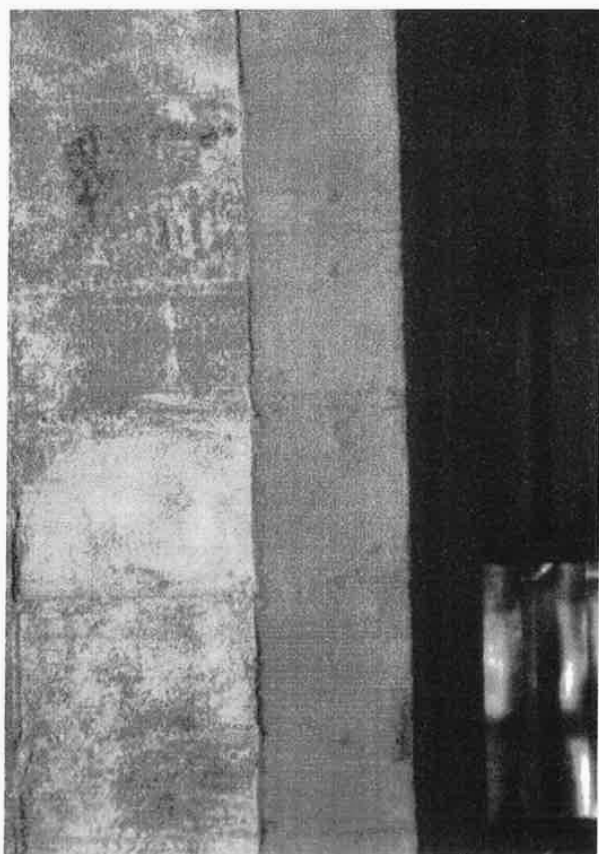
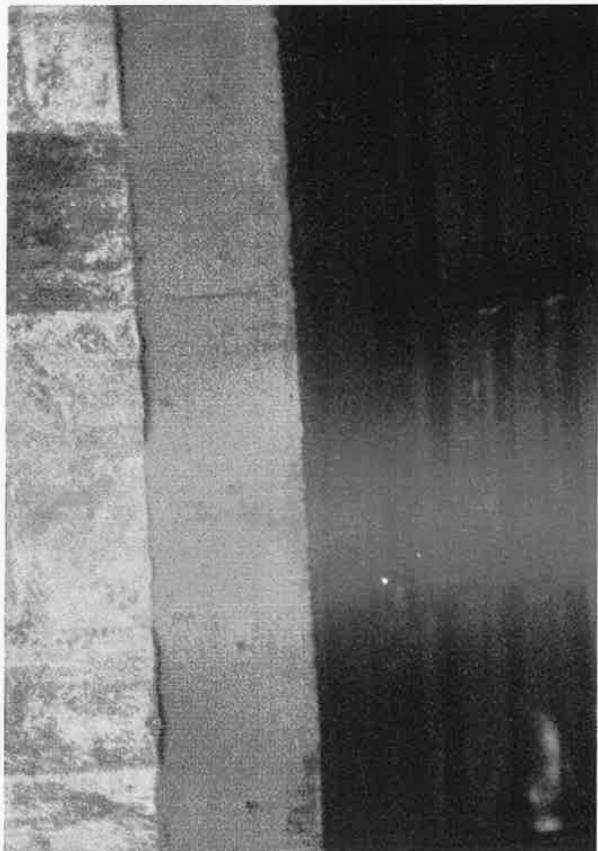
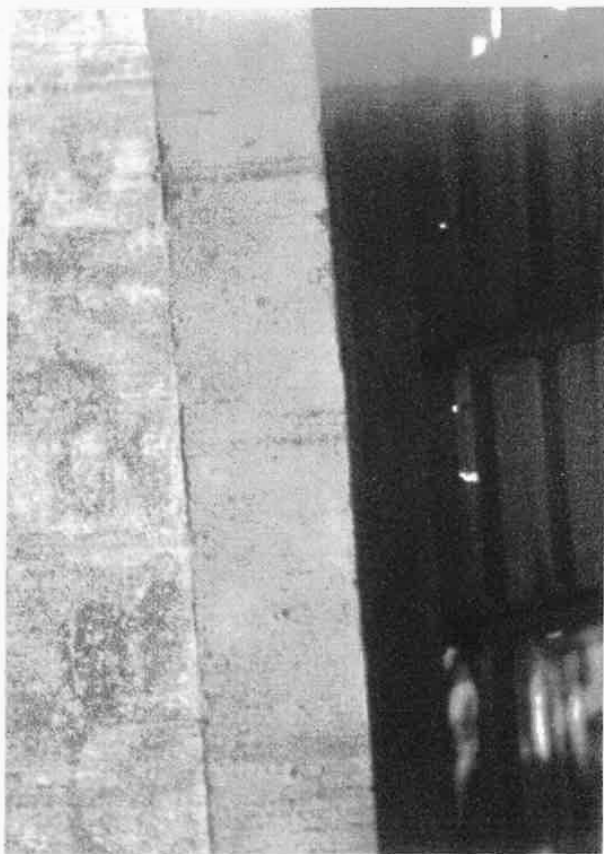
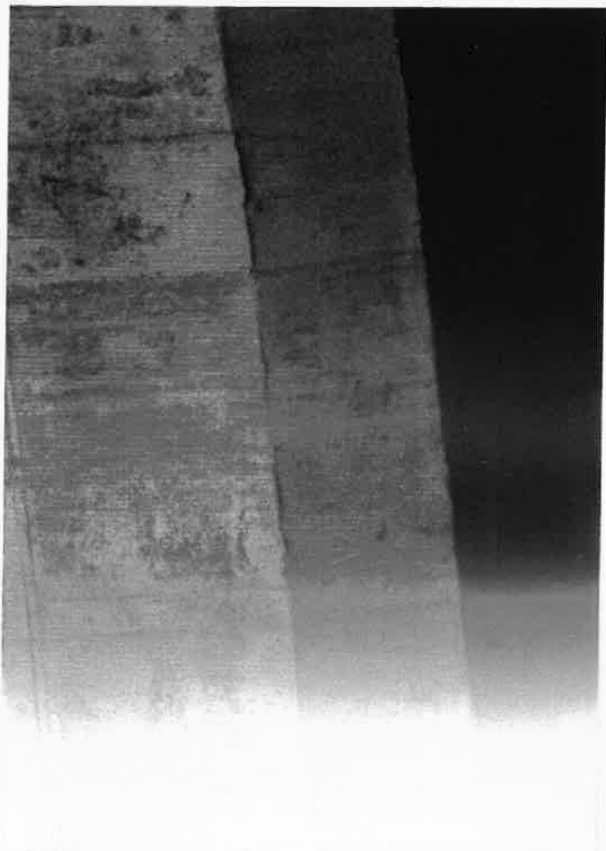
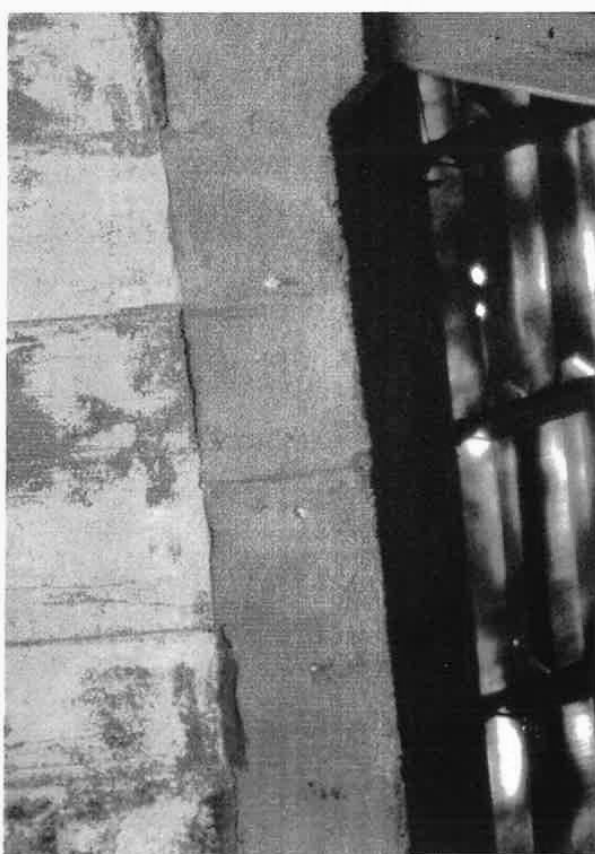
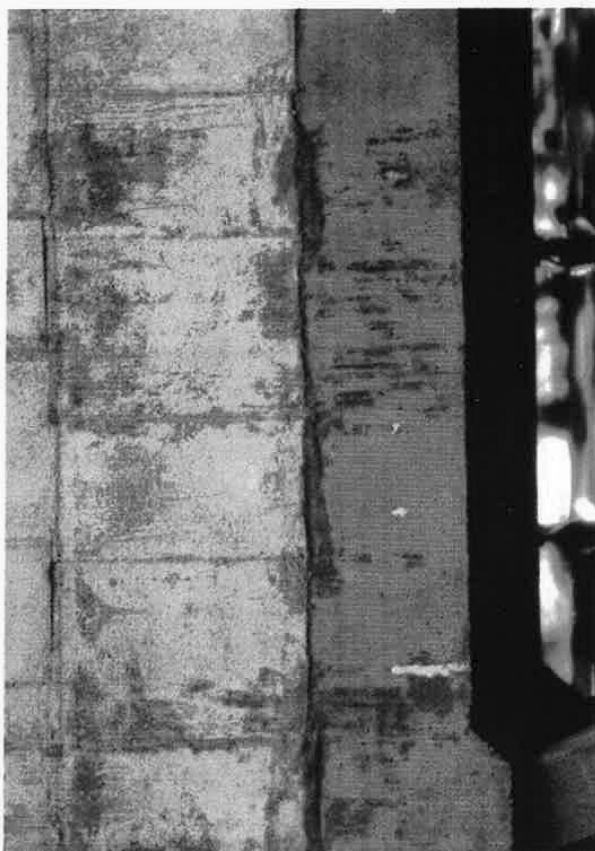
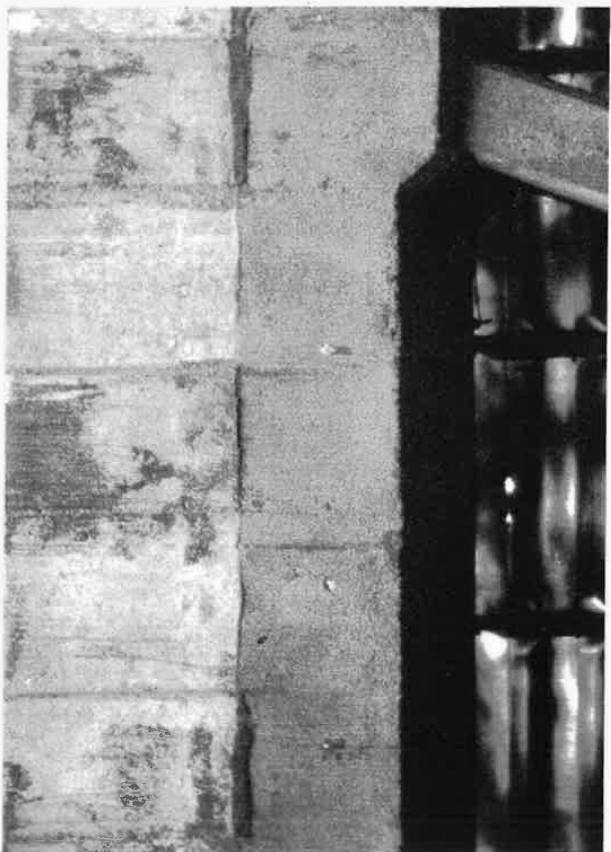
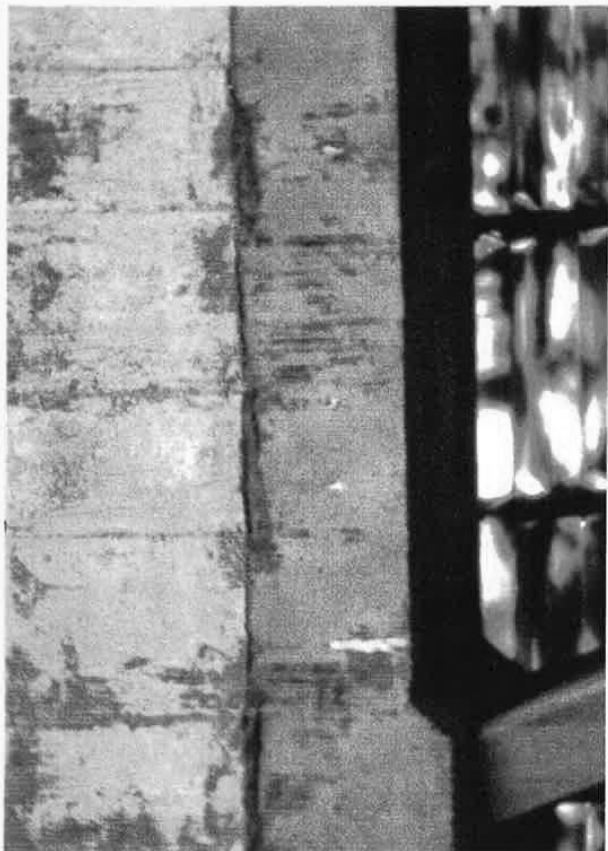
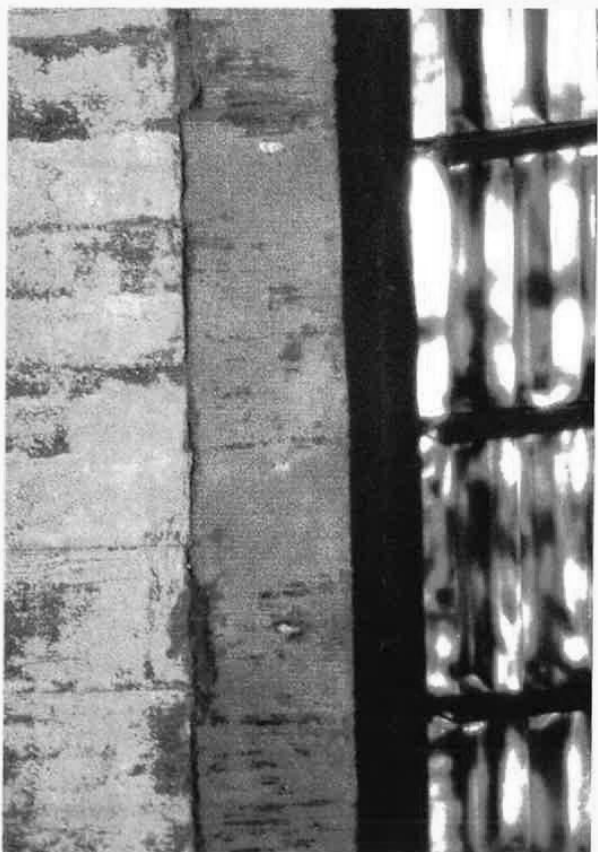
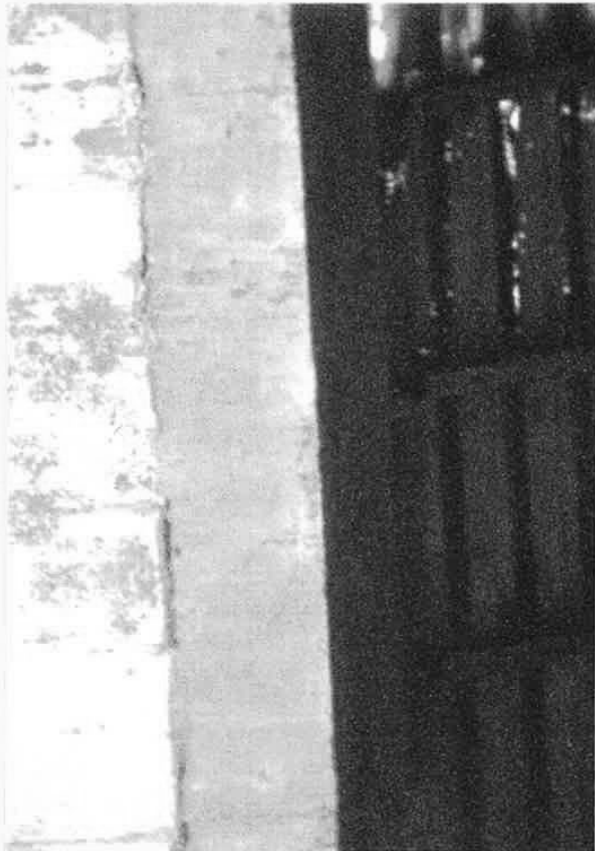
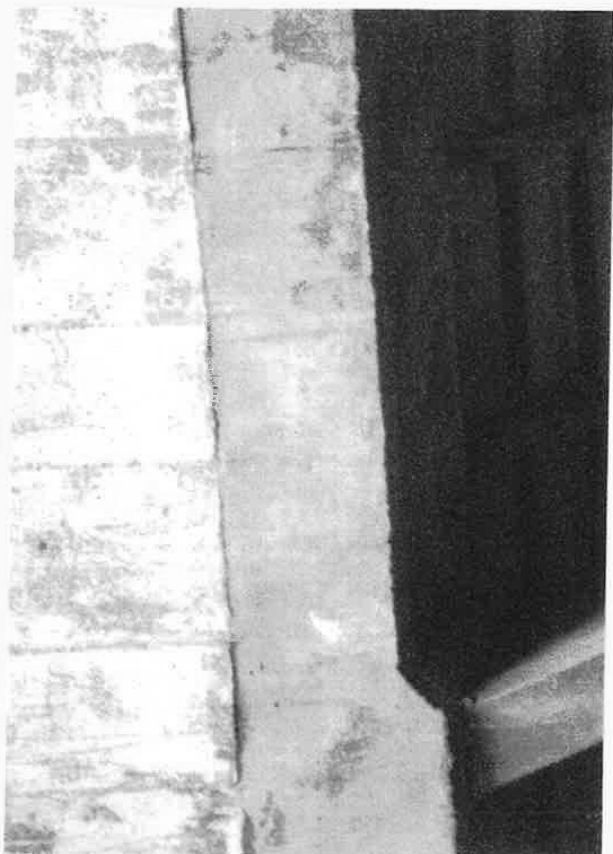
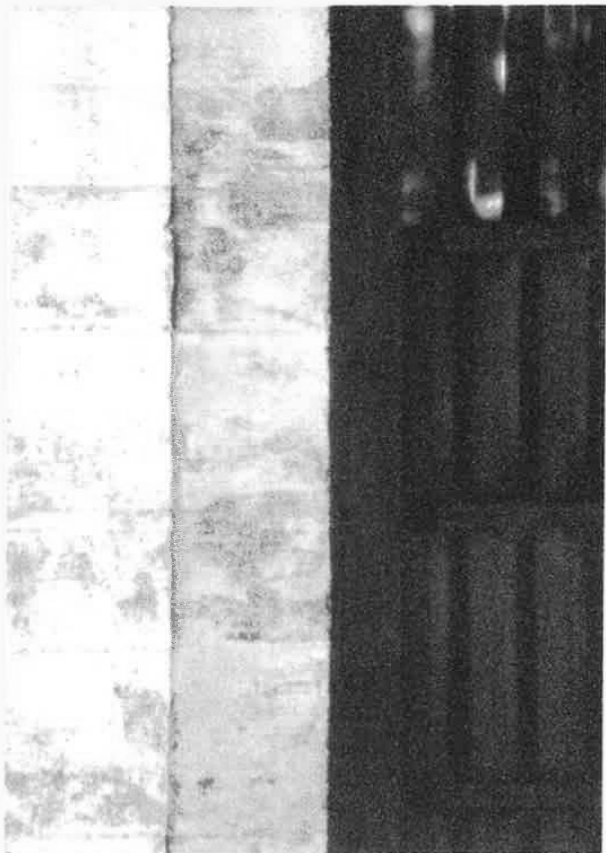
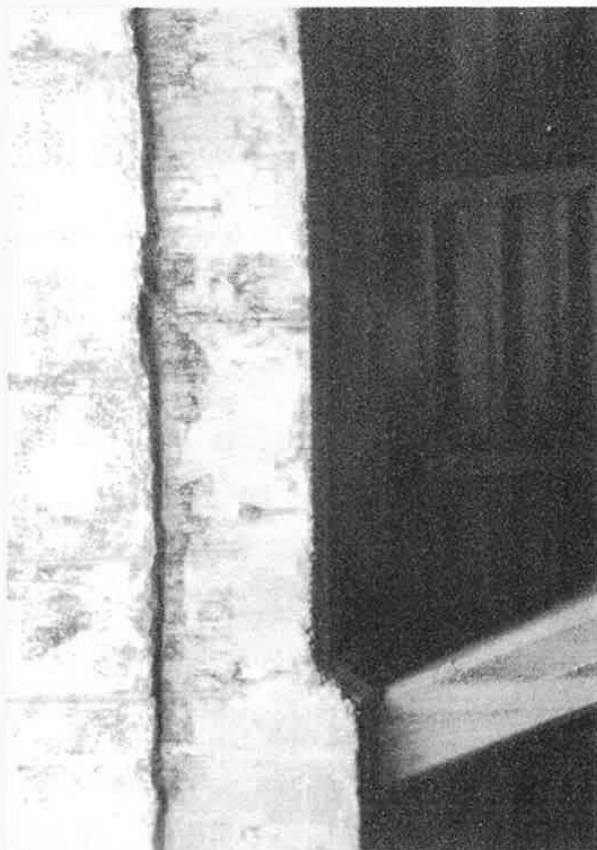
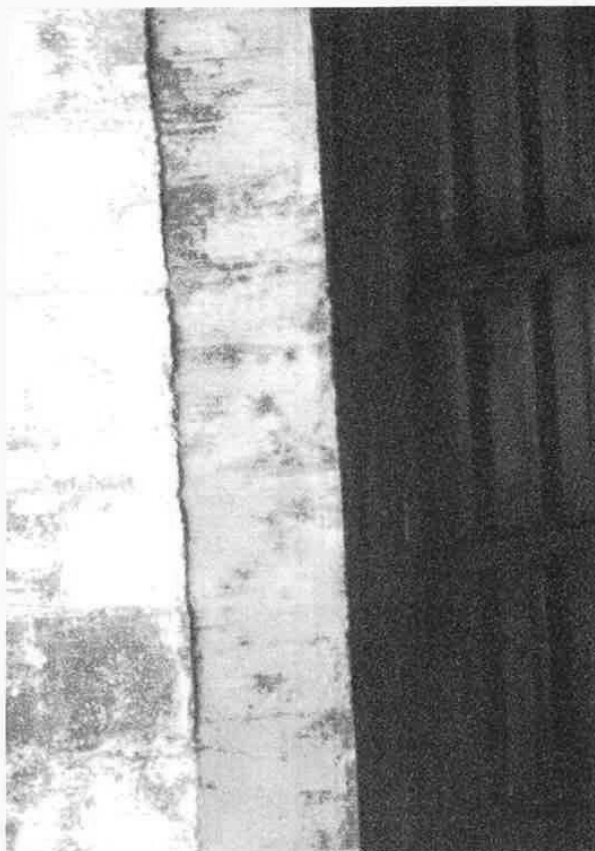
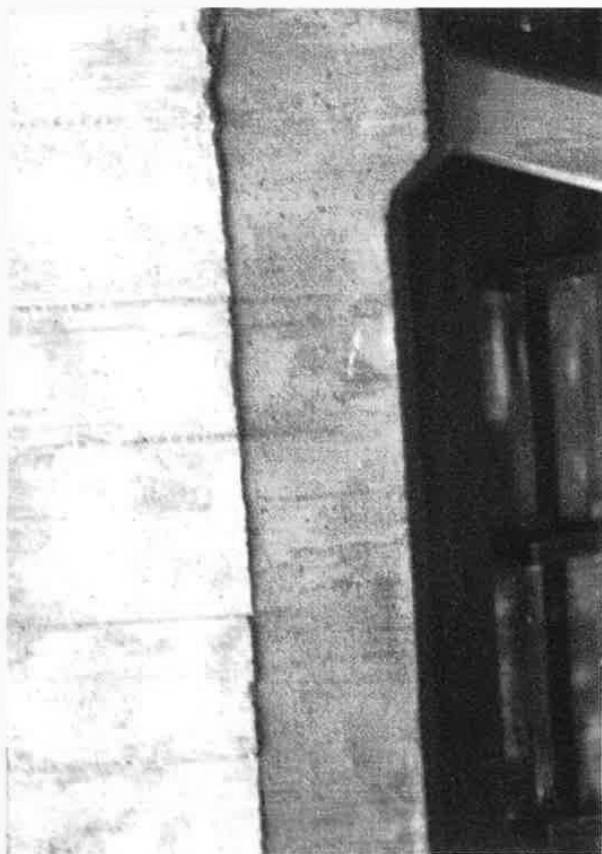
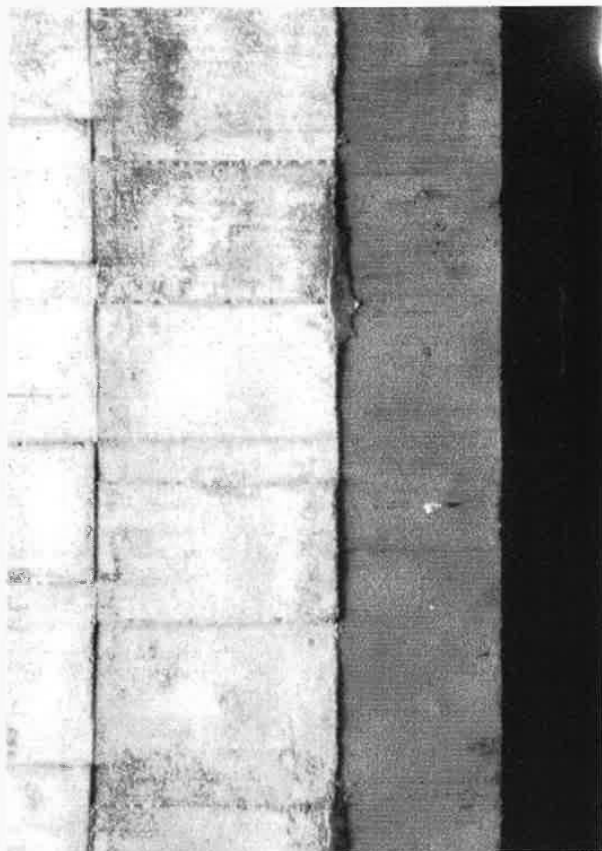
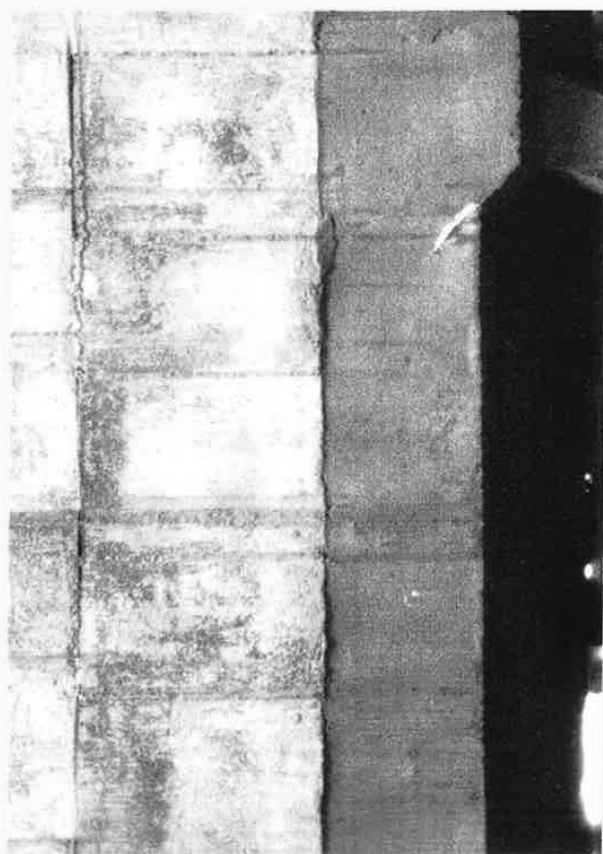
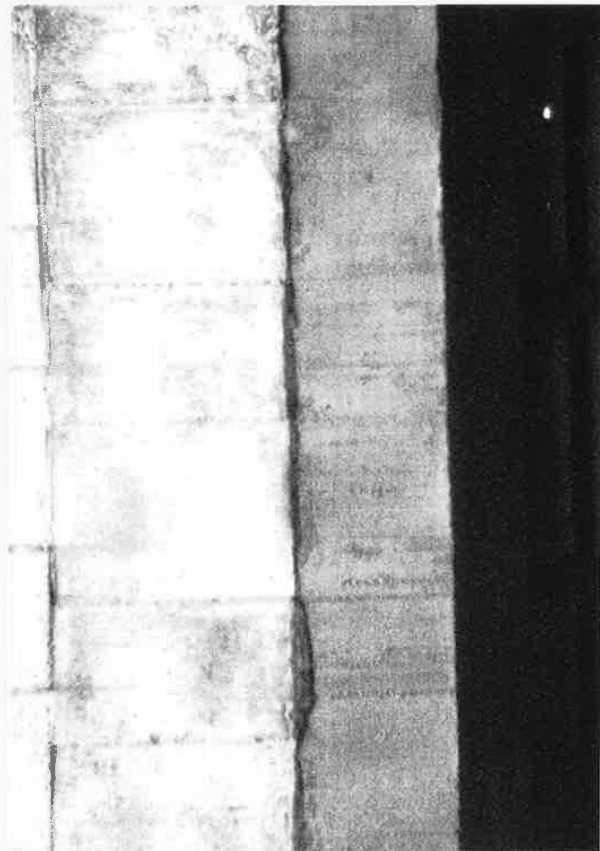
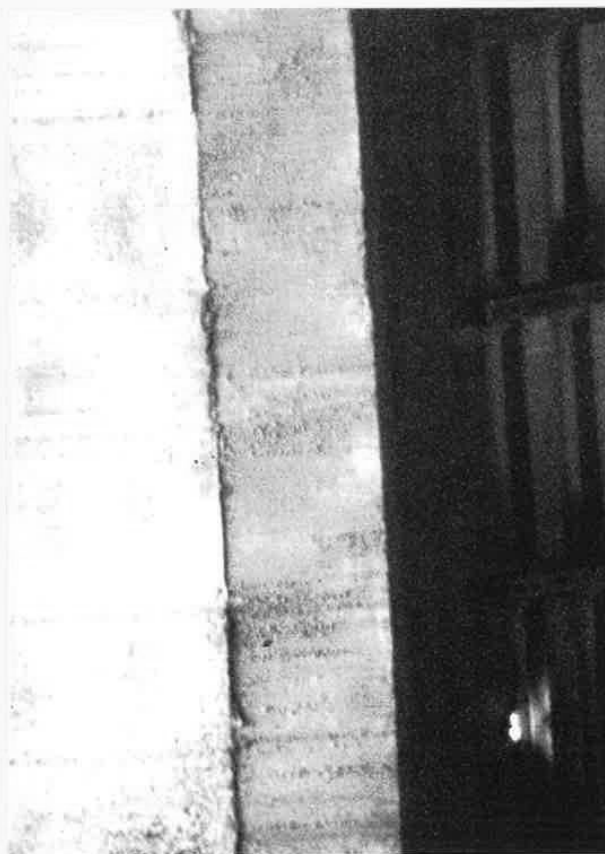
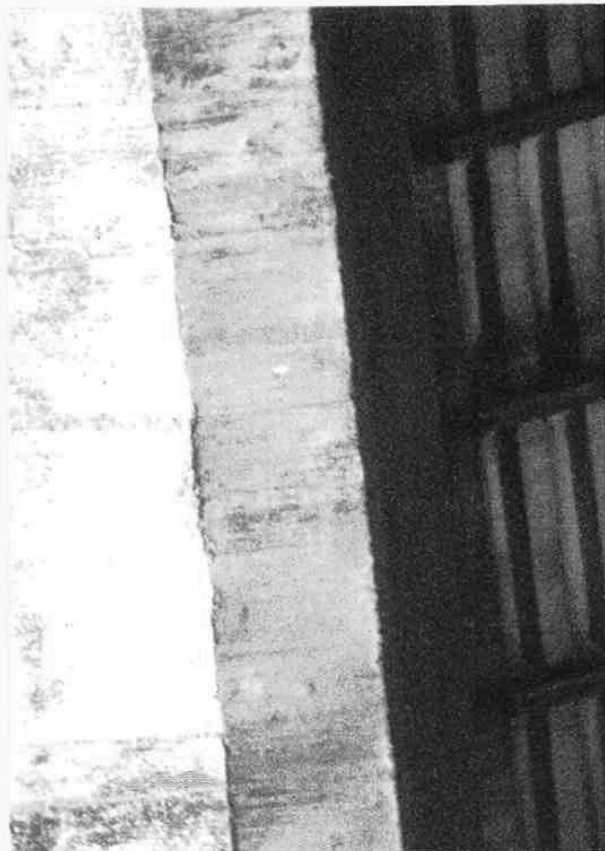
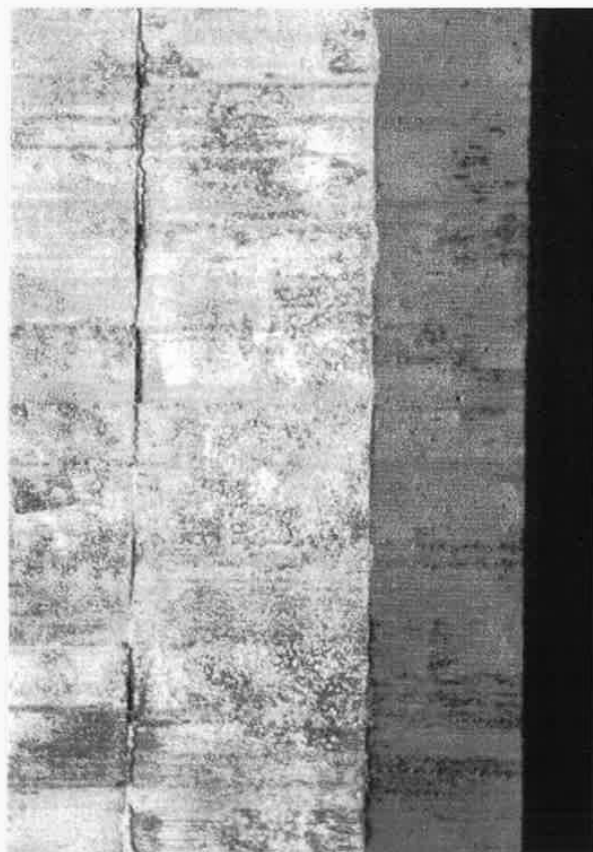
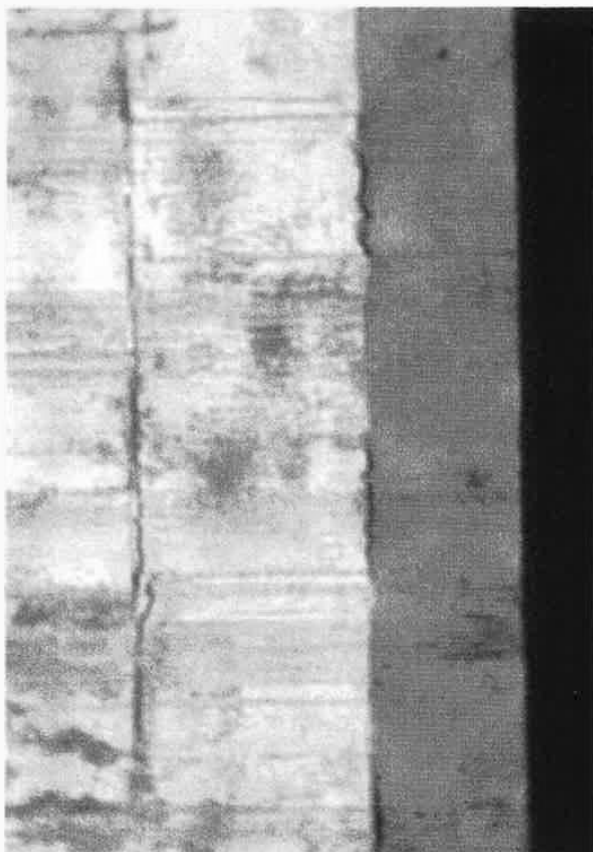
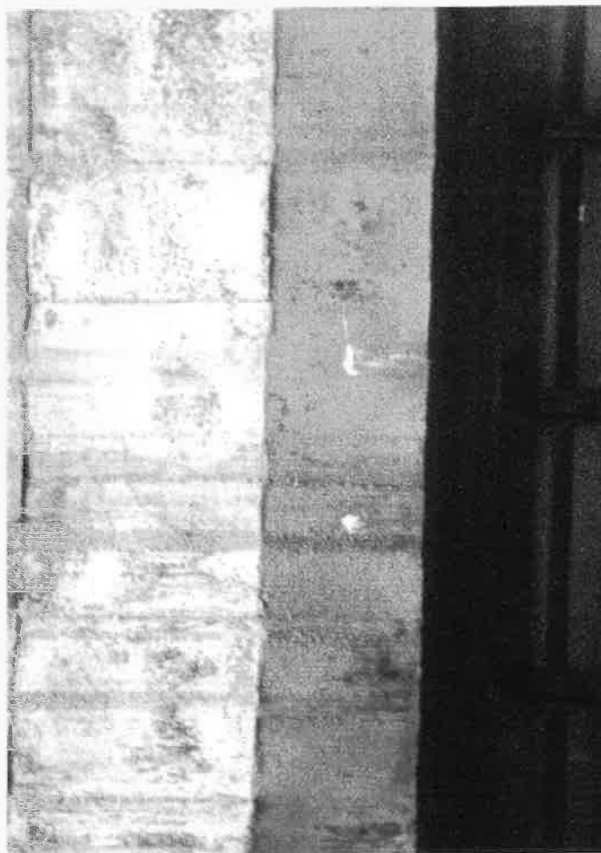
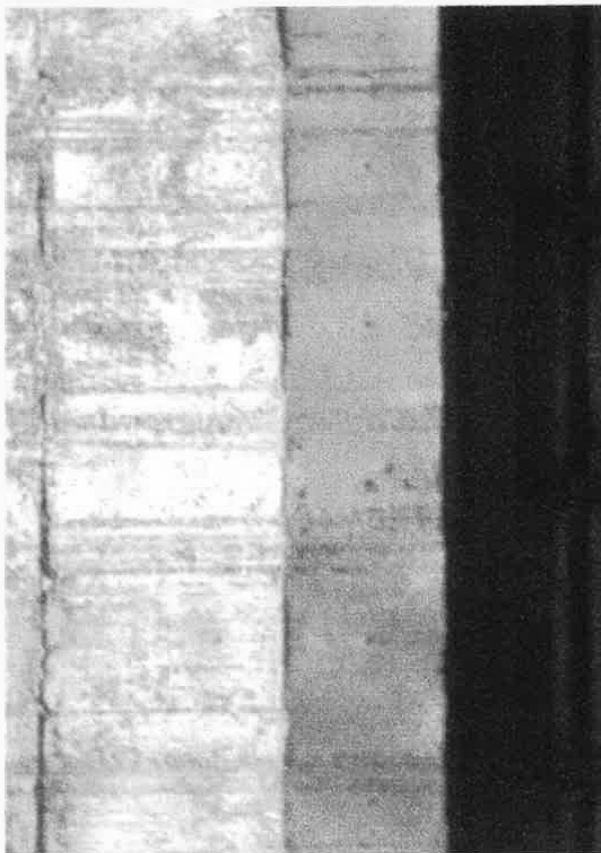
Photographs no. 324 - 353 document typical conditions of the 32 lintel beam segment areas secured from the cold water basin within the tower. The bottom portion of the lintel beam shows signs of erosion and exposed aggregate exemplified by photographs no. 324, 332, 336 and 338. Noted cracks in lintel are as follows: segment no. 1, photograph no. 325, exhibits a crack in the thickened portion of the lintel beam between the X-braces at the far right of the photograph; segment no. 14 has a reported crack stemming from a wall tie located just left of center in photograph no. 333; segment no. 15 exhibits a crack the full height of the lintel area shown just right of center in photograph no. 334; segment no. 22 has a reported crack that begins at the top of the lintel and extends vertically for one-half its height (photograph no. 341); segment no. 24 exhibits a crack in the thickened portion at the far right in photograph no. 344 and segment no. 26 exhibits a notable crack with efflorescence deposits as shown in photograph no. 346. Lintel beam segment areas no. 6 - 10 are not represented in this report by photographs due to film damage, however, the areas were reported to be relatively free from notable defects with exception to segment no. 9 which has a reported small, hairline crack. Also noted was the efflorescence deposits stemming from the wall tie areas as seen in most of this set of photographs.

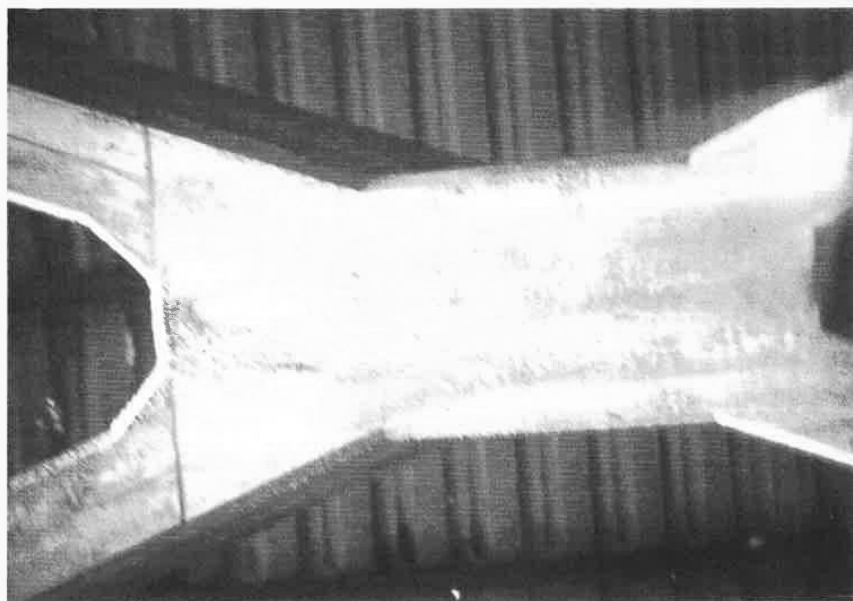
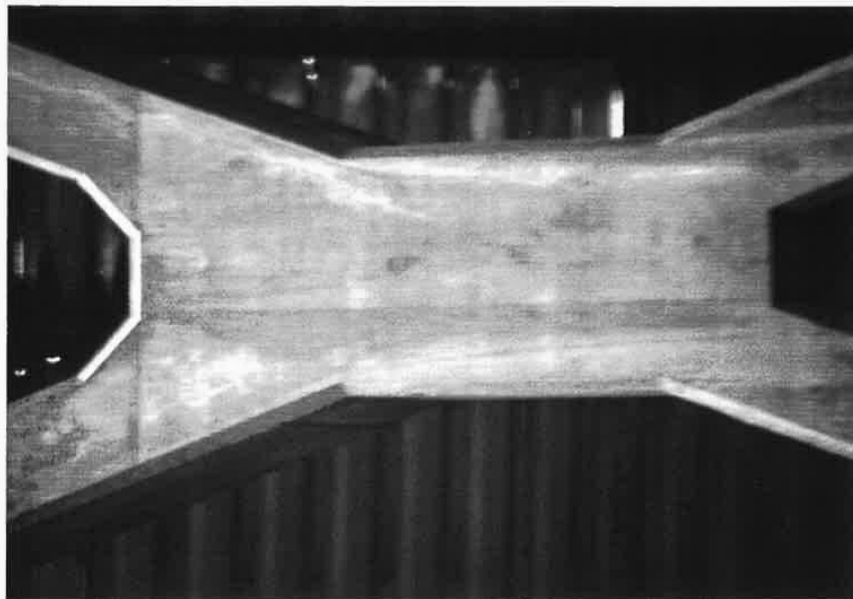
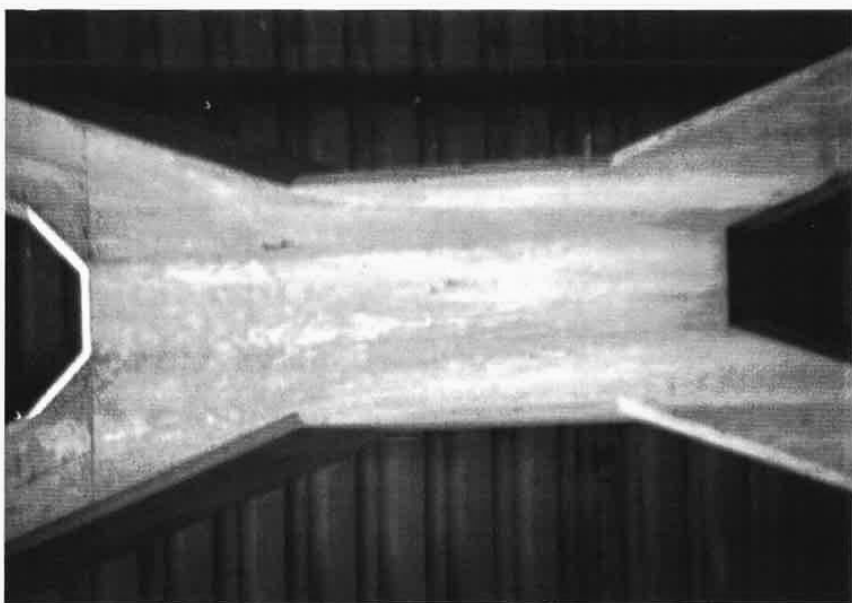
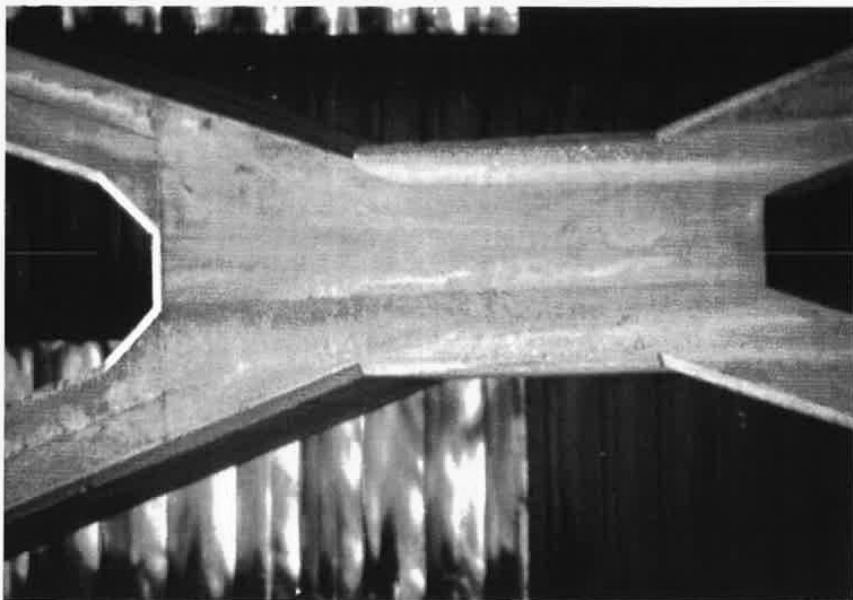
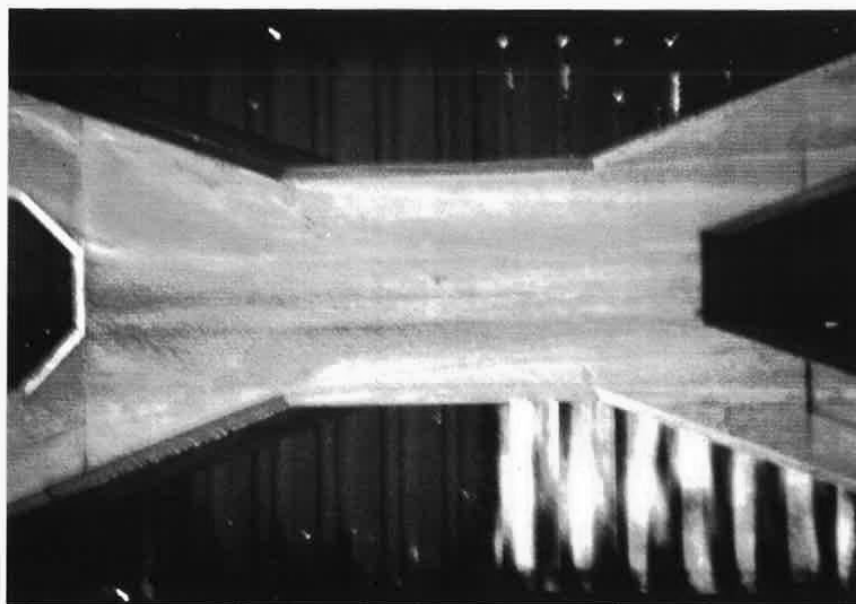
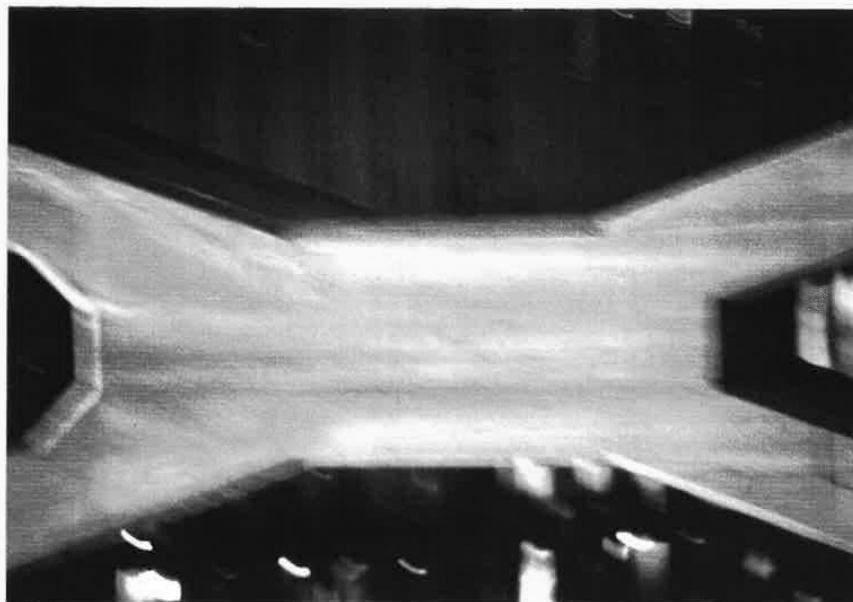
Photographs no. 354 - 385 represent the 32 X-brace columns that were visually inspected from the cold water basin. Reports indicate the columns are in relatively good condition with exception to the following noted defects: X-brace no. 8 was found to have a hairline crack, difficult to see in photograph no. 361, however, this crack is reported to be on the top right leg of the brace just adjacent to the top crotch; X-brace no. 9 exhibits two (2)

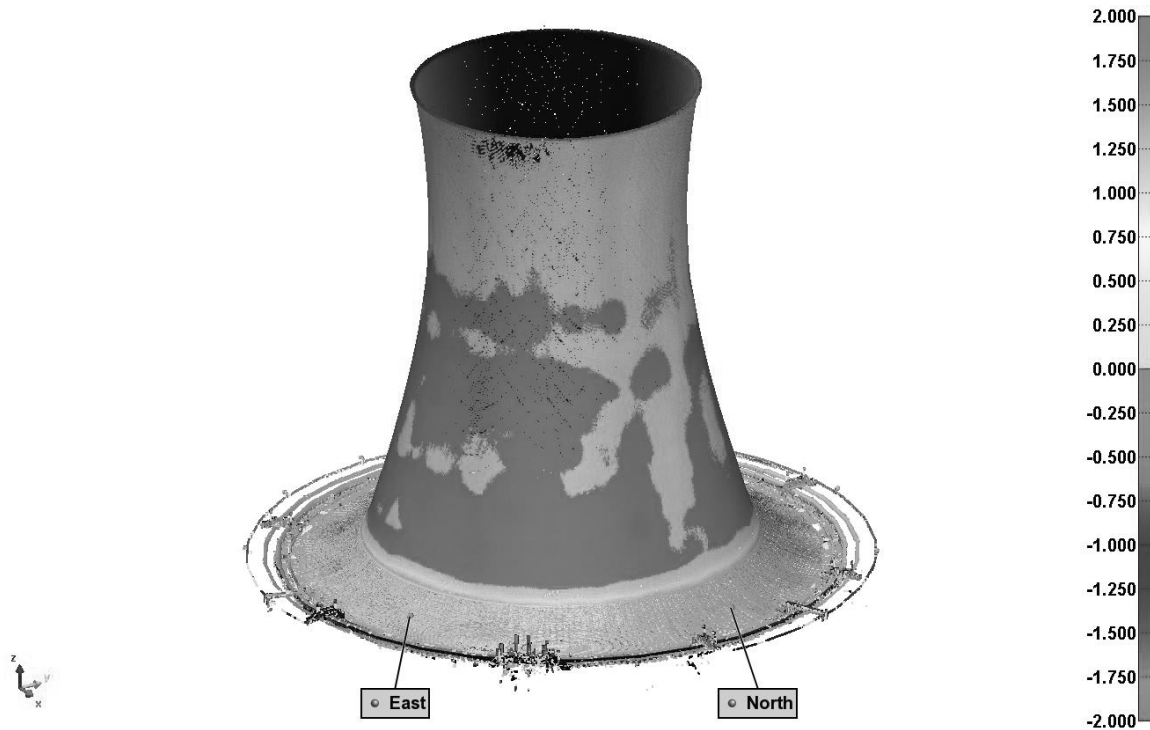
Scan to CAD Comparison (Best Fit Alignment) with +/- 2.000 ft color scale range. Note that positive deviations mean the scan data is above the CAD model surface and negative deviations mean the scan data is below the CAD model surface. Areas shown in grey represent areas of the scan that are either outside of the scale area shown or areas in which no data was collected and are not compared.

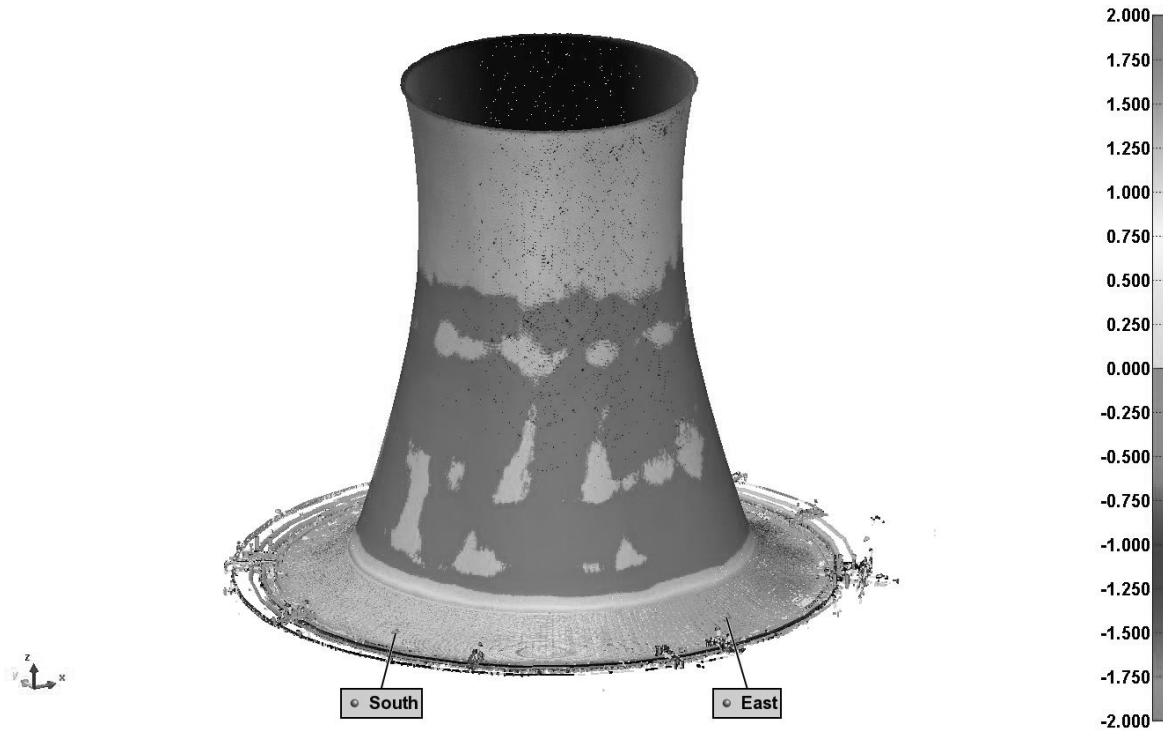
Scan to CAD Comparison (Best Fit Alignment) with +/- 2.000 ft color scale range. Note that positive deviations mean the scan data is above the CAD model surface and negative deviations mean the scan data is below the CAD model surface. Areas shown in grey represent areas of the scan that are either outside of the scale area shown or areas in which no data was collected and are not compared.

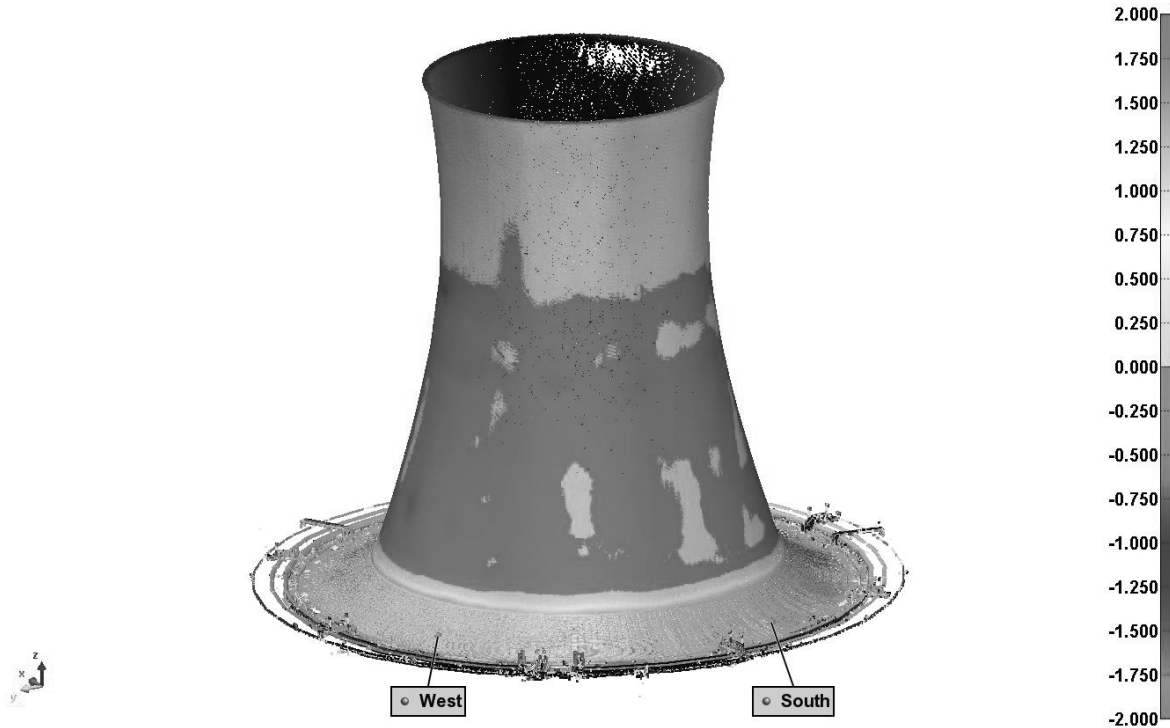
Scan to CAD Comparison (Best Fit Alignment) with +/- 2.000 ft color scale range. Note that positive deviations mean the scan data is above the CAD model surface and negative deviations mean the scan data is below the CAD model surface. Areas shown in grey represent areas of the scan that are either outside of the scale area shown or areas in which no data was collected and are not compared.

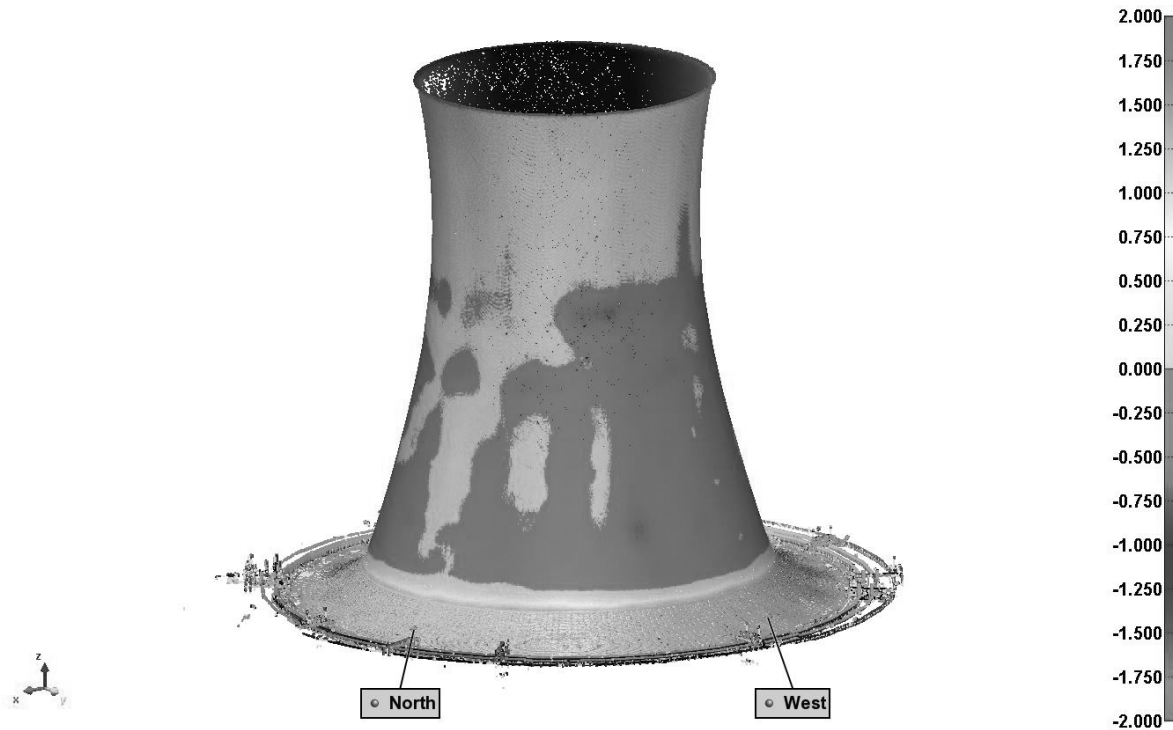
Scan to CAD Comparison (Best Fit Alignment) with +/- 2.000 ft color scale range. Note that positive deviations mean the scan data is above the CAD model surface and negative deviations mean the scan data is below the CAD model surface. Areas shown in grey represent areas of the scan that are either outside of the scale area shown or areas in which no data was collected and are not compared.

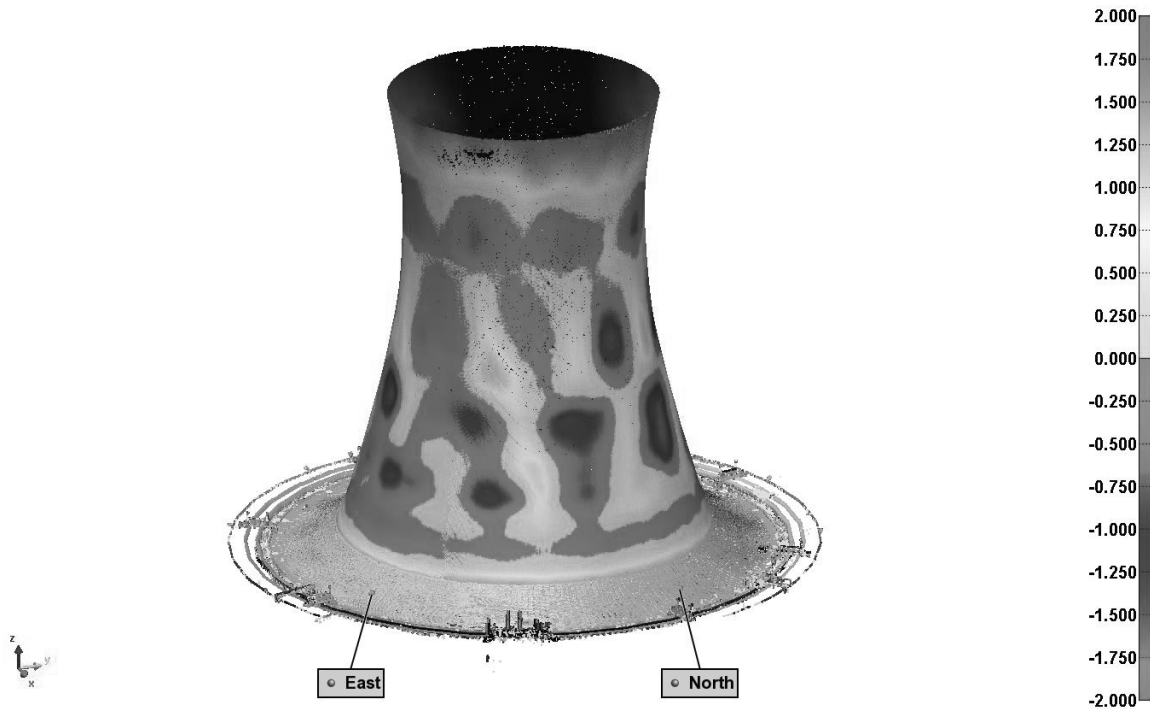
Scan to CAD Comparison (Best Fit Alignment) with +/- 2.000 ft color scale range. Note that positive deviations mean the scan data is above the CAD model surface and negative deviations mean the scan data is below the CAD model surface. Areas shown in grey represent areas of the scan that are either outside of the scale area shown or areas in which no data was collected and are not compared.

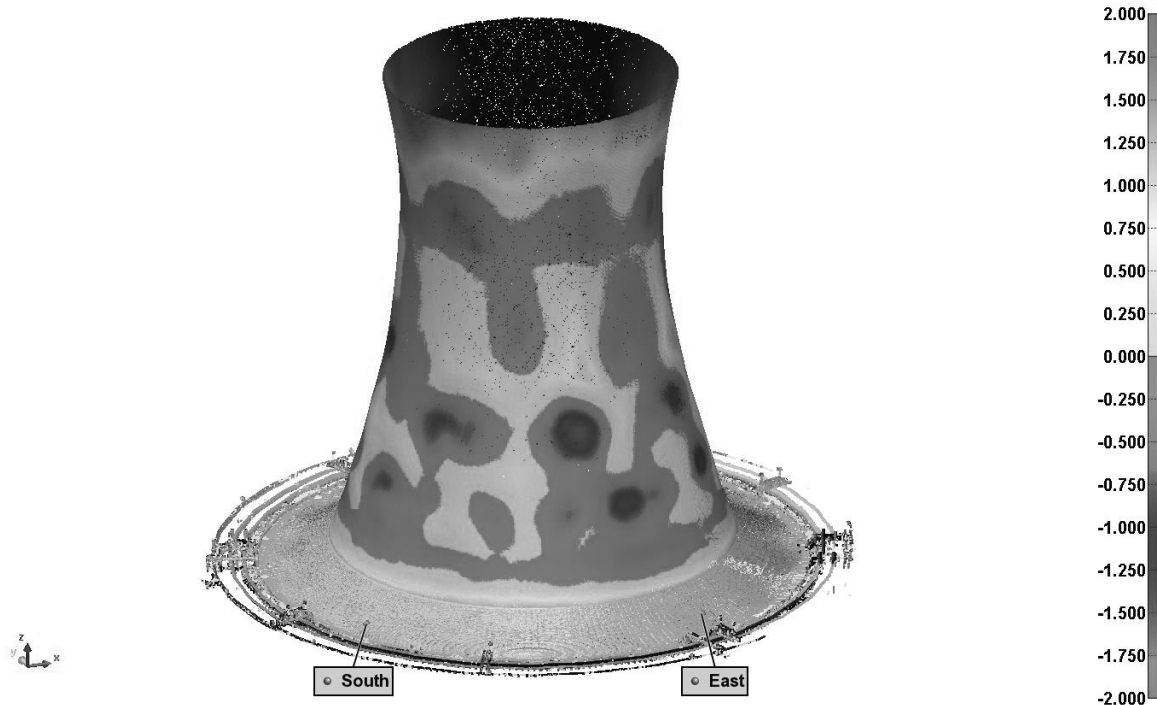
Scan to CAD Comparison (Best Fit Alignment) with +/- 2.000 ft color scale range. Note that positive deviations mean the scan data is above the CAD model surface and negative deviations mean the scan data is below the CAD model surface. Areas shown in grey represent areas of the scan that are either outside of the scale area shown or areas in which no data was collected and are not compared.
