Kentucky Power Company
KPSC Case No. 2026-00001
Commission Staff's First Set of Data Requests
Dated March 19, 2026

**AMERICAN ELECTRIC POWER SERVICE CORPORATION
OHIO POWER COMPANY
MITCHELL PLANT, UNIT NO. 1
MOUNDSVILLE, WEST VIRGINIA**

**Report
for
Inspection of 370'-0" High
Reinforced Concrete Cooling Tower**

American Electric Power Service Corporation
Ohio Power Company
Service Order B-6858
March 12, 1990

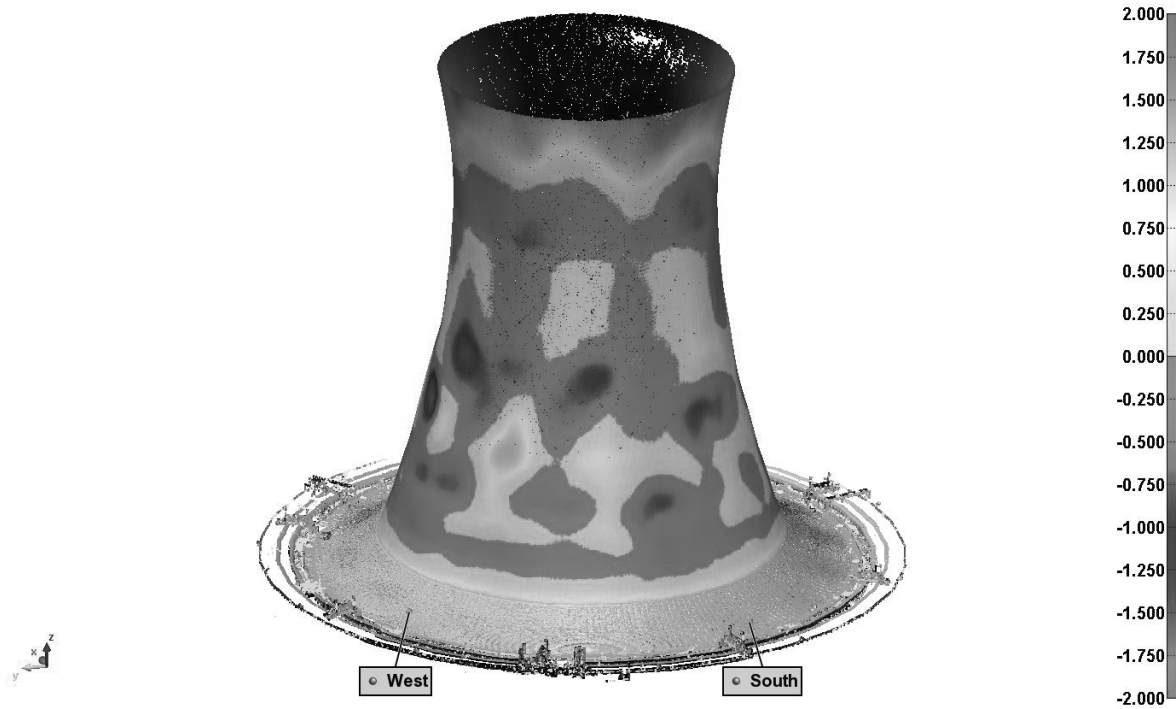
Scan to CAD Comparison (Best Fit Alignment) with +/- 2.000 ft color scale range. Note that positive deviations mean the scan data is above the CAD model surface and negative deviations mean the scan data is below the CAD model surface. Areas shown in grey represent areas of the scan that are either outside of the scale area shown or areas in which no data was collected and are not compared.

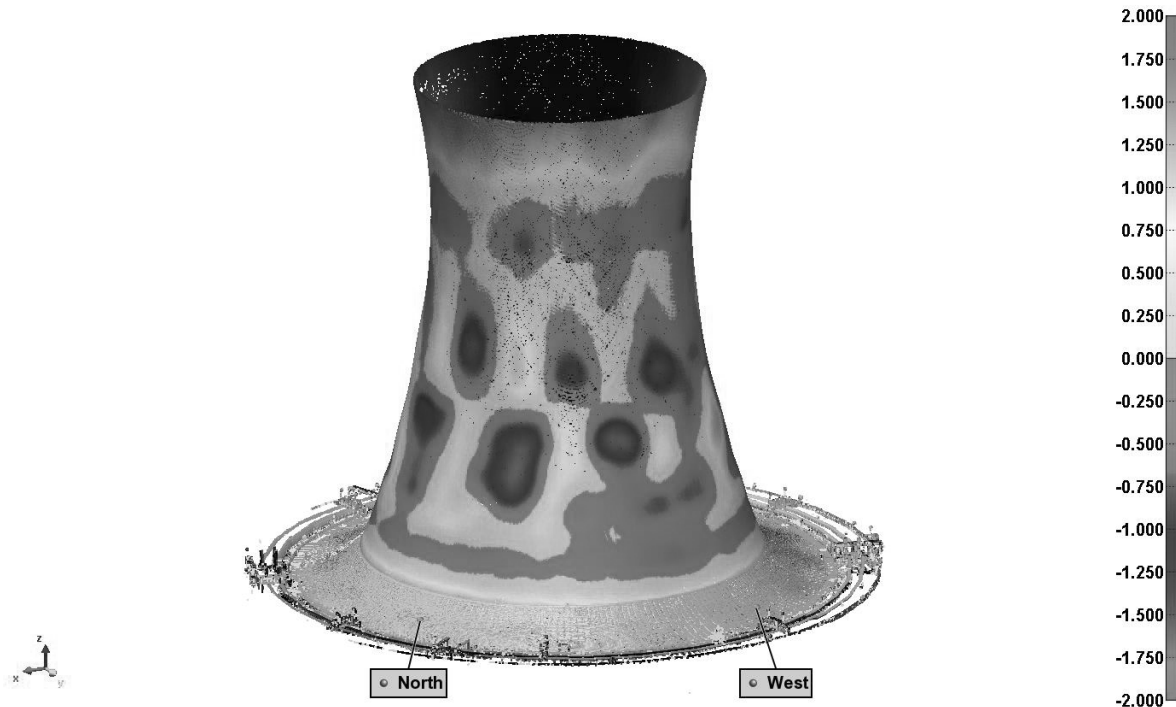
Scan to CAD Comparison (Best Fit Alignment) with +/- 2.000 ft color scale range. Note that positive deviations mean the scan data is above the CAD model surface and negative deviations mean the scan data is below the CAD model surface. Areas shown in grey represent areas of the scan that are either outside of the scale area shown or areas in which no data was collected and are not compared.

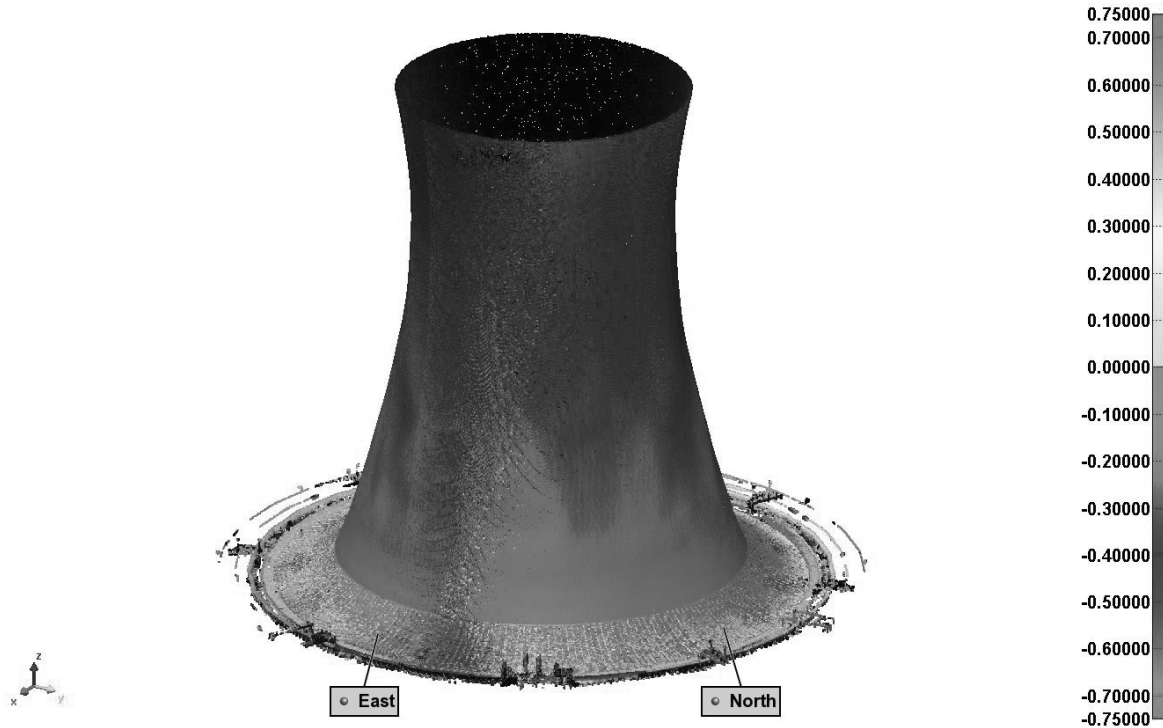
The temperature range during the scan session on 4/13/16 was 32°F to 45°F. The temperature range during the scan session on 1/13/17 was 30°F to 36°F. From the scan to scan comparison, it should be noted that the new scan shows an overall pattern of negative deviation, and specifically, the northeast side of Tower 2 showed a larger deviation than the rest of the structure possibly due to wind effects.

Scan to CAD Comparison (Best Fit Alignment) with +/- 0.750 ft color scale range. Note that positive deviations mean the 1/13/17 scan data is above the 4/13/16 scan surface and negative deviations mean the 1/13/17 scan data is below the 4/13/16 scan surface. Areas shown in grey represent areas of the scan that are either outside of the scale area shown or areas in which no data was collected and are not compared.

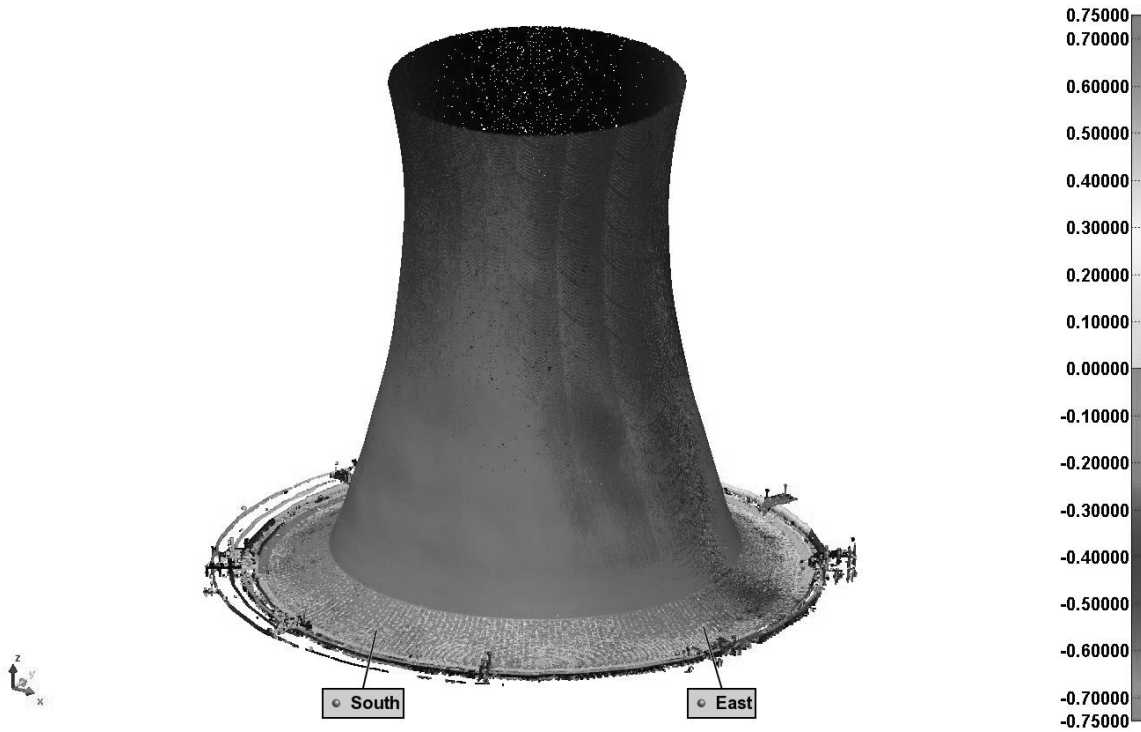
Scan to CAD Comparison (Best Fit Alignment) with +/- 0.750 ft color scale range. Note that positive deviations mean the 1/13/17 scan data is above the 4/13/16 scan surface and negative deviations mean the 1/13/17 scan data is below the 4/13/16 scan surface. Areas shown in grey represent areas of the scan that are either outside of the scale area shown or areas in which no data was collected and are not compared.

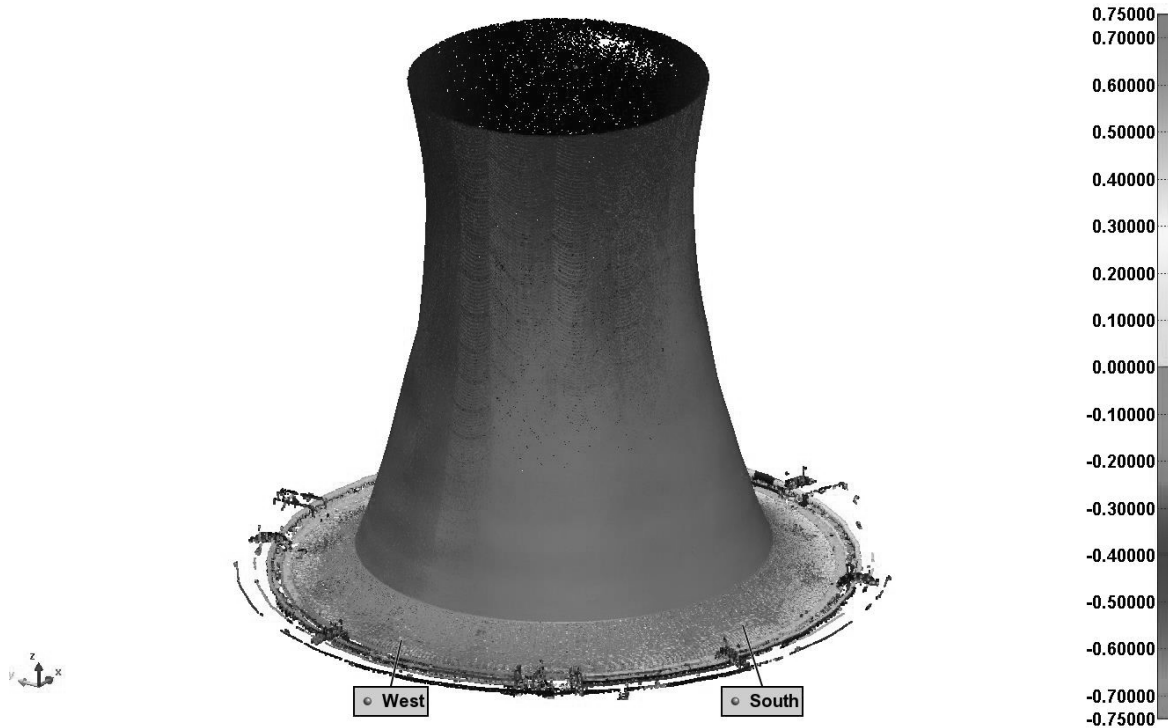
Scan to CAD Comparison (Best Fit Alignment) with +/- 0.750 ft color scale range. Note that positive deviations mean the 1/13/17 scan data is above the 4/13/16 scan surface and negative deviations mean the 1/13/17 scan data is below the 4/13/16 scan surface. Areas shown in grey represent areas of the scan that are either outside of the scale area shown or areas in which no data was collected and are not compared.

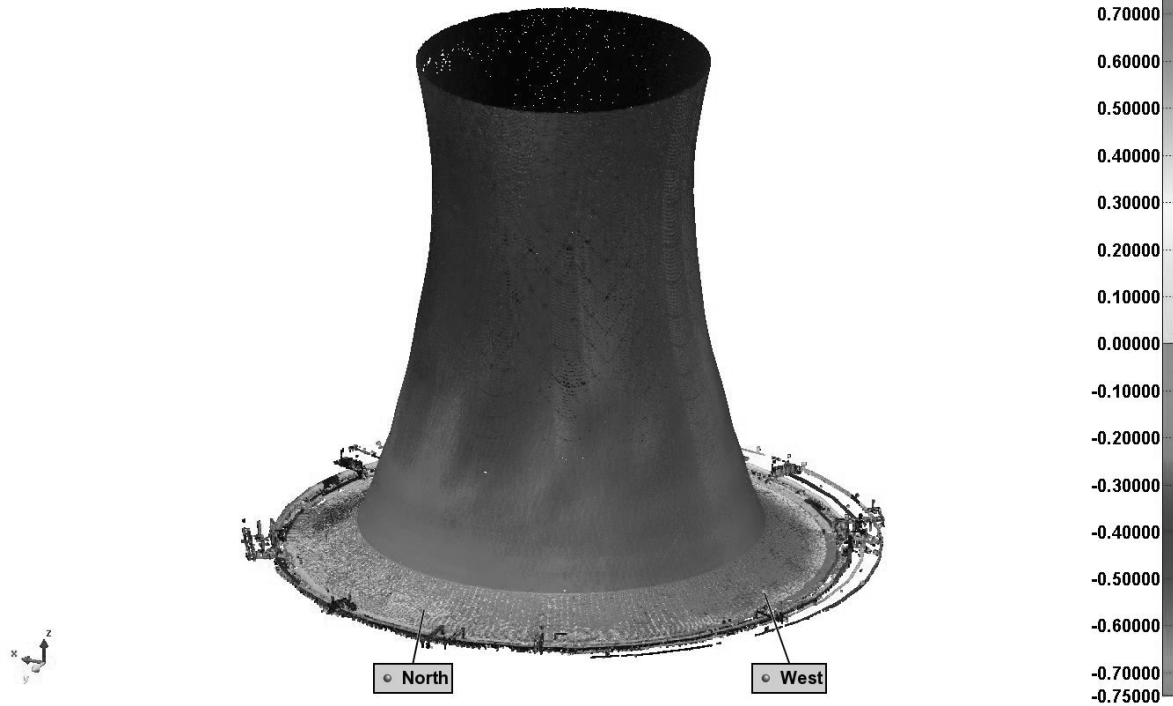
Scan to CAD Comparison (Best Fit Alignment) with +/- 0.750 ft color scale range. Note that positive deviations mean the 1/13/17 scan data is above the 4/13/16 scan surface and negative deviations mean the 1/13/17 scan data is below the 4/13/16 scan surface. Areas shown in grey represent areas of the scan that are either outside of the scale area shown or areas in which no data was collected and are not compared.

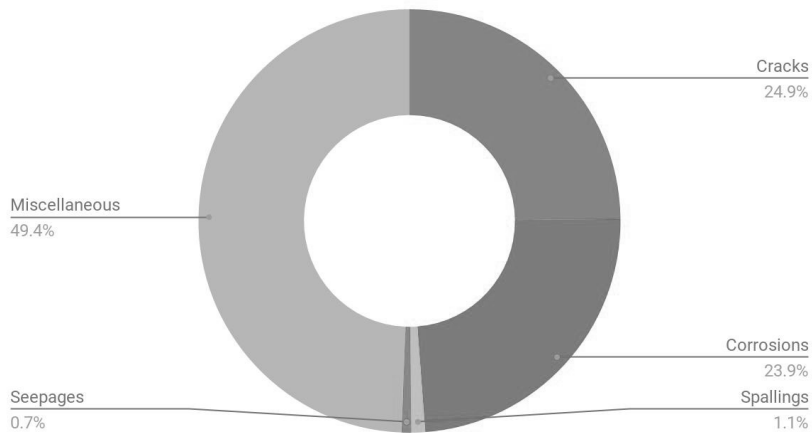
Defects are spread all over the tower.

The large number of defects are miscellaneous defects (2897). Most of the miscellaneous defects are efflorescences (2420) with no seepage. When an efflorescence has water seepage, it is classified as a seepage with efflorescence.

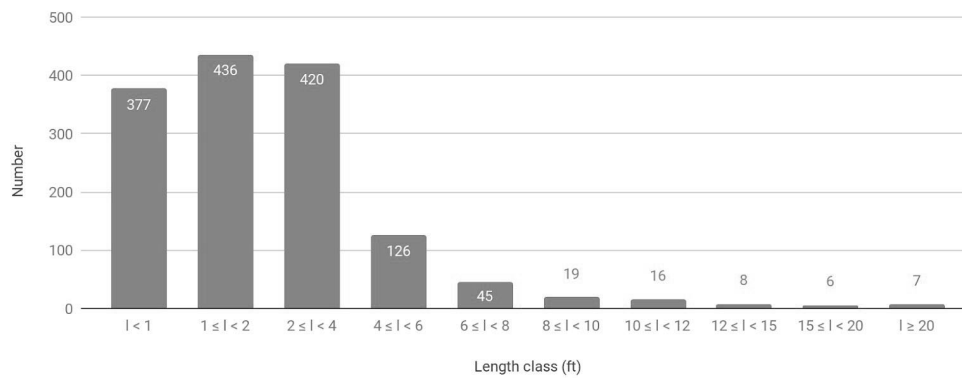
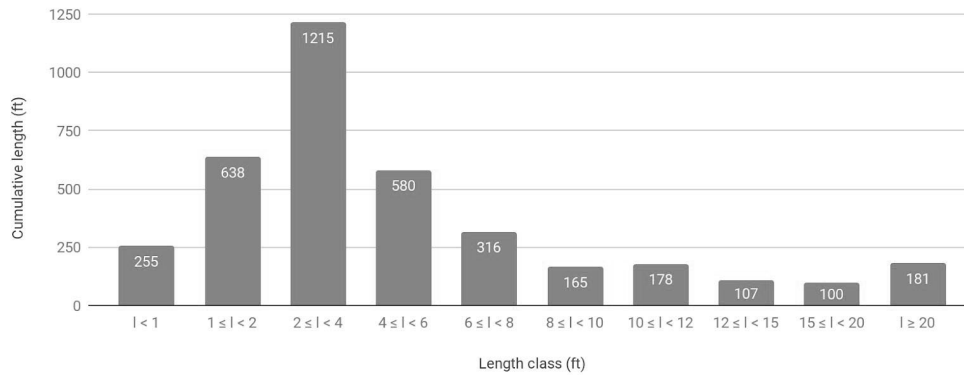
Cracks distribution per length

The main part of the cracks are smaller than 8 ft and 86.3% of them are measuring less than 4 ft long.

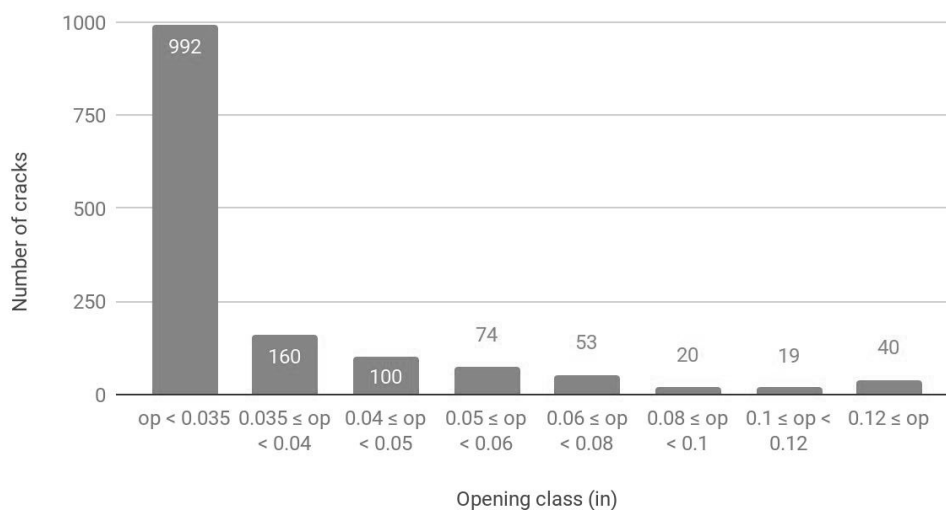
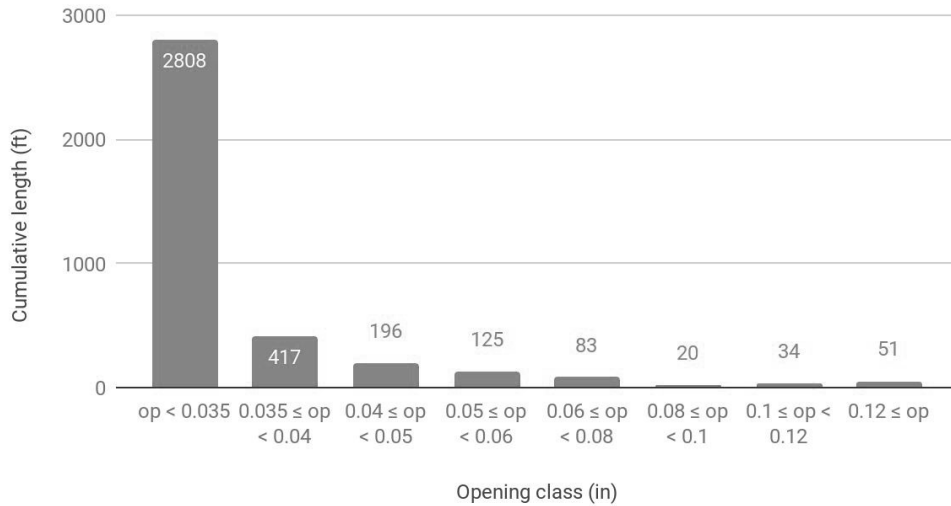
Cracks distribution per opening

Opening class (in)	op < 0.035	0.035 ≤ op < 0.04	0.04 ≤ op < 0.05	0.05 ≤ op < 0.06	0.06 ≤ op < 0.08	0.08 ≤ op < 0.1	0.1 ≤ op < 0.12	0.12 ≤ op
Number	992	160	100	74	53	20	19	40
Cumulative length (ft)	2808	417	196	125	83	20	34	51

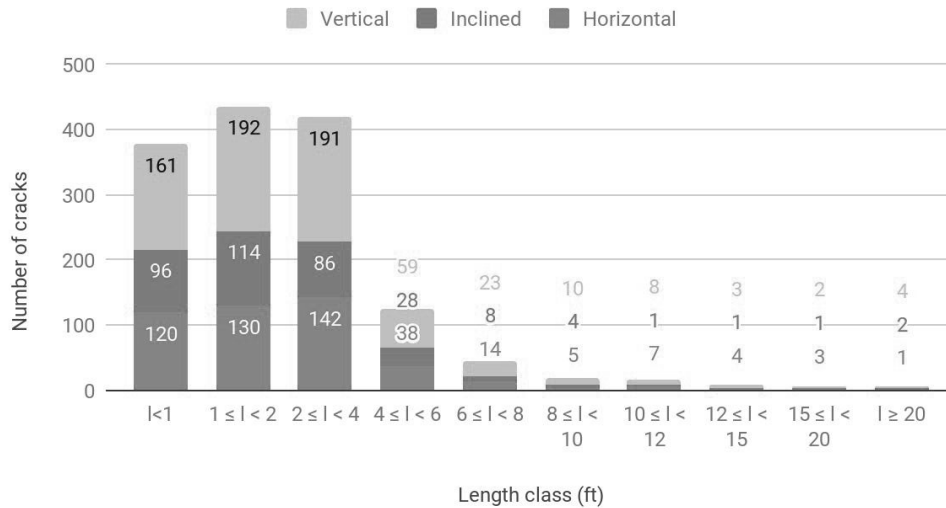
Horizontal, Inclined and Vertical Cracks

Most of the cracks are inclined.

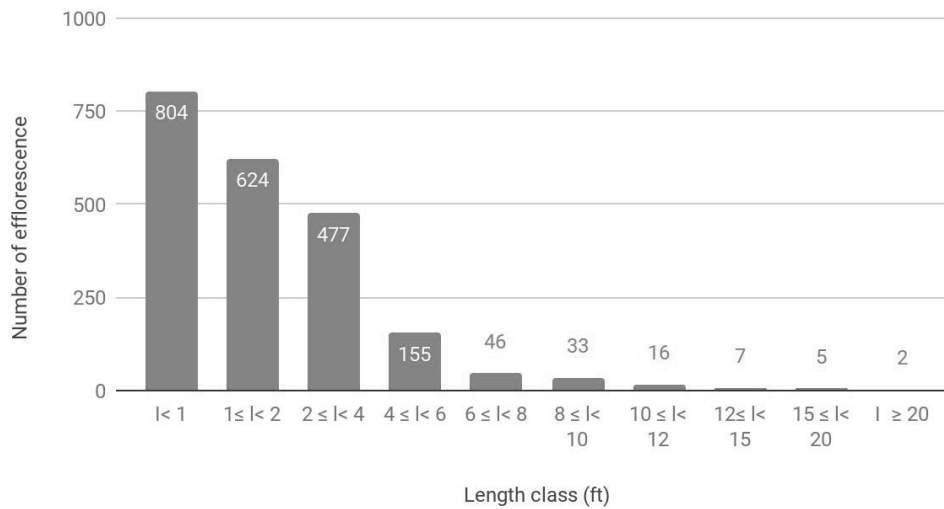
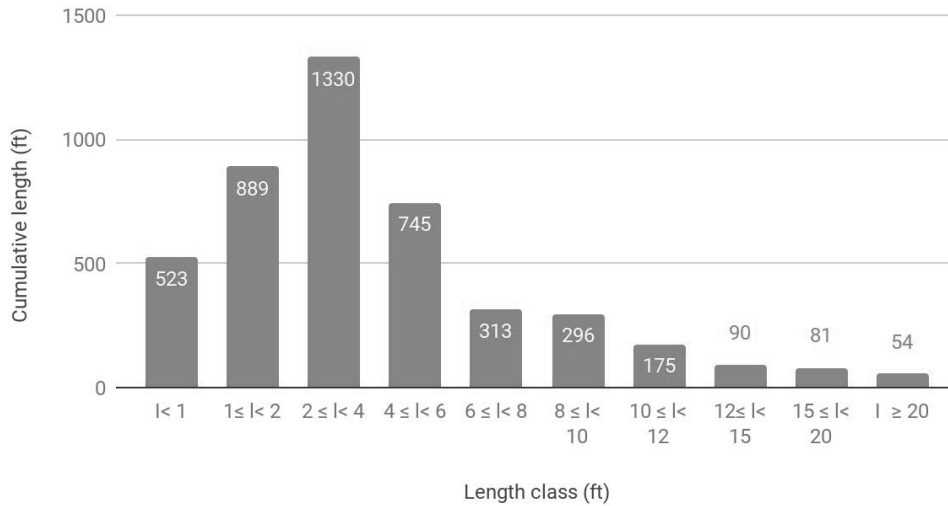
Efflorescence distribution per length class

Approximatively 80% of efflorescences are shorter than 2 ft (0.61 m).

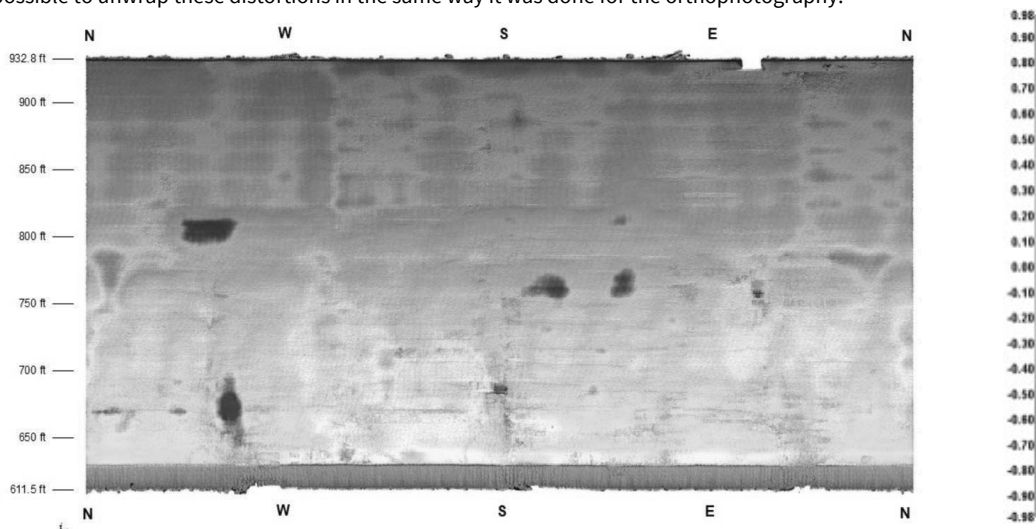
Cylindrical unwrapping of the distortions - scale in feet (right)

The superposition of the disorder mapping with the deformations measured in relation to the theoretical drawings show that there does not seem to be a correlation between deformations and defects. The deformations remain low.
