**TAYLOR MILL TREATMENT PLANT**  
**UPGRADES AND IMPROVEMENTS**

**Preliminary Engineering Report**

**Northern Kentucky Water District  
2835 Crescent Springs Road  
Erlanger, KY 41018**

**November 2020**

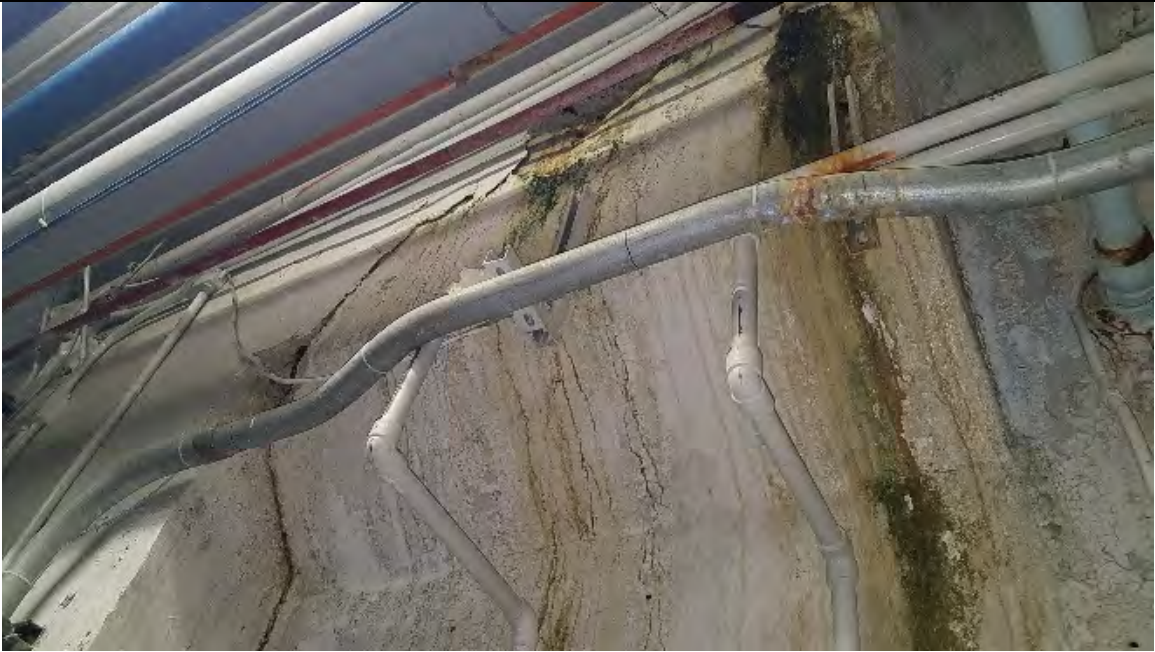
1. Upon entering the tunnel, it was observed that concrete has fallen from a deteriorating corbel and debris was on the floor below refer to photograph T2. The reinforced concrete corbel is at the location indicated by T1 on the attached photo location sketch. The cracks and spalling concrete at the corbel correspond to the termination of the expansion joint running along the South Flocculator Basin. See the termination of the expansion joint in the photograph below.

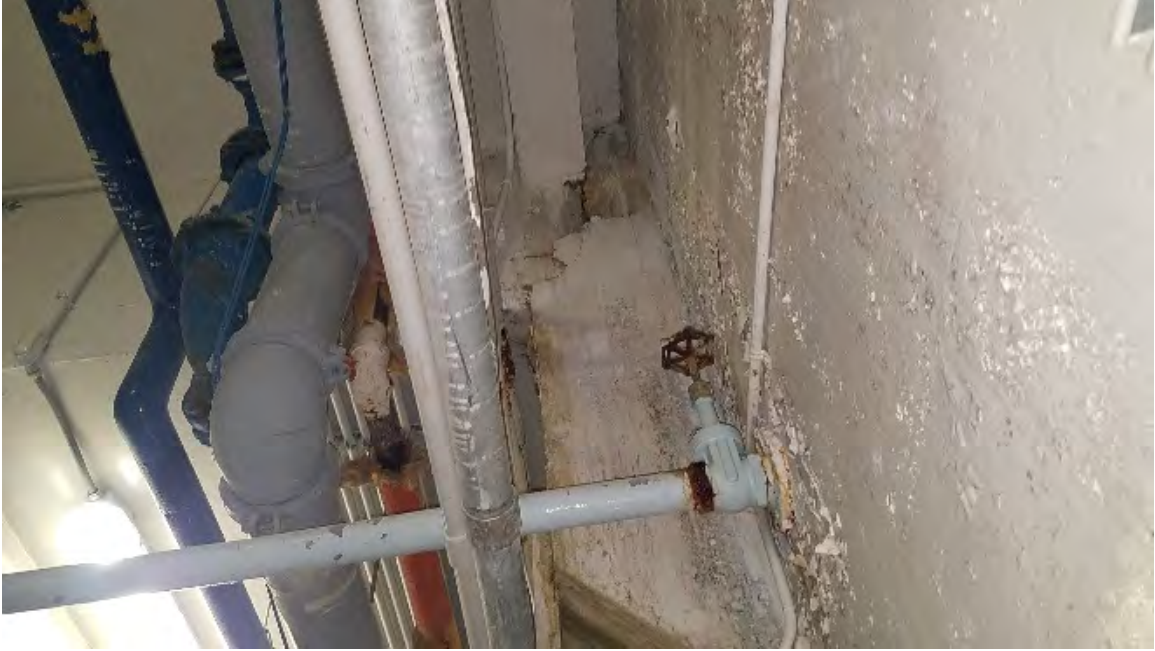
T3

2. The paint on the tunnel walls is peeling from the basin walls in numerous locations throughout the length of the tunnel. Refer to photographs T3, T4, T5, T7, T8, T9, T10 and T16.
3. Minor cracks were observed in the basin wall of the tunnel. No water was observed to be running through the cracks. Refer to photographs T11, T12-T16 and T18.

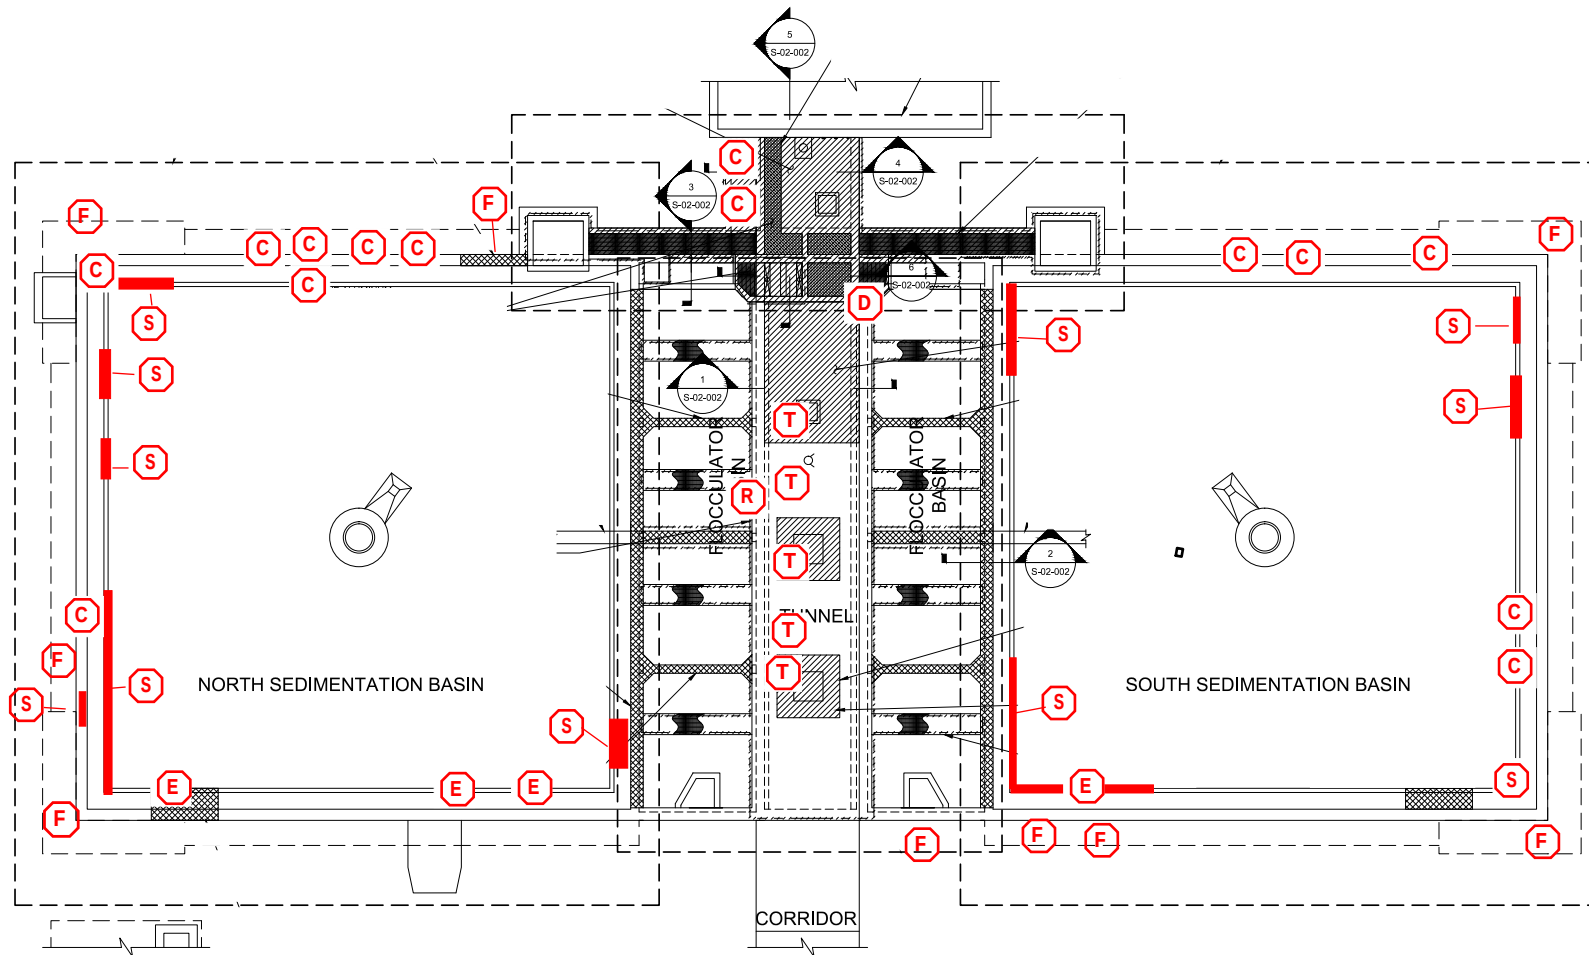
## Observed Damage Summary

| (S) Surface Spalling of Trough wall | (F) Failed Repair Area |
| (C) Crack through wall | (D) Damaged Corbel and Spalling of Trough Wall |
| (E) Exposed Reinforcing Steel | (T) Crack in Basin Wall at Tunnel Side |
| (R) Corroded Steel | |
