COMMONWEALTH OF KENTUCKY
BEFORE THE PUBLIC SERVICE COMMISSION

SOUTH KENTUCKY RURAL ELECTRIC)	
COOPERATIVE CORPORATION)	CASE NO.
_____)	2009-00015
)	
ALLEGED FAILURE TO COMPLY WITH)	
KRS 278.042)

INCIDENT INVESTIGATION ~ Staff Report

Electric Utility Personal Injury Incident Report

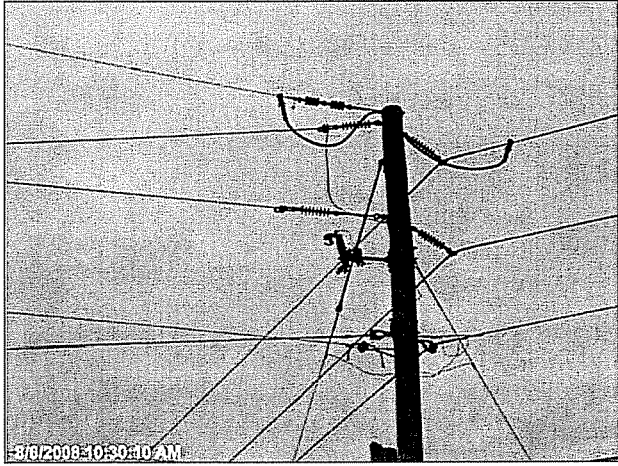
#1

1 looking up at take off pole # 128159. VB3 construction. Existing phase 6A CWC on top right hand side with Mechanical Jumper. Top left hand is short tap take off. Second take off is new conductor #2 ACSR that was pulled in to replace 6A.
