COMMONWEALTH OF KENTUCKY
BEFORE THE PUBLIC SERVICE COMMISSION

LARRY MORTON CONSTRUCTION)	
)	
_____)	CASE NO.
)	2023-00171
ALLEGED VIOLATION OF UNDERGROUND)	
FACILITY DAMAGE PREVENTION ACT)

INITIATING ORDER FOR ALLEGED 811 VIOLATION OF THE KENTUCKY
UNDERGROUND FACILITY DAMAGE PREVENTION ACT

PIPELINE DAMAGE INVESTIGATION REPORT

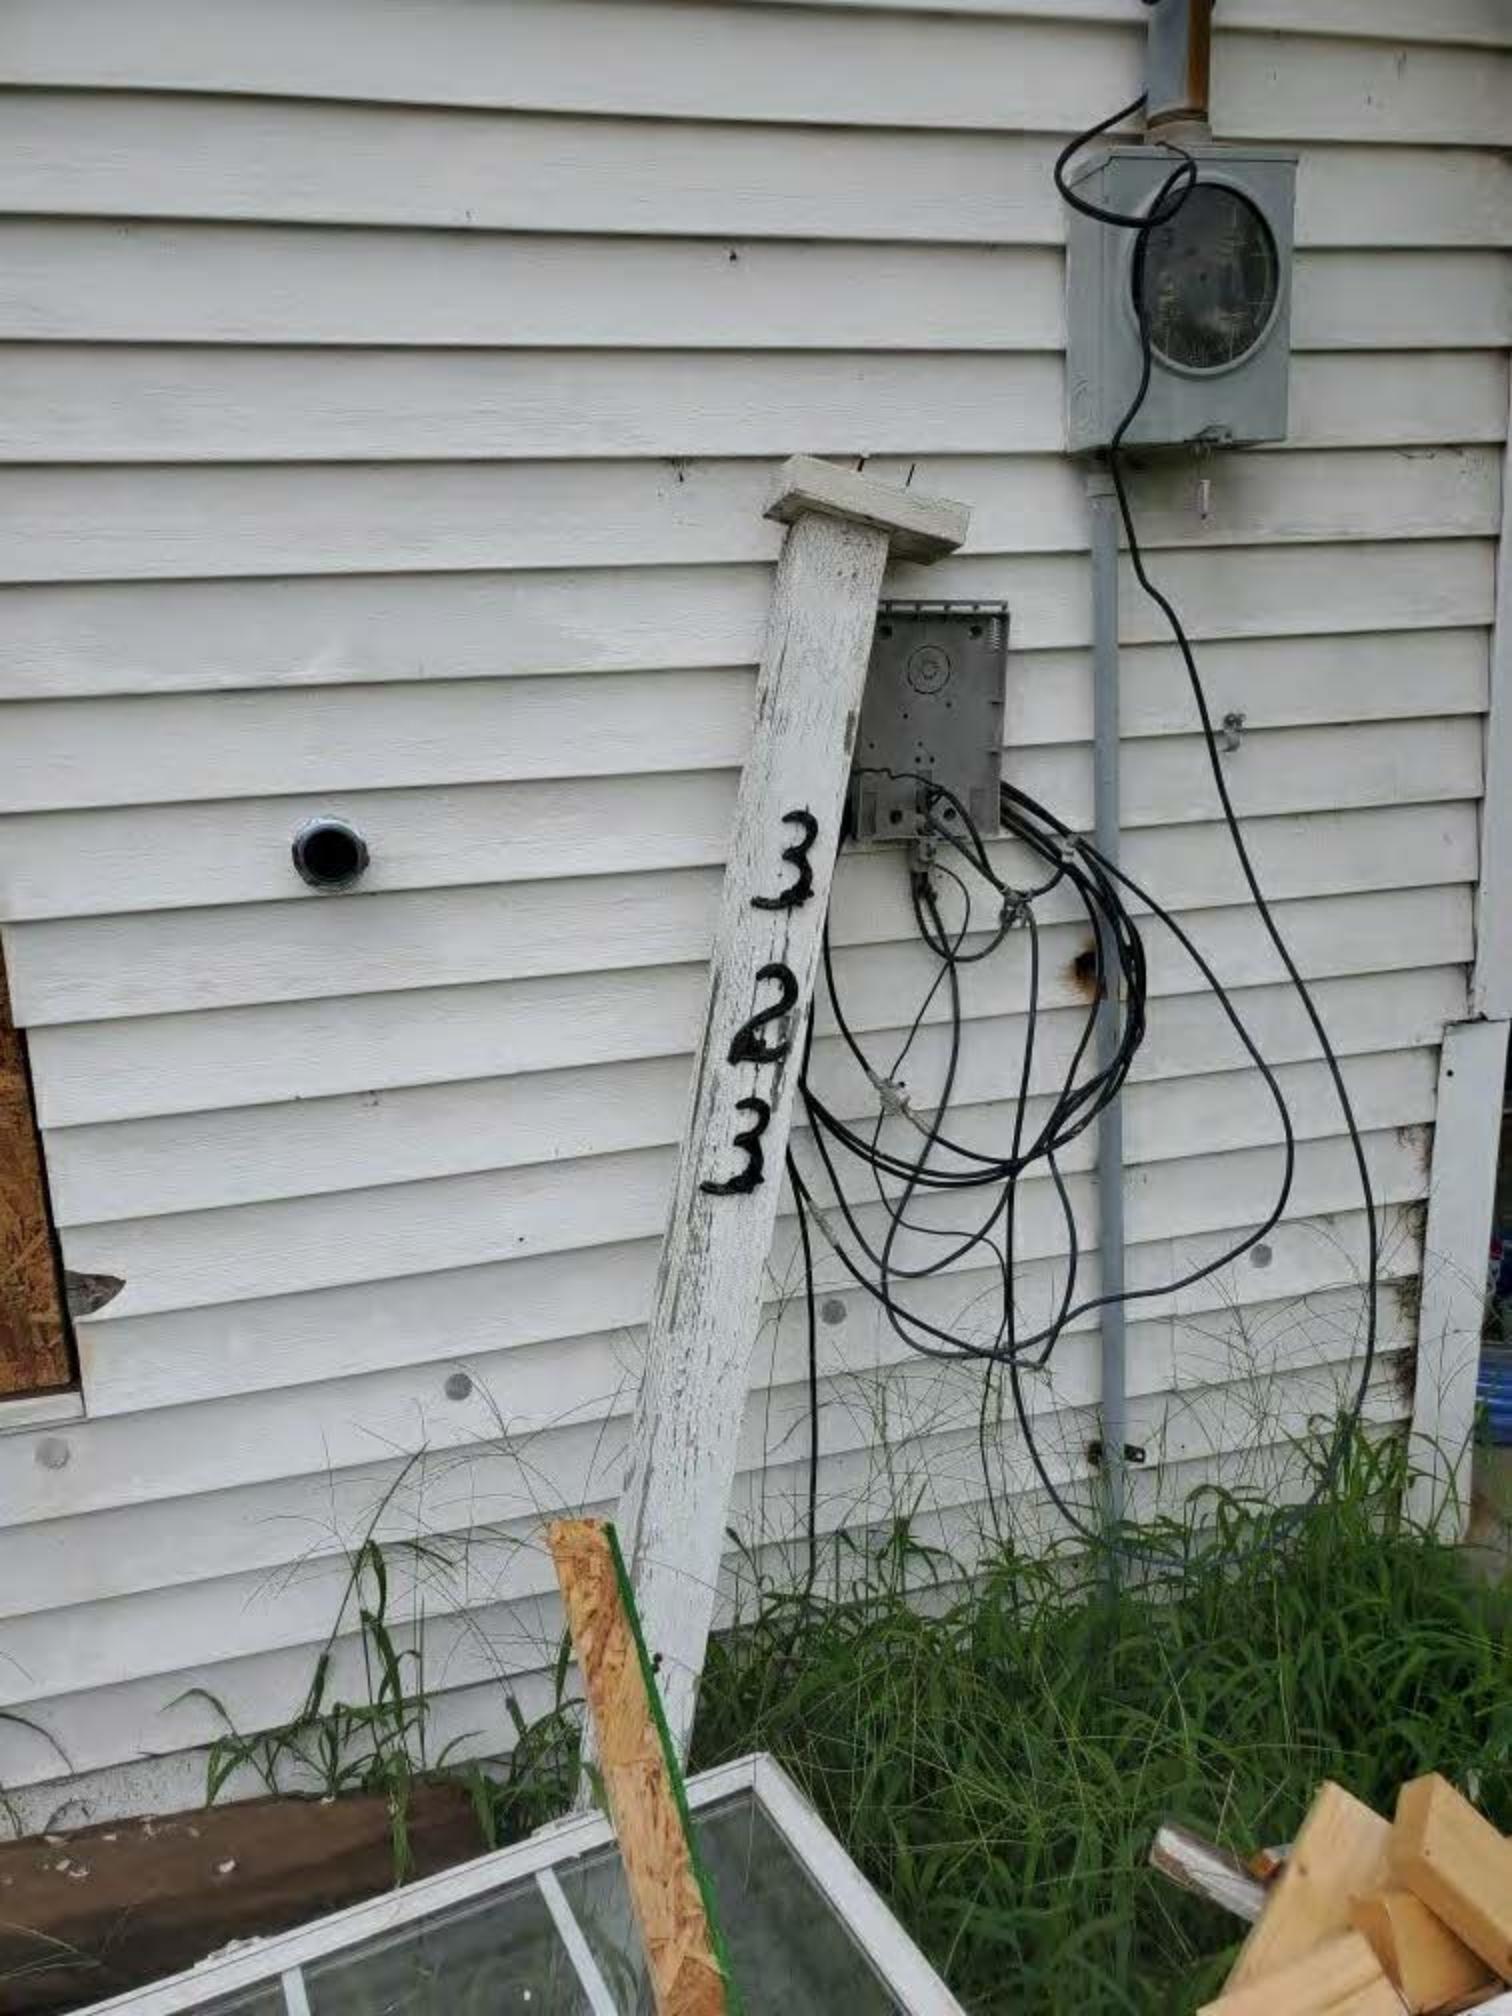
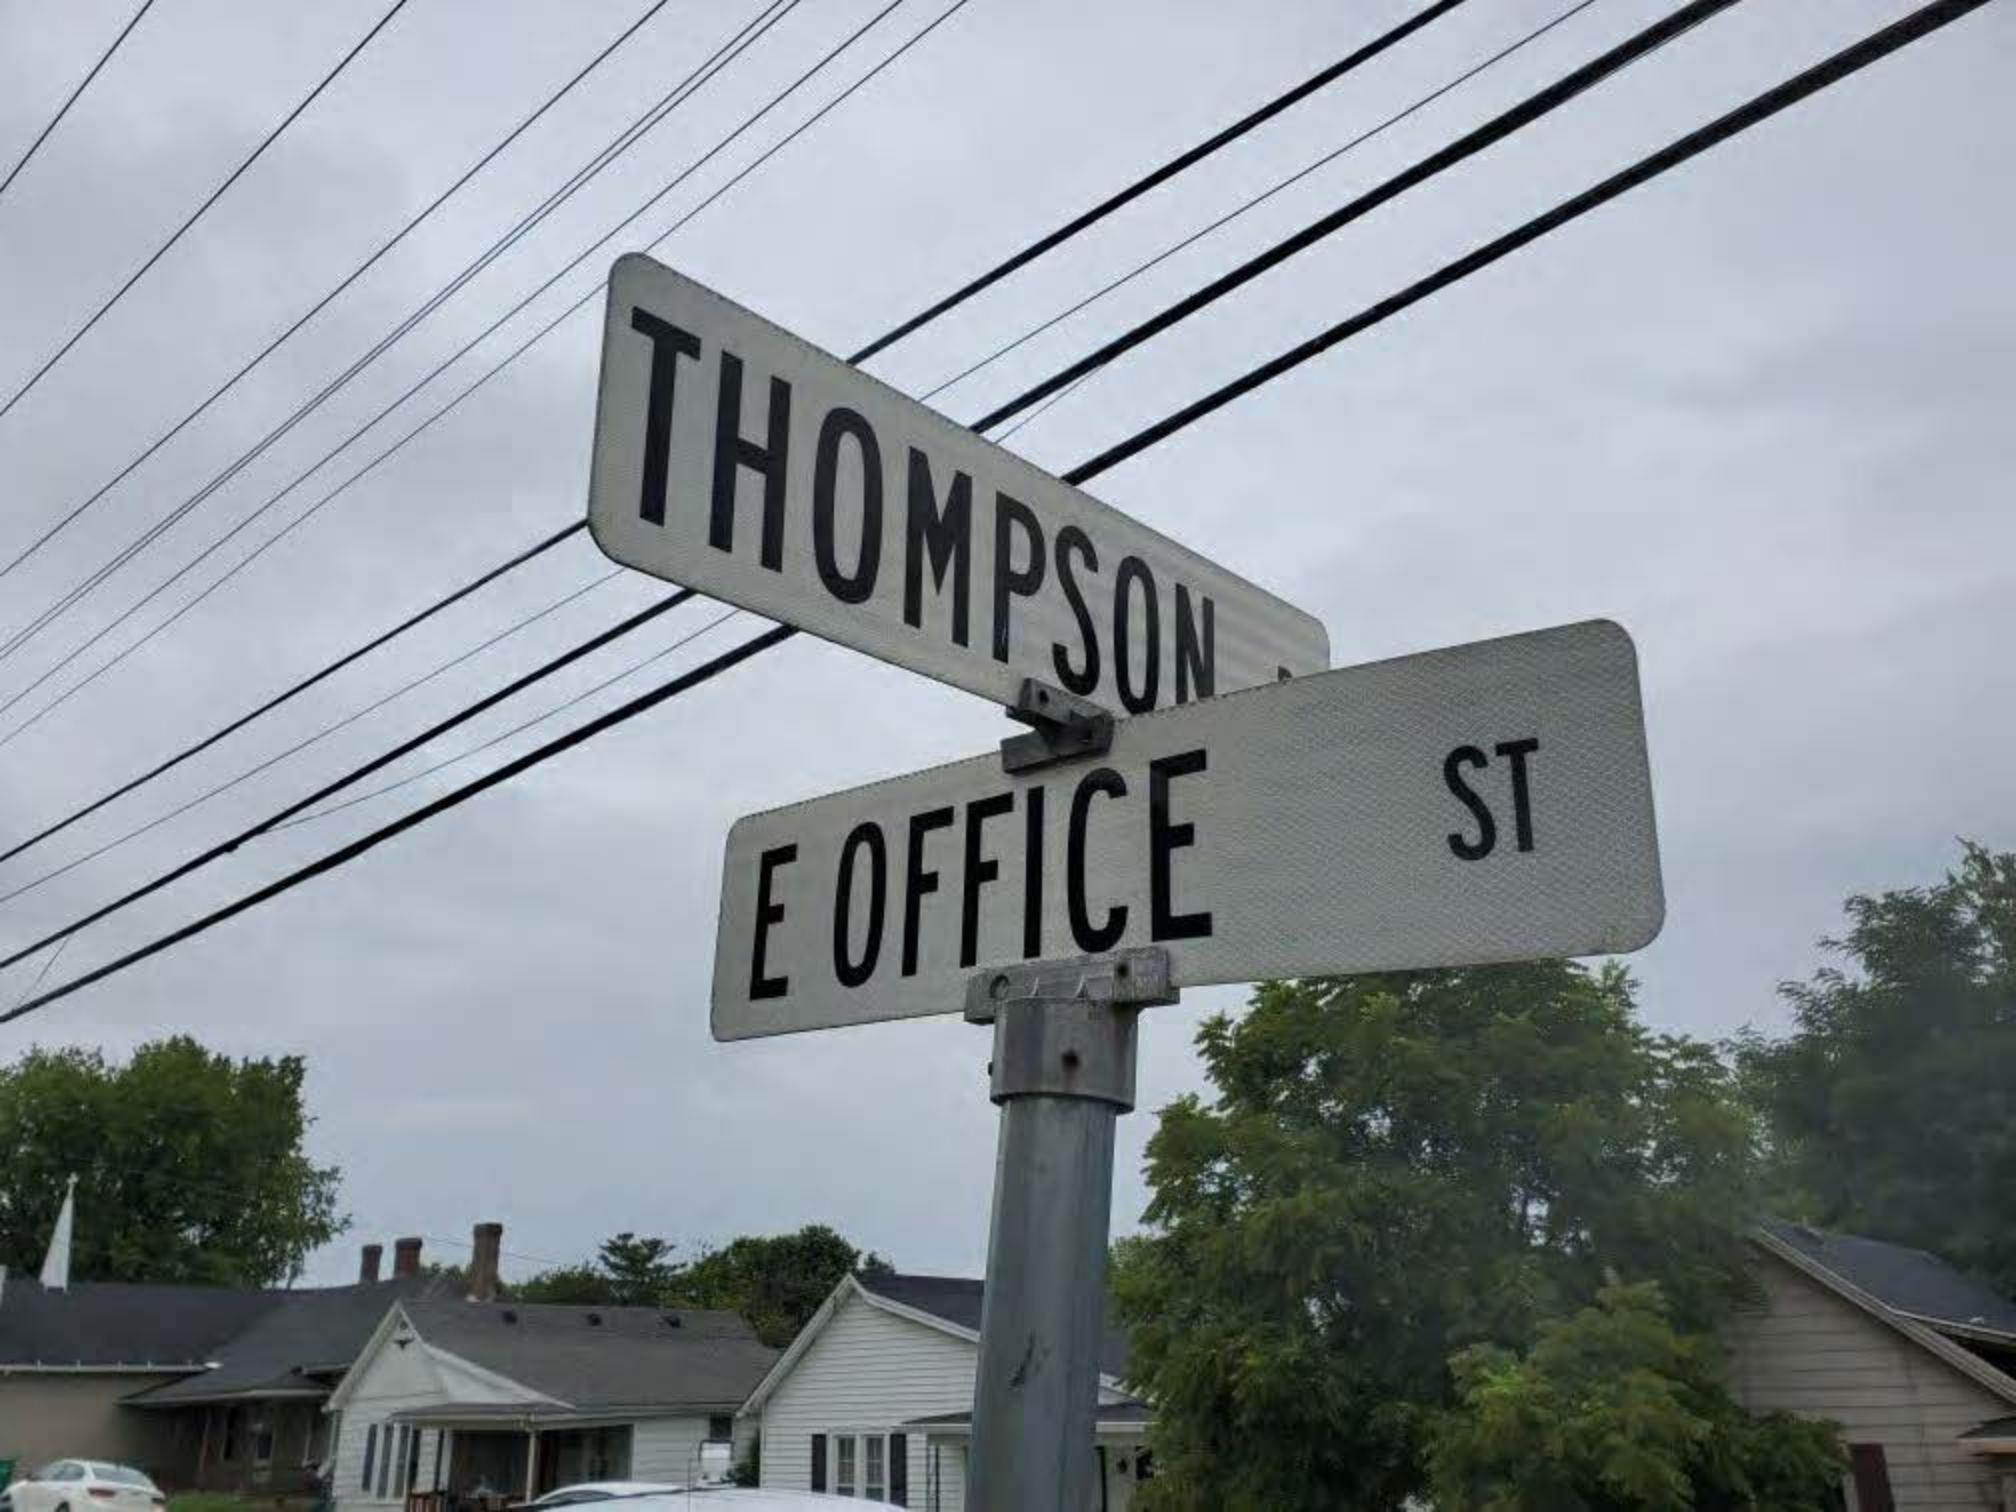
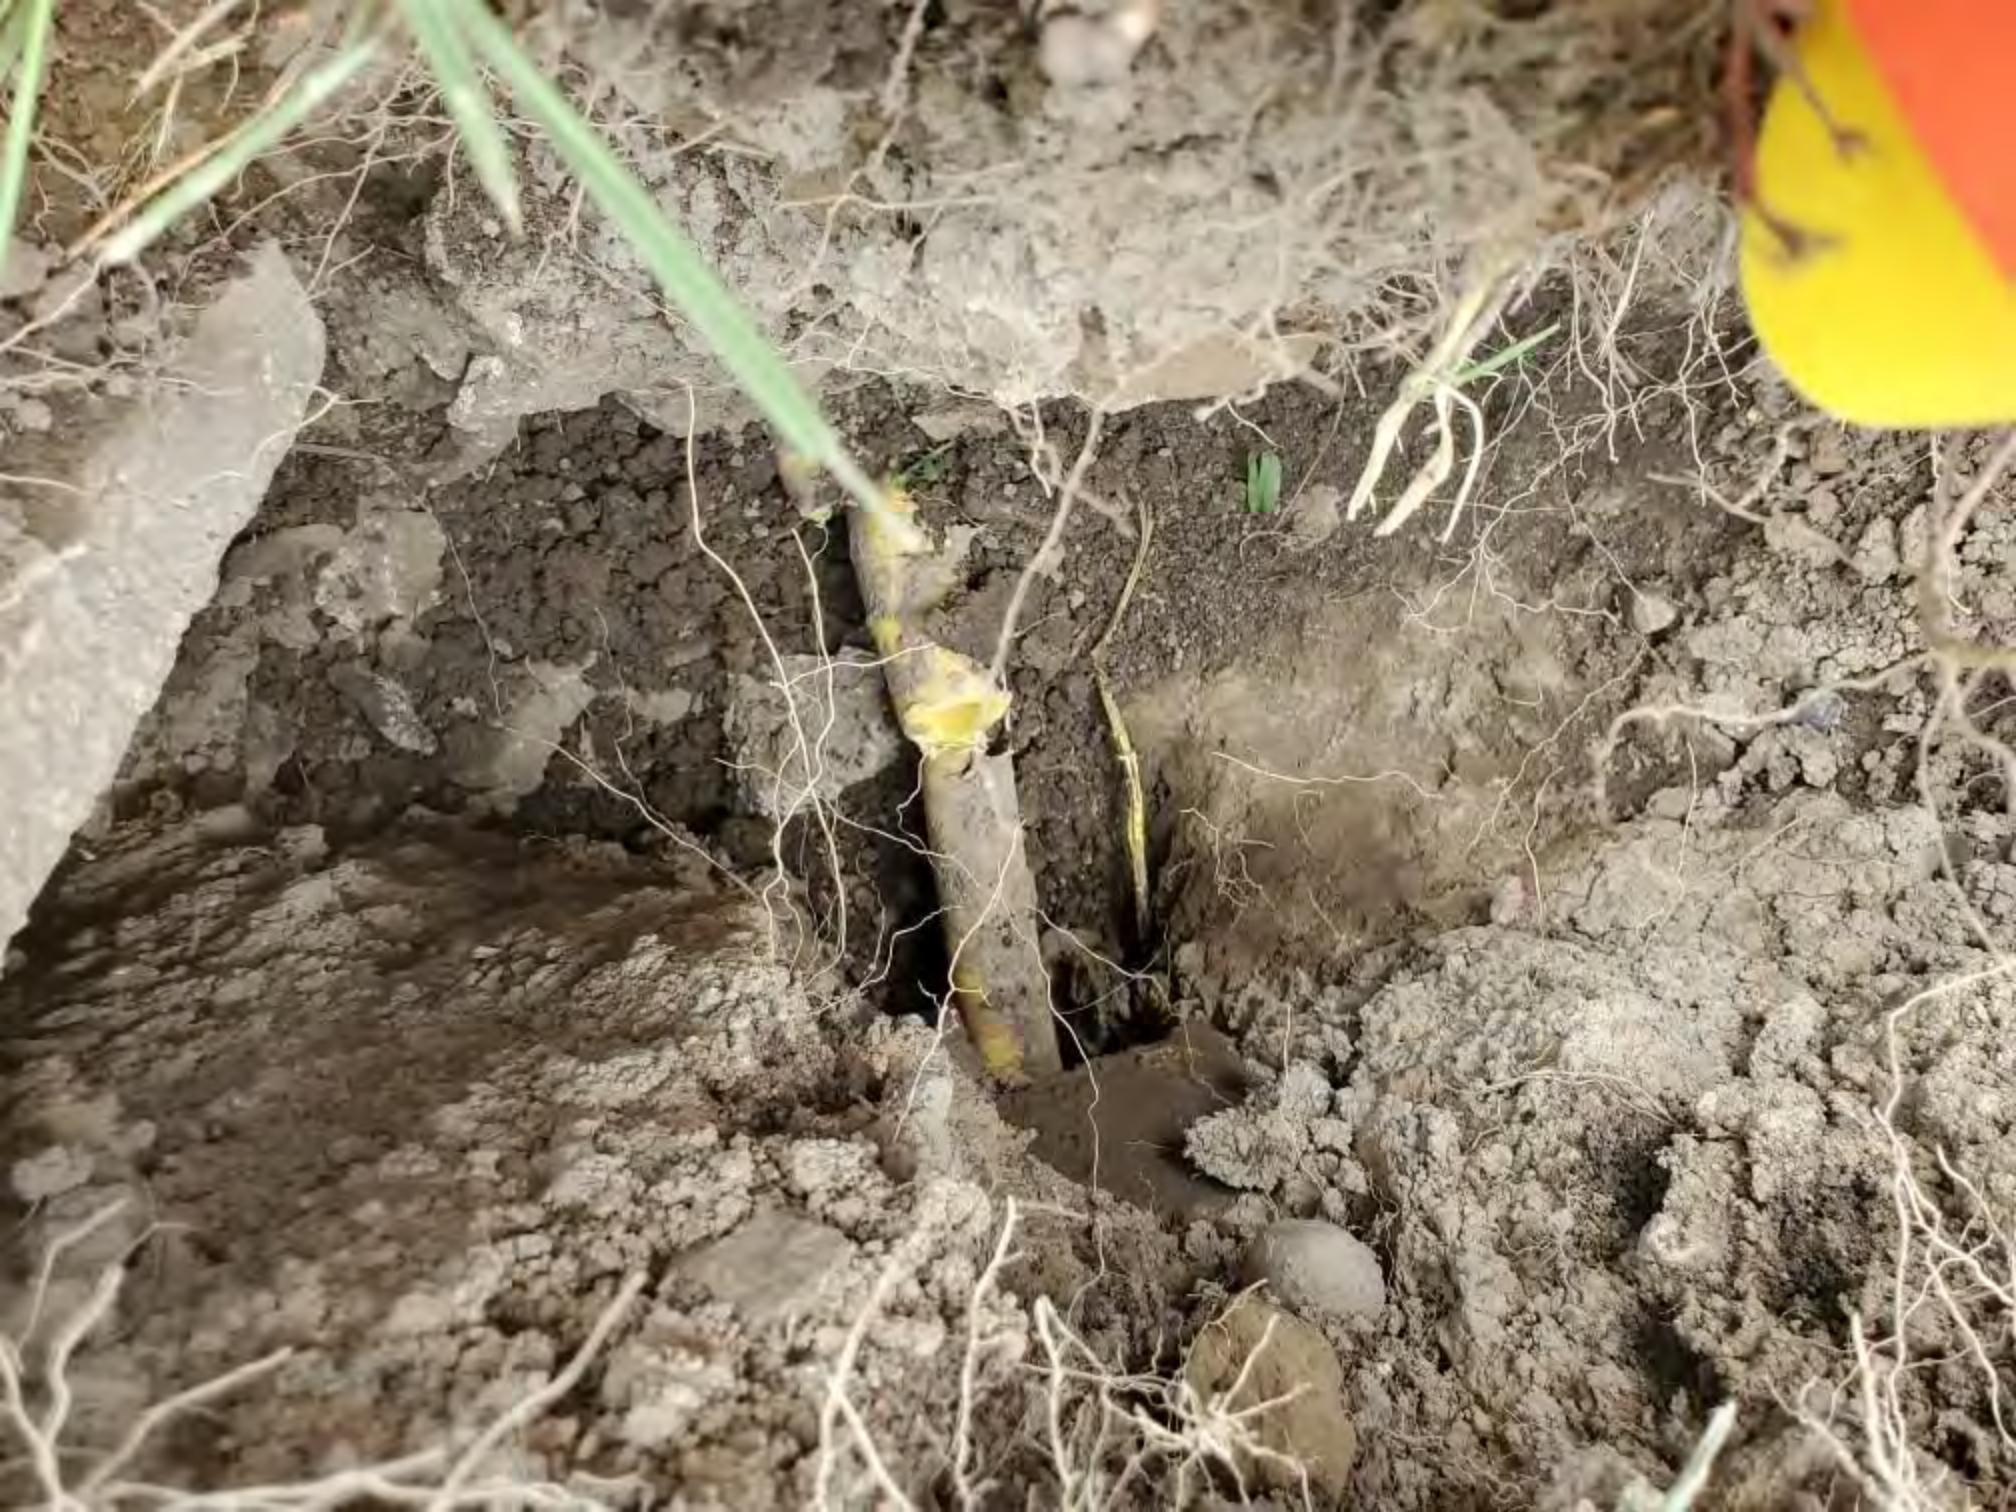
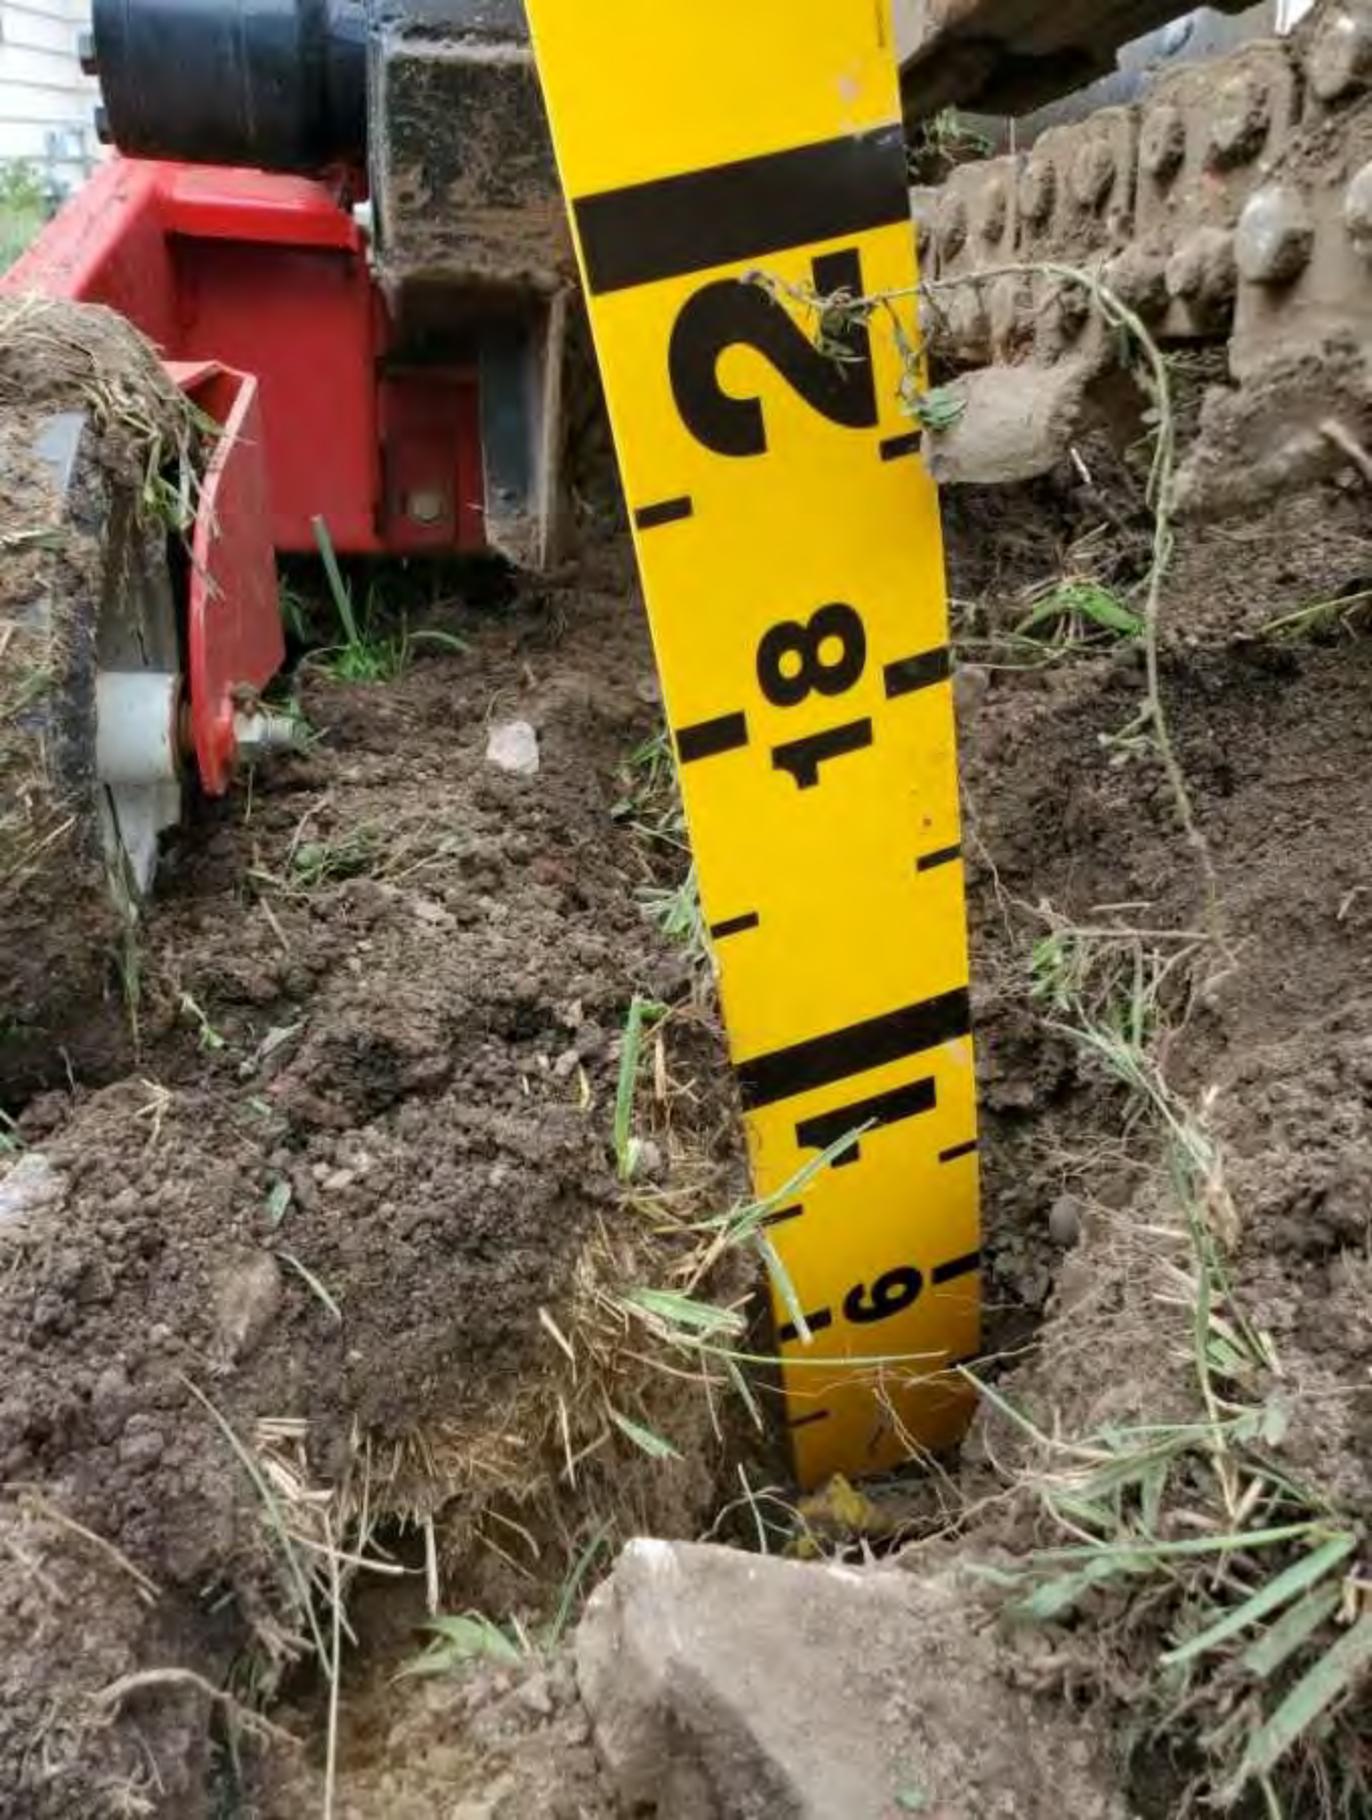
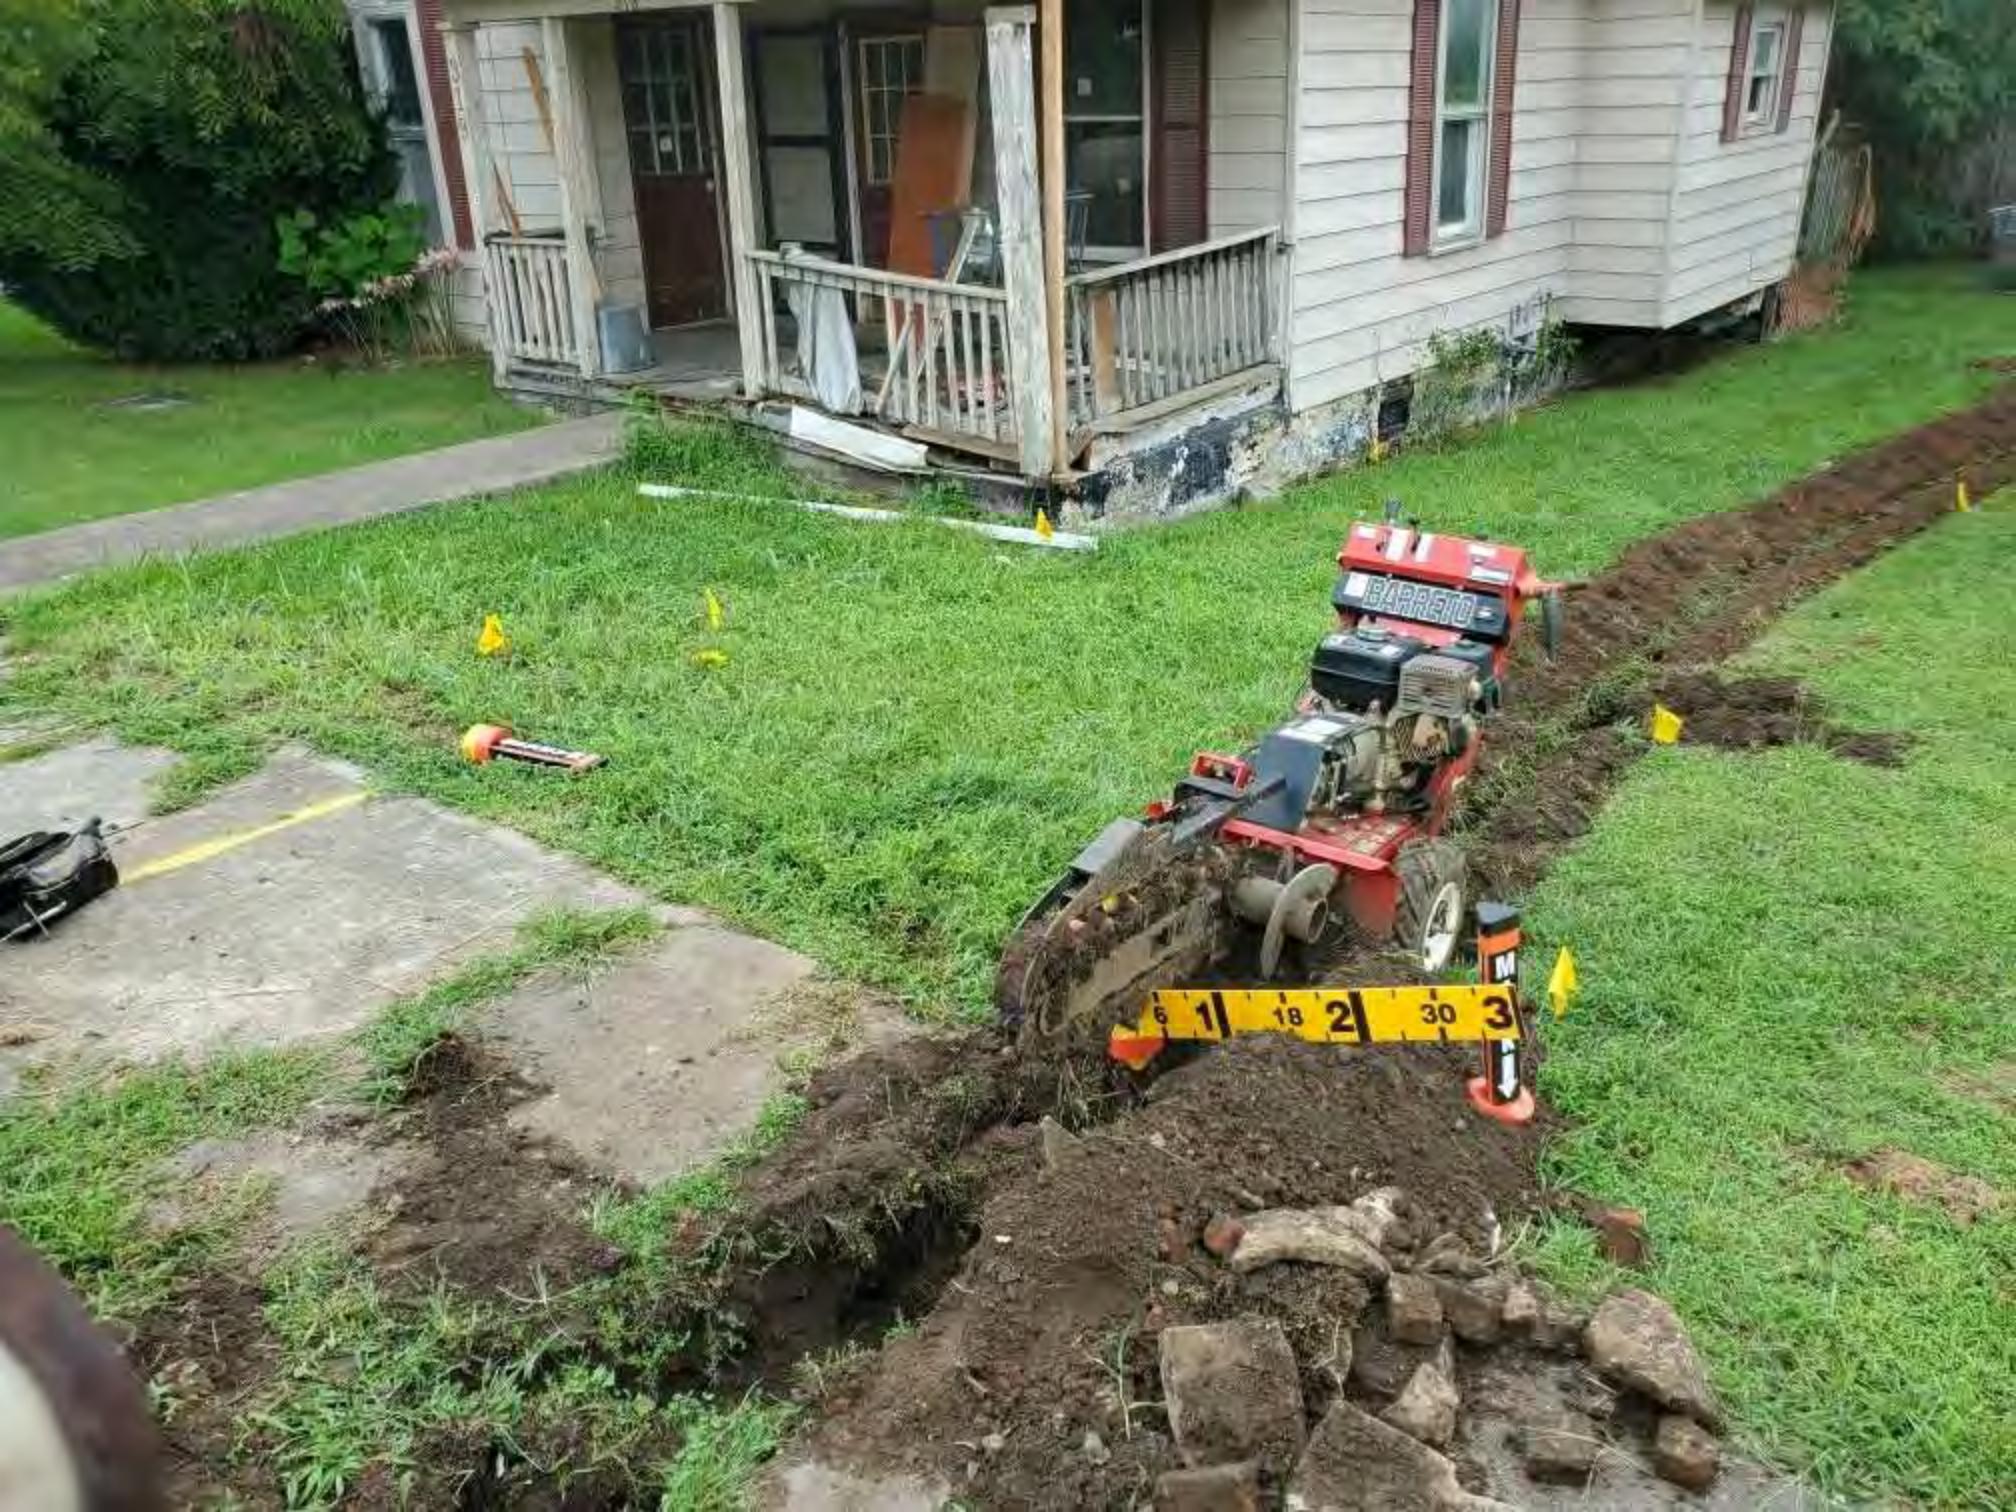
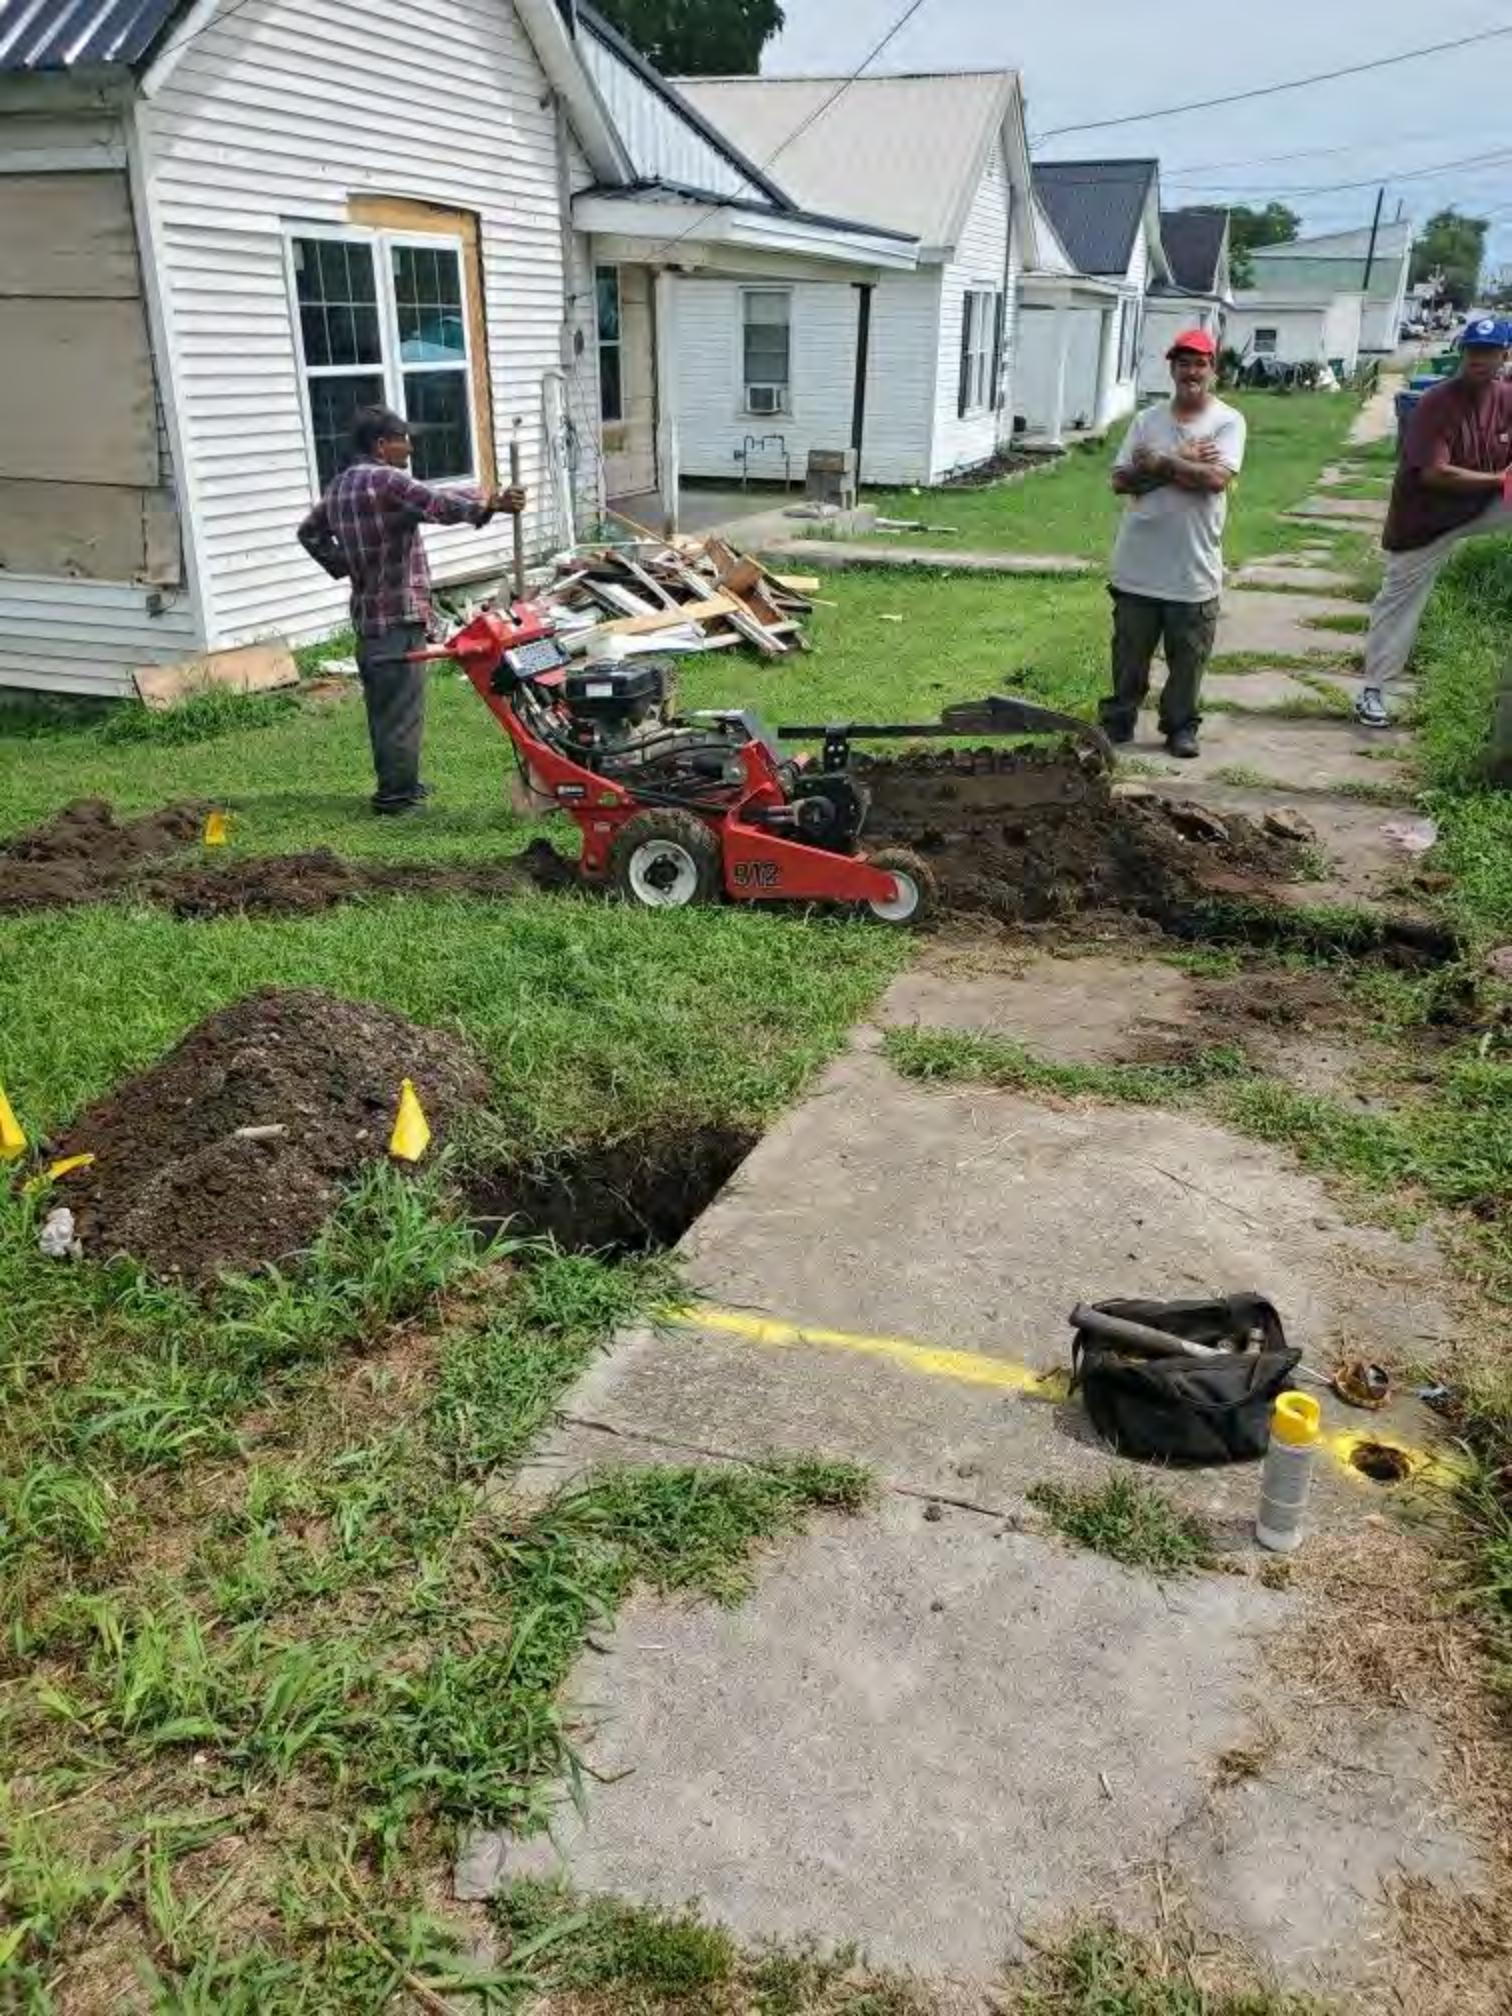
DAMAGE

Excavation Damage: Failure to use hand tools where required

Service repaired. No active customers off.

Damaged Pipe Diameter: 3/4 inches Depth of Facility: 1 feet 6 inches

Line Pressure: 45 psig Pipe Damage: (Length) 1 inches (Width) _____ inches
 Leak Duration: 20 minutes Locate Priority: _____ FERC Account: _____
 Insurance Company: _____ Agent Name: _____ Phone #: _____
 Locate Mark within State Law: Yes No Police Report Number: _____
 Pre-Damage Photos: Yes No Post-Damage Photos: Yes No Billing Required: Yes No

Cost of the damage	\$933.00
Steps taken to prevent re-occurrence	Larry Morton was educated on using hand tools within the tolerance zone and maintaining marks. Work began 15 days after the initial request. Larry Morton was billed for the repairs.
Amount billed to excavator	\$933.00
