Case No. 2012-00362

The following documentation is being submitted by RussMar Logistics, LLC. on behalf of Tompkinsville Natural Gas System.

MARTIN CONTRACTING, INC.
LEAK SURVEY

Leak Survey Pt 1

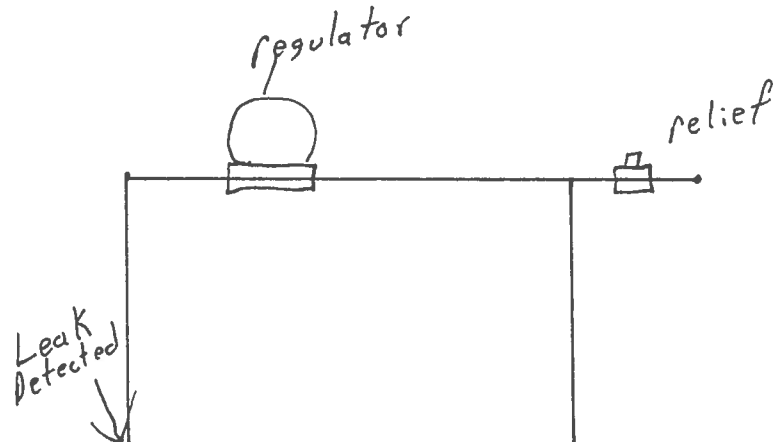
Address | 1373 Hwy 63 Farm Tap | City/County | Tompkinsville/Monroe | State | KY | Date | 4-9

1496 Hwy 63	4-9			✓	3/4	Inlet side of farm top on 1st 90°	✓	
1373 Hwy 63 "Farm Top"	4-9			✓	3/4	Leak detected in the ground on the inlet side of the farm top.		
1373 Hwy 63	4-9			✓	3/4	Inlet side top of the tee - on outlet spool.		
1434 Hwy 63 "Farm Top"	4-9			✓	3/4	Outlet side on relief valve nut.	✓

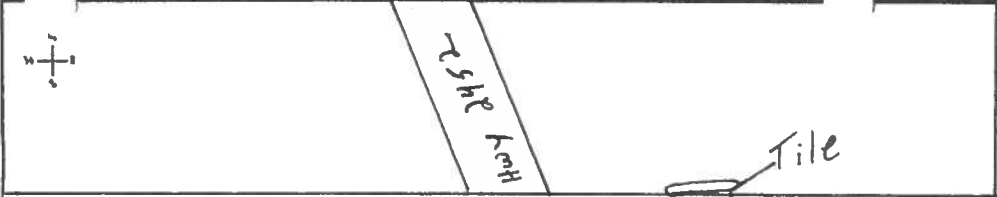
Address Intersection of Hwy 63 & Hwy 2452 City/County Monroe / Tompkinsville State KY

Compression leaking.

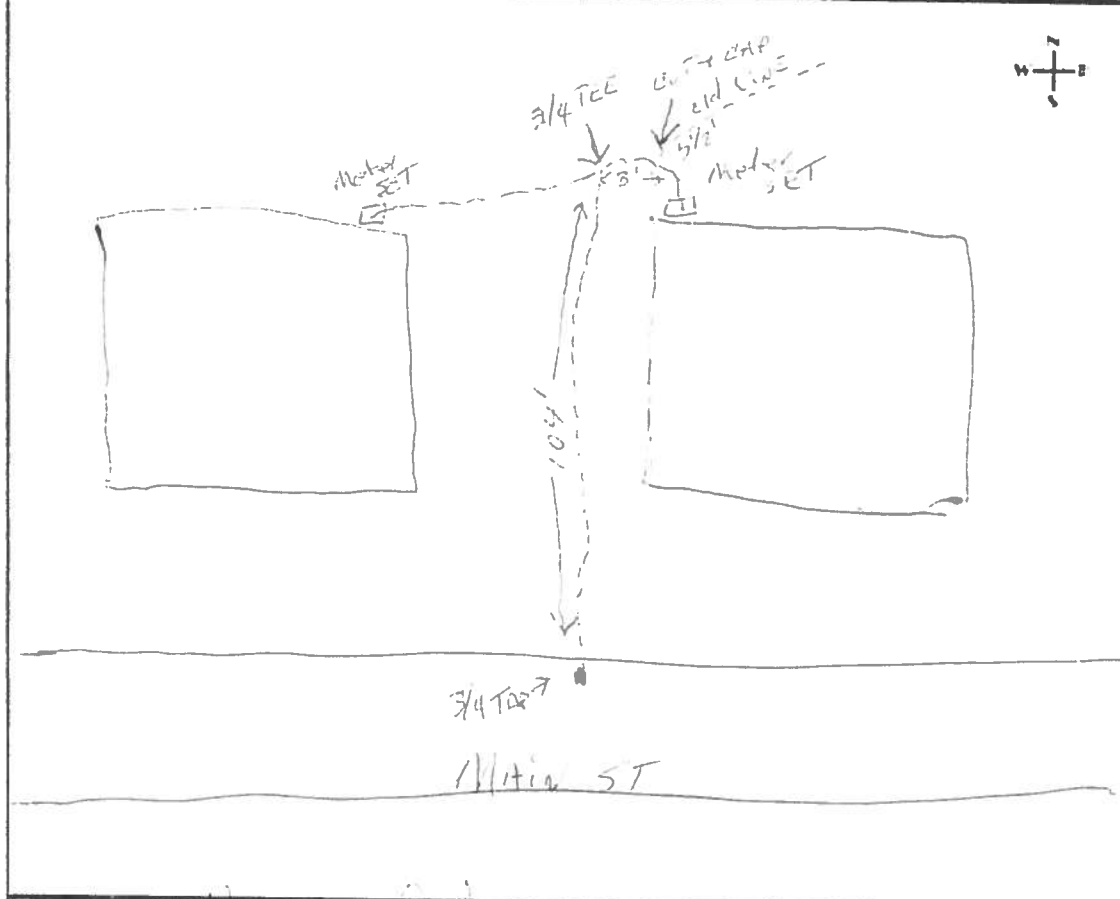
Meter Locked	Yes	No	Card Left	Yes	No
LOCATION					
Gas Main Location	Main St.				
Mainline Valve Installed	Yes	No	<input checked="" type="checkbox"/>		
Service Location	603 Main.				
Service Valve	Tapping Tee	<input checked="" type="checkbox"/>			
REMARKS					
Installed 112' of 3/4 PE PIPE					
USED 2 3/4 COUPLINGS AND 1 3/4					
TEE. COTF CAP OLD SERVICE TEE					
IT IS LOCATED APPROX 5 1/2' STRAIGHT					
OFF THE BACK EDGE OF BLDG					
(QUICK SHOP) TESTED AND SCAP TEST					
SERVICE LINE AND METER SET

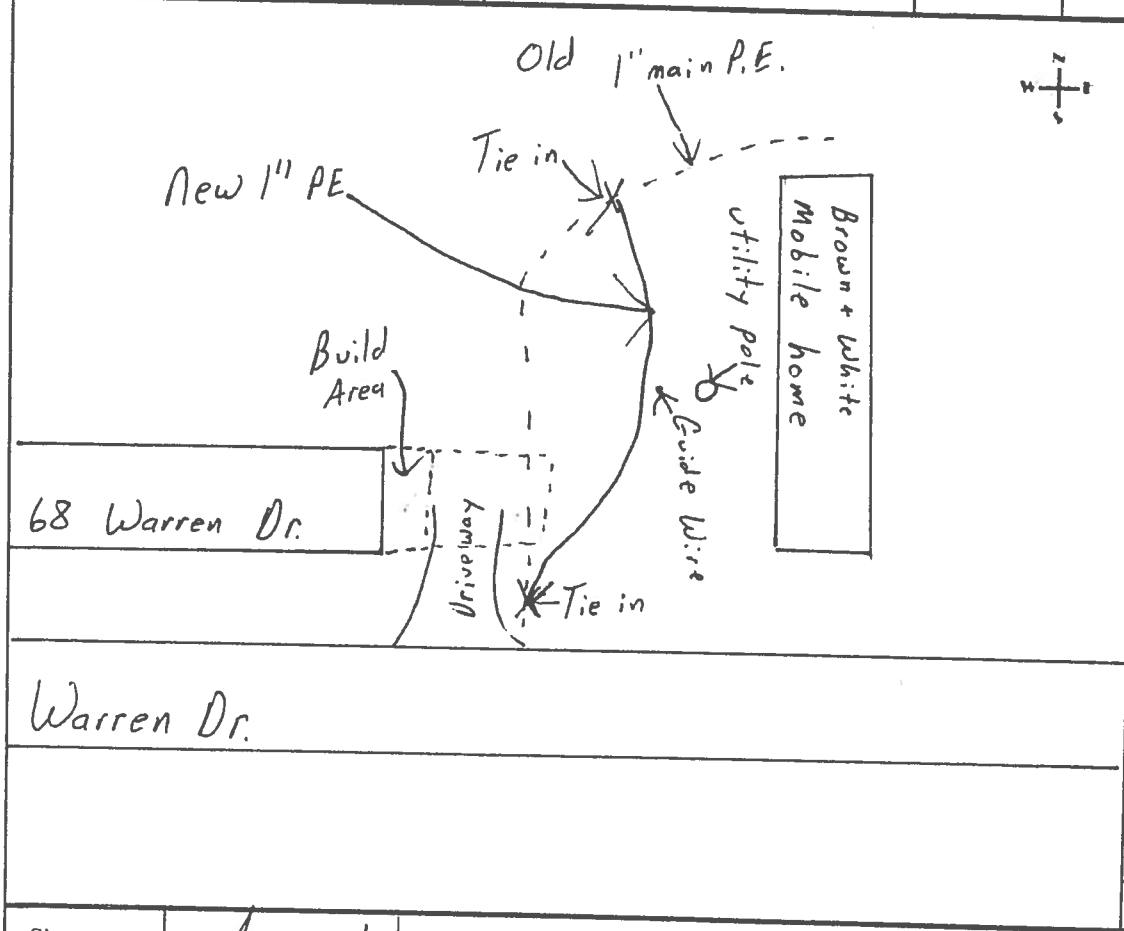
Meter Locked	Yes	No	Card Left	Yes	No
LOCATION					
Gas Main Location	Right side of home, facing front				
Mainline Valve Installed	Yes	No	<input checked="" type="checkbox"/>		
Service Location					
Service Valve	Tapping Tee				
REMARKS					
The customer is adding a garage on to the end of the home. The existing 1" PE gas line was put on the customer's property without permission. We moved the line up the hill appx. 20ft to allow the homeowner to proceed with the addition.

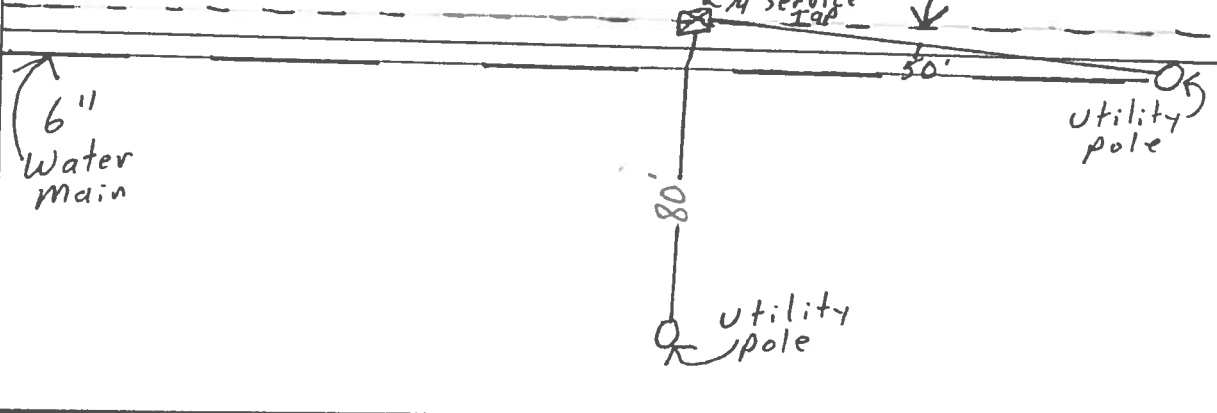
2" steel gas main

TYPE	CONDITION	CORROSION	COATING TYPE
Steel	✓ Excellent	Localized	Millwrap
PE	Good	✓ General	Enamel
Cast Iron	Slight Pitting	Other	Roskote
CSST	Extreme Pitting	Pitting Depth	Oxidemp
Main	Hole/Voids		Xtrucoat
Service	Graphitization		Mastic
Other	Bent		Cold Roll
	Broken		Hot Wrap
	Other		Heat Shrink

COATING CONDITION	SOIL TYPE	SOIL COMPOSITION	EXCAVATION
Good	✓ Rock	Dry	Main Extension
Poor	Cinder	Wet/Swampy	Service Tap
Damaged	Clay	Normal	✓ Leak Repair
Other	Loam	✓ Moisture Range (3-5)	Re-routing
	Sand	Moisture Range (5-8)	Third Party
	Alluvion		Abandonment
	Other		Deactivation
			Utility Theft
			Other

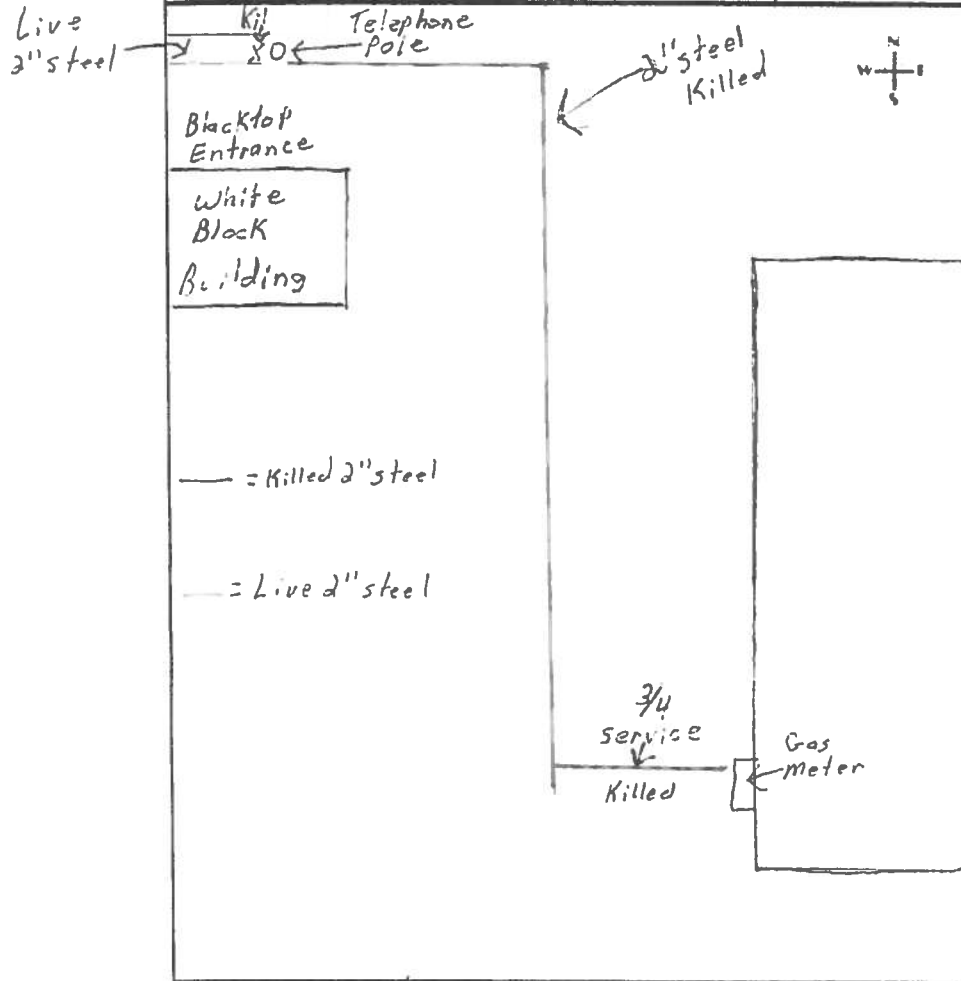
Riser Removed	Yes <input checked="" type="checkbox"/> No <input type="checkbox"/>	Riser Locked	Yes <input type="checkbox"/> No <input checked="" type="checkbox"/>
Pipe Size	2"	Pipe Type	Steel
Seal Type/Material			
LOCATION/TYPE TASK RENDERED			
Gas Main Location	509 N. Main St.		
Removed Valve box/Barricade	Yes <input type="checkbox"/> No <input type="checkbox"/>		
Service Location	Same		
Piping Class Removed	Main Removed <input checked="" type="checkbox"/>	Service Removed <input type="checkbox"/>	
Drawing of streets relational to removed pipe			
REMARKS			
We removed a 2" main line in the parking lot of the old building. The main was capped & a service was ran off of it at the end.

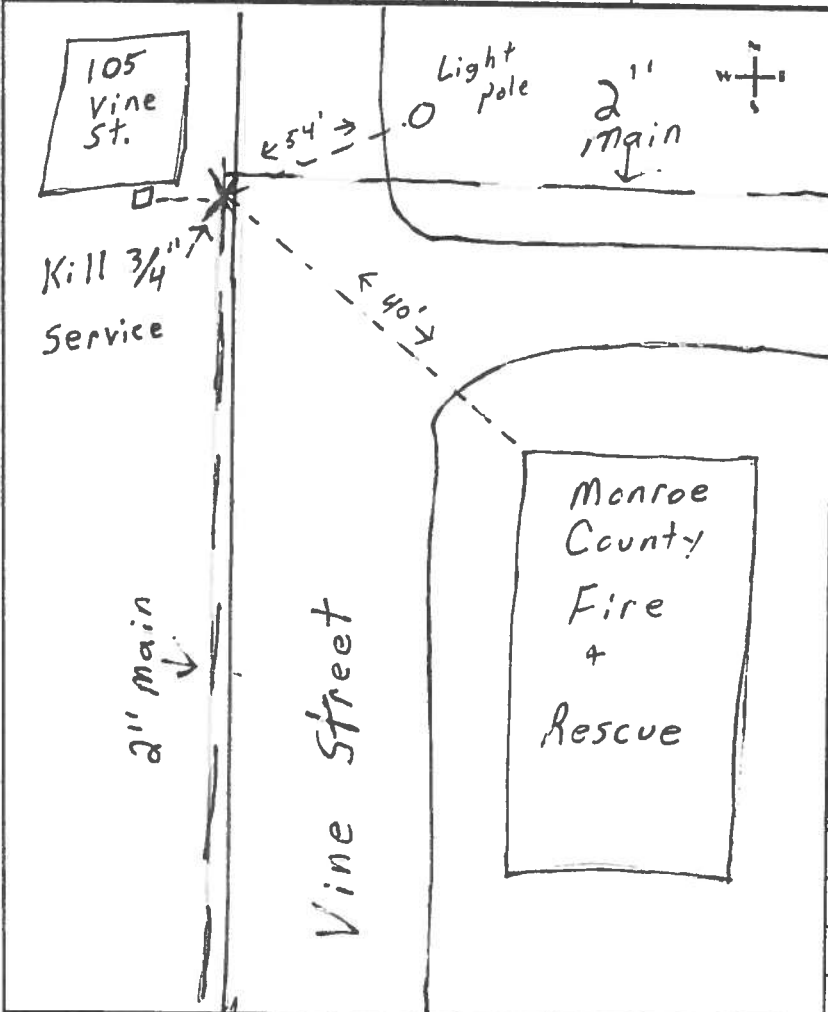
Removed gas service back to the main. The riser on the service was rusted almost into. The customer planned to demolish the house + said to kill the service. She also said she may want to hook back on to the service in the future. We left the tap + took measurements on the work order so we could find it again.

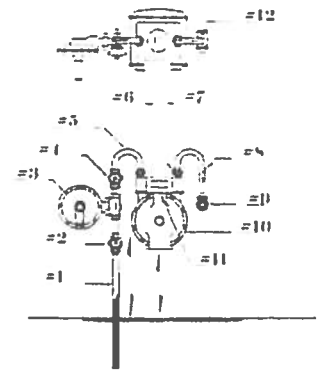
Customer complained of a gas leak outside the home. We arrived & searched for the leak using the soap test on the meter & bar hole test with the CGI, with no results of gas. A flame pack was then used outside to look for the leak, with once again no results. The homeowner opened the door & the flame pack went off. We immediately had them to open windows & doors. The gas meter was shut off & locked until repairs inside the home could be made.

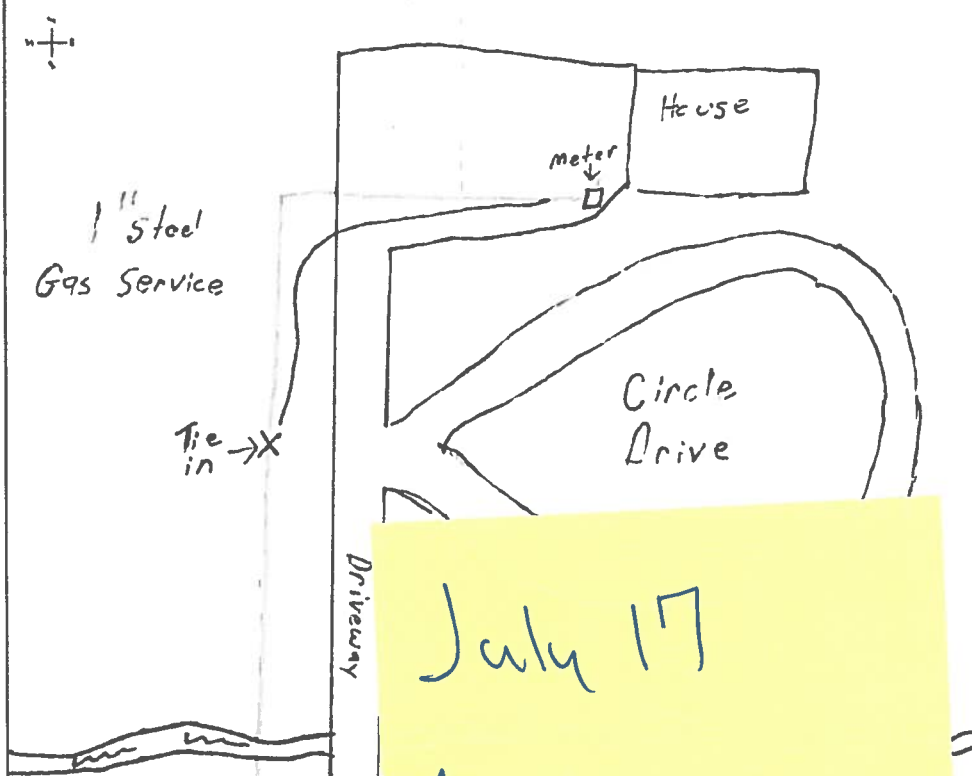
old service
new service

Address | Spring Valley Dr. "Dr. Carter" | City/County | Tompkinsville / Monroe | State

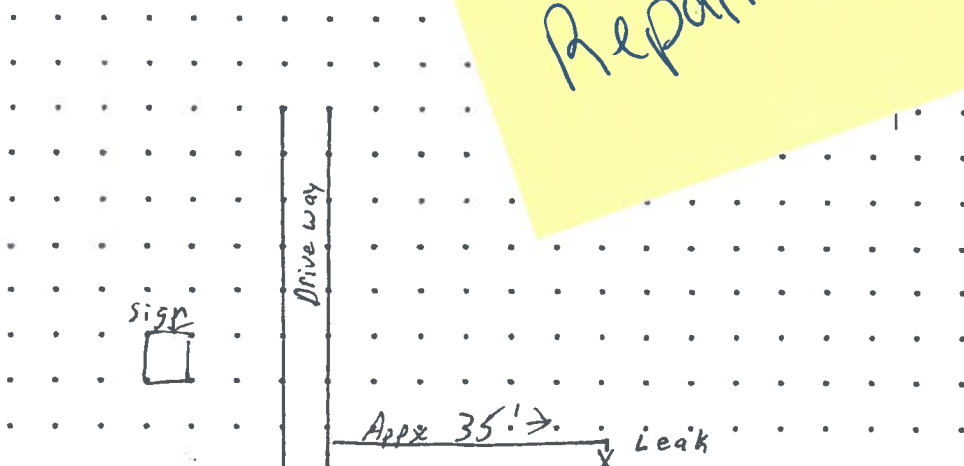
Columbia Ave

Remarks The leak here was on a 2 inch steel main. Corrosion had built up on a weld that looked like it hadn't been wrapped after it was completed. We put a repair clamp on it to fix the problem.

Repaired 5-29-13

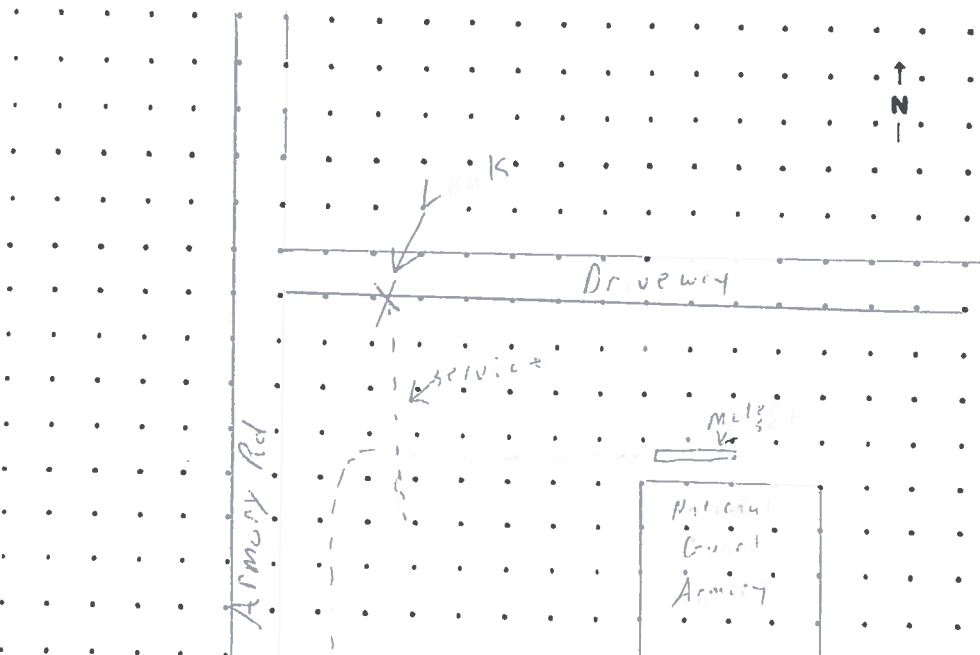
Remarks We found a hole in the steel service line at this location. It was pit together with a steel fitting to PE pipe. We cut out the bad section of steel, welded on a transit on fitting, & fused the PE back together. This made a solid section of pipe on the repair.

Repaired 5-2-13
