COMMONWEALTH OF KENTUCKY  
BEFORE THE PUBLIC SERVICE COMMISSION  
CASE NO. 2015-00100

AN INVESTIGATION OF CEDAR HILLS DISPOSAL  
SANITATION CORPORATION'S NOTICE OF  
INTENT TO ABANDON SERVICE

DAVIESS COUNTY FISCAL COURT'S RESPONSE  
TO COMMISSION STAFF'S FIRST REQUEST FOR INFORMATION

Answer: Please see the attached report along with the Cedar Hills Private Sewer System Inspection Executive Summary

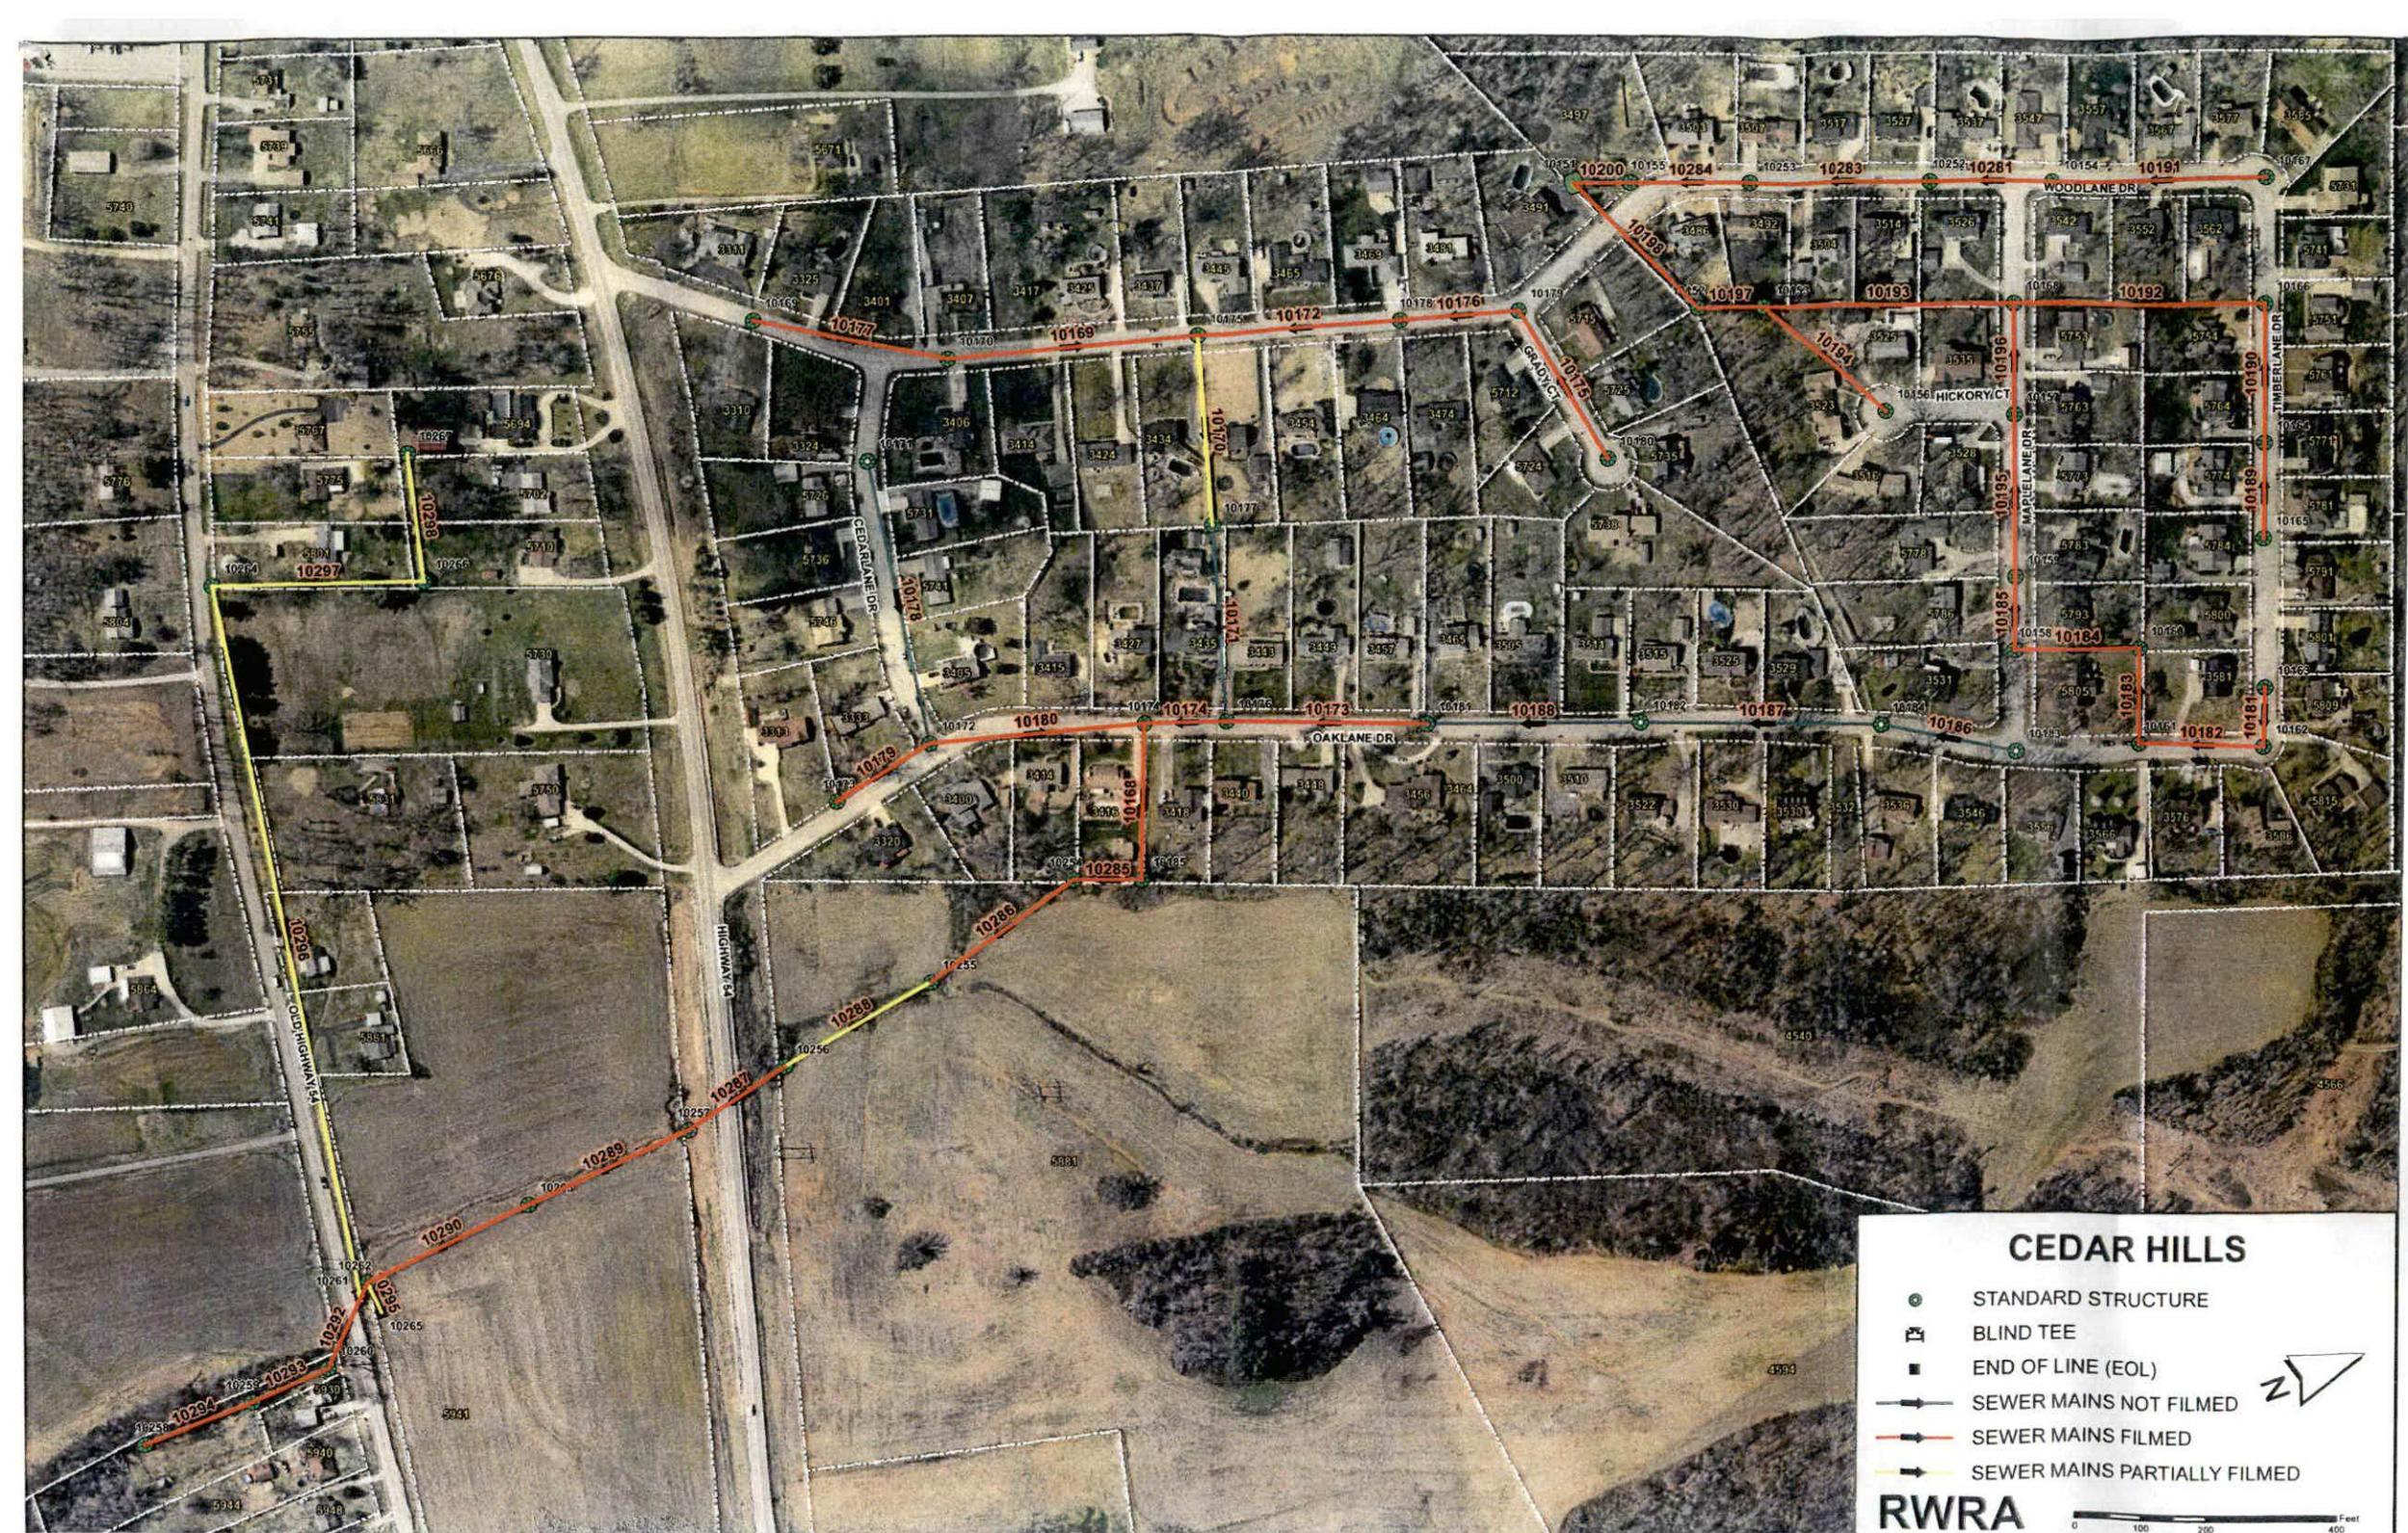
### CEDAR HILLS

- STANDARD STRUCTURE
- BLIND TEE
- END OF LINE (EOL)
- SEWER MAINS NOT FILMED
- SEWER MAINS FILMED
- SEWER MAINS PARTIALLY FILMED
