COMMONWEALTH OF KENTUCKY
BEFORE THE PUBLIC SERVICE COMMISSION

HENDERSON-UNION RURAL ELECTRIC)	
COOPERATIVE CORPORATION, INC.)	
)	
_____)	CASE NO. 92-416
)	
ALLEGED FAILURE TO COMPLY WITH)	
COMMISSION REGULATION 807 KAR 5:006)

O R D E R

Commission Staff has submitted to the Commission an Electrical Utility Accident Investigation Report dated August 19, 1992, appended hereto, which alleges that:

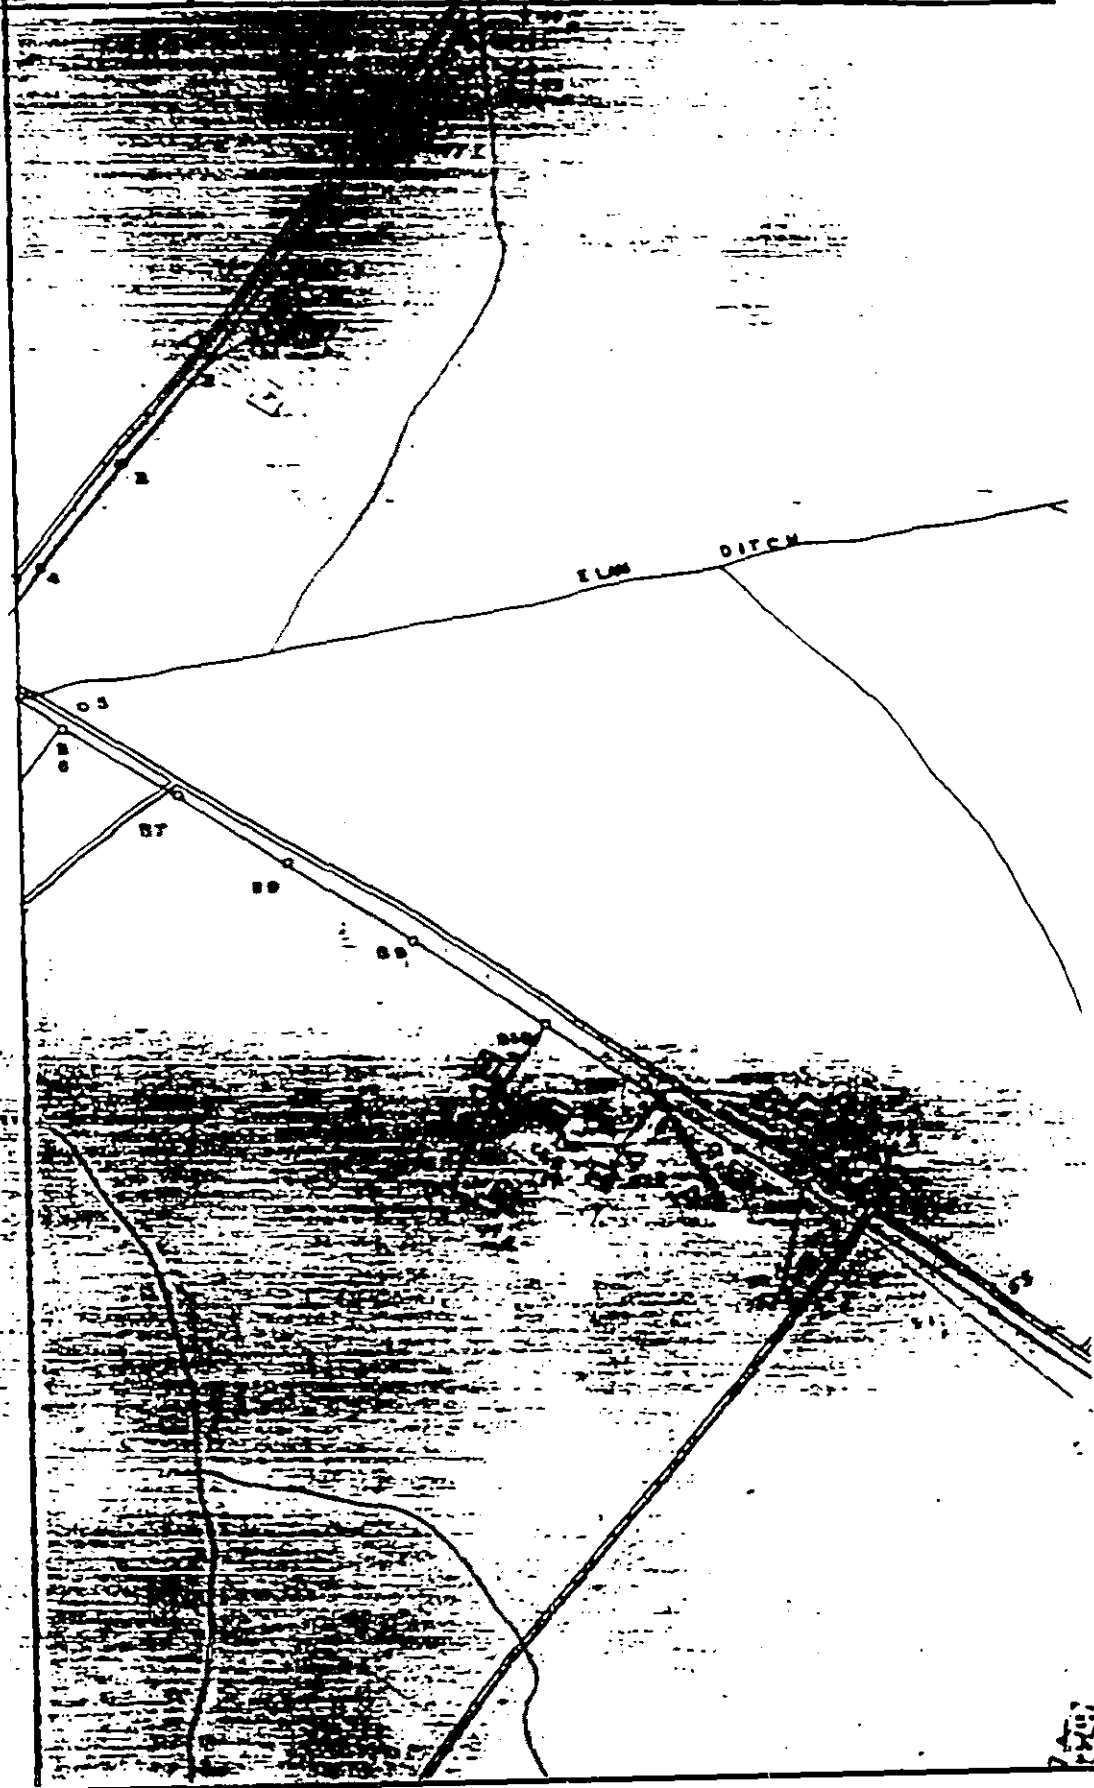
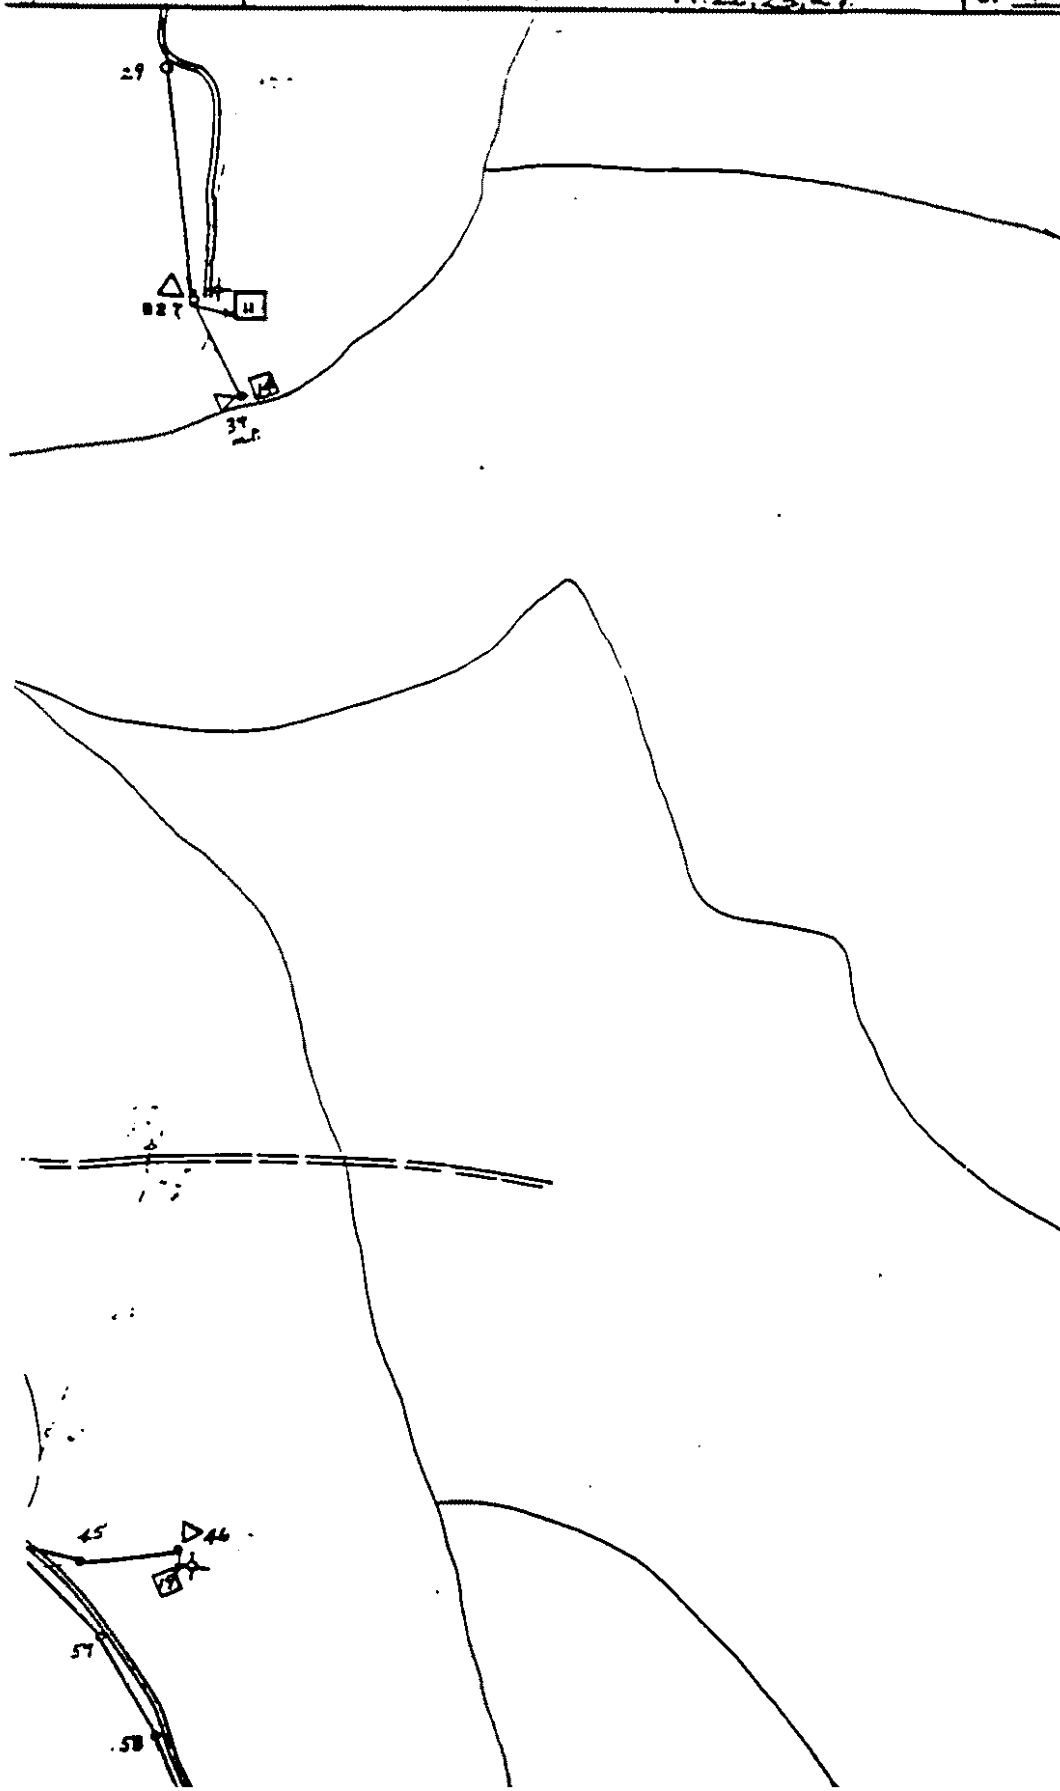
DATE	LAST MILE NO.	60 44 46 47 49 50 58	SHEET 1
	LAST CUST NO.	11.22.23.24	OF 1

HENDERSON-UNION RURAL

JOINT USE RECCT B RECC

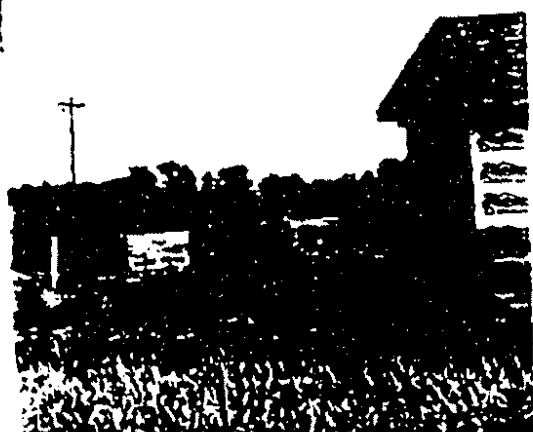
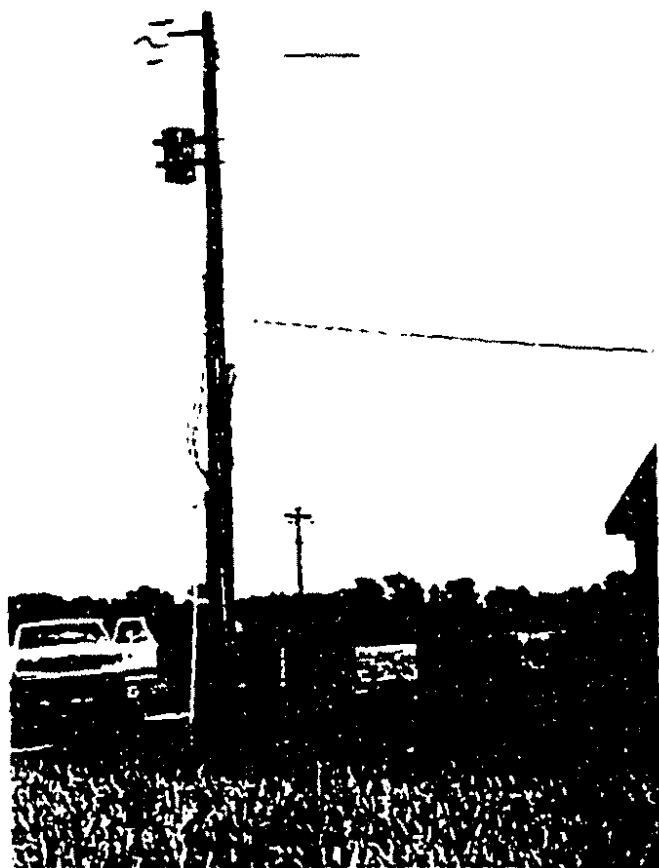
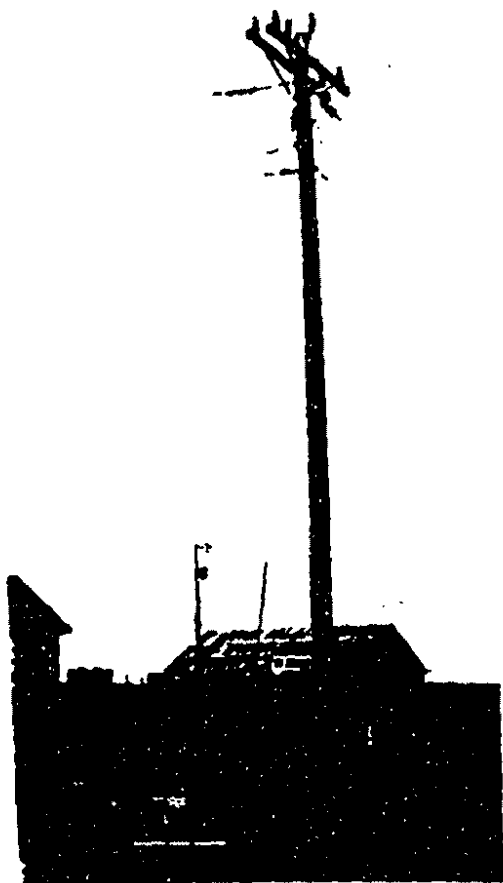
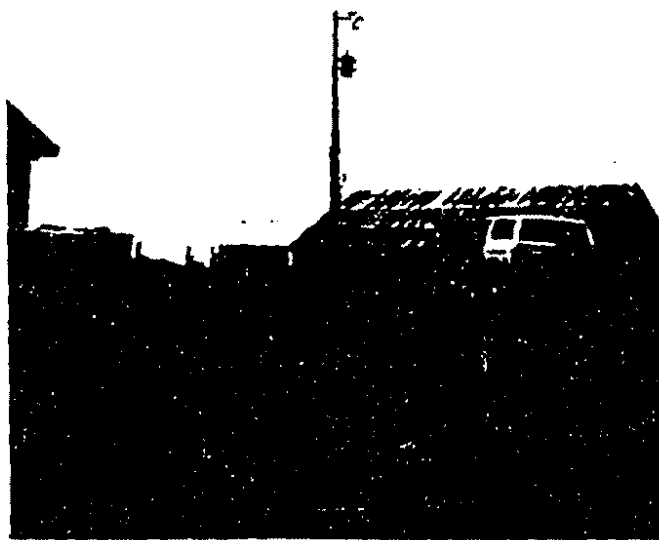
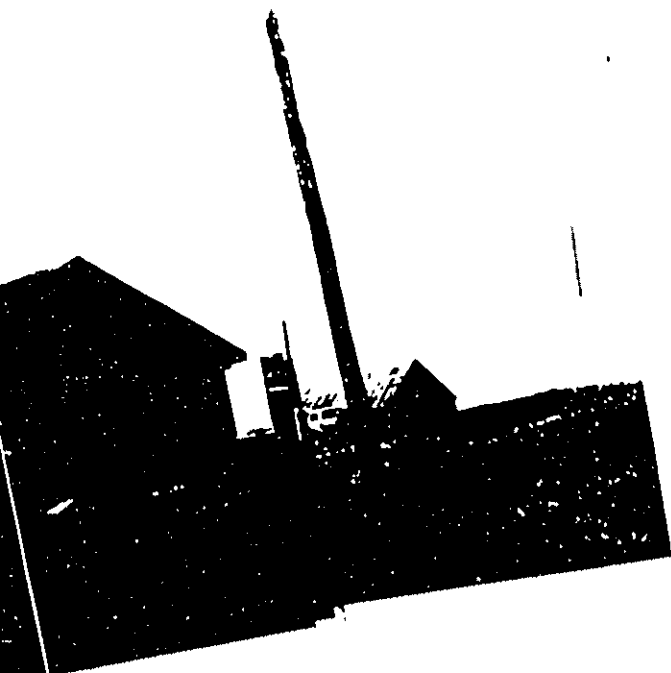
FIELD PHOTOGRAPHS

ATTACHMENT D

WHAT MR COTE WAS OPERATING A BOOM TRUCK, UNLOADING
BRICK. HE WAS ON GROUND USING CABLE STYLE REMOTE (C
HE MISTAKEDLY PUSHED BUTTON TO MAKE BOOM GO IN DIRE
TO CONTACT 7200 VOLT 1P 4W GCSB PRIMARY. THE BOOM
TRUCK BURNED THE PRIMARY WIRE INTO. THE PROTECTIVE DEV
WAS 2 1/2 MILES AWAY. IT IS ALSO A TYPE L, KYLE HEAVY
OIL CIRCUIT RECLOSER. THE RECLOSER LOCKED OPEN AND WE
RECEIVED CALLS FROM CONSUMERS ON THE LINE.
WHEN WE ARRIVED MR. COTE SAID HE WAS ALRIGHT. WE
HE TO SEE DOCTOR. WE TOOK HIM TO A FAMILY MEMBER
TOOK HIM TO A DOCTOR AT THE EMERGENCY ROOM, COMMUNIT
METHODIST HOSPITAL.
HE WAS KEPT OVERNIGHT & RELEASED FRIDAY A.M. HE WA
TO RETURN TO DOCTOR TUESDAY, 6/16 TO HAVE FOOT EXAMINED
HAS MINOR BURNS ON BOTH HANDS & A MINOR BURN ON O
WE HAVE TAKEN PICTURES AND WILL COMPLETE OUR REPORT
THE NEXT 2 WEEKS. OUR CLEARANCE WAS 20'-1" TO NEUTRAL
23'-11" TO OUR PRIMARY. WE FEEL THE RECLOSER OPERATE
PROPERLY.

ON 6-11-92 AT LOCATION 10-72-23 A TRUCK HAULING BRICKS WHICH WAS
BY MEUTH CONSTRUCTION WAS UNLOADING BRICKS WHEN IT CAME IN CONTACT
A SINGLE PHASE 7200 VOLT LINE. THE FOUR ACSR PRIMARY WIRE WAS BURNED
DOWN. THE DRIVER WAS BURNED ON BOTH HANDS AND ONE FOOT. THE TRUCK
RECEIVED SOME DAMAGE. I RECEIVED THE FIRST REPORT OF THE OUTAGE AT
15:45 FROM MRS. JAMES MCCONATHY. HER ACCOUNT NUMBER IS [REDACTED]. K
LIGGETT WAS DISPATCHED TO THE TROUBLE SITE WHERE HE OPENED THE TAP
RESTORED POWER TO THE REST OF THE CONSUMERS AT 16:25. AFTER I RECEIVED
THE FIRST REPORT OF LIGHTS OUT A ROGER MEUTH CALLED AND SAID THAT
HIS TRUCKS HAD HIT OUR LINE BUT THAT THE DRIVER WAS NOT HURT AND
TRUCK WAS OK.
