COMMONWEALTH OF KENTUCKY
BEFORE THE PUBLIC SERVICE COMMISSION

ALTERNATIVE RATE FILING OF HILLRIDGE) CASE NO. 2010-00426
FACILITIES, INC.)

COMMISSION STAFF'S REQUEST FOR INFORMATION
TO LOUISVILLE-JEFFERSON COUNTY METROPOLITAN SEWER DISTRICT

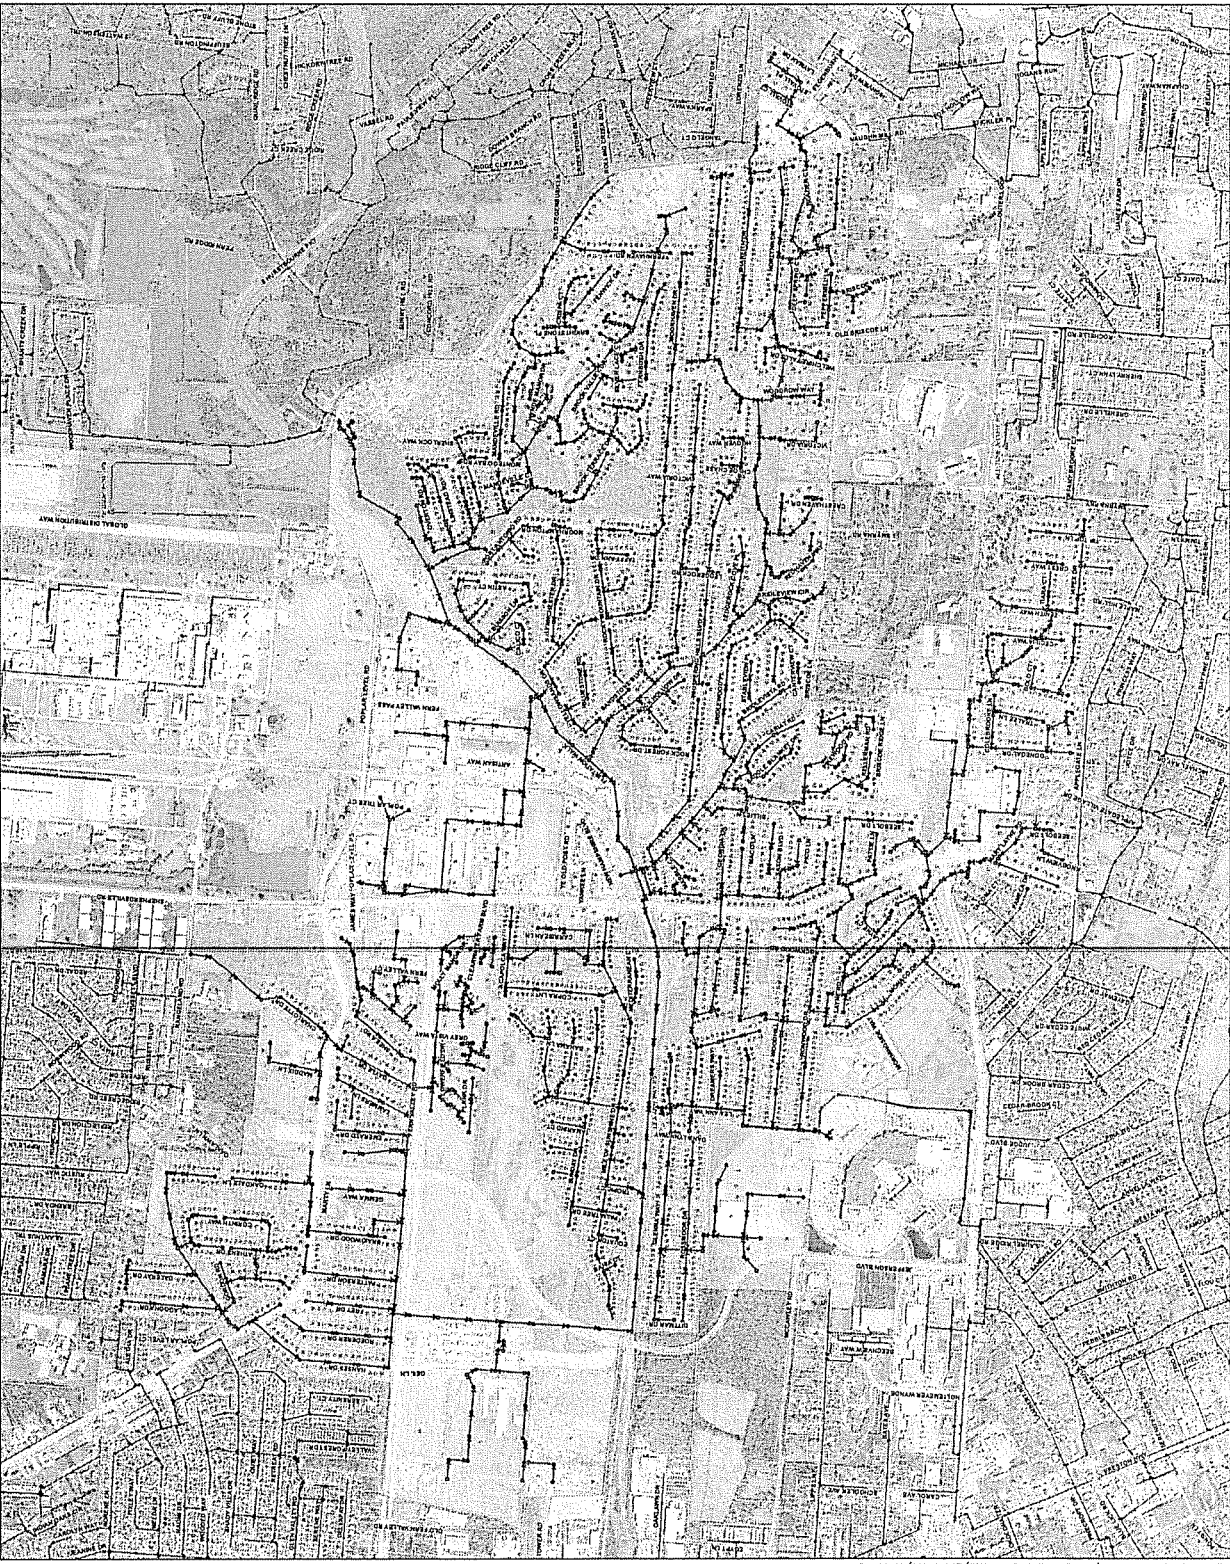
- MSD
- Private
- P - Operated by MSD

Sewers

Map Revision: September 2008 Aerial Date: 2006
