Visual Impact Analysis for Proposed Electric Transmission Line Case No. 2004-00351 City of Melbourne Campbell County, Kentucky

November 19, 2004

Lead Agency: Kentucky State Board of Electric Generation and Transmission Siting

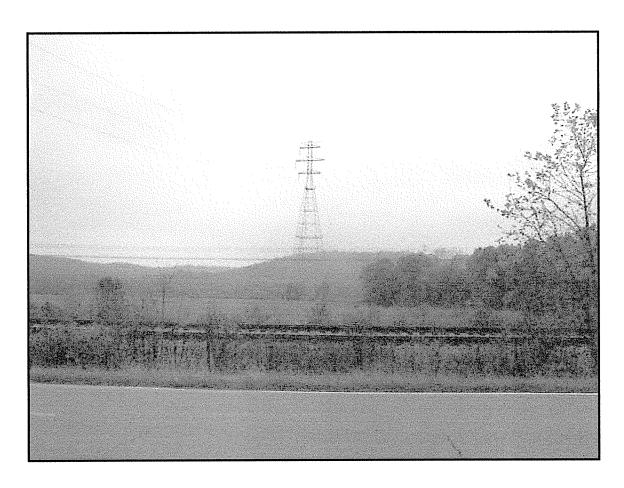
**Photograph 1** View of Tower 20 Close to the Ohio River View from Mary Inglis Highway looking toward Tower 20 and the Ohio River

Beginning at the Ohio River running westward for 2.67 miles to Tower 11, the new line will be placed on the existing tower structures. The existing structures carry 345-kV lines. See Photographs 1 and 2 for pictures of the structures near the Ohio River. Tower 11 is located near the intersection of Nine Mile and Gunkel Roads.

An additional 138-kV wire will be added to existing towers numbered 20 through 11. Photographs 1 and 2, located in Attachment 1, show the existing Towers 20 and 19. Tower 19 is typical of the structures used between Towers 19 and 11. Because of its location crossing Highway 8, this portion of the corridor has more viewers that any other area of the project. However, the addition of another wire to an existing structure does not provide more visual contrast or add to the dominance of the existing structure or add view impairment. There is no additional visual impact for this area or in any of the 2.67 miles of project corridor extending to Tower 11. No adverse construction impacts or change in easement maintenance management practices are anticipated from the addition of a new wire to these existing structures.

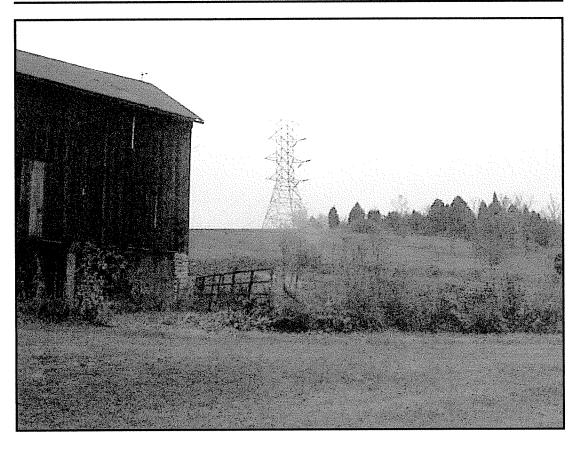
Photograph 2 View of Existing Towers From Intersection of Mary Inglis Highway (State Highway 8) and Ten Mile Road
Looking Northwest Toward Tower 19

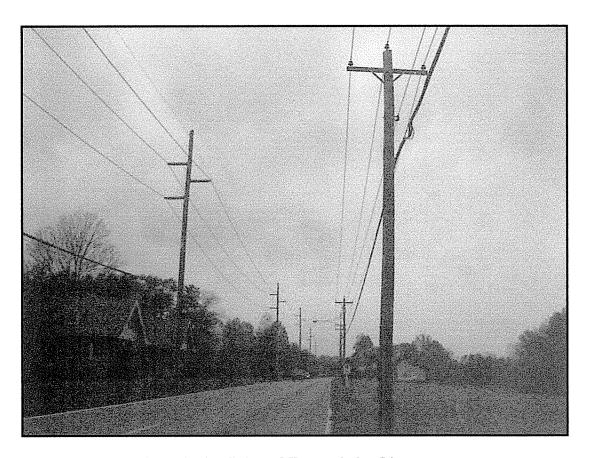
Photograph 4 Typical Wooden Pole and Transmission Lines

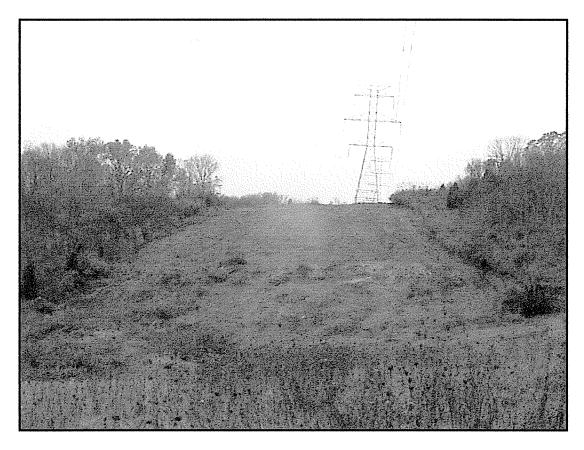
Photograph 5 View Looking West from Farm on Dead End Road.

Photograph 5 shows a pasture area located off Dead End Road. In this area, the new line on wood poles is proposed. A typical pole would be located slightly to the right of the tower seen in this picture and at a lower elevation. The 70- to 100-foot pole would be approximately the same height as the first cross-arm. No additional clearing would be required in this area, and the construction impacts would be minimal and temporary.

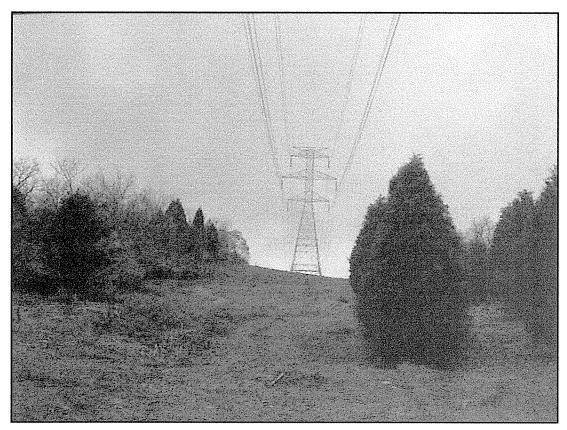
**Photograph 7** View Westward from Subdivision on Lakewood Drive of Cleared Easement

A subdivision home is located immediately to the right of this picture.

Photograph 7 shows the cleared easement looking west from the subdivision. Houses are located just to the right, outside the view of this photograph. Tower 3 is in the view close to the top of the ridge. A series of four poles is proposed to be located in a line 100 feet to the left of the tower and the wires shown in this picture. Some maintenance mowing and clearing has occurred within the maintained portion of this easement. Additional clearing may occur to the left side of this picture; however, the edge of vegetation will remain similar because the type and mass of vegetation is fairly consistent in this area. The visual contrast will not increase with the addition of the poles in this area but the dominance of the transmission wires and tower will increase in this view. The view however will not
