Kentucky Power Company
 KPSC Case No. 2019-00154
 Commission Staff's First Set of Data Requests
 Dated September 16, 2019

- KPSC 1_2** Refer to the Ali Testimony, unnumbered page 14, lines 12-17.
- a. Identify the nine project components that were previously designated as Supplemental Projects but are now reclassified as Baseline Projects by PJM.
 - b. Explain when these project components were designated by PJM as Baseline Projects along with the identified need for these particular project components and the determination that these components represent the optimal solution to address those needs.

AEP Transmission Zone: Baseline Hazard – Wooton 161kV Circuit

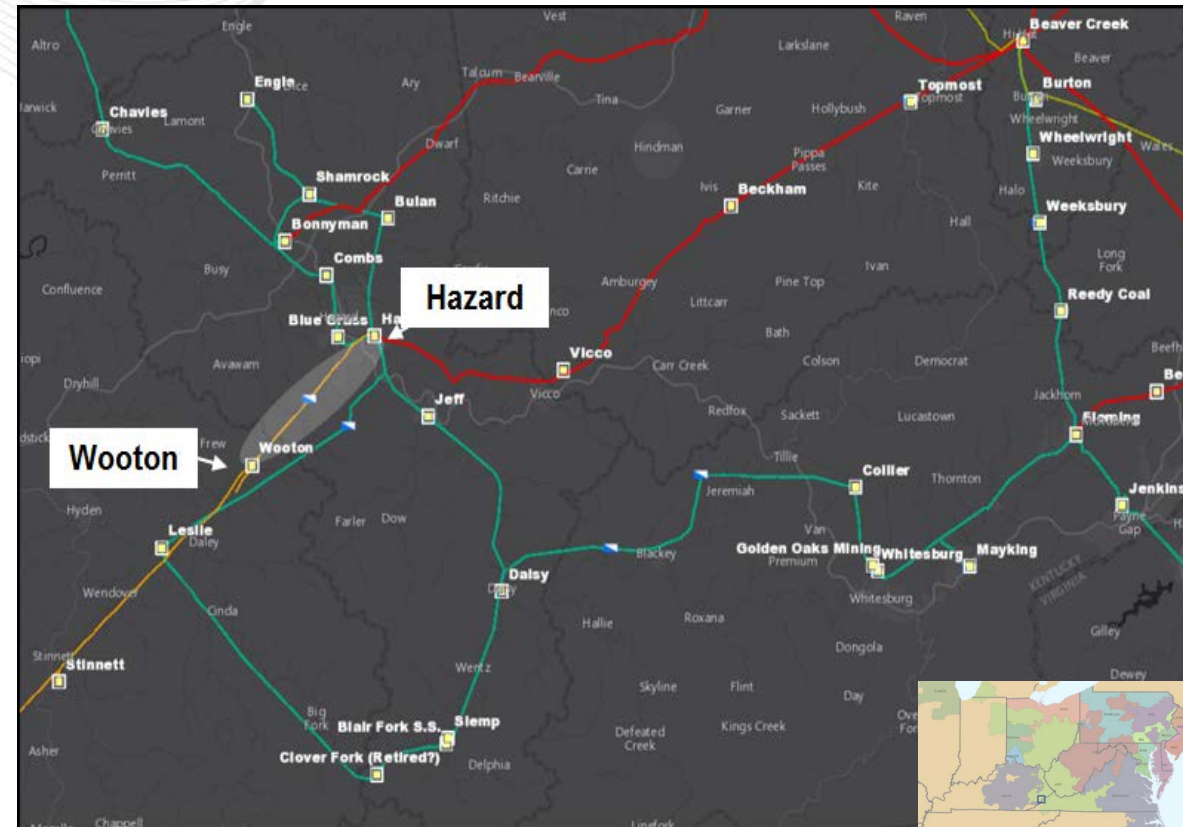
Original Scope Description: Rebuild the Hazard – Wooton 161 kV line utilizing 795 26/7 ACSR conductor (300 MVA rating).

New Scope Description: Rebuild the Hazard – Wooton 161 kV line utilizing 795 26/7 ACSR conductor (300 MVA rating). **Replace line relaying and associated termination equipment .**

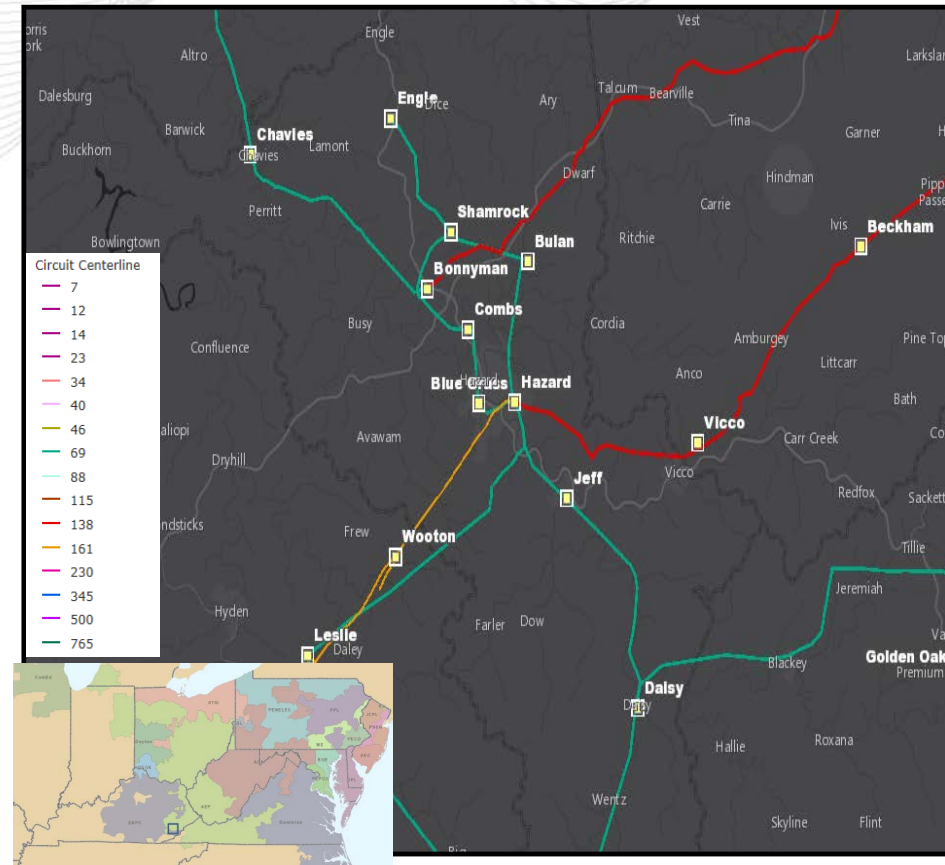
AEP Transmission Zone: Supplemental Hazard Station

Circuit breakers S (1100 A, 11.3 kA) and E (1800 A, 27 kA) at Hazard station are FK type breakers all over 40 years old. Circuit breaker F at Hazard is a 1200 A, 31.5 kA CG type breaker. These are oil breakers that have come more difficult to maintain due to the required oil handling. In general, oil spills occur often during routine maintenance and failures with these types of breakers. Other drivers include PCB content, damage to bushings and number of fault operations exceeding the recommendations of the manufacturer. Breakers S, E, and F have experienced 82, 184, and 193 fault operations respectively, well above the manufacturer's recommendation of 10.

Circuit breaker M (2000 A, 40 kA) will need to be relocated in association with the baseline project to replace the existing 161/138 kV transformer at Hazard station (b2761) in order to limit outage times. The breaker is an SF6-gas breaker, 29 years old and has experienced 21 fault operations, which exceeds the manufacturer's recommendation of 10.

Transformer #1 (1974 vintage, 50 MVA) and #2 (1973 vintage, 130 MVA) show dielectric breakdown (insulation), accessory damage (bushings/windings) and short circuit breakdown (due to amount of through faults). Transformer #1 also shows signs of corrosion on radiators as well as oil leaks.

Circuit Switcher BB a MARK V unit which have presented AEP with a large amount of failures and mis-operations. AEP has determined that all MARK V's will be replaced and upgraded with the latest AEP cap-switcher design standard. **Capacitor bank BB will need to be relocated in association with the baseline project to replace the existing 161/138 kV transformer at Hazard station (b2761).** Additional engineering design has indicated that Capacitor bank BB would not need to be relocated to accommodate the baseline 161/138 kV transformer replacement/relocation.

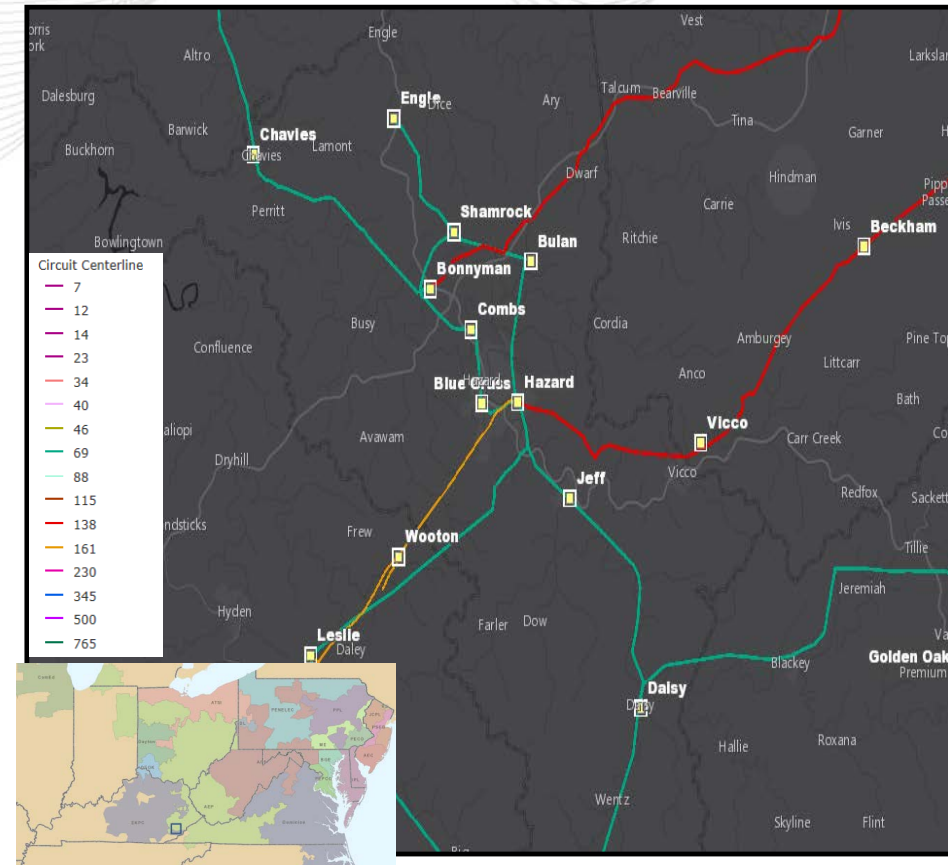
AEP Transmission Zone: Supplemental Hazard Station

Install a new 3000 A 40 kA 138 kV circuit breaker at Hazard station on the line exit towards Beckham station. (s1412.1)

Replace 138 kV capacitor bank and switcher BB with a new switcher and 43.2 MVAR capacitor bank. (s1412.3)

Replace 138/69 kV transformers #1 and #2 with new 138/69 kV 130 MVA transformers with 138 kV circuit switchers on the high side and 3000 A 40 kA 69 kV breakers on the low side. (s1412.4)

Replaces 69 kV circuit breakers S, E, and F with 3000 A 40 kA 69 kV circuit breakers with a bus tie 3000A 69 kV circuit breaker being installed between the existing 69 kV box bays. (s1412.5)

Replace 69 kV capacitor bank and switcher CC with a new switcher and 28.8 MVAR capacitor bank. 69 kV capacitor bank and switcher AA will be retired.

Replace 161 kV circuit breaker M towards Wooton with a 161 kV 3000 A 40 kA breaker. (s1412.6)
This work is already included in the baseline project (b2761).
