Kentucky State Board on Electric Generation and Transmission Siting Henderson County Solar, LLC – Case No. 2020-00391 Application – Exhibit 14 Volume 2, Tab 14

Additional Information

Wetlands Delineation Report

EXHIBIT 14 ATTACHMENT 14.1

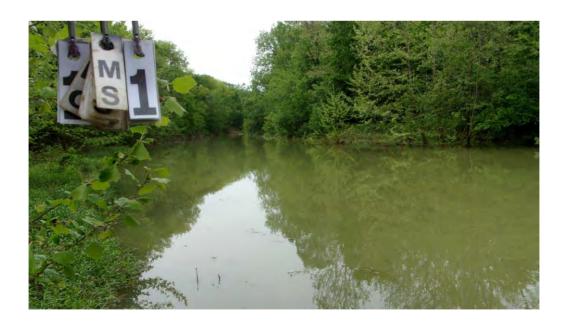
Width / Depth Ra Stream Type:	atio:	6.00 E6	Percent Riffle: Percent Run:	25 35	
			Percent Pool: Step Pool:	40

Comments: Canoe Creek back watered by Ohio River at time of assessment.

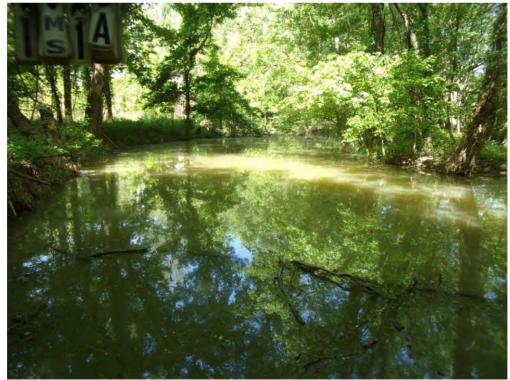
Entrenchment Ratio:		1.40	Altered Channel:	СН		
			Percent Riffle:	40		
Width / Depth R	atio:	8.33				
Stream Type:		G6c	Percent Run:	20		
			Percent Pool:	40		
			Step Pool:

Comments: Stream measurements estimated due to Ohio River back water conditions in stream.

Project ID: Henderson	County Solar	Stream Class:	Perennial Exhibit 14 Attachment 14.1
Stream ID: 1MS1A		Location;	HENDERSON KY Page 48 of 237
Lat: 37.80330	Long: -87.63178	River Basin	Ohio
Investigators: Ryan Wi	-	- <u>-</u>	
Signature:	Date: 04-May-20		Reason for Survey:
5	Time: 9:30 AM		404 functional Assessment:
WEATHER	Current Past 24 Hour	Hopyy rain	in last 7 days
CONDITIONS			
	Storm (Heavy Rain) Storm (Heavy Rain)	No No	Yes
	Rain Steady Rain Steady	Air Temp F	65
	Showers (Intermittent) Showers (Intermittent)	Air Temp C	18
	Cloud Cover % 0 Cloud Cover %	Other	
	Clear/Sunny		
STREAM			Stream Type
CHARACTERIZATION	Stream Subsystem		
	Perennial Intermittent Ephemeral		Coldwater
	Stream Origin		✓ Warmwater Catchment Area
	Stream Origin		Mile ² 2.89
	Upland Runoff Mixture of Origins		Km ² 7.49
	Spring-fed/Ground Water Wetland Other		Kii <u>7.49</u>
WATERSHED	Surrounding Land Use & Percentage	Local V	Vatershed NPS Pollution

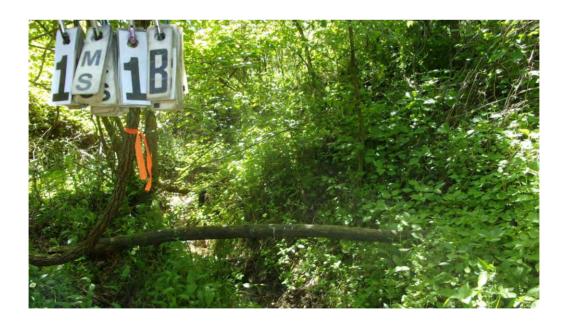
Entrenchment R		1.43	Dama ant Diffini	60		
Width / Depth Ratio: 11.67		Percent Riffle:	60			
Stream Type:		B6	Percent Run:	30		
			Percent Pool:	10		
		f stream backwater	Step Pool:

Comments: Lower portion of stream backwaters from Ohio River.

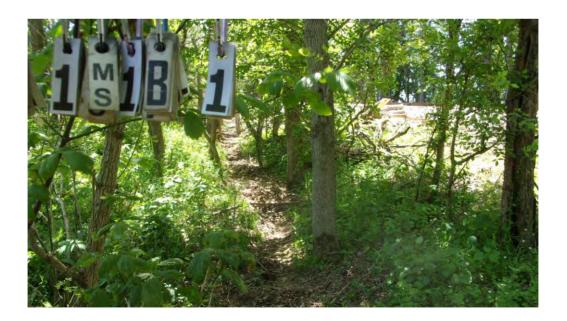
3.23	Percent Riffle:	60	
Width / Depth Ra	atio:	20.67			
Stream Type:		C6	Percent Run:	35	
			Percent Pool:	5	
Comments: Stre		t runs parallel to R	Step Pool:

Stream segment runs parallel to Rail line.

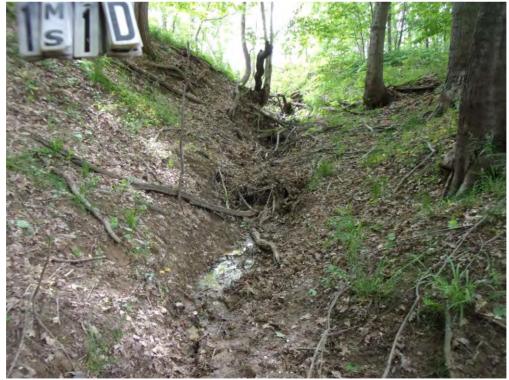
Entrenchment R	•	1.41	Altered Channel:	DAM		
Width / Depth R		9.14	Percent Riffle:	60		
Stream Type:		G6	Percent Run:	30		
P			Percent Pool:	10		
			Step Pool:

Comments: Rock/debris weir at edge of crop field to prevent further head cutting.

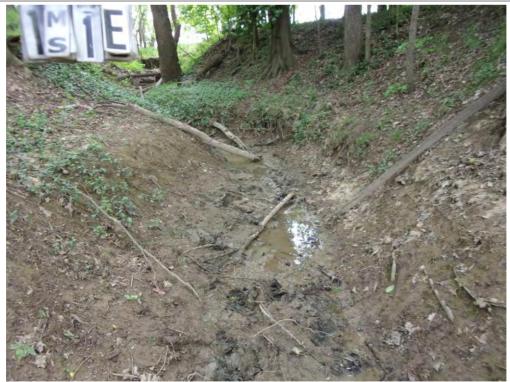
-	logical De	-	Meander Patterns:	M-1		PI = Pipe RSC = Road	Side Channel
Width at Bottom	•	1.80	Stream Channel Debris:	D3			-
Bankfull Surface	Width:	5.20	Stream Bank Erosion:	High			
Width of Flood F	Prone Area:	8.10	Stream Aggradation:	SI deg			
Bankfull Mean D	epth:	0.40	Channel Stability:	Poor			
Entrenchment R	atio:	1.56	Altered Channel:	DAM			
Width / Depth R	atio:	13.00	Percent Riffle:	60			
Stream Type:		B6	Percent Run:	20			
P		,	Percent Pool:	20			
			Step Pool:

Comments: Rock weir at head of stream to prevent headcutting into crop field has failed.

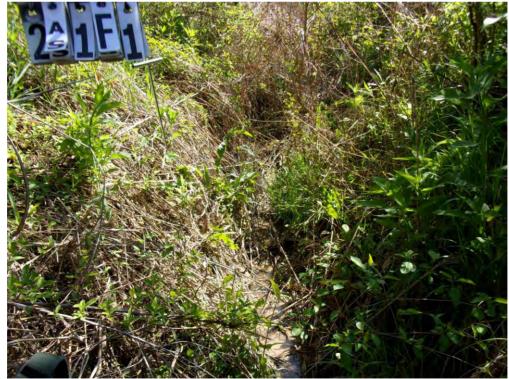
Entrenchment R		1.33	Altered Channel:	CH,RSC	
		6.75	Percent Riffle:	20	
Width / Depth Ra	auo.	G6	Percent Run:	70	
Stream Type:		Go	Percent Pool:	10	
			Step Pool:

Comments: Jursidiction is questionable. Rail/Road side channel.

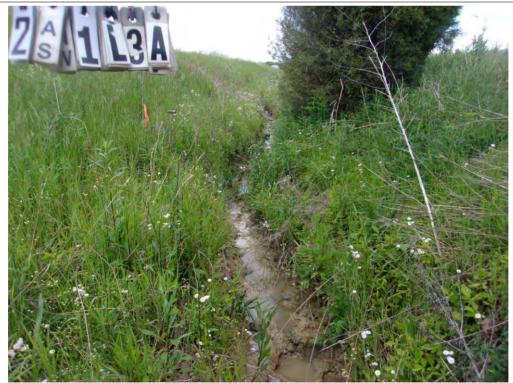
Stream 2AS1L3A Date: 5/11/20		Date: 5/11/2020	Inv.: Scott Mitchell	Entry:	Ryan Winka
Latitude: Longitude:		37.77994 N -87.62812 W	Level III - Stream State or Condition Morphological Description		
Length:		748	Primary Riparian Left:	4b 10	Altered Channel Key
Distance:		745	Primary Riparian Right:	7a 10	CH = Channelized
Sinuosity:		1.00	Secondary Riparian Left:	RV 1 90	CV = Culvert DAM = Weir, Dam, or Rock
FlowType:		Intermittent	Secondary Riparian Right:	RV 1 90	Checks
Area In Acres:		0.06	Stream Flow Regime:	12	DG = Dredged LWC = Low Water Crossing
Slope %:		1.5	Stream Size:	S-2	NA = Not applicable
Level II - Stream		Depositional Features:	NA	OT = Other (See Comments)	
	logical Des		Meander Patterns:	M-1	PI = Pipe RSC = Road Side Channel
Width at Bottom	•	0.60	Stream Channel Debris:	D1	
Bankfull Surface	Width:	3.50	Stream Bank Erosion:	Moderate	
Width of Flood F	rone Area:	4.50	Stream Aggradation:	Stable

Bankfull Mean D	epth:	0.80	Channel Stability:	Fair	
Entrenchment R		1.29	Altered Channel:	CH,CV,PI	
Width / Depth Ra	atio:	4.38	Percent Riffle:	40	
Stream Type:		G6c	Percent Run:	55	
1			Percent Pool:	5	
			Step Pool:

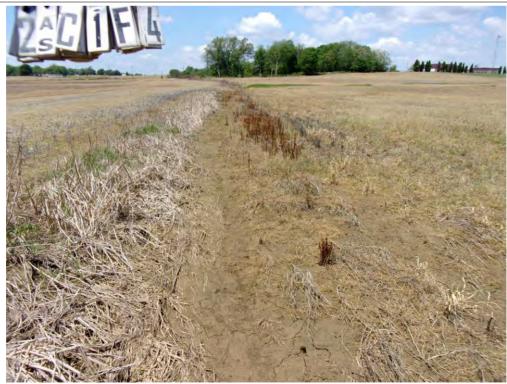
Stream 2ASC1F4		Date: 5/7/2020	Inv.: Keith Michalski	Entry: Scott Mitchell	
Latitude: 37.78978 N Longitude: -87.64062 W		Level III - Stream State or Condition Morphological Description			
Length:		1741	Primary Riparian Left: Primary Riparian Right:		Altered Channel Key
Distance: Sinuosity:		1735 1.00	Secondary Riparian Left:		CH = Channelized CV = Culvert DAM = Weir, Dam, or Rock
FlowType: Area In Acres:	Nor	u Jurisdictional 0.00	Secondary Riparian Right: Stream Flow Regime:		Checks DG = Dredged
Slope %:		1	Stream Size:	S-1	LWC = Low Water Crossing NA = Not applicable OT = Other (See
Level II - Stream Morphological Description		Depositional Features: Meander Patterns:	M-1	Comments) PI = Pipe RSC = Road Side Channel	
Width at Bottom	of Stream:	0.00	Stream Channel Debris: Stream Bank Erosion:		
Bankfull Surface	Width:	0.00	Stream Aggradation:		
Width of Flood F	Prone Area:	0.00	Channel Stability:		
Bankfull Mean Depth:		0.00	Altered Channel:

Entrenchment R	atio:	0.00			
Width / Depth Ratio:		0.00	Percent Riffle:	0	
Stream Type:		Swale	Percent Run:	0	
			Percent Pool:	0	
			Step Pool:

Comments: Feature is hillside diversion.

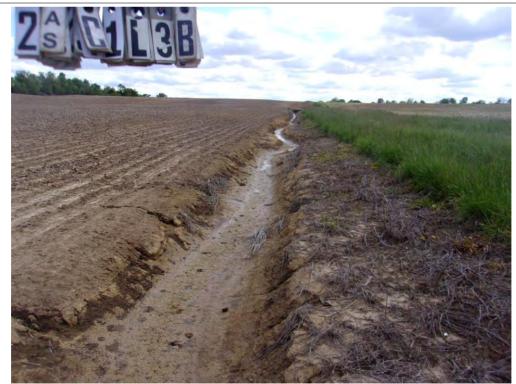
Stream 2ASC	:1L3B	Date: 5/11/2020	Inv.: Scott Mitchell	Entry: Ry	yan Winka
Latitude: 37.77863 N Longitude: -87.62927 W		Level III - Stream State or Condition Morphological Description			
Length: Distance: Sinuosity: FlowType: Area In Acres: Slope %:	vel II - Stree logical Des of Stream:	644 640 1.01 1.01 0.00 2	Primary Riparian Left: Primary Riparian Right: Secondary Riparian Left: Secondary Riparian Right: Stream Flow Regime: Stream Size: Depositional Features: Meander Patterns: Stream Channel Debris: Stream Bank Erosion: Stream Aggradation:	generation generation	Altered Channel Key CH = Channelized CV = Culvert DAM = Weir, Dam, or Rock Checks DG = Dredged LWC = Low Water Crossing NA = Not applicable OT = Other (See Comments) PI = Pipe RSC = Road Side Channel
Width of Flood F Bankfull Mean D Entrenchment R Width / Depth R Stream Type:	epth: atio:	0.00 0.00 0.00 Gulley	Channel Stability: Altered Channel: Percent Riffle: Percent Run: Percent Pool: Step Pool:

Comments: Watershed entirely in agriculture production.

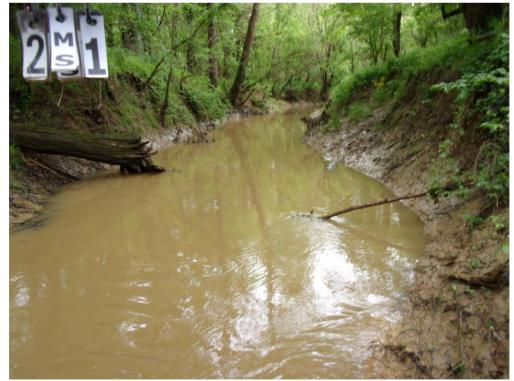
Stream 2MS1		Date: 5/5/2020	Inv.: Keith Michalski	Entry: Ryan Harris			
Latitude: 037.78741 N Longitude: -87.62783 W			Level III - Stream State or Condition Morphological Description				
Length:		1987	Primary Riparian Left:	10b	100	Altered Cl	hannel Key
Distance:		1755	Primary Riparian Right:	10b	60	CH = Channel	-
Sinuosity:		1.13	Secondary Riparian Left:		U	CV = Culvert DAM = Weir, I	Dam or Pock
FlowType:		Perennial	Secondary Riparian Right:	RV 1	40	Checks	,
Area In Acres:		1.28	Stream Flow Regime:	P2		DG = Dredgeo LWC = Low W	
Slope %:		1	Stream Size:	S-4		NA = Not appl	licable
Level II - Stream			Depositional Features:	OT = Other (See Comments)		bee	
	logical De		Meander Patterns:	M-1		PI = Pipe RSC = Road S	Side Channel
Width at Bottom	•	14.00	Stream Channel Debris:	D3			
Bankfull Surface	Width:	28.00	Stream Bank Erosion:	High			
Width of Flood F	Prone Area:	200.00	Stream Aggradation:	Stable			
Bankfull Mean Depth:		4.60	Channel Stability:	Fair

Entrenchment Ratio:		7.14	Altered Channel:	PI			
Width / Depth Ratio:		6.09	Percent Riffle:	20			
Stream Type:		E6	Percent Run:	50			
1			Percent Pool:	30			
			Step Pool:

Comments: Stream accesses floodplain irregularly and may backwater flood.

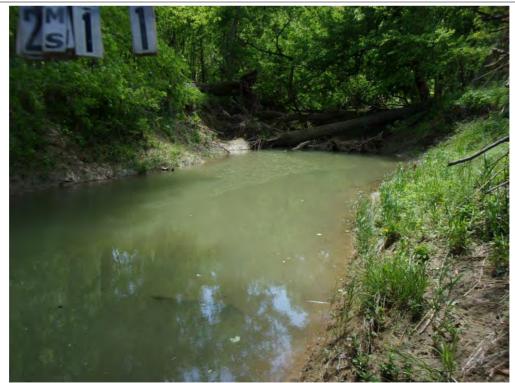
Stream 2MS1-1		Date: 5/6/2020	Inv.: Ryan Winka	Entry: Ryan Harris		
Latitude: 37.78477 N Longitude: -87.63895 W			Level III - Stream State or Condition Morphological Description			
Length:		780	Primary Riparian Left:	10b 100	Altered Channel Key	
Distance:		677	Primary Riparian Right:	10b 50) CH = Channelized	
Sinuosity:		1.15	Secondary Riparian Left:		0 CV = Culvert DAM = Weir, Dam, or Rock	
FlowType:		Perennial	Secondary Riparian Right:	RV 1 5	0 Checks	
Area In Acres:		0.54	Stream Flow Regime:	P1	DG = Dredged LWC = Low Water Crossing	
Slope %:		1.5	Stream Size:	S-5	NA = Not applicable OT = Other (See	
Level II - Stream		Depositional Features:	B-1,B-4	Comments)		
	logical De		Meander Patterns:	M-1	PI = Pipe RSC = Road Side Channel	
Width at Bottom	•	15.00	Stream Channel Debris:	D3		
Bankfull Surface	Width:	30.00	Stream Bank Erosion:	High		
Width of Flood F	Prone Area:	200.00	Stream Aggradation:	SI deg

Bankfull Mean D	epth:	4.00	Channel Stability:	Poor		
Entrenchment Ratio:		6.67	Altered Channel:	NA		
Width / Depth Ratio:		7.50	Percent Riffle:	30		
Stream Type:		E6	Percent Run:	40		
1			Percent Pool:	30		
			Step Pool:

Comments: Evidence of past overbank flooding.

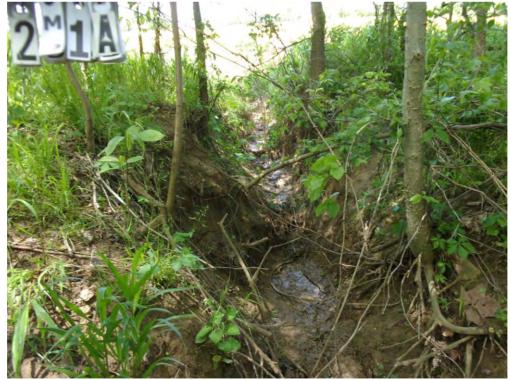
Stream 2MS1A		Date: 5/6/2020	Inv.: Keith Michalski	Entry: Ryan Harris		
Latitude: 37.78752 N Longitude: -87.62620 W			Level III - Stream State or Condition Morphological Description			
Length:		51	Primary Riparian Left:	10c 50	Altered Channel Key	
Distance:		48	Primary Riparian Right:	10c 50	CH = Channelized	
Sinuosity:		1.06	Secondary Riparian Left:	RV 1 50	CV = Culvert DAM = Weir, Dam, or Rock	
FlowType:		Ephemeral	Secondary Riparian Right:	RV 1 50	Checks	
Area In Acres:		0.00	Stream Flow Regime:	E2	DG = Dredged LWC = Low Water Crossing	
Slope %:		4	Stream Size:	S-2	NA = Not applicable	
Level II - Stream			Depositional Features:	None	OT = Other (See Comments)

-	logical Des	-	Meander Patterns:	M-1	PI = Pipe RSC = Road Side Channel	
Width at Bottom	•	1.00	Stream Channel Debris:	D2		
Bankfull Surface	Width:	2.80	Stream Bank Erosion:	High		
Width of Flood F	Prone Area:	3.40	Stream Aggradation:	Deg		
Bankfull Mean D	enth.	0.40	Channel Stability:	Poor		
Entrenchment Ratio:		1.21	Altered Channel:	NA		
Width / Depth Ratio:		7.00	Percent Riffle:	0		
Stream Type:		G6	Percent Run:	0		
			Percent Pool:	0		
			Step Pool:	\checkmark

Comments: Gully like steam drains crop field.

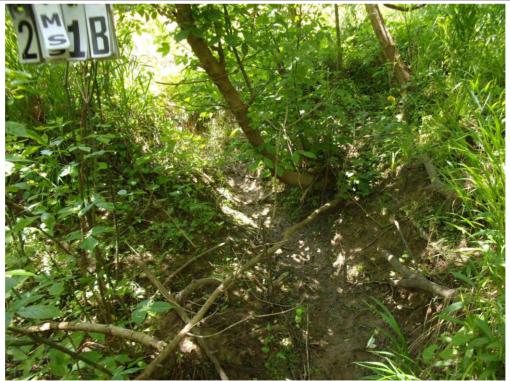
Stream 2MS1B		Date: 5/6/2020	Inv.: Keith Michalski	Entry: Ryan Harris		
Latitude: 37.78720 Longitude: -87.62802			Level III - Stream State or Condition Morphological Description			
Length:		47	Primary Riparian Left:	10c 50	Altered Channel Key	
Distance:		40	Primary Riparian Right:	10c 50	CH = Channelized	
Sinuosity:		1.18	Secondary Riparian Left:	RV 1 50	CV = Culvert DAM = Weir, Dam, or Rock	
FlowType:		Ephemeral	Secondary Riparian Right:	RV 1 50	Checks	
Area In Acres:		0.00	Stream Flow Regime:	E2	DG = Dredged LWC = Low Water Crossing	
Slope %:		3	Stream Size:	S-2	NA = Not applicable	
Level II - Stream			Depositional Features:	NA	OT = Other (See Comments)	
_	logical Des	-	Meander Patterns:	M-1	PI = Pipe RSC = Road Side Channel	
Width at Bottom	•	1.20	Stream Channel Debris:	D2		
Bankfull Surface	Width:	2.60	Stream Bank Erosion:	High		
Width of Flood F	Prone Area:	3.50	Stream Aggradation:	SI deg		
Bankfull Mean D	enth.	0.40	Channel Stability:	Poor

Entrenchment Ratio:		1.35	Altered Channel:	NA		
Width / Depth Ratio:		6.50	Percent Riffle:	20		
Stream Type:		G6	Percent Run:	80		
			Percent Pool:	0		
			Step Pool:

Comments: Gully like stream drains crop field.

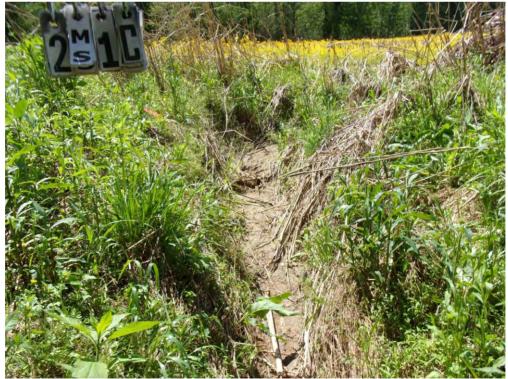
Entrenchment R	•	1.42	Altered Channel:	NA		
Width / Depth R		8.00	Percent Riffle:	20		
-	all0.	G6	Percent Run:	75		
Stream Type:		Go	Percent Pool:	5		
			Step Pool:			
				<u> </u>

Comments: Gully like stream drains crop field.

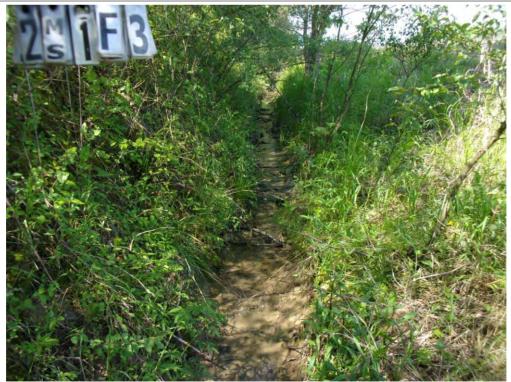
Stream 2MS1F3 Date: 5/7/202		Date: 5/7/2020	Inv.: Ryan Winka	Entry: Scott Mitchell			
Latitude: Longitude:		37.78805 N 87.64140 W	Level III - Stre Morphole	eam State		on	-
Length:		412	Primary Riparian Left: Primary Riparian Right:	10b 8a	30	Altered	Channel Key
Distance: Sinuosity:		410	Secondary Riparian Left:	RV 1	70	CH = Chanr CV = Culver	
FlowType:		Intermittent	Secondary Riparian Right: Stream Flow Regime:	RV 1	95	Checks DG = Dredg	, ,
Area In Acres: Slope %:		0.02	Stream Size:	S-2		NA = Not ap	
Level II - Stream Morphological Description		Depositional Features: Meander Patterns:	NA M-1		OT = Other (See Comments) PI = Pipe RSC = Road Side Channel		
Width at Bottom	•	1.40	Stream Channel Debris:	D2			
Bankfull Surface	Width:	2.60	Stream Bank Erosion: Stream Aggradation:	Low SI deg			
Width of Flood F		3.70	Channel Stability:	Fair			
Bankfull Mean D Entrenchment R	•	0.25	Altered Channel:	CH,RSC

Width / Depth R		10.40	Percent Riffle:	35			
Stream Type:		G6c	Percent Run:	55			
			Percent Pool:	10			
			Step Pool:

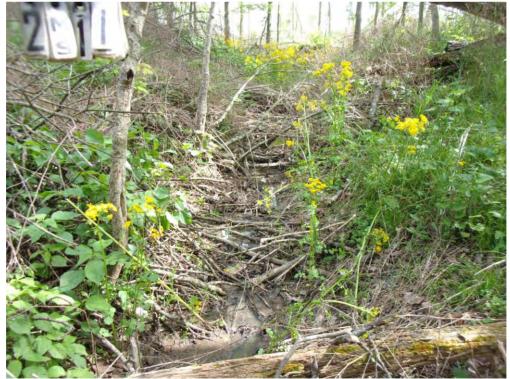
Stream 2MS1	I	Date: 5/7/2020	Inv.: Ryan Winka		Entry: Sc	ott Mitchell	
Latitude: Longitude:		37.78665 N -87.62786 W	Level III - Stre Morphole	eam State c ogical Desc		on	-
Length:		208	Primary Riparian Left:	10b	100	Altered	Channel Key
Distance:		197	Primary Riparian Right:	10b	100	CH = Chann	elized
Sinuosity:		1.06	Secondary Riparian Left:		0	CV = Culver	t , Dam, or Rock
FlowType:		Ephemeral	Secondary Riparian Right:		0	Checks	
Area In Acres:		0.02	Stream Flow Regime:	E2		DG = Dredg LWC = Low	ed Water Crossing
Slope %:		2	Stream Size:	S-2		NA = Not ap OT = Other	
Level II - Stream		Depositional Features:	B-4		Comments)	(See	
_	logical Des	-	Meander Patterns:	M-1		PI = Pipe RSC = Road	Side Channel
Width at Bottom	•	1.40	Stream Channel Debris:	D4			
Bankfull Surface	Width:	3.90	Stream Bank Erosion:	Low			
Width of Flood F	Prone Area:	5.60	Stream Aggradation:	Stable			
Bankfull Mean D	epth:	0.20	Channel Stability:	Good

Entrenchment R		1.44	Altered Channel:	ОТ			
Width / Depth Ra	atio:	19.50	Percent Riffle:	25			-
Stream Type:		B6	Percent Run:	55			
<u> </u>			Percent Pool:	20			
			Step Pool:

Comments: Large amounts of slash throughout stream due to past logging.

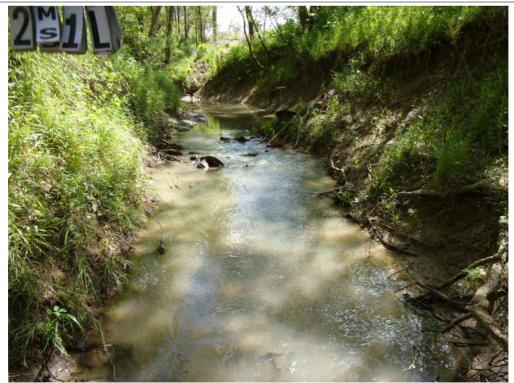
Stream 2MS1	L	Date: 5/11/2020	Inv.: Keith Michalski		Entry: Ry	an Winka	
Latitude: Longitude:		37.78248 N -87.63264 W	Level III - Stre Morphole	eam State ogical Des		on	
Length:		687	Primary Riparian Left:	10b	20	Altered 0	Channel Key
Distance:		653	Primary Riparian Right:	10b	30	CH = Chann	elized
Sinuosity:		1.05	Secondary Riparian Left:	RV 1	80	CV = Culvert	t , Dam, or Rock
FlowType:		Perennial	Secondary Riparian Right:	RV 1	70	Checks	, ,
Area In Acres:		0.26	Stream Flow Regime:	12		DG = Dredge LWC = Low	ed Water Crossing
Slope %:		1.5	Stream Size:	S-4		NA = Not applicable OT = Other (See	
Level II - Stream		Depositional Features:	B-1		Comments)	366	
Morphological Description			Meander Patterns:	M-1		PI = Pipe RSC = Road	Side Channel
Width at Bottom	•	6.20	Stream Channel Debris:	D2			
Bankfull Surface	Width:	16.80	Stream Bank Erosion:	High			
Width of Flood F	Prone Area:	26.00	Stream Aggradation:	Stable

Bankfull Mean D	epth:	3.80	Channel Stability:	Fair			
Entrenchment R		1.55	Altered Channel:	CV			
Width / Depth Ra	atio:	4.42	Percent Riffle:	25			
Stream Type:		G5c	Percent Run:	40			
1			Percent Pool:	35			
			Step Pool:

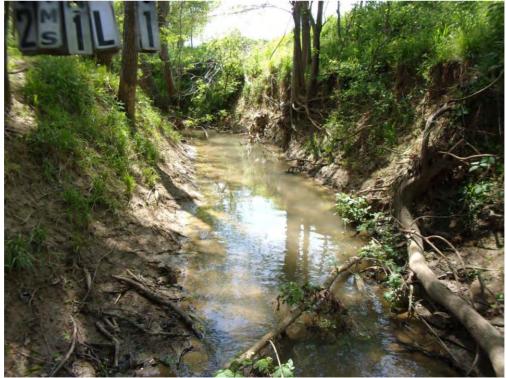
Stream 2MS1L-1 Date: 5/12/2020		Inv.: Ryan Harris	Entry: Keith Michalski			i	
Latitude: Longitude:		37.77949 N 87.63468 W	Level III - Stre Morphole	eam State o ogical Des		ion	-
Length:		2313	Primary Riparian Left:	10b	50	Altered	Channel Key
Distance:		2032	Primary Riparian Right:	10b	20	CH = Chann	
Sinuosity:		1.14	Secondary Riparian Left:	RV 1	50	CV = Culver	t , Dam, or Rock
FlowType:		Intermittent	Secondary Riparian Right:	RV 1	80	Checks	, ,
Area In Acres:		0.76	Stream Flow Regime:	12		DG = Dredg LWC = Low	ed Water Crossing
Slope %:		1	Stream Size:	S-3		NA = Not ap	plicable
Level II - Stream		Depositional Features:	B-1,B-4		OT = Other Comments)	(See	
Morphological Description			Meander Patterns:	M-1		PI = Pipe RSC = Road	d Side Channel
Width at Bottom	•	6.90	Stream Channel Debris:	D3			
Bankfull Surface	Width:	14.30	Stream Bank Erosion:	High			
Width of Flood F	Prone Area:	22.00	Stream Aggradation:	Stable

Bankfull Mean D	epth:	3.10	Channel Stability:	Fair			
Entrenchment R	•	1.54	Altered Channel:	CH,PI			
Width / Depth Ra	atio:	4.61	Percent Riffle:	30			
Stream Type:		G4c	Percent Run:	40			
1			Percent Pool:	30			
			Step Pool:

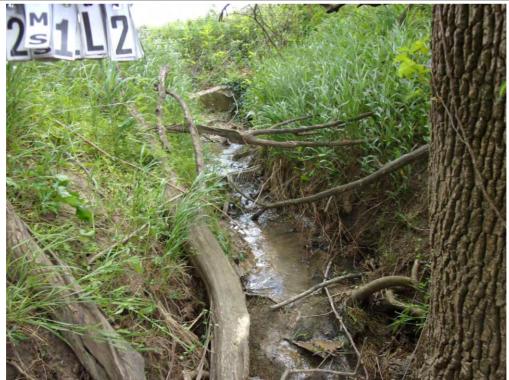
Stream 2MS1	L2	Date: 5/11/2020	Inv.: Keith Michalski		Entry: Ry	an Winka
Latitude: Longitude:		37.78302 N -87.63232 W	Level III - Stre Morphole	eam State c ogical Desc		on
Length:		48	Primary Riparian Left:	10b	20	Altered Channel Key
Distance:		46	Primary Riparian Right:	10b	20	CH = Channelized
Sinuosity:		1.04	Secondary Riparian Left:	RV 1	80	CV = Culvert DAM = Weir, Dam, or Rock
FlowType:		Intermittent	Secondary Riparian Right:		0	Checks
Area In Acres:		0.00	Stream Flow Regime:	12		DG = Dredged LWC = Low Water Crossing
Slope %:		3	Stream Size:	S-2		NA = Not applicable
Level II - Stream		Depositional Features:	NA		OT = Other (See Comments)	
Morphological Description		Meander Patterns:	M-1		PI = Pipe RSC = Road Side Channel	
Width at Bottom	•	1.60	Stream Channel Debris:	D3		
Bankfull Surface	Width:	3.10	Stream Bank Erosion:	High		
Width of Flood F	Prone Area:	4.00	Stream Aggradation:	Deg		
Bankfull Mean D	enth:	0.60	Channel Stability:	Poor

Entrenchment R		1.29	Altered Channel:	DAM,OT,PI		
Width / Depth Ra		5.17	Percent Riffle:	40		
Stream Type:		G6	Percent Run:	55		
1-			Percent Pool:	5		
			Step Pool:

Comments: Old trash has been dumped in stream.

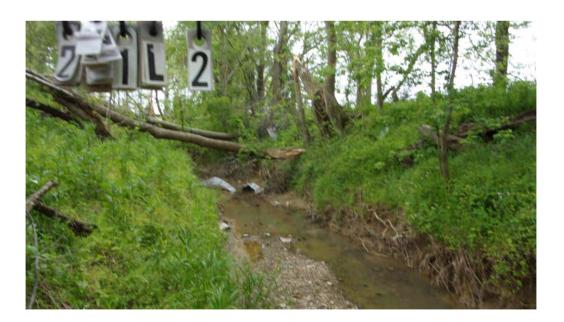
Stream 2MS1	L-2	Date: 5/12/2020	Inv.: Ryan Harris	E	Entry: Ke	ith Michalski
Latitude: Longitude:		37.77345 N -87.63566 W	Level III - Stre Morphol	eam State or ogical Descri		on
Length:		1439	Primary Riparian Left:	10b	30	Altered Channel Key
Distance:		1413	Primary Riparian Right:	10b	20	CH = Channelized
Sinuosity:		1.02	Secondary Riparian Left:	RV 1	70	CV = Culvert DAM = Weir, Dam, or Rock
FlowType:		Intermittent	Secondary Riparian Right:	RV 1	80	Checks
Area In Acres:		0.44	Stream Flow Regime:	12		DG = Dredged LWC = Low Water Crossing
Slope %:		1	Stream Size:	S-3		NA = Not applicable
Level II - Stream		Depositional Features:	B-2		OT = Other (See Comments)	
Morphological Description		Meander Patterns:	M-1		PI = Pipe RSC = Road Side Channel	
Width at Bottom	-	10.80	Stream Channel Debris:	D2		
Bankfull Surface	Width	13.30	Stream Bank Erosion:	High		
Width of Flood P		19.00	Stream Aggradation:	Stable

2.00	Channel Stability:	Fair		
Bankfull Mean De	•		Altered Channel:	CH,CV,OT,PI		
		1.43	Dereent Diffler	20	1	
Width / Depth Ra	atio:	6.65	Percent Riffle:	30]	
Stream Type:		G5c	Percent Run:	60]	
			Percent Pool:	10]	
Commenter Old	f awa t ua - 1	houdhout stream se	Step Pool:

Old farm trash thoughout stream segment. omments:

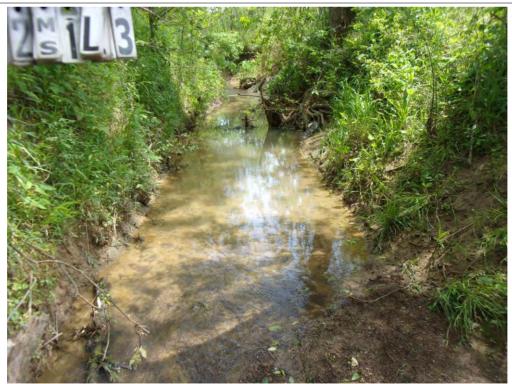
Stream 2MS1L3 Date: 5/11/20		Date: 5/11/2020	Inv.: Ryan Harris	Entry: F	Ryan Winka
Latitude: Longitude:		37.78131 N 87.63165 W		eam State or Cond ogical Description	ition
Length:		2421	Primary Riparian Left:	10b 20	Altered Channel Key
Distance:		2381	Primary Riparian Right:	10b 20	CH = Channelized
Sinuosity:		1.02	Secondary Riparian Left:	RV 1 80	CV = Culvert DAM = Weir, Dam, or Rock
FlowType:		Intermittent	Secondary Riparian Right:	RV 1 80	Checks
Area In Acres:		0.66	Stream Flow Regime:	12	DG = Dredged LWC = Low Water Crossing
Slope %:		1.5	Stream Size:	S-3	NA = Not applicable
Level II - Stream		Depositional Features:	B-4	OT = Other (See Comments)	
Morphological Description			Meander Patterns:	M-1	PI = Pipe RSC = Road Side Channel
Width at Bottom	•	5.90	Stream Channel Debris:	D3	
Bankfull Surface	Width:	11.90	Stream Bank Erosion:	High	
Width of Flood F	rone Area:	15.50	Stream Aggradation:	SI deg	
Bankfull Mean D	epth:	2.80	Channel Stability:	Fair

Entrenchment R	•	1.30	Altered Channel:	CH,CV,PI	
Width / Depth Ra	atio:	4.25	Percent Riffle:	30	
Stream Type:		G5c	Percent Run:	40	
1			Percent Pool:	30	
			Step Pool:

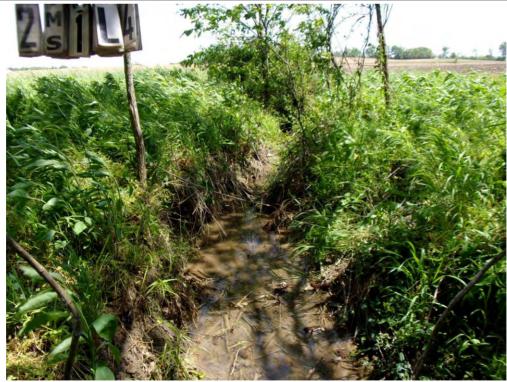
Stream 2MS1	L4	Date: 5/12/2020	Inv.: Ryan Harris		Entry: Kei	ith Michalsk	i
Latitude: Longitude:		37.77897 N -87.63469 W	Level III - Stre Morphole	eam State ogical Des		on	-
Length:		118	Primary Riparian Left:	10b	15	Altered	Channel Key
Distance:		110	Primary Riparian Right:	10b	10	CH = Chann	
Sinuosity:		1.07	Secondary Riparian Left:	RV 1	85	CV = Culver	t , Dam, or Rock
FlowType:		Ephemeral	Secondary Riparian Right:	RV 1	90	Checks	
Area In Acres:		0.01	Stream Flow Regime:	E2		DG = Dredg LWC = Low	ed Water Crossing
Slope %:		1.5	Stream Size:	S-2		NA = Not ap	plicable
Level II - Stream		Depositional Features:	B-4		OT = Other (See Comments)		
Morphological Description		Meander Patterns:	M-1		PI = Pipe RSC = Road	l Side Channel	
Width at Bottom	-	1.80	Stream Channel Debris:	D2		rioo rioud	
Bankfull Surface	Width:	3.70	Stream Bank Erosion:	High			
Width of Flood F	Prone Area	5.20	Stream Aggradation:	Stable

Bankfull Mean D		0.60	Channel Stability:	Fair			
Entrenchment R	•		Altered Channel:	DAM,PI			
		1.41	D (D)(()	00			-
Width / Depth Ra	atio:	6.17	Percent Riffle:	30			
Stream Type:		G6c	Percent Run:	60			
			Percent Pool:	10			
			Step Pool:

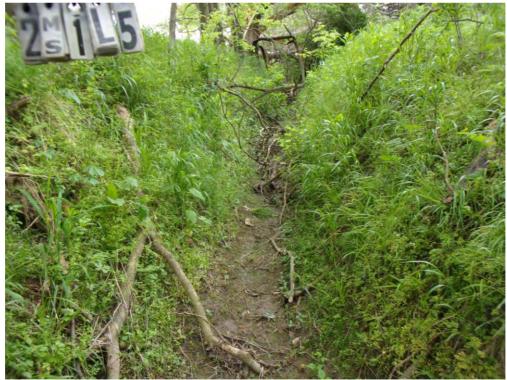
Stream 2MS1	L5	Date: 5/12/2020	Inv.: Ryan Winka	Entr	y: Keith Michalski
Latitude: Longitude:		37.77918 N 87.63500 W		eam State or Co ogical Descripti	
Length:		124	Primary Riparian Left:	10b :	50 Altered Channel Key
Distance:		120	Primary Riparian Right:	10b	50 CH = Channelized
Sinuosity:		1.03	Secondary Riparian Left:	RV 1	50 CV = Culvert DAM = Weir, Dam, or Rock
FlowType:		Ephemeral	Secondary Riparian Right:	RV 1	50 Checks
Area In Acres:		0.01	Stream Flow Regime:	E2	DG = Dredged LWC = Low Water Crossing
Slope %:		1.5	Stream Size:	S-2	NA = Not applicable
Level II - Stream		Depositional Features:	NA	OT = Other (See Comments)

-	logical Des	-	Meander Patterns:	M-1	PI = Pipe RSC = Road Side Channel
Width at Bottom	-	1.00	Stream Channel Debris:	D3	
Bankfull Surface	Width:	3.20	Stream Bank Erosion:	Moderate	
Width of Flood F	rone Area:	4.40	Stream Aggradation:	SI deg	
Bankfull Mean D		0.40	Channel Stability:	Fair	
Entrenchment R	•	1.38	Altered Channel:	NA	
Width / Depth Ra		8.00	Percent Riffle:	40	
Stream Type:		G6c	Percent Run:	55	
cacan Type.			Percent Pool:	5	
			Step Pool:

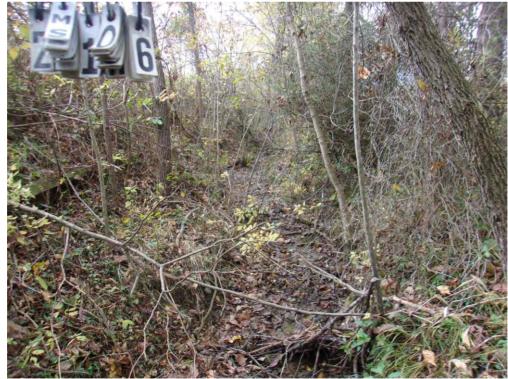
Stream 2MS1	06	Date: 10/26/2020	Inv.: Ryan Harris	Entr	y: Ryan Harris
Latitude: Longitude:		37.79163 N -87.62754 W		eam State or Co ogical Descripti	
Length:		22	Primary Riparian Left:	10b 2	20 Altered Channel Key
Distance:		22	Primary Riparian Right:	10a 2	20 CH = Channelized
Sinuosity:		1.00	Secondary Riparian Left:	3b	80 CV = Culvert DAM = Weir, Dam, or Rock
FlowType:		Ephemeral	Secondary Riparian Right:	RV 1	80 Checks
Area In Acres:		0.00	Stream Flow Regime:	E2	DG = Dredged LWC = Low Water Crossing
Slope %:		1	Stream Size:	S-3	NA = Not applicable OT = Other (See
Level II - Stream		Depositional Features:	NA	Comments)	
	logical De		Meander Patterns:	M-1	PI = Pipe RSC = Road Side Channel
Width at Bottom	•	2.80	Stream Channel Debris:	D2	
Bankfull Surface	Width:	5.30	Stream Bank Erosion:	Moderate	
Width of Flood F	Prone Area:	8.20	Stream Aggradation:	Stable	
Bankfull Mean D	epth:	0.50	Channel Stability:	Fair

Entrenchment R	atio:	1.55	Altered Channel:	CH,PI,RSC	
Width / Depth Ra	atio:	10.60	Percent Riffle:	20	
Stream Type:		G4c	Percent Run:	70	
1			Percent Pool:	10	
			Step Pool:

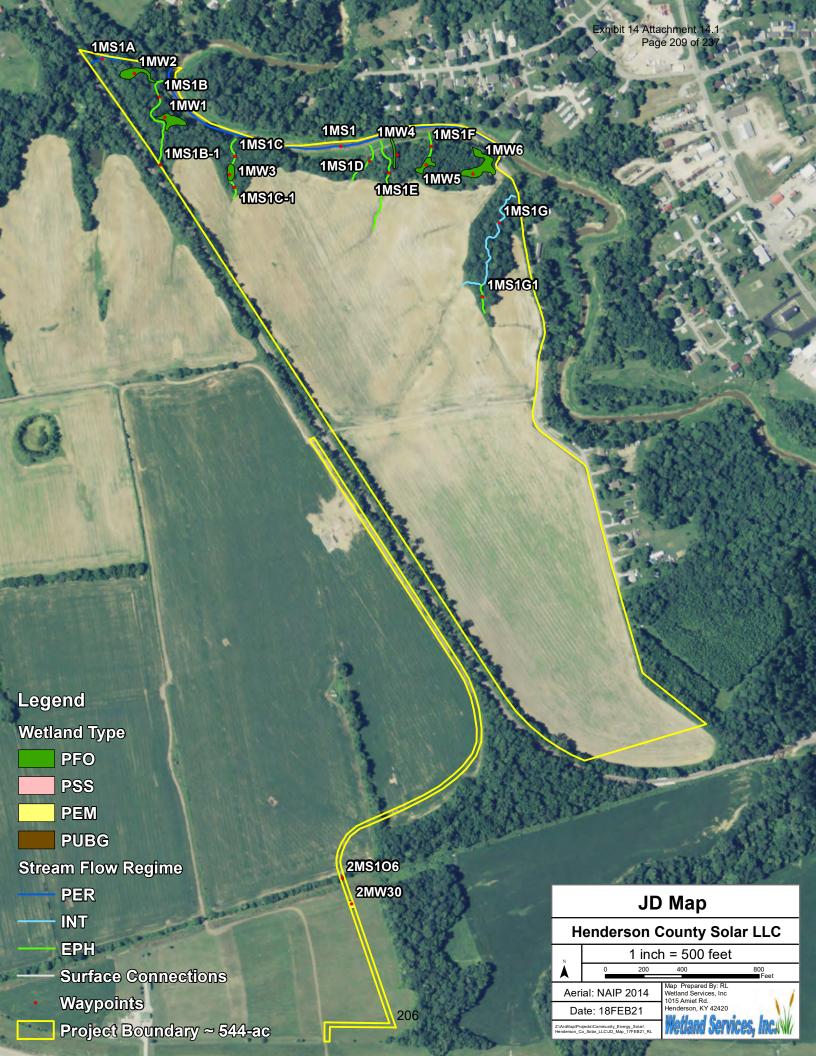
JD Map Henderson County Solar LLC 1 inch = 1,250 feet 0 500 1.000 2.000 1 inch = 1,250 feet 0 500 1.000 2.000 Feet Aerial: NAIP 2014 Date: 18FEB21 MapPrepared By: RL MapPrepared By: RL Wetland Services, Inc Henderson, KY 42420 Wetland Services, Inc Date: 18FEB21

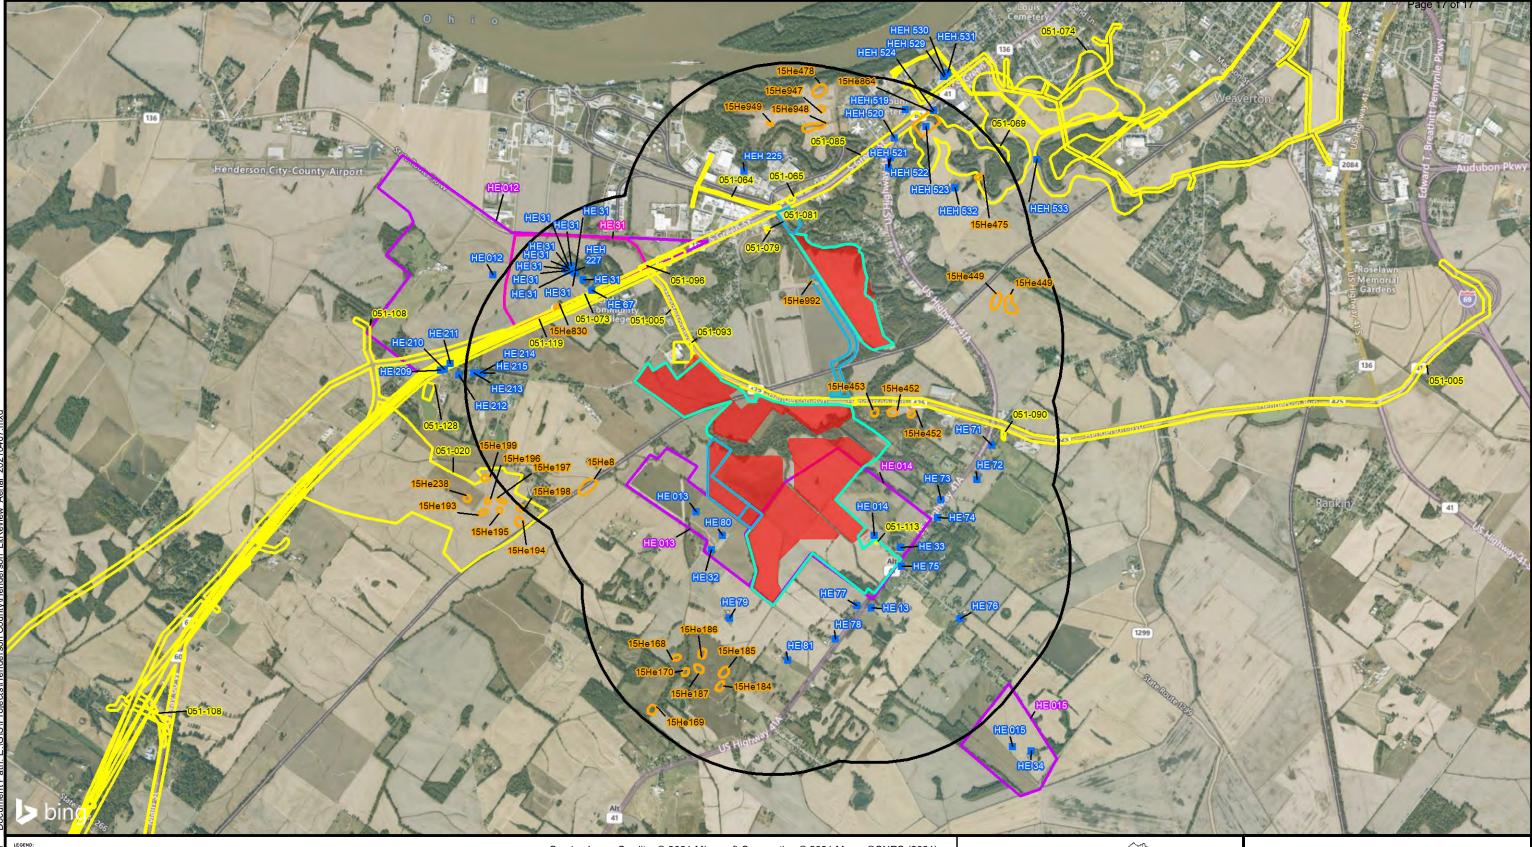
7	LITERATURE REVIEW HENDERSON COUNTY SOLAR PROJECT		
	DATE: 4/7/2021	SCALE: 1 in = 914 meters	
	CREATED BY: BSG	CHECKED BY: CGL	
	JOB NO.	AECOM

Proposed April 2021 Project Limits May 2020 Field Reconnaissance December 2020 Field Reconnaissance

Historic Resource Historic Property NRHP Property Preliminary Archaeology Site

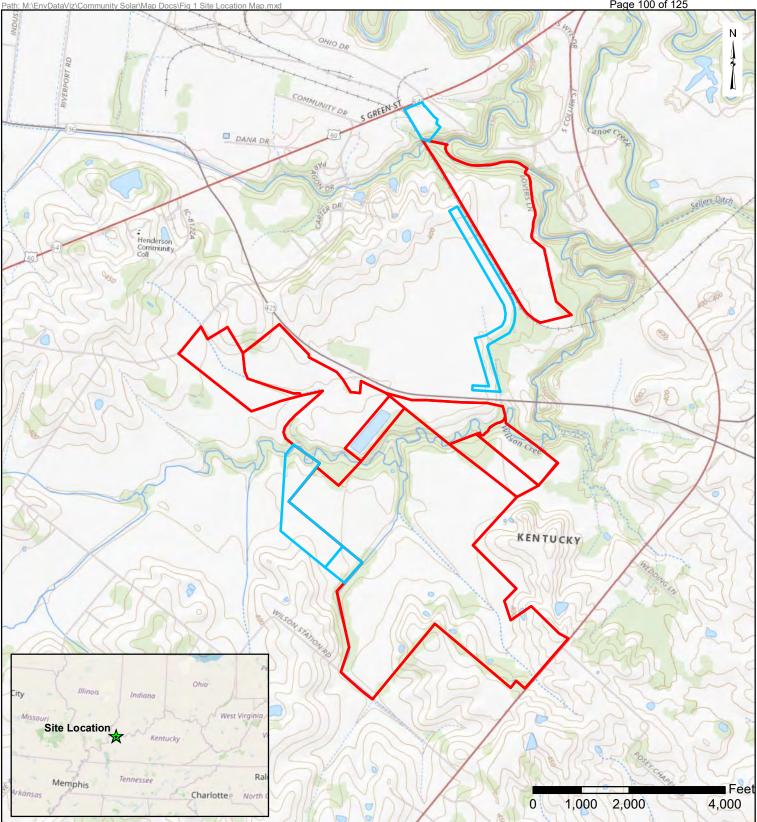
SITE LOCATION MAP

- Original Study Areas
- Additional Study Areas

AECOM was contracted to conduct an ecological survey focused on an endangered species review associated with the Proposed Henderson County Solar Project Site ("site") near Henderson in Henderson County, Kentucky in June 2020 (**Figure 1**). The site is located on the southwest side of Henderson, which is located near the Ohio River. The survey included land located in two sites of approximately 625 and 94 acres, for a total area of approximately 719 acres. In December 2020 the site was revisited to include three additional tracts totaling 71 acres, **Figure 2**. The additional property included three new tracts identified as the north tract, 6.7 acres; middle tract 25.4 acres and the south tract 38.9 acres.
