**KENTUCKY-AMERICAN WATER COMPANY**  
**CASE NO. 2021-00376**  
**COMMISSION STAFF'S SECOND REQUEST FOR INFORMATION**

1. Regarding the State Street Phase I and II projects, explain why additional feet of main installation were necessary and what relationship that had to the explanation in the Application, Exhibit 2, in which it stated that the variance between actual and projects costs was due to valve that broke during construction.

2. Regarding the State Street Phase I and II projects, explain what Kentucky-American meant that the existing valves that were replaced during the two phases were inoperable and explain why the valves were inoperable.

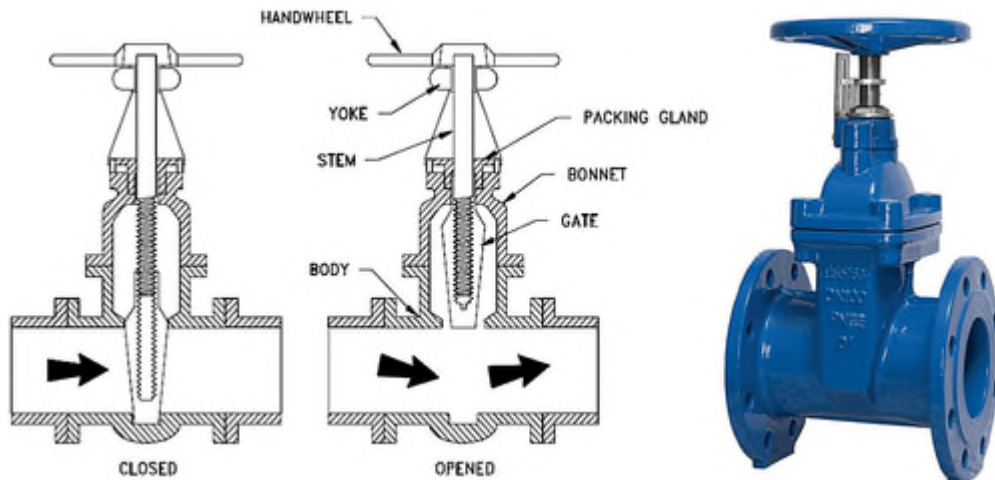
The primary function of a valve on a water main is to control the flow of water through the pipe. When the valve is closed, the water should be isolated to one side. When the valve is opened, water can flow through unimpeded. A fully functional valve can be fully closed with no water leaking past the valve's equipment. However, over time, parts of the valve may wear down or not operate correctly anymore, allowing some water to pass through. Other issues that can occur may include: the valve stem no longer turning well; the valve stem can occasionally break off completely during operation as the torque required to turn the valve apparatus puts a large amount of force on the stem; bolts can shear and the valve housing can separate; and, the operating nut or handwheel can break or strip so that it cannot be turned until it is replaced. Yearly inspections on large valves, while important and necessary, also put wear and tear on the stems and valves.

*Typical gate valve diagram*

The result of any of these occurrences is that the valve is no longer fully controlling the flow of water through the pipe. In order for main replacements or other work to take place, the water must be shut off. If valves are closed to isolate a section of main but water continues to leak out, work cannot continue. On larger diameter pipes this can mean a large quantity of water.
