**KyPSC Case No. 2022-00084**  
**TABLE OF CONTENTS**

**Duke Energy Kentucky**  
**Case No. 2022-00084**  
**STAFF First Set Data Requests**  
**Date Received: May 19, 2022**

**STAFF-DR-01-001**

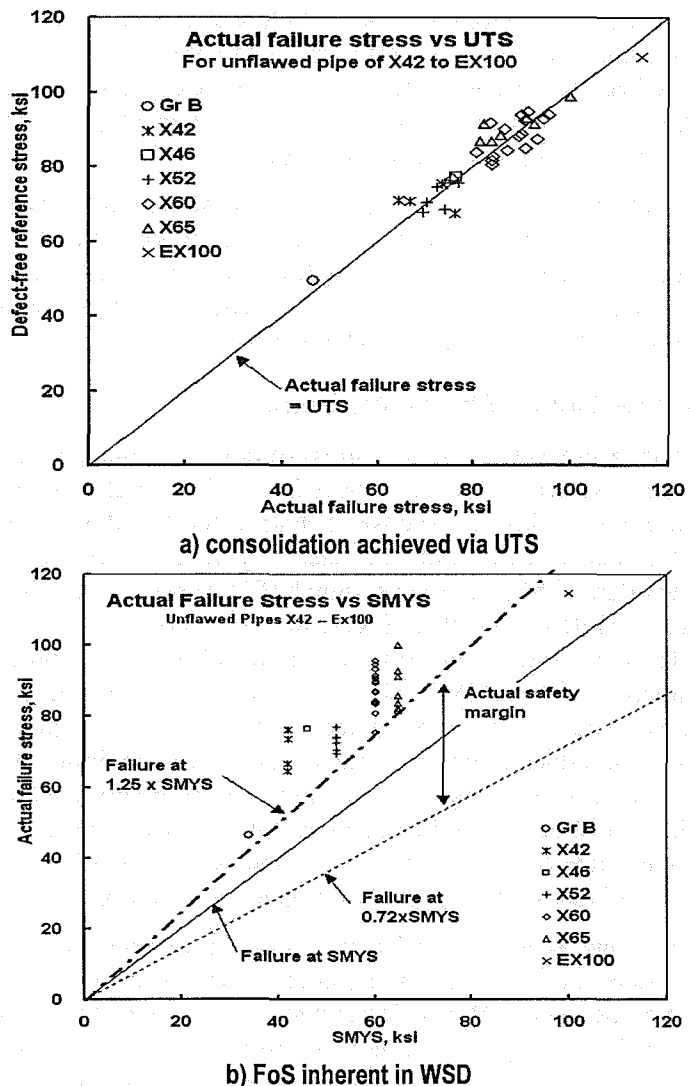
Figure 7. Plastic-collapse in defect-free pipe

Consider first the failure behavior of line pipe that is defect free, which is the reference condition to assess failure response of code-accepted failure criteria such as ASME B31G<sup>(26)</sup>, and other such failure criteria for pipelines. Figure 7 characterizes the failure stress of defect-free pipes in grades from Gr. B through X65, which span the range of grades typically available prior to 1970, and includes a late 1960s vintage experimental X100 grade designated in the figure as EX100. Figure 7a shows, the defect free failure stress of end-capped pipe is on average characterized very well by the UTS<sup>7</sup>. The range of the ratio of UTS / actual failure stress for these data runs from 1.09 to 0.88, or data scatter of roughly  $\pm 10$  percent uniformly around the one-to-one trend. Figure 7b contrasts the value of the UTS as a function of SMYS and the maximum allowable stress (MAS) for US pipelines, which by code is set at 72-percent of SMYS for Class I design that applies to cross-country pipelines. From Figure 7b it can be seen that the MAS leads to a factor of safety the order of  $(SMYS / (0.72)) = 1.39$ . And given failure occurs at about the UTS that for these vintage grades is about 25-percent larger than SMYS, the actual factor of safety for defect-free line pipe is about 1.74.

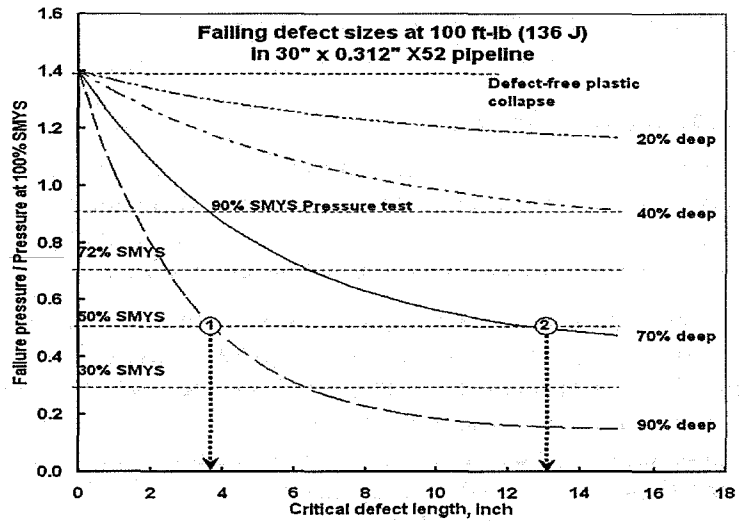
a) at 100 ft-lb FSE CVN

b) at 10 ft-lb FSE CVN

Figure 8. Failing defect sizes vs. toughness

Figure 8 presents the failure stress of defects in line pipe calculated using software developed at Battelle as detailed in References 24 and 25, which has been extensively validated. These trends represent the failure response of sharp crack-like defects in a 30-inch diameter pipeline made with a 0.312-inch-thick wall of X52 steel. Figure 8a represents results for X52 steel with full-size equivalent (FSE) Charpy vee-notch (CVN) energy (toughness) of 100 ft-lbs, which reflects modern steels, while the results in Figure 8b reflect critical defects in X52 line pipe with CVN energy of 10 ft-lb, which reflects the lower end typical for some vintage steels. The vertical axis is hoop stress as a fraction of the SMYS. The horizontal axis is the axial extent or length of the crack-like defect. The curved lines represent defect depth relative to the pipe's wall thickness (e.g., the curve labeled 70 percent deep represents defects that have a maximum depth 70-percent through the wall). The dashed horizontal lines correspond to low-wall stress operation (30 percent SMYS), operation in Class 3 (50 percent SMYS) and operation in Class 1 (72 percent SMYS). The horizontal line at the y-axis value of ~1.4 corresponds to the ratio of the UTS to SMYS for this X52 pipe, which indicates this steel has slightly improved properties as compared to the results shown in Figure 7b.

Each point along the labeled curves in Figure 8 represents a critical length and depth for a given pressure. For example, in reference to the higher toughness steel reflected in the trends in Figure 8a – at 50 percent SMYS, a defect that is 90 percent of the wall thickness deep and 3.7 inches long (point 1 in the figure) will fail, as will a defect that is 70 percent deep and about 13 inches long (point 2 in the figure). Similar values can be determined for other combinations of depth and pressure. At higher pressures, the critical defect sizes are smaller, and at lower pressures, they are larger.

While not evident from the information supplied in reference to Figure 8a, the trends for defect depths 40-percent and 90-percent through wall represent failures that are controlled by the strength of the pipeline steel. This occurs for these depths because the toughness supplied (at 100 ft-lb) leads to toughness independent failure, or plastic collapse. If the toughness were much lower (as occurs for some vintage pipelines), the failure response of some defect depths and lengths would be controlled by toughness rather than strength. This is the case in reference to Figure 8b, which represents CVN energy of 10 ft-lb. Notice first that for this lower-toughness steel that defect-free failure is indicated at a y-axis value of ~1.4, just as it did for the higher-toughness scenario in Figure 8a. Thus, defect-free lower-toughness pipe fails by plastic collapse.

For the lower-toughness steel, Figure 8b indicates the critical defect length at 50 percent SMYS for a 90 percent deep defect is 3.3 inches long, while that for a 70 percent deep defect is ~4.8 inches long. In contrast to Figure 8a, lower toughness pipelines have smaller critical defect sizes, although there is little difference for very deep defects as these remain close to a plastic-collapse condition. Aside from somewhat smaller defect sizes and failure more often under fracture rather than collapse control, there is little difference in the performance between vintage pipelines and those made of modern steels.

Figure 8 shows that critical defect sizes for in-service failures are quite large, even for anomalies in the lower-toughness steels. With the exception of weld-seam anomalies, many historic anomalies are short and not critical unless they are very deep. In contrast, the dimensions of weld-seam anomalies cover a wide range of shapes and sizes. The most significant are usually longer and when located in lower toughness weld zones can be critical at shallower depths.

The curves in Figure 8 correspond to sharp axially aligned (i.e. defect length along the pipeline) anomalies. Blunt anomalies and those that are not axially aligned have much larger critical dimensions<sup>(e.g., see 15)</sup>. A tolerance for relatively large defects, even in lower-toughness steels, implies that pipelines can operate safely with stable anomalies less than critical size. More importantly, use of high-pressure or code required hydrostatic testing would expose all defects whose size lies below the test pressure. Thus, even though as-produced vintage pipe contained anomalies, the use of

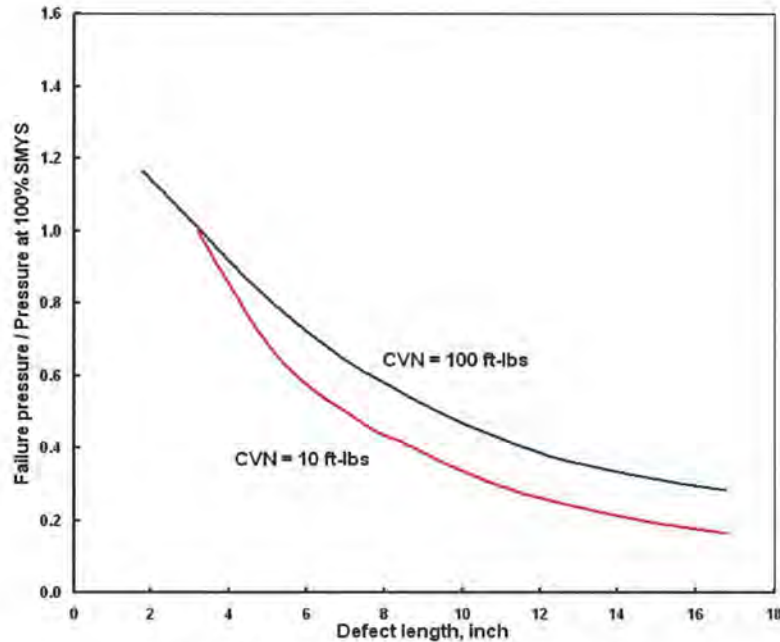
Figure 9. Leak versus rupture boundary

Figure 9 depicts the calculated demarcation between leaks and ruptures for the two cases shown earlier in Figure 8. Below and to the left of each curve in Figure 9 the defect will fail as a leak, whereas defects that are above and to the right of the curves will rupture. Longer defects are more likely to rupture than shorter defects, but the effect of material toughness can be relatively small<sup>10</sup>, particularly at higher stress. This is evident in Figure 9, where at stresses the order of high-pressure

hydrotesting the trends for quite different toughness become coincident. As noted earlier, with the exception of weld-seam anomalies, most historic anomalies are short in length. Thus, these defects are more likely to fail by leaking than by rupturing. Weld-seam anomalies, which can be long, may fail by rupturing the pipe.

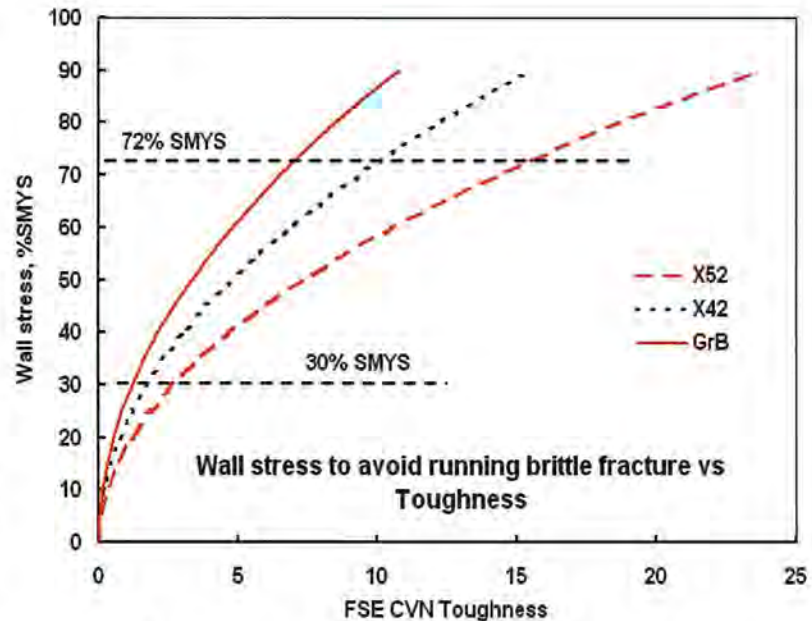
Figure 10. Arrest toughness for propagating brittle fractures

The material property that controls whether a propagating fracture will stop is the arrest toughness of the line pipe steel. Figure 10 presents the minimum arrest toughness for steady-state running brittle fracture on the horizontal axis, as a function of wall stress plotted on the y-axis. The curves represent 16-inch diameter line pipe with a 0.250-inch thick wall made of one of three grades of steel – Grade B, X42, and X52. For this example, toughness equivalent

Many early pipelines in Class Locations 3 and 4 were of smaller diameter and were built from materials with lower strength (typically Grades A, B, X42). In light of the trends in Figure 10 and typical toughness available for such steels, these pipelines operate with limited concern for propagating brittle fracture. Consequently, brittle propagation is not considered a significant issue in most vintage pipelines.

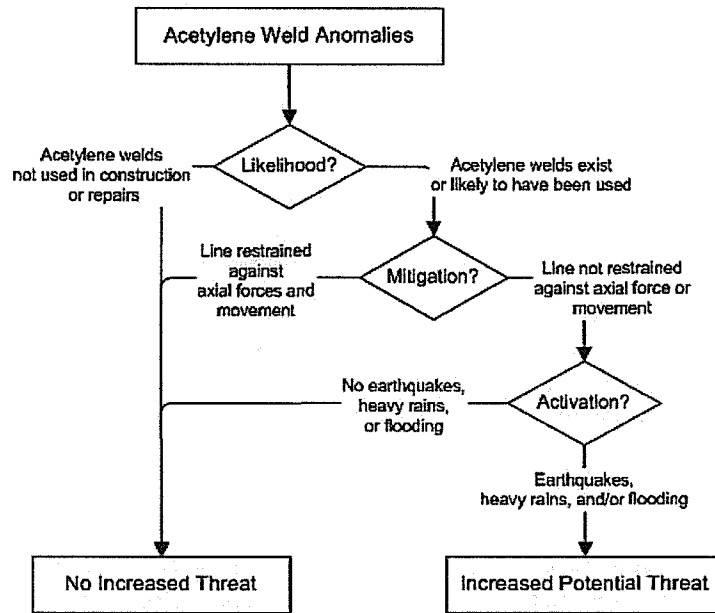
Figure 16. Flowchart for acetylene weld anomalies

The flowchart shown in Figure 16 can be used to assess the potential threat due to acetylene welds as follows:

1. Determine date of pipeline construction and whether or not acetylene welds are known to exist. If the pipe is newer than 1950, the likelihood that acetylene welds were used during pipeline construction is relatively small.
2. If there is a likelihood that acetylene welds exist, evaluate the restraint against pipe movement and axial forces. If the line is adequately restrained and/or weld reinforcements have been installed, the potential for acetylene weld related problems is small.
3. If there is a likelihood that acetylene welds exist and the acetylene welds have not been reinforced and pipeline in these areas is not anchored or restrained, evaluate the potential for earthquakes, heavy rains, and other events that have the potential to introduce large axial or lateral loads. If such events are likely, there is an increased risk due to the existence of acetylene welds.

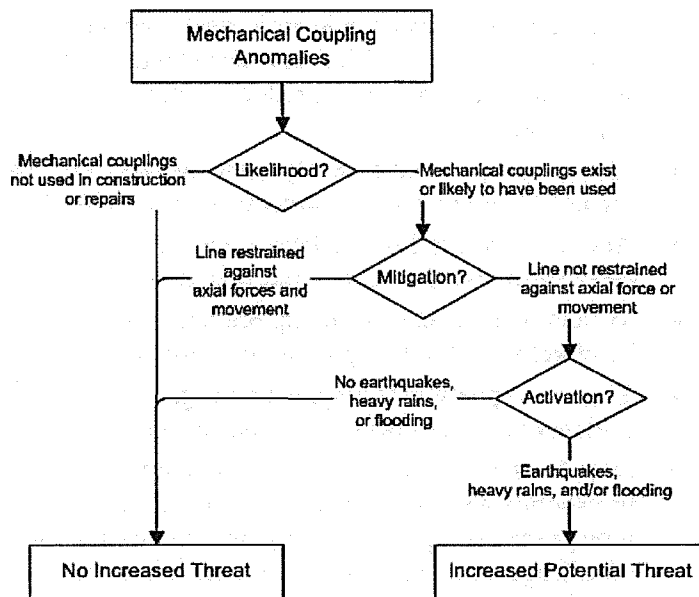
**Figure 17. Flowchart for coupling anomalies**

The flowchart shown in Figure 17 can be used to assess the potential threat due to mechanical couplings in much the same manner discussed for acetylene welds, as follows:

1. Determine date of pipeline construction and whether or not couplings are known to exist. If the pipe is newer than 1960, the likelihood that mechanical couplings were used during pipeline construction is relatively small.
2. If there is a likelihood that mechanical couplings exist, evaluate the restraint against pipe movement and axial forces. If the line is adequately restrained and/or coupling reinforcements have been installed, the potential for coupling-related problems is small.
3. If there is a likelihood that couplings exist and the couplings have not been reinforced and pipeline in these areas is not anchored or restrained, evaluate the potential for earthquakes, heavy rains, and other events that have the potential to introduce large axial or lateral loads. If such events are likely, there is an increased risk due to the existence of couplings.

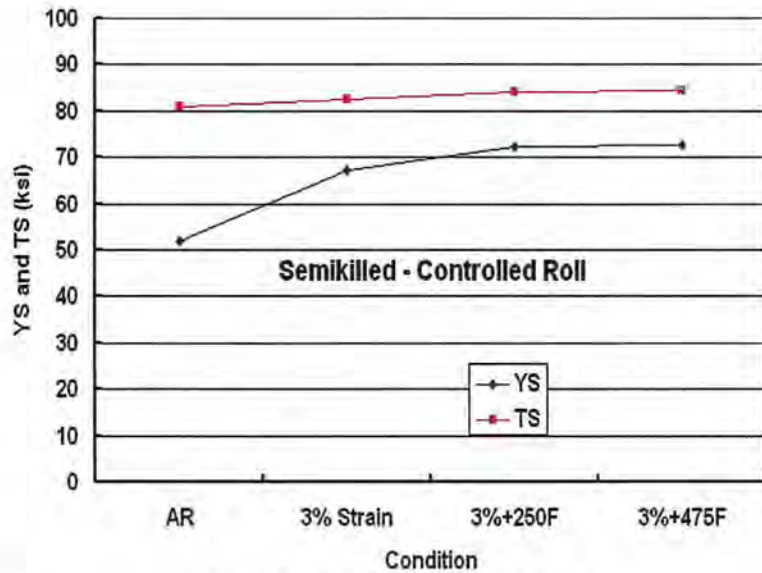
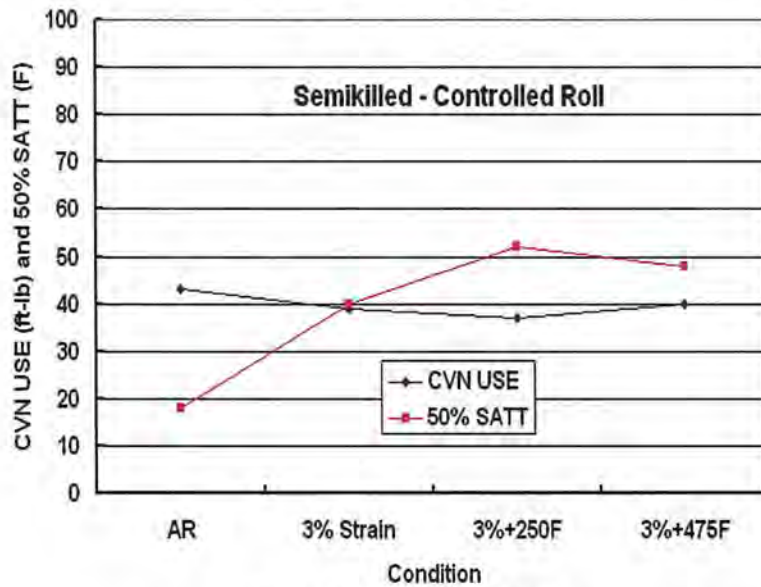
a) variation in yield and tensile stress

b) variation in CVN properties

Figure C-4. Effect of aging on a Si-Al killed steel

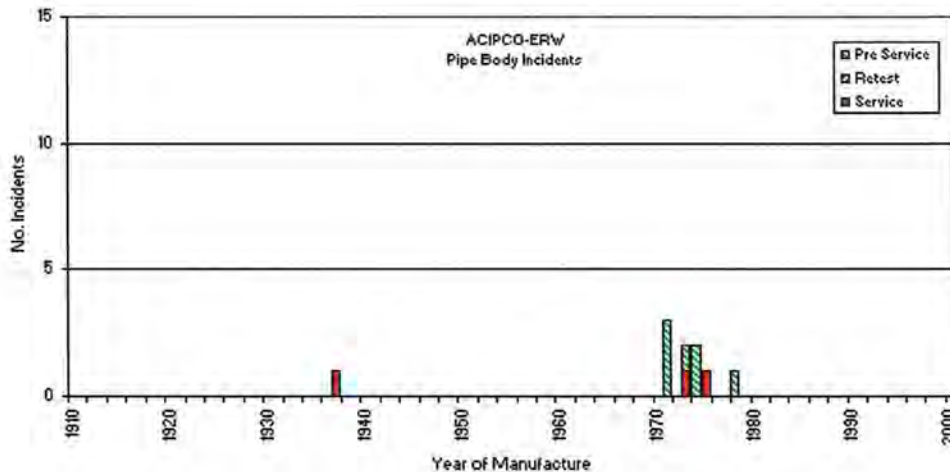
Figure F1. ACIPCO-ERW pipe body incidents by year

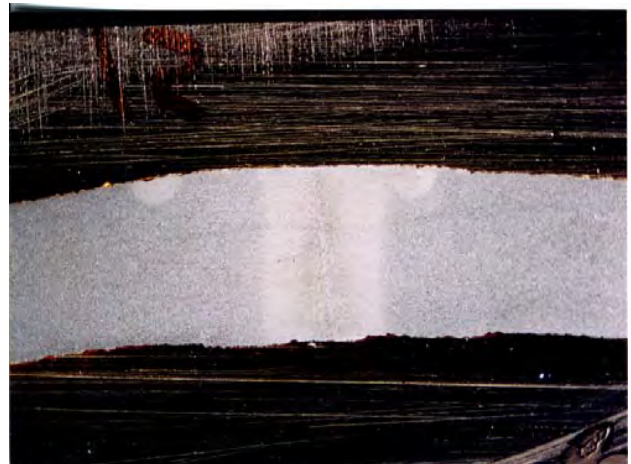
1967, LF ERW

Ring flattening test results

Weld Location, degrees	Opening observed when flattened to					
	2/3 D		1/3 D		Walls Meeting	
	Cracks	Location	Cracks	Location	Cracks	Location
0°	No	-	No	-	No	-
90°	No	-	No	-	Yes	Seam

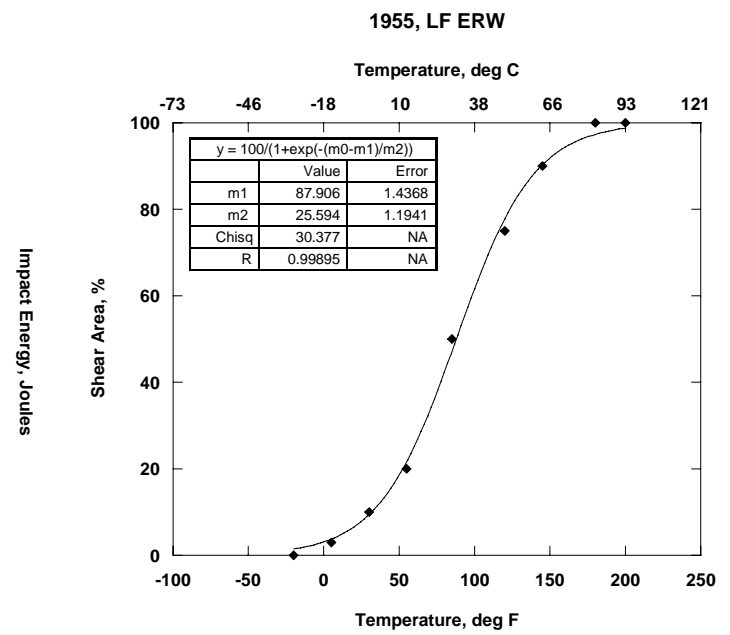
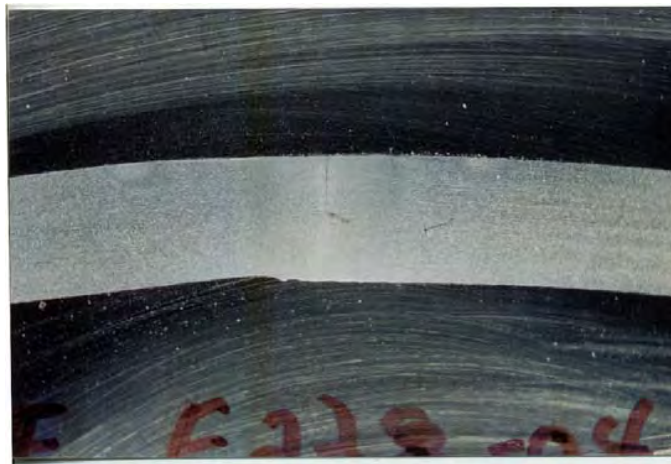
<u>Transition temperature, 85% shear area for specimen</u>	130 °F	54 °C
<u>Charpy upper shelf energy, (full size specimen)</u>	18 ft-lbs	24 Joules

Photographs of Charpy specimens were not found in this record

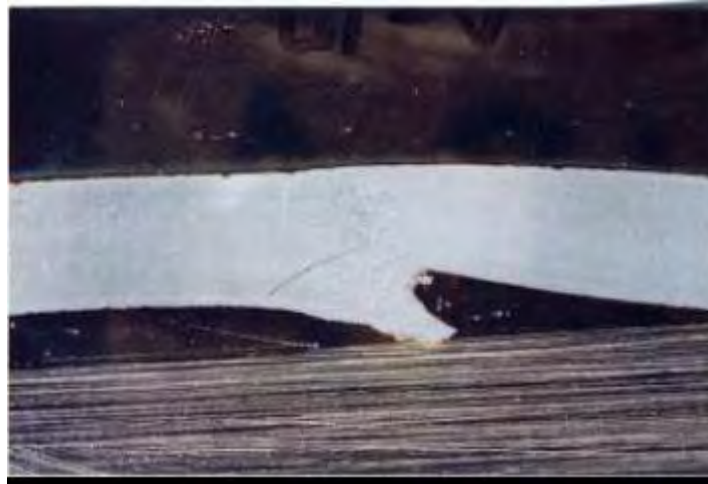
Ring flattening test results

Weld Location, degrees	Opening observed when flattened to					
	2/3 D		1/3 D		Walls Meeting	
	Cracks	Location	Cracks	Location	Cracks	Location
0°	No	-	No	-	No	-
90°	No	-	No	-	No	-

General notes and observations for this pipe section:

Pipe section submitted by anonymous donor.  
 Offset skelp edges at the seam and  
 inadequate trim of the upset at the ID

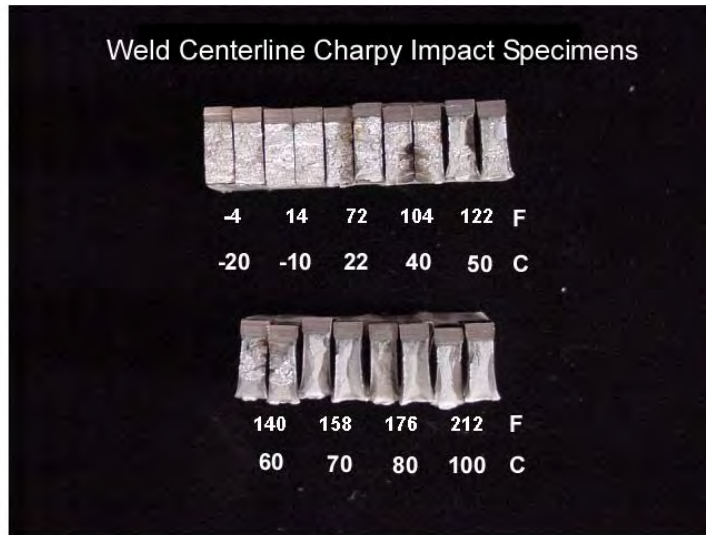
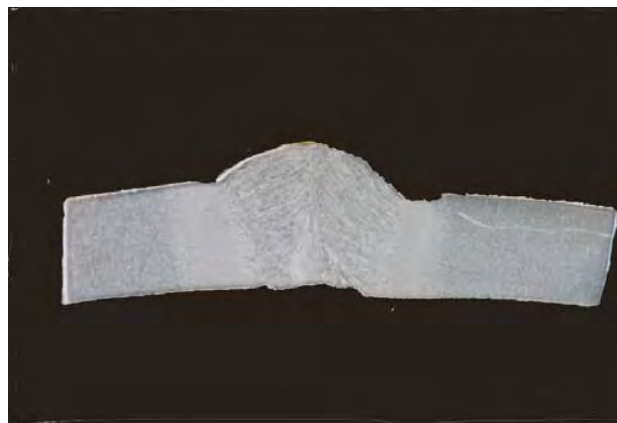
1957, Electric Fusion Weld

Ring flattening test results

Weld Location, degrees	Opening observed when flattened to					
	2/3 D		1/3 D		Walls Meeting	
	Cracks	Location	Cracks	Location	Cracks	Location
0°	No	-	No	-	No	-
90°	No	-	No	-	No	-

Tensile strength	63,400 psi	437 MPa
Yield strength	46,200 psi	319 MPa
Elongation, %	29.1	
Reduction of area, %	48.5	
Mode of failure	Ductile

#1	Failed in base metal @ 64,700 psi	446 MPa
#1	Failed in base metal @ 66,000 psi	455 MPa

<u>Transition temperature, 85% shear area for specimen</u>	125 °F	52 °C
<u>Charpy upper shelf energy, (full size specimen)</u>	13 ft-lbs	18 Joules

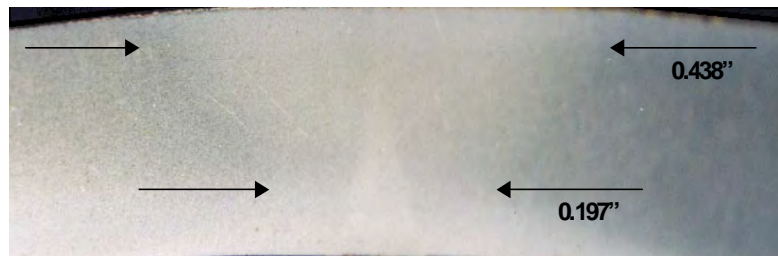
1951, LF ERW

Ring flattening test results

Weld Location, degrees	Opening observed when flattened to					
	2/3 D		1/3 D		Walls Meeting	
	Cracks	Location	Cracks	Location	Cracks	Location
0°	No	-	No	-	No	-
90°	No	-	No	-	No	-

Tensile strength	68,500 psi	472 MPa
Yield strength	50,700 psi	350 MPa
Elongation, %	24.9	
Reduction of area, %	36.9	
Mode of failure	Ductile

#1	Failed in base metal @ 70,200 psi	484 MPa
#1	Failed in base metal @ 68,800 psi	474 MPa

<u>Transition temperature, 85% shear area for specimen</u>	100 °F	38 °C
<u>Charpy upper shelf energy, (full size specimen)</u>	24 ft-lbs	34 Joules

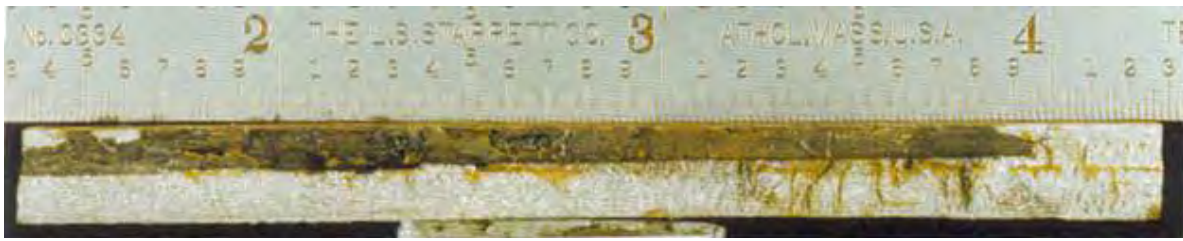
Catalog #: 134  
 Report #: 12  
 Defect #: 68C

**OD Hook Crack**

Photograph of Fracture Surface.

NDE technique(s): TOFD, MPI  
 NDE result(s): 99%, 2.25 inch (57.2 mm) OD-Connected Non-Fusion  
 Visual: OD Hook Crack  
 L > 2.7 inch (69 mm)  
 depth/t<sub>weld</sub> 52%  
 depth: 0.130 inch (3.30 mm)  
 t<sub>weld</sub> 0.248 inch (6.30 mm)

Seam Type: LF-ERW  
 Grade: API 5L X42  
 D<sub>nominal</sub> 12.75 inch (324 mm)  
 t<sub>nominal</sub> 0.250 inch (6.35 mm)  
 t<sub>pipe</sub> Not Determined  
 Failure: N/A

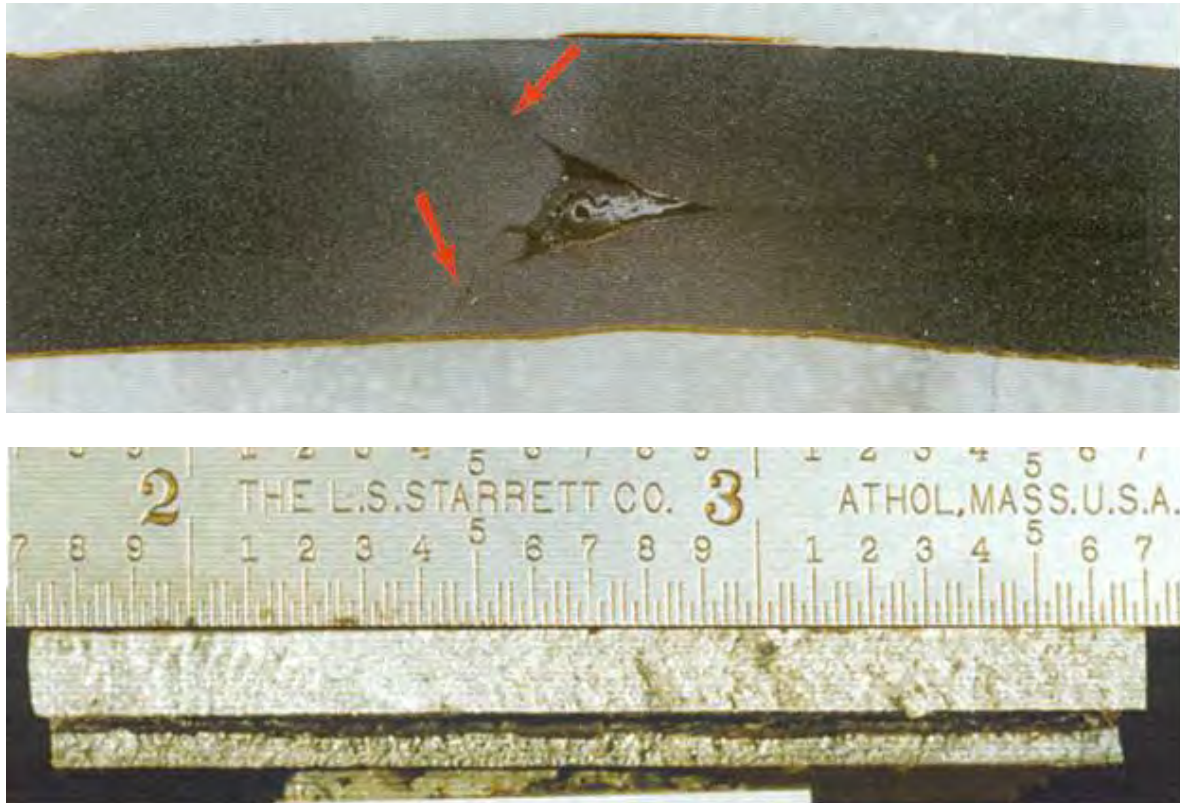
Catalog #: 135  
 Report #: 12  
 Defect #: 71A

Mid-Wall Void + Laminations + ID Hook Crack

Photographs of Metallographic Section and Fracture Surface.

$D_{nominal}$ : 12.75 inch (324 mm)  
 $t_{nominal}$ : 0.250 inch (6.35 mm)  
 $t_{pipe}$ : Not Determined  
 Failure: N/A

NDE technique(s): Fast UT, MPI  
 NDE result(s): 60%, 8.5 inch (216 mm) ID & Mid-wall Non-Fusion  
 Visual: Mid-wall Void + Laminations + ID Hook Crack  
 L: > 2 inch (51 mm) (ID Hook Crack)  
 $depth/t_{weld}$ : 48% (ID Hook Crack)  
 $depth$ : 0.122 inch (3.10 mm)  
 $t_{weld}$ : 0.251 inch (6.38 mm)

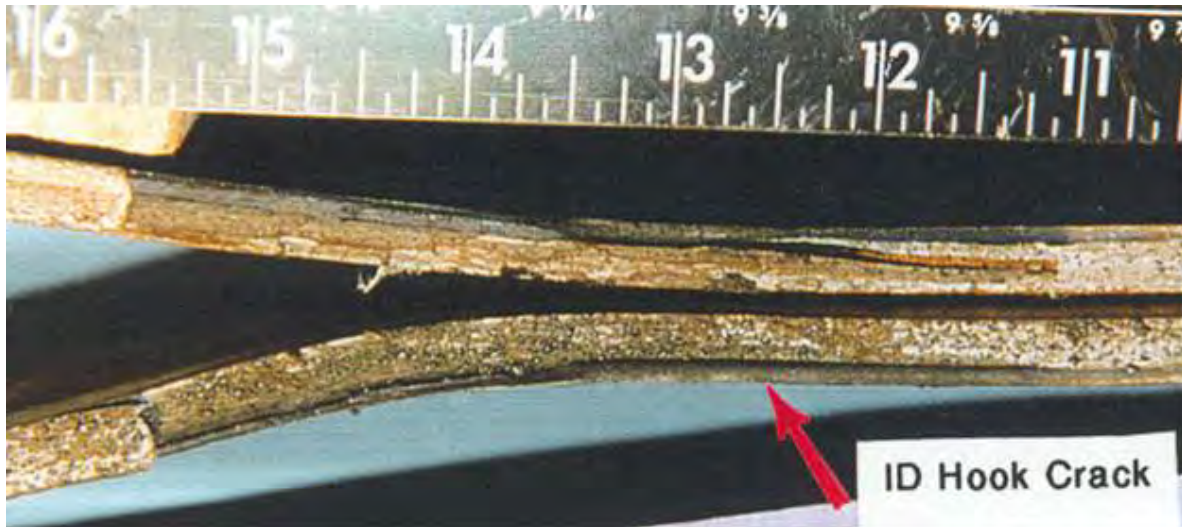
Catalog #: 22  
 Report #: 2  
 Defect #: 421

ID Hook Crack

Photograph of Fracture Surfaces.

Seam Type: ERW  
 Grade: X52  
 $D_{nominal}$ : 20 inch (508 mm)  
 $t_{nominal}$ : 0.312 inch (7.92 mm)  
 $t_{pipe}$ : 0.326 inch (8.28 mm)  
 Failure: Burst test rupture at  
 2,200 psig (15.17 MPa) (136% of SMYS)

NDE technique(s): UT  
 NDE result(s): 50%, 7 inch (178 mm)  
 crack like  
 Visual: ID Hook crack  
 L: 5.5 inch (140 mm)  
 depth/ $t_{weld}$ : 43%  
 depth: 0.150 inch (3.81 mm)  
 $t_{weld}$ : 0.344 inch (8.74 mm)

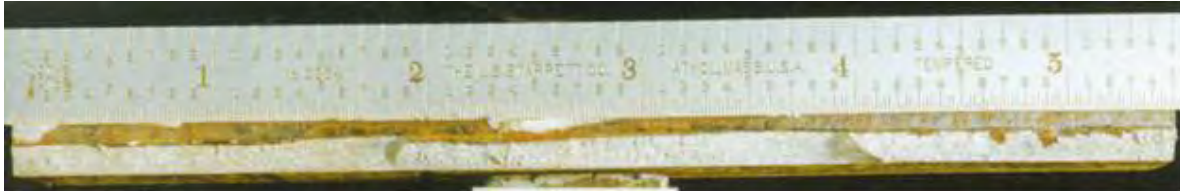
Catalog #: 126  
 Report #: 12  
 Defect #: 67A

**OD Hook Crack**

Photograph of Fracture Surface.

Seam Type: LF-ERW  
 Grade: API 5L X42  
 $D_{nominal}$ : 12.75 inch (324 mm)  
 $t_{nominal}$ : 0.250 inch (6.35 mm)  
 $t_{pipe}$ : Not Determined  
 Failure: N/A

Visual: OD Hook Crack  
 L: 5.4 inch (137 mm)  
 depth/ $t_{weld}$ : 43%  
 depth: 0.106 inch (2.69 mm)  
 $t_{weld}$ : 0.147 inch (3.73 mm)

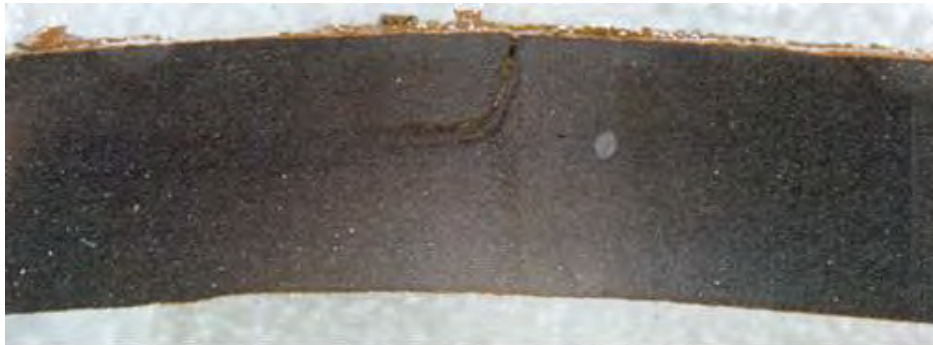
Catalog #: 140  
 Report #: 12  
 Defect #: 73D

**OD Hook Crack**

Photograph and Photomicrograph of Metallographic Section.

Seam Type: LF-ERW  
 Grade: API 5L X42  
 $D_{nominal}$ : 12.75 inch (324 mm)  
 $t_{nominal}$ : 0.250 inch (6.35 mm)  
 $t_{pipe}$ : Not Determined  
 Failure: N/A

Visual: OD Hook Crack  
 L: Not Determined  
 depth/ $t_{weld}$ : 38%  
 depth: 0.090 inch (2.29 mm)  
 $t_{weld}$ : 0.236 inch (5.99 mm)

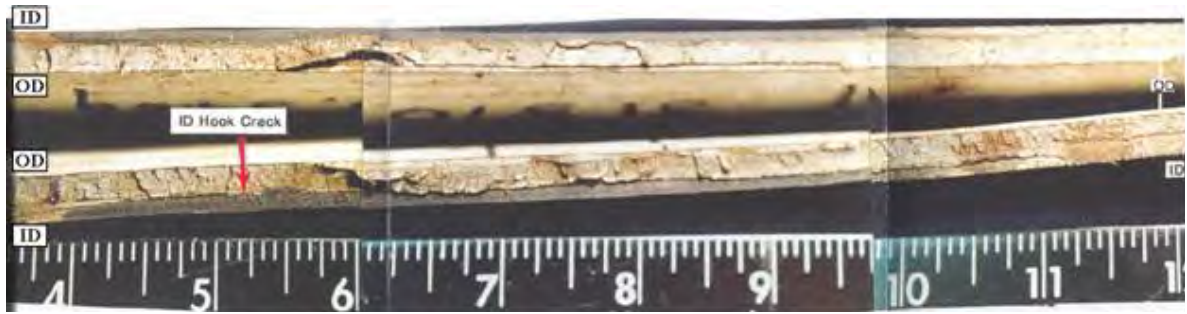
Catalog #: 23  
 Report #: 2  
 Defect #: 551-38.8.b

**ID Hook Crack**

Photographs of Fracture Surfaces.

(\*) Burst test failed two adjacent hook cracks at one pressure.

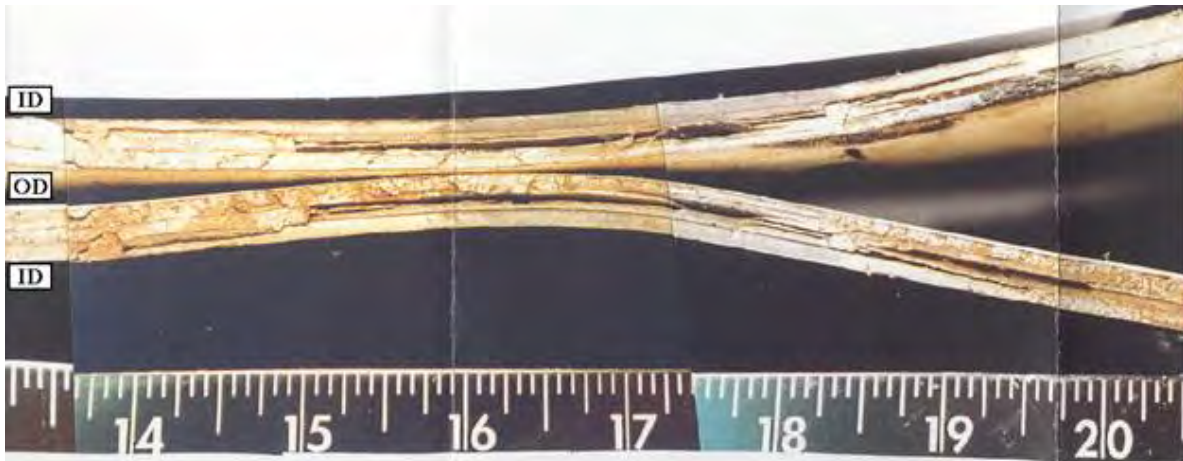
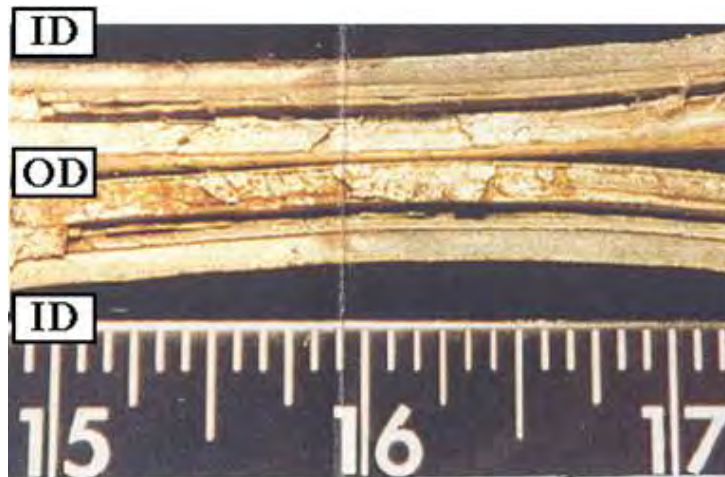
Catalog #: 24  
 Report #: 2  
 Defect #: 551-39.6.b

ERW

ID Hook Crack

Photographs of Fracture Surfaces.

Seam Type: ERW  
 Grade: X52  
 $D_{nominal}$ : 20 inch (508 mm)  
 $t_{nominal}$ : 0.312 inch (7.92 mm)  
 $t_{pipe}$ : 0.332 inch (8.43 mm)  
 Failure: Burst test rupture(\*) at  
 2,200 psig (15.17 MPa)  
 (116% of SMYS)

NDE technique(s): UT  
 NDE result(s): 80%, 5.5 inch (140 mm)  
 ID crack like  
 Visual: ID Hook crack  
 L: 7.0 inch (178 mm)  
 depth/ $t_{weld}$ : 35%  
 depth: 0.120 inch (3.05 mm)  
 $t_{weld}$ : 0.346 inch (8.79 mm)

(\*) Burst test failed two adjacent hook cracks at one pressure.

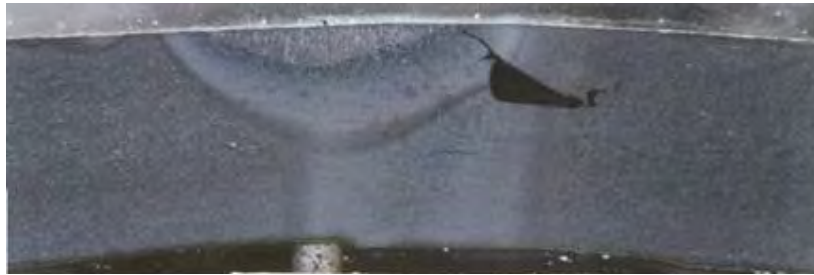
Catalog #: 108  
 Report #: 11  
 Defect #: 4A

ERW

OD Hook Crack + Mid-Wall Void + OD Weld Repair

Photograph and Photomicrograph of Metallographic Section.

$t_{nominal}$ : 0.250 inch (6.35 mm)  
 $t_{pipe}$ : Not Determined  
 Failure: N/A

NDE technique(s): Fast UT  
 NDE result(s): 40%, 3.5 inch (89 mm) OD Crack  
 Visual: OD Hook Crack + Mid-Wall Void + OD Weld Repair  
 L depth/ $t_{weld}$ : Not Determined  
 33.5% (OD Hook Crack)  
 depth: Not Determined  
 $t_{weld}$ : Not Determined

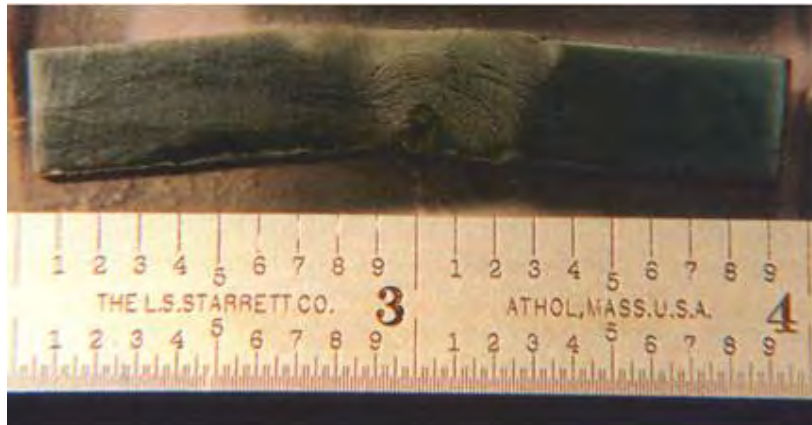
Catalog #: 9  
 Report #: 1  
 Defect #: 469

**ERW**

**ID Hook Crack**

Photograph and Photomicrograph Metallographic Section.

Seam Type: ERW  
 Grade: X52  
 $D_{nominal}$ : 20 inch (508 mm)  
 $t_{nominal}$ : 0.312 inch (7.92 mm)  
 $t_{pipe}$ : 0.309 inch (7.85 mm)  
 Failure: None at 2,175 psig  
 (15.00 MPa) (134%  
 of SMYS)

NDE technique(s): UT  
 NDE result(s): 30% x 2.5 inch  
 (63.5 mm) ID crack  
 ID hook crack  
 Visual: ID hook crack  
 L: N/A  
 depth/ $t_{weld}$ : 29%  
 depth: 0.096 inch (2.44 mm)  
 $t_{weld}$ : 0.330 inch (8.38 mm)

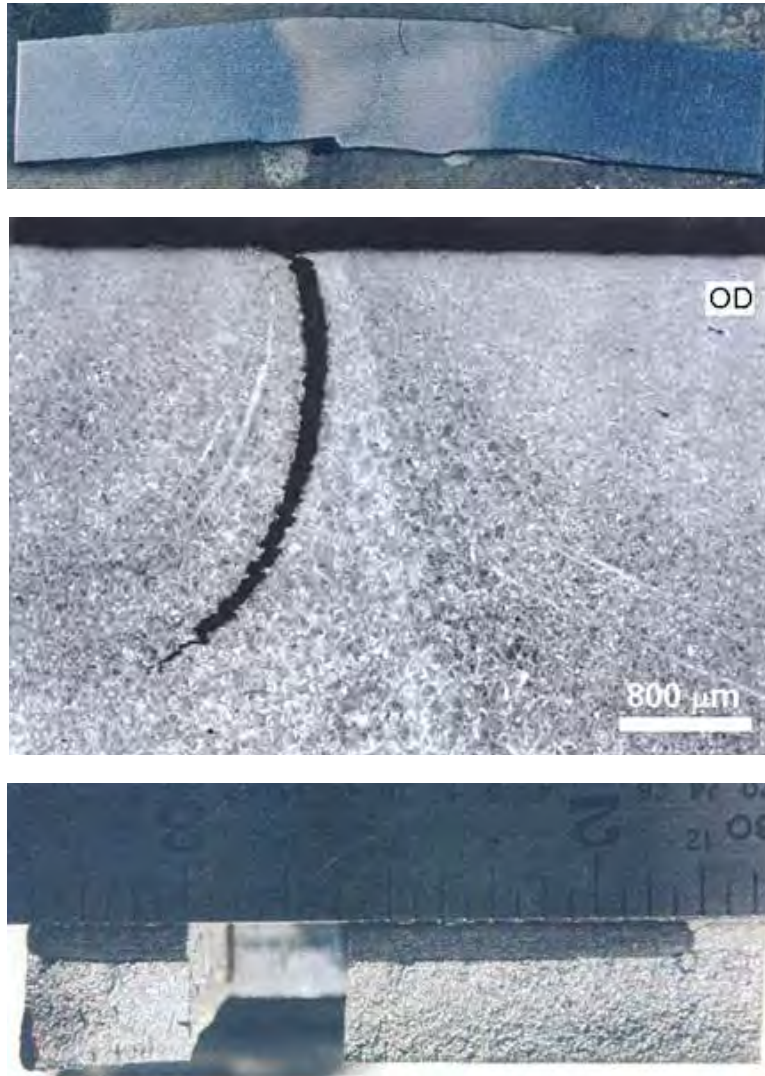
Catalog #: 98  
 Report #: 10  
 Defect #: CY-7

**ERW**

**OD Hook Crack**

Photographs and Photomicrograph of Metallographic Section and Fracture Surface.

Vintage: circa 1950  
 Manufacturer: Youngstown  
 Seam Type: ERW  
 Grade: X52  
 $D_{nominal}$ : 20 inch (508 mm)  
 $t_{nominal}$ : 0.312 inch (7.92 mm)  
 $t_{pipe}$ : Not Determined  
 Failure: N/A

NDE technique(s): N/A  
 NDE result(s): N/A  
 Visual: OD Hook Crack  
 L: 1.6 inch (41 mm)  
 $depth/t_{weld}$ : 27.5 %  
 depth: 0.100 inch (2.54 mm)  
 $t_{weld}$ : 0.363 inch (9.22 mm)

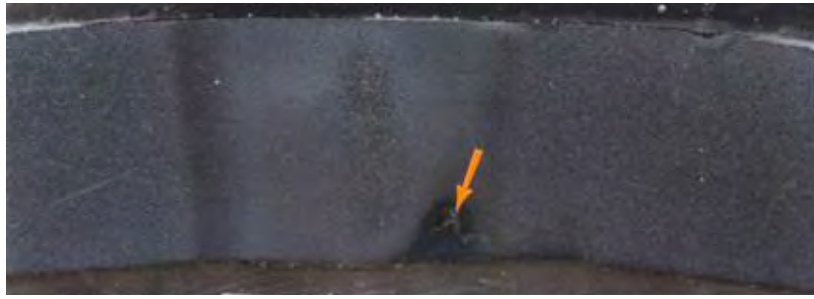
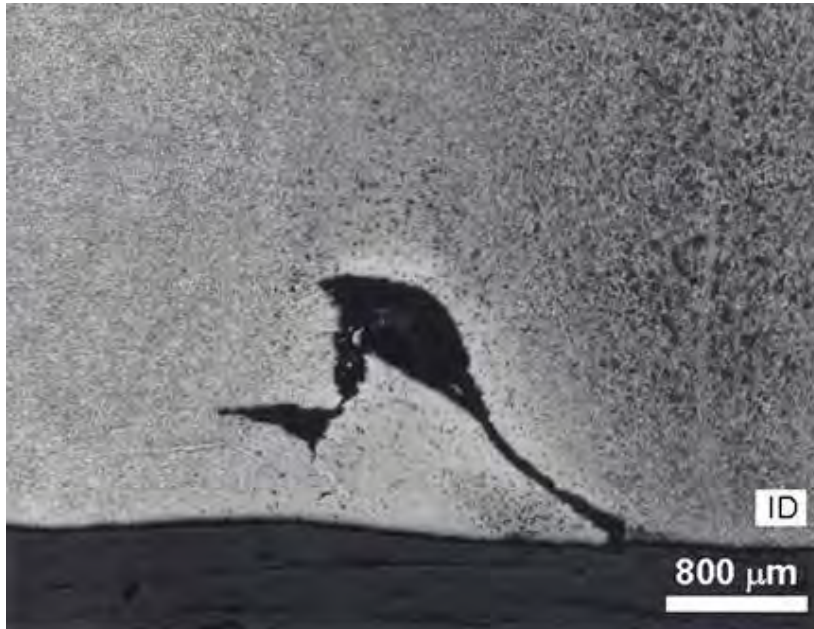
Catalog #: 106  
 Report #: 11  
 Defect #: 3D

**ERW**

**ID Hook Crack + Mid-Wall Void**

Photograph and Photomicrograph of Metallographic Section.

Vintage: 1953  
 Manufacturer: Unknown  
 Seam Type: LF-ERW  
 Grade: API 5L X42  
 $D_{nominal}$ : 12.75 inch (324 mm)  
 $t_{nominal}$ : 0.250 inch (6.35 mm)  
 $t_{pipe}$ : Not Determined  
 Failure: N/A

NDE technique(s): Fast UT  
 NDE result(s): 30%, 2.5 inch (63 mm) ID Crack  
 ID Hook Crack Mid-wall Void  
 Visual: Not Determined  
 L: 24.2% (ID Hook Crack)  
 depth/ $t_{weld}$ : Not Determined  
 depth: Not Determined  
 $t_{weld}$ : Not Determined

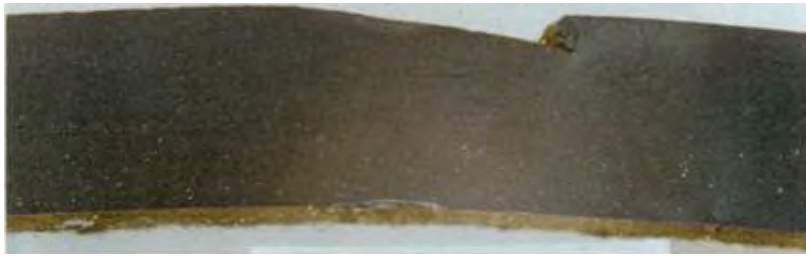
Catalog #: 125  
 Report #: 12  
 Defect #: 62A

**ERW**

**Misalignment + Hook Crack + Alloy Segregation**

Photograph and Photomicrograph of Metallographic Section.

Grade: API 5L X42  
 $D_{\text{nominal}}$ : 12.75 inch (324 mm)  
 $t_{\text{nominal}}$ : 0.250 inch (6.35 mm)  
 $t_{\text{pipe}}$ : Not Determined  
 Failure: N/A

Visual: Misalignment + Hook Crack + Alloy Segregation

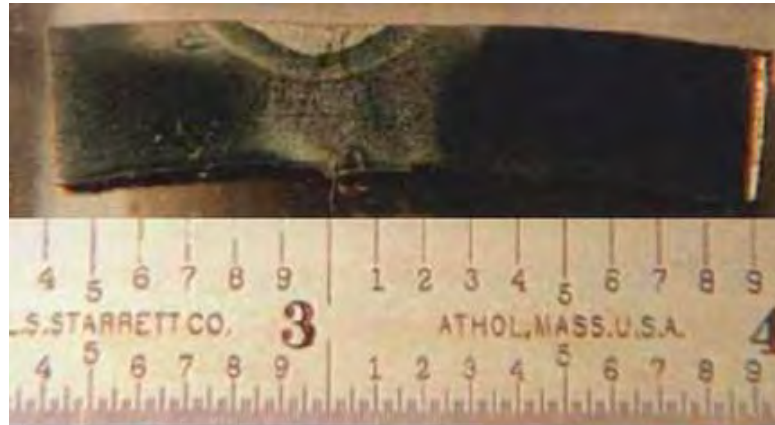
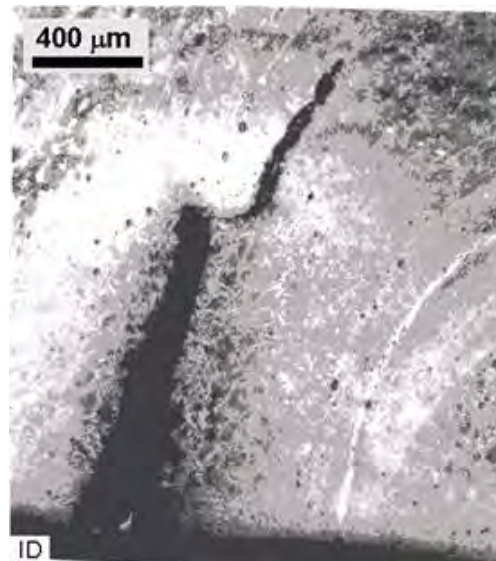
Catalog #: 8  
 Report #: 1  
 Defect #: 451

ERW

ID Hook Crack

Photograph and Photomicrograph of Metallographic Section.

Seam Type: ERW  
 Grade: X52  
 $D_{nominal}$ : 20 inch (508 mm)  
 $t_{nominal}$ : 0.312 inch (7.92 mm)  
 $t_{pipe}$ : 0.330 inch (8.38 mm)  
 Failure: None at 2,250 psig  
 (15.51 MPa) (139% of SMYS)

NDE technique(s): UT  
 NDE result(s): 7% x 2.5 inch  
 (63 mm) grind area on seam  
 Visual: ID hook crack  
 L: N/A  
 depth/ $t_{weld}$ : 4.3%  
 depth: 0.0136 inch (0.35 mm)  
 $t_{weld}$ : 0.319 inch (8.10 mm)

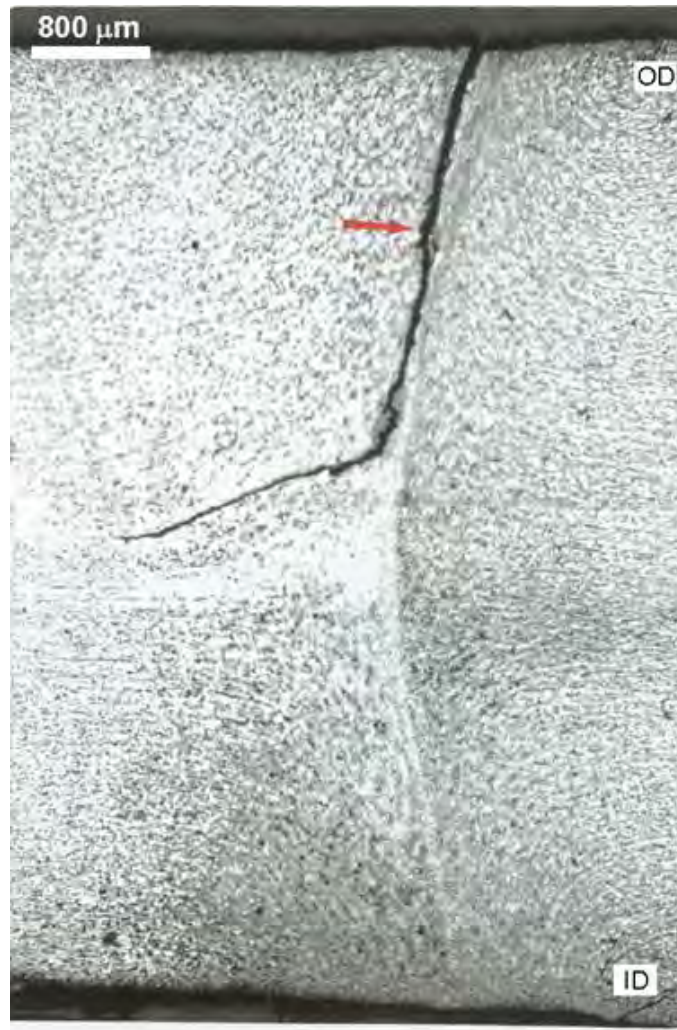
Catalog #: 114  
 Report #: 12  
 Defect #: 46B-D

**ERW**

**Hook Crack**

Photograph and Photomicrograph of Metallographic Section.

Seam Type: LF-ERW  
 Grade: API 5L X42  
 $D_{nominal}$ : 12.75 inch (324 mm)  
 $t_{nominal}$ : 0.250 inch (6.35 mm)  
 $t_{pipe}$ : Not Determined  
 Failure: N/A

Visual: Hook Crack  
 L: Not Determined  
 $depth/t_{weld}$ : Not Determined  
 depth: Not Determined  
 $t_{weld}$ : Not Determined

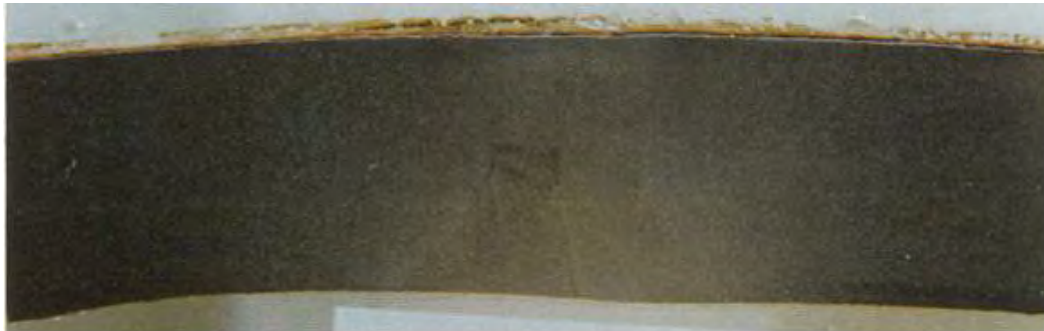
Catalog #: 112  
 Report #: 12  
 Defect #: 46B-B

**ERW**

**Hook Crack + Alloy Segregation**

Photograph and Photomicrograph of Metallographic Section.

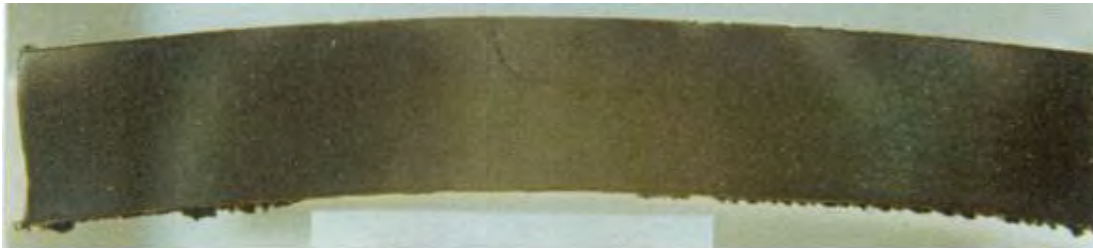
Catalog #: 143  
 Report #: 12  
 Defect #: 79B

**ERW**

**Hook Crack + Alloy Segregation**

Photograph and Photomicrograph of Metallographic Section.

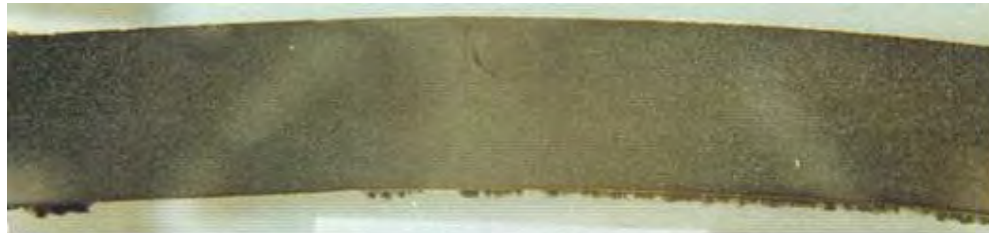
Catalog #: 144  
 Report #: 12  
 Defect #: 79C

**ERW**

**Hook Crack + Alloy Segregation**

Photograph and Photomicrograph of Metallographic Section.

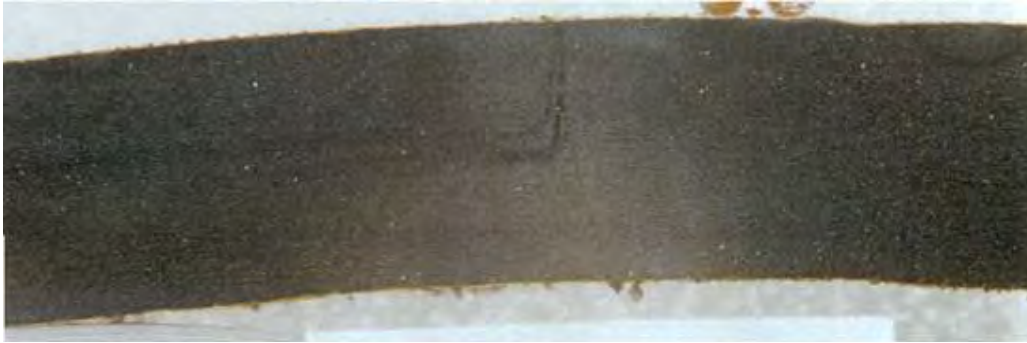
Catalog #: 141  
 Report #: 12  
 Defect #: 73E

**ERW**

**OD Hook Crack + Alloy Segregation**

Photograph and Photomicrograph of Metallographic Section.

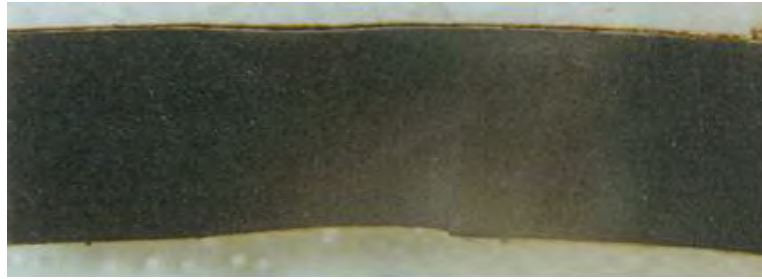
Catalog #: 145  
 Report #: 12  
 Defect #: 80A

**ERW**

***Weld Area Crack, Weld Crack, + Misalignment + Alloy Segregation***

Photograph and Photomicrograph of Metallographic Section.

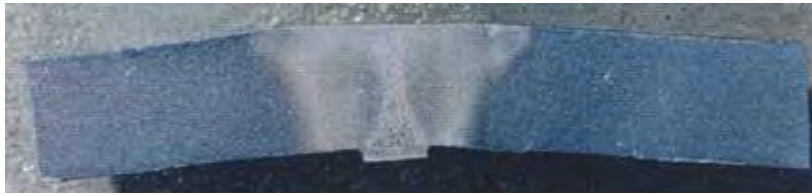
Catalog #: 100  
 Report #: 10  
 Defect #: CY-9

**ERW**

**OD Crack at Contact Mark + ID Under-Trim**

Photograph and Photomicrograph of Metallographic Section.

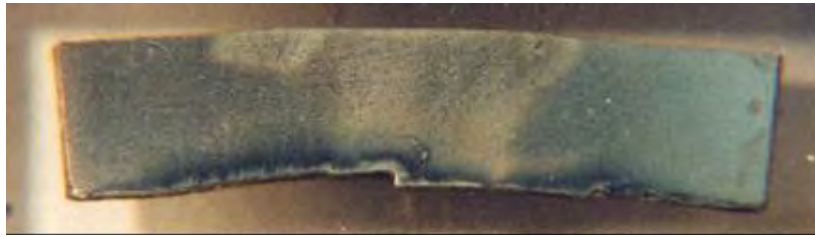
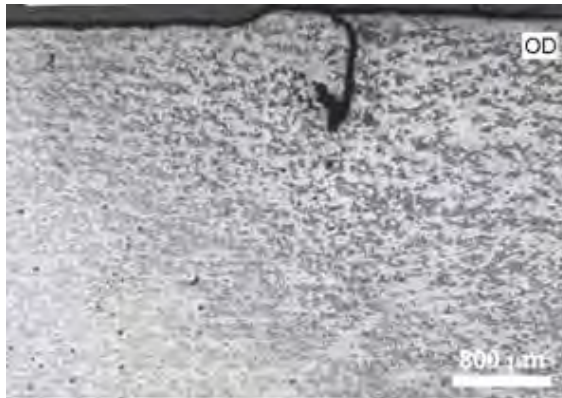
**ERW**

**OD Crack + ID Outbent Fiber + Contact Marks**

Photograph and Photomicrographs of Metallographic Section.

Catalog #:	63		
Report #:	7		
Defect #:	432-4.09		
<b>Pipe</b>		<b>Defect</b>	
Vintage:	circa 1950	NDE technique(s):	Fast UT
Manufacturer:	Youngstown	NDE result(s):	No Anomaly Revealed OD Crack + ID
Seam Type:	ERW	Visual:	Outbent fiber + Contact Marks
Grade:	X52	L	Not Determined
D <sub>nominal</sub>	20 inch (508 mm)	depth/t <sub>weld</sub>	11% (OD Crack)
t <sub>nominal</sub>	0.312 inch (7.92 mm)	depth:	0.036 inch (0.91 mm) (OD Crack)
t <sub>pipe</sub>	Not determined	t <sub>weld</sub>	0.319 inch (8.10 mm)
Failure:	N/A

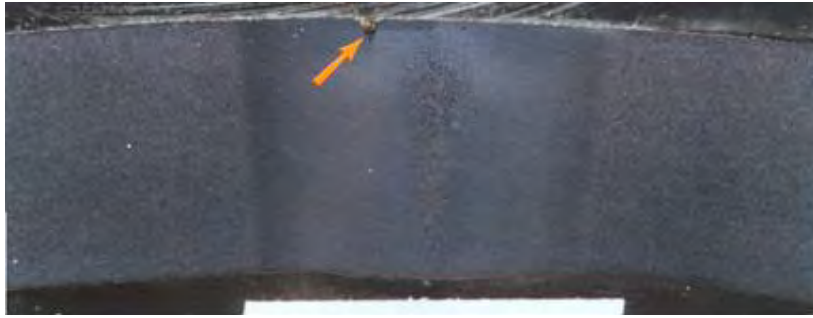
Catalog #: 107  
 Report #: 11  
 Defect #: 3E

**ERW**

**OD Crack**

Photograph and Photomicrograph of Metallographic Section.

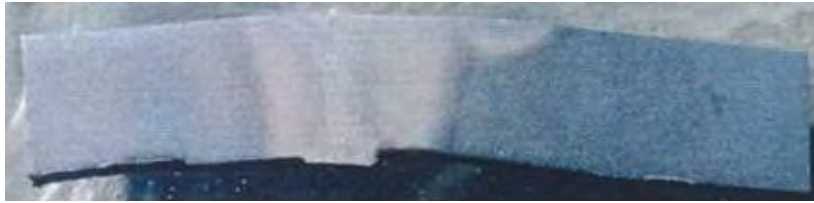
Catalog #: 93  
 Report #: 10  
 Defect #: CY-2

**OD Crack**

Photograph and Photomicrograph of Metallographic Section.

Vintage: circa 1950  
 Manufacturer: Youngstown  
 Seam Type: ERW  
 Grade: X52  
 $D_{nominal}$ : 20 inch (508 mm)  
 $t_{nominal}$ : 0.312 inch (7.92 mm)  
 $t_{pipe}$ : Not Determined  
 Failure: N/A

NDE technique(s): N/A  
 NDE result(s): N/A  
 Visual: OD Crack  
 L: Not Determined  
 depth/ $t_{weld}$ : 8.8%  
 depth: 0.031 inch (0.79 mm)  
 $t_{weld}$ : 0.353 inch (8.97 mm)
