**KyPSC Case No. 2022-00084**  
**TABLE OF CONTENTS**

**Duke Energy Kentucky**  
**Case No. 2022-00084**  
**STAFF First Set Data Requests**  
**Date Received: May 19, 2022**

**STAFF-DR-01-001**

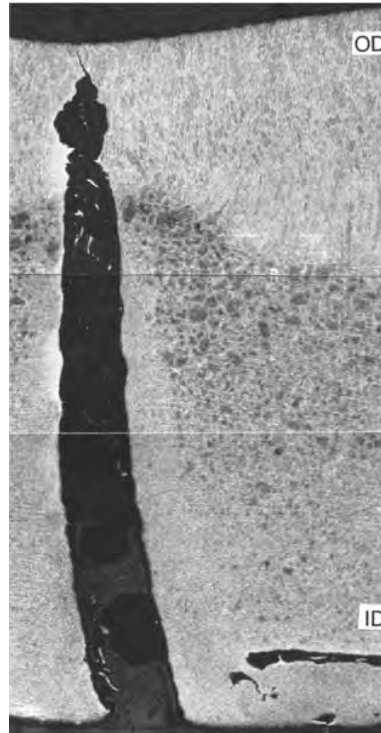
Catalog #: 29  
 Report #: 3  
 Defect #: 12A

**ID Lack of Fusion and Small Crack**

Photographs and Photomicrograph of Metallographic Section, and Fracture Surfaces.

Seam Type: LF-ERW  
 Grade: X52  
 $D_{nominal}$ : 20 inch (508 mm)  
 $t_{nominal}$ : 0.312 inch (7.92 mm)  
 $t_{pipe}$ : 0.320 inch (8.13 mm)  
 Failure: None

NDE technique(s): UT, MT, and Fast UT  
 12 x 7 inch (305 x 178 mm)  
 OD seam grind area (UT) +  
 11 x 1.0 inch (280 x 25.4 mm)  
 OD weld repair (UT) +  
 0.4 x 0.1 inch (10.2 x 2.5 mm)  
 OD grind area (UT) +  
 0.25 inch (6.35 mm)  
 OD crack (MT) + 100%, 1.9 inch (48.3 mm)  
 ID hook crack (Fast UT)  
 ID Lack of Fusion & Small crack  
 1.9 inch (48 mm)  
 99%  
 depth/ $t_{weld}$ : 0.317 inch (8.05 mm)  
 depth: 0.332 inch (8.43 mm)  
 $t_{weld}$

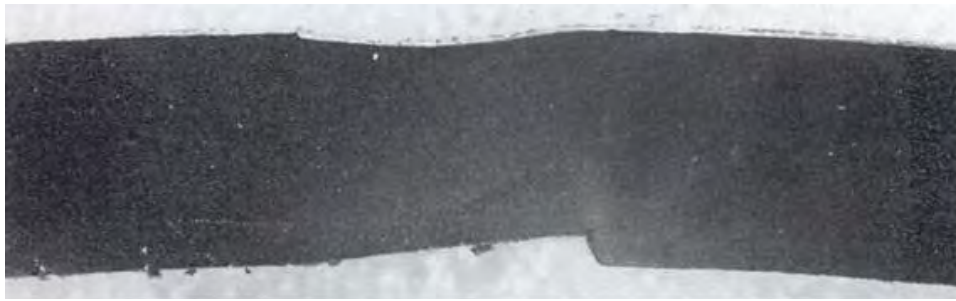
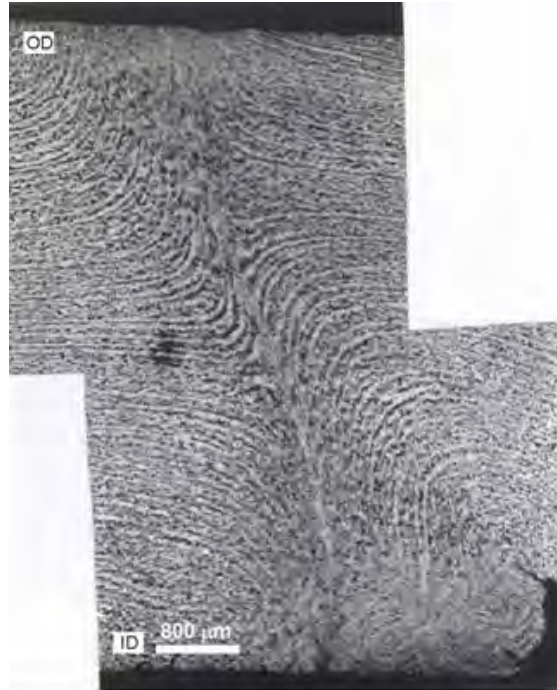
Catalog #: 139  
 Report #: 12  
 Defect #: 73B

**ID Extrusion Cracks + Alloy Segregation + Misalignment**

Photograph and Photomicrograph of Metallographic Section.

Grade: API 5L X42  
 $D_{\text{nominal}}$ : 12.75 inch (324 mm)  
 $t_{\text{nominal}}$ : 0.250 inch (6.35 mm)  
 $t_{\text{pipe}}$ : Not Determined  
 Failure: N/A

Visual: ID Extrusion Cracks + Alloy Segregation + Misalignment

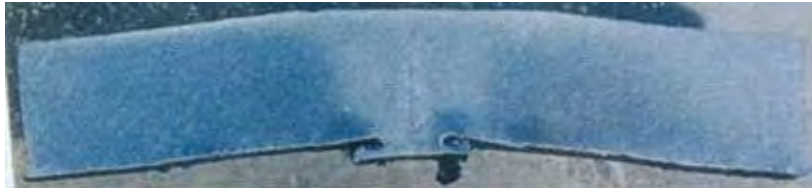
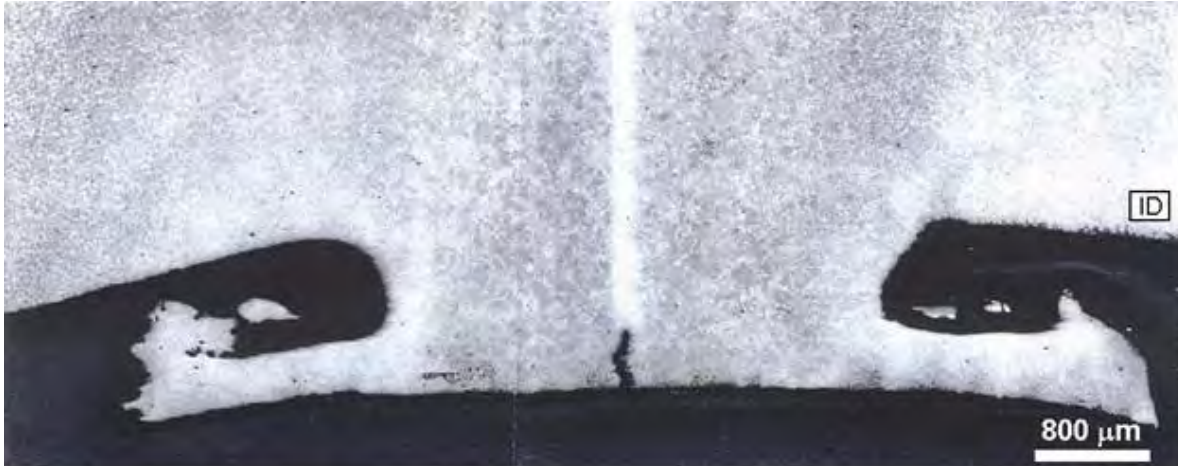
Catalog #: 101  
 Report #: 10  
 Defect #: CY-10

**ID Crack + ID Under-Trim**

Photograph and Photomicrograph of Metallographic Section.

Grade: X52  
 $D_{nominal}$ : 20 inch (508 mm)  
 $t_{nominal}$ : 0.312 inch (7.92 mm)  
 $t_{pipe}$ : Not Determined  
 Failure: N/A

NDE technique(s): N/A  
 NDE result(s): N/A  
 Visual: ID Crack + ID Under-trim  
 L: Not Determined  
 depth/ $t_{weld}$ : 4.2% (ID Crack)  
 depth: 0.015 inch (0.38 mm)  
 $t_{weld}$ : 0.350 inch (8.89 mm)

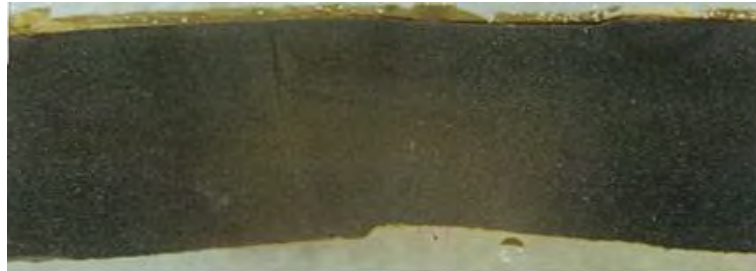
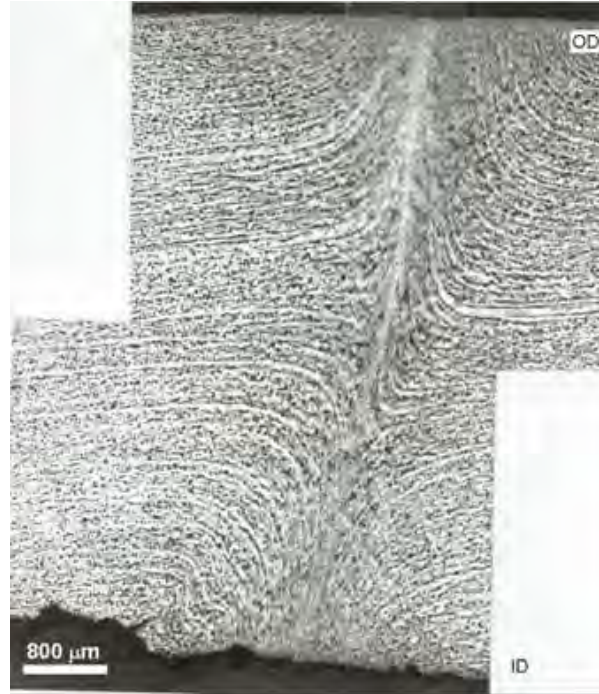
Catalog #: 130  
 Report #: 12  
 Defect #: 67E

**Misalignment + Alloy Segregation**

Photograph and Photomicrograph of Metallographic Section.

Grade: API 5L X42  
 $D_{nominal}$ : 12.75 inch (324 mm)  
 $t_{nominal}$ : 0.250 inch (6.35 mm)  
 $t_{pipe}$ : Not Determined  
 Failure: N/A

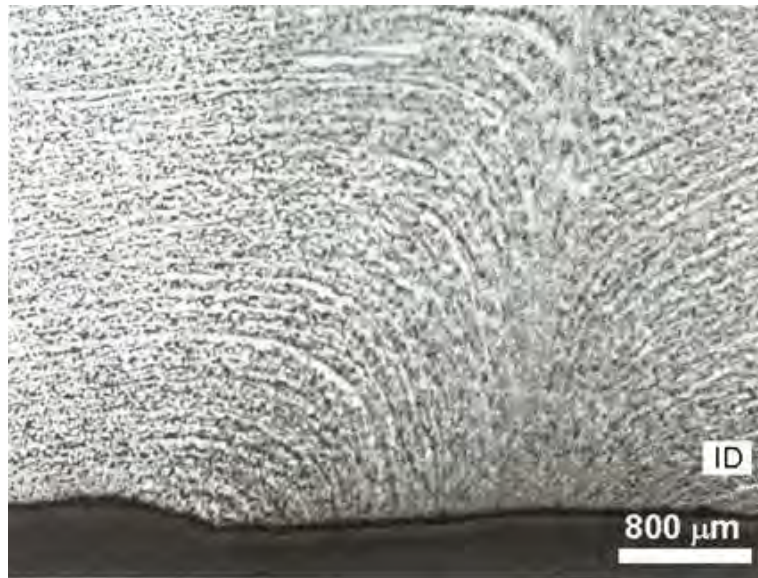
Catalog #: 129  
 Report #: 12  
 Defect #: 67D

**Misalignment + Alloy Segregation**

Photograph and Photomicrograph of Metallographic Section.

Grade: API 5L X42  
 $D_{nominal}$ : 12.75 inch (324 mm)  
 $t_{nominal}$ : 0.250 inch (6.35 mm)  
 $t_{pipe}$ : Not Determined  
 Failure: N/A

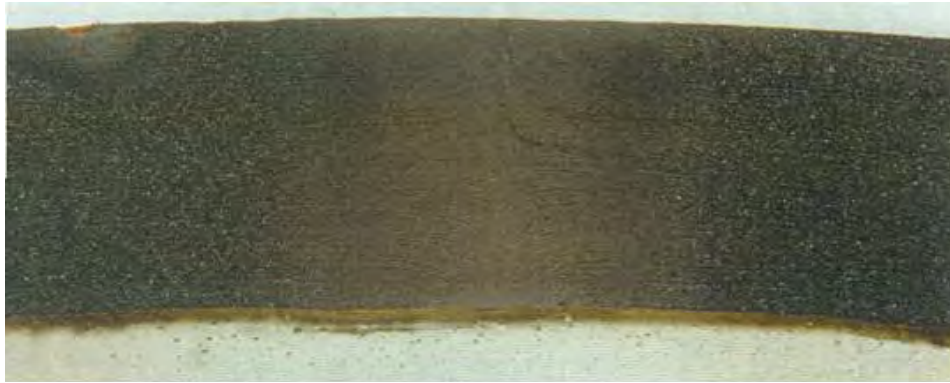
Catalog #: 131  
 Report #: 12  
 Defect #: 67F

**Misalignment + Alloy Segregation**

Photograph and Photomicrograph of Metallographic Section.

Grade: API 5L X42  
 $D_{nominal}$ : 12.75 inch (324 mm)  
 $t_{nominal}$ : 0.250 inch (6.35 mm)  
 $t_{pipe}$ : Not Determined  
 Failure: N/A

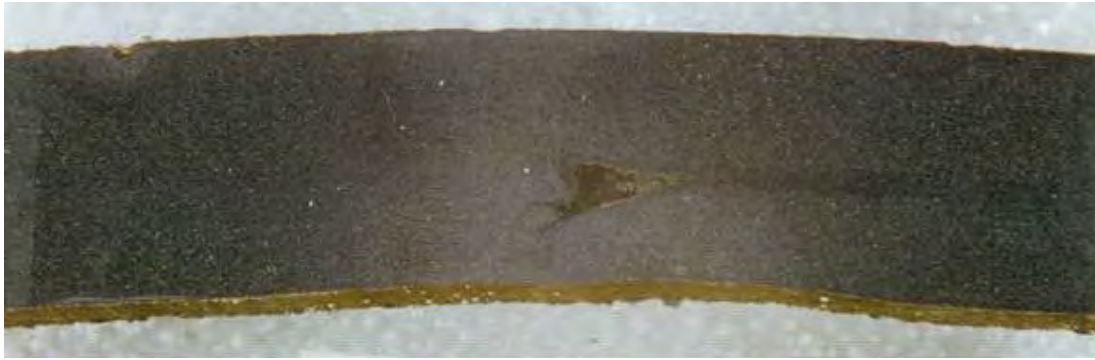
Catalog #: 127  
 Report #: 12  
 Defect #: 67B

***Mid-Wall Void + Laminations + Misalignment + Alloy Segregation***

Photograph of Metallographic Section.

Grade: API 5L X42  
 $D_{\text{nominal}}$ : 12.75 inch (324 mm)  
 $t_{\text{nominal}}$ : 0.250 inch (6.35 mm)  
 $t_{\text{pipe}}$ : Not Determined  
 Failure: N/A

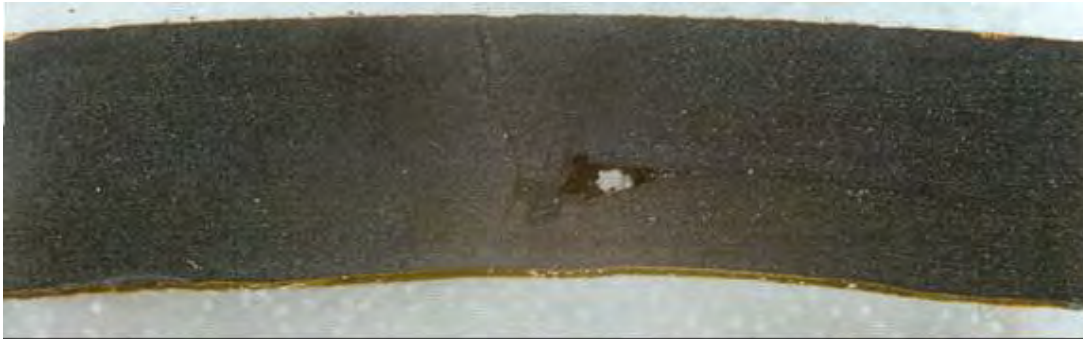
Catalog #: 128  
 Report #: 12  
 Defect #: 67C

**Mid-Wall Void + Laminations + Misalignment + Alloy Segregation**

Photograph of Metallographic Section.

Grade: API 5L X42  
 $D_{nominal}$ : 12.75 inch (324 mm)  
 $t_{nominal}$ : 0.250 inch (6.35 mm)  
 $t_{pipe}$ : Not Determined  
 Failure: N/A

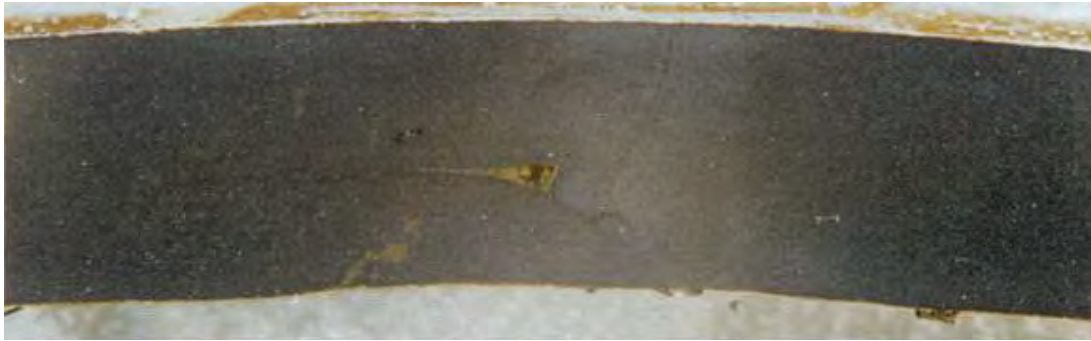
Catalog #: 132  
 Report #: 12  
 Defect #: 68A

**Mid-Wall Void + Laminations + Alloy Segregation + Misalignment**

Photograph of Metallographic Section.

Grade: API 5L X42  
 $D_{nominal}$ : 12.75 inch (324 mm)  
 $t_{nominal}$ : 0.250 inch (6.35 mm)  
 $t_{pipe}$ : Not Determined  
 Failure: N/A

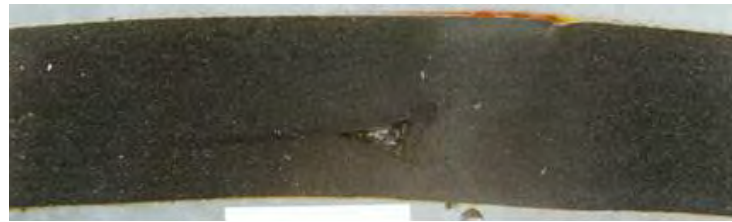
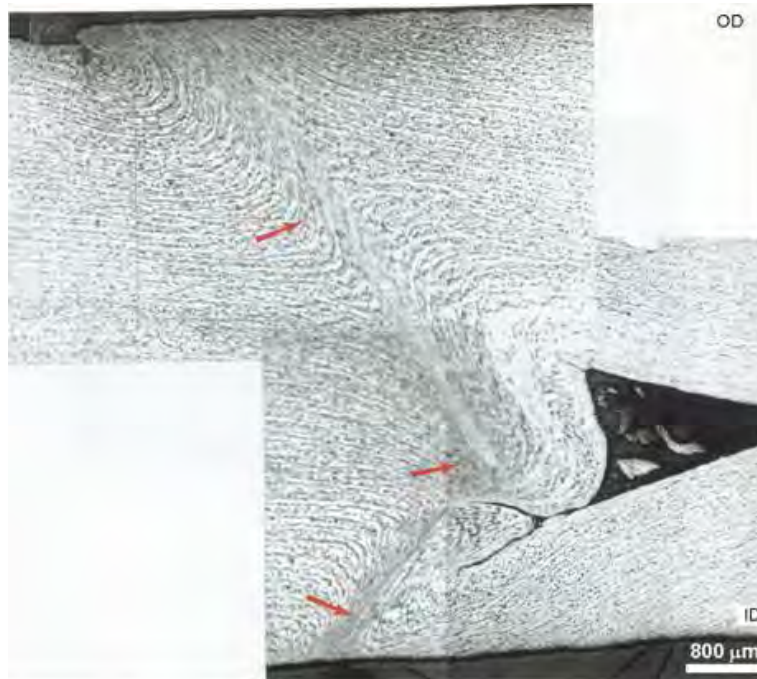
Catalog #: 117  
 Report #: 12  
 Defect #: 52B

**External Corrosion on Seam + Alloy Segregation + Misalignment**

Photograph and Photomicrograph of Metallographic Section.

Grade: API 5L X42  
 $D_{nominal}$ : 12.75 inch (324 mm)  
 $t_{nominal}$ : 0.250 inch (6.35 mm)  
 $t_{pipe}$ : Not Determined  
 Failure: N/A

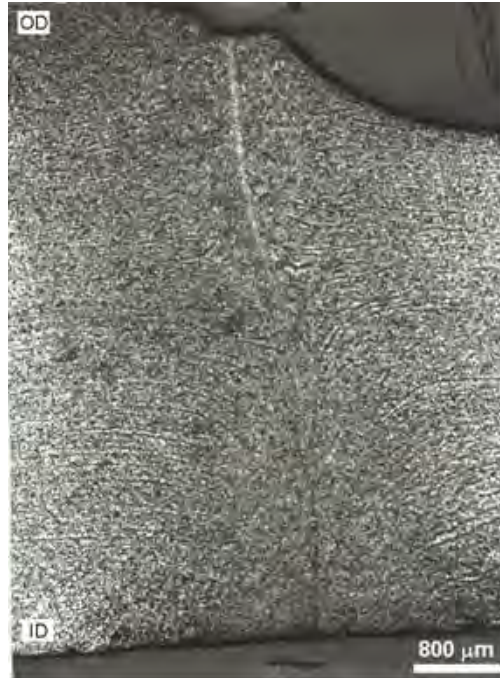
Catalog #: 119  
 Report #: 12  
 Defect #: 53A

**External Corrosion on Seam + Alloy Segregation + Misalignment**

Photograph and Photomicrograph of Metallographic Section.

Grade: API 5L X42  
 $D_{nominal}$ : 12.75 inch (324 mm)  
 $t_{nominal}$ : 0.250 inch (6.35 mm)  
 $t_{pipe}$ : Not Determined  
 Failure: N/A

NDE technique(s): Fast UT, MPI  
 NDE result(s): 30%, 2 inch (51 mm) Metal Loss  
 Visual: External Corrosion on Seam + Alloy Segregation + Misalignment  
 L depth/ $t_{weld}$ : Not Determined  
 depth: 29% (Corrosion)  
 $t_{weld}$ : 0.075 inch (1.9 mm)  
 0.257 inch (6.98 mm)

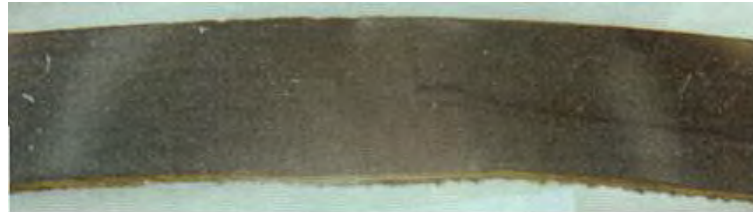
Catalog #: 116  
 Report #: 12  
 Defect #: 52A

**Alloy Segregation + Misalignment**

Photograph and Photomicrograph of Metallographic Section.

Grade: API 5L X42  
 $D_{\text{nominal}}$ : 12.75 inch (324 mm)  
 $t_{\text{nominal}}$ : 0.250 inch (6.35 mm)  
 $t_{\text{pipe}}$ : Not Determined  
 Failure: N/A

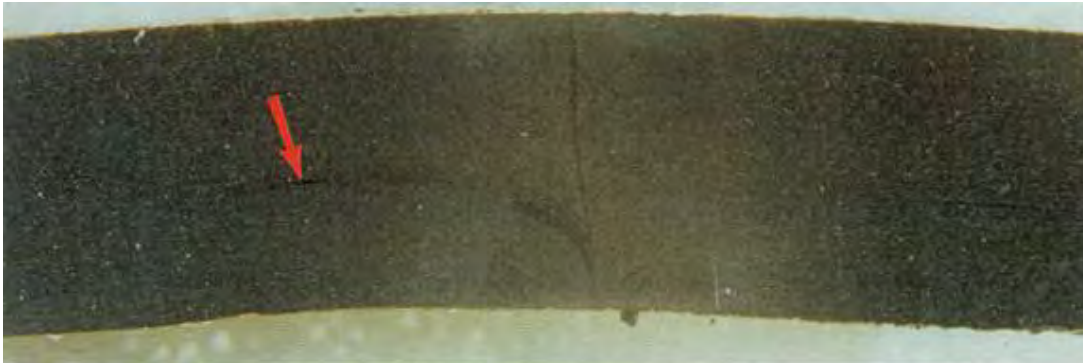
Catalog #: 133  
 Report #: 12  
 Defect #: 68B

**Alloy Segregation + Misalignment**

Photograph and Photomicrograph of Metallographic Section.

Grade: API 5L X42  
 $D_{nominal}$ : 12.75 inch (324 mm)  
 $t_{nominal}$ : 0.250 inch (6.35 mm)  
 $t_{pipe}$ : Not Determined  
 Failure: N/A

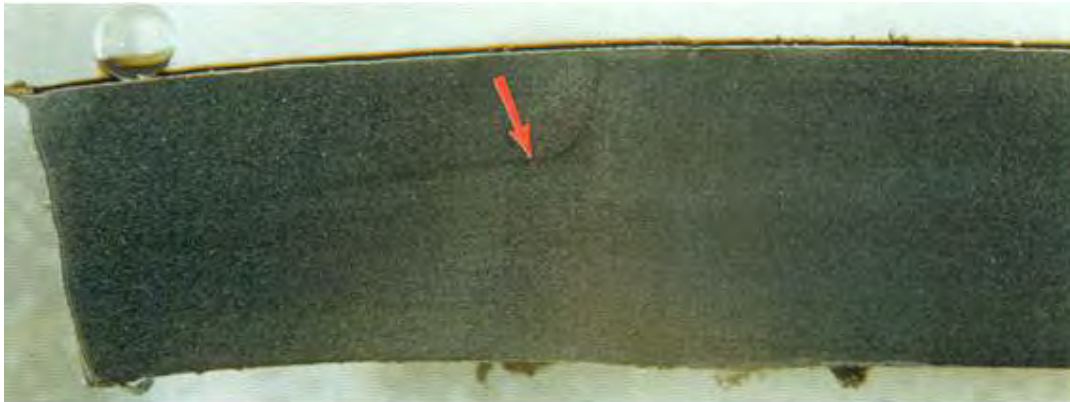
Catalog #: 113  
 Report #: 12  
 Defect #: 46B-C

**Alloy Segregation**

Photograph and Photomicrograph of Metallographic Section.

Vintage: Unknown  
 Manufacturer: Unknown  
 Seam Type: LF-ERW  
 Grade: API 5L X42  
 $D_{nominal}$ : 12.75 inch (324 mm)  
 $t_{nominal}$ : 0.250 inch (6.35 mm)  
 $t_{pipe}$ : Not Determined  
 Failure: N/A

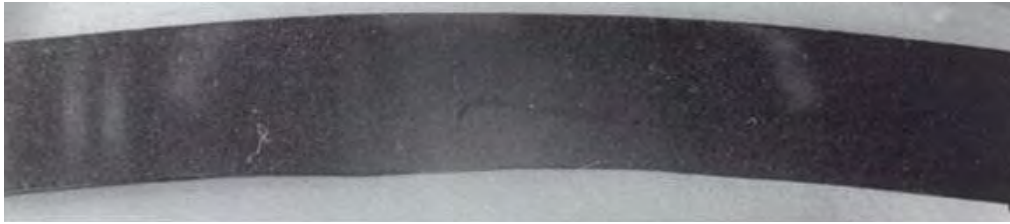
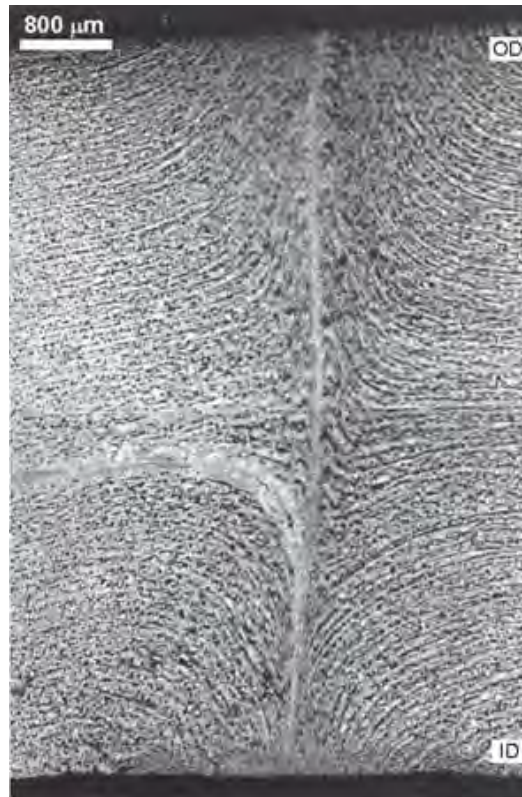
Catalog #: 118  
 Report #: 12  
 Defect #: 52C

**Alloy Segregation**

Photograph and Photomicrograph of Metallographic Section.

Vintage: Unknown  
 Manufacturer: Unknown  
 Seam Type: LF-ERW  
 Grade: API 5L X42  
 $D_{nominal}$ : 12.75 inch (324 mm)  
 $t_{nominal}$ : 0.250 inch (6.35 mm)  
 $t_{pipe}$ : Not Determined  
 Failure: N/A

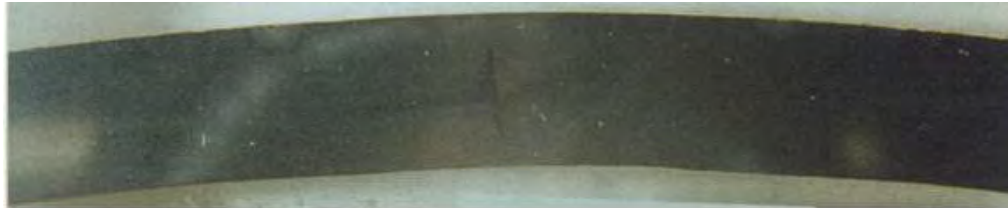
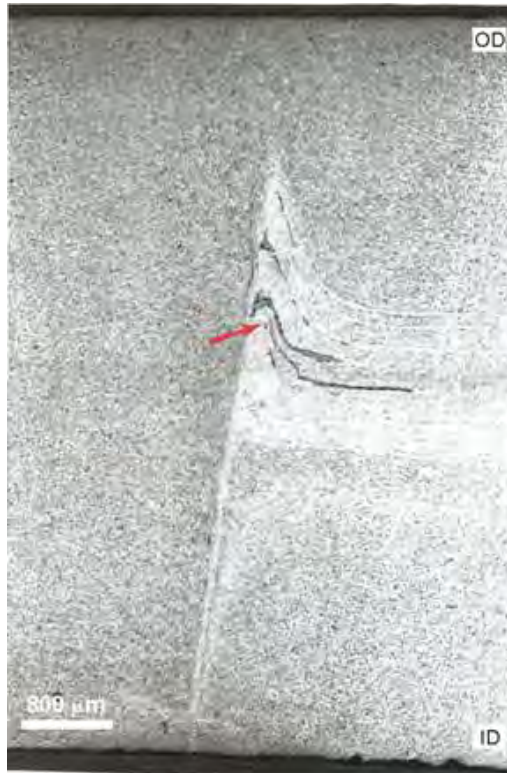
Catalog #: 137  
 Report #: 12  
 Defect #: 72C

**Alloy Segregation**

Photograph and Photomicrograph of Metallographic Section.

Seam Type: LF-ERW  
 Grade: API 5L X42  
 $D_{nominal}$ : 12.75 inch (324 mm)  
 $t_{nominal}$ : 0.250 inch (6.35 mm)  
 $t_{pipe}$ : Not Determined  
 Failure: N/A

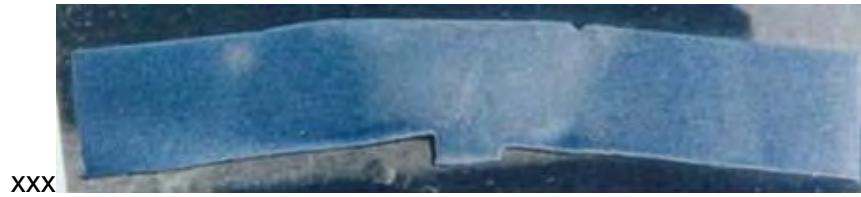
Catalog #: 95  
 Report #: 10  
 Defect #: CY-4

**Offset Plate Edges + OD Notch**

Photograph of Metallographic Section.

Grade:	X52	L	Not Determined
D <sub>nominal</sub>	20 inch (508 mm)	depth/t <sub>weld</sub>	Not Determined
t <sub>nominal</sub>	0.312 inch (7.92 mm)	depth:	Not Determined
t <sub>pipe</sub>	0.280 inch (7.11 mm) (at offset)	t <sub>weld</sub>	Not Determined
Failure:	N/A

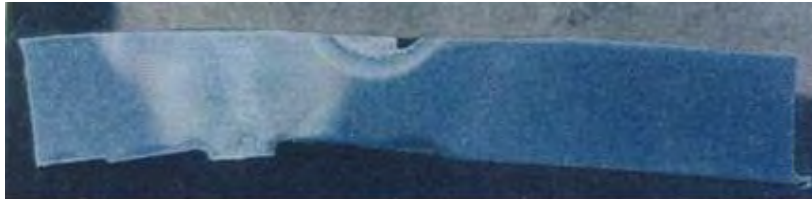
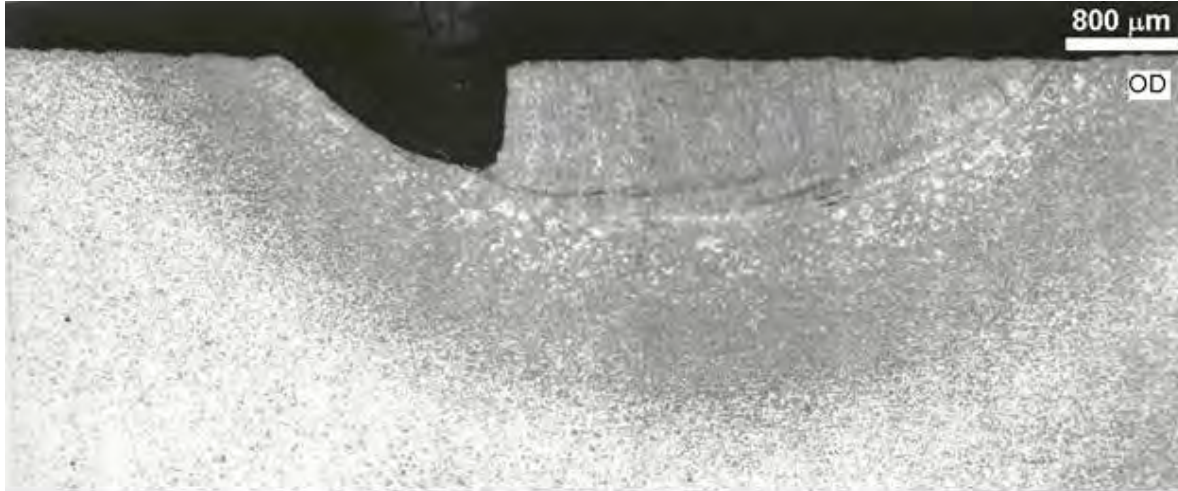
Catalog #: 96  
 Report #: 10  
 Defect #: CY-5

**Offset Plate Edges + OD Notch**

Photograph and Photomicrograph of Metallographic Section.

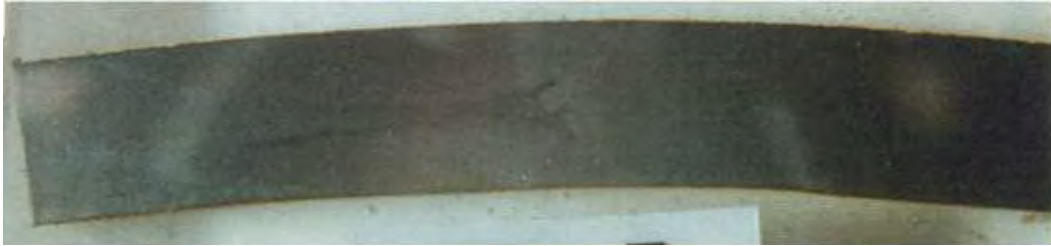
Catalog #: 138  
 Report #: 12  
 Defect #: 72D

**Mid-Wall Void + Lamination**

Photograph and Photomicrograph of Metallographic Section.

Grade: API 5L X42  
 $D_{nominal}$ : 12.75 inch (324 mm)  
 $t_{nominal}$ : 0.250 inch (6.35 mm)  
 $t_{pipe}$ : Not Determined  
 Failure: N/A

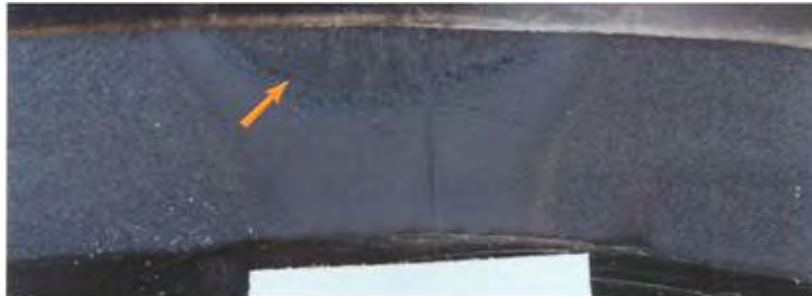
Catalog #: 109  
 Report #: 11  
 Defect #: 5A

**ID Over-Trim + OD Weld Repair**

Photograph and Photomicrograph of Metallographic Section.

Visual: ID Over-trim + OD  
 Weld Repair

L  
 $depth/t_{weld}$ : Not Determined  
 8.3% (Over-Trim) +  
 45% (Weld Repair)

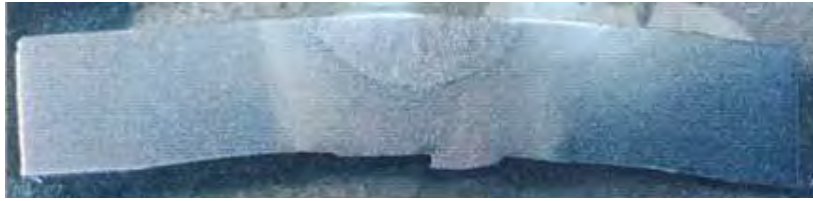
Catalog #: 92  
 Report #: 10  
 Defect #: CY-1

**ID Under-Trim + Weld Repair**

Photograph of Metallographic Section.

Grade: X52  
 $D_{nominal}$ : 20 inch (508 mm)  
 $t_{nominal}$ : 0.312 inch (7.92 mm)  
 $t_{pipe}$ : Not Determined  
 Failure: N/A

NDE technique(s): N/A  
 NDE result(s): N/A  
 Visual: ID Under-trim +  
 Weld Repair  
 Not Determined  
 $L$   
 $depth/t_{weld}$ : 55% (Weld Repair)  
 depth: Not Determined  
 $t_{weld}$ : Not Determined

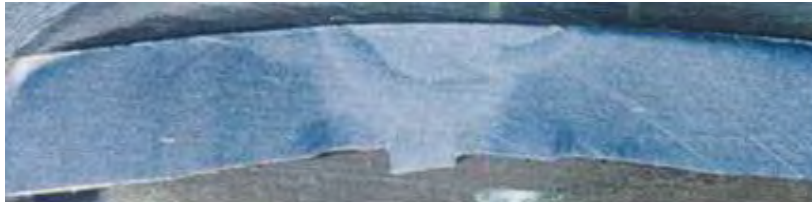
Catalog #: 99  
 Report #: 10  
 Defect #: CY-8

**ID Under-Trim + OD Weld Repair**

Photograph of Metallographic Section.

Grade: X52  
 $D_{nominal}$ : 20 inch (508 mm)  
 $t_{nominal}$ : 0.312 inch (7.92 mm)  
 $t_{pipe}$ : Not Determined  
 Failure: N/A

NDE technique(s): N/A  
 NDE result(s): N/A  
 Visual: ID Under-trim + OD  
 Weld Repair  
 Not Determined  
 $depth/t_{weld}$ : 45% (Weld Repair)  
 depth: Not Determined  
 $t_{weld}$ : Not Determined

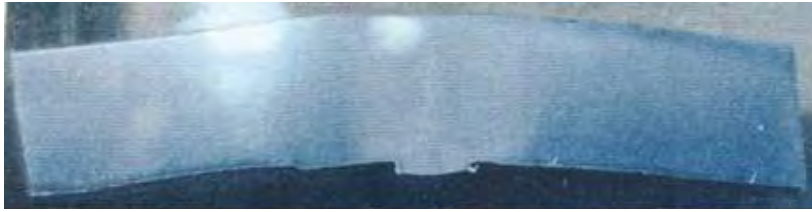
Catalog #: 94  
 Report #: 10  
 Defect #: CY-3

**ID Under-Trim + OD Notch at Contact Mark**

Photograph and Photomicrograph of Metallographic Section.

Grade: X52  
 $D_{\text{nominal}}$ : 20 inch (508 mm)  
 $t_{\text{nominal}}$ : 0.312 inch (7.92 mm)  
 $t_{\text{pipe}}$ : Not Determined  
 Failure: N/A

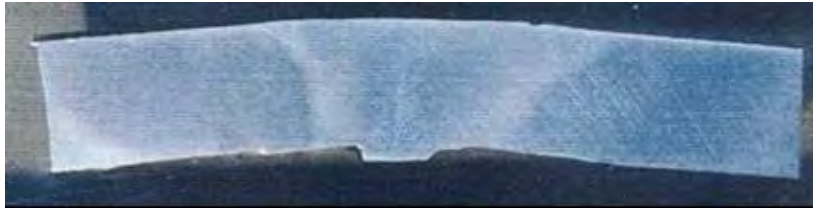
Catalog #: 97  
 Report #: 10  
 Defect #: CY-6

**ID Under-Trim + OD Notch**

Photograph of Metallographic Section.

Grade: X52  
 $D_{\text{nominal}}$ : 20 inch (508 mm)  
 $t_{\text{nominal}}$ : 0.312 inch (7.92 mm)  
 $t_{\text{pipe}}$ : Not Determined  
 Failure: N/A

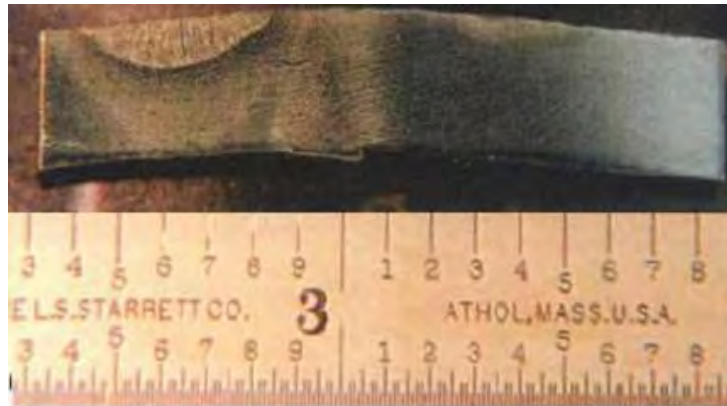
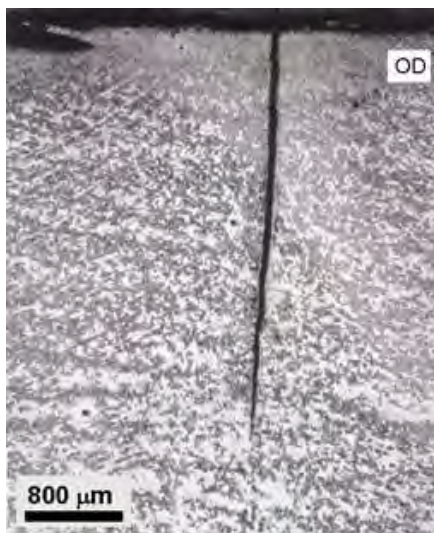
**OD Lack of Fusion + OD Repair Weld**

Photograph and Photomicrograph of Metallographic Section.

Catalog #:	12		
Report #:	1		
Defect #:	573-14.8		
<b>Pipe</b>		<b>Defect</b>	
Vintage:	1950s	NDE technique(s):	UT
Manufacturer:	Youngstown	NDE result(s):	30% x 0.7 inch (17.8 mm) OD crack
Seam Type:	ERW	Visual:	OD lack of fusion + OD repair weld
Grade:	X52	L	N/A
D <sub>nominal</sub>	20 inch (508 mm)	depth/t <sub>weld</sub>	37.2%
t <sub>nominal</sub>	0.312 inch (7.92 mm)	depth:	0.128 inch (3.25 mm)
t <sub>pipe</sub>	0.311 inch (7.9 mm)	t <sub>weld</sub>	0.344 inch (8.74 mm)
Failure:	None at 2,275 psig (15.69 MPa) (140% of SMYS)

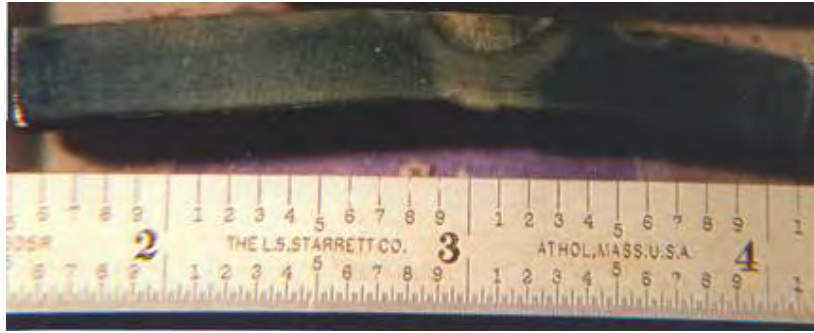
Catalog #: 11  
 Report #: 1  
 Defect #: 573-5.1

**OD Repair Weld**

Photograph of Metallographic Section.

Seam Type: ERW  
 Grade: X52  
 $D_{nominal}$ : 20 inch (508 mm)  
 $t_{nominal}$ : 0.312 inch (7.92 mm)  
 $t_{pipe}$ : 0.330 inch (8.38 mm)  
 Failure: None at 2,275 psig  
 (15.69 MPa) (140%  
 of SMYS)

NDE technique(s): UT  
 NDE result(s): 10% x 2 inch (51 mm)  
 grind area on seam  
 OD repair weld  
 Visual: OD repair weld  
 L: N/A  
 depth/ $t_{weld}$ : N/A  
 depth: N/A  
 $t_{weld}$ : 0.330 inch (8.38 mm)

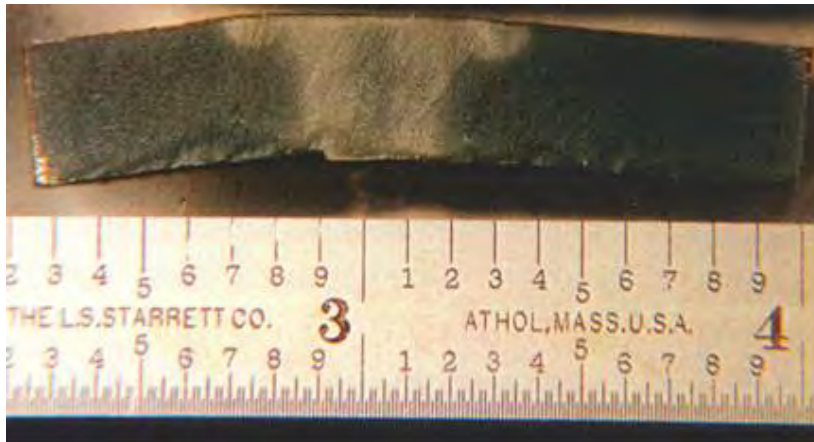
**OD Repair Weld**

Photograph of Metallographic Section.

Catalog #:	14		
Report #:	1		
Defect #:	598		
<b><u>Pipe</u></b>		<b><u>Defect</u></b>	
Vintage:	1950s	NDE technique(s):	UT
Manufacturer:	Youngstown	NDE result(s):	<10% multiple minor cracks at weld toe
Seam Type:	ERW	Visual:	OD repair weld
Grade:	X52	L	N/A
D <sub>nominal</sub>	20 inch (508 mm)	depth/t <sub>weld</sub>	N/A
t <sub>nominal</sub>	0.312 inch (7.92 mm)	depth:	N/A
t <sub>pipe</sub>	0.330 inch (8.38 mm)	t <sub>weld</sub>	0.330 inch (8.38 mm)
Failure:	None at 2,100 psig (14.48 MPa) (129% of SMYS)

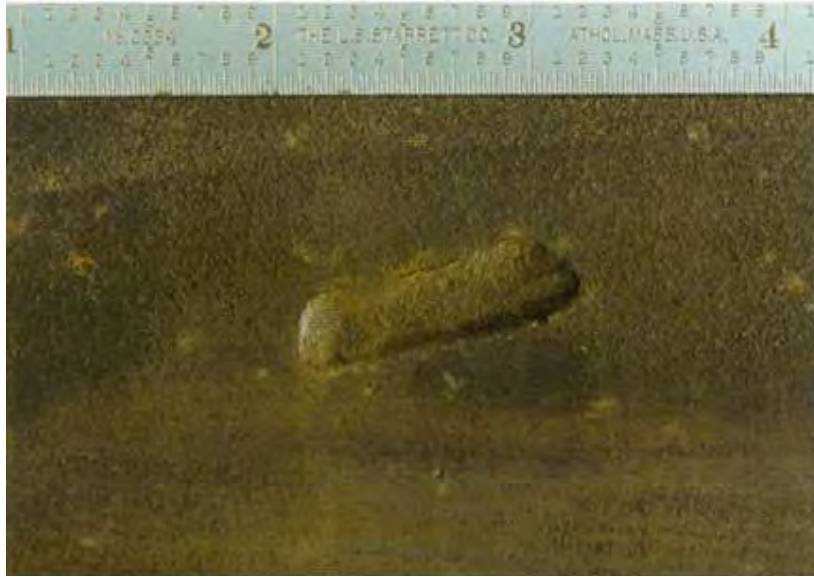
Catalog #: 111  
 Report #: 12  
 Defect #: 45A

**ID Pit**

Photograph of ID Pipe Surface Near Seam Weld.

Vintage: Unknown  
 Manufacturer: Unknown  
 Seam Type: LF-ERW  
 Grade: API 5L X42  
 $D_{nominal}$ : 12.75 inch (324 mm)  
 $t_{nominal}$ : 0.250 inch (6.35 mm)  
 $t_{pipe}$ : Not Determined  
 Failure: N/A

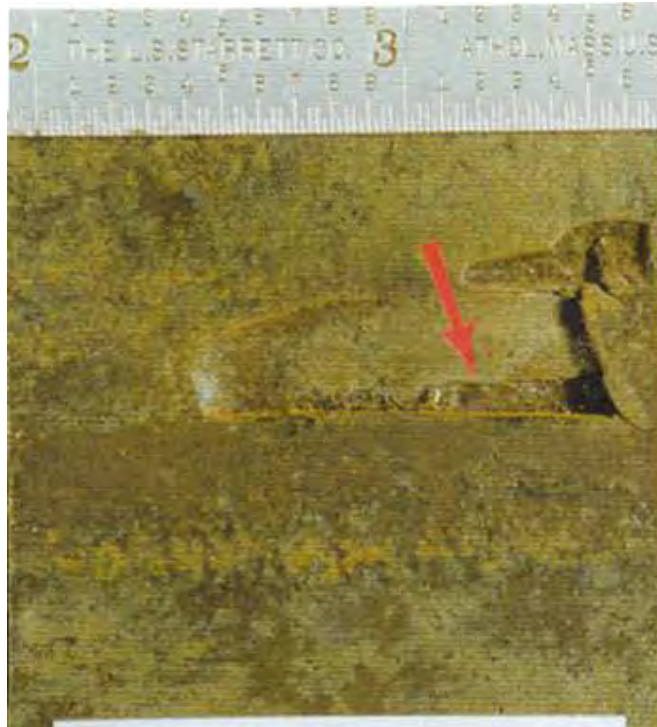
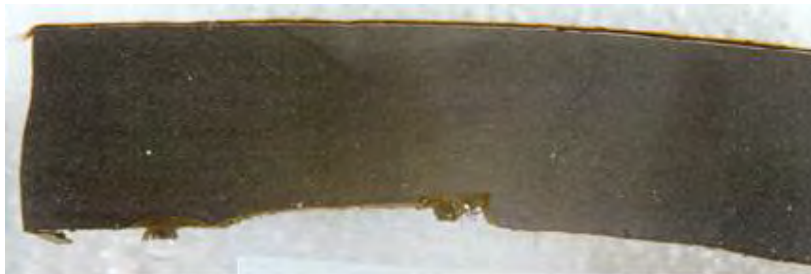
Catalog #: 123  
 Report #: 12  
 Defect #: 59A

**ID Pit**

Photographs of Pipe Seam ID Surface and Metallographic Section.

Seam Type: LF-ERW  
 Grade: API 5L X42  
 $D_{nominal}$ : 12.75 inch (324 mm)  
 $t_{nominal}$ : 0.250 inch (6.35 mm)  
 $t_{pipe}$ : Not Determined  
 Failure: N/A

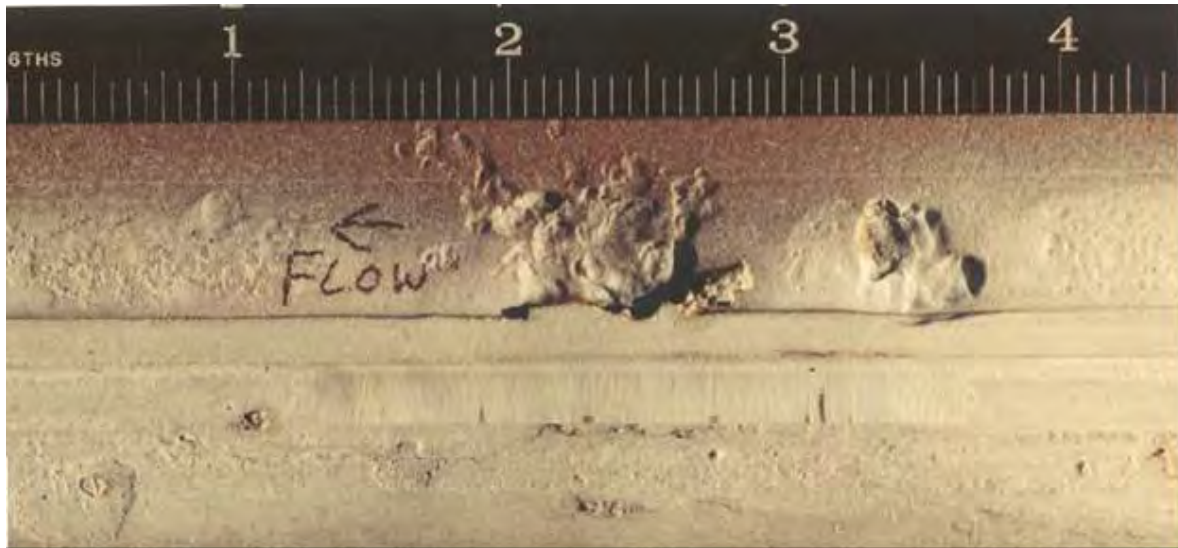
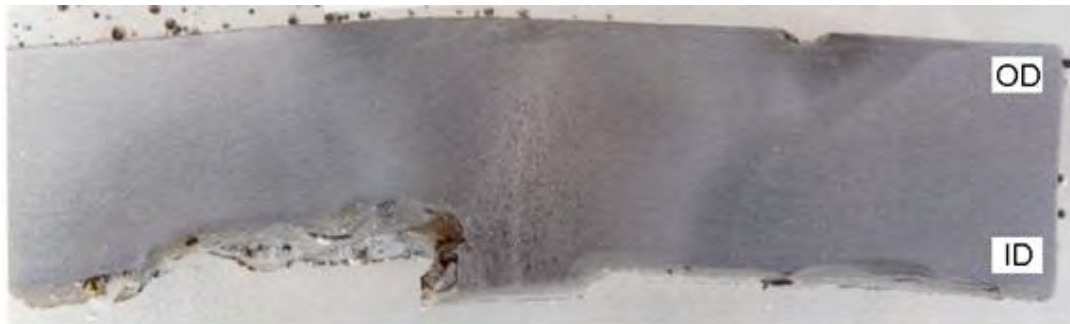
Catalog #: 73  
 Report #: 7  
 Defect #: 1084

ID Plate Edge Defect (Roll-in) + Contact Location Arc

Photographs of Weld Seam ID Surface and Metallographic Section.

NDE technique(s): Fast UT  
 NDE result(s): ID Gouges  
 Visual: ID Plate Edge Defect (Roll-in) + Contact Location Arc

Grade: X52  
 $D_{nominal}$ : 20 inch (508 mm)  
 $t_{nominal}$ : 0.312 inch (7.92 mm)  
 $t_{pipe}$ : Not Determined  
 Failure: N/A

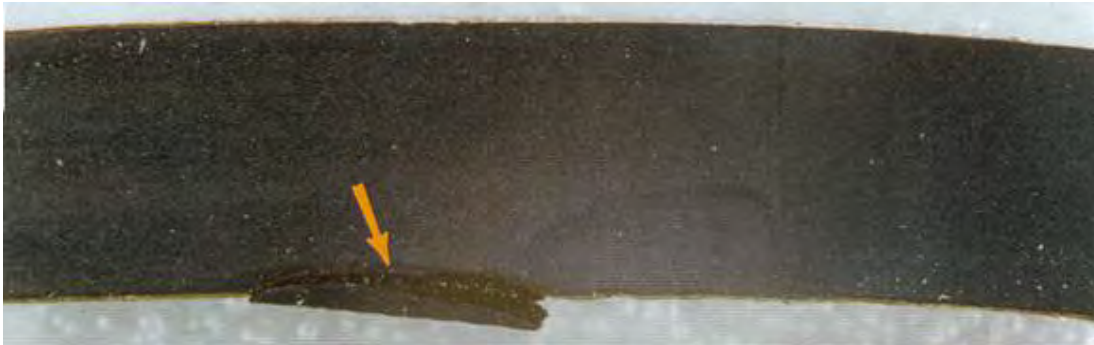
Catalog #: 136  
Report #: 12  
Defect #: 72B

**Roll-in**

Photograph of Metallographic Section.

Seam Type: LF-ERW  
Grade: API 5L X42  
 $D_{\text{nominal}}$ : 12.75 inch (324 mm)  
 $t_{\text{nominal}}$ : 0.250 inch (6.35 mm)  
 $t_{\text{pipe}}$ : Not Determined  
Failure: N/A

NDE technique(s): TOFD, MPI  
NDE result(s): 48%, 1.25 inch (31.7 mm)  
OD Hook Crack

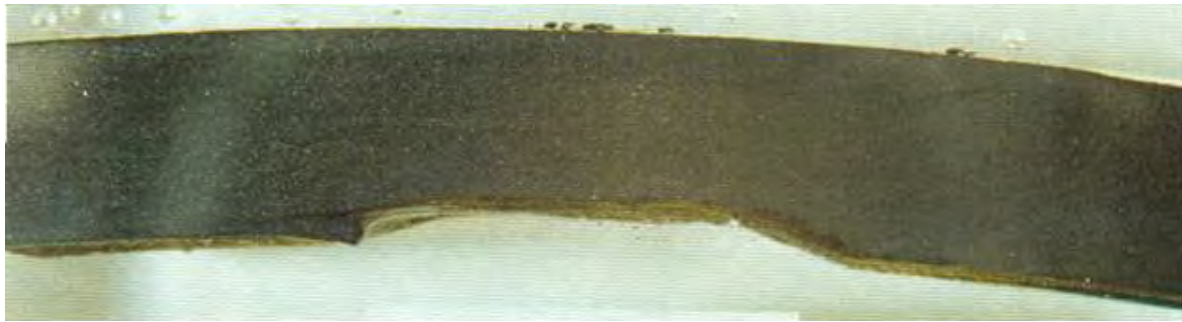
Catalog #: 120  
 Report #: 12  
 Defect #: 54B

ID Scab

Photograph and Photomicrograph of Pipe Seam ID Surface and Metallographic Section.

Seam Type: LF-ERW  
 Grade: API 5L X42  
 $D_{nominal}$ : 12.75 inch (324 mm)  
 $t_{nominal}$ : 0.250 inch (6.35 mm)  
 $t_{pipe}$ : Not Determined  
 Failure: N/A

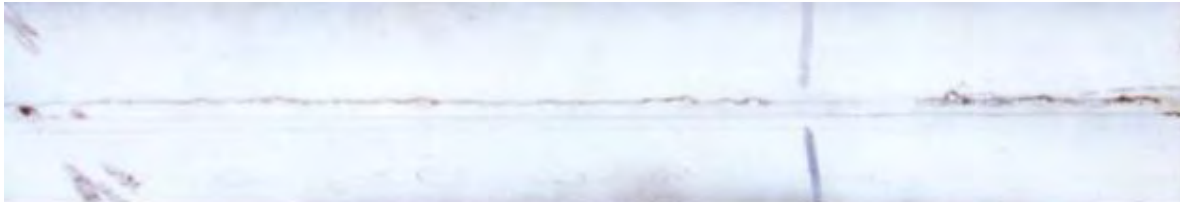
Catalog #: 82  
 Report #: 7  
 Defect #: 1640

**Not Determined**

Photograph of Weld Seam ID Surface.

Seam Type: ERW  
 Grade: X52  
 $D_{nominal}$ : 20 inch (508 mm)  
 $t_{nominal}$ : 0.312 inch (7.92 mm)  
 $t_{pipe}$ : Not Determined  
 Failure: N/A

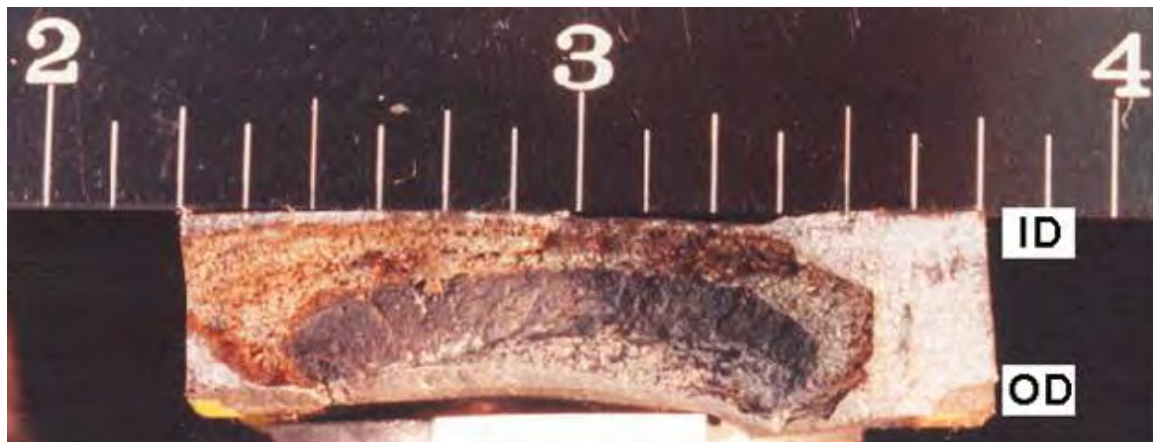
Catalog #: 62  
 Report #: 6  
 Defect #: 1450

Dent and Hook Crack

Photographs/Micrographs of Weld Seam OD Surface and Fracture Surface.

NDE technique(s): Fast UT  
 NDE result(s): 0.300 inch (7.62 mm)  
 RDI Mechanical  
 Damage + 70%, 1 inch  
 (25.4 mm) OD Crack  
 Dent and Hook Crack  
 1 inch (25.4 mm)  
 Visual:  
 L  
 depth/ $t_{weld}$  70%  
 depth: 0.312 inch (7.92 mm)  
 $t_{weld}$  0.445 inch (11.3 mm)

Seam Type: FW  
 Grade: X52  
 $D_{nominal}$  20 inch (508 mm)  
 $t_{nominal}$  0.312 inch (7.92 mm)  
 $t_{pipe}$  Not Determined  
 Failure: Leak at 2,250 psig (15.51 MPa) (138% of SMYS)

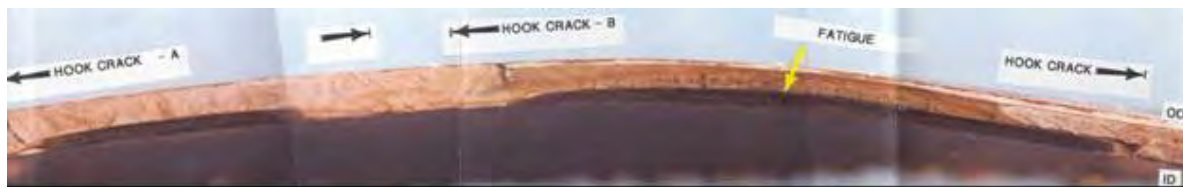
Catalog #: 48  
 Report #: 5  
 Defect #: 44

**ID Hook Crack (Evidence of Crack Extension)**

Photograph of Fracture Surface.

NDE technique(s): Fast UT  
 NDE result(s): 13.5 inch (343 mm)  
 intermittent NF  
 2(1.6)5.3(.5)4.1 inch  
 (gap)  
 Visual: ID Hook Crack  
 (evidence of crack  
 extension)  
 > 12 inch (305 mm)  
 depth/t<sub>weld</sub> 48% (incl. 11% crack  
 extension)  
 depth: 0.189 inch (4.8 mm)  
 (incl. 0.043 inch  
 (1.09 mm) crack  
 extension)  
 t<sub>weld</sub> 0.394 inch (10.1 mm)

t<sub>pipe</sub>: 0.312 inch (7.92 mm)  
 Failure: Burst test failure at  
 1,950 psig (13.44 MPa)  
 (120% of SMYS)

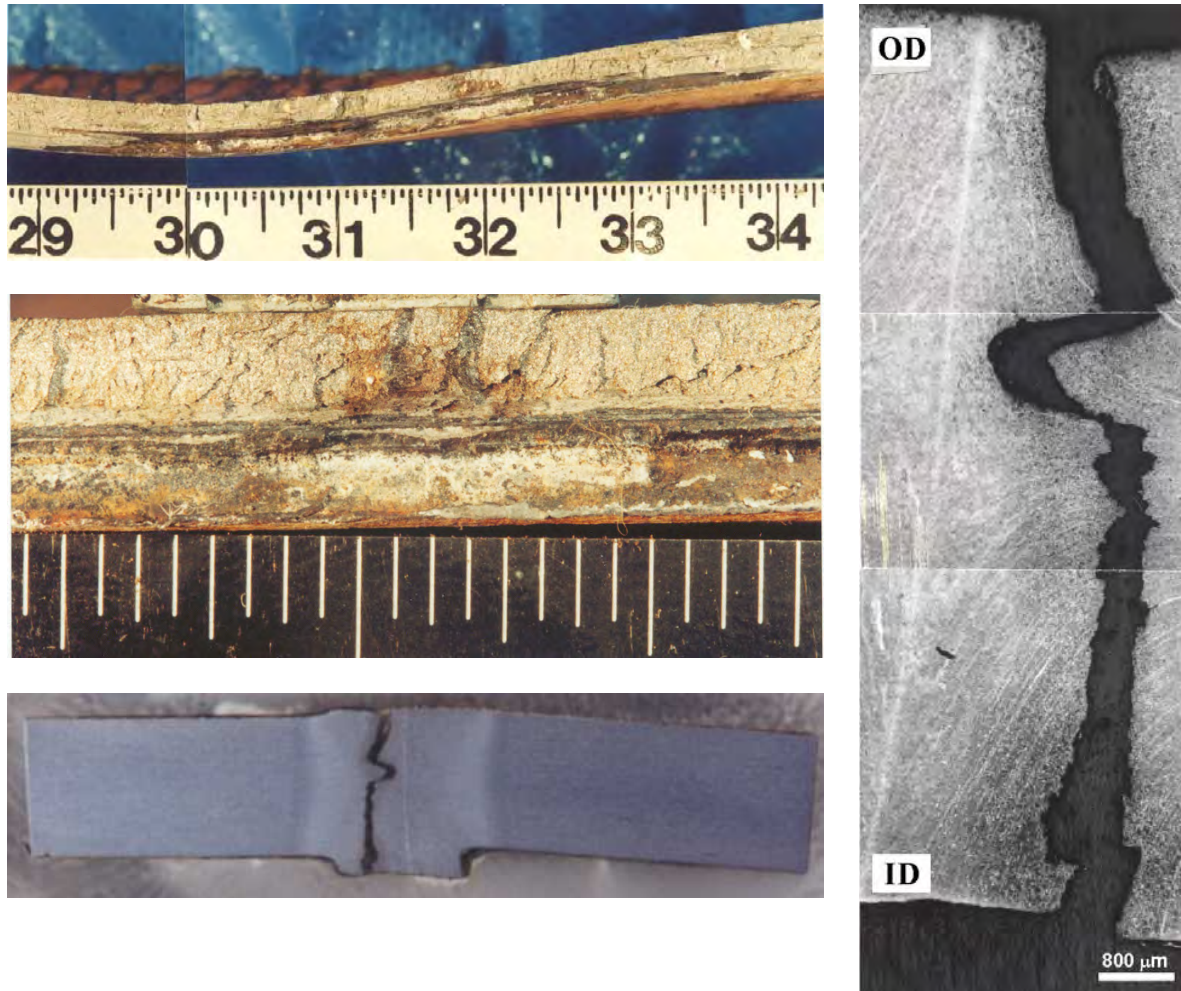
Catalog #: 55  
 Report #: 6  
 Defect #: 707

**OD Hook Crack**

Photographs and Photomicrograph of Fracture Surface and Metallographic Section.

Vintage: circa 1950  
 Manufacturer: AO Smith  
 Seam Type: FW  
 Grade: X52  
 $D_{nominal}$ : 20 inch (508 mm)  
 $t_{nominal}$ : 0.312 inch (7.92 mm)  
 $t_{pipe}$ : Not Determined  
 Failure: Burst test failure at  
 1,675 psig (11.55 MPa)  
 (103% of SMYS)

NDE technique(s): Fast UT  
 NDE result(s): 75% OD Crack  
 Visual: OD Hook Crack  
 L: > 5 inch (127 mm)  
 $depth/t_{weld}$ : 47%  
 depth: 0.187 inch (4.75 mm)  
 $t_{weld}$ : 0.400 inch (10.2 mm)

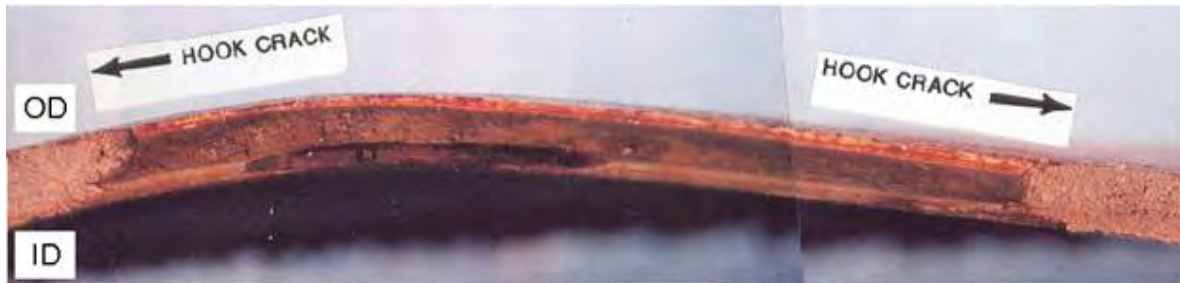
Catalog #: 45  
 Report #: 5  
 Defect #: 24

ID Hook Crack

Photograph of Fracture Surface.

Seam Type: FW  
 Grade: X52  
 $D_{nominal}$ : 20 inch (508 mm)  
 $t_{nominal}$ : 0.312 inch (7.92 mm)  
 $t_{pipe}$ : 0.310 inch (7.87 mm)  
 Failure: Burst Test: No failure at 2,200 psig (15.17 MPa) (136% of SMYS) + Yielding at 2,175 psig (15.00 MPa) (134% of SMYS)

NDE technique(s): Fast UT  
 NDE result(s): 2.4 inch (61 mm) long, 50% crack-like ID Hook Crack  
 Visual: L  
 depth/ $t_{weld}$ : 40%  
 depth: 0.158 inch (4.01 mm)  
 $t_{weld}$ : 0.394 inch (10.1 mm)

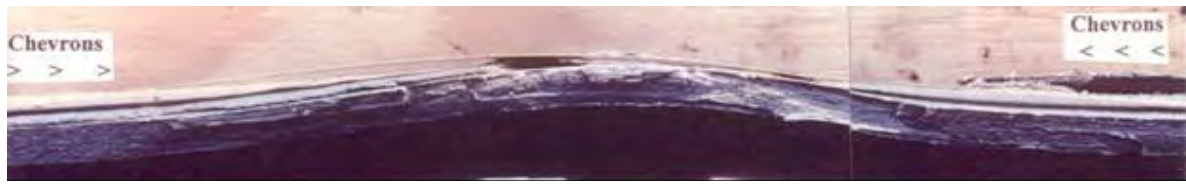
Catalog #: 84  
 Report #: 4  
 Defect #: 964+53

ID Over-Trim + ID Hook Crack + Fatigue Crack

Photographs of Fracture Surfaces and Metallographic Section.

Failure: In-Service rupture at 897 psig (6.18 MPa) (55% of SMYS) Hydrotested at 1,460 psig (10.07 MPa) (90% of SMYS) 32 to 35 years earlier

NDE technique(s): N/A  
 NDE result(s): N/A  
 Visual: ID Overtrim + ID Hook Crack + Fatigue Crack  
 L: 11 feet long, 5.875 inch (149 mm) wide  
 depth/ $t_{weld}$ : 40% (Hook Crack)  
 depth: 0.162 inch (4.11 mm)  
 $t_{weld}$ : 0.405 inch (10.3 mm)

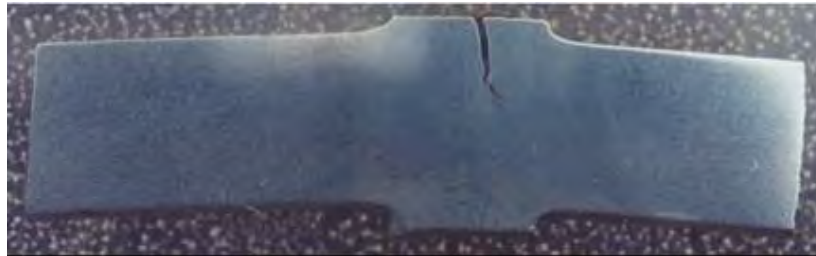
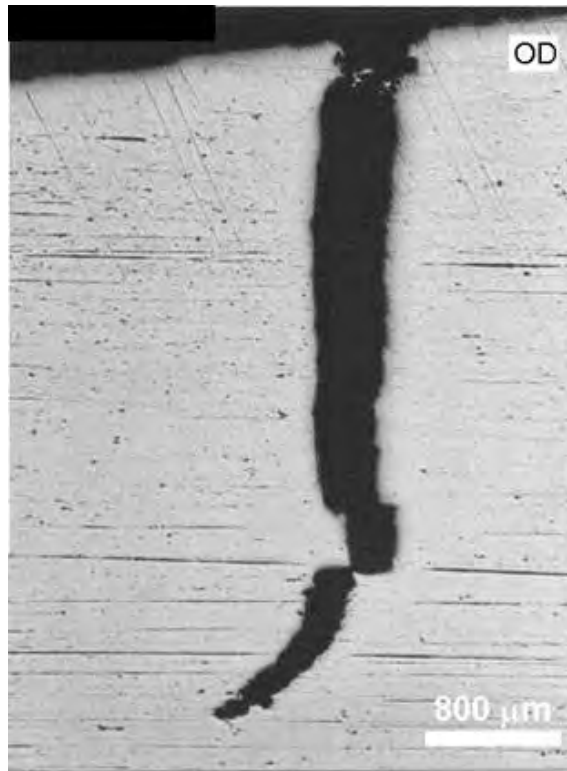
Catalog #: 76  
 Report #: 7  
 Defect #: 1328

**OD Hook Crack**

Photograph and Photomicrograph of Metallographic Section.

Seam Type: FW  
 Grade: X52  
 $D_{nominal}$ : 20 inch (508 mm)  
 $t_{nominal}$ : 0.312 inch (7.92 mm)  
 $t_{pipe}$ : 0.318 inch (8.08 mm)  
 Failure: N/A

NDE technique(s): Fast UT  
 NDE result(s): 40% (0.158 inch (4.01 mm))  
 OD Crack  
 OD Hook Crack  
 Visual: Not Determined  
 L  
 depth/ $t_{weld}$ : 39%  
 depth: 0.155 inch (3.94 mm)  
 $t_{weld}$ : 0.398 inch (10.1 mm)

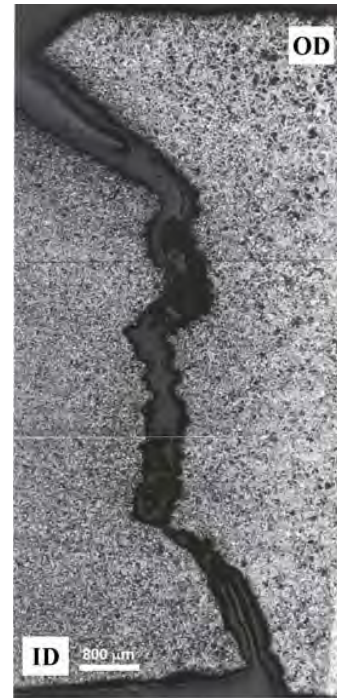
Catalog #: 60  
 Report #: 6  
 Defect #: 968

**ID Hook Crack**

Photographs and Photomicrograph of Metallographic Section and Fracture Surfaces.

Vintage: circa 1950  
 Manufacturer: AO Smith  
 Seam Type: FW  
 Grade: X52  
 $D_{nominal}$ : 20 inch (508 mm)  
 $t_{nominal}$ : 0.312 inch (7.92 mm)  
 $t_{pipe}$ : Not Determined  
 Failure: Burst test failure at  
 1,950 psig (13.44 MPa)  
 (120% of SMYS)

NDE technique(s): Fast UT  
 NDE result(s): 65% ID Crack  
 Visual: ID Hook Crack  
 L: 8.25 inch (210 mm)  
 depth/ $t_{weld}$ : 34%  
 depth: 0.125 inch (3.17 mm)  
 $t_{weld}$ : 0.371 inch (9.42 mm)

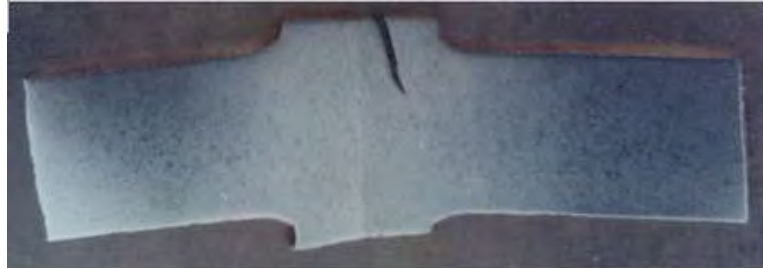
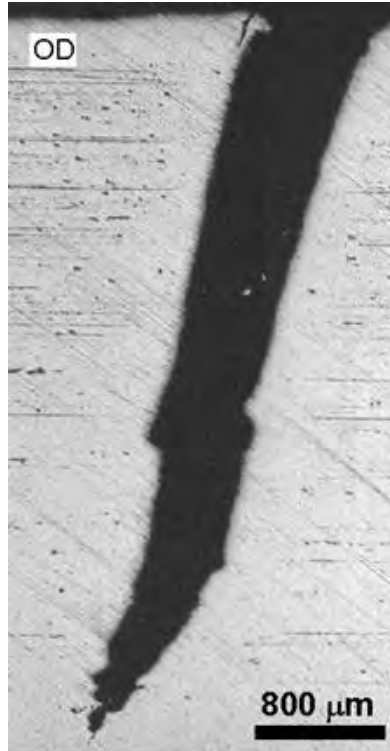
Catalog #: 78  
 Report #: 7  
 Defect #: 1381

**OD Hook Crack**

Photograph and Photomicrograph of Metallographic Section.

Vintage: circa 1950  
 Manufacturer: AO Smith  
 Seam Type: FW  
 Grade: X52  
 $D_{nominal}$ : 20 inch (508 mm)  
 $t_{nominal}$ : 0.312 inch (7.92 mm)  
 $t_{pipe}$ : 0.306 inch (7.77 mm)  
 Failure: N/A

NDE technique(s): Fast UT  
 NDE result(s): 30% (0.128 inch (3.25 mm))  
 OD Crack-Like  
 Visual: OD Hook Crack  
 L: Not Determined  
 $depth/t_{weld}$ : 34%  
 depth: 0.145 inch (3.68 mm)  
 $t_{weld}$ : 0.425 inch (10.8 mm)

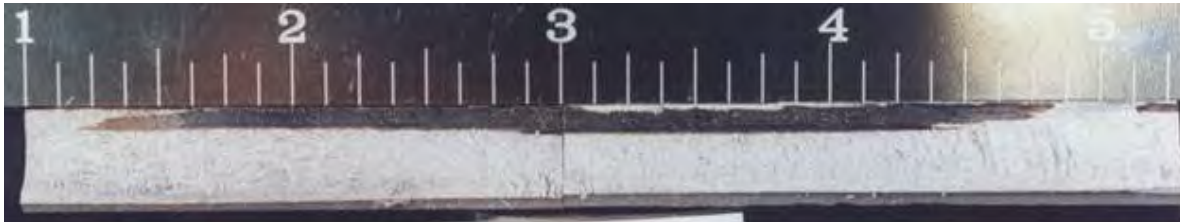
Catalog #: 72  
 Report #: 7  
 Defect #: 1017

ID Hook Crack

Photographs of Weld Seam ID Surface and Fracture Surface.

Vintage: circa 1950  
 Manufacturer: AO Smith  
 Seam Type: FW  
 Grade: X52  
 $D_{nominal}$ : 20 inch (508 mm)  
 $t_{nominal}$ : 0.312 inch (7.92 mm)  
 $t_{pipe}$ : Not Determined  
 Failure: N/A

NDE technique(s): Fast UT  
 NDE result(s): 30% ID Crack  
 Visual: ID Hook Crack  
 L: 3.5 inch (89 mm)  
 $depth/t_{weld}$ : 32%  
 depth: 0.116 inch (2.95 mm)  
 $t_{weld}$ : 0.365 inch (9.27 mm)
