**KyPSC Case No. 2022-00084**  
**TABLE OF CONTENTS**

**Duke Energy Kentucky**  
**Case No. 2022-00084**  
**STAFF First Set Data Requests**  
**Date Received: May 19, 2022**

**STAFF-DR-01-001**

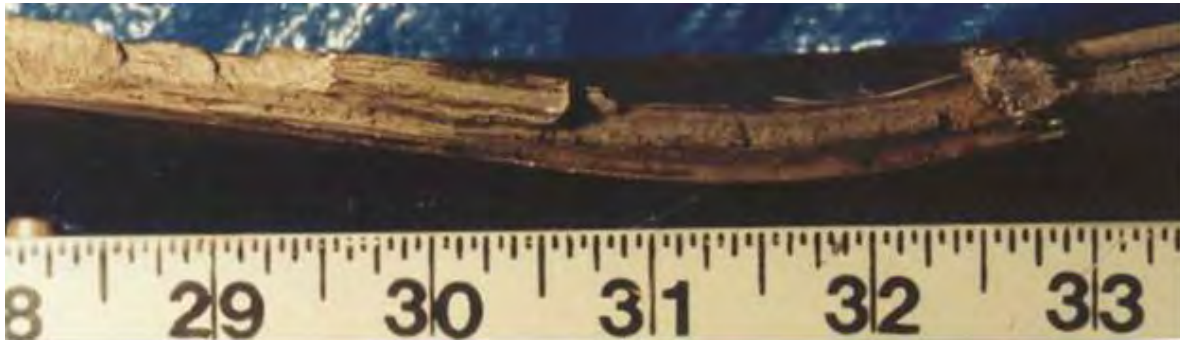
Catalog #: 57  
 Report #: 6  
 Defect #: 808

OD Hook Crack + Inclusions

Photographs of Fracture Surface.

NDE technique(s): Fast UT  
 NDE result(s): 65% OD Crack  
 Visual: OD Hook Crack +  
 inclusions  
 5 inch (127 mm)  
 L  
 depth/ $t_{weld}$  32%  
 depth: 0.125 inch (3.17 mm)  
 $t_{weld}$  0.385 inch (9.78 mm)

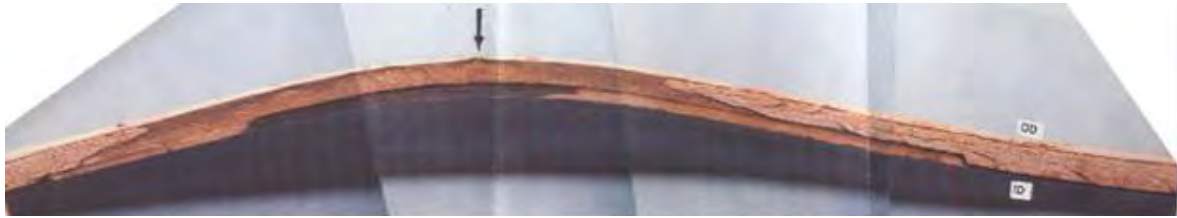
Catalog #: 50  
 Report #: 5  
 Defect #: 46

**ID Hook Crack**

Photographs of Fracture Surface and Metallographic Section.

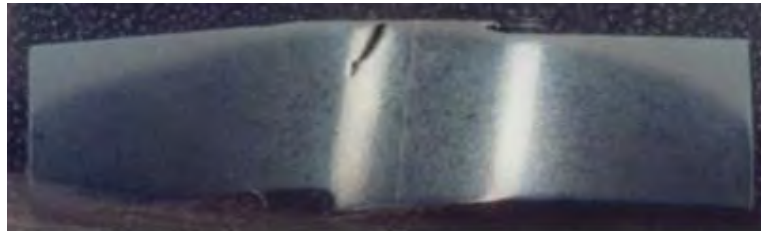
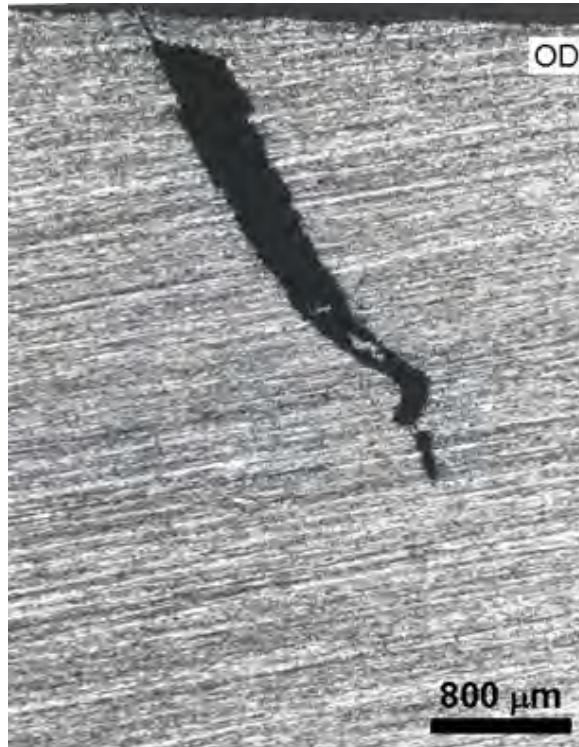
Catalog #: 77  
 Report #: 7  
 Defect #: 1339

OD Hook Crack

Photograph and Photomicrograph of Metallographic Section.

NDE technique(s): Fast UT  
 NDE result(s): 30% (0.105 inch (2.67 mm)) OD  
 Crack-like

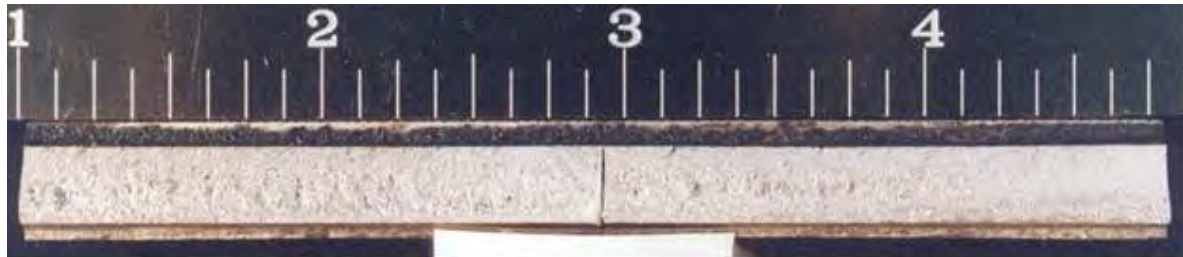
Catalog #: 69  
 Report #: 7  
 Defect #: 941

ID Hook Crack

Photographs of Weld Seam ID Surface and Fracture Surface.

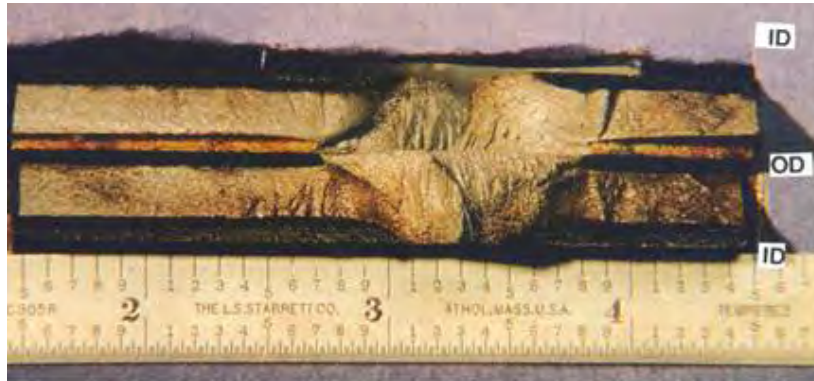
**ID Hook Crack**

Photograph of Fracture Surfaces.

Catalog #:	4		
Report #:	1		
Defect #:	169		
<b><u>Pipe</u></b>		<b><u>Defect</u></b>	
Vintage:	1950s	NDE technique(s):	UT
Manufacturer:	AO Smith	NDE result(s):	40% x 5.5 inch (140 mm) crack
Seam Type:	FW	Visual:	ID hook crack
Grade:	X52	L	> 6 inch (152 mm)
D <sub>nominal</sub>	20 inch (508 mm)	depth/t <sub>weld</sub>	24.4%
t <sub>nominal</sub>	0.312 inch (7.92 mm)	depth:	0.09375 (3/32 inch (2.38 mm))
t <sub>pipe</sub>	0.310 inch (7.87 mm)	t <sub>weld</sub>	0.384 inch (9.75 mm)
Failure:	None at 2,275 psig (15.69 MPa) (140% of SMYS)

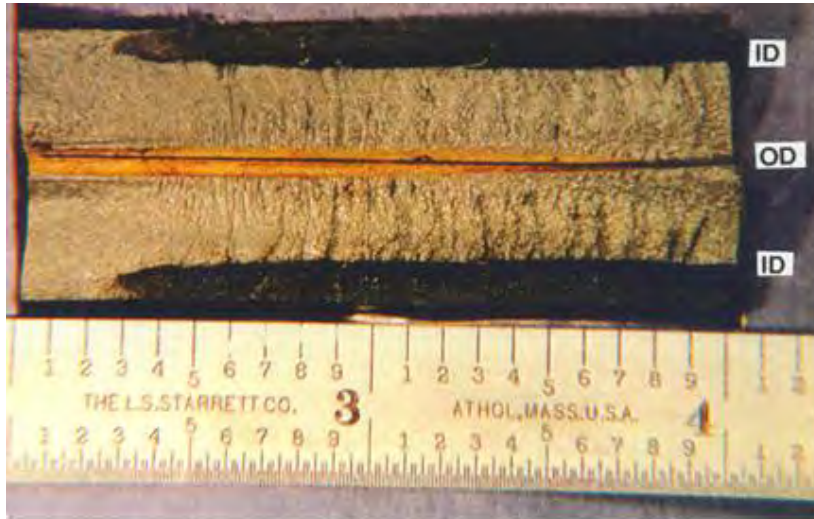
Catalog #: 16  
 Report #: 1  
 Defect #: 643

ID Hook Crack

Photograph of Fracture Surfaces.

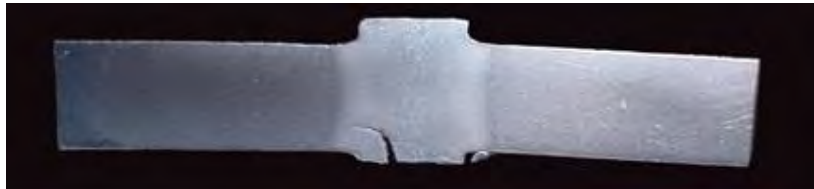
Catalog #: 17  
 Report #: 13  
 Defect #: 1

ID Hook Crack

Photographs and Photomicrograph of Pipe ID Surface and Metallographic Section.

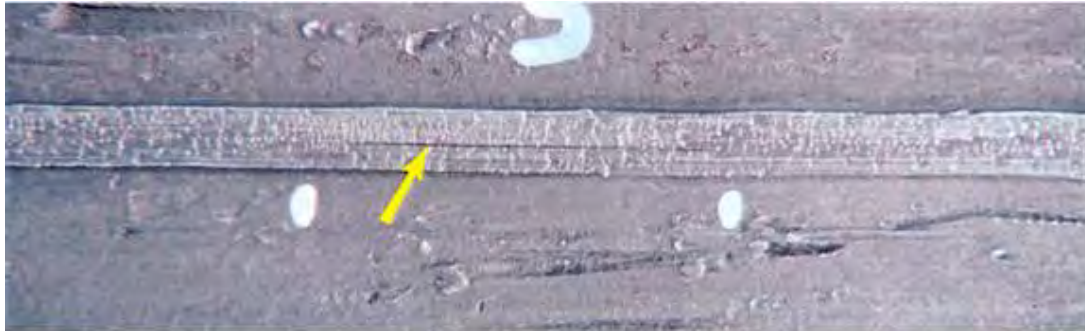
Catalog #: 40  
 Report #: 5  
 Defect #: 3

**ID Hook Crack (Surmised, Defect Not Exposed)**

Photograph of Weld Seam ID Surface.

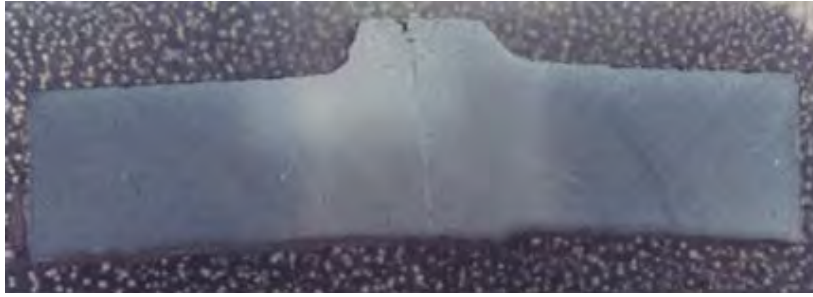
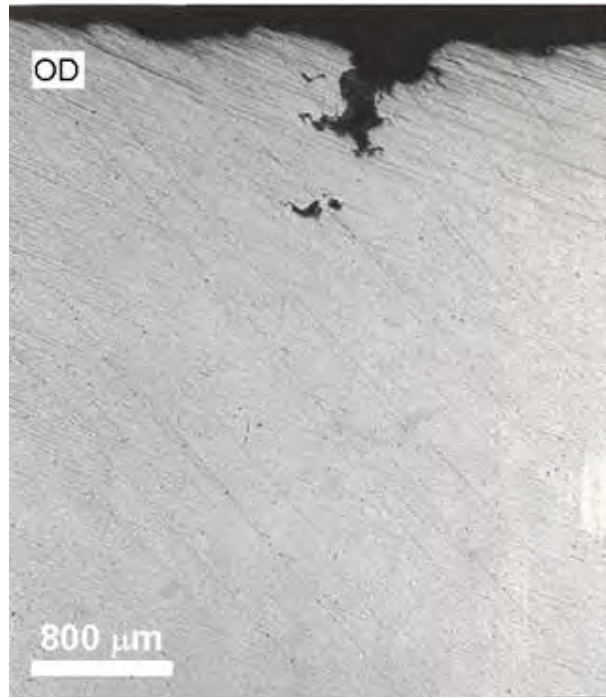
**OD Shrinkage Crack**

Photograph and Photomicrograph of Metallographic Section.

Catalog #: 68  
 Report #: 7  
 Defect #: 904

Vintage: circa 1950  
 Manufacturer: AO Smith  
 Seam Type: FW  
 Grade: X52  
 $D_{nominal}$ : 20 inch (508 mm)  
 $t_{nominal}$ : 0.312 inch (7.92 mm)  
 $t_{pipe}$ : Not Determined  
 Failure: N/A

NDE technique(s): Fast UT  
 NDE result(s): 20% OD Crack-Like  
 Visual: OD Shrinkage Crack  
 L: Not Determined  
 depth/ $t_{weld}$ : 10%  
 depth: 0.040 inch (1.02 mm)  
 $t_{weld}$ : 0.396 inch (10.1 mm)

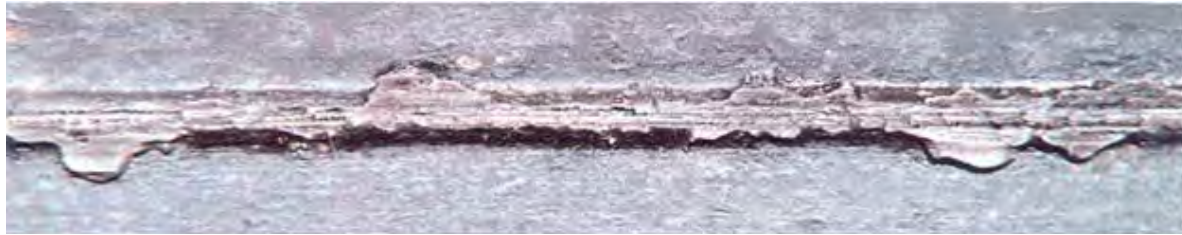
**ID Shrinkage Crack (Under-Trim)**

Photographs of Weld Seam ID Surface and Metallographic Section.

Catalog #: 39  
 Report #: 5  
 Defect #: 1

NDE technique(s): Fast UT  
 NDE result(s): 1.0 (25.4 mm) and 1.5 inch (38.1 mm) (long, 30% radial extent NF at Mid-wall  
 Visual: ID Shrinkage Crack (Under-trim)  
 L N/A  
 depth/ $t_{weld}$  < 7%  
 depth: < 0.033 inch (8.38 mm)  
 $t_{weld}$  0.470 inch (11.9 mm)

Grade: X52  
 $D_{nominal}$  20 inch (508 mm)  
 $t_{nominal}$  0.312 inch (7.92 mm)  
 $t_{pipe}$  0.313 inch (7.95 mm)  
 Failure: Burst test: No failure at 2,250 psig (15.51 MPa)  
 + Yielding at 2,250 psig (15.51 MPa) (139% of SMYS)

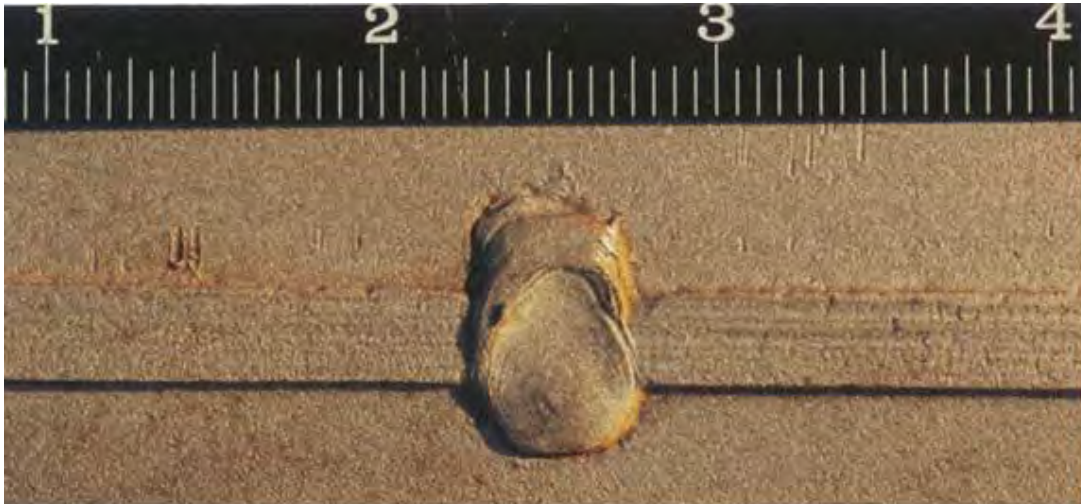
OD Weld Repair + No Cracking Visible From ID Surface

Photograph of Weld Seam OD Surface.

Catalog #: 79  
 Report #: 7  
 Defect #: 1422

NDE technique(s): Visual  
 NDE result(s): OD Weld repair  
 Visual: OD Weld repair + No  
 cracking visible from  
 ID surface

Grade: X52  
 $D_{nominal}$ : 20 inch (508 mm)  
 $t_{nominal}$ : 0.312 inch (7.92 mm)  
 $t_{pipe}$ : Not Determined  
 Failure: N/A

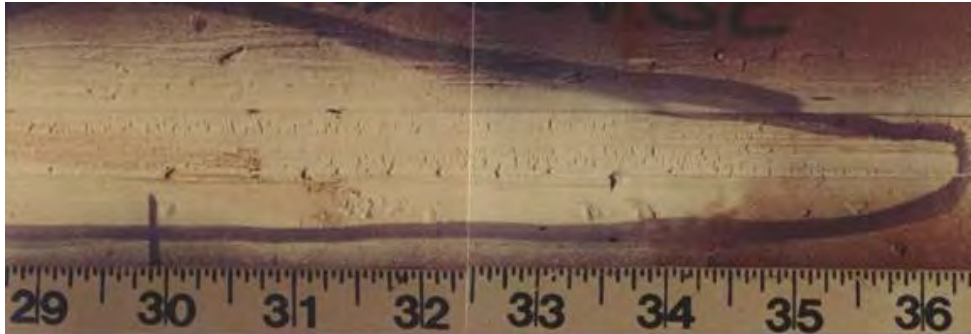
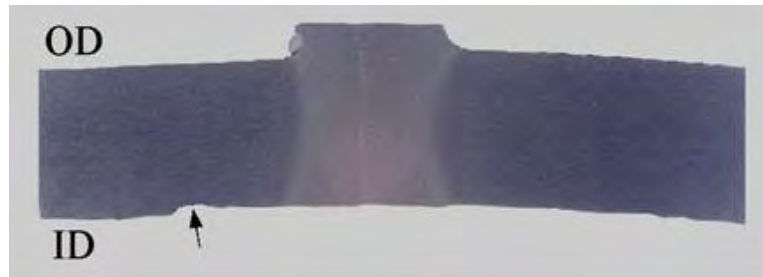
3 ID Gouges + Weld Over-Trim

Photographs of Weld Seam ID Surface and Metallographic Section.

Catalog #: 71  
 Report #: 7  
 Defect #: 1003

$D_{nominal}$  20 inch (508 mm)  
 $t_{nominal}$  0.312 inch (7.92 mm)  
 $t_{pipe}$  Not Determined  
 Failure: N/A

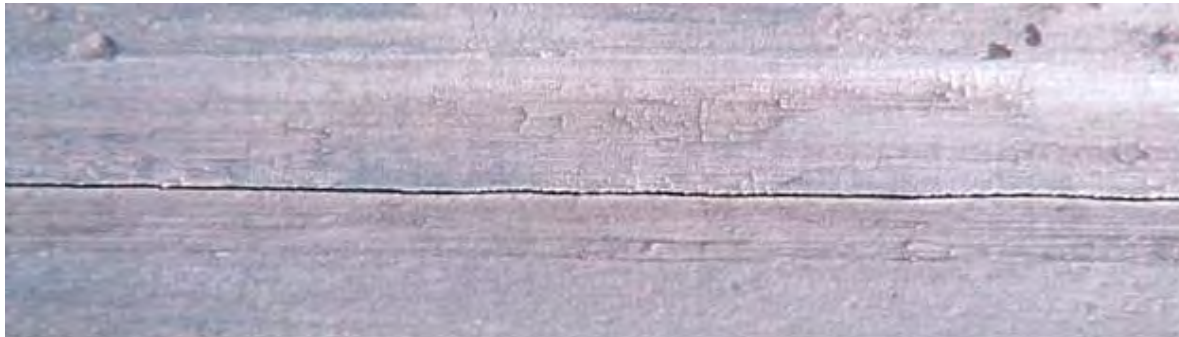
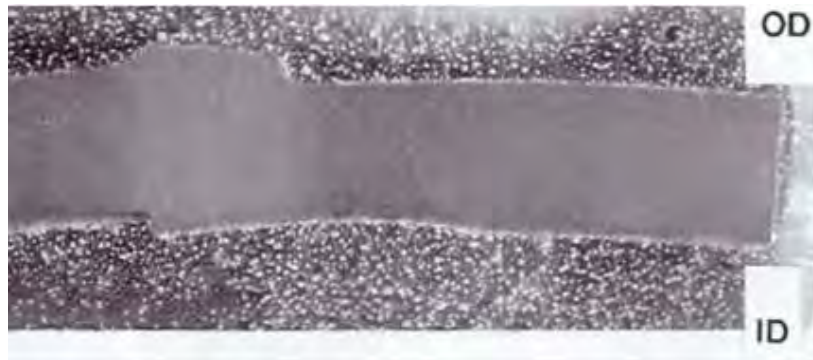
**ID Over-Trim (Scrape)**

Photographs of Weld Seam ID Surface and Metallographic Section.

Catalog #: 52  
 Report #: 5  
 Defect #: 53

NDE technique(s): MT  
 NDE result(s): 9.2 inch (234 mm)  
 linear indications + <  
 5% two small cracks  
 0.1"(1.6")0.3" (1.54  
 mm(41 mm)7.6mm)

Seam Type: FW  
 Grade: X52  
 $D_{nominal}$ : 20 inch (508 mm)  
 $t_{nominal}$ : 0.312 inch (7.92 mm)  
 $t_{pipe}$ : 0.307 inch (7.8 mm)  
 Failure: Burst test: No failure at  
 2,300 psig (15.86 MPa)  
 (142% of SMYS) +  
 Yielding at 2,000 psig  
 (13.79 MPa) (123% of  
 SMYS)

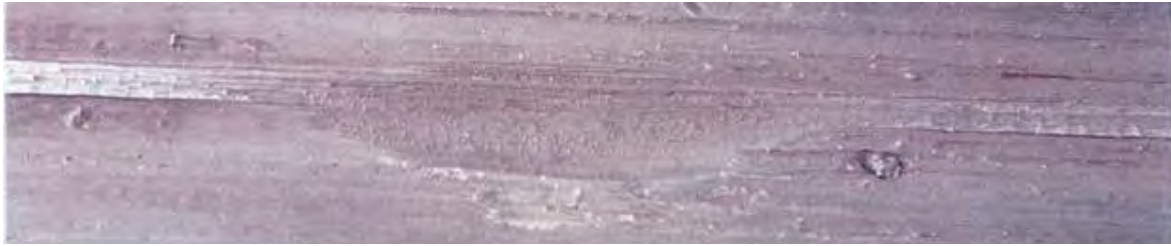
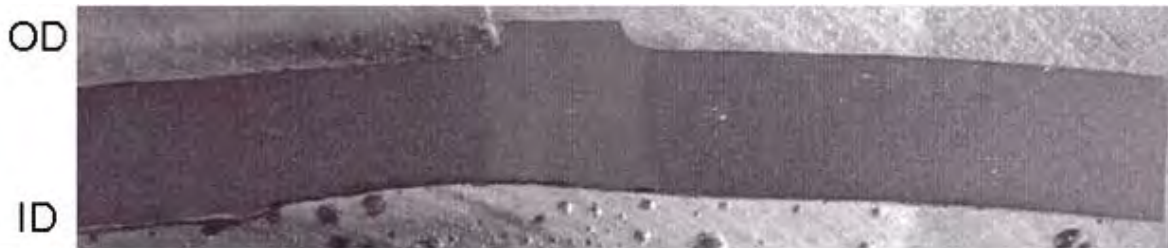
ID Over-Trim (Scrape)

Photographs of Weld Seam ID Surface and Metallographic Section.

Catalog #: 53  
 Report #: 5  
 Defect #: 56

NDE technique(s): Fast UT  
 NDE result(s): < 5%, 3.1 inch (79 mm)  
 OD crack-like + 1.4  
 inch (36 mm) NF +  
 10%, 7.8 inch (198  
 mm) linear indications  
 (over 9.5 inches (241  
 mm))

Seam Type: FW  
 Grade: X52  
 $D_{nominal}$ : 20 inch (508 mm)  
 $t_{nominal}$ : 0.312 inch (7.92 mm)  
 $t_{pipe}$ : 0.316 inch (8.03 mm)  
 Failure: Burst test: No failure at  
 2,300 psig (15.86 MPa)  
 (142% of SMYS)

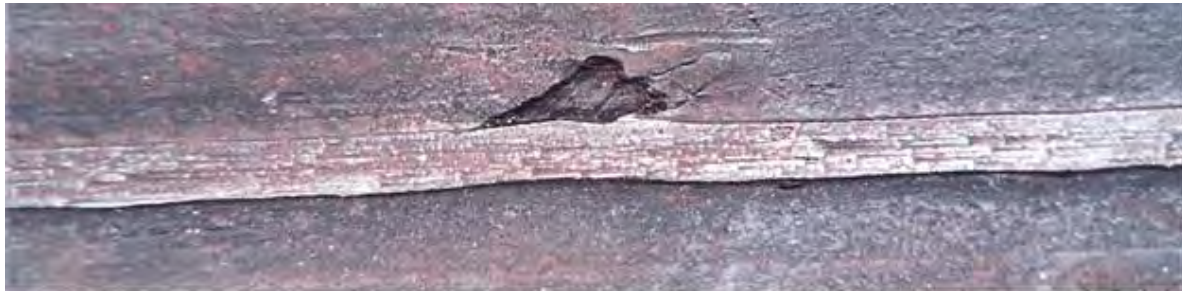
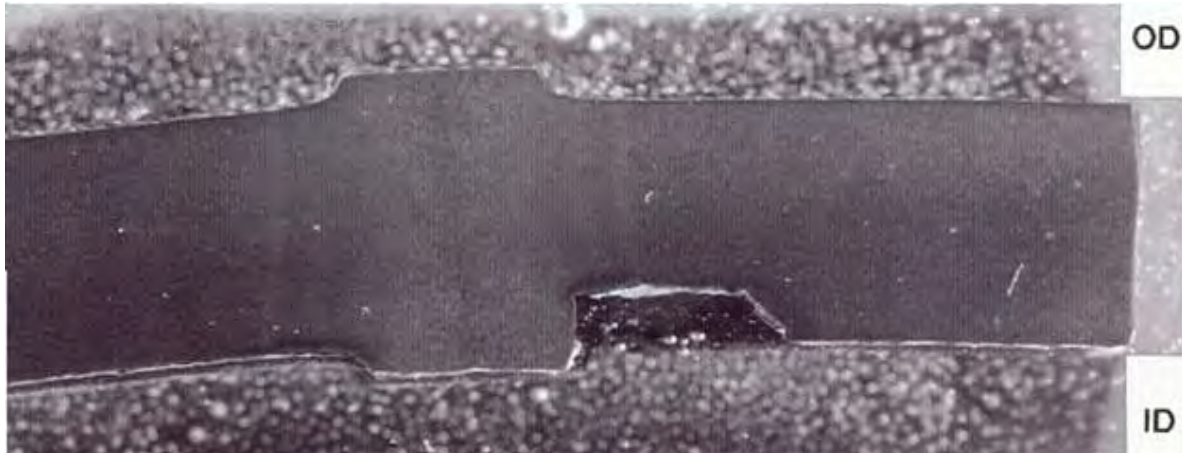
**Plate Roll-in**

Photographs of Weld Seam ID Surface and Metallographic Section.

Catalog #: 46  
 Report #: 5  
 Defect #: 26

Seam Type: FW  
 Grade: X52  
 $D_{nominal}$ : 20 inch (508 mm)  
 $t_{nominal}$ : 0.312 inch (7.92 mm)  
 $t_{pipe}$ : 0.319 inch (8.1 mm)  
 Failure: Burst test: No failure at 2,300 psig (15.86 MPa) (142% of SMYS) + Yielding at 2,175 psig (15.00 MPa) (134% of SMYS)

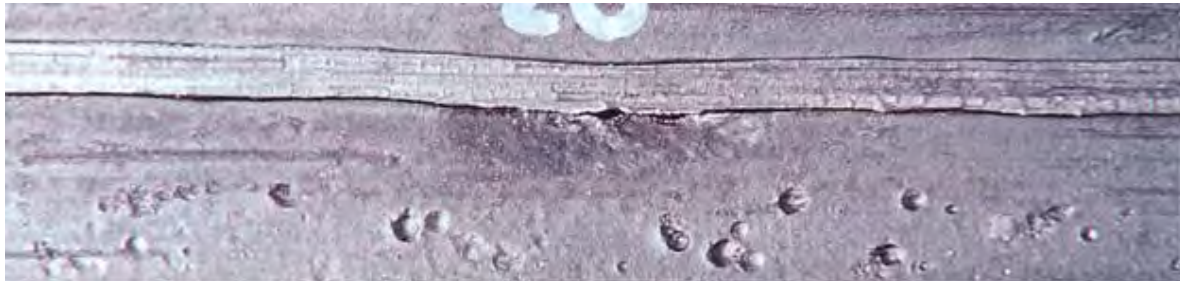
Plate Roll-in

Photographs of Weld Seam ID Surface and Metallographic Section.

Catalog #: 43  
 Report #: 5  
 Defect #: 20

Seam Type: FW  
 Grade: X52  
 $D_{nominal}$ : 20 inch (508 mm)  
 $t_{nominal}$ : 0.312 inch (7.92 mm)  
 $t_{pipe}$ : 0.312 inch (7.92 mm)  
 Failure: Burst Test: No failure at 2,250 psig (51.51 MPa) (139% of SMYS) + Yielding at 2,200 psig (15.17 MPa) (136% of SMYS)

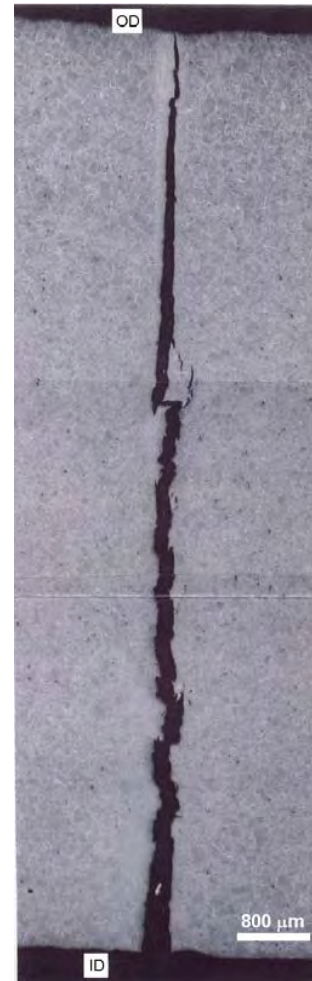
**Lack of Fusion**

Photographs and Photomicrograph of Metallographic Section and Fracture Surfaces.

Catalog #: 34  
 Report #: 5  
 Defect #: C5

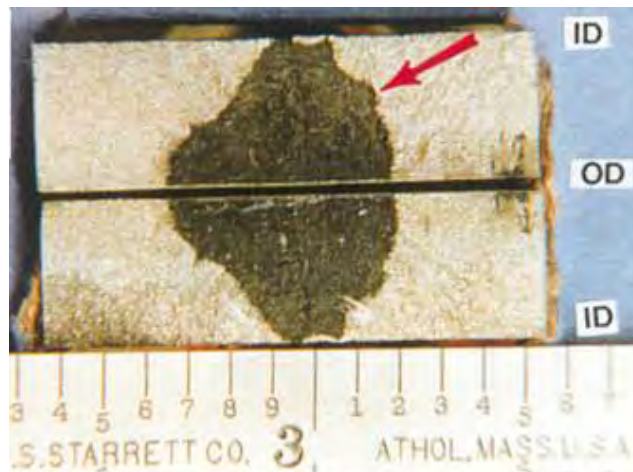
OD Lack of Fusion

Photograph of Magnetic Particle Indication on Pipe OD Surface and of Fracture Surfaces.

Catalog #: 20  
 Report #: 2  
 Defect #: 356

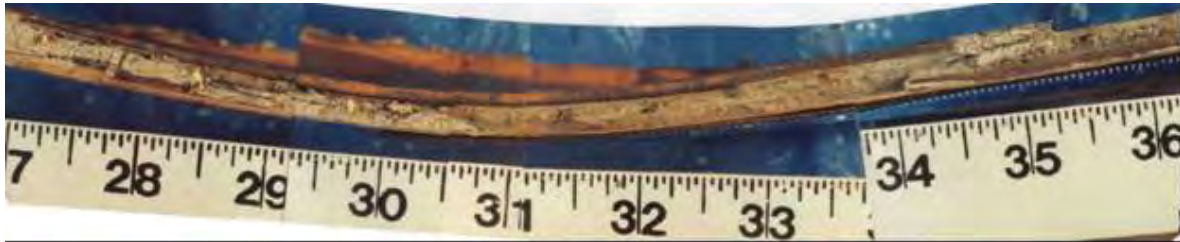
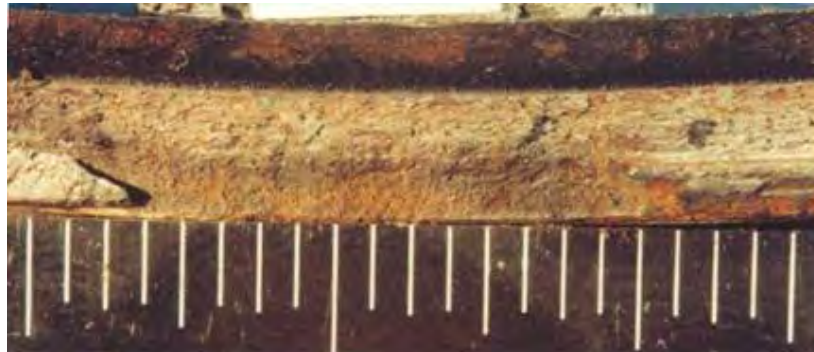
**ID and Hook Cracks + Lack of Fusion**

Photographs of Fracture Surface.

Catalog #:	54		
Report #:	6		
Defect #:	685		
<b><u>Pipe</u></b>		<b><u>Defect</u></b>	
Vintage:	circa 1950	NDE technique(s):	Fast UT
Manufacturer:	AO Smith	NDE result(s):	70% (0.300 inch (7.62 mm)) ID Crack + 30% (0.128 inch (3.25 mm)) OD Crack
Seam Type:	FW	Visual:	ID & Hook Cracks + Lack of Fusion
Grade:	X52	L	8.5 inch (216 mm) (ID Crack) + 4.0 inch (102 mm) (OD Crack)
D <sub>nominal</sub>	20 inch (508 mm)	depth/t <sub>weld</sub>	44% (22% ID + 22% OD)
t <sub>nominal</sub>	0.312 inch (7.92 mm)	depth:	0.094 inch (23.9 mm) (ID Crack) + 0.094 inch (23.9 mm) (OD Crack)
t <sub>pipe</sub>	Not determined	t <sub>weld</sub>	0.428 inch (10.9 mm)
Failure:	Burst test failure at 2,050 psig (14.13 MPa) (126% of SMYS)

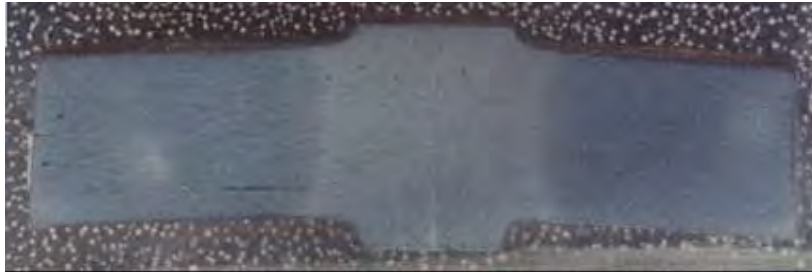
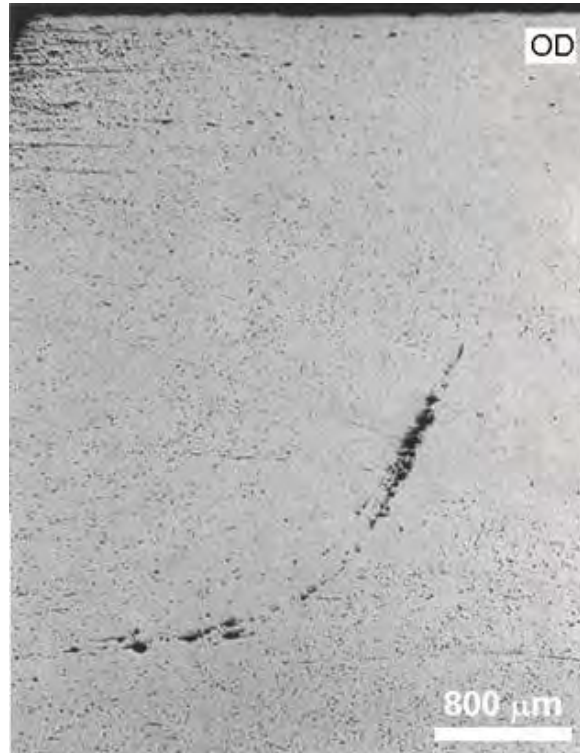
**OD Outbent Fiber**

Photograph and Photomicrograph of Metallographic Section.

Vintage: circa 1950  
 Manufacturer: AO Smith  
 Seam Type: FW  
 Grade: X52  
 $D_{nominal}$ : 20 inch (508 mm)  
 $t_{nominal}$ : 0.312 inch (7.92 mm)  
 $t_{pipe}$ : Not determined  
 Failure: N/A

NDE technique(s): Fast UT  
 NDE result(s): 30% OD Crack-like  
 Visual: OD Outbent Fiber  
 L: N/A  
 $depth/t_{weld}$ : 33%  
 depth: 0.145 inch (3.68 mm)  
 $t_{weld}$ : 0.433 inch (11 mm)

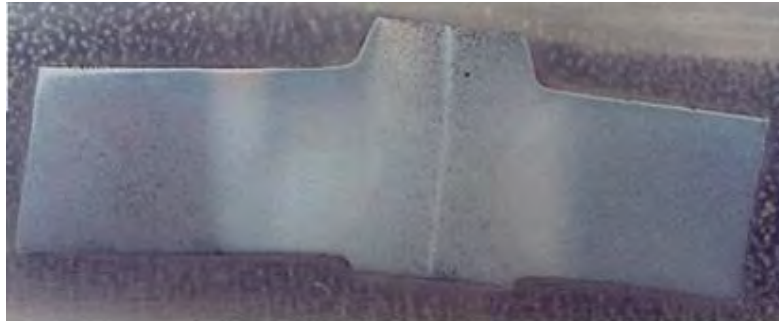
**No Anomaly Revealed**

Photograph of Metallographic Section.

Vintage: circa 1950  
Manufacturer: AO Smith  
Seam Type: FW  
Grade: X52  
 $D_{\text{nominal}}$ : 20 inch (508 mm)  
 $t_{\text{nominal}}$ : 0.312 inch (7.92 mm)  
 $t_{\text{pipe}}$ : 0.336 inch (8.53 mm)  
Failure: N/A

NDE technique(s): Fast UT  
NDE result(s): <10% OD Crack-like  
Visual: No Anomaly Revealed  
L: N/A  
depth/ $t_{\text{weld}}$ : N/A  
depth: N/A  
 $t_{\text{weld}}$ : 0.468 inch (11.9 mm)

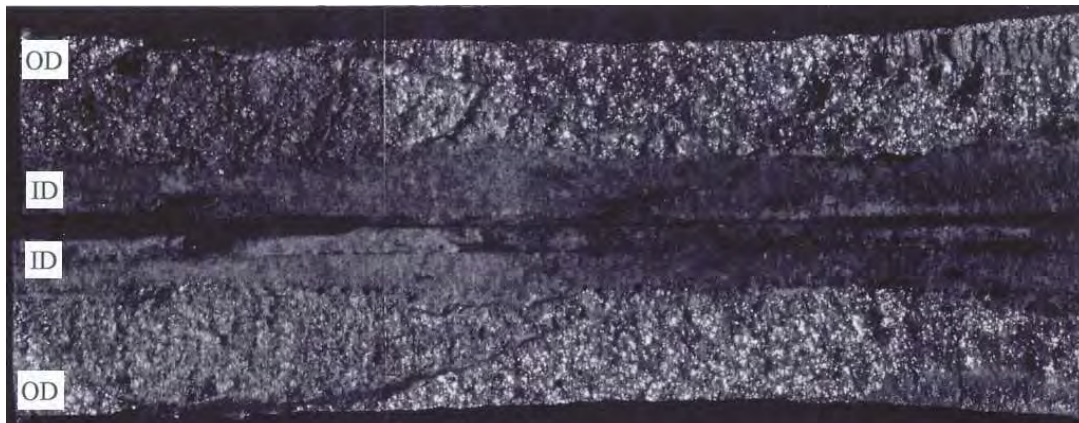
**Through-Wall Flaw + ID Seam Ground Flush + Lack of Fusion**

Photographs of Pipe Seam ID Surface and Fracture Surfaces.

L  
 $depth/t_{weld}$ : N/A  
 100% (Leak) + 30% (LOF)

$t_{nominal}$ : 0.344 inch (8.74 mm)  
 $t_{pipe}$ : Not Determined  
 Failure: Hydrotest Leak at 1,517 psig (10.46 MPa) (85% of SMYS)

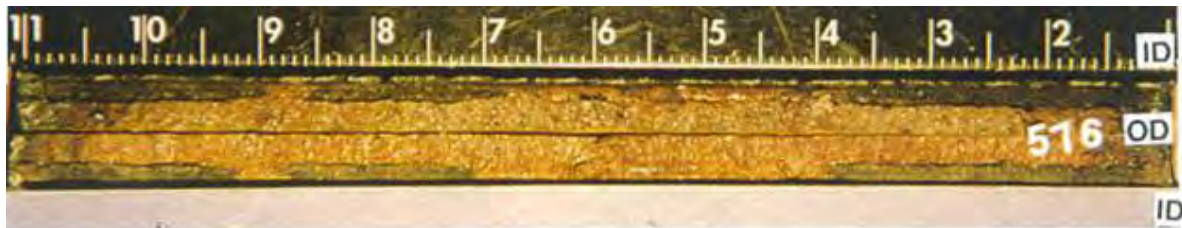
Intermittent ID Lack of Fusion

Photograph of Fracture Surfaces.

$D_{nominal}$  20 inch (508 mm)  
 $t_{nominal}$  0.344 inch (8.74 mm)  
 $t_{pipe}$  0.342 inch (8.69 mm)  
 Failure: Burst test rupture at  
 2,075 psig (14.31 MPa)  
 (116% of SMYS)

NDE technique(s): UT  
 NDE result(s): 20%, 9.4 feet long (2.9 m)  
 ID crack like  
 Visual: Intermittent ID Lack of  
 Fusion  
 L Entire joint, in photo: 2.0,  
 1.75 & 2.9 inch  
 (51, 44.5 & 74 mm)  
 depth/ $t_{weld}$  45%  
 depth: 0.150 inch (38 mm)  
 $t_{weld}$  N/A

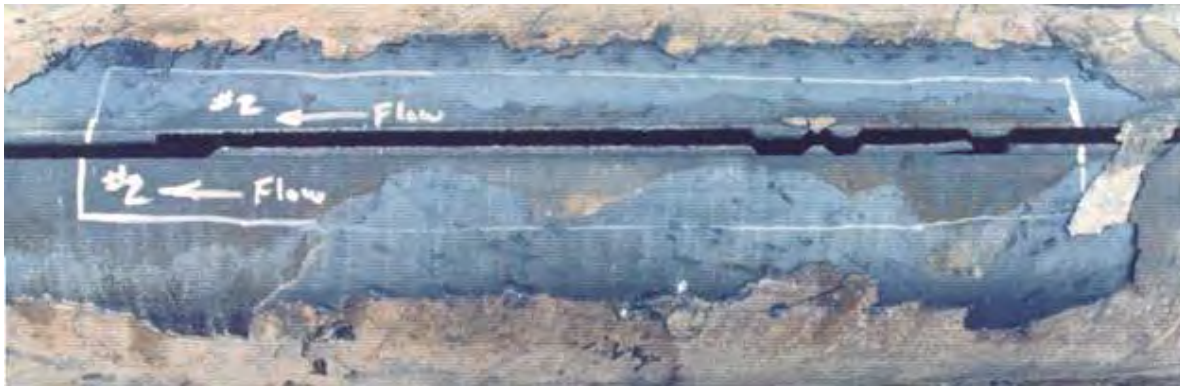
**Seam Split**

Photograph of Pipe Outside Surface.

Vintage: circa 1952  
 Manufacturer: Kaiser  
 Seam Type: SSAW  
 Grade: API 5L X52  
 $D_{nominal}$ : 20 inch (508 mm)  
 $t_{nominal}$ : 0.344 inch (8.74 mm)  
 $t_{pipe}$ : Not Determined  
 Failure: Hydrotest Leak at 1,570 psig (10.82 MPa) (88% of SMYS)

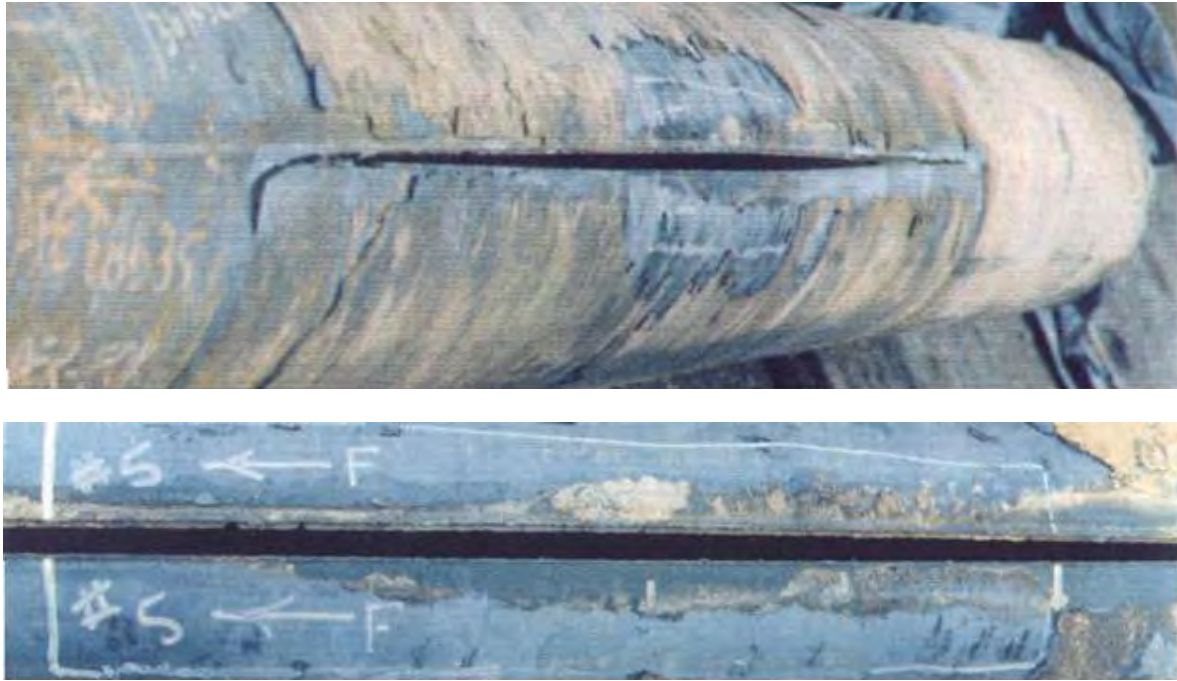
**Seam Split**

Photographs of Pipe Outside Surface.

NDE technique(s): N/A  
 NDE result(s): N/A  
 Visual: Seam split  
 L: 12 ft-8 inch (3.9 m)  
 $\text{depth}/t_{\text{weld}}$ : Not Determined  
 depth: Not Determined  
 $t_{\text{weld}}$ : Not Determined
