Case No. 2024-00290
Kentucky Municipal Energy Agency
Response to Siting Board's Post-Hearing Request for Information

PHASE I ANALYSIS OF POTENTIAL CONSTRUCTION SITE NEAR MADISONVILLE, KENTUCKY

PHASE 2 ANALYSIS OF A SUBSIDENCE HAZARD FOR A POTENTIAL CONSTRUCTION SITE IN MADISONVILLE, KENTUCKY

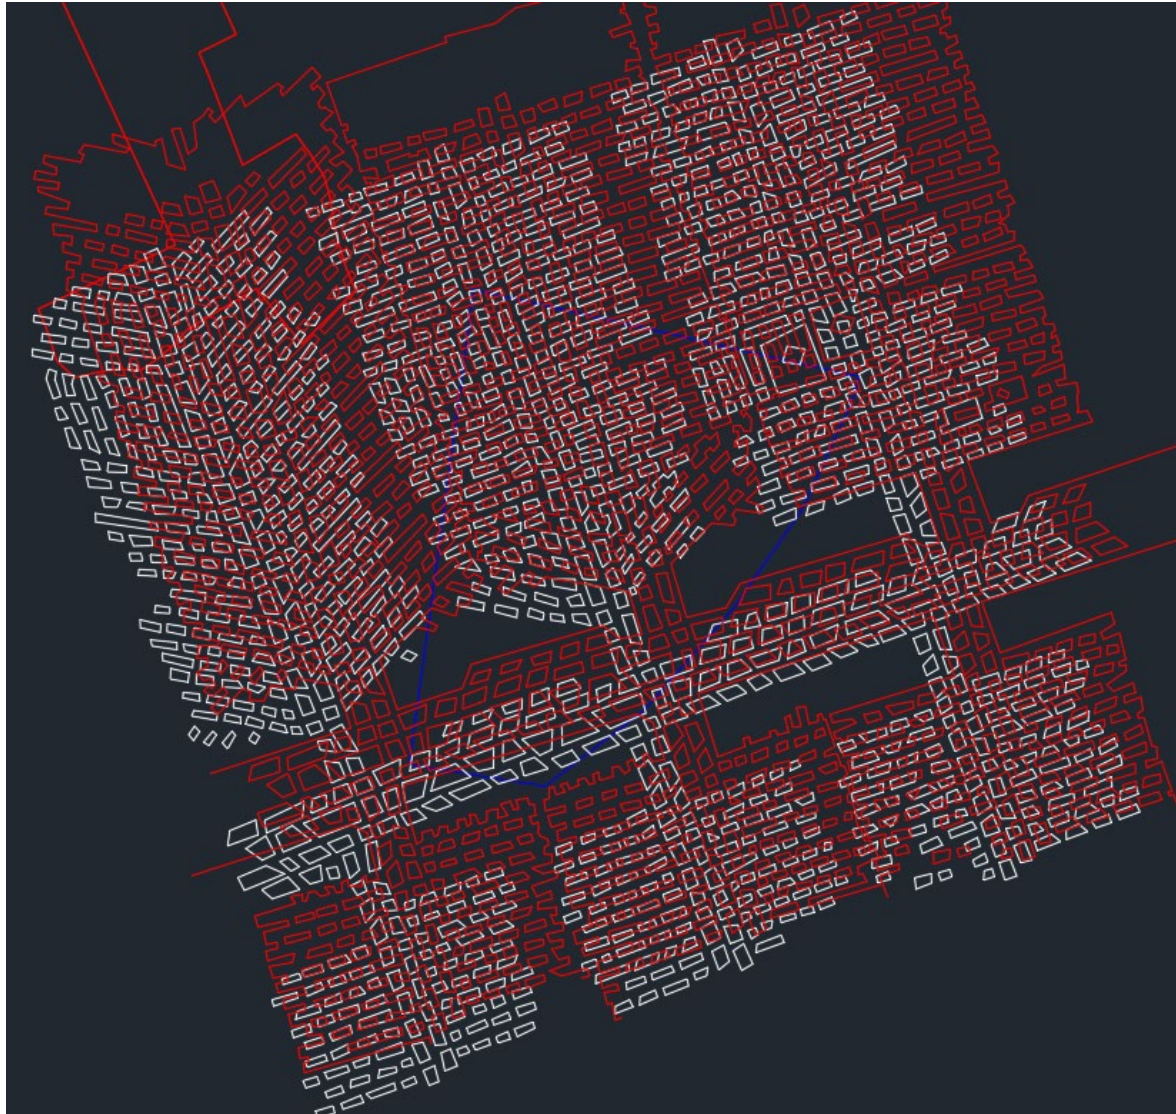
Figure B-2. Comparison of the Kentucky Geological Survey (White) and RESPEC Georeferenced (Red) Mine Maps for WKY 11.

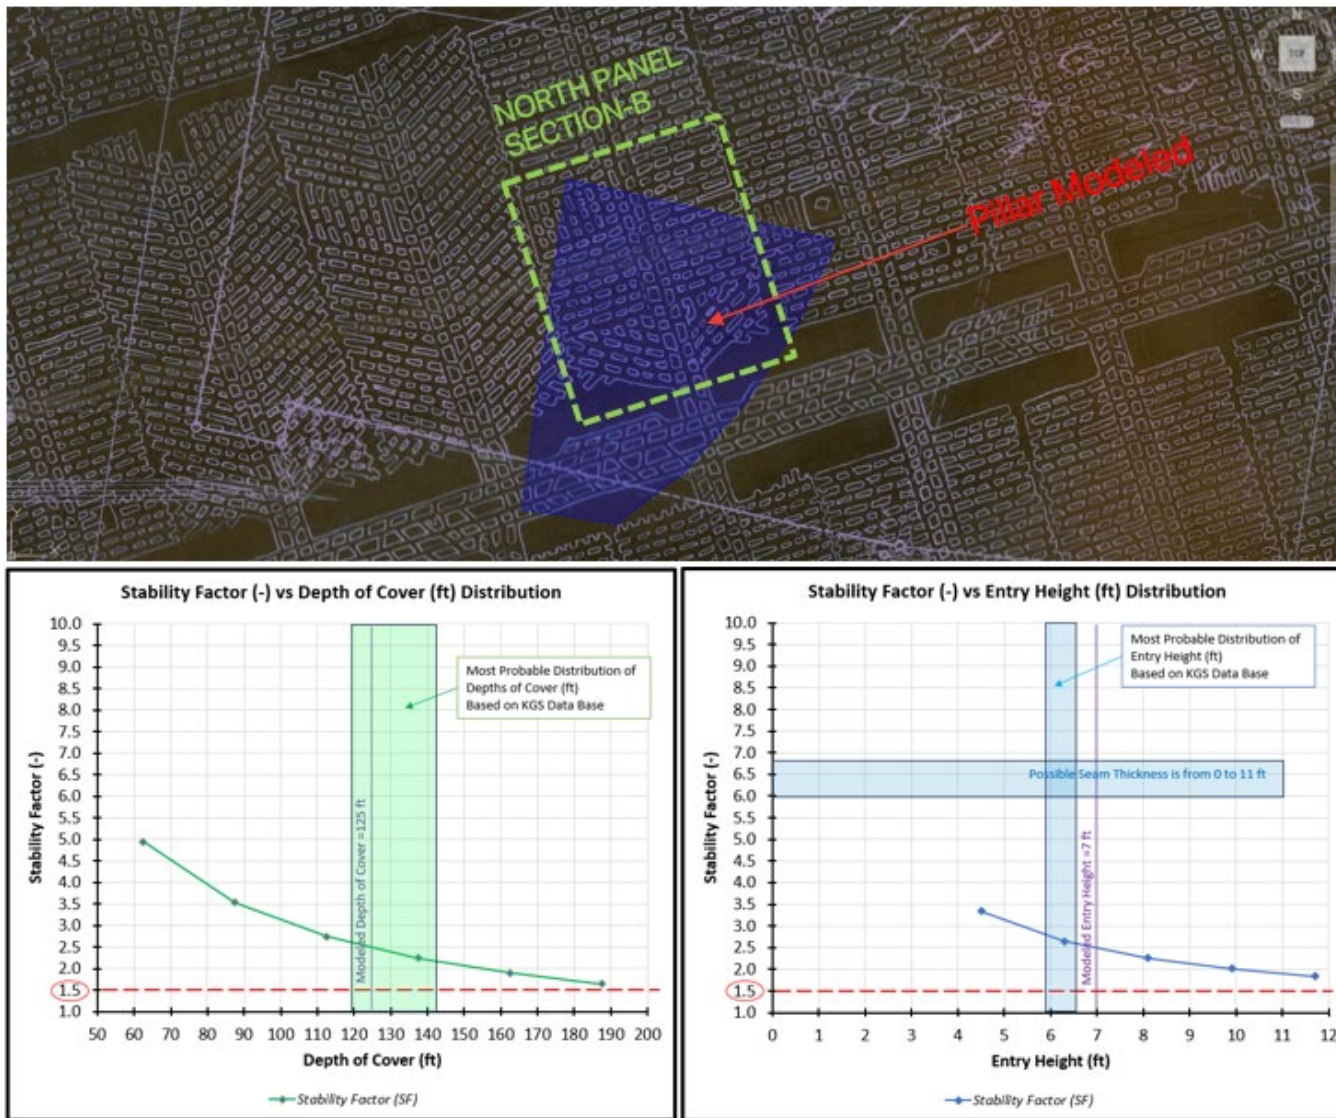
Figure B-10. Upper Mine Level – North Panel – Section B, Analysis of Coal Pillar Stability Analysis Results. The top figure shows the smallest pillar in the section that was modeled. The bottom left figure shows the stability factor distribution for varying depths of cover. The bottom right figure shows the stability factor distribution for varying entry heights.

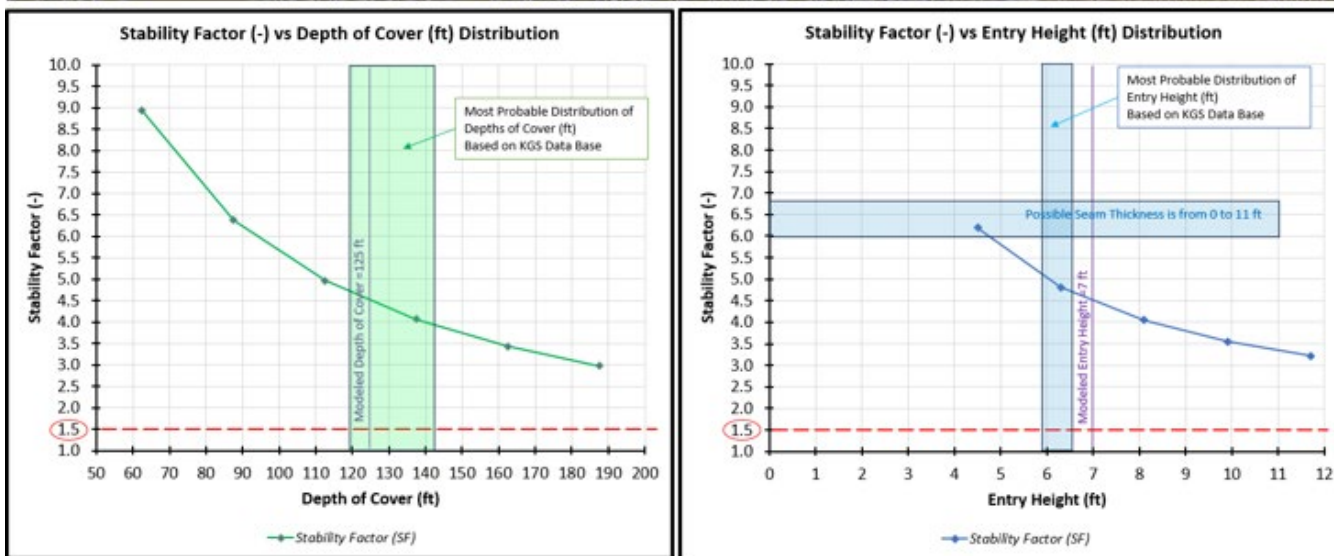
Figure B-11. Upper Mine Level – North Panel – Section C, Analysis of Coal Pillar Stability Analysis Results. The top figure shows the smallest pillar in the section that was modeled. The bottom left figure shows the stability factor distribution for varying depths of cover. The bottom right figure shows the stability factor distribution for varying entry heights.

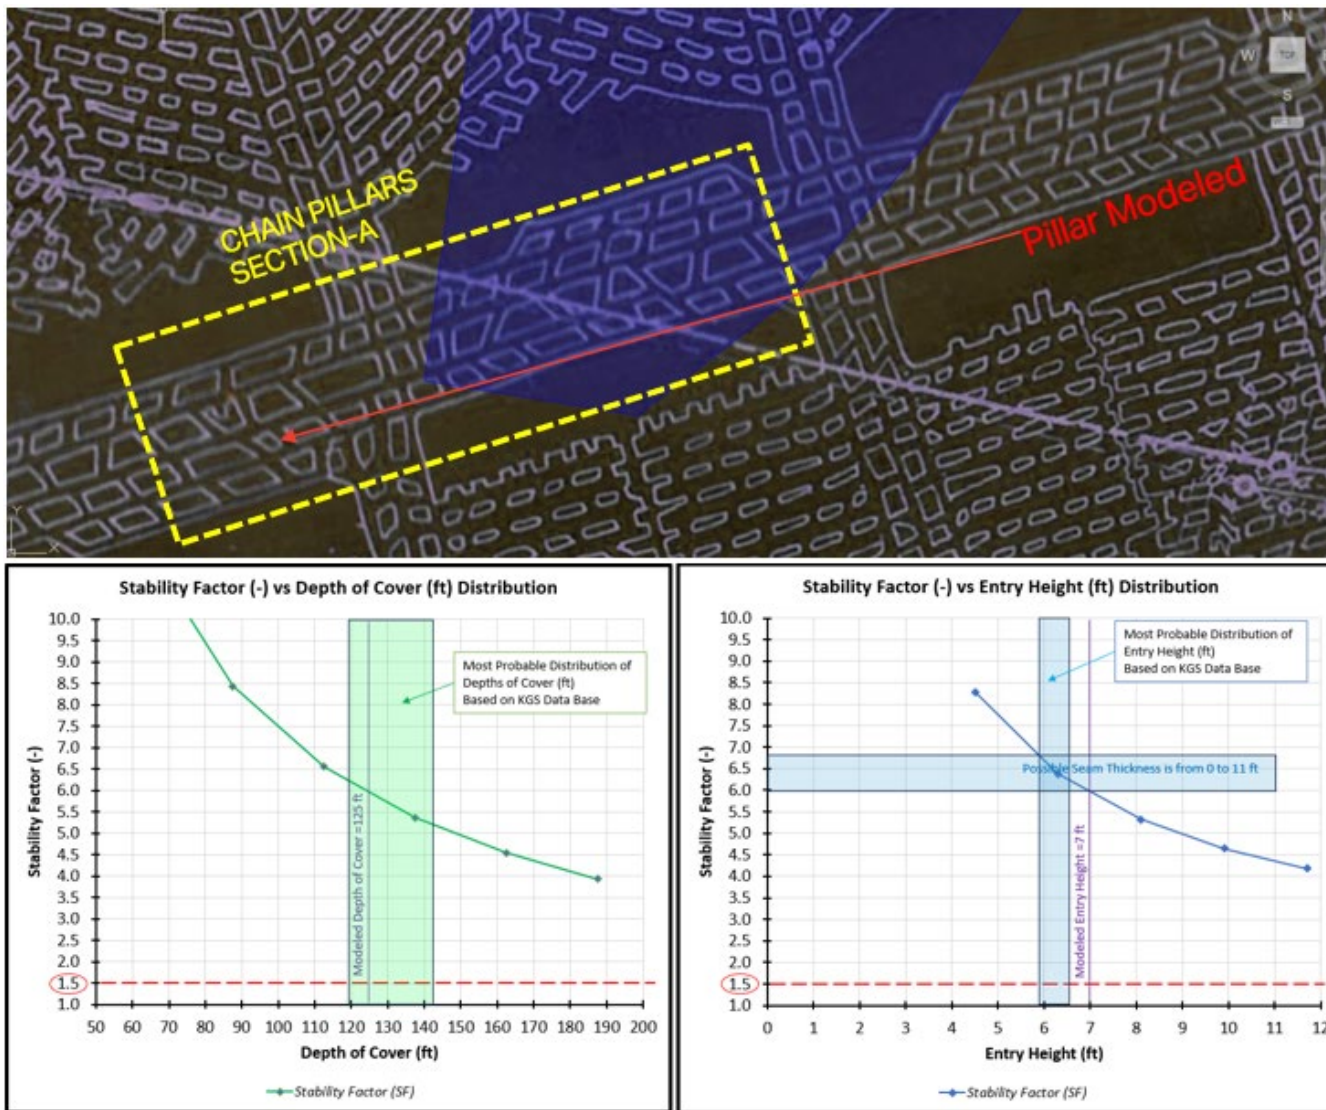
Figure B-12. Upper Mine Level – Chain Pillars – Section A, Analysis of Coal Pillar Stability Analysis Results. The top figure shows the smallest pillar in the section that was modeled. The bottom left figure shows the stability factor distribution for varying depths of cover. The bottom right figure shows the stability factor distribution for varying entry heights.

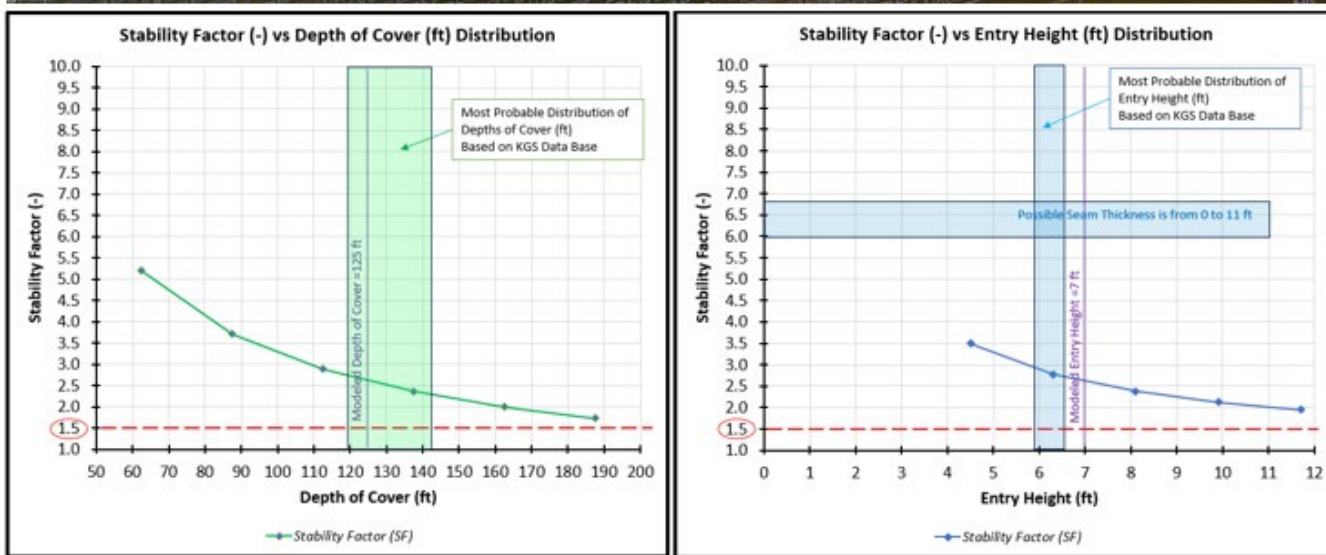
Figure B-14. Upper Mine Level – South Panel – Section A, Analysis of Coal Pillar Stability Analysis Results. The top figure shows the smallest pillar in the section that was modeled. The bottom left figure shows the stability factor distribution for varying depths of cover. The bottom right figure shows the stability factor distribution for varying entry heights.

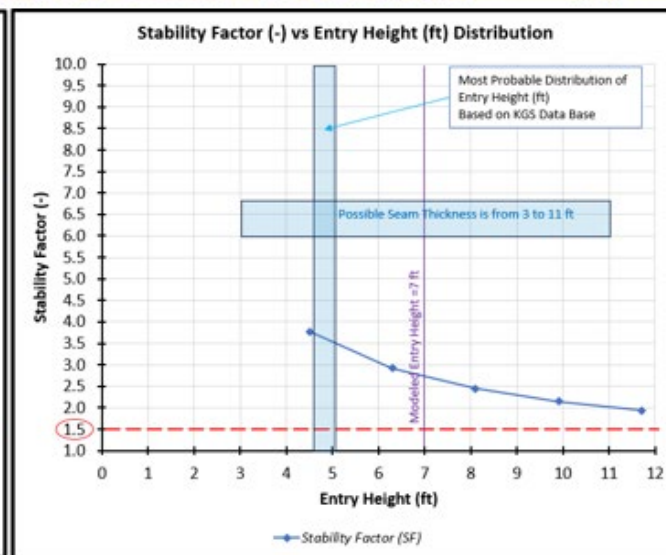
B-21

Figure B-21. Lower Mine Level – Chain Pillars – Section A, Analysis of Coal Pillar Stability Analysis Results. The top figure shows the smallest pillar in the section that was modeled. The bottom left figure shows the stability factor distribution for varying depths of cover. The bottom right figure shows the stability factor distribution for varying entry heights.

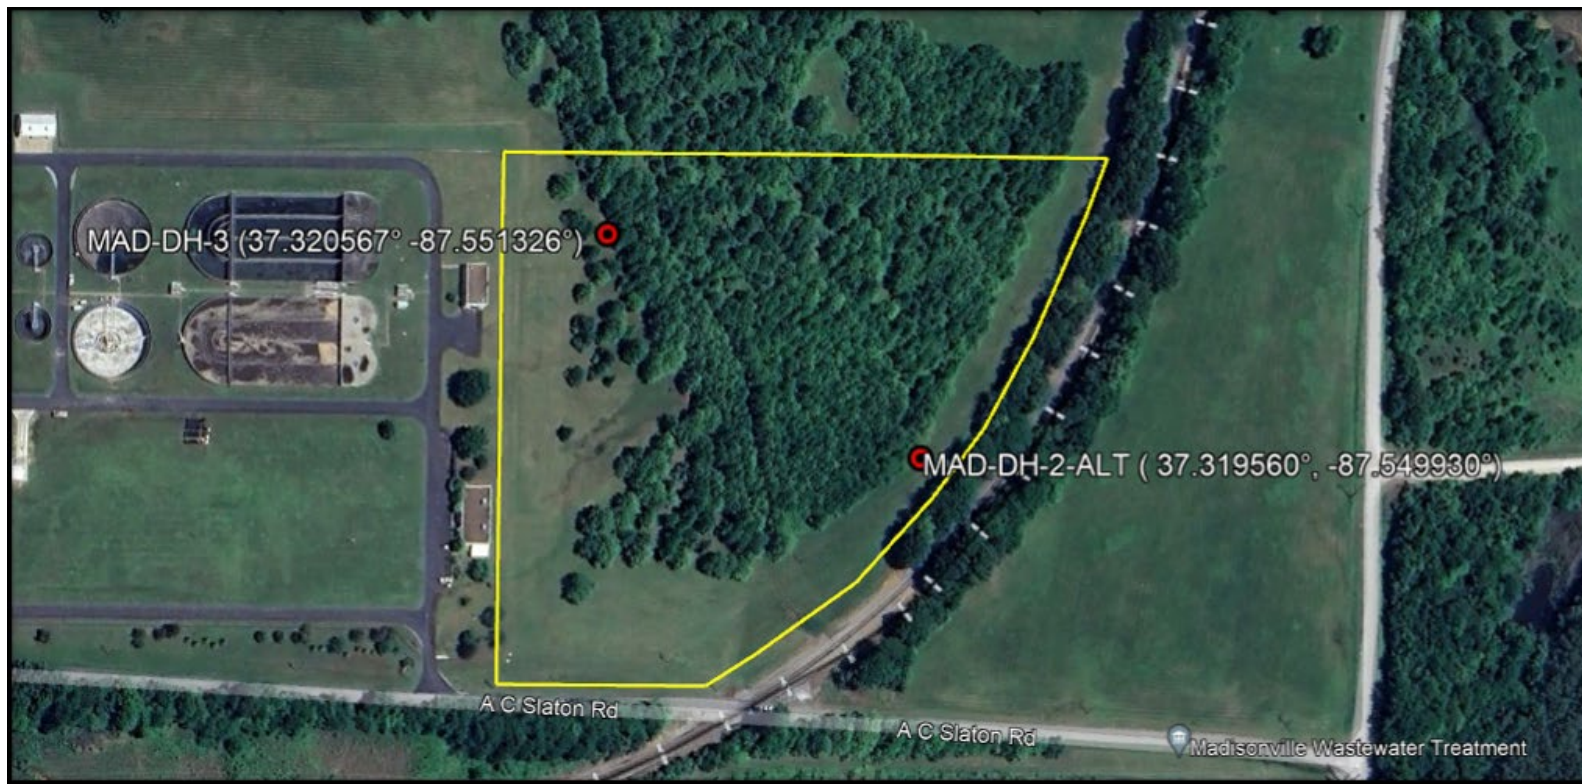
Figure B-26. Approximate Locations of the Two Drillholes Drilled on the Madisonville Property.

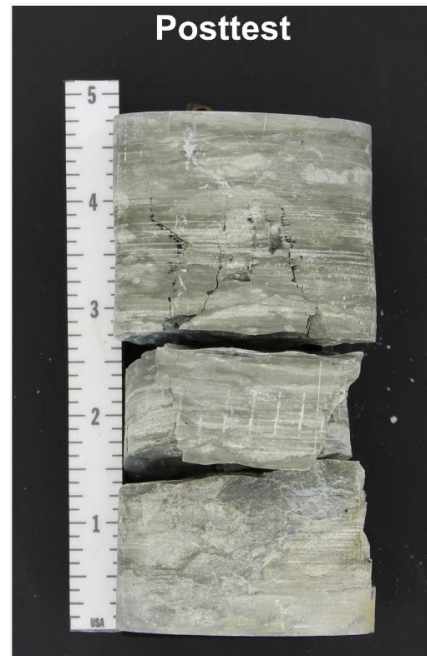
NFRONT/MAD-05/99.6

Figure D-2. Unconfined Compression and Constant Strain Rate Test Plot and Pre- and Posttest Photographs of Specimen NFRONT/MAD-05/99.6.

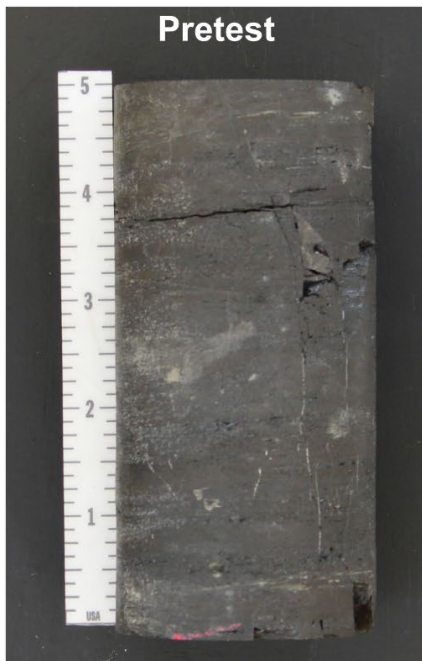
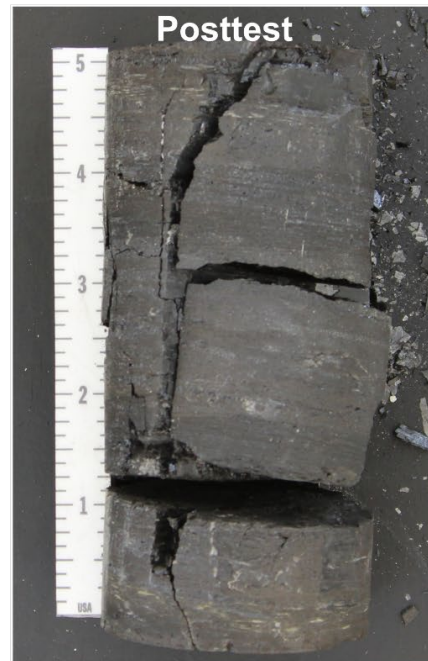
NFRONT/MAD-09/134.8

Figure D-4. Unconfined Compression and Constant Strain Rate Test Plots and Pre- and Posttest Photographs of Specimen NFRONT/MAD-09/134.8.

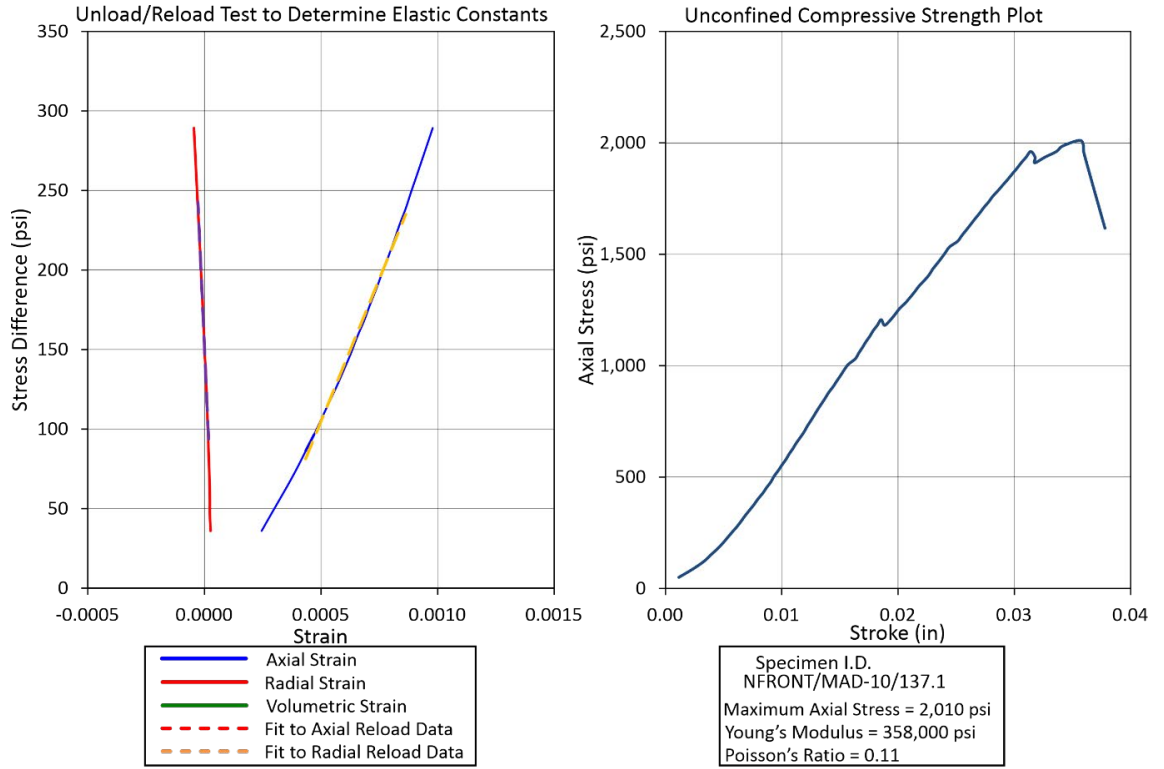
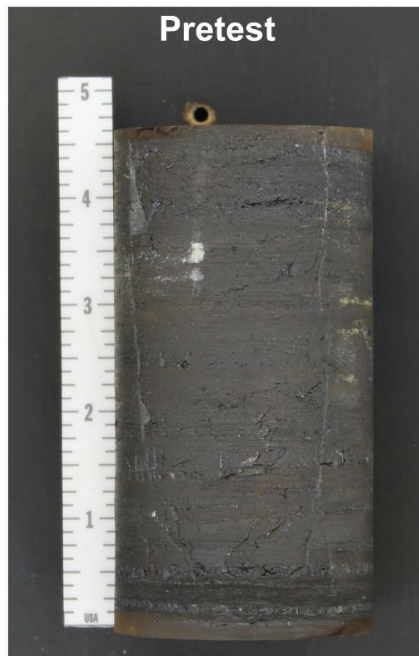
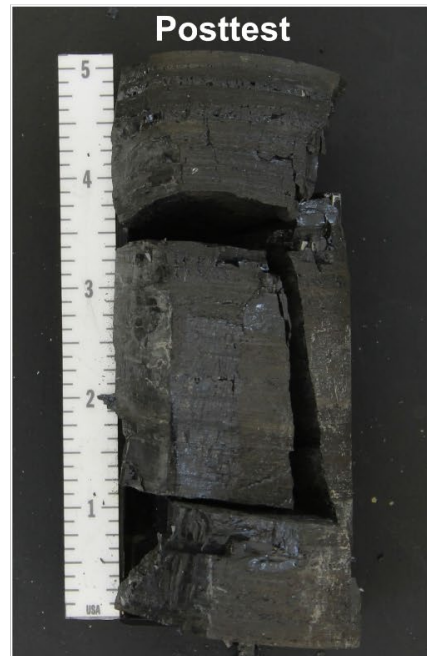
NFRONT/MAD-10/137.1

Figure D-5. Unconfined Compression and Constant Strain Rate Plots and Pre- and Posttest Photographs of Specimen NFRONT/MAD-10/137.1.

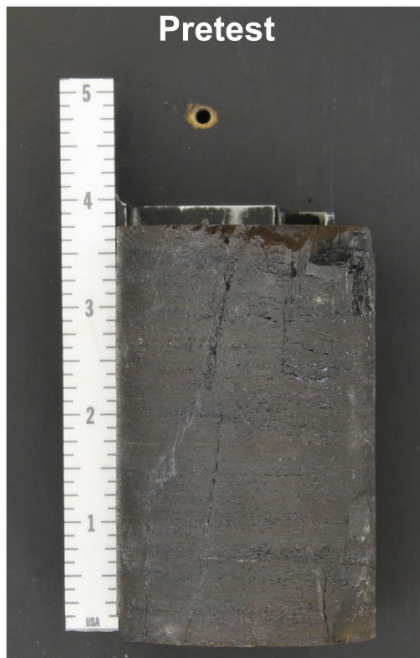
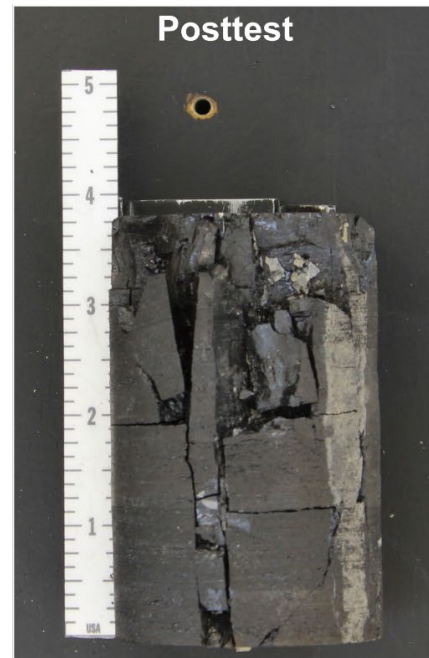
NFRONT/MAD-10/143.0

Figure D-6. Unconfined Compression and Constant Strain Rate Test Plots and Pre- and Posttest Photographs of Specimen NFRONT/MAD-10/143.0.

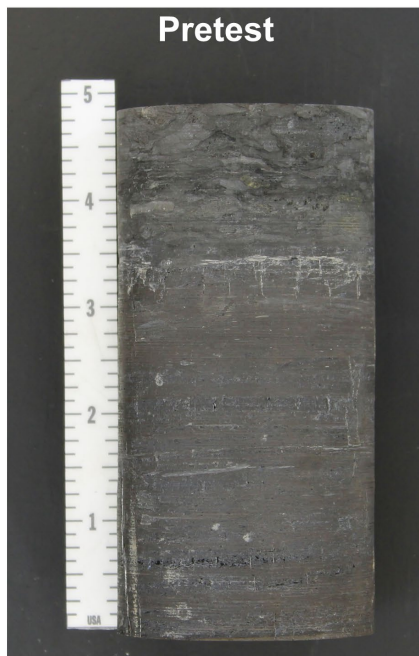
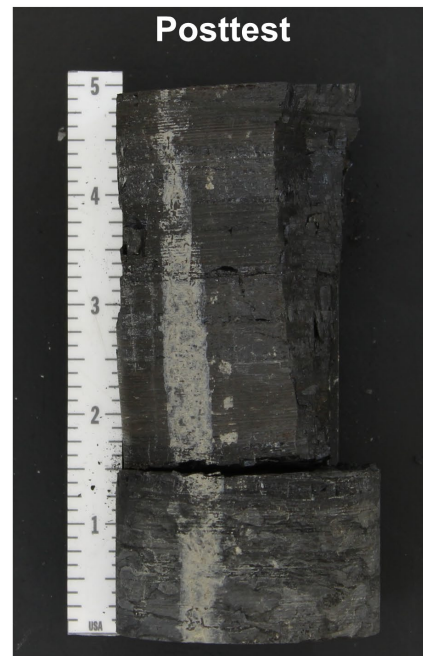
NFRONT/MAD-16/122.4

Figure D-8. Unconfined Compression and Constant Strain Rate Test Plots and Pre- and Posttest Photographs of Specimen NFRONT/MAD-16/122.4.

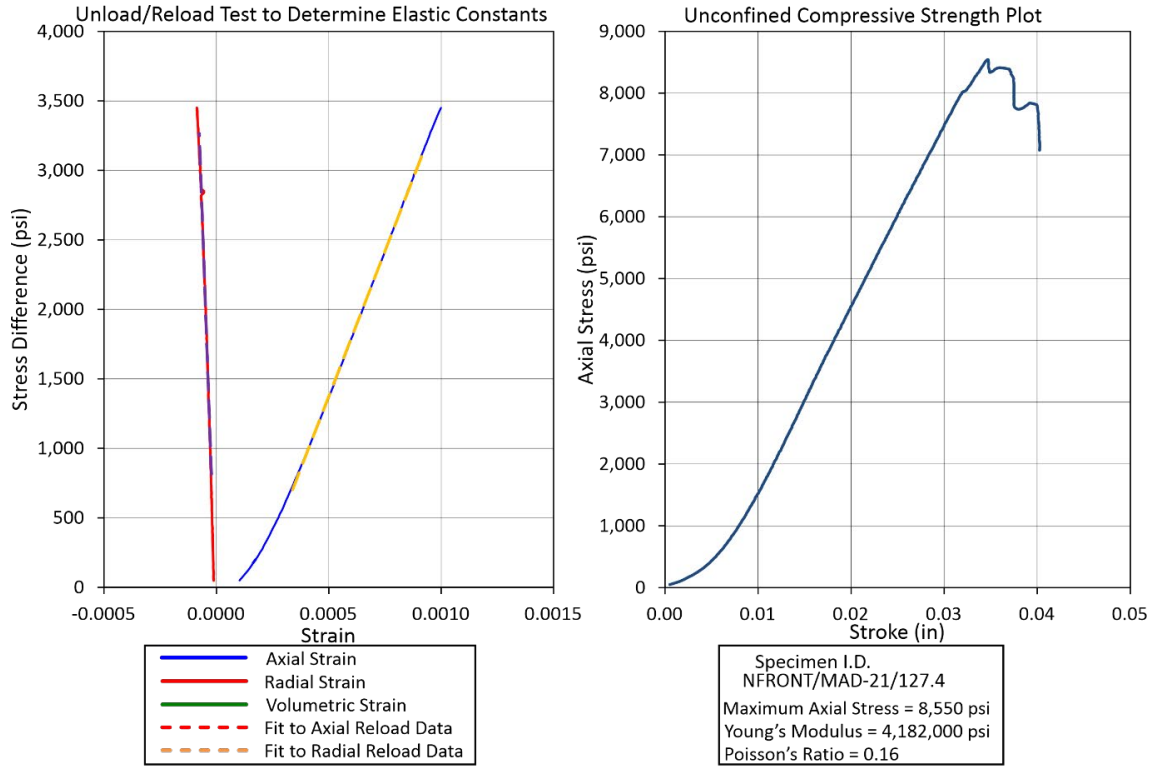
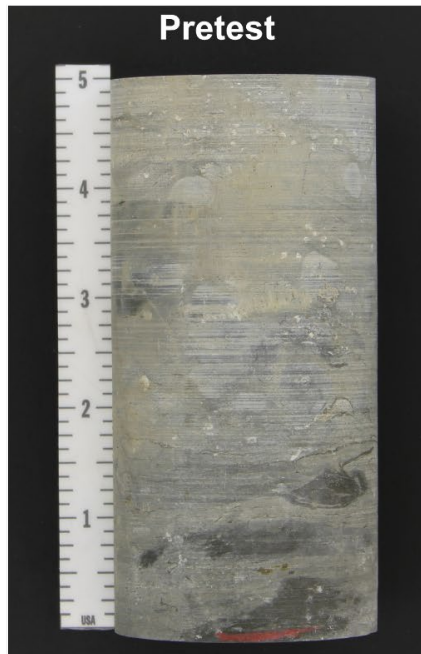
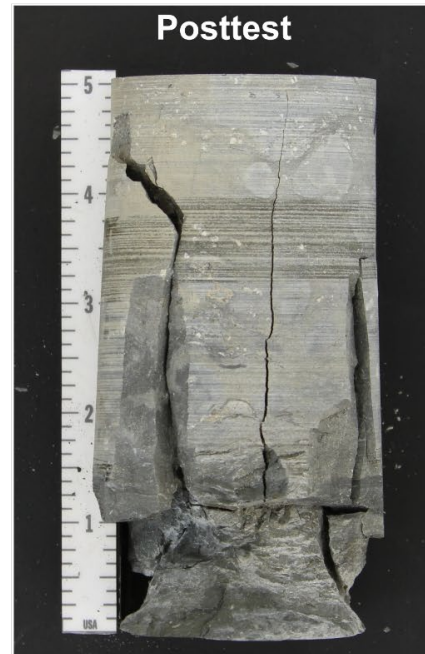
NFRONT/MAD-21/127.4

Figure D-10. Unconfined Compression and Constant Strain Rate Test Plots and Pre- and Posttest Photographs of Specimen NFRONT/MAD-21/127.4.

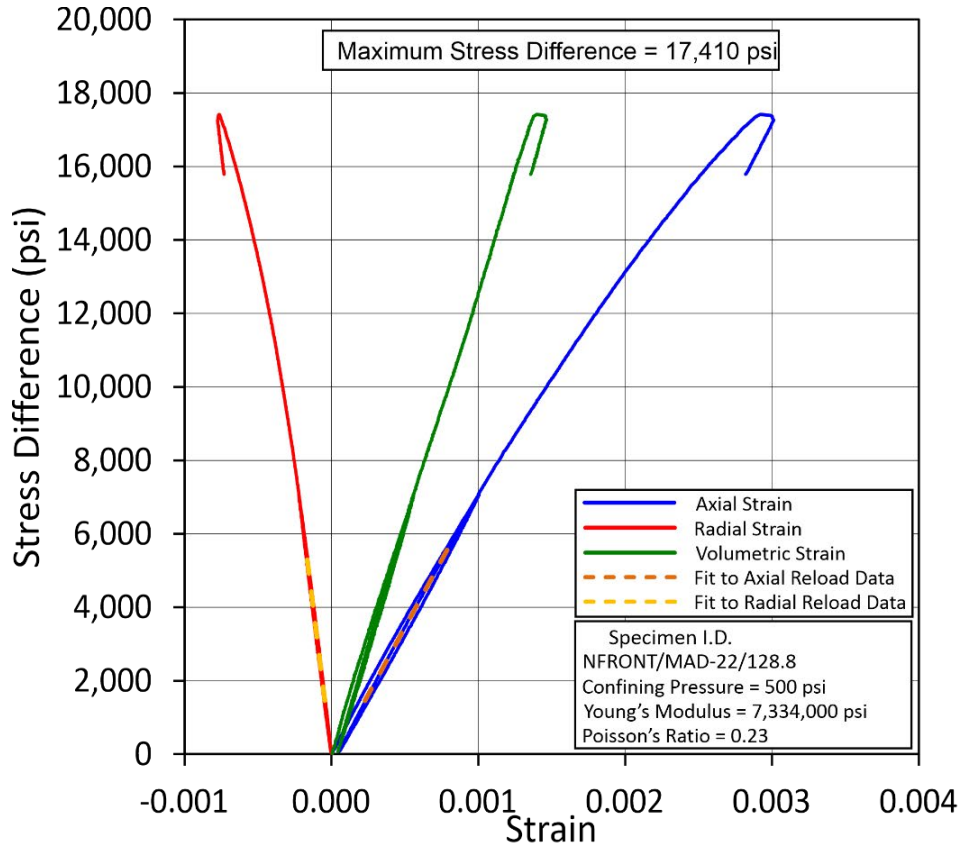
Figure D-11. Constant Strain Rate and Standard Triaxial Compression Test Plot and Pre- and Posttest Photographs of Specimen NFRONT/MAD-22/128.8.

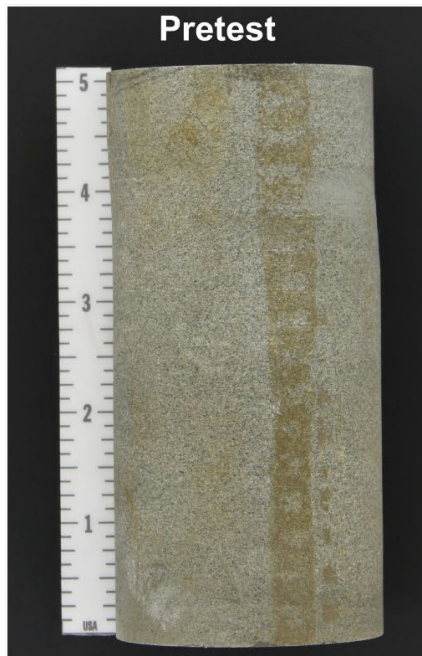
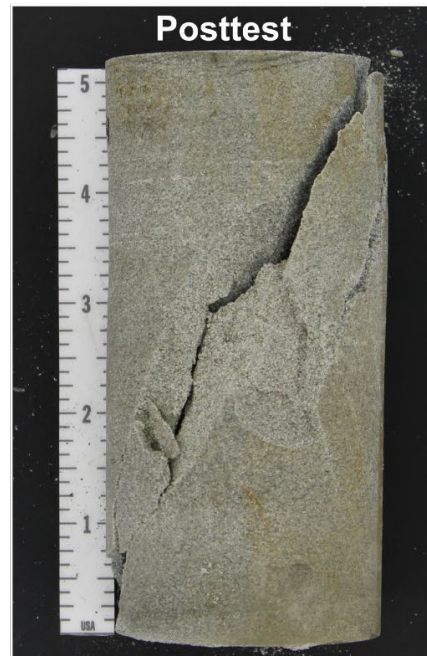
Figure D-14. Unconfined Compression and Constant Strain Rate Test Plots and Pre- and Posttest Photographs of Specimen NFRONT/MAD-24/206.2.

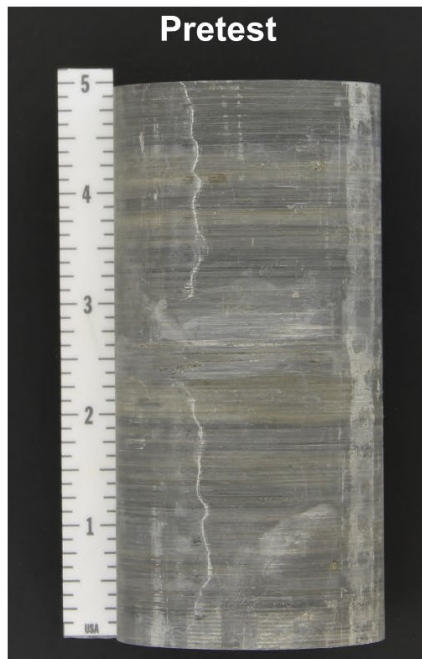
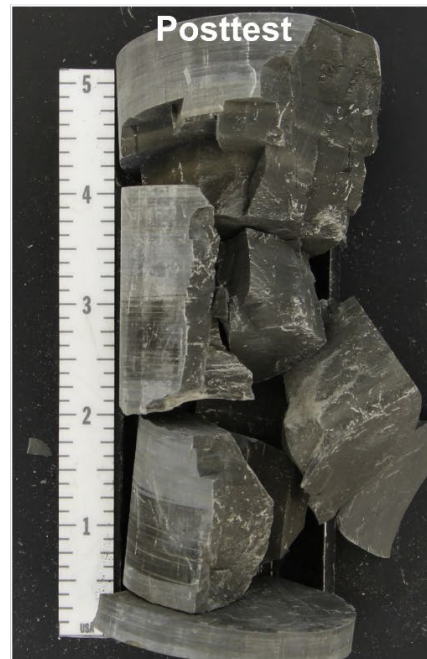
NFRONT/MAD-28/228.5

Figure D-15. Unconfined Compression and Constant Strain Rate Test Plots and Pre- and Posttest Photographs of Specimen NFRONT/MAD-28/228.5.
