EXHIBIT 7 Part 3 of 3

PRESTONSBURG - THELMA TRANSMISSION LINE REBUILD PROJECT

Kentucky Power representatives plan to upgrade the electric transmission grid in Floyd and Johnson counties to enhance electric reliability for area customers. Crews plan to begin construction summer 2026 and conclude by spring 2028.

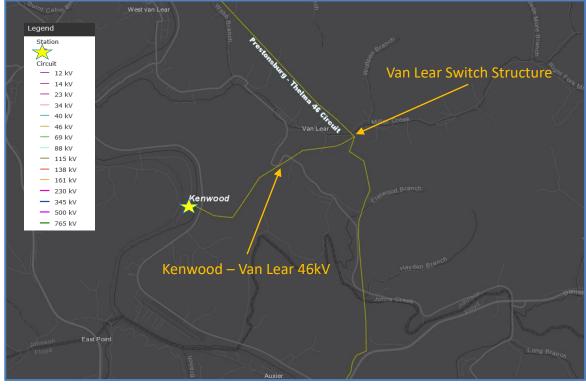
The switches at Van Lear have been tagged as inoperable and unsafe to operate. The old hydraulic type mechanism on these switches does not operate properly, arcing horns are burnt off, and operating rod supports are damaged.

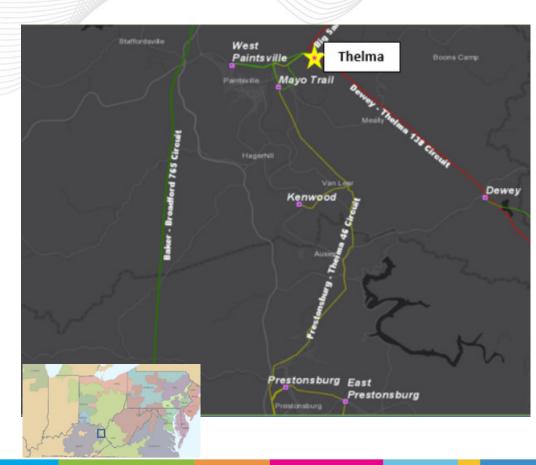
AEP Transmission Zone: Baseline Thelma Transformer Replacement

Recommended Solution:

Replace Thelma Transformer #1 with a 138/69/46kV 130/130/90 MVA transformer and replace 46kV risers and relaying towards Kenwood substation. Existing TR#1 to be used as spare. (**B3360**)

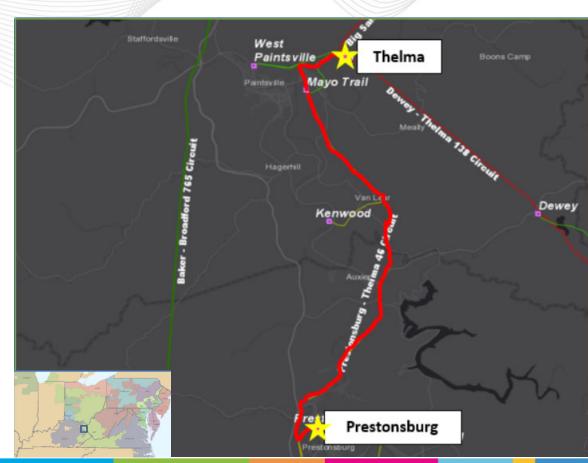
AEP Transmission Zone: Baseline Prestonsburg - Thelma 46kV Rebuild

Recommended Solution:
