Re: Caldwell Solar Karst Survey and Assessment Caldwell Solar, LLC Princeton, Caldwell County, Kentucky Terracon Project No. 57205061

Karst Survey and Assessment

Caldwell Solar Karst Assessment Caldwell County, Kentucky February 5, 2021 Terracon Project No. 57205061

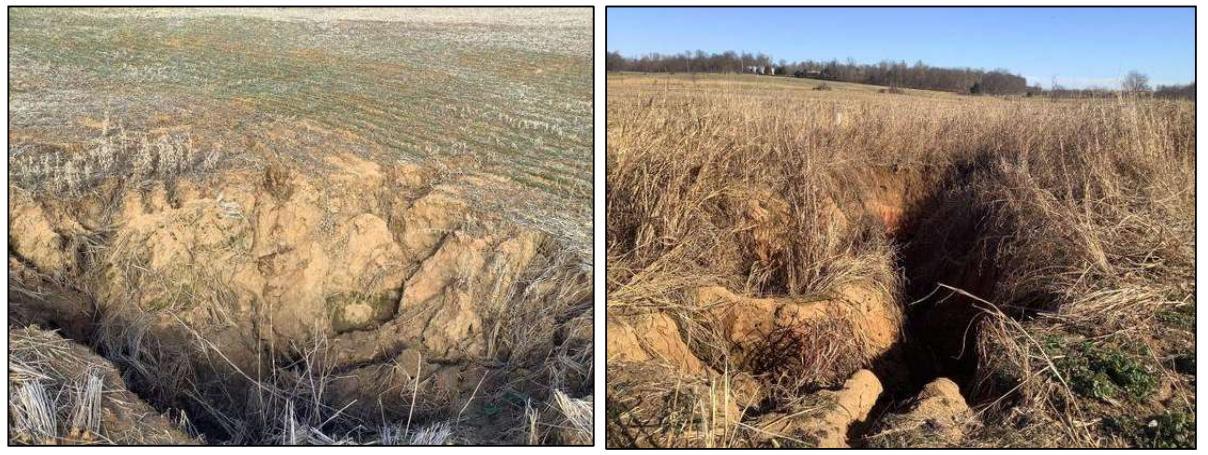
Type 1 – This type of karst feature is characterized by the presence of an open throat at the base and active erosion along the walls and parapet of the feature. These features are considered the highest risk since they are actively growing and may continue to collapse and widen during construction activities and post development. Two examples of such features are shown below in Image 1.

Image 1. Both sinkholes are undergoing erosion and expansion of the parapet limits as demonstrated by the rough, raveling, and incised surfaces. In addition, the open throats present in the base of the sinkholes readily receive surface runoff with little to no filtration.

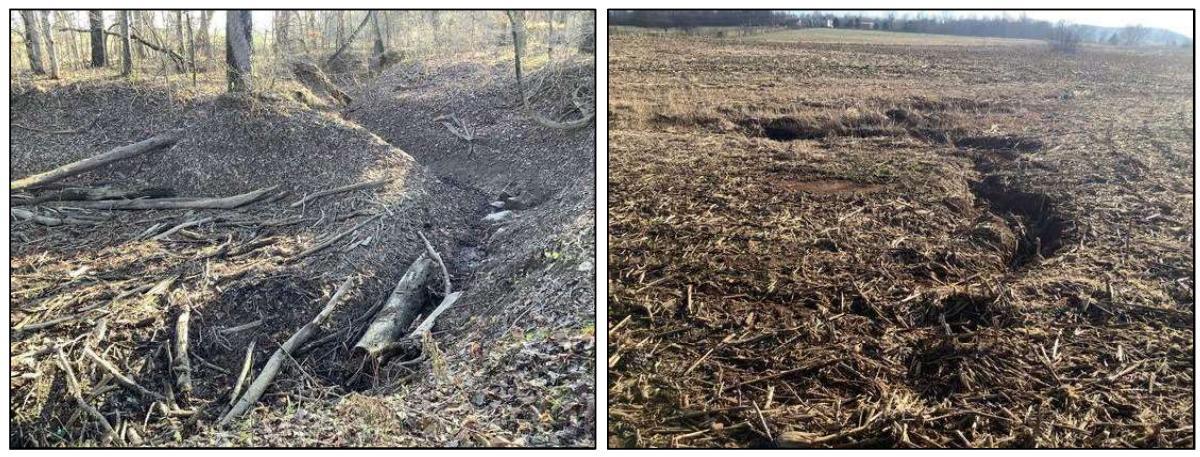
Type 2 – This type of karst feature is characterized by the presence of an incised drainage channel leading to the karst feature indicating that focused drainage enters the structure, which commonly results in active erosion and growth of the sinkhole (Image 2). In addition, they nearly always contain an open throat. Additionally, these features can be problematic as potential construction activities within the drainage may result in the uncontrolled flow of water transporting sediment and contaminants into the subsurface via the open throat. Awareness of the drainage catchment extent and implementation of proper erosion and sediment controls (ESC) are crucial for these types of karst features.

Image 2. Two examples of drainage channels leading towards sinkholes with open throats.

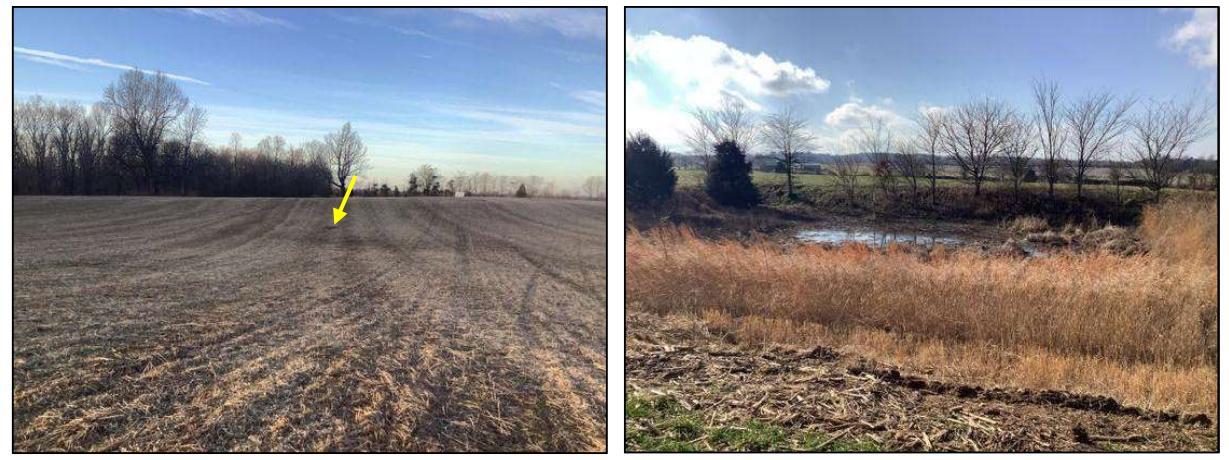
Type 8 – This types of sinkhole is present as a broad and shallow depression, ranging in size from tens to hundreds of feet in diameter and commonly referred to as a "mature" or paleokarst sinkhole (Image 8). Mature sinkholes often have a roughly circular parapet outline, are bowl shaped, lacking any opening to the subsurface (i.e. "throat") or showing evidence of active soil raveling or tension cracks around the parapet. Thus, whatever conduit or opening into the

underlying karst aquifer that may have functioned to create the structure is probably now clogged with soil, which would act as a filter for water infiltrating from the surface.

Image 8. Examples of mature sinkholes. The feature on the left is a large closed depression which has a subsidiary collapse located at the center of the feature (pointed out by the yellow arrow). The newly formed collapse acting as a drain to the closed depression indicates that reactivation has occurred. The image on the right shows a closed depression which has presumably been repurposed into a pond.
