Re: Caldwell Solar Karst Survey and Assessment Caldwell Solar, LLC Princeton, Caldwell County, Kentucky Terracon Project No. 57205061

As requested, Terracon Consultants, Inc. (Terracon) is submitting this report summarizing the karst survey and assessment at the proposed Caldwell Solar site in northern Caldwell County, Kentucky.

Karst Survey and Assessment

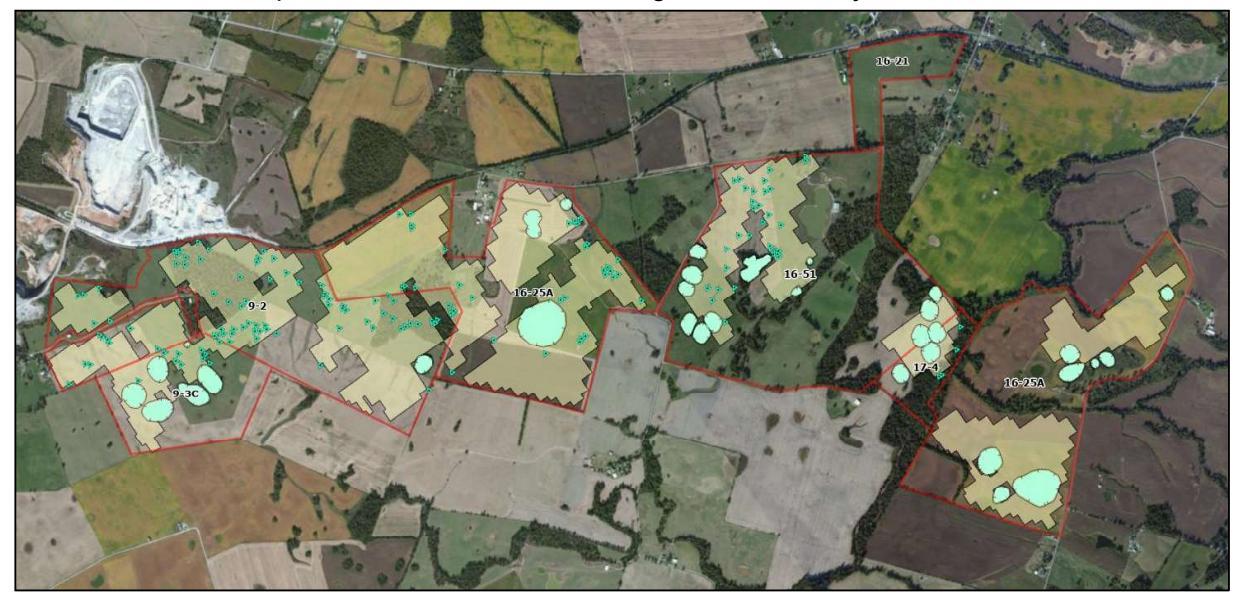
Figure 1. Map of the site showing the SKF zones identified during the data review prior to field exploration. Proposed workspace (outlined in red), SKF (blue points and blue areas), proposed solar arrays (yellow).

Based on the methods and procedures for the data review as detailed previously in Section 2.1, the majority of identified suspect karst features (SKFs) were identified throughout the proposed site. Review of the existing high-resolution LiDAR datasets resulted in one hundred and ninety-seven (197) suspect karst features. These SKF areas are highlighted in Figure 1 and indicate areas of karst development that were verified during the field survey.

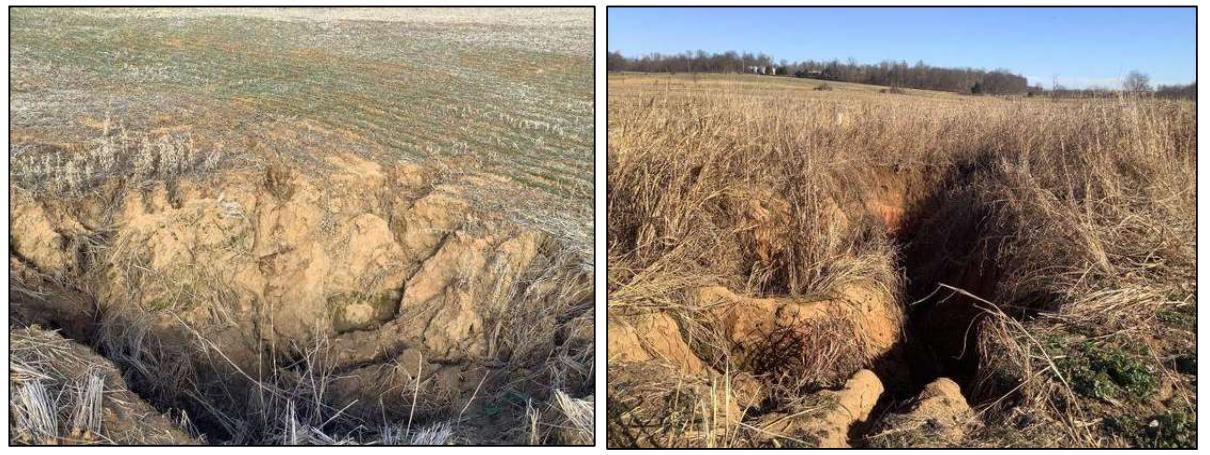
Type 1 – This type of karst feature is characterized by the presence of an open throat at the base and active erosion along the walls and parapet of the feature. These features are considered the highest risk since they are actively growing and may continue to collapse and widen during construction activities and post development. Two examples of such features are shown below in Image 1.

Image 1. Both sinkholes are undergoing erosion and expansion of the parapet limits as demonstrated by the rough, raveling, and incised surfaces. In addition, the open throats present in the base of the sinkholes readily receive surface runoff with little to no filtration.

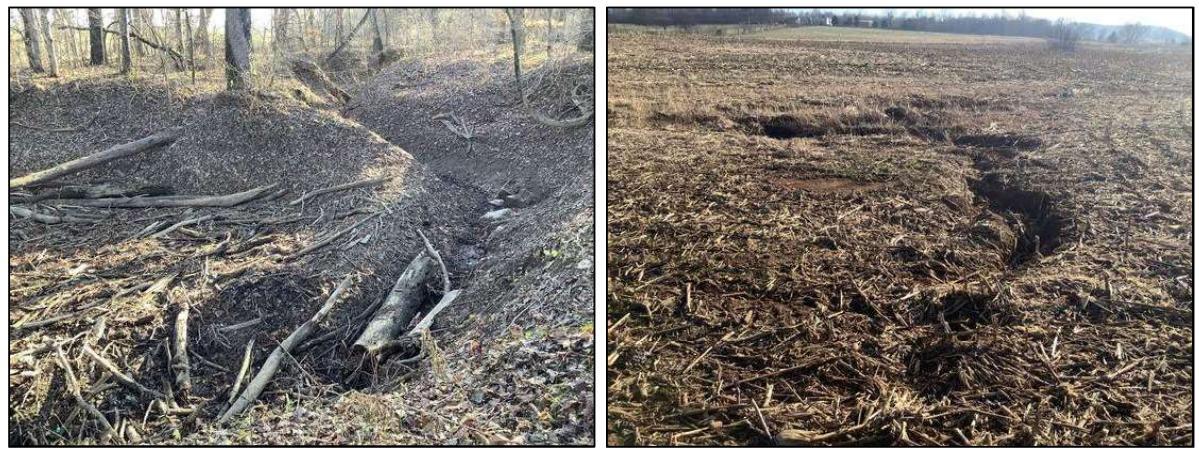
Type 2 – This type of karst feature is characterized by the presence of an incised drainage channel leading to the karst feature indicating that focused drainage enters the structure, which commonly results in active erosion and growth of the sinkhole (Image 2). In addition, they nearly always contain an open throat. Additionally, these features can be problematic as potential construction activities within the drainage may result in the uncontrolled flow of water transporting sediment and contaminants into the subsurface via the open throat. Awareness of the drainage catchment extent and implementation of proper erosion and sediment controls (ESC) are crucial for these types of karst features.

Image 2. Two examples of drainage channels leading towards sinkholes with open throats.

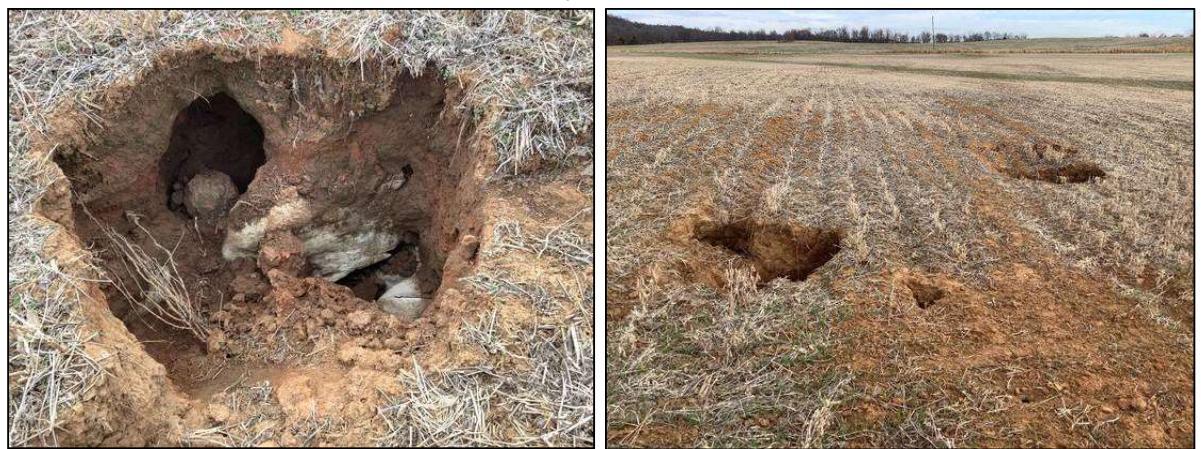
Type 3 – This type of karst feature has an open throat and rough, irregular parapet edges, indicating active erosion, collapse, and growth. The features are typically small (<5 feet) yet indicate that the area around the soil piping is undergoing sinkhole development which may widen, deepen, and affect the surrounding area (Image 3). It is commonplace to observe multiple soil piping features which may all be feeding into a single open throat in the subsurface. These features pose a significant risk because the karst features are actively developing; therefore, official remediation or avoidance is necessary.

Image 3. Examples of soil piping structures and open throats which are newly developed and indicate that growth and widening of these features is likely.

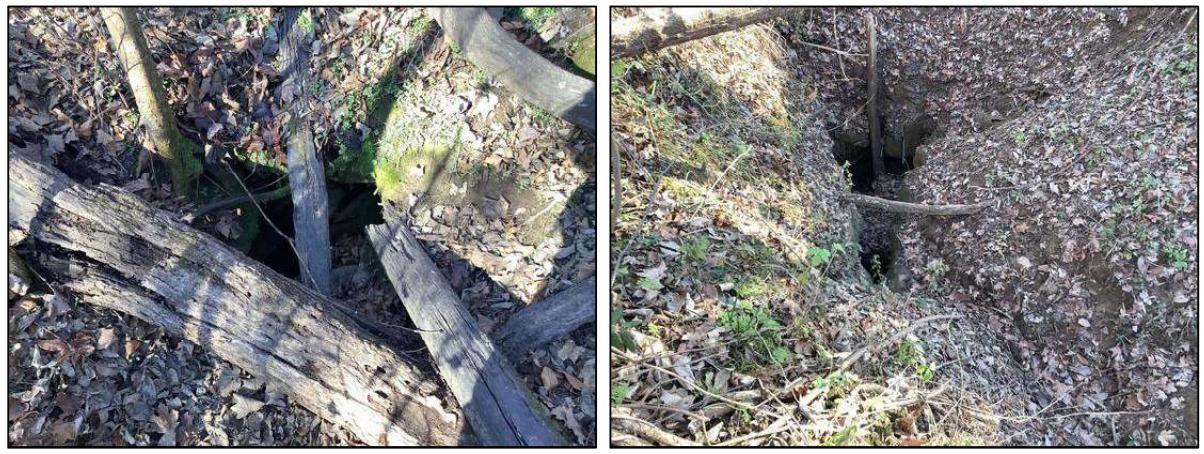
Type 4 – This type of karst feature is a sinkhole with a cave entrance located at the base or within the sidewall of the structure (Image 4). Caves pose a significant risk since they are relatively large openings that can receive surface runoff, may contain significantly sized chambers and passages below the surface, and may host cave fauna and sensitive biological habitats. Aside from having certified spelunkers enter the caves and map out the passages, geophysical techniques are often utilized to determine the presence, extent, depth, and size of cave passages in relationship to planned construction.

Image 4. Two cave entrances observed during the field survey, where the right entrance is located at the base of a sinkhole and the left image shows a cave entrance at the base of a drainage channel.

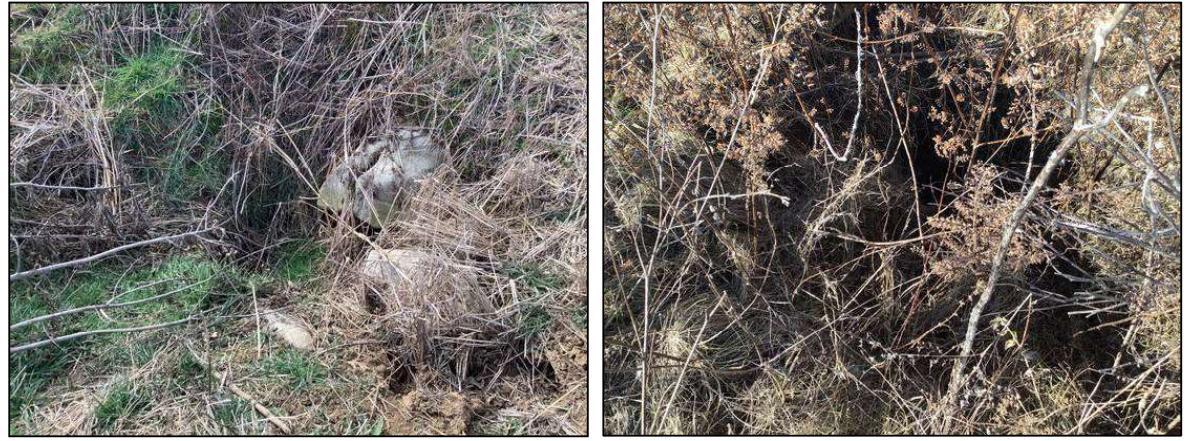
Type 5 – This type of karst feature has an open throat within the structure, yet the remainder of the sinkhole is overgrown with vegetation and the parapet appears to be stable² (Image 5). Although there is an opening present leading into the subsurface, the protection and stabilization of the feature by maintaining a vegetated buffer dramatically reduces the risk of impacting the subsurface habitat during construction activities.

Image 5. Examples of overgrown open throats located at the base of sinkholes. The presence of the plant life indicates that little to no recent erosion has occurred.

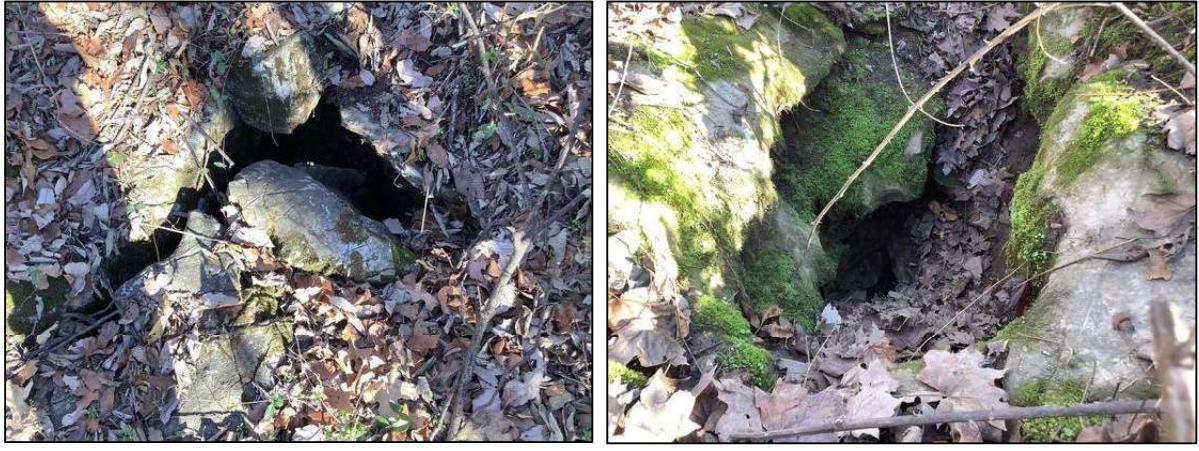
Type 6 – This type of karst feature is characterized by bedrock bound open throats and rock outcrops either located at the base of sinkholes or within generally flat laying bedrock benches (Image 6). Although the open throats clearly connect to the subsurface, the bedrock does not present much risk of collapse or change in architecture unless the bedrock layer is very thin above an open chamber.

Image 6. Bedrock bound open throats located within a bedrock outcrop (left) or at the base of a depression (right).

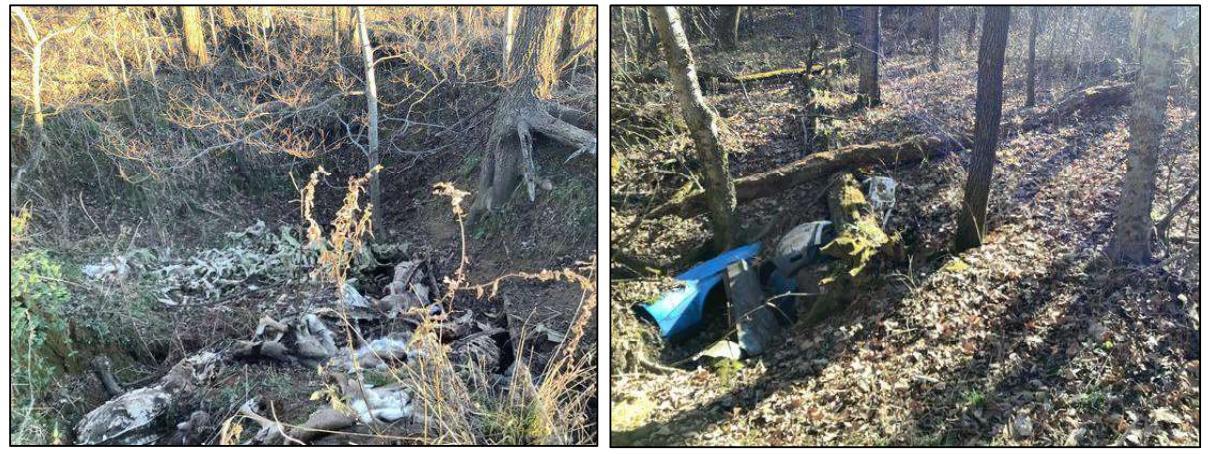
Type 7 – This type of sinkhole has been used by farmers and landowners as a convenient place to deposit field rock, trees, trash, and a menagerie of various items and materials. This practice of depositing trash is highly discouraged since the contaminants originating from the infill material may quickly reach and may affect the subsurface aquifer. Nevertheless, these karst features were present within the AOI and most typically observed to be infilled with trash and occasional trees (Image 7). Since these may have been partially or completely filled, it is impossible to fully characterize these features for the presence or absence of an open throat. Therefore, we assume that there is an open throat at the base in order to be conservative for protection measures during construction activities.

Image 7. Examples of trash filled sinkholes observed during the field survey. The feature on the left is filled with presumably cow and deer carcasses and the feature on the right is filled with old vehicles.

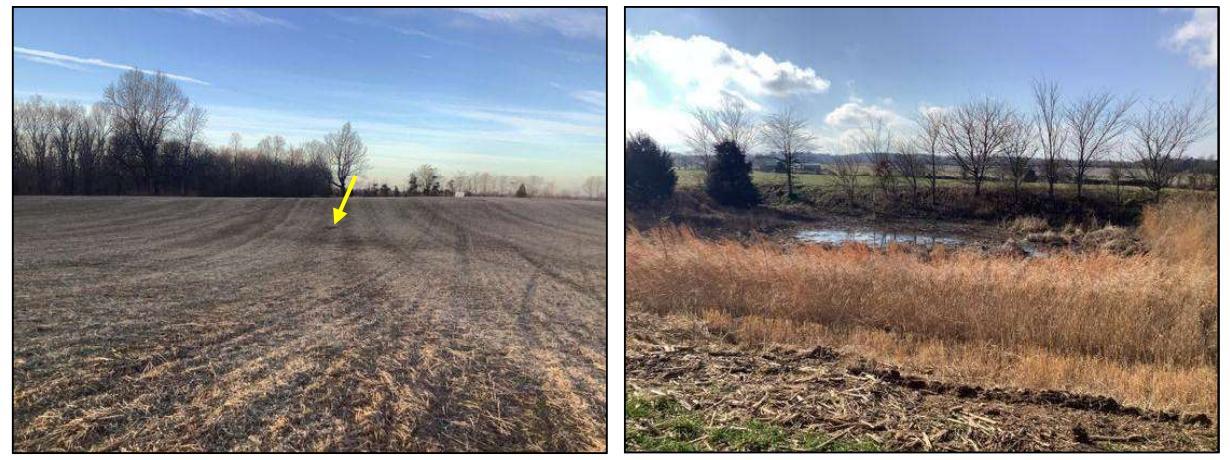
Type 8 – This types of sinkhole is present as a broad and shallow depression, ranging in size from tens to hundreds of feet in diameter and commonly referred to as a "mature" or paleokarst sinkhole (Image 8). Mature sinkholes often have a roughly circular parapet outline, are bowl shaped, lacking any opening to the subsurface (i.e. "throat") or showing evidence of active soil raveling or tension cracks around the parapet. Thus, whatever conduit or opening into the

underlying karst aquifer that may have functioned to create the structure is probably now clogged with soil, which would act as a filter for water infiltrating from the surface.

Image 8. Examples of mature sinkholes. The feature on the left is a large closed depression which has a subsidiary collapse located at the center of the feature (pointed out by the yellow arrow). The newly formed collapse acting as a drain to the closed depression indicates that reactivation has occurred. The image on the right shows a closed depression which has presumably been repurposed into a pond.
