COMMONWEALTH OF KENTUCKY BEFORE THE PUBLIC SERVICE COMMISSION

| In the Matter of: | | |
|---|---|---|
| ALLEGED VIOLATION OF UNDERGROUND FACILITY DAMAGE PREVENTION ACT |) | 2021 00002 |

OPENING ORDER

PIPELINE DAMAGE INVESTIGATION REPORT

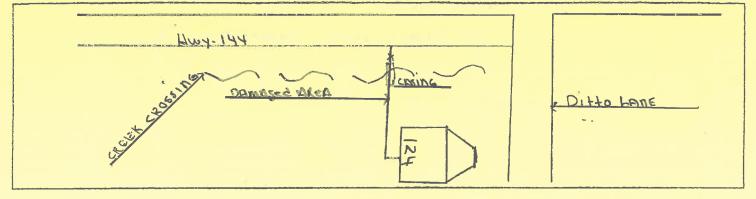
PLEASE PROVIDE A SKETCH OF THE DAMAGE LOCATION INCLUDING ANY LOCATE MARKINGS.

| - | POINTIAITALA | | | | | | Ti . | | | |
|---|---|---|---|---|---|---|---|---|---|---|
| 4 | while Exce | VICTO CITO | Repair Les | k on worth | main com | WACTON ! | ROKE! A | cuss. 1" | PL-435 | SERVICE |

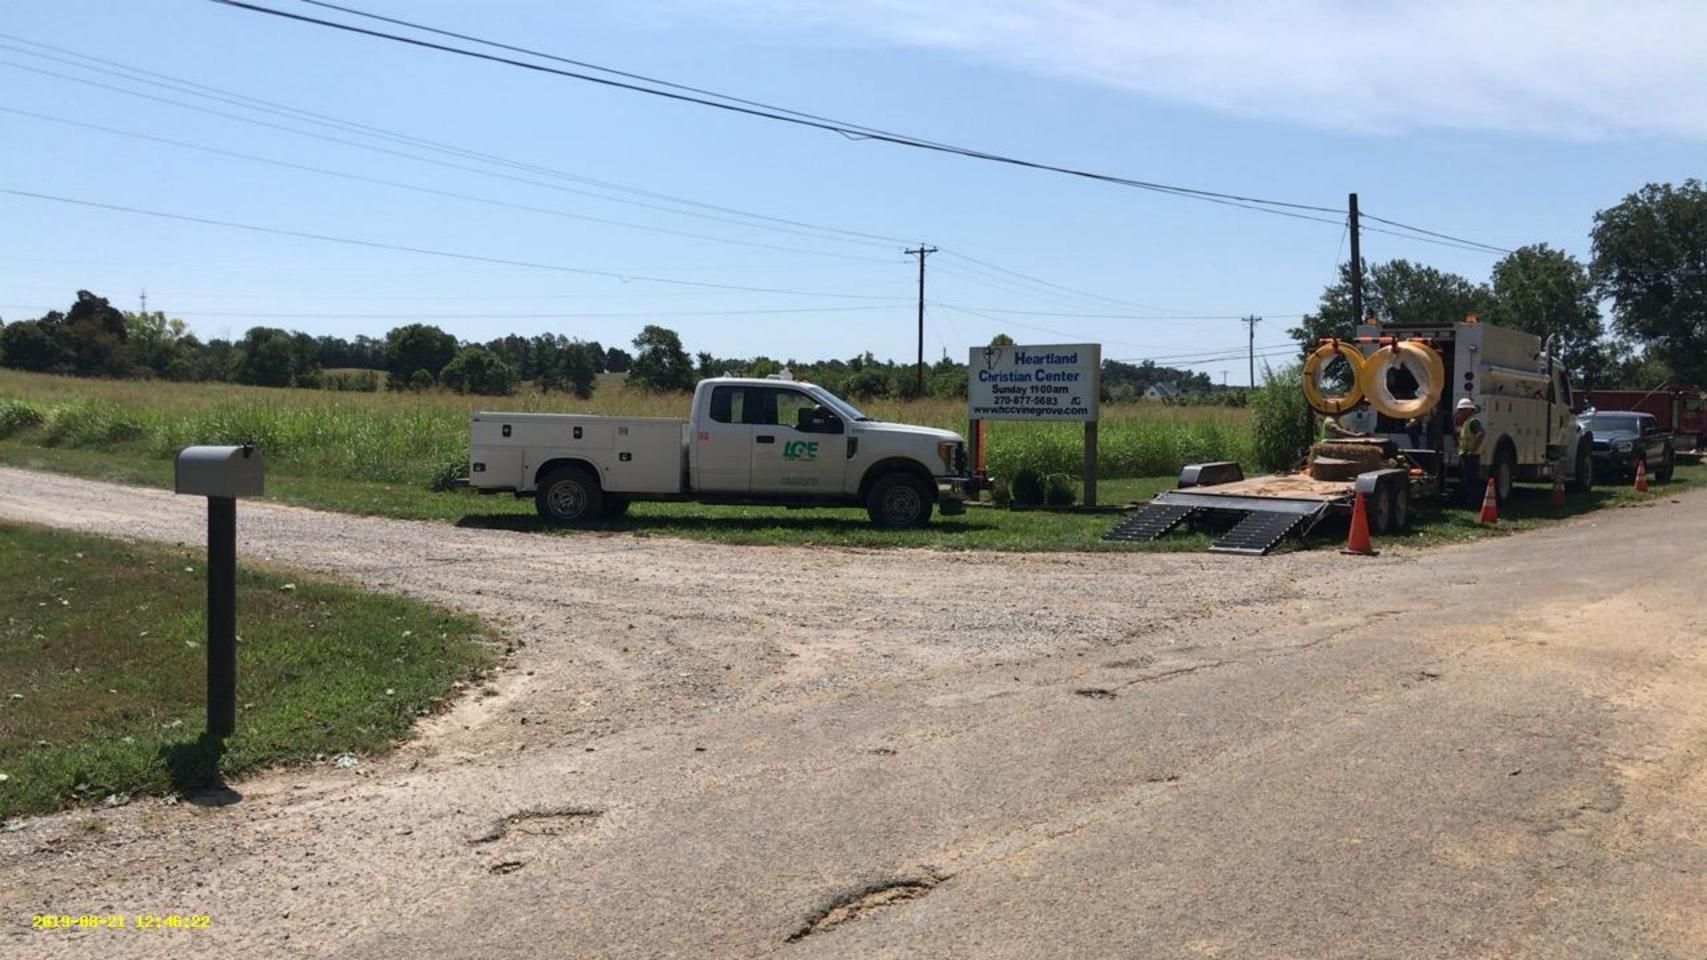
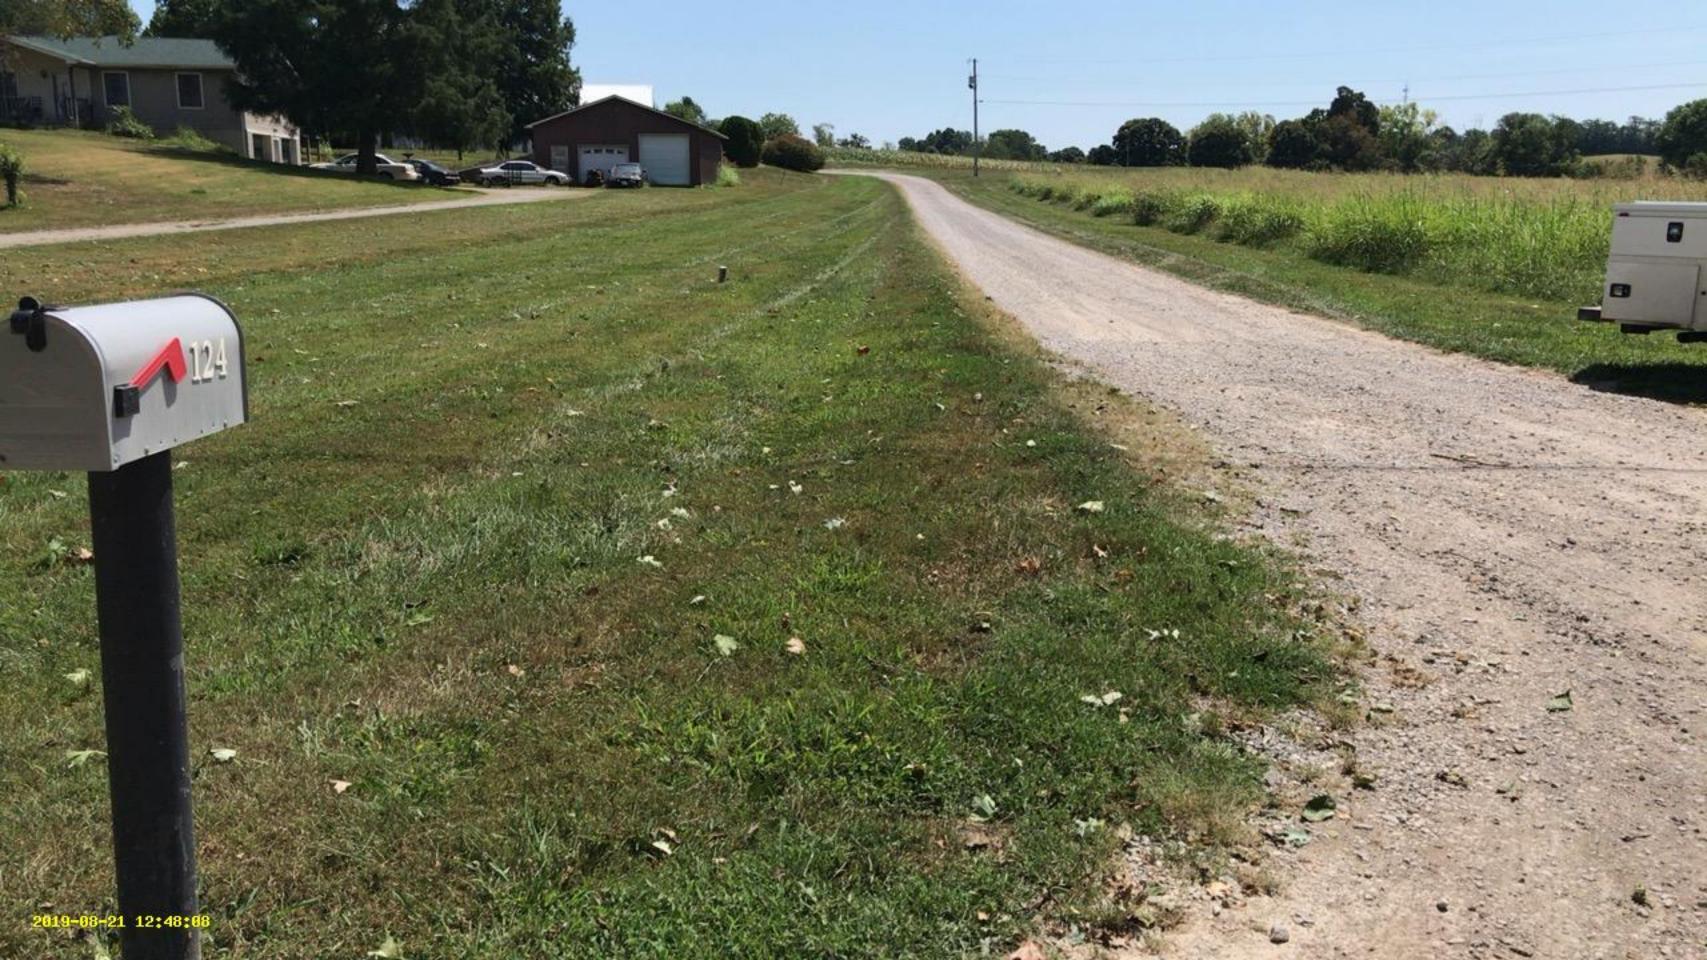
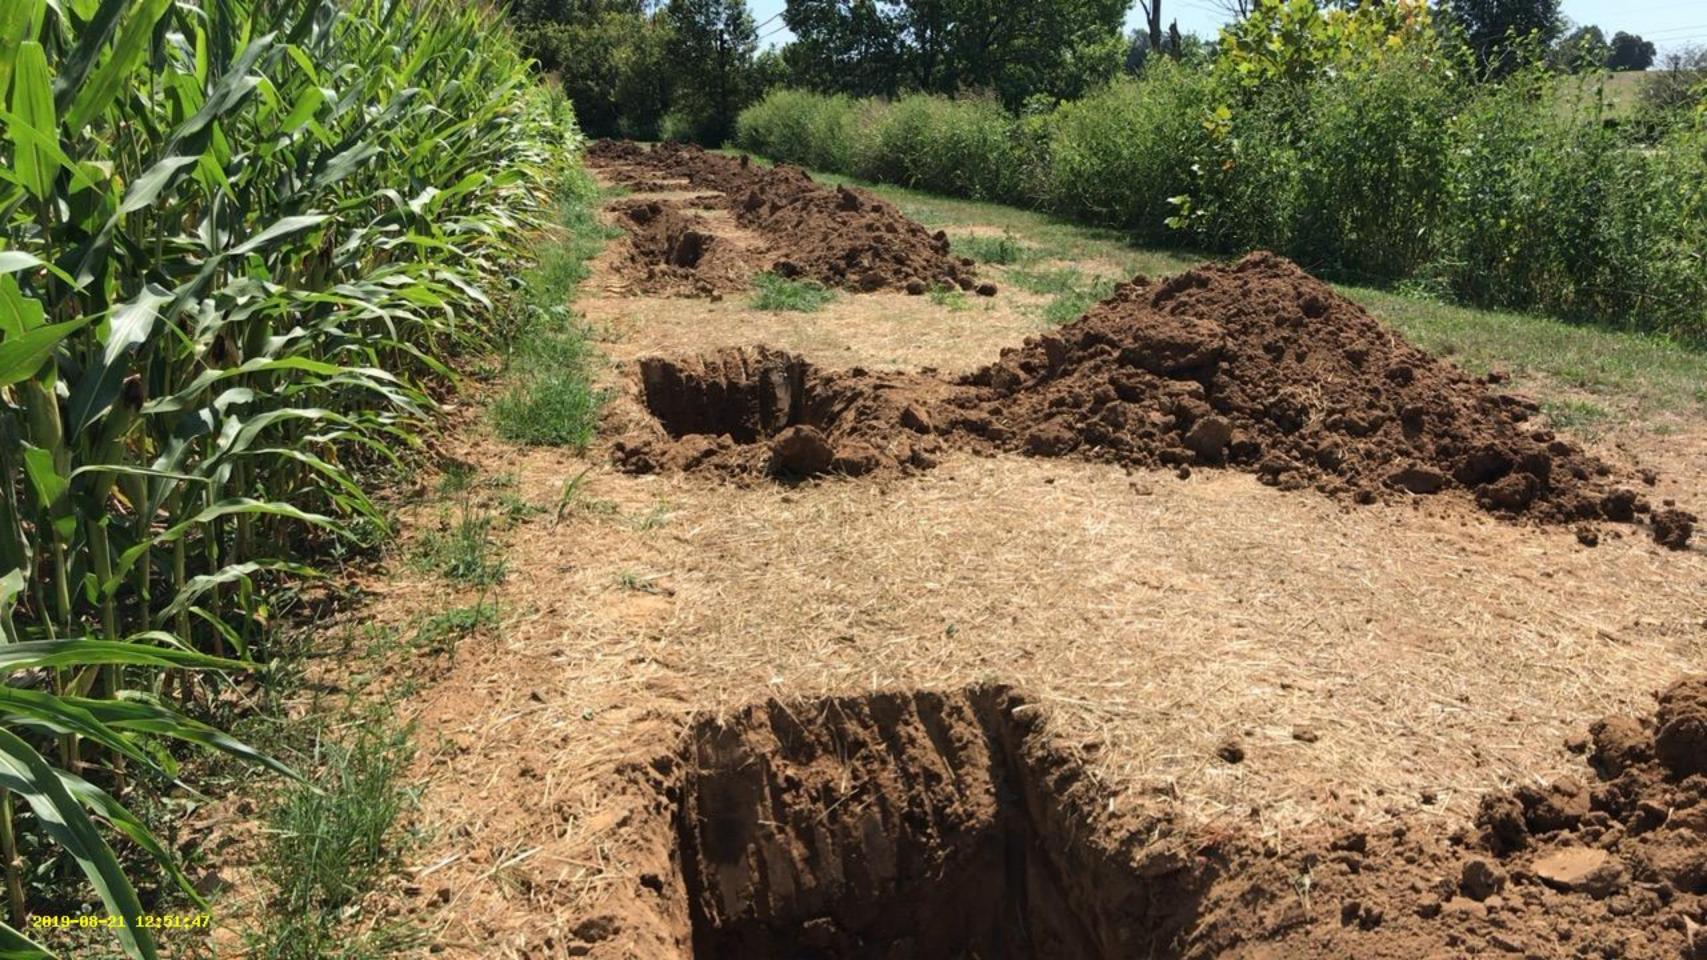
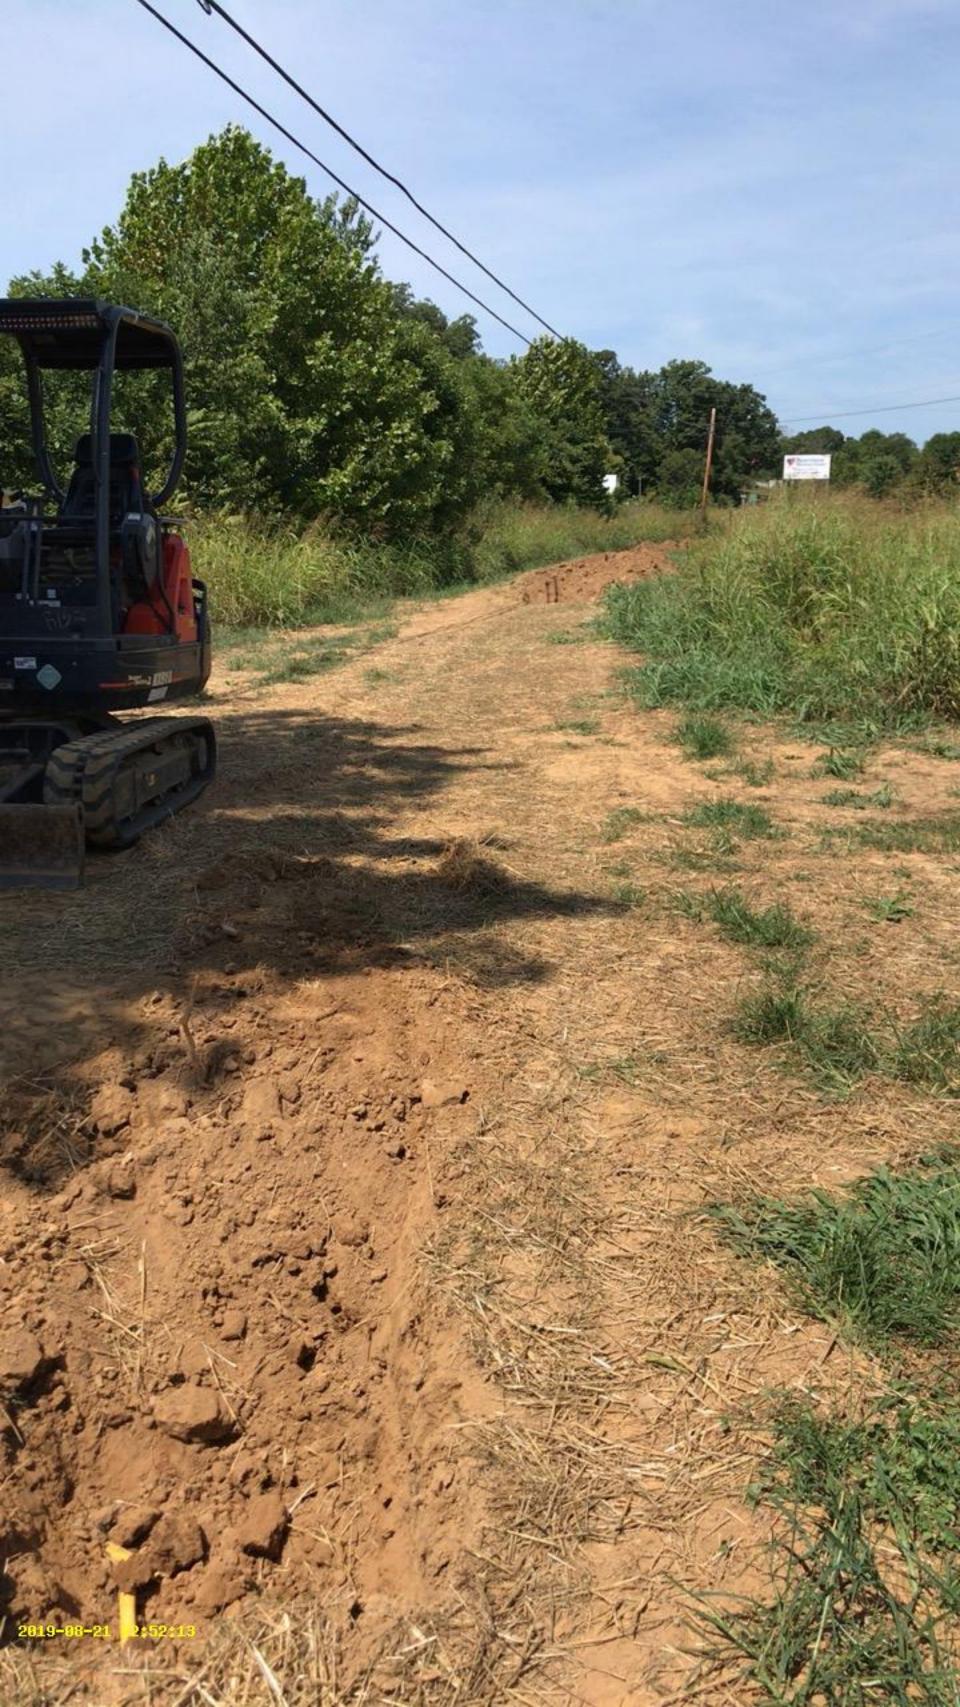
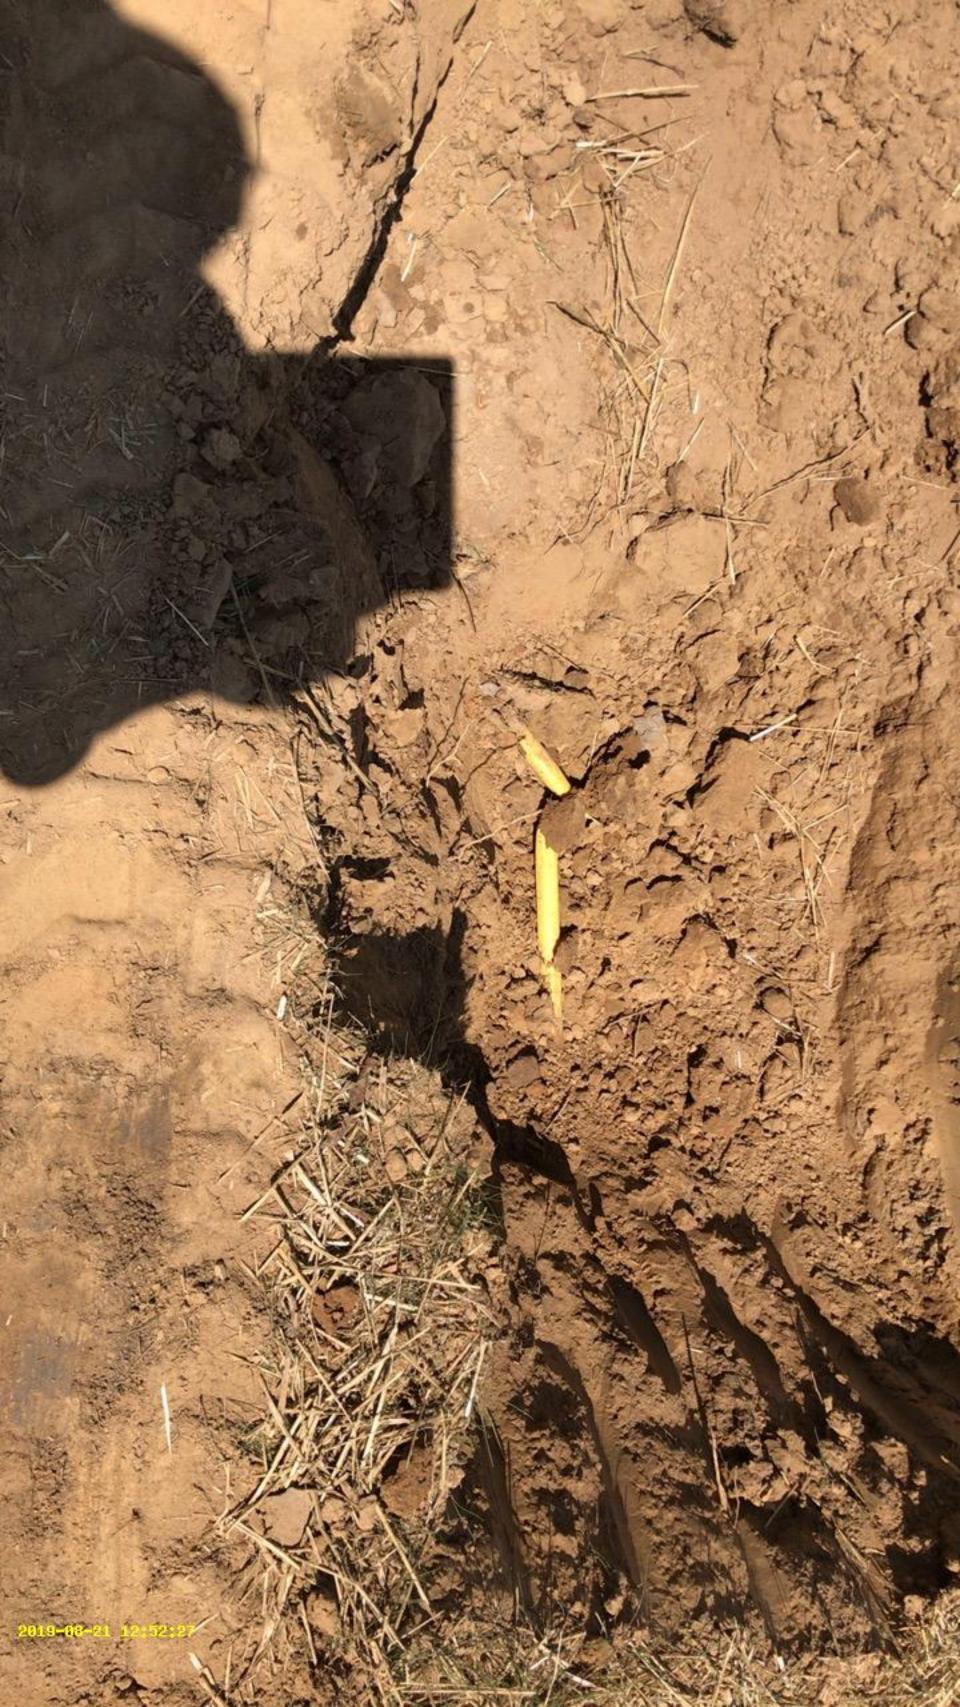
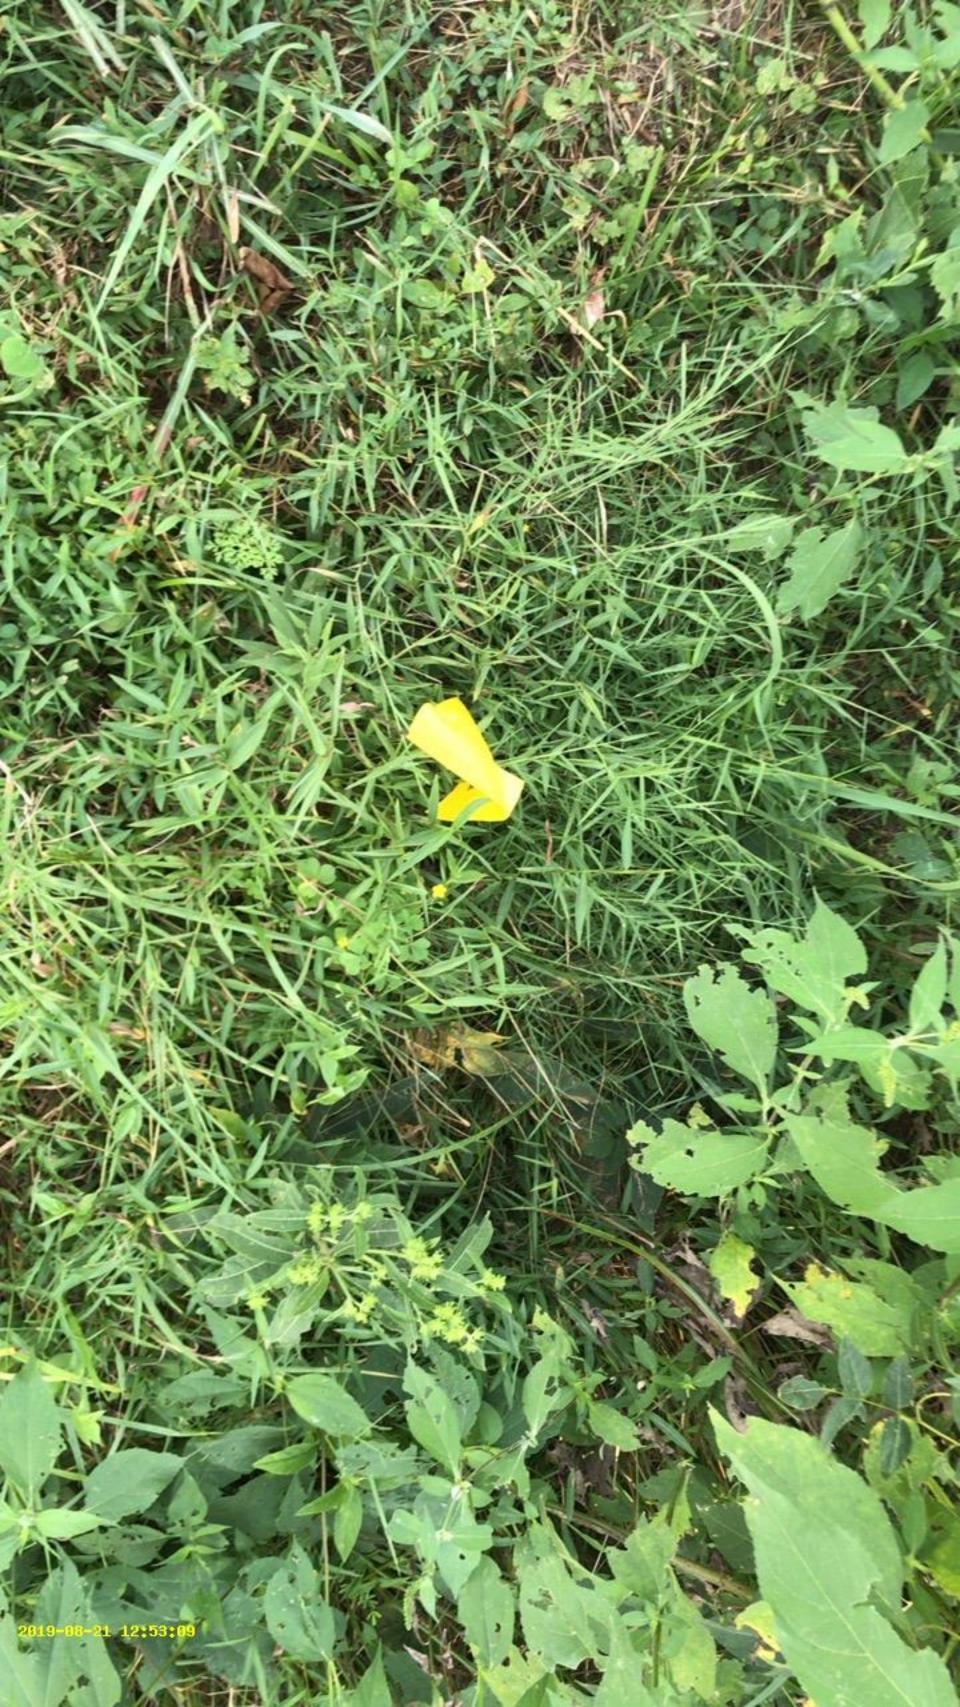
Photographs and invoice are included as Attachment 5.

- 15 Photographs: Depicting the damage and vehicles at the incident location all with LG&E logos.
- <u>Invoice:</u> Indicating Schroeder Construction was billed \$651.13 for the damage and Mr. Jones stated Schroeder Construction paid for the damages in September 2019 but provided no receipt of payment.

Description of Incident Excavator damaged 2" plastic service.

Broken 2" service \$651.00
