RE: TRACY MATHIS V. LOUISVILLE GAS AND ELECTRIC

Case No. 2014-00198

RESPONSE OF
LOUISVILLE GAS AND ELECTRIC COMPANY
TO
COMMISSION STAFF'S FIRST REQUEST FOR INFORMATION
AND PRODUCTION OF DOCUMENTS
DATED AUGUST 14, 2014

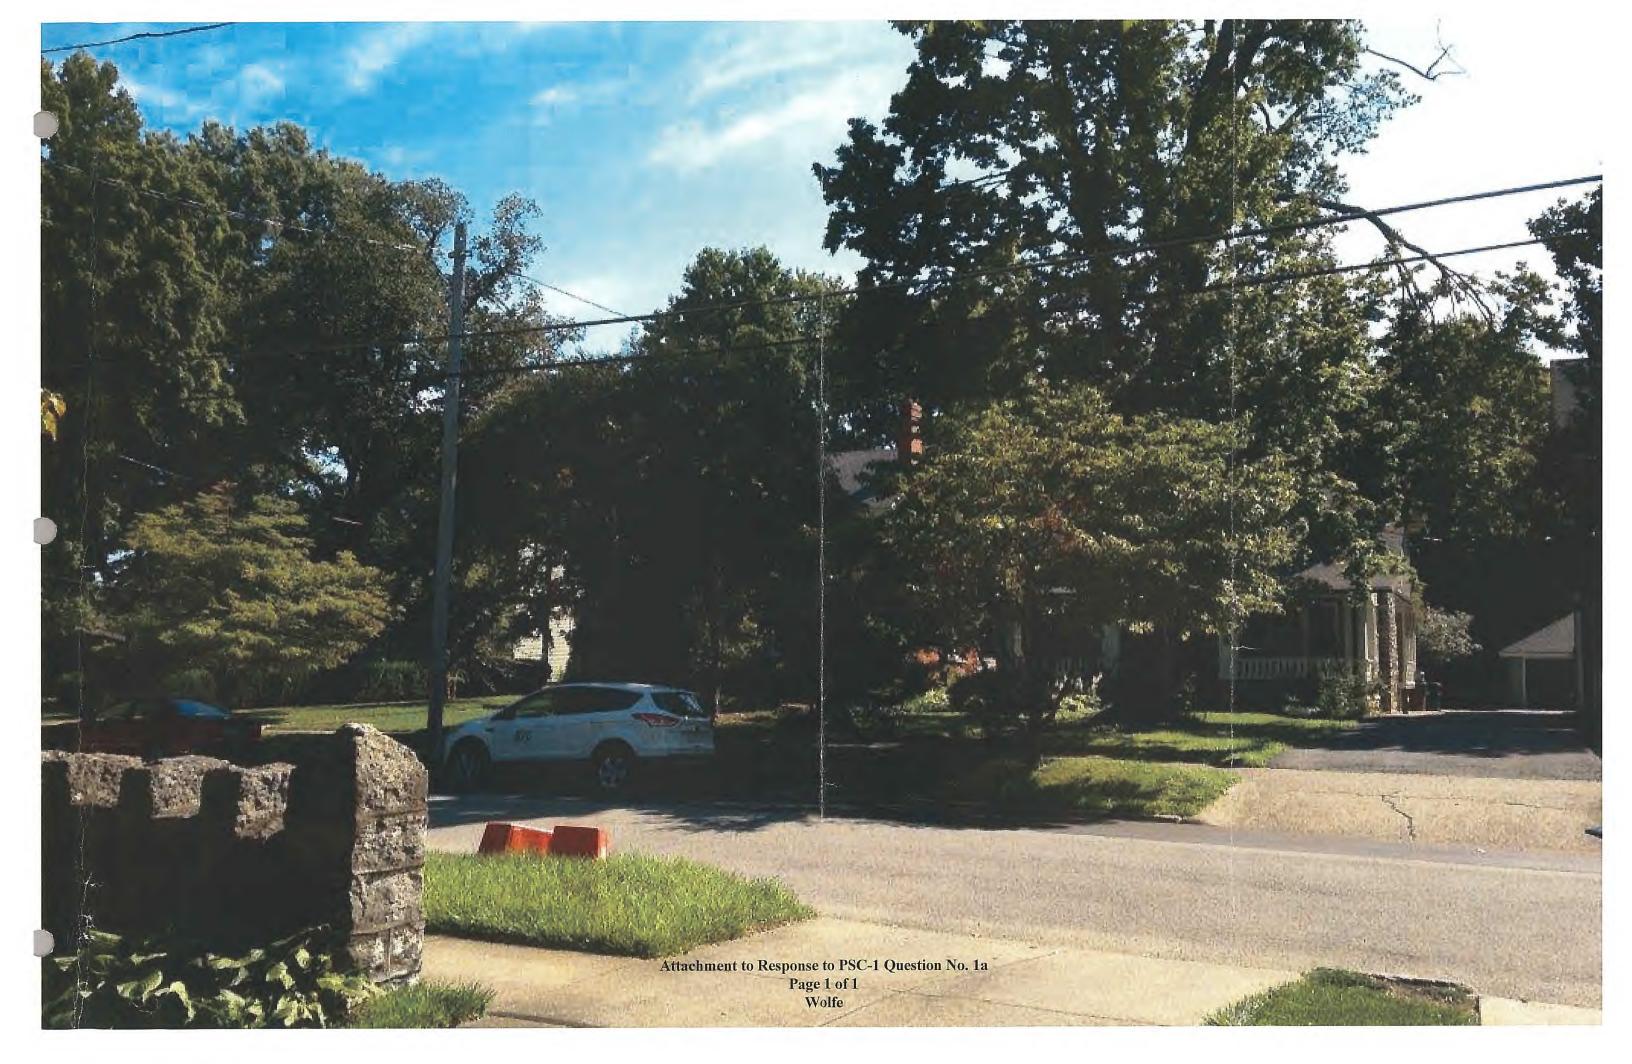
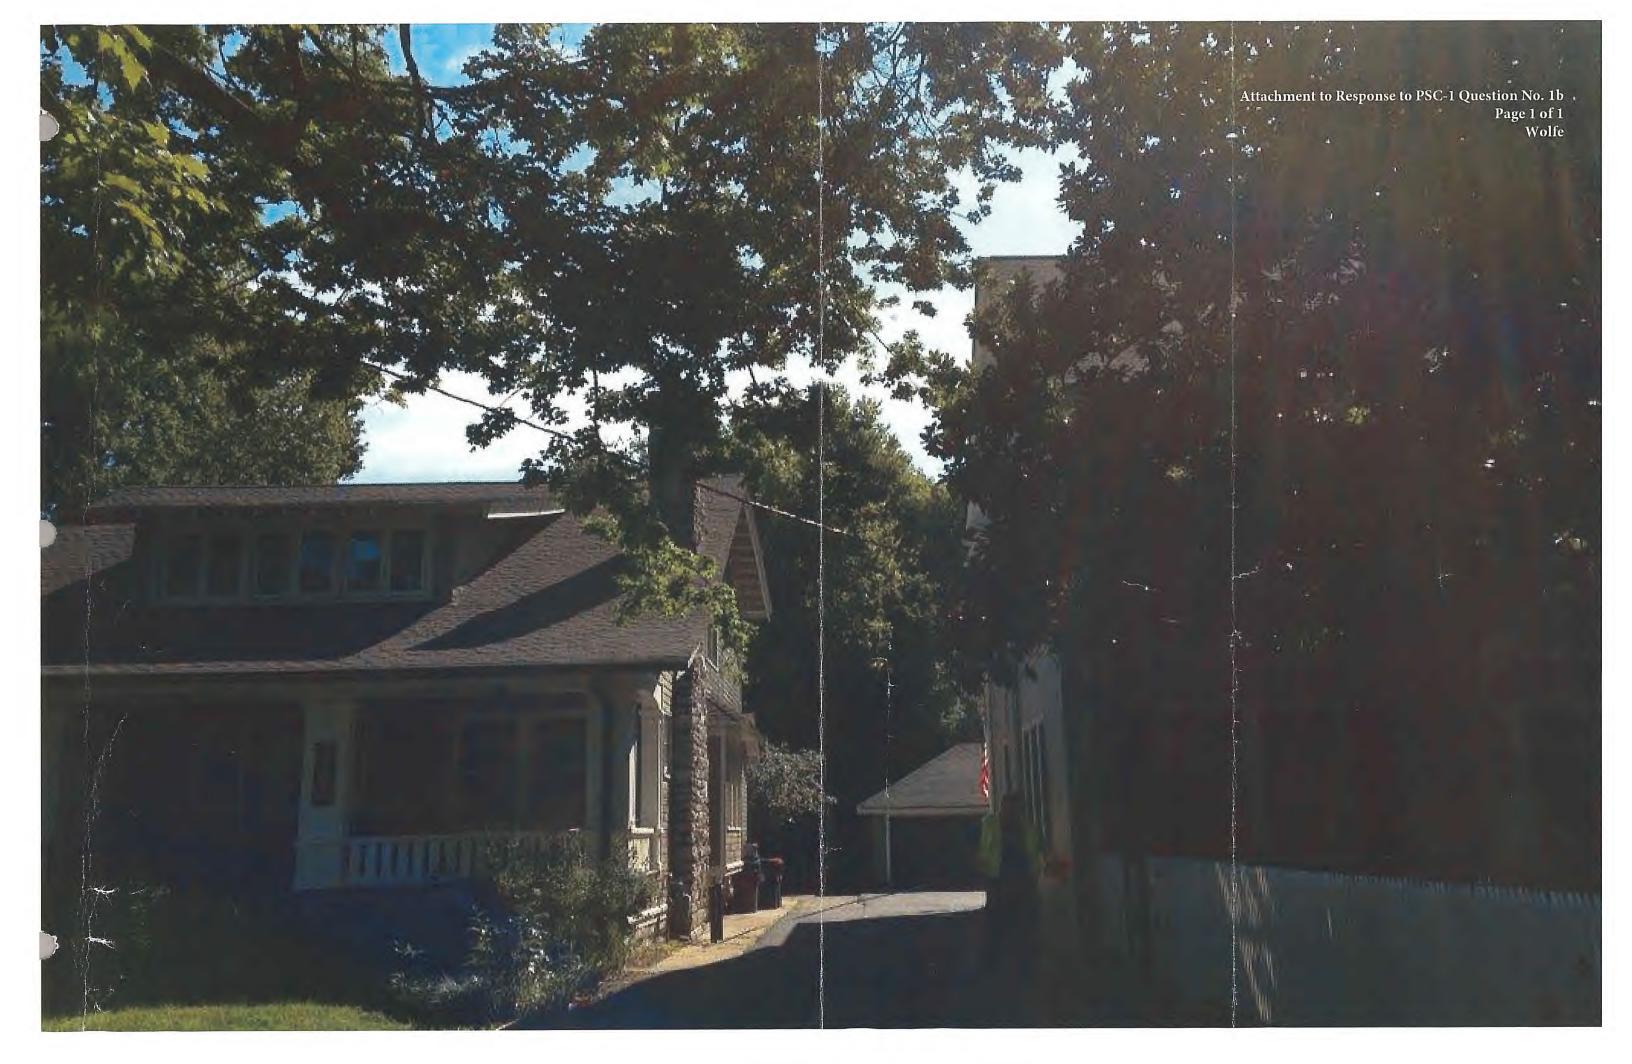
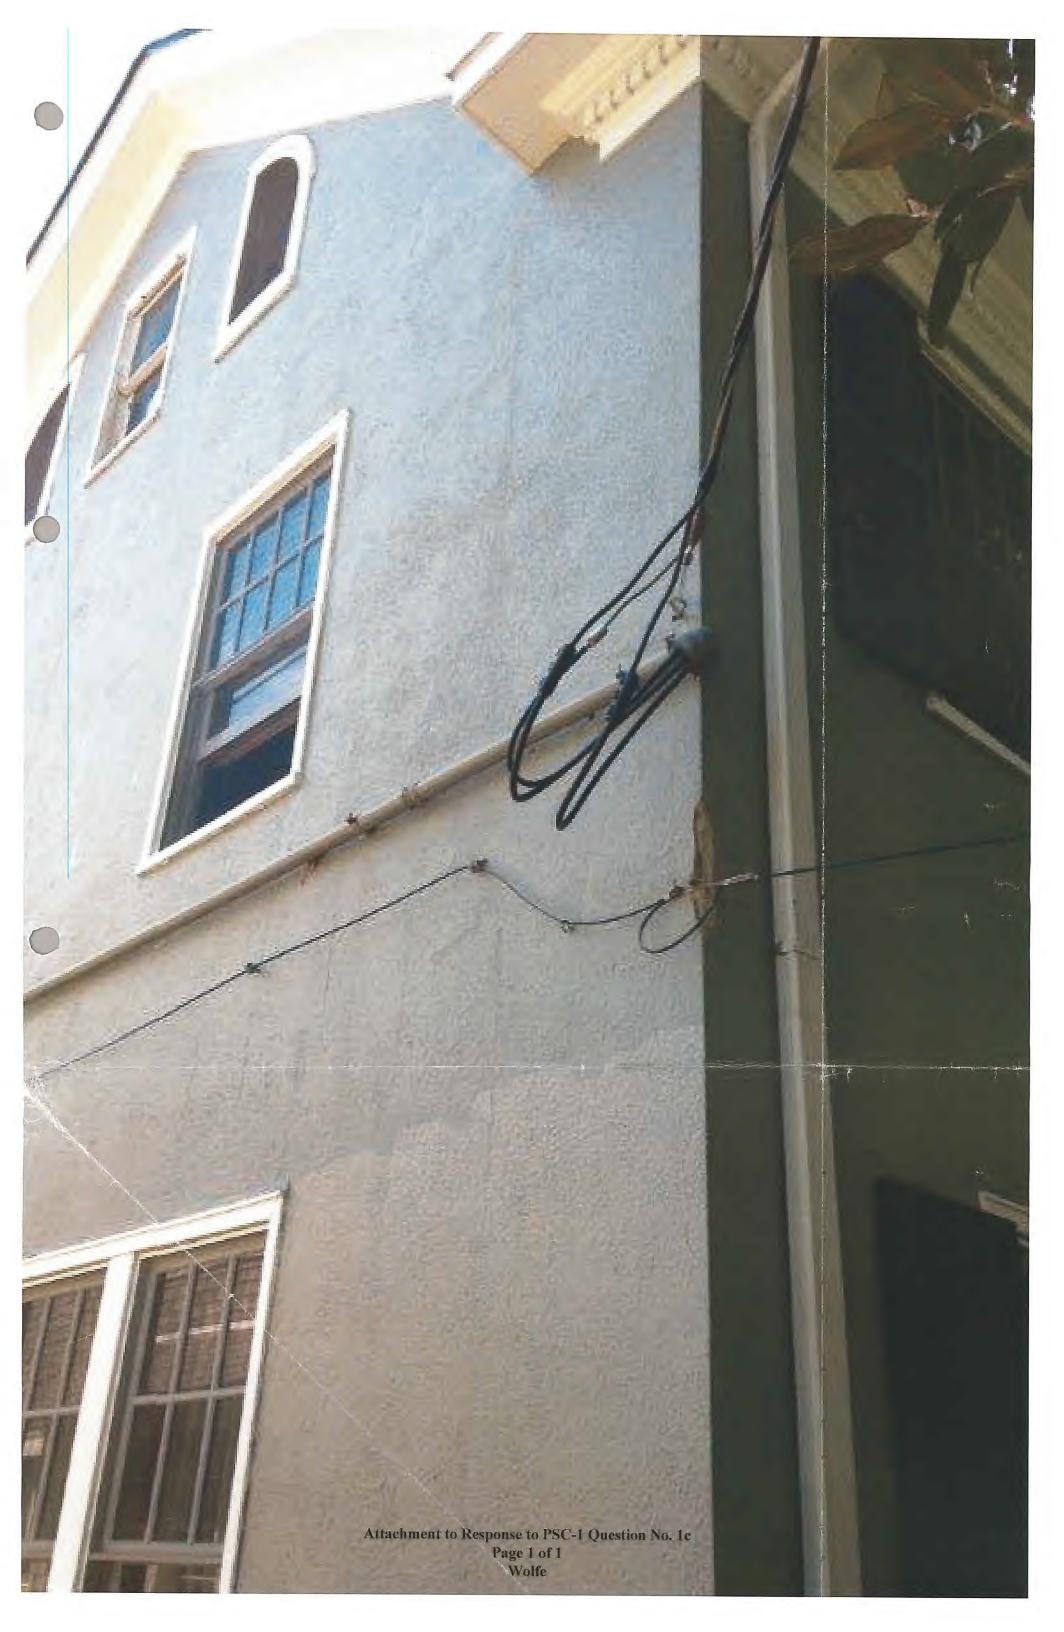
- a. The service pole at or near 163 Crescent Avenue, Louisville, Kentucky, where service wire at issue originates;
- b. The service wire as it crosses over the front yard at 163 Crescent Avenue, Louisville, Kentucky, to neighbor's home; and
- c. The connection to the neighbor's home where service wire enters the neighbor's home.
- A-1. See photographs attached.

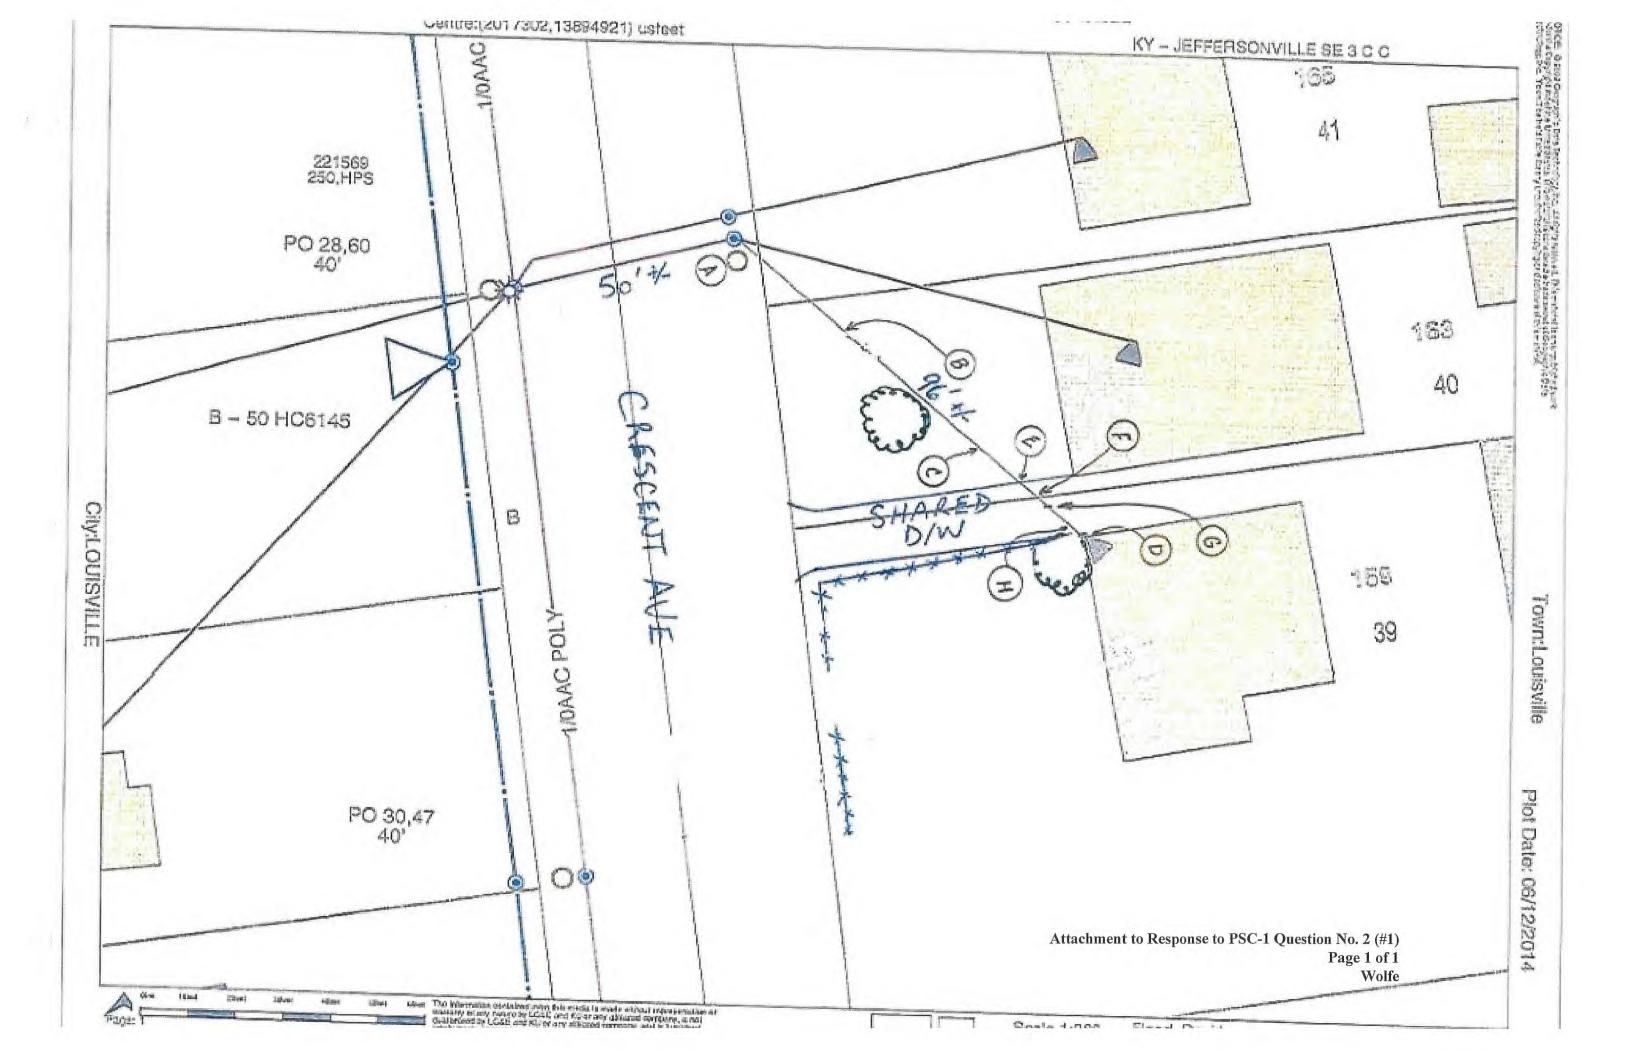
- Q-2. Provide drawings showing horizontal and vertical views of the overhead service wire, to include:
 - a. The service pole at or near 163 Crescent Avenue, Louisville, Kentucky, where service wire at issue originates;
 - b. The service wire as it crosses over the front yard at 163 Crescent Avenue, Louisville, Kentucky to neighbor's home; and
 - c. The connection to the neighbor's home where service wire enters the neighbor's home.
- A-2. See attached drawing and photograph with embedded notations.

- Q-4. Referring to Paragraph 2(a) of LG&E's Answer, what is the current attachment height of the overhead service wire at issue in this matter at the service pole located at or near 163 Crescent Avenue, Louisville, Kentucky?
- A-4. The current attachment height of the overhead service wire at issue at the service pole is thirty feet, ten inches (30'10").

- Q-5. Referring to Paragraph 2(a) of LG&E's Answer, what is the current overhead clearance, at the lowest point, of the overhead service wire at issue in this matter as it crosses over the residential property located at 163 Crescent Avenue, Louisville, Kentucky?
- A-5. The current overhead clearance, at the lowest point, of the overhead service wire at issue over the residential property located at 163 Crescent Avenue is fourteen feet, four inches (14'4").

- Q-6. Referring to Paragraph 2(a) of LG&E's Answer, what is the current overhead clearance, at the lowest point, of the overhead service wire at issue in this matter as it crosses over the driveway attached to the residential property located at 163 Crescent Avenue, Louisville, Kentucky?
- A-6. The current overhead clearance, at the lowest point, of the overhead service wire at issue as it crosses over the driveway between the residential properties located at 159 Crescent Avenue and 163 Crescent Avenue is fourteen feet, one inch (14'1").

- Q-7. Referring to Paragraph 2(a) of LG&E's Answer, what is the current overhead clearance of the overhead service wire at issue in this matter at Tracy Mathis's neighbor's service entrance?
- A-7. The current overhead clearance of the overhead service wire at issue at the neighbor's service connection point is fourteen feet (14'0").
