Re: Case No. 2017-00053

Leak Survey Report

CITY OF LIBERTY GAS DEPARTMENT

LIBERTY, KY.

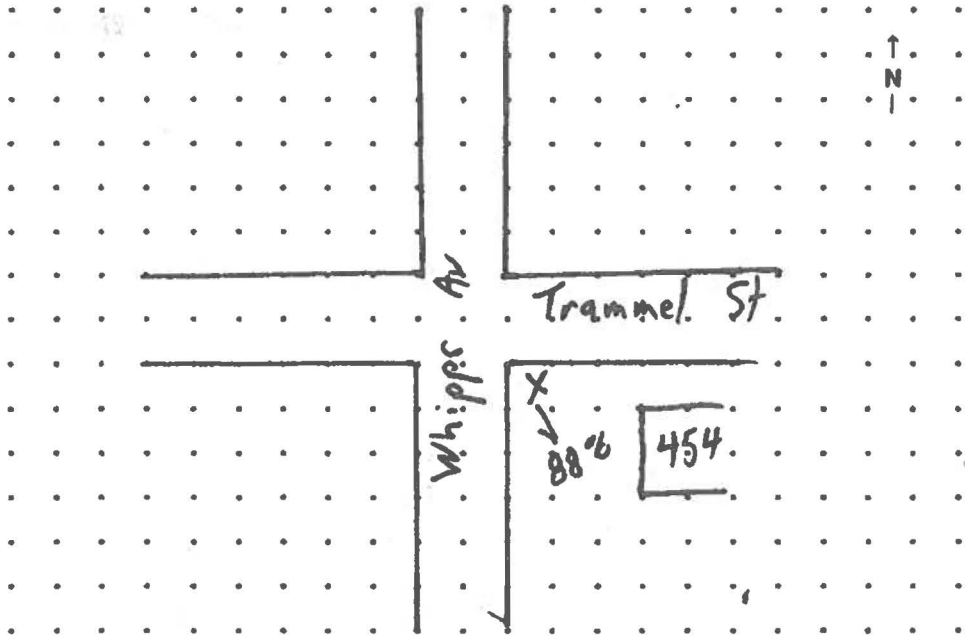
454 Whipp Ave

| LEAK INDICATION APPEARS TO BE AT: | |
|---|---|
| Main | <input checked="" type="checkbox"/> |

| CGI TEST | |
|---|---|
| Positive <u>88%</u> | <input checked="" type="checkbox"/> |

| LOCATION OF PIPE | |
|---|---|
| Between St. & Sidewalk | <input checked="" type="checkbox"/> |

Remarks Leak appears to be on Main

| COVER | |
|---|---|
| Soil | <input checked="" type="checkbox"/> |

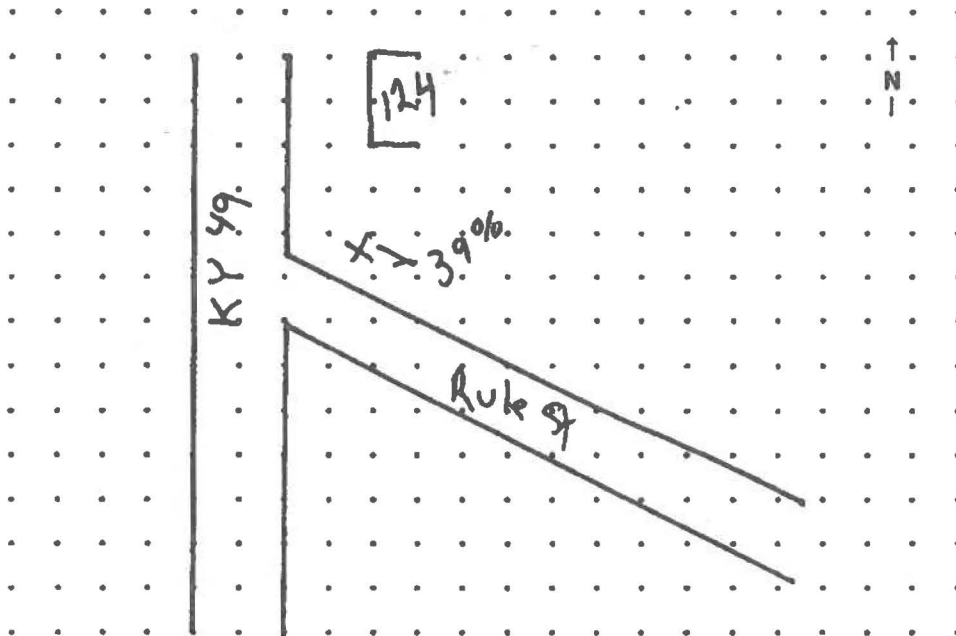
124 KY 49

| LEAK INDICATION APPEARS TO BE AT: | |
|---|---|
| Main | <input checked="" type="checkbox"/> |

| CGI TEST | |
|---|--|
| Positive | <u>39%</u> <input checked="" type="checkbox"/> |

| LOCATION OF PIPE | |
|---|---|
| Between St. & Sidewalk | <input checked="" type="checkbox"/> |

Remarks Leak appears to be on main

| COVER | |
|---|---|
| Soil | <input checked="" type="checkbox"/> |
