COMMONWEALTH OF KENTUCKY
BEFORE THE PUBLIC SERVICE COMMISSION

SCHROEDER CONSTRUCTION INCORPORATED)	
_____)	
ALLEGED VIOLATION OF UNDERGROUND)	CASE NO.
FACILITY DAMAGE PREVENTION ACT)	2021-00032
)	
)

PIPELINE DAMAGE INVESTIGATION REPORT

The Operator reports that the Excavator damaged a 2" gas service with no valid Locate Ticket (LT).
The Damage Report is include as Attachment 1.

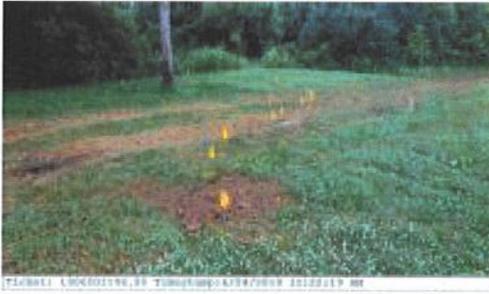
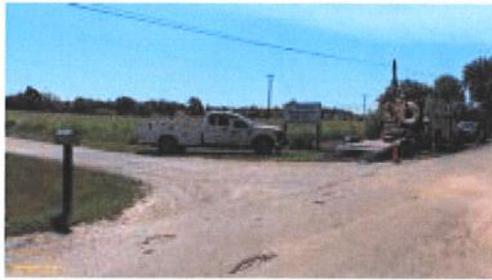
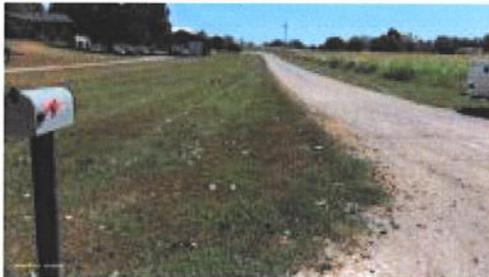
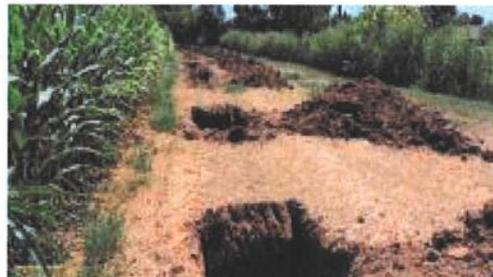
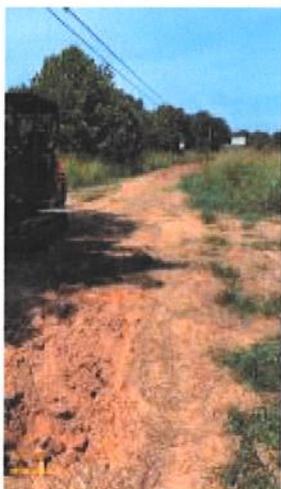
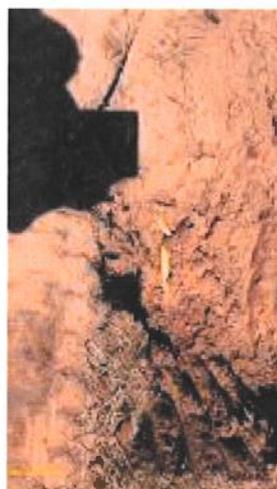
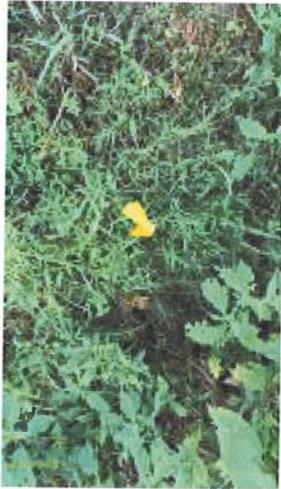
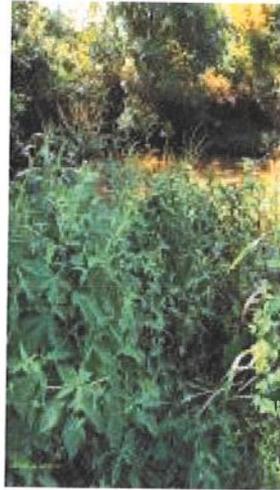
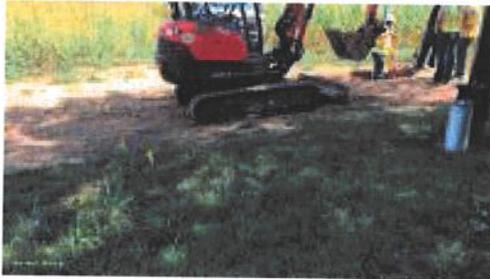
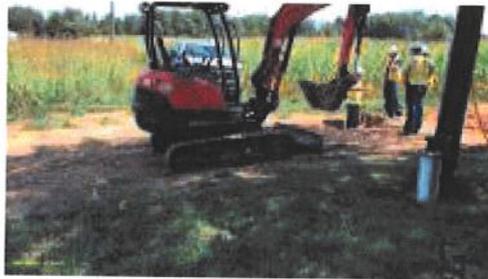
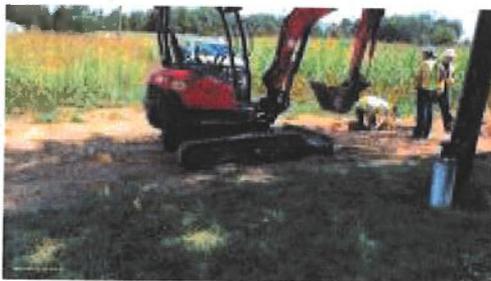
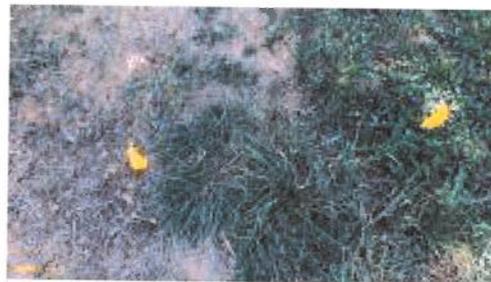
Facts-Based Investigation

Description and extent of damage: Contractor damaged 2" pl customer service to a church digging on a ticket that is two months old. Some flags remain on the service but I could not determine if they were in line with the service. Per post-locate photo on 6/24 the service was accurately marked and locator, Howard Warren, told me he potholed, which is evident in that photo.

Locate accurate (Within tolerance zone)?: N If No, Distance markings off?: 18'

Were marks visible at time of damage: N

Were damaged facilities within scope of ticket?: N

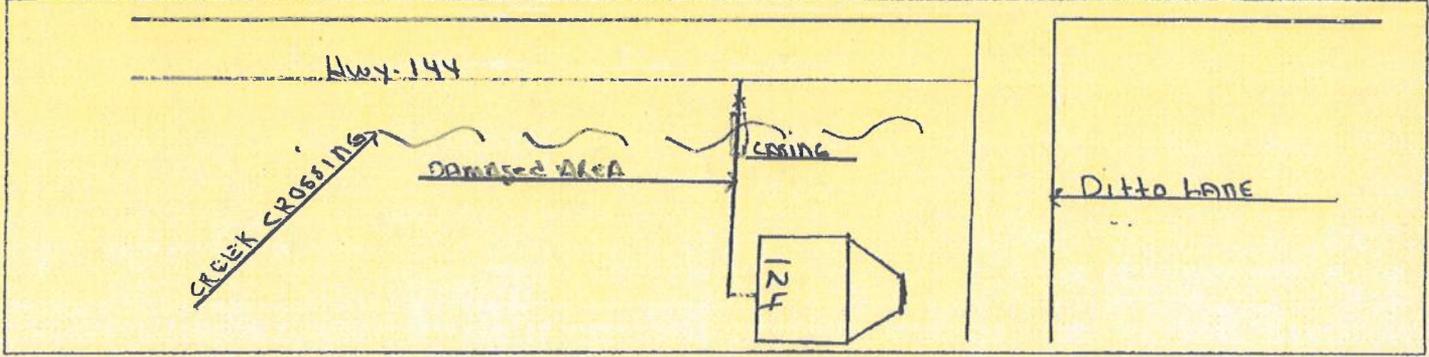
PLEASE PROVIDE A SKETCH OF THE DAMAGE LOCATION INCLUDING ANY LOCATE MARKINGS

BUD NUMBER AND REQUESTING PARTY'S NAME 1906191318
WERE FACILITIES MARKED? YES / NO DID EXCAVATOR AGREE? YES / NO
IF YES, WERE FACILITIES PROPERLY MARKED? YES / NO DID EXCAVATOR AGREE? YES / NO
IF NO, HOW WERE THEY MISMARKED? (BE SPECIFIC) _____
Flags outside dig area, Bud expired on original ticket, new ticket not submitted
WAS LINE LOCATING CONTRACTOR ON THE JOB? YES / NO

While excavating to repair leak on watermain, contractor broke 10 cust. 1" PL-CTS service

DATE OF INCIDENT Aug-21-2019 TIME 11:10 AM PM
ADDRESS/LOCATION OF DAMAGE 124 Birtto Lane One Grove Ky 40175
SUBDIVISION NAME _____
TIME DISPATCHED 11:20 AM PM TIME OF COMPLETION _____ AM/PM
WHO CAUSED DAMAGE? Schroeder Construction
(NAME OF CONTRACTOR, UTILITY, INDIVIDUAL, ETC.)
ADDRESS OF PARTY CAUSING DAMAGE 589 Franklin Lane Elizabethtown Ky 42701
(STREET) (CITY) (STATE) (ZIP CODE)
PHONE NUMBER OF PARTY CAUSING DAMAGE (703) 312-7904
WAS PARTY CAUSING DAMAGE STILL ON THE JOB? YES / NO
IF YES, WHO WAS IN CHARGE? Jacob Schroeder
IF NO HOW DID YOU OBTAIN NAME OF PARTY CAUSING DAMAGE? _____
WHAT WAS DAMAGED? (CIRCLE) - COMPANY MAIN - COMPANY SERVICE - CUSTOMER SERVICE
OTHER _____
WHAT TYPE OF WORK WAS BEING PERFORMED? laying water line
PARTY'S EXPLANATION FOR DAMAGE Returned to job to repair leak on main
WHAT REPAIRS WERE MADE? Repaired with PL service
ANY ADDITIONAL WORK TO BE PERFORMED? YES / NO
IF YES, BY WHOM? _____

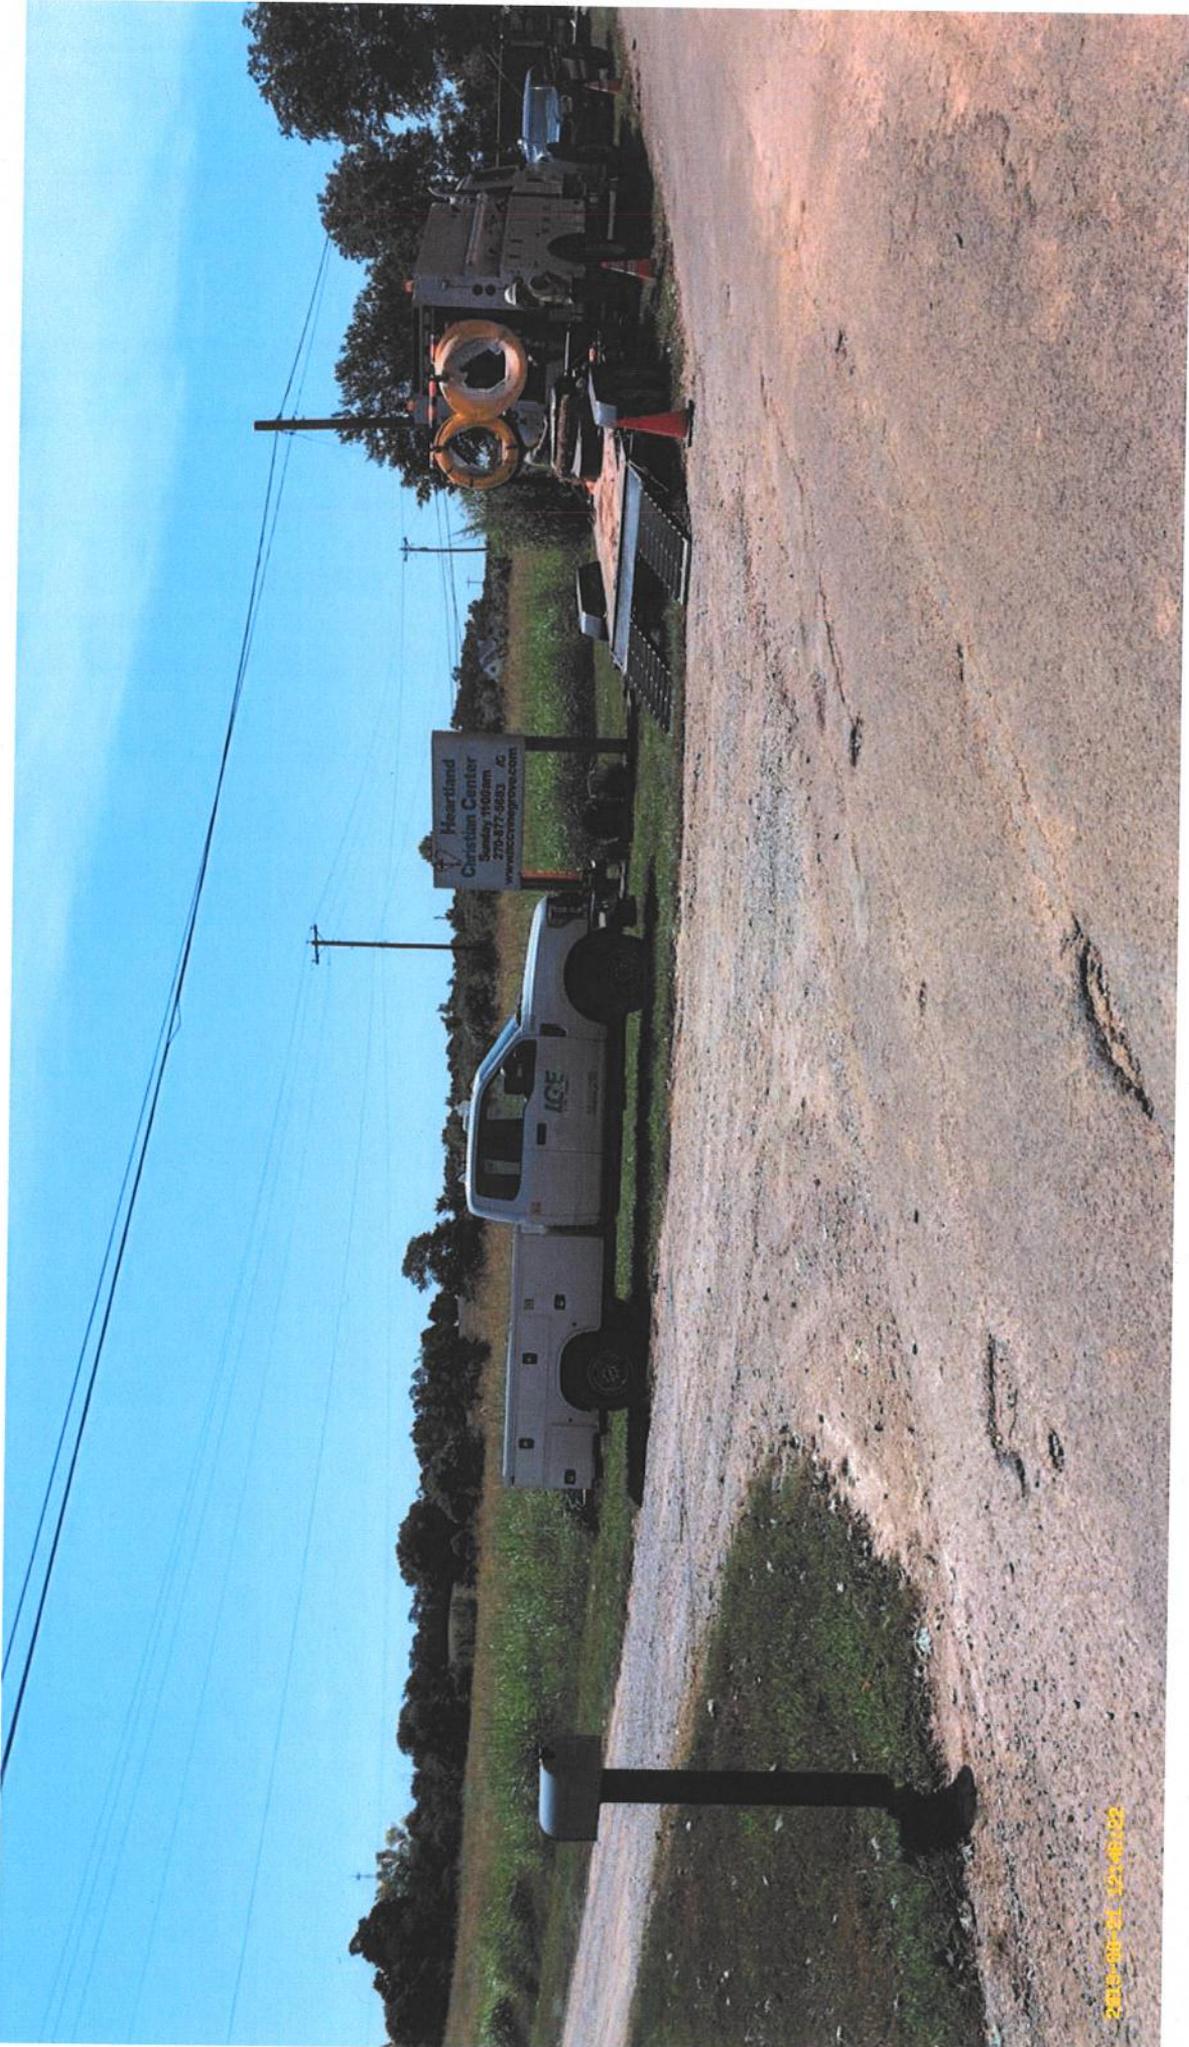
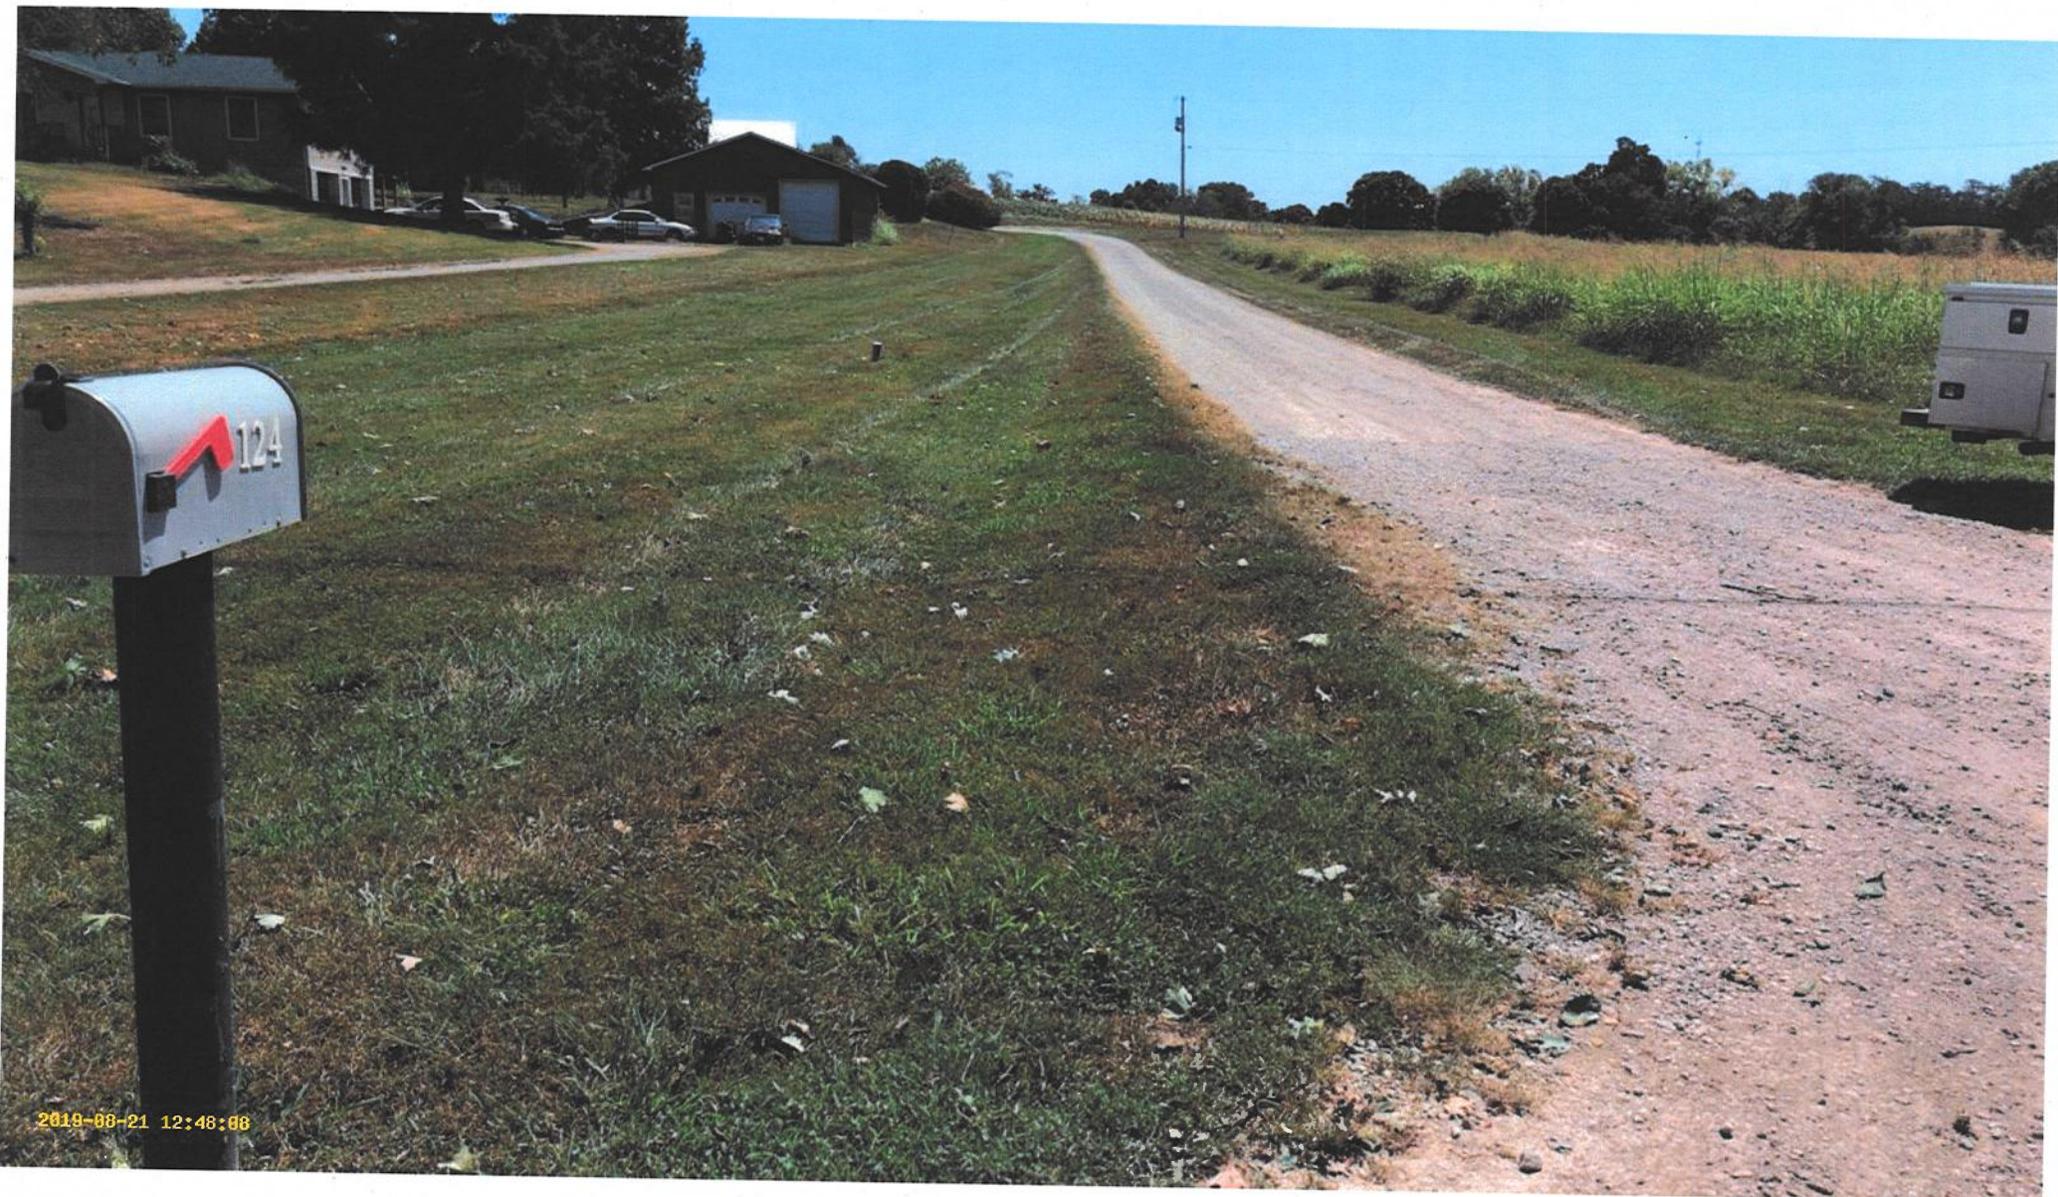
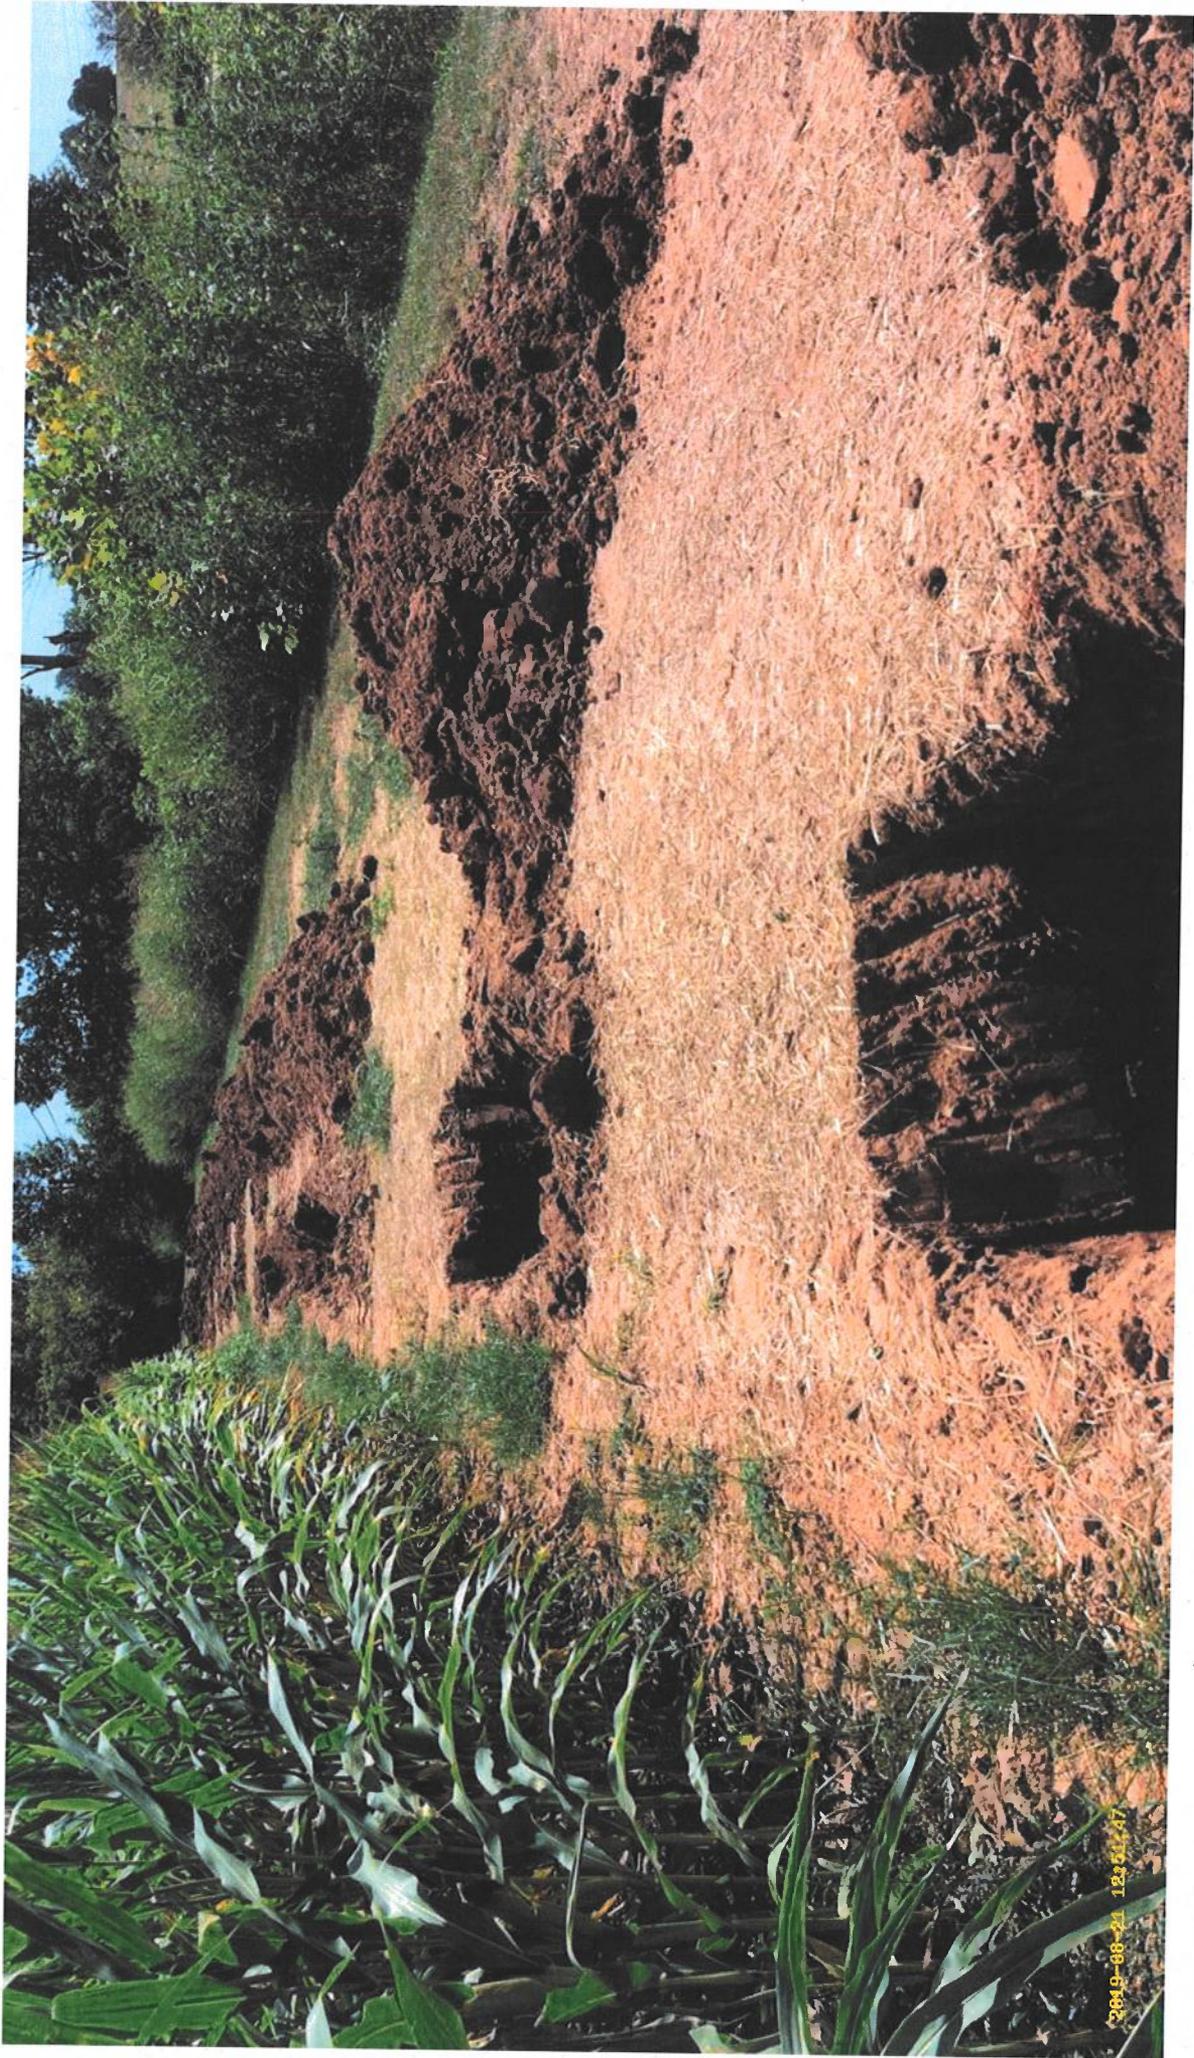
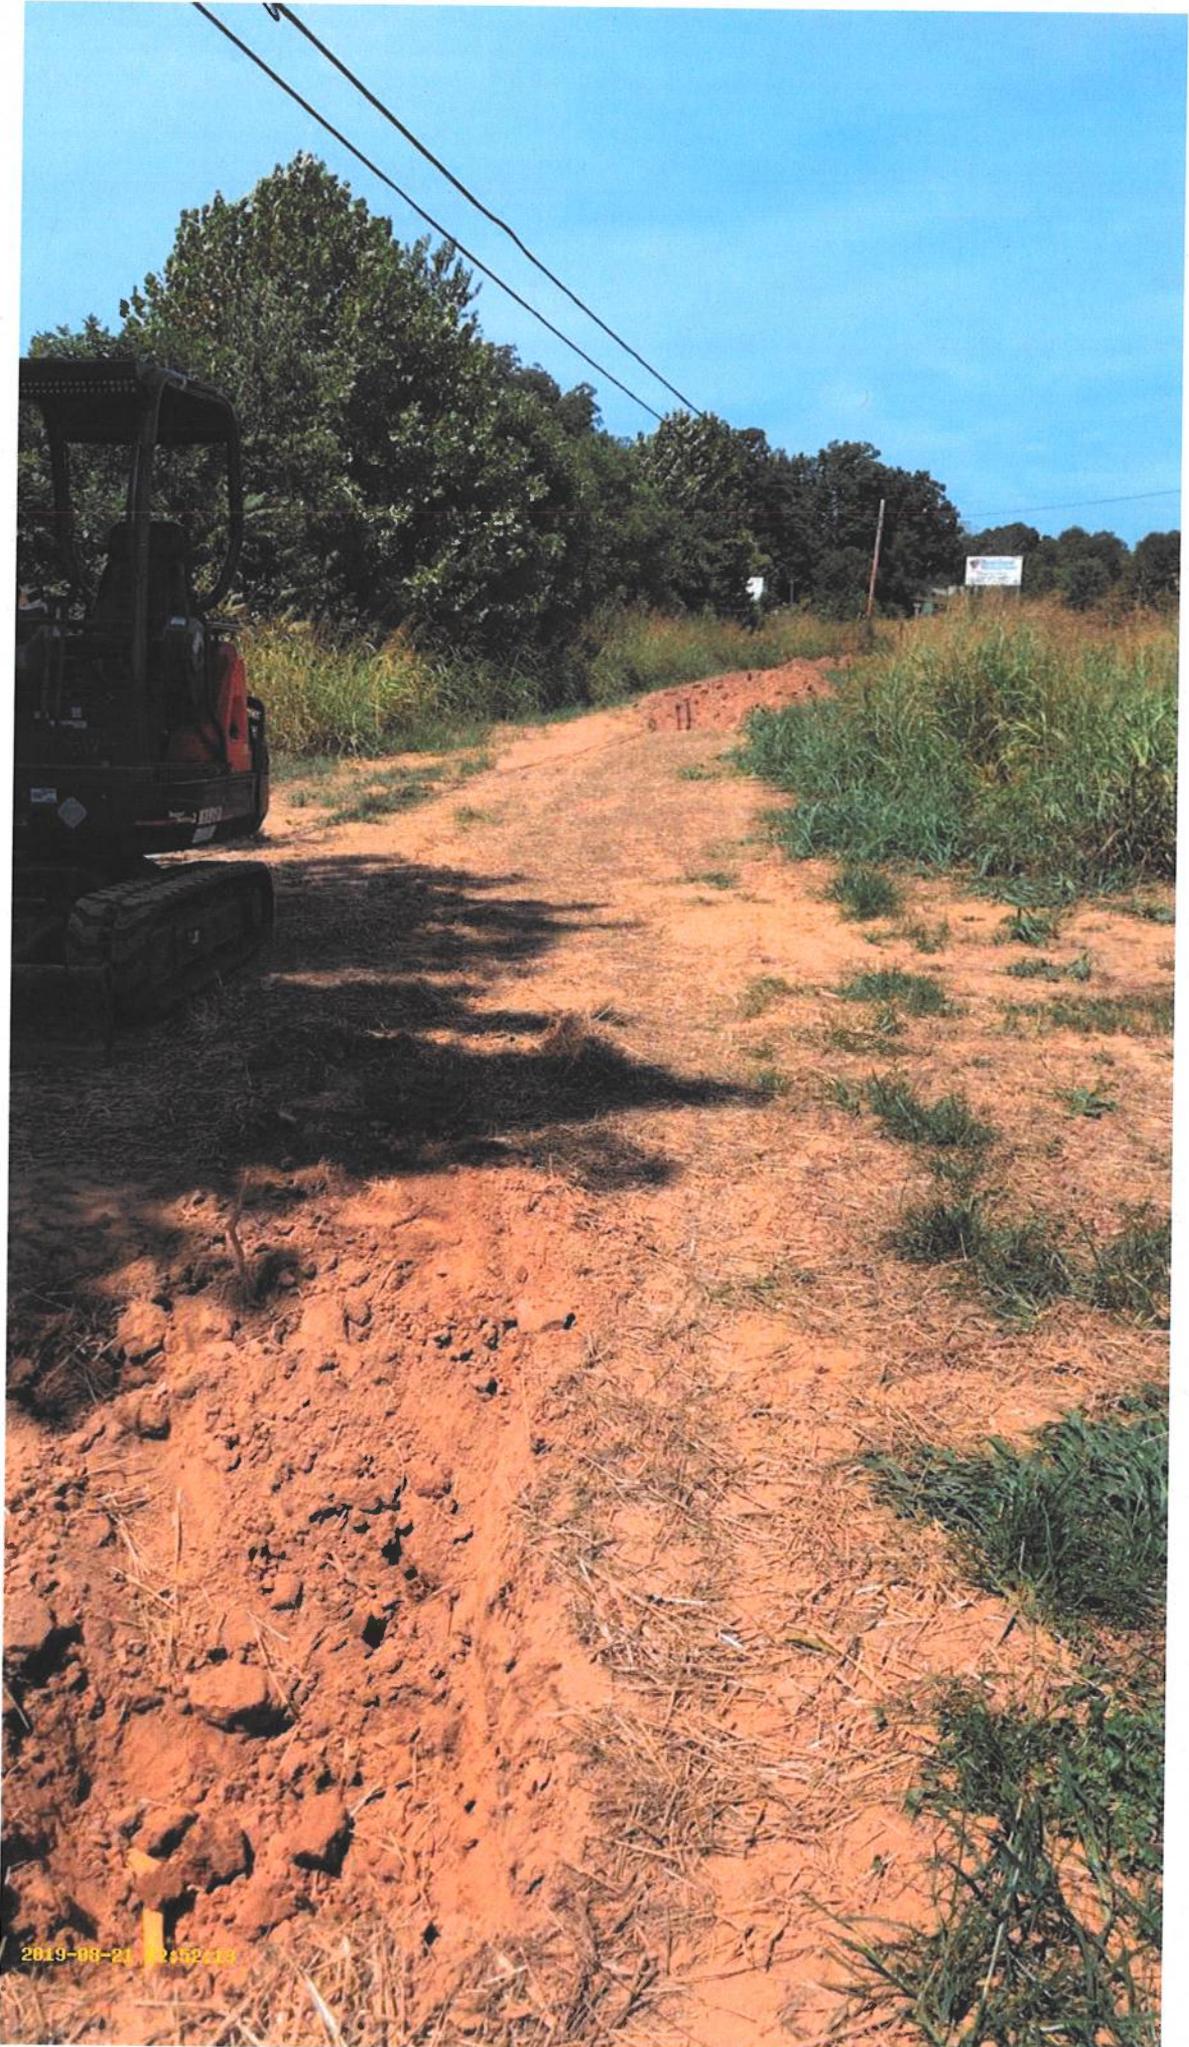
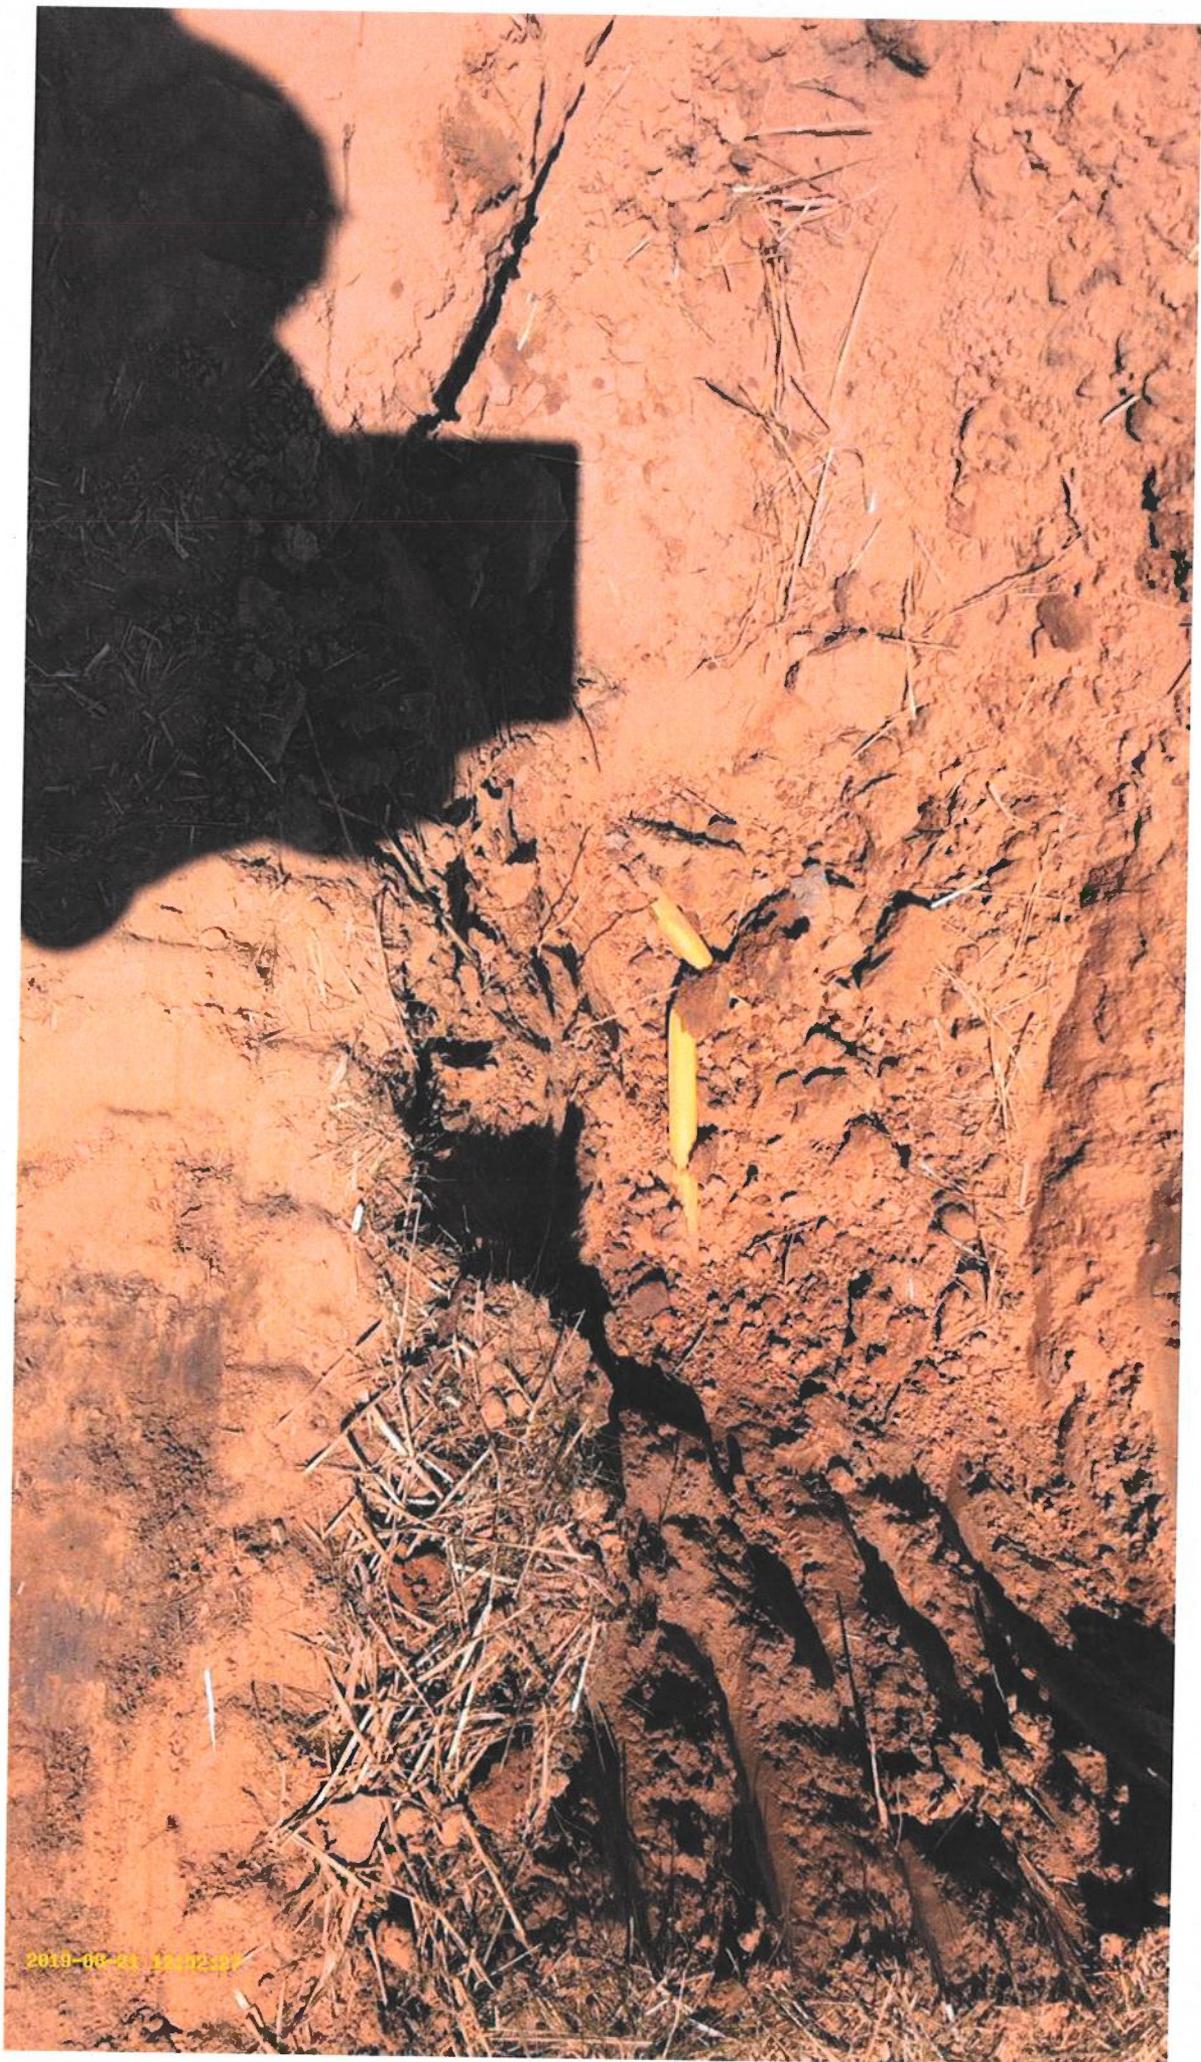
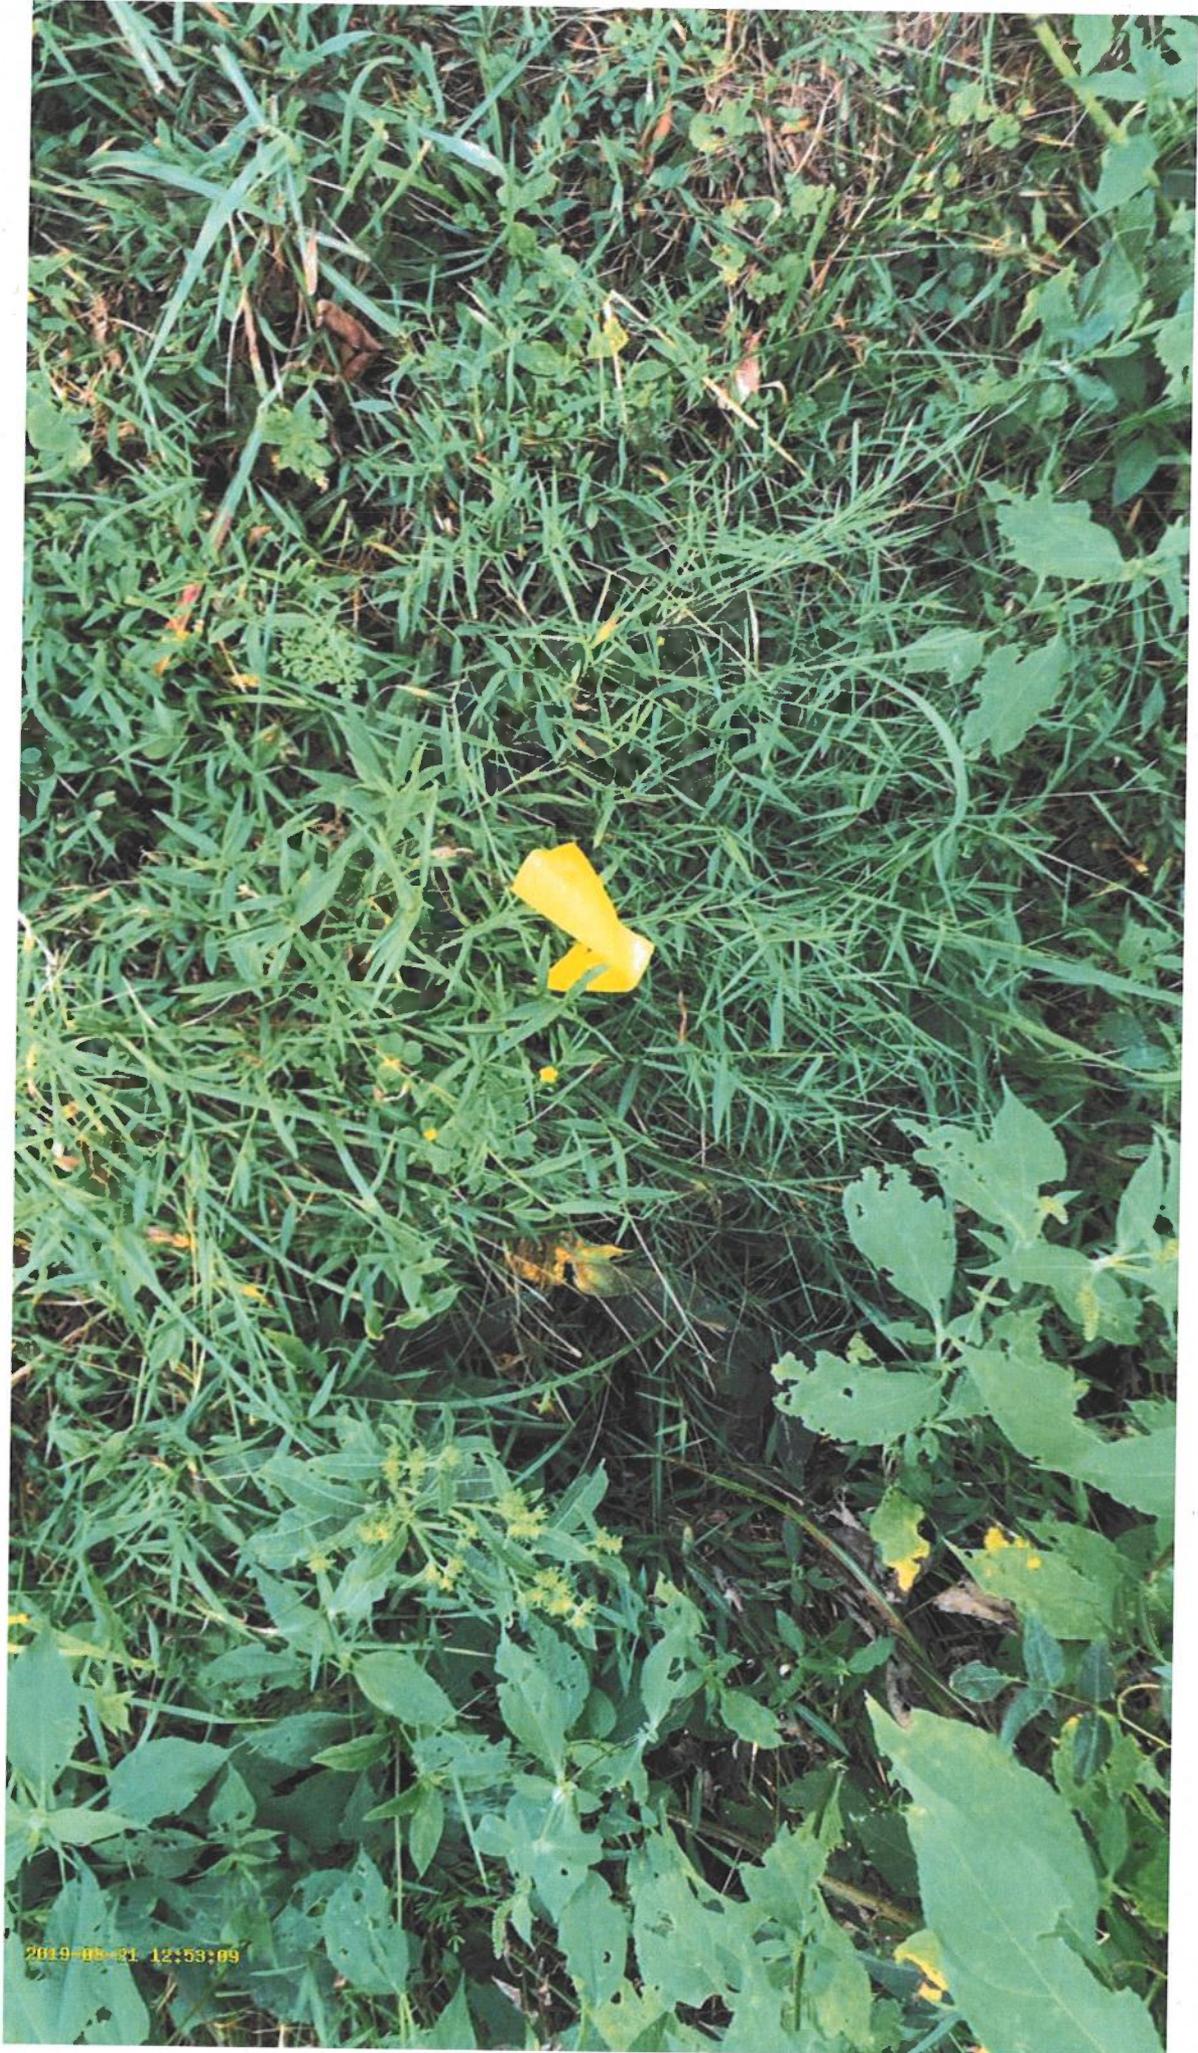
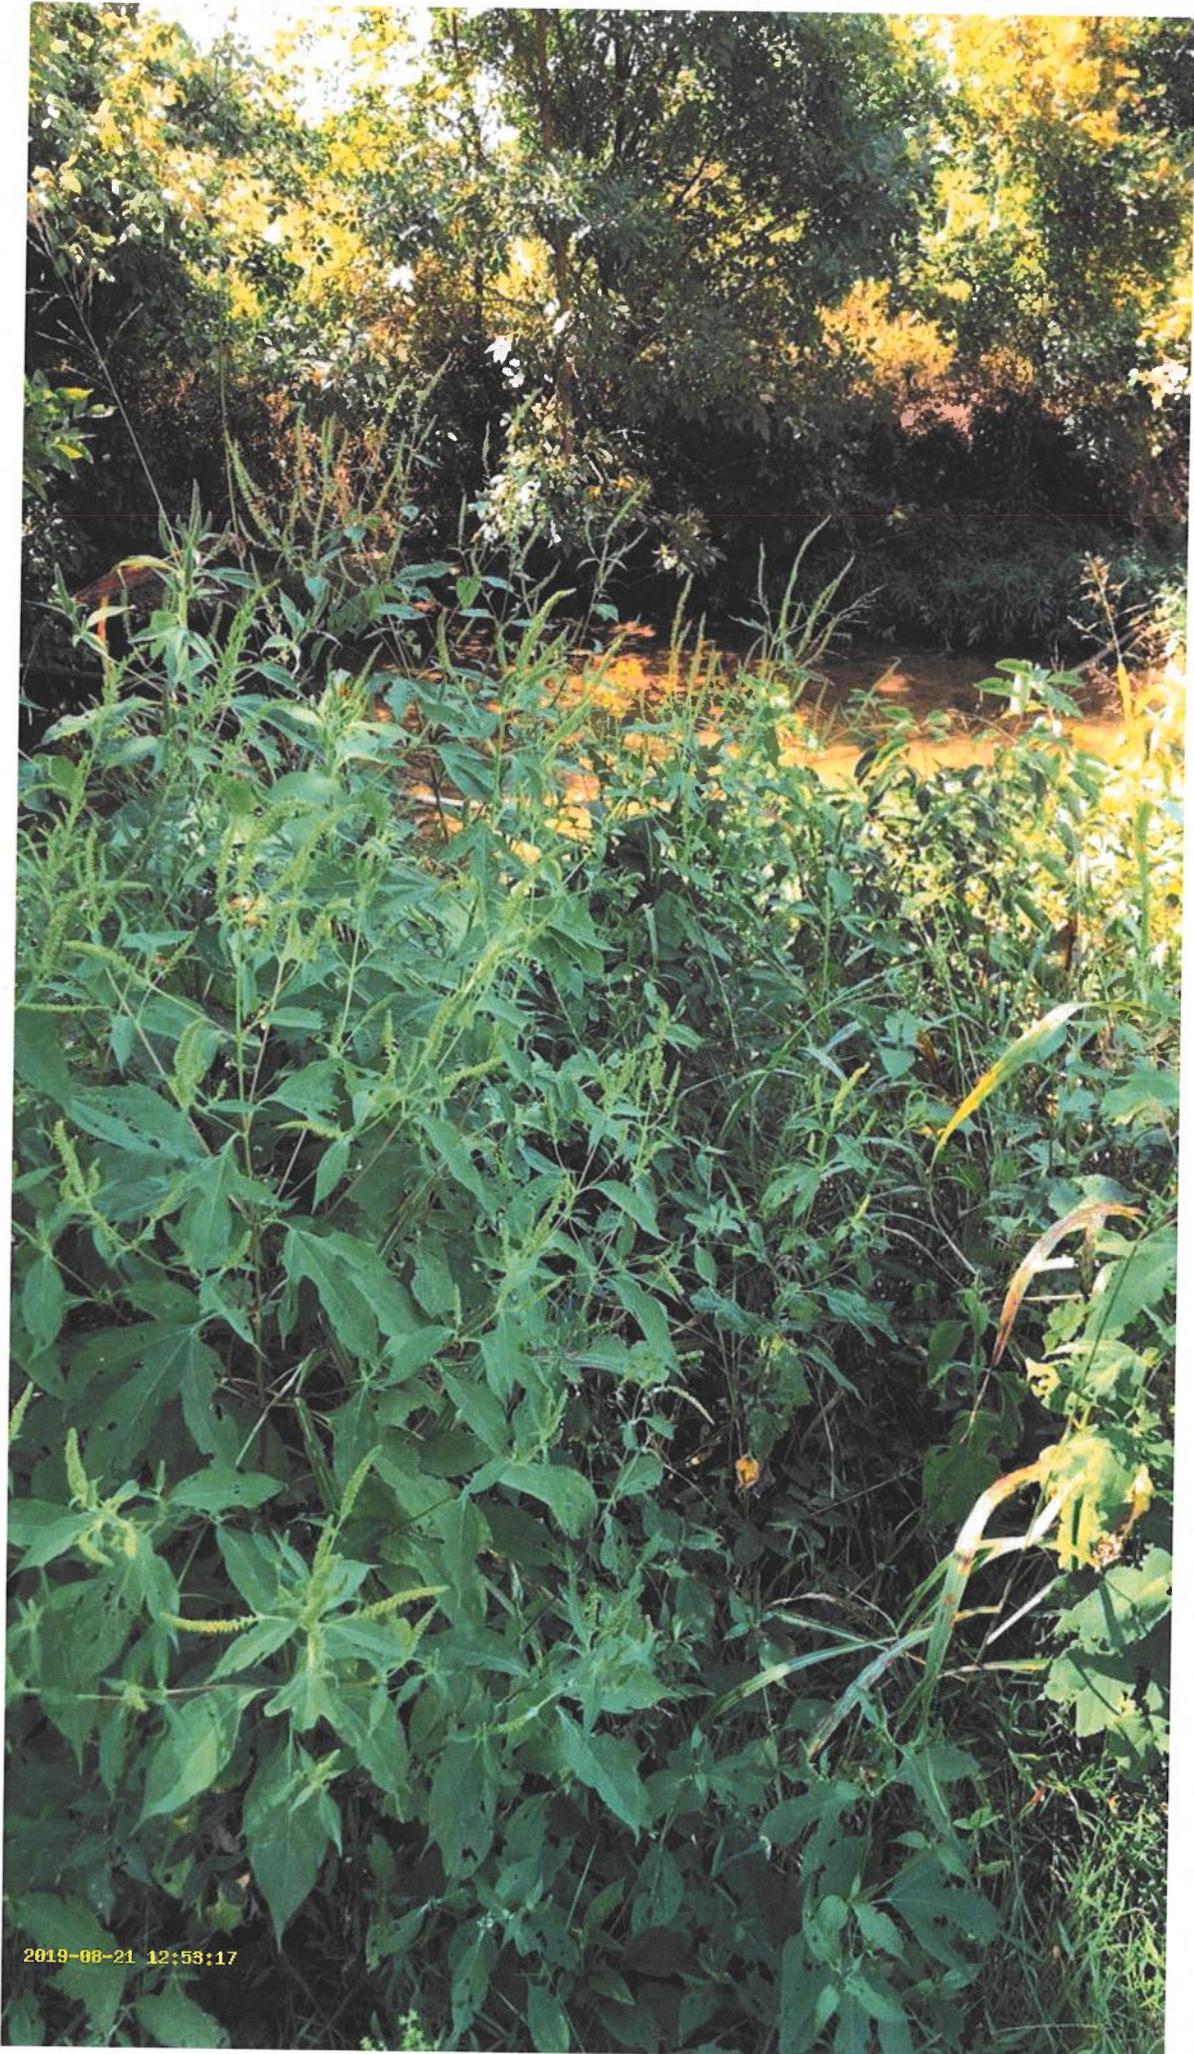
Attachment 5

- 15 Photographs: Depicting the damage and vehicles at the incident location all with LG&E logos.
- Invoice: Indicating Schroeder Construction was billed \$651.13 for the damage and Mr. Jones stated Schroeder Construction paid for the damages in September 2019 but provided no receipt of payment.
