ATTACHMENT H

Time line of events and actions from 0354 to 1225 on 12/6/11.

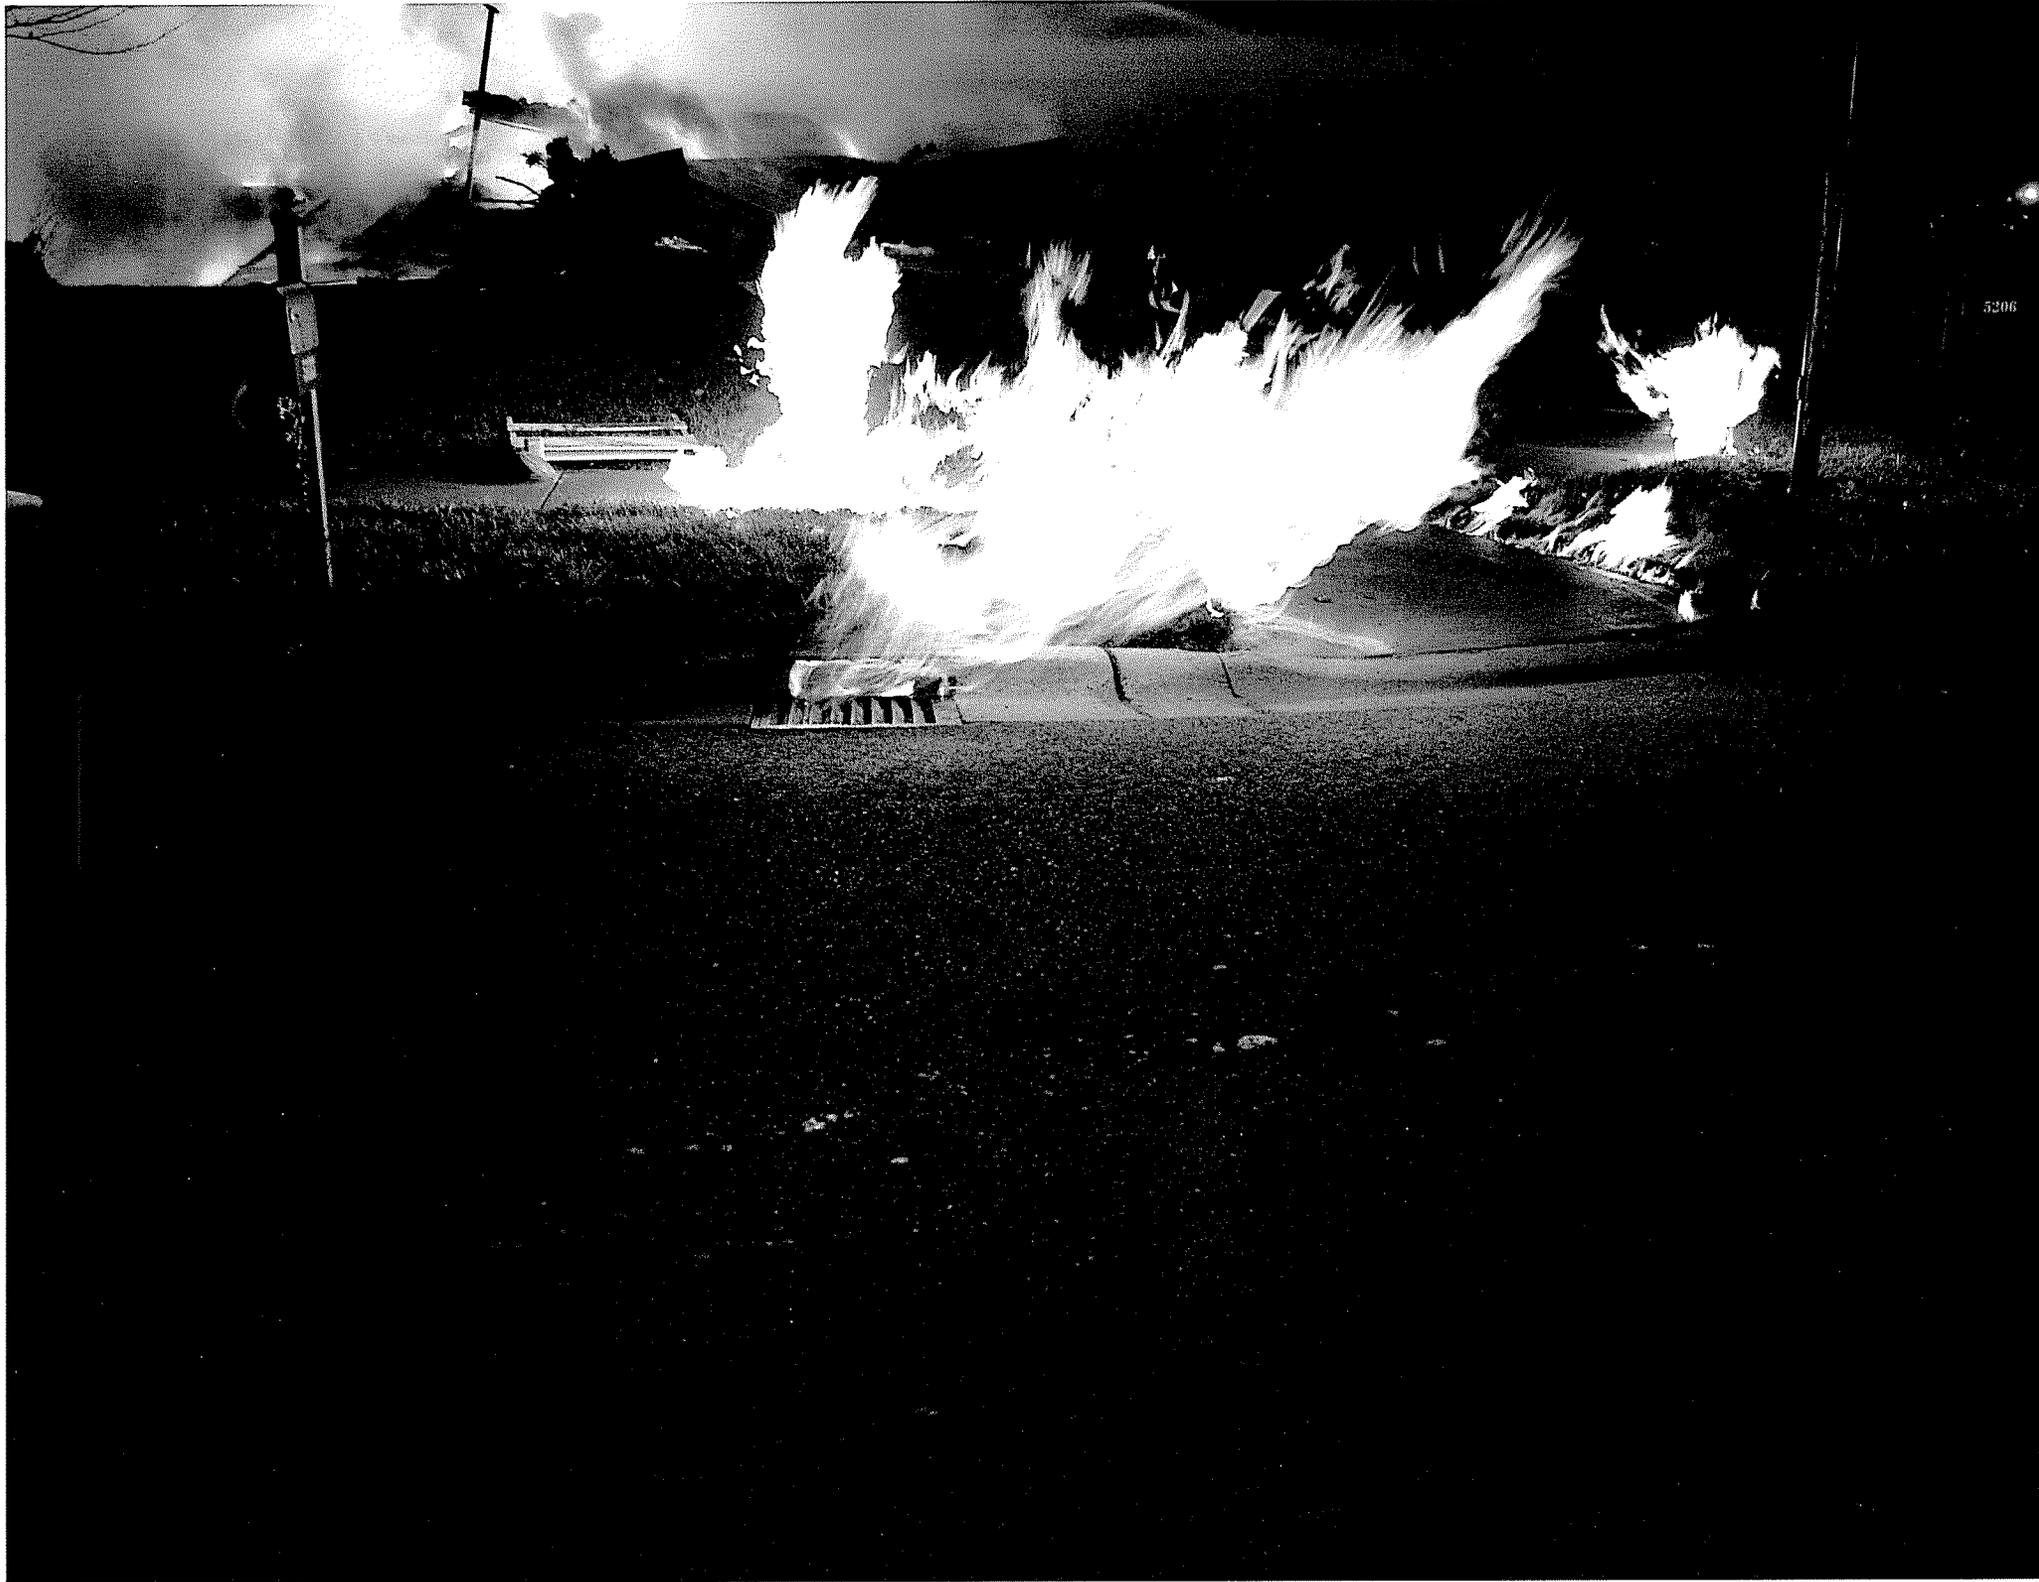
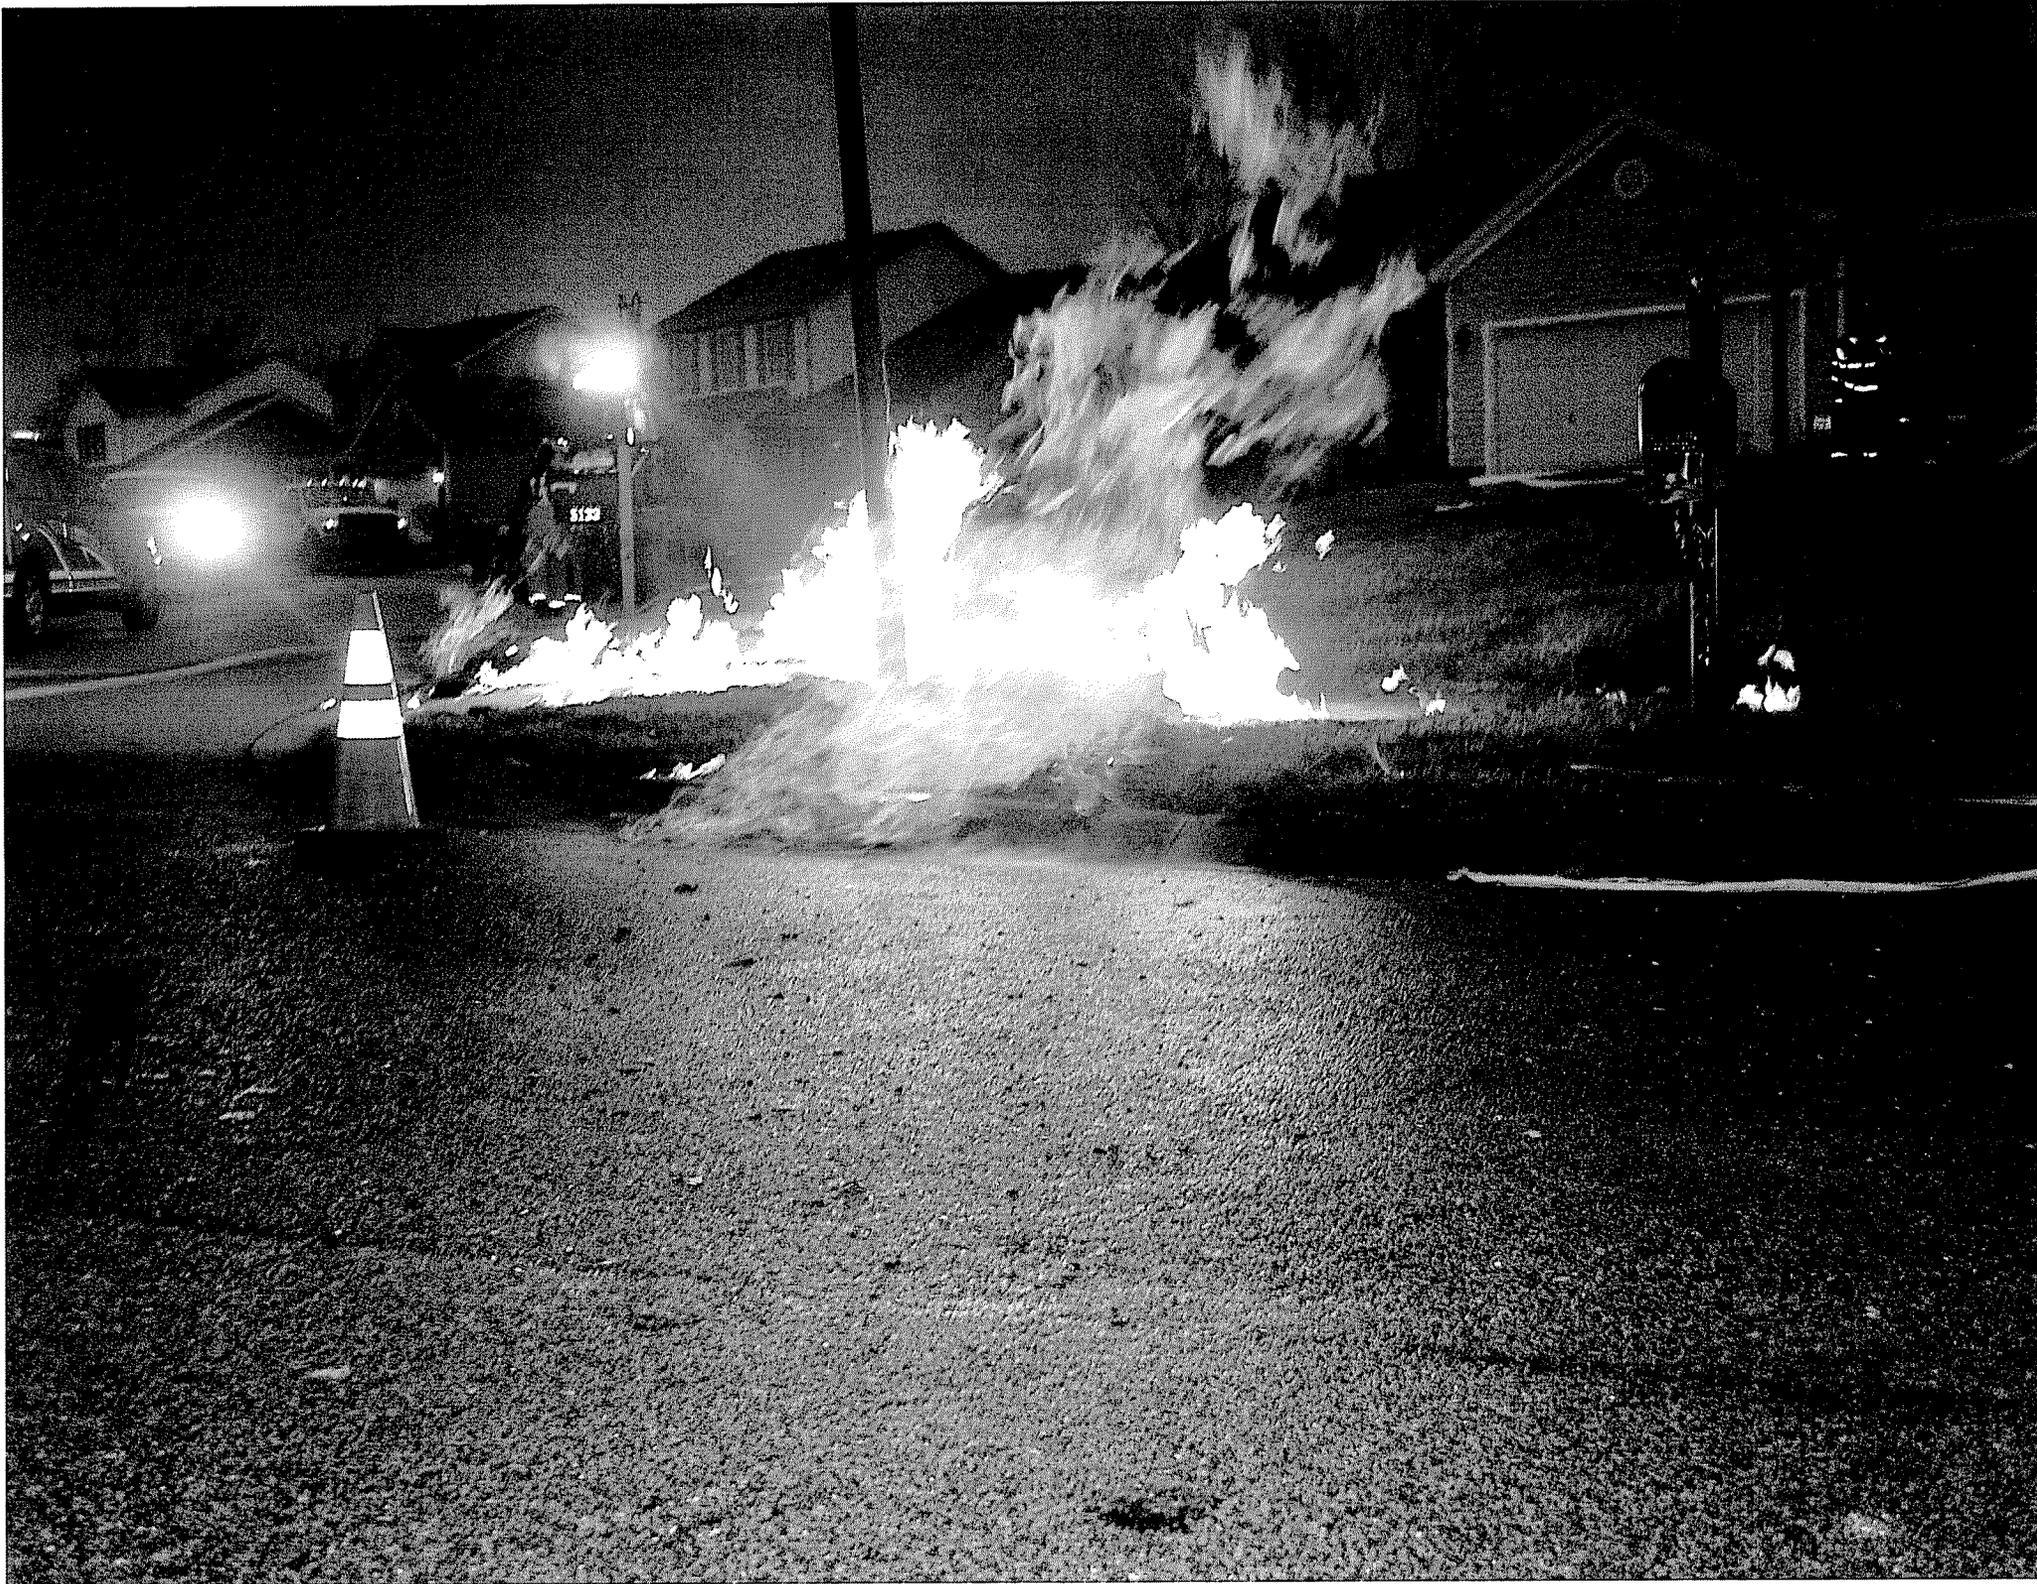
0703 – LG&E dispatch receives notification 5206 River Trail Place house explosion from team leader.

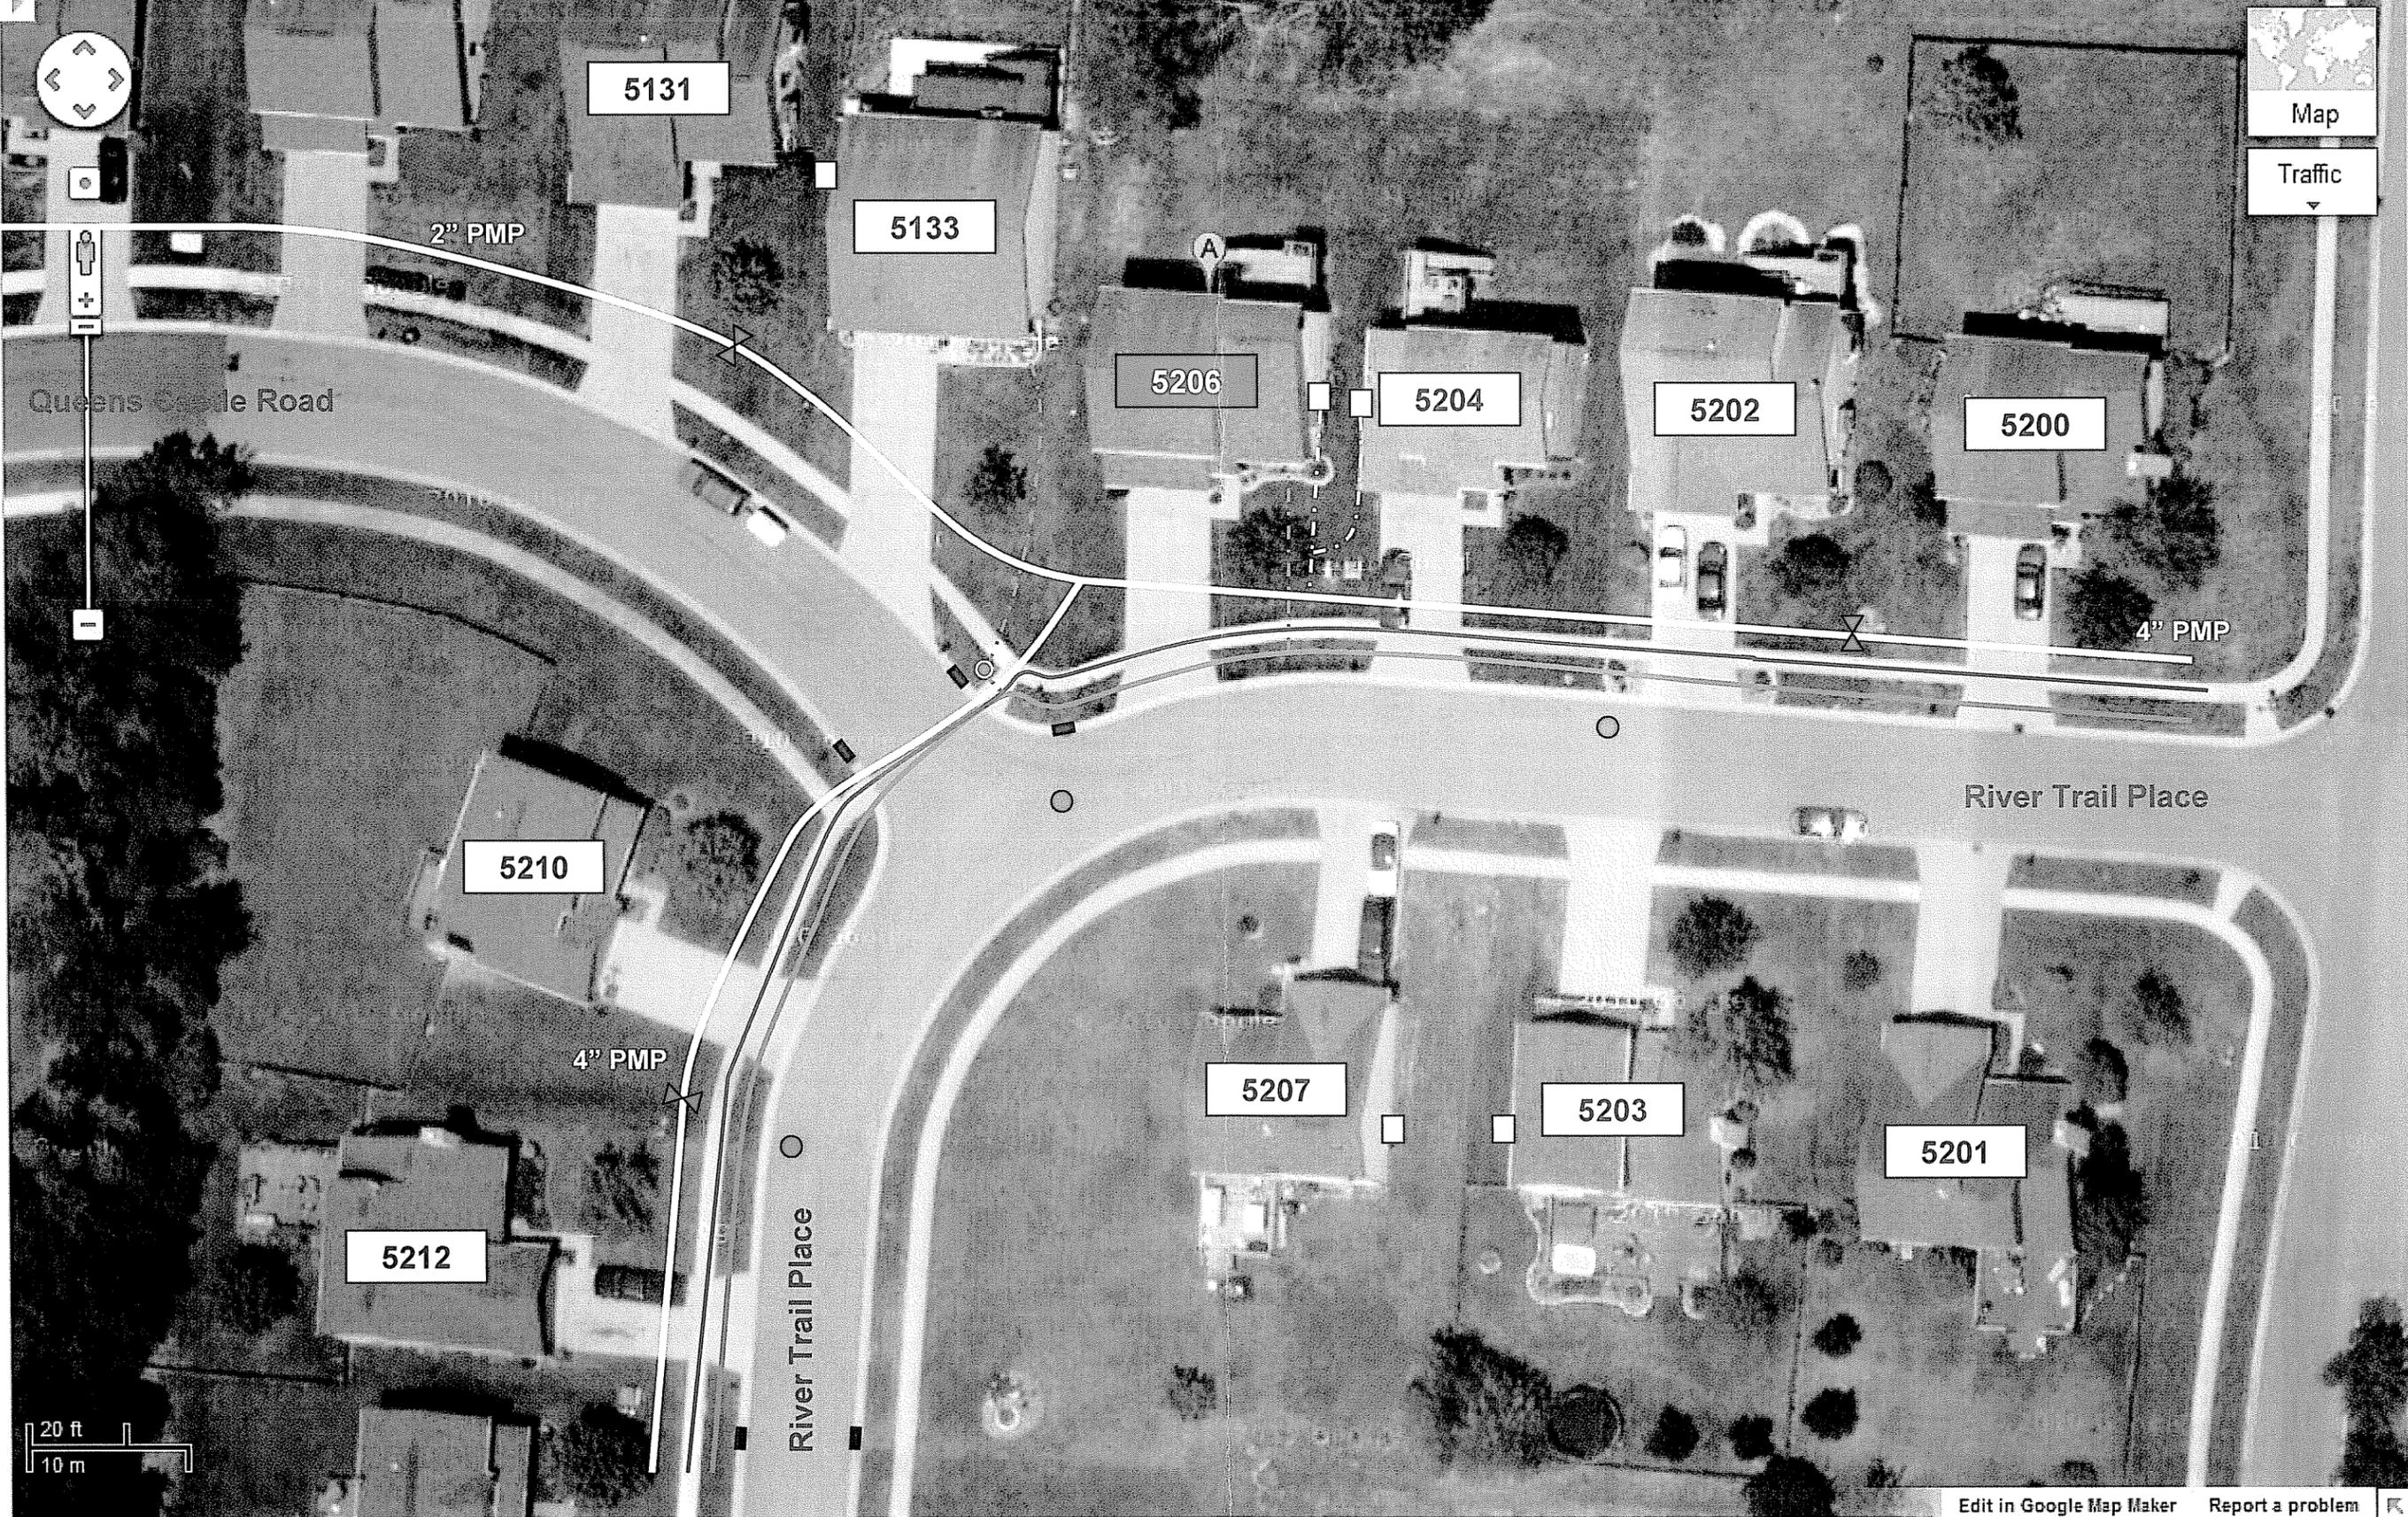
NOTE: Drawing is not to scale; all facility locations are approximate.

— Natural Gas Line — Telephone/Cable/Electric Lines — Waterline
⌵ Squeeze Off Location □ Gas Meter ○ Sewer Manhole ■ Storm Drain ● Water Meter
