COMMONWEALTH OF KENTUCKY  
BEFORE THE PUBLIC SERVICE COMMISSION

INITIATING ORDER FOR ALLEGED 811 VIOLATION OF THE KENTUCKY  
UNDERGROUND FACILITY DAMAGE PREVENTION ACT

# PIPELINE DAMAGE INVESTIGATION REPORT

**Investigator** Eric V. Tout **Incident ID** 53746 **Investigation** 8698  
**Incident Date** 6/15/2021 12:06:00 PM **Report Submitted** 7/6/2021

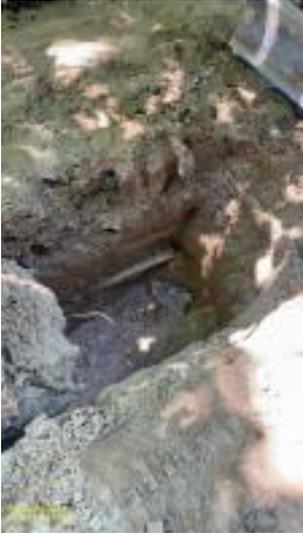
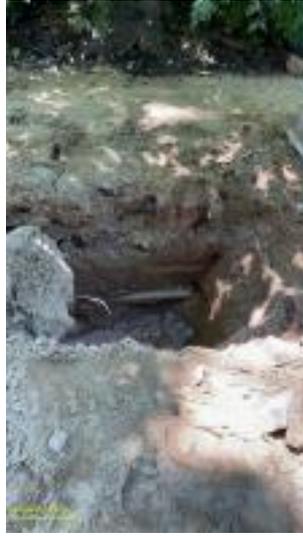
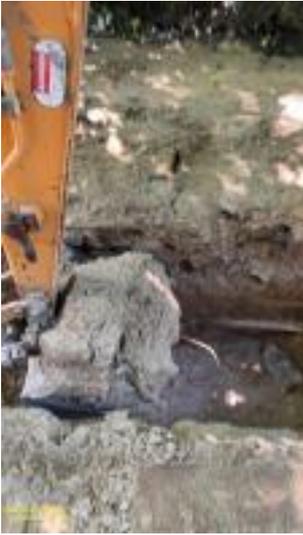
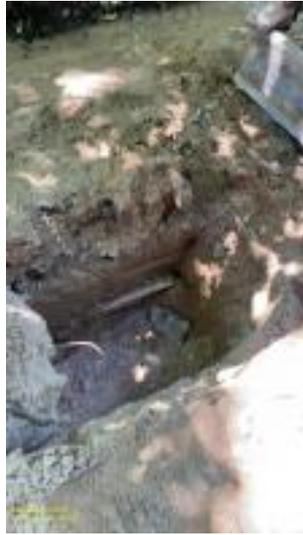
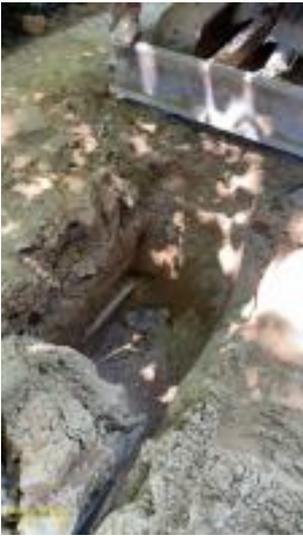
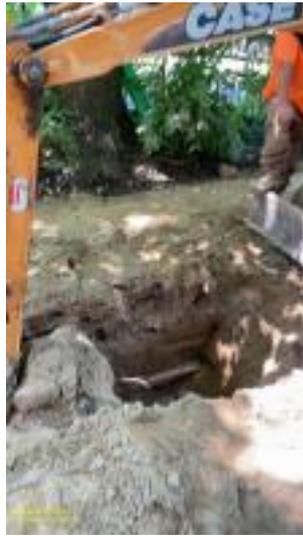
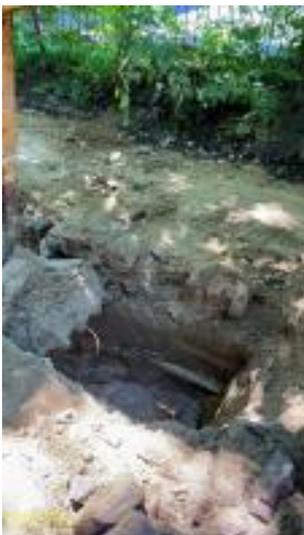
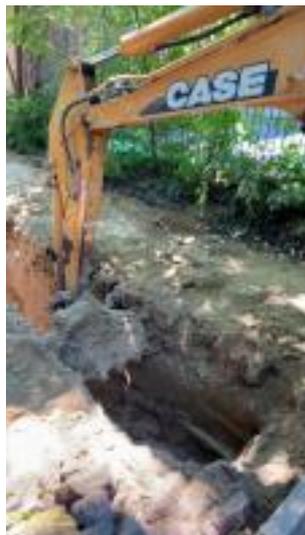
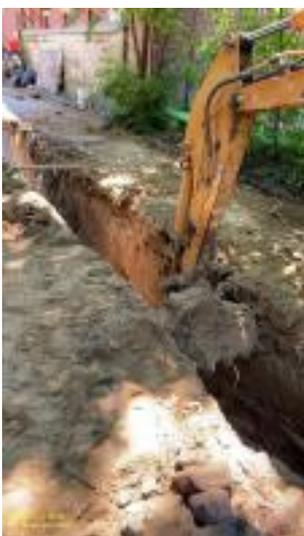
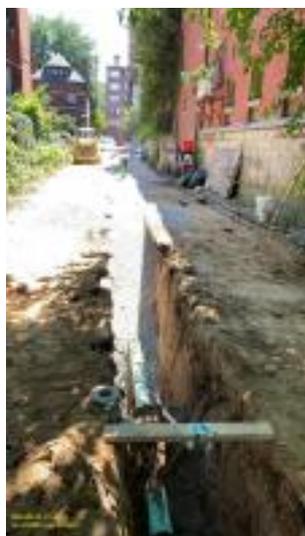
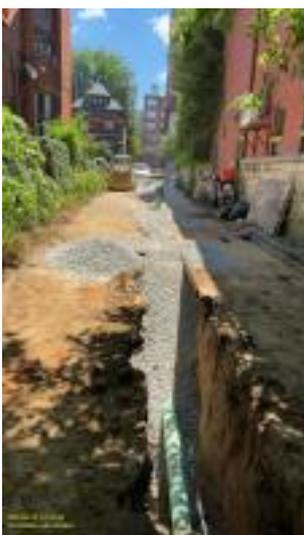
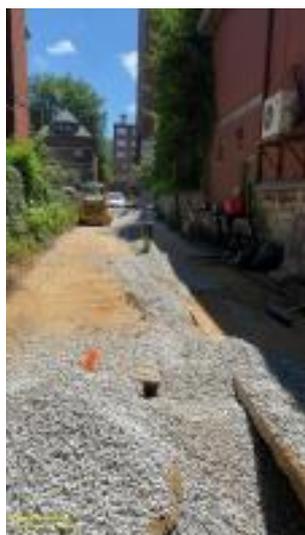
**NOTE:** Only 12 most recent photos shown. To view all 90 attachments, please view the ticket within DigTix.

While digging Trinity Service Company damaged an accurately marked 2" MP PL G/M (#449728).

The gas main was damaged approximately(area was full of spoil piles & debris, so measuring exact footage was difficult) 135' west of the west curb line on Garvin Place, and 5'2" off the south curb line in the alley.

I hooked up to the gas service for 1238 Garvin Place and the wire at the gas main "T" on Garvin Place, and it appears to me that Trinity Service Company was digging within the 18" tolerance zone with their excavator for nearly the entire alley. I got the exact same locate marks that I found in post-locate photos from ELM's locate.

Cause Code: Failure to use hand tools within tolerance zone

Responsible Party Comments: Gas damage was 135' west of west curb of Garvin. 72' east of the t in alley. 5' north of south alley. LG&E put a dead end cap on the gas main at the point it was damaged.

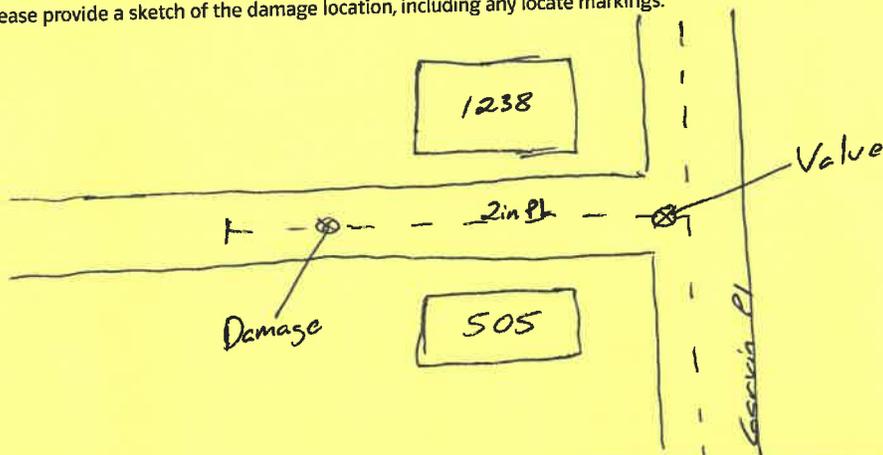
Please provide a sketch of the damage location, including any locate markings.

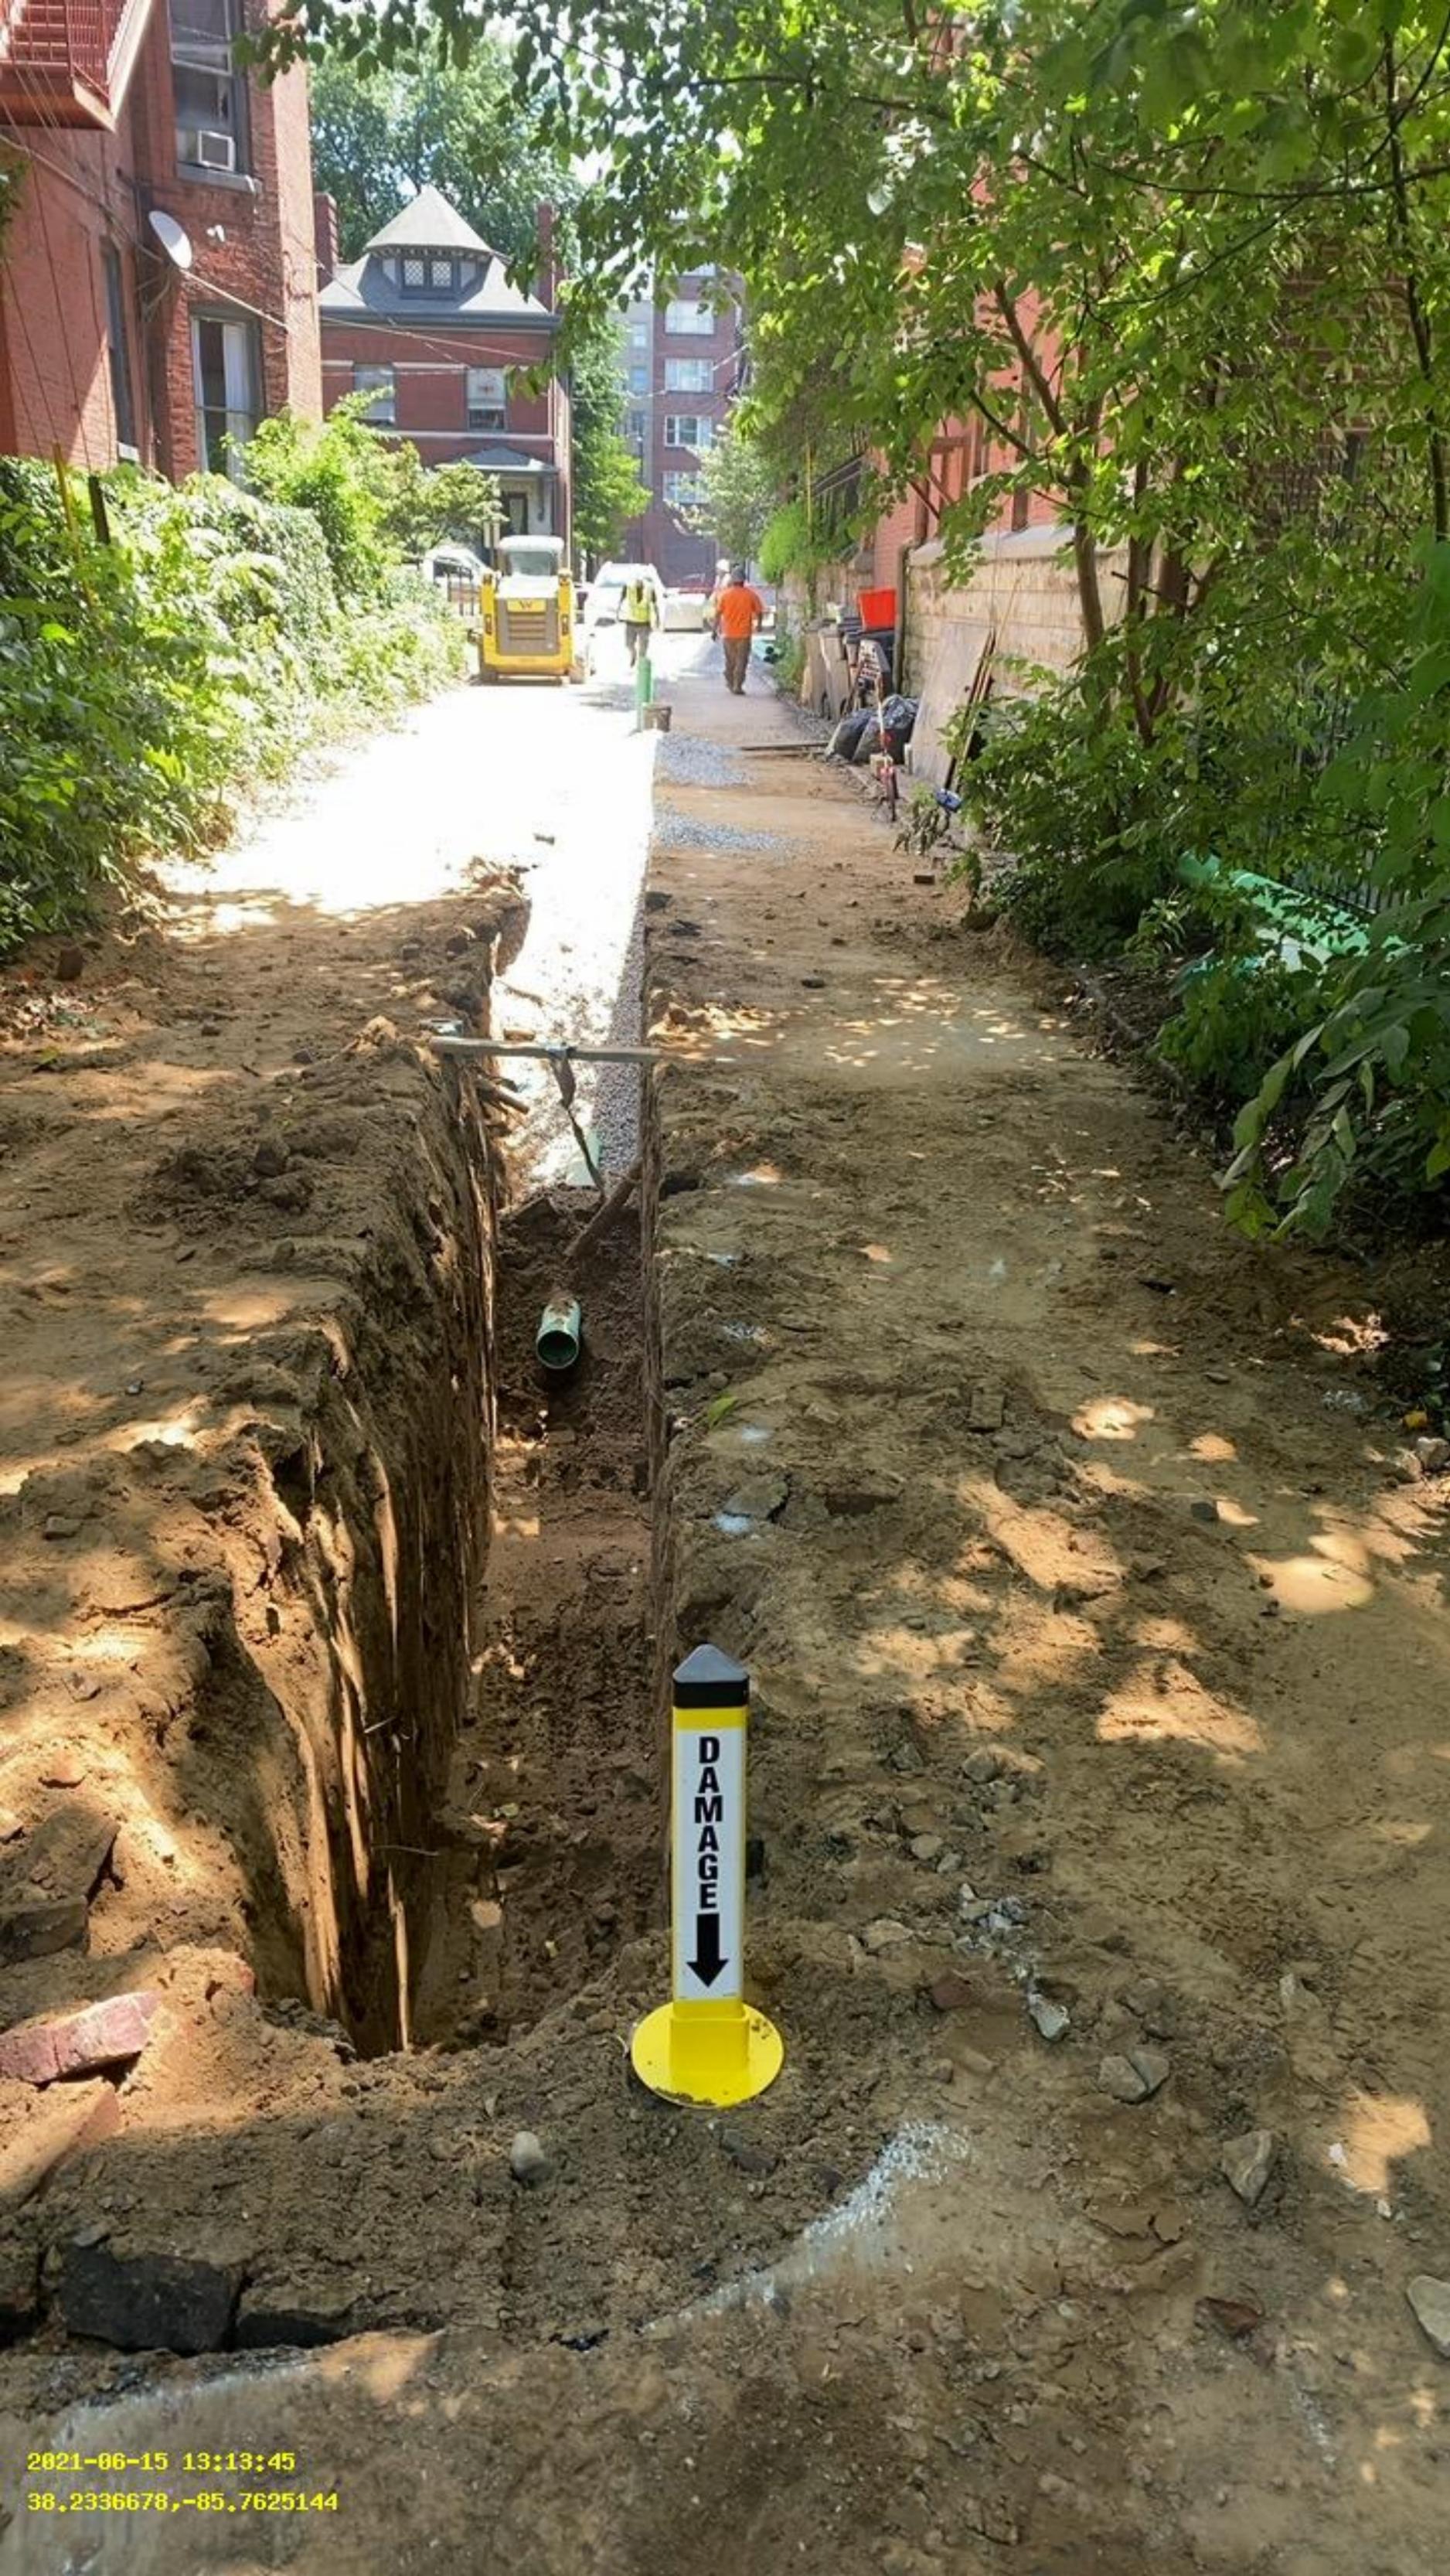
**D  
A  
M  
A  
G  
E**  
↓

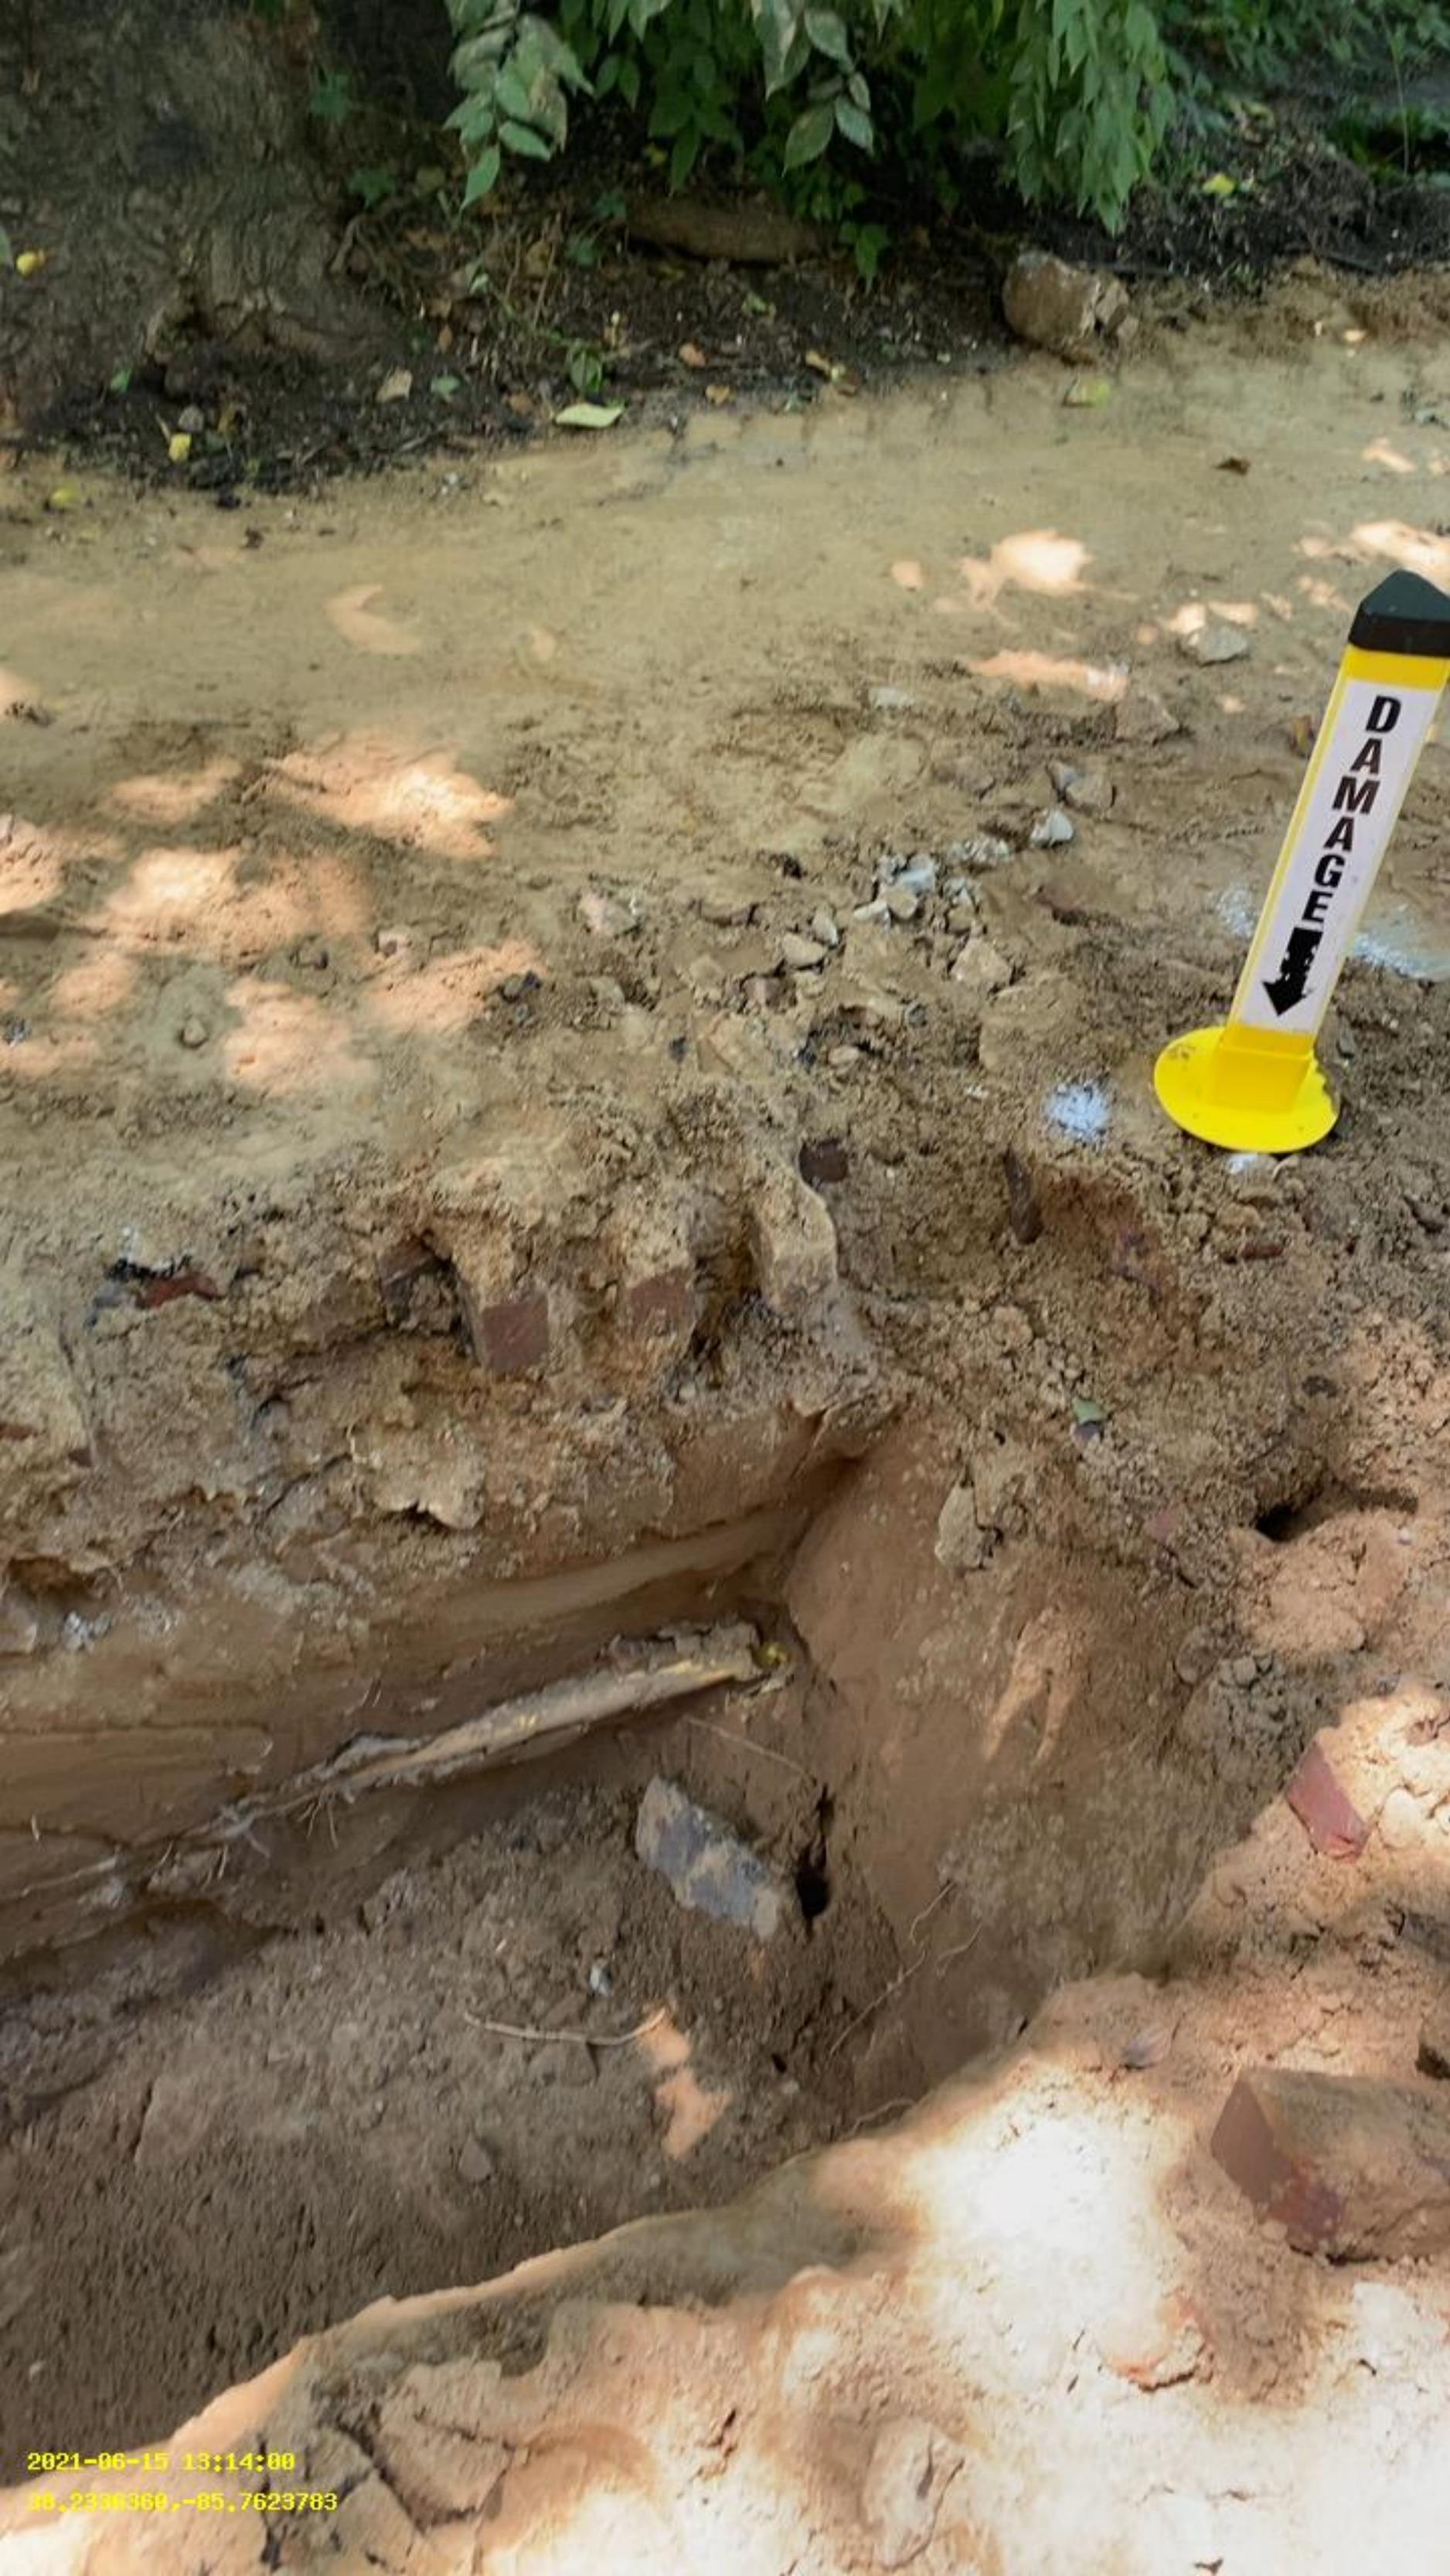
**DAMAGE**

Damaged 2" plastic gas main
