COMMONWEALTH OF KENTUCKY  
BEFORE THE PUBLIC SERVICE COMMISSION

INITIATING ORDER FOR ALLEGED 811 VIOLATION OF THE KENTUCKY  
UNDERGROUND FACILITY DAMAGE PREVENTION ACT

# PIPELINE DAMAGE INVESTIGATION REPORT

**Investigator** Eric V. Tout **Incident ID** 53746 **Investigation** 8698  
**Incident Date** 6/15/2021 12:06:00 PM **Report Submitted** 7/6/2021

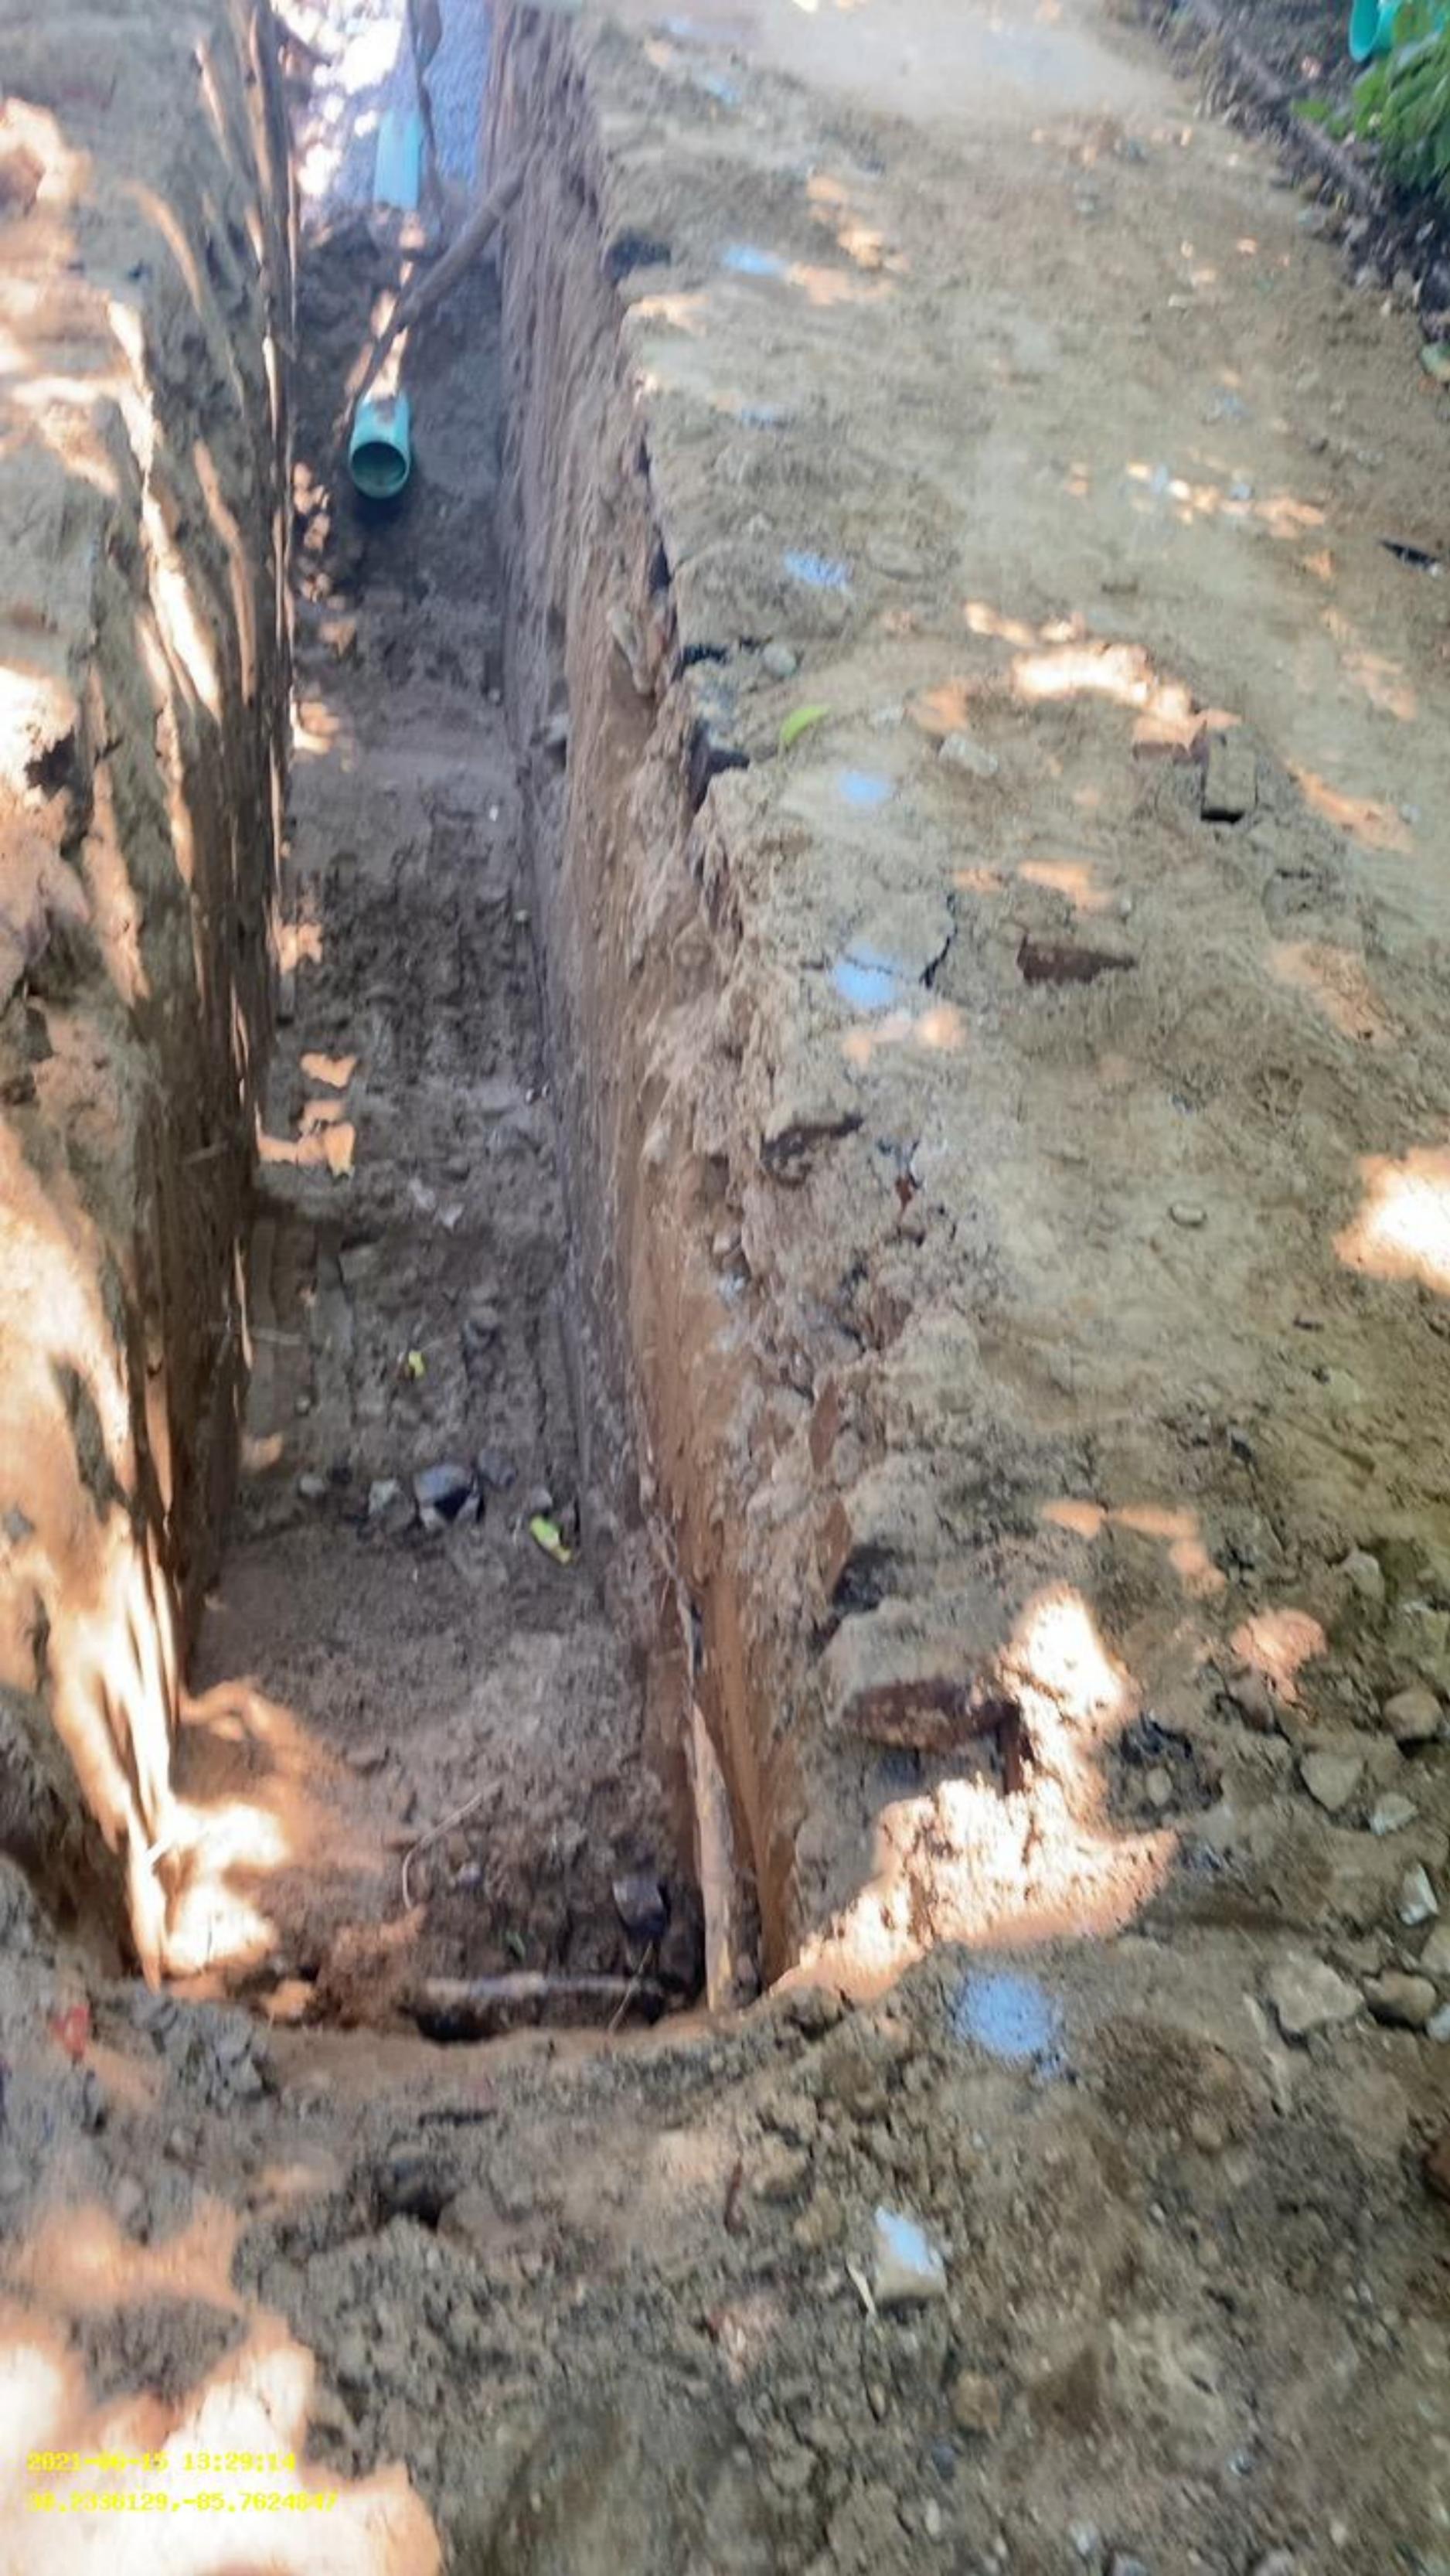
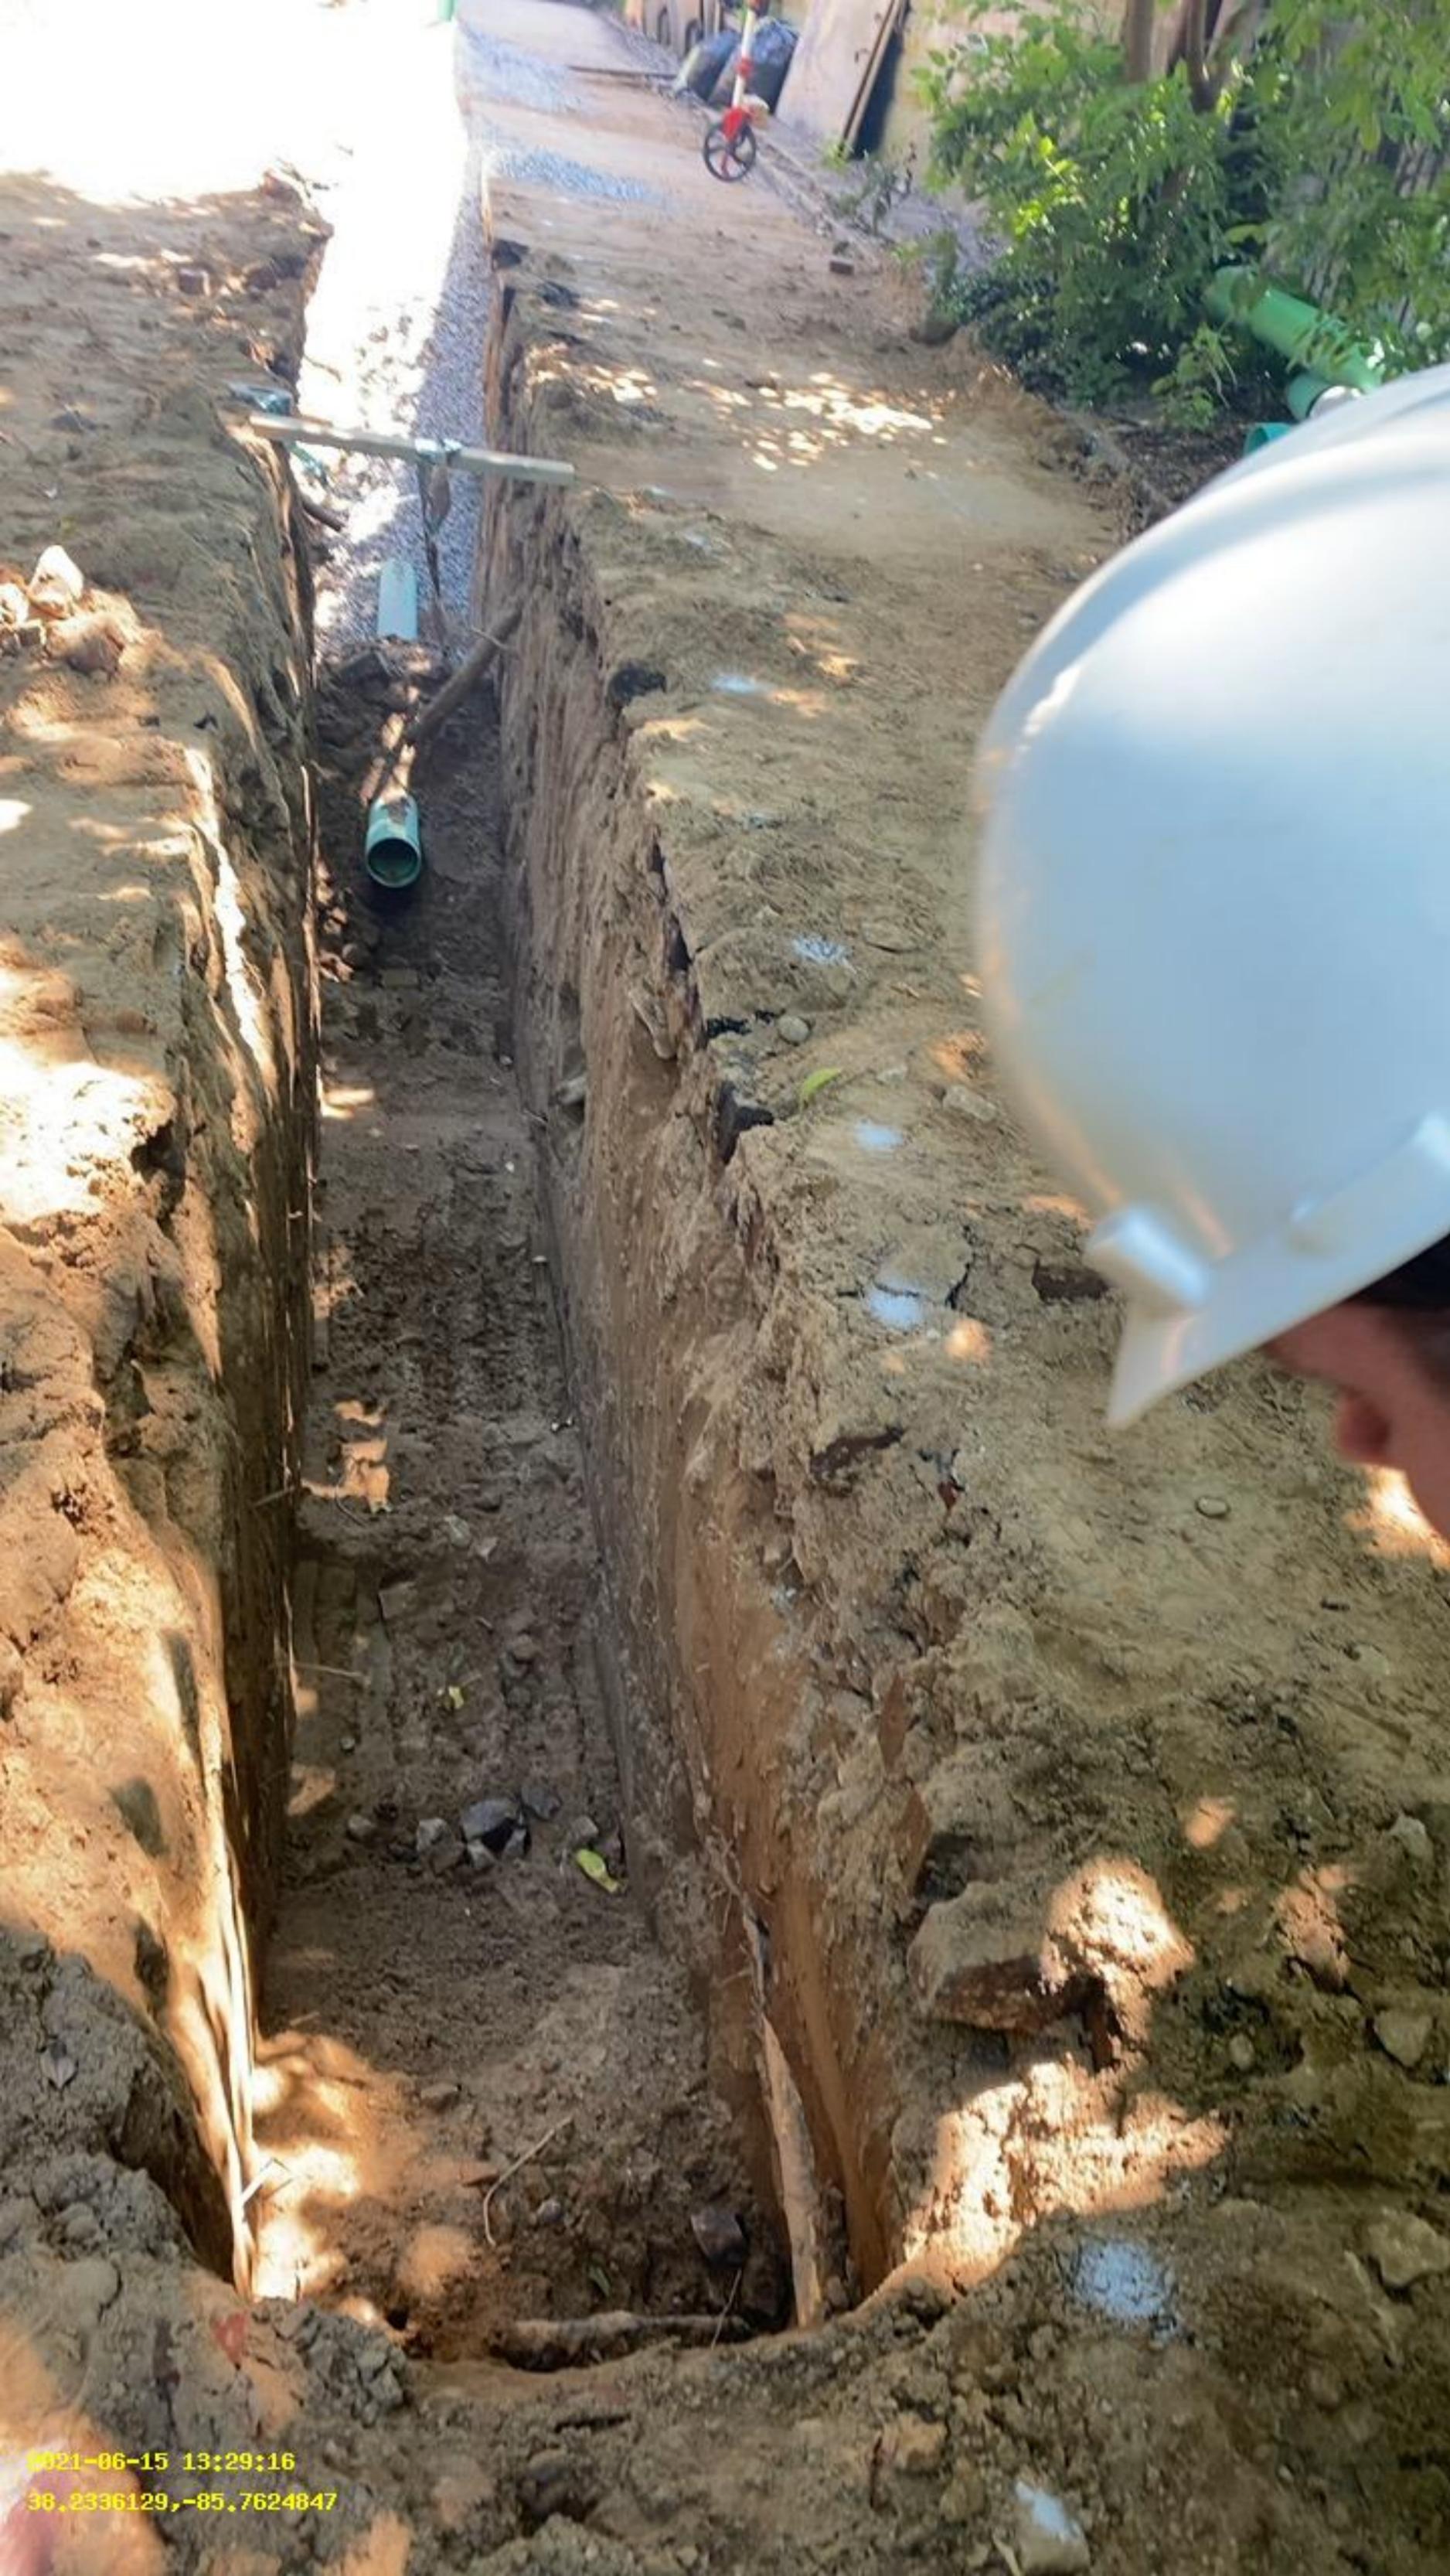
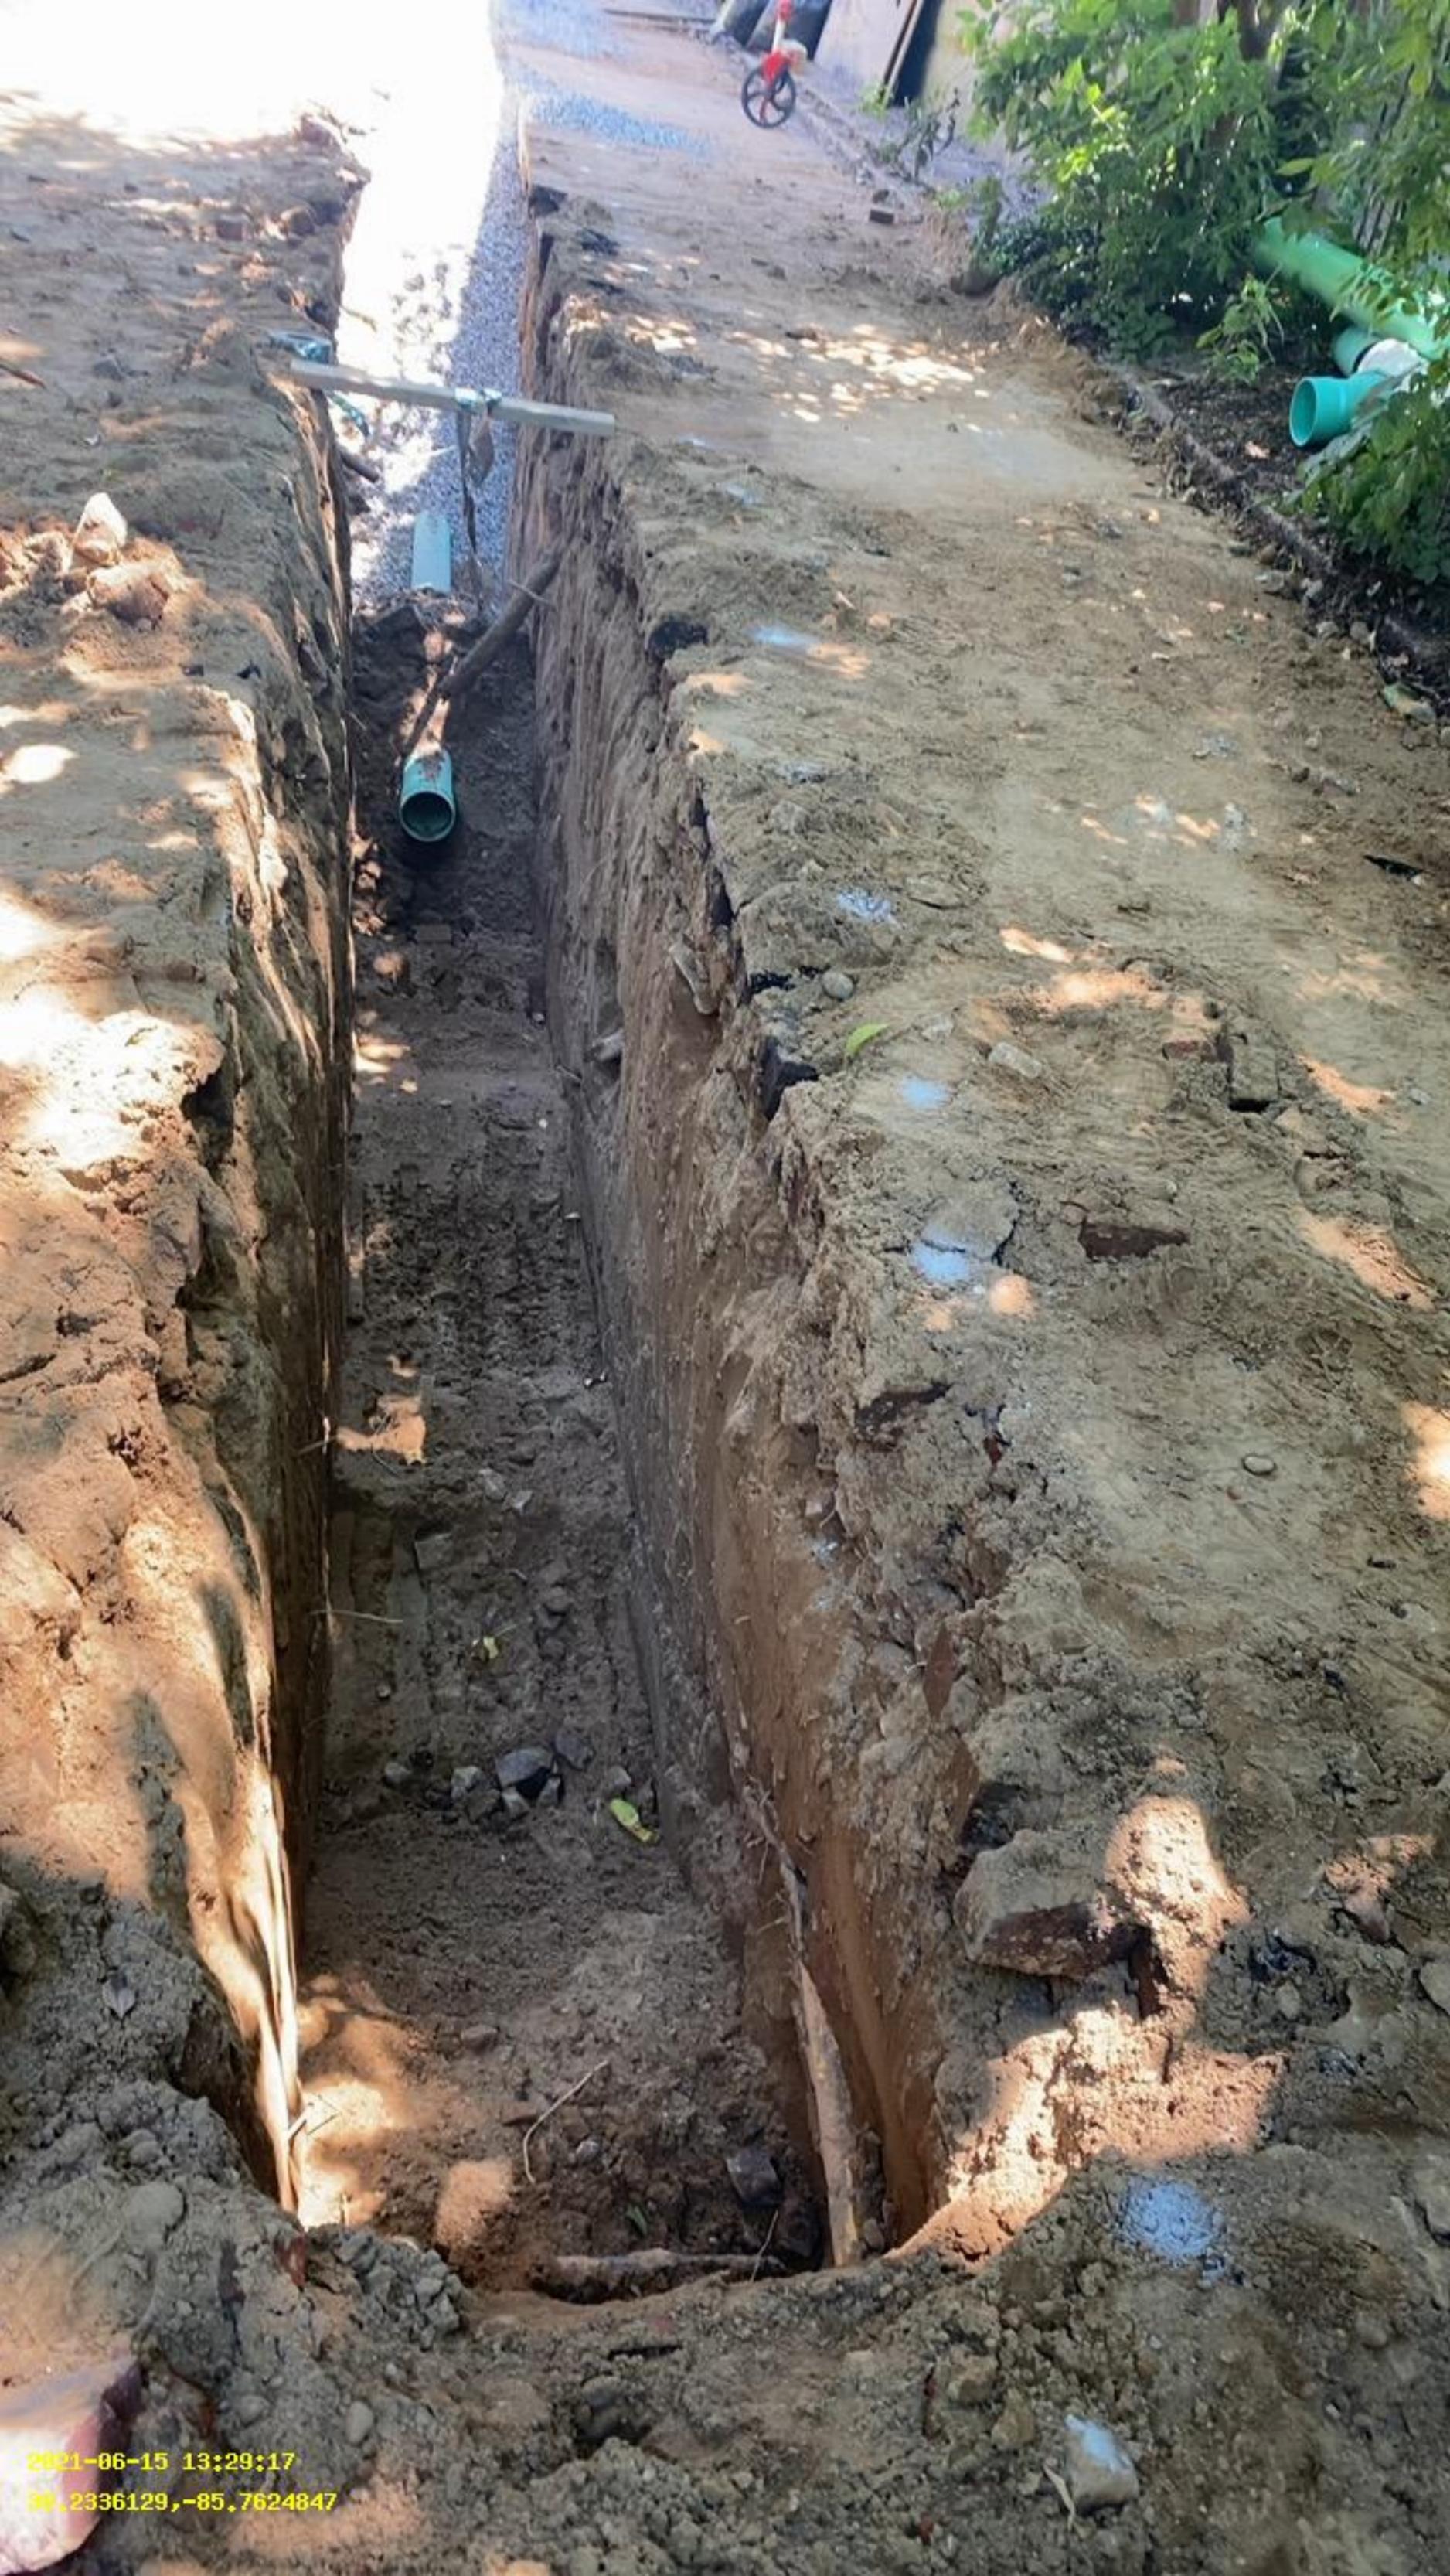
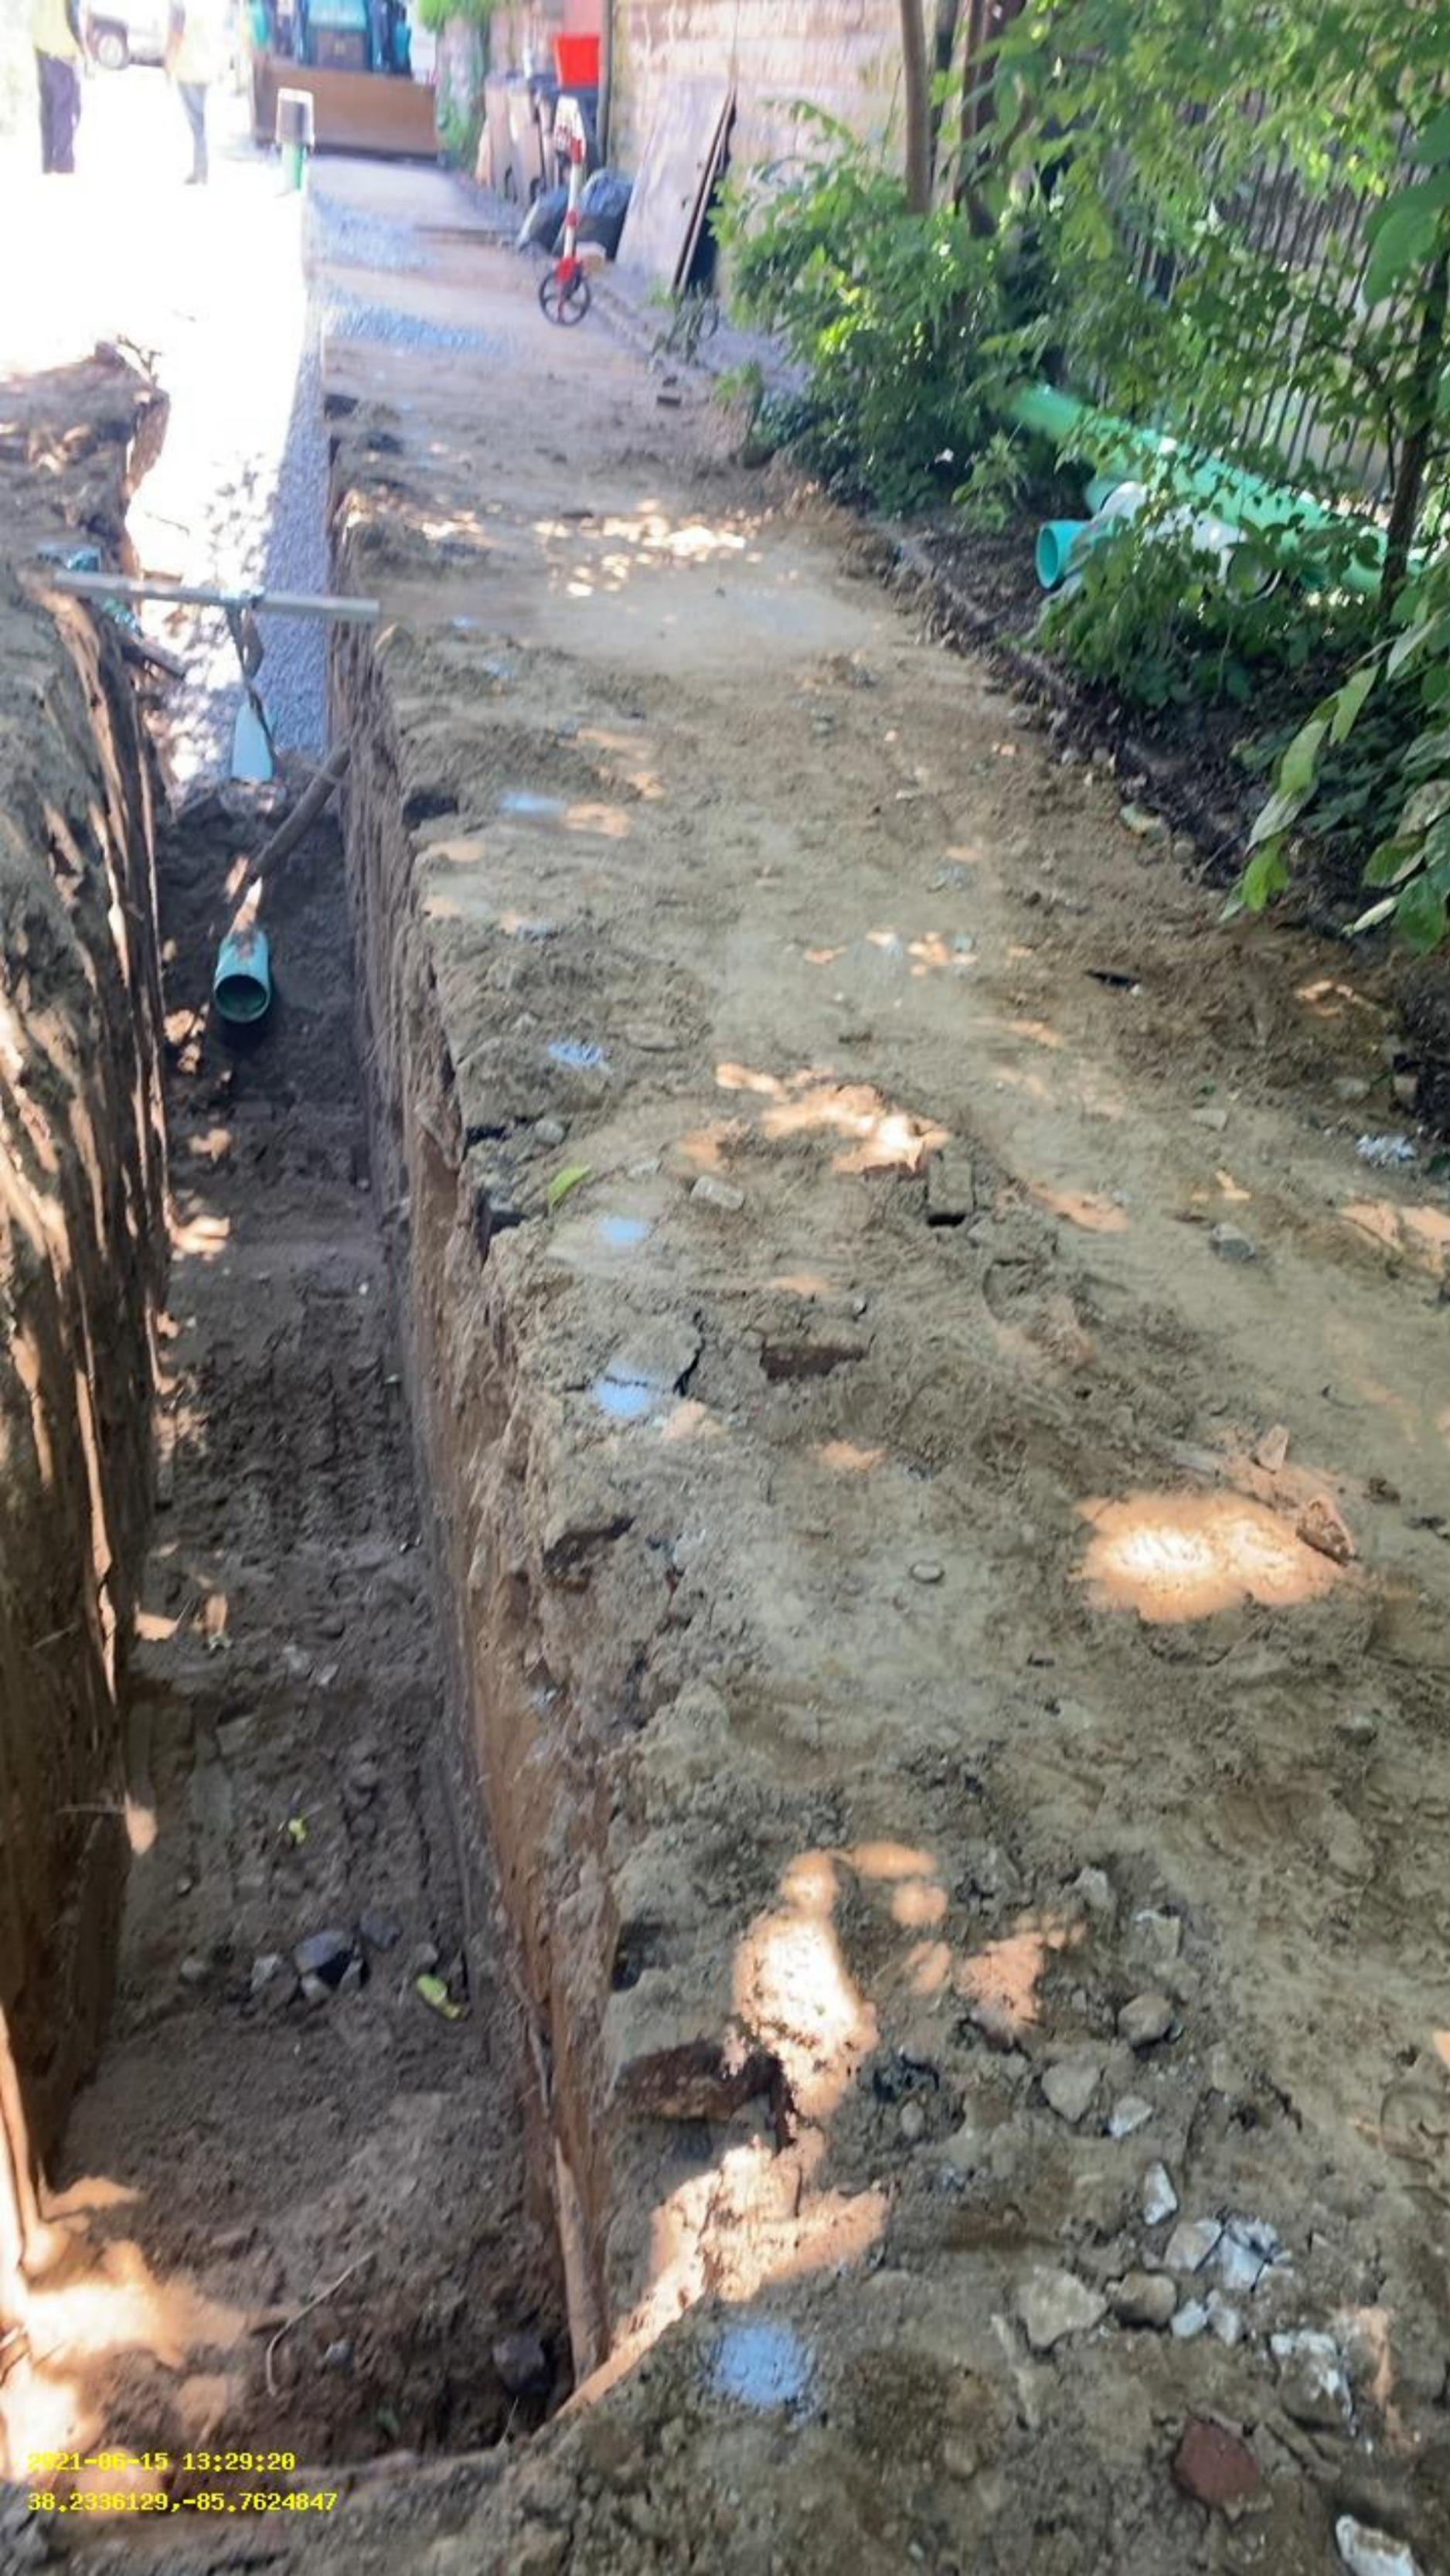
Responsible Party Comments: Gas damage was 135' west of west curb of Garvin. 72' east of the t in alley. 5' north of south alley. LG&E put a dead end cap on the gas main at the point it was damaged.

Cause Code: Failure to use hand tools within tolerance zone

Party's explanation for damage tried to split ditch between tele + gas, gas starts to work.

Yes, the white dots are post damage locates for the main.

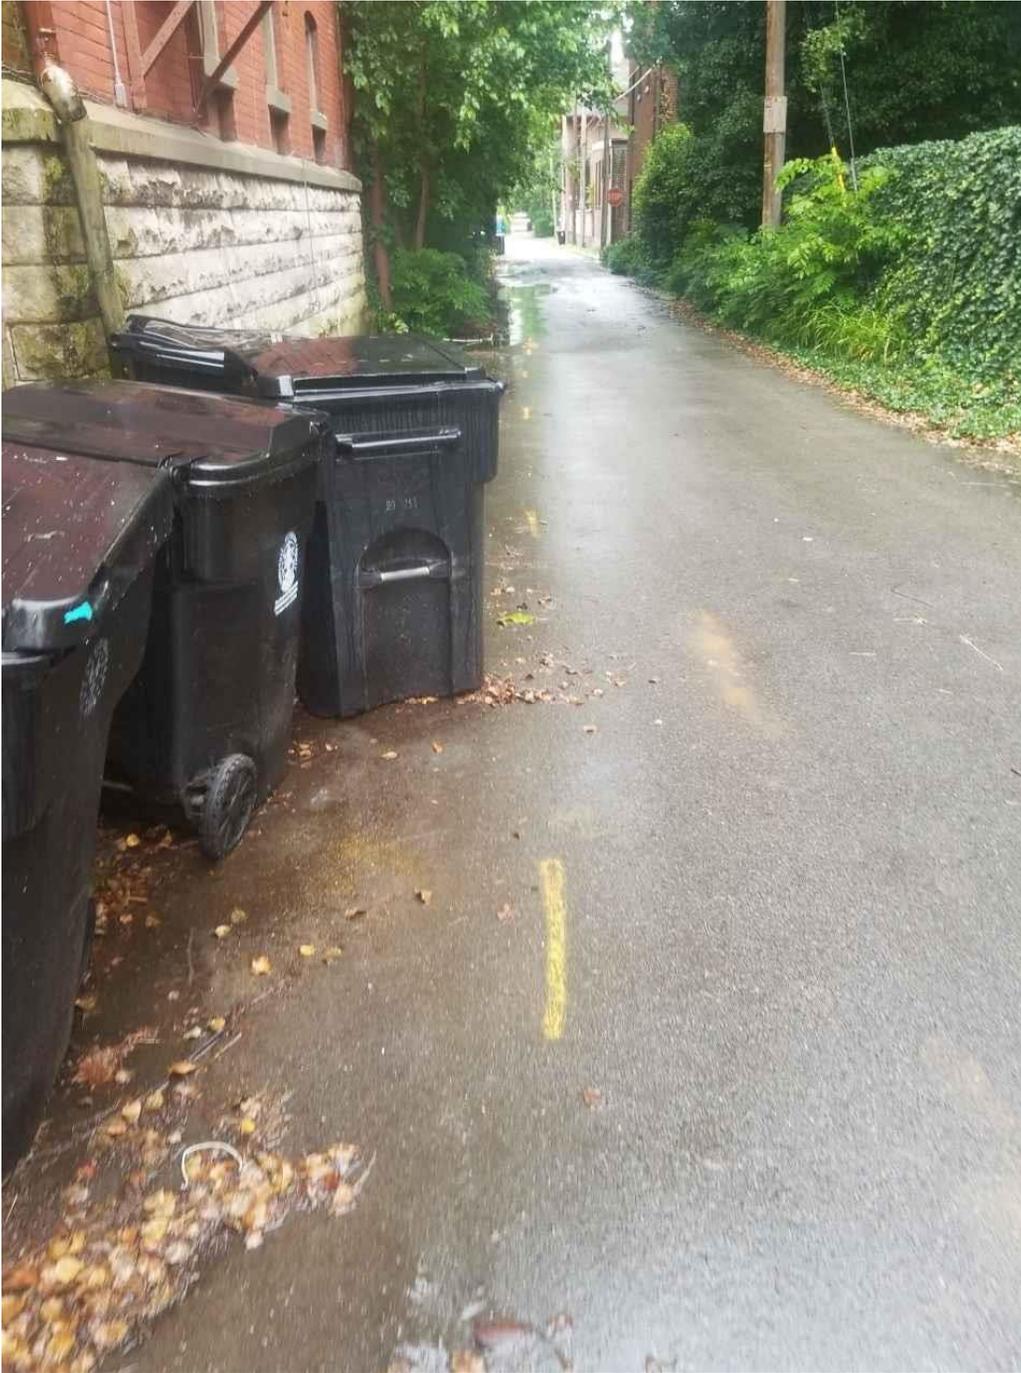
Ticket: 2106071602.00 Timestamp: 6/7/2021 2:04:44 PM

I think this photo is the same stretch looking the other direction. Those are the only angles we have.

- Invoice: Indicating the Excavator was bill \$1,623.46 for the damage repair.
- Photographs - 3: Two pre-excavation photographs taken on 06/07/21 indicating the incident location was marked with yellow paint and one damage photograph taken of the incident location depicting spoil piles and debris with white paint dots representing the gas main's path. Comparing these three photographs, the gas main was marked with yellow paint before excavation occurred and the excavation activities destroy all pre-excavation yellow markings.

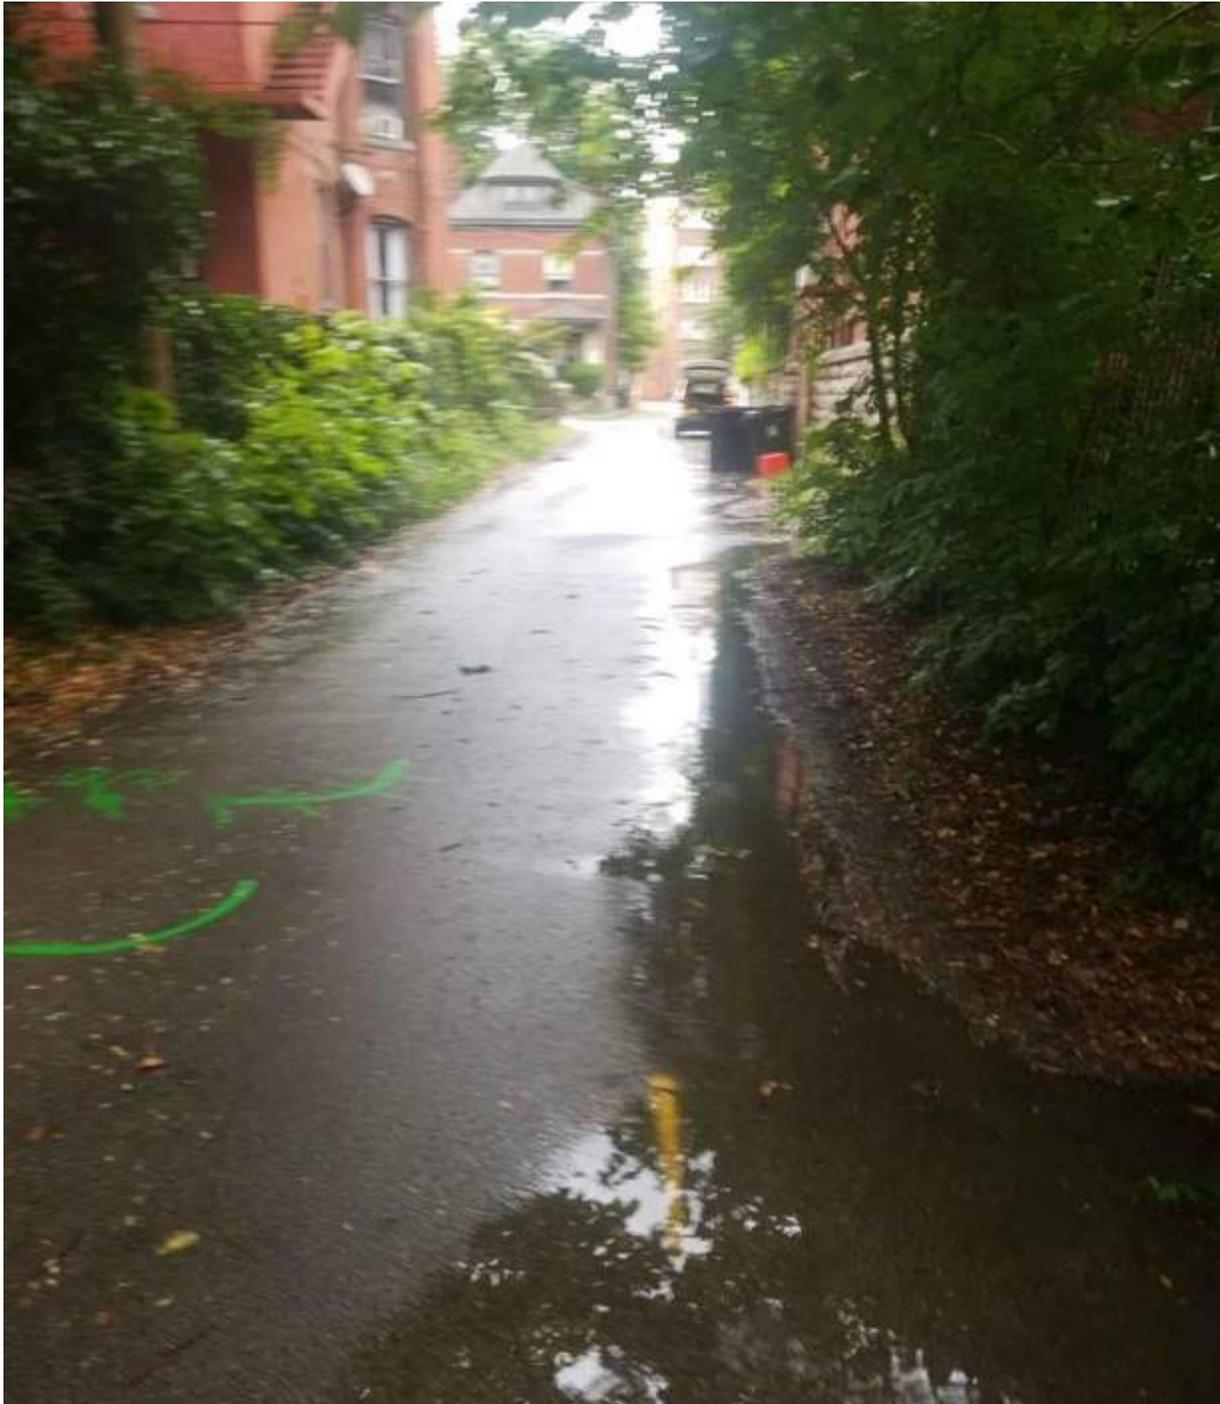
The first is a post locate photo, the second a damage photo you already have. Let me know if you need anything else.

photographs. *Note:* Pre Mr. Jones the white paint dots on the ground represent the gas main's path.
