**LEAKAGE CONTROL REPORT
 FIELD SURVEY**

Company Martin Contracting District _____
 City Tompkinsville State Ky
 No Address Nearest Street Address
Sicott + Hallee 7th Street

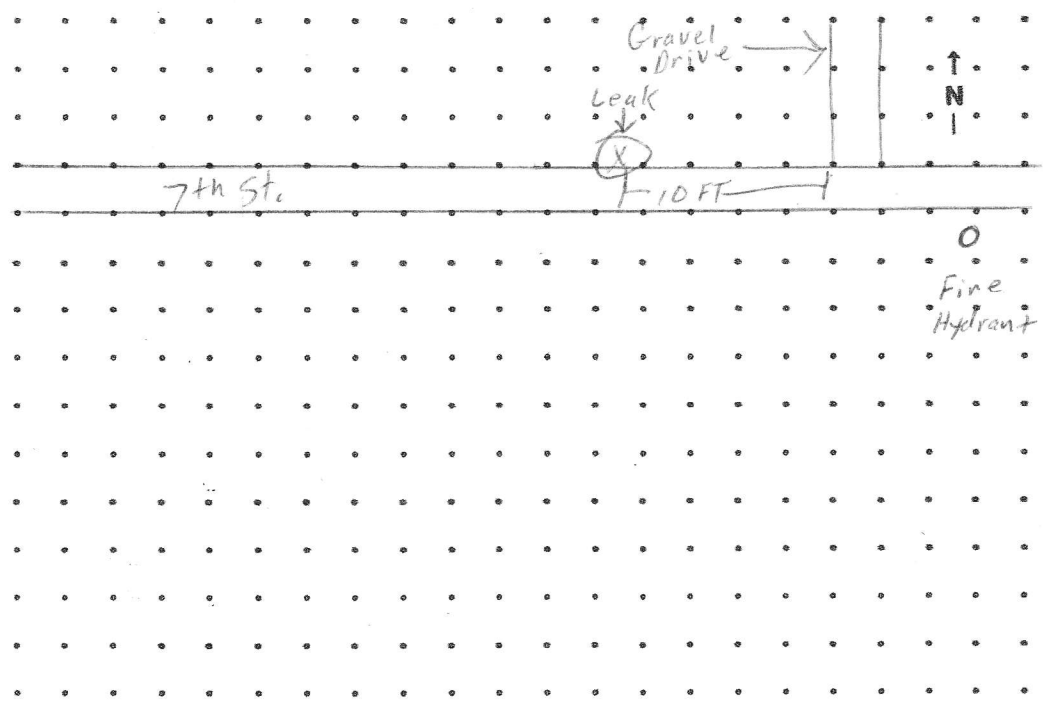
Remarks When we dug this up we found a 1" steel main with a pin hole in it. We repaired it with a clamp. There is also a threaded coupling in the section that needs replaced. When our welder is back, we will repair the entire section with new pipe.
