Field Site 60 Adamson Cemetery CA-25 Circirca1816-1963 Southwest corner of Henry Jones Road and Pleasant Valley Road Fredonia, KY 42411 37.159435, -87.993338

Field Site 61 Old Turley Farm CA-24 Circa 1910 East side of Crider Spur Road Fredonia, KY 42411 37.157066, -87.988215

Field Site 62 Wyatt-Wilson Farm CA-27 Circa 1850 575 Adamson Road Princeton, KY 42445 37.164416, -88.007071

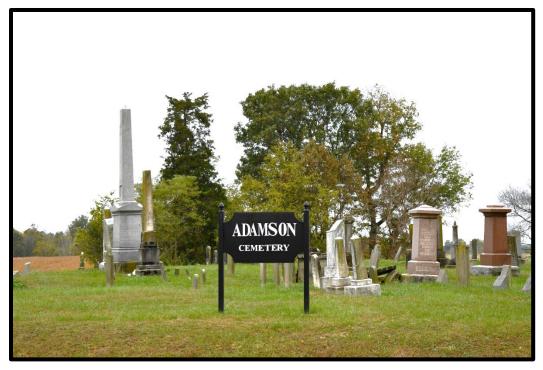
Plate 163. CA-25, Adamson Cemetery, looking southwest.

This 0.6-acre parcel is the Adamson Cemetery (**Plate 163**) associated with the Adamson Farm. The remains of this farm are situated northwest of this parcel (Field Site 59; CA-454). The Adamson family first settled this property in the 1820s when John Alexander Adamson, the original patriarch, purchased this land. A stone mason from Scotland, he chose the area, known as "The Knob," for its available rock. He died in 1834 and his son, George Warner Adamson, took over running the farm with his mother, Isabella. The stonework evident in the family cemetery and on the adjacent farm ruins was likely constructed from stone cut and laid by John Alexander or his son. Neighboring farmer James A. Wilson (1806-1868), who was also a stonecutter born in Fifeshire, Scotland, may have also carved some of the markers as well.⁹⁵

The Adamson Cemetery is recommended *Eligible* for the NRHP as one of the earliest cemeteries in the area, exhibiting notable Scottish stonemasonry work and designs. Per the guidance under Criterion Consideration D, cemeteries are not ordinarily considered eligible for listing in the National Register of Historic Places unless they contain the grave of a historical figure of outstanding importance and there is no appropriate site or building directly associated with his or her productive life, or if the cemetery derives its significance from graves of persons of transcendent importance; from age; from distinctive design features; from association with historic events; or for the ability to yield important information. The Adamson Cemetery appears to meet some of these considerations in terms of distinctive design features representing the work of local stone masons exhibiting traditional Scottish burial traditions. Therefore, it is recommended eligible for the NRHP under Criterion C for its design values. The cemetery has a high level of integrity of design, materials, workmanship, feeling, association, location, and setting.

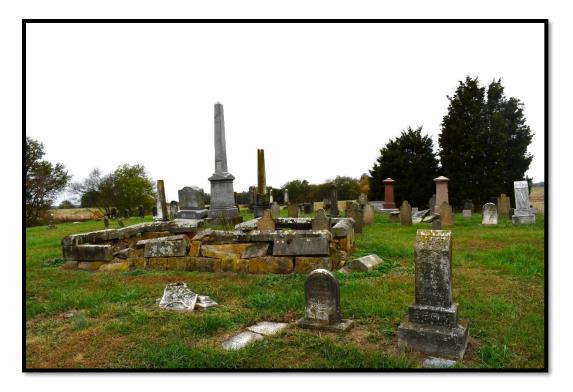
Plate 164. CA-25, Adamson Cemetery, looking south.

Situated on the southwest corner of Henry Jones Road and Pleasant Valley Road, the Adamson Cemetery is identified by a modern sign, but no fence or other boundary encloses the parcel. Many of the 106 marked burials represent the Adamson family or their extended relatives, including family names such as Boyd, Dishington, Glenn, Grove, Johnson, Leech, Maxwell, Peek, Wilson, and Wyatt. The oldest marked grave is that of Robert Smith, who died in 1816. The most recent burial is for siblings James and Grace Adamson, who died in the Adamson family homestead when the house burned in 1963.⁹⁶ All of the graves are older, with the majority dating from 1830 through 1900; only four graves postdate 1910. Although no grave depressions were noted, unmarked graves may be present considering the age of the cemetery. In the Christian tradition, the graves are oriented east-west with most of them legible. Most of the markers are stone, with a few from the later era of marble or granite. Some monuments have deteriorated or are broken; a family group enclosure of cut stone is in deteriorated condition (Plate 164). Marker forms represent a variety of shapes including pointed, rounded, rounded with square (Plate 165) or rounded corners, and squared upright markers. A few more elaborate designs include pedestal tombs with a vaulted roof or with a cap, pulpit markers, grave covers, obelisks, and a few newer plaque markers. Some footstones are present. Iconography present includes religious symbols including gates, lambs, and angel wings; flowers such as roses and morning glories; Masonic emblems; and a sunrise.

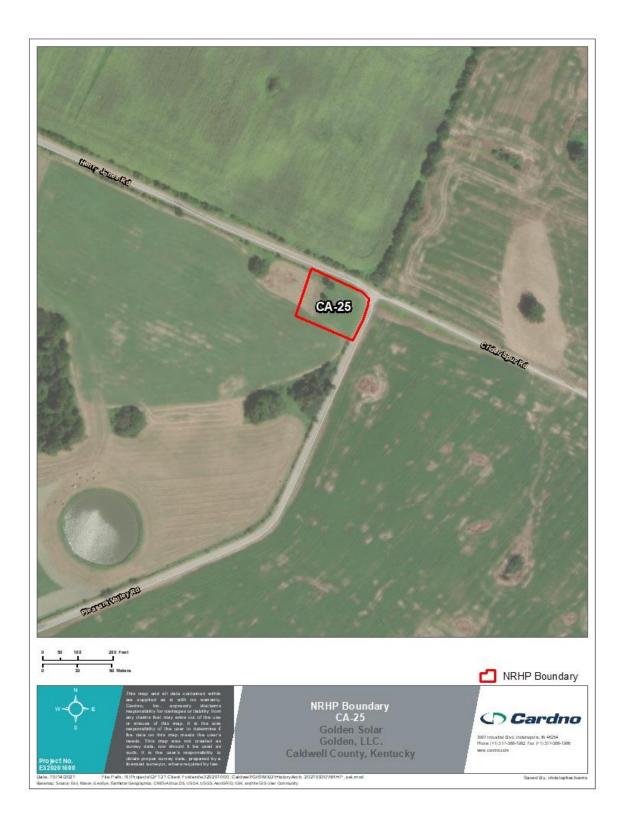
The recommended NRHP boundary includes the entire parcel on which the cemetery is situated, which encompasses the contributing elements historically associated with the property (**Figure 13**).

Figure 13. Proposed NRHP Boundary for the Adamson Cemetery (CA-25).

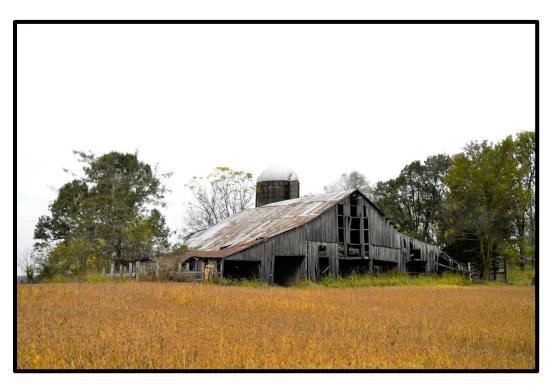
Plate 166. CA-24A and B, Transverse frame barn and Silo, southeast (front) and southwest elevation, looking north.

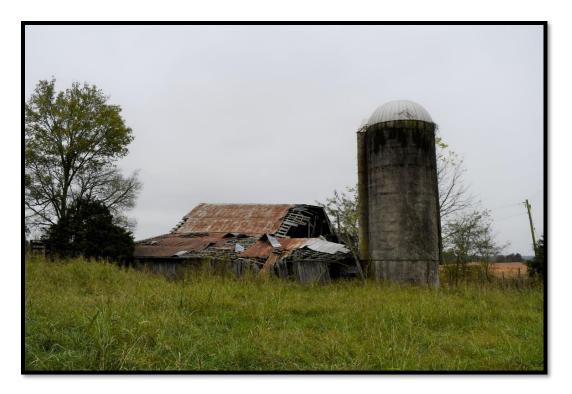
shaped metal top appears contemporaneous with the barn (**Plate 167**). An equipment shed (C) and chicken house (F) are situated north of the primary barn (**Plate 168**). The circa 1945 equipment shed has vertical wood siding and five open equipment bays on the southeast elevation. The shed roof, surfaced with corrugated metal, is supported by wood posts on the open elevation. Exposed rafter ends are in the eaves. The chicken house (F), also in poor condition, is immediately north of the equipment shed. It has a corrugated metal shed roof, vertical wood plank siding, and a door composed of vertical boards. Both buildings were evident on 1952 aerials.⁹⁸

Plate 167. CA-24A, Barn, and CA-24B, silo, northwest and northeast elevations, looking south.

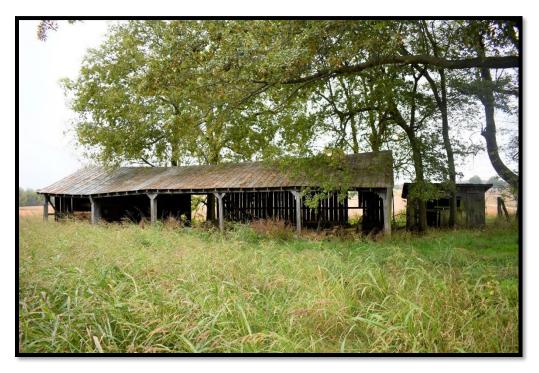
Plate 168. CA-24C, Equipment shed (left), and CA-24F, chicken house (right), southeast elevations, looking northwest.

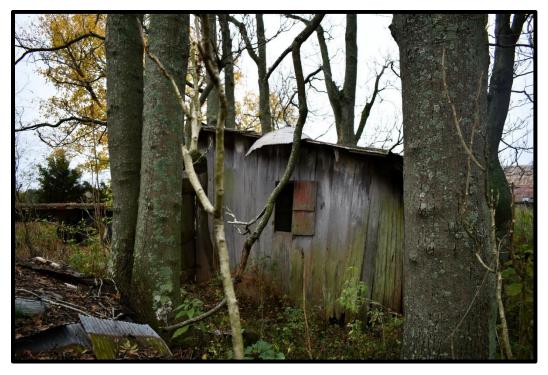
Plate 169. CA-24D, Shed, northwest elevation, looking southeast.

Within the trees to the southeast of the equipment shed are the ruins of two small sheds whose use remains unclear. Both were also evident on the 1952 aerials.⁹⁹ The one still partially standing (D) is a one-story, wood frame building with vertical wood plank siding and a corrugated metal gable roof**Plate 169**). It has a rectangular window opening without a window, which can be secured with an operable wood shutter. The collapsed wood shed (E) is a ruin with a corrugated metal shed roof and vertical wood plank siding (**Plate 170**). A modern Midwest Three-Portal barn (G) is a wood frame building clad with corrugated metal siding, set under a gable roof (**Plate 171**). A large center aisle is flanked by two smaller aisles. This barn was erected between 1998 and 2004 and enlarged with shed additions on the sides by 2006. A smaller barn was situated just south of this barn and is visible on the 1952 aerial with a water tower adjacent. The older barn was demolished circa 2008.¹⁰⁰ The ruins of the metal water tower (H) are evident south of the existing barn (**Plate 172**).

Within the trees to the southeast of the equipment shed are the ruins of two small sheds whose use remains unclear. Both were also evident on the 1952 aerials.¹⁰¹ The one which is still partially standing (D) is a one-story, wood frame structure with vertical wood plank siding and a corrugated metal gable roof (**Plate 169**). It has a rectangular window opening without a window, but which can be secured with an operable wood shutter. The collapsed wood shed (E) is a ruin with a corrugated metal shed roof and vertical wood plank siding (**Plate 170**).

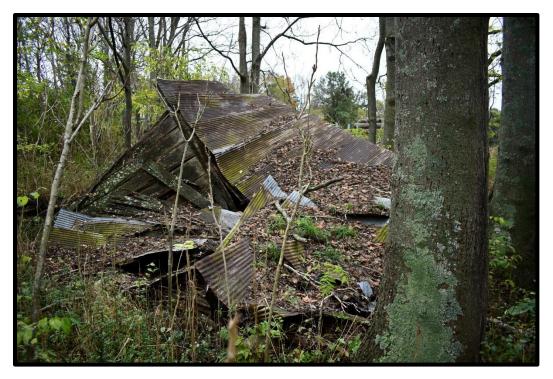
Plate 170. CA-24E, Ruinous shed, northwest elevation, looking southeast.

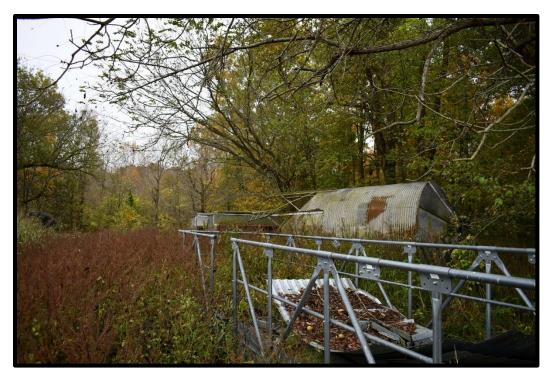
Plate 172. CA-24H, Collapsed Water Tower, looking southeast.

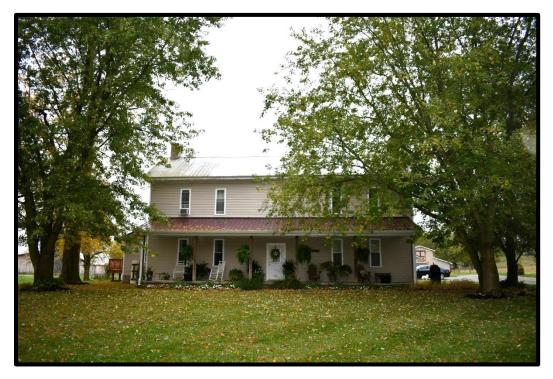
Plate 173. CA-27, I-House, looking southwest.

This two-story, wood frame house has a single-pile plan measuring five bays wide by one bay deep, and has a W-W-D-W-W fenestration pattern (Plate 173). It has a side-gable roof clad in corrugated metal with boxed eaves. An interior brick chimney is located at the northwest and southeast ends of the house along the ridge; another masonry chimney is along the slope of the roof in the rear ell. Set on a continuous stone foundation, the exterior walls are surfaced in vinyl siding and pierced by 1/1 vinyl, single-hung sash replacement windows. The window openings appear to have been reduced in size, when vinyl was installed as the primary cladding material. The façade includes a one-story, five-bay, open shed roof porch supported by square wood posts set on a poured concrete foundation; the porch was rebuilt circa 1945. The porch shelters a one-light, two-panel fiberglass main entry door. A one-story rear ell addition, wrapped in vinyl siding, extends from the southwest elevation with a gable roof clad in corrugated metal. Windows on the rear ell include 1/1 and 6/6 vinyl, single-hung sash windows set independently. The rear ell addition dates to the 1880s, but was enlarged with a sewing room, bath, utility room, and basement on the southeast elevation circa 1950. Wooden decks extend from the rear ell on the southeast and southwest elevations. A rear porch wraps around the west side of the house and rear ell. Similar to the front porch with square wood posts set on a poured concrete foundation, it has a shed roof on the portion attached to the main house and is incorporated under the main roof of the rear ell. Inspection of Google maps historic imagery indicates that the smokehouse and outhouse noted on the original form were demolished or relocated between 2008 and 2011.¹⁰⁵

This property is recommended *Not Eligible* for the NRHP. Extensive alterations have impacted the integrity of this I-House and its associated agricultural landscape. It is not a notable example of a midnineteenth/early twentieth century farmstead in Caldwell County. It does not display the distinctive characteristics of a type of building design that is rare or innovative in the region or state; therefore, it is not eligible for the National Register under Criterion C. This property does not have an association with a significant person; therefore, it is not eligible for the NRHP under Criterion B. Finally, the property does not have an association significant to the history of Caldwell County, and is therefore not eligible under Criterion A.

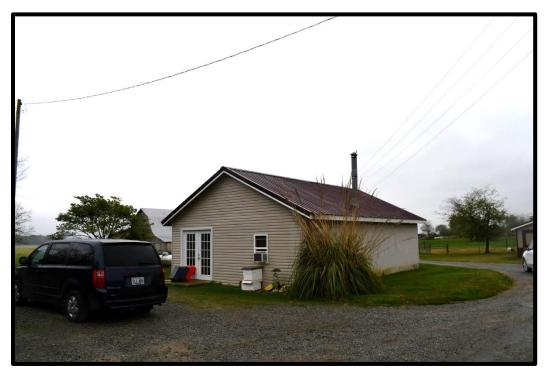
A garage (B), built circa 1950, is to the southwest of the residence (**Plate 174**). Constructed of concrete block, the garage has a front-gable roof clad in corrugated metal, pierced by a metal flue on the northwest slope. The garage was enclosed and converted to an alternate use. Vinyl siding extends from the ground surface to the eaves on the façade, which features fifteen-light, wood, paired French doors and a 1/1 vinyl, single-hung sash window. A small modern transverse frame horse barn (C) is situated to the southwest of the converted garage on the opposite side of the driveway (**Plate 175**).¹⁰⁶ It has a monitor roof and both the walls and the roof are clad in corrugated metal sheeting; the building rests on a poured concrete foundation. The barn doors, hay loft, and main entry door have cross buck detailing, and two-light vinyl, sliding windows are present on the southeast elevation. The barn has a center aisle and open pens on the northwest. A wood frame outhouse (D) (**Plate 176**) and a metal Quonset hut (E) (**Plate 177**) are located to the southeast of the monitor-roofed, transverse frame barn. The outhouse was either relocated here or built circa 2013, and may have been the original one situated behind the

Plate 174. CA-27B, Garage, northeast (front) and northwest elevations, looking south.

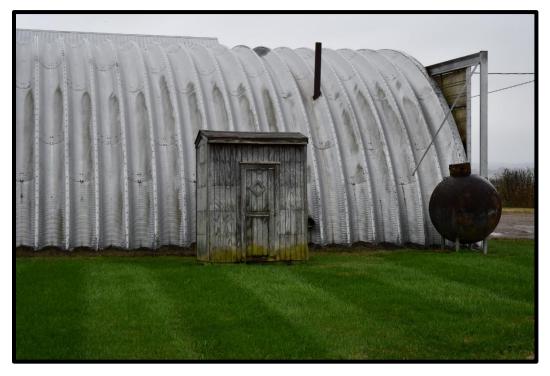
Plate 176. CA-27D, Outhouse, northwest elevation, looking southeast.

house when it was originally recorded.¹⁰⁷ It sits on a pier foundation and is topped by a side-gable roof clad in asphalt shingles with vertical wood panel walls. The Quonset hut, which serves as a garage, was installed circa 1975 and is wrapped in corrugated metal with paired corrugated metal sliding doors on both the southwest and northeast elevations.

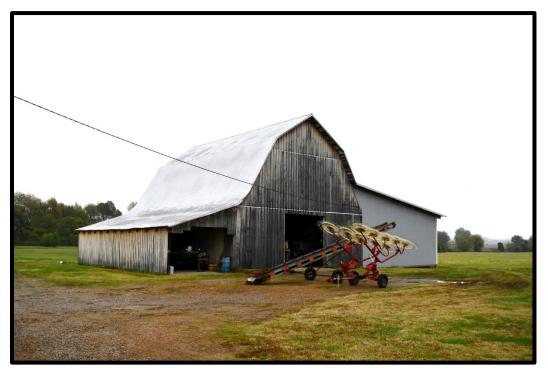
A large wood frame barn, southeast of the Quonset hut, appears to be a multi-purpose barn (F) (Plate 178). The building features a relatively tall and narrow gambrel roof surfaced in corrugated metal and a central aisle accessed on the gable end. The overall dimensions suggest it was a dark-fired tobacco barn, converted to a stock barn. Evident on 1952 aerials, this barn may be the 1892 tobacco barn referenced in the previously mentioned Crittenden Press.¹⁰⁸ The exterior walls of the barn are board and batten set on a continuous stone foundation. An older wood frame shed addition with a shed roof and exposed rafter ends is on the northwest elevation. A larger, two-story shed addition built between 1955 and 1967 is present on the southeast elevation of the barn. The roof and exterior walls of the shed addition are covered in corrugated metal sheeting. The foundations of metal silos northeast of the barn are all that remains of the silos constructed between 1955 and 1967.¹⁰⁹ A small wood shed (G) is located southwest of this barn (Plate 179). Constructed circa 2019, the walls are vertical wood panels pierced by window openings that have been narrowed with wood to resemble arrow slits. The shed is topped by a gable roof surfaced in corrugated metal. Across the farm road from the shed, to the northwest, is a concrete block well/pump house (H) (Plate 180). Built circa 1950, the well house is wrapped in corrugated fiberglass sheeting on the southeast and southwest elevations and topped by a shed roof clad in corrugated metal. The wood door is held in place by long strap hinges.

Plate 178. CA-27F, Finnish Cattle Barn, northwest and southwest (front) elevations, looking east.

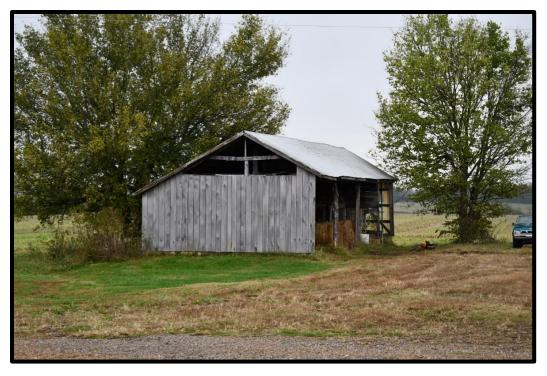
A four-bay machine shed is situated south of the shed and well house and was on site by 1952 (I) (**Plate 181**).¹¹⁰ With open bays on the southwest elevation, the other enclosed sides are clad with vertical plank wood. The wood frame building rests on a poured concrete foundation and sits under a salt box roof surfaced in corrugated metal. The gable ends are open. Built between 1955 and 1967, the building furthest to the south on the property is a modern front-gable pole barn (J) (**Plate 182**). The roof and walls of the barn are covered in corrugated metal. The building has open eaves with exposed rafter tails, a central aisle, and a continuous foundation. There is a shed addition on the southwest elevation of the barn added circa 2016.¹¹¹ The final barn located on the property is a large pole barn used for cattle operations (K) (**Plate 183**). Present by 1952, the open, wood frame barn rests on a concrete foundation.¹¹² The barn is sheltered by a shed roof surfaced in corrugated metal and supported by timber posts. Two ventilators are situated along the ridge. The walls are dressed in vertical wood panels and a large sliding corrugated metal door is located on the northeast elevation.

Plate 181. CA-27I, Machine shed, northwest and southwest elevations, looking east.

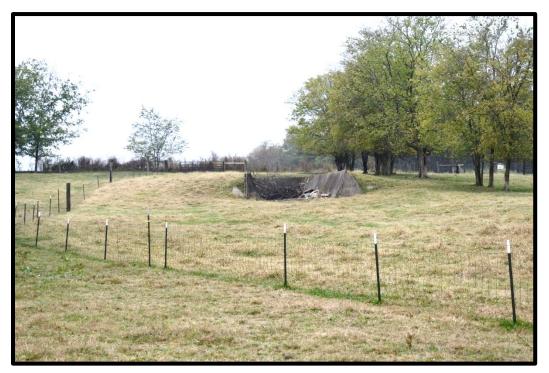
In a field to the west of the cluster of buildings is a horizontal bunker silo (L) (**Plate 184**). The grain storage facility is constructed of poured concrete and measures approximately 105 ft. long by 22 ft. wide. It does not appear to be in use any longer and is currently is a deteriorated state. Typically built after World War II, this structure was installed between 1952 and 1955.¹¹³

Plate 184. CA-27L, Bunker silo, looking northwest.

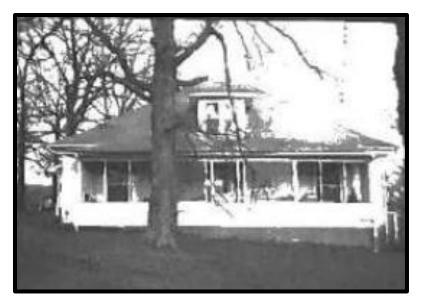
Figure 14. KHC Survey Photo, Job Dean House.¹¹⁶

Originally recorded in 1991, this 441.85-acre property was known as Dean Hill or the Job Dean Farm. When recorded, the circa 1915 Craftsman Bungalow was extant. A combination smokehouse and coal shed with board and batten siding and a fieldstone pier foundation was also on the property behind the house. No other buildings were noted on the form.¹¹⁴ However, both the bungalow and the smokehouse/coal house appear to have been demolished between 2012 and 2014. A large, older dairy barn, along with smaller outbuildings, were demolished between 2014 and 2016.¹¹⁵ The buildings that remain include a small circa 1900 frame house, a circa 1975 trailer, several sheds and carports, and the ruins of several agricultural features.

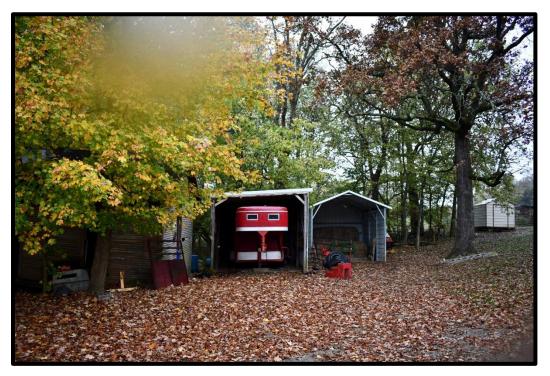
Plate 186. CA-28B, Carports, northeast elevations, looking southwest.

Immediately northwest of the house, two small, single-vehicle carports (B) were added to the site in the 2010s (**Plate 186**). The carport closest to the house is a wood frame building clad with corrugated metal siding and a corrugated metal shed roof. The second carport has a front gable roof covered with corrugated metal and a metal frame surfaced with corrugated metal. West of the carports are a set of sheds (**Plate 187**). The prefabricated metal shed (C) was added to the property circa 2016. Further west, the older shed (D) with a corrugated metal gable roof and vertical wood siding was built on the site circa 1980. Northeast of the sheds is a circa 1980, single-wide prefabricated mobile home (E) (**Plate 188**). It features corrugated metal siding, 1/1 metal windows placed independently, and a rebuilt corrugated metal gable roof. A small entry porch is located on the southeast elevation. Several small carports and sheds (F, G, and H) are northeast, north, and northwest (respectively) of the mobile home (**Plate 189**). One shed (H) appears to date to the installation of the mobile home, but the remaining buildings were

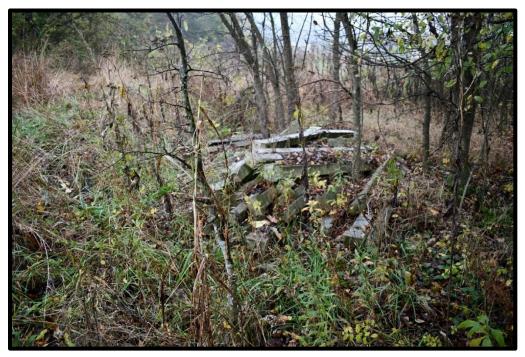
Plate 190. CA-28I, Building ruins, looking southeast.

The ruins of several agricultural features are southwest of the cluster of buildings and southwest of the site of the original house and barn. The first feature consists of the ruins of a poured concrete foundation (I) (**Plate 190**). Aerials indicate it was an outbuilding with a gable roof constructed between 1967 and 1982, which appears to have collapsed circa 2008.¹¹⁸ Immediately southeast, a larger, gabled outbuilding was constructed during the same period and collapsed circa 2010.¹¹⁹ All that remains of this building are two parallel, concrete block trenches (J) crossed by large wood ties laid across the top and pipes (**Plate 191**). Northwest of these two ruins, the remains of an equipment shed (K) with wood siding and a corrugated metal roof are apparent (**Plate 192**). Numerous wood posts are placed south of the ruins. This building was built between 1983 and 1998.¹²⁰ Several other buildings, such as silos, were recently demolished, based on a review of aerials.¹²¹

This property is recommended *Not Eligible* for the NRHP. Demolition of the main house and a number of agricultural buildings has adversely impacted the integrity of this property. It is not a notable example of an early-twentieth-century farm in Caldwell County. It does not display the distinctive characteristics of a type of building design that is rare or innovative in the region or state; therefore, it is not eligible for the National Register under Criterion C. This property does not have an association with a significant person; therefore, it is not eligible for the NRHP under Criterion B. Finally, the property does not have an association significant to the history of Caldwell County, and is therefore not eligible under Criterion A.

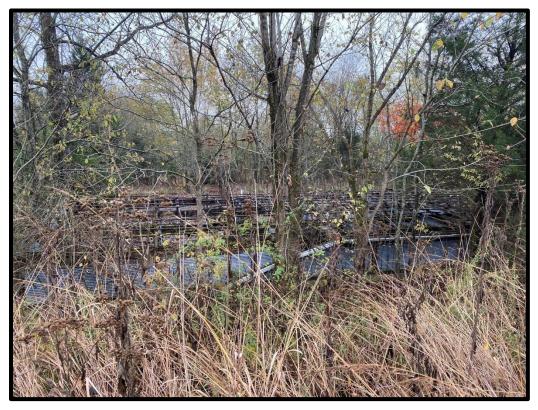
Plate 192. CA-28K, Equipment shed (ruin), looking south.

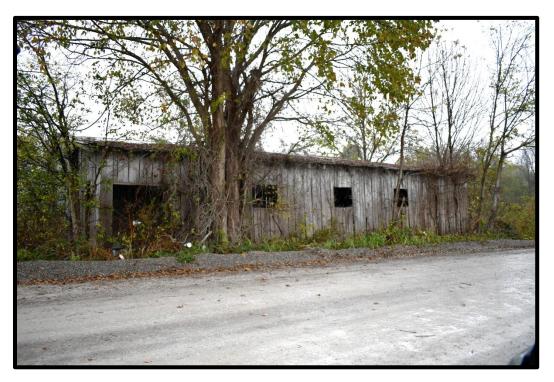
Plate 193. CA-455, Stock Barn, southeast elevation, looking northeast.

The only building currently on this 103-acre property is a stock barn (**Plate 193**), but historic aerials indicate that this was a functioning farm in the 1950s. Inspection of historic aerials indicates that this building was erected circa 1961. The associated farm buildings were demolished by 2006. The property was purchased by N.H. and Carrie Talley Sr. in 1961 and remains owned by their family.¹²²

This wood frame barn features vertical wood plank siding and a shallowly-pitched gable roof surfaced with corrugated metal. Exposed rafter ends are present in the eaves. Most openings are missing windows and doors, but sliding corrugated metal doors are present at the aisle opening on the northeast elevation. The barn appears to have been intended for a specialized type of stock, due to its small size. Cardno also surveyed this property in 2020 as part of the Caldwell Solar project. This project has not yet been reviewed by KHC/SHPO.

This property is recommended *Not Eligible* for the NRHP. This building is not a notable example of a midtwentieth century barn in Caldwell County. This barn does not display the distinctive characteristics of a type of building design that is rare or innovative in the region or state, and therefore, it is not eligible for the National Register under Criterion C. This property does not have an association with a significant person; therefore, it is not eligible for the NRHP under Criterion B. Finally, the property does not have an association significant to the history of Caldwell County, and is therefore not eligible under Criterion A.

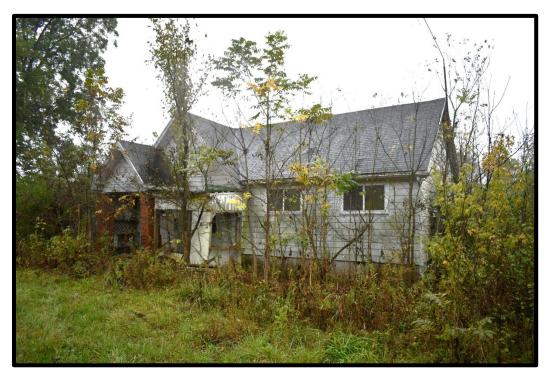
Plate 195. CA-456, House, northeast elevation, looking south.

Built circa 1948, this one-story house (**Plate 195**) appears to be the sole building on the 29.53-acre parcel. The building was heavily overgrown with vegetation at the time of the site visit, and appears abandoned. This one-story, wood frame house is clad with aluminum siding set on a continuous concrete block foundation. The cross-gable roof is surfaced with asphalt shingles. Visible windows are two-light vinyl siding and 6/1 wood, double-hung sash. A front gable porch, resting on brick piers, extends northeast on the façade. A shed roofed extension of this porch with wood posts is northwest of the porch. Aerials indicate an addition on the southeast elevation, but it was obscured by vegetation. Cardno also surveyed this property in 2020 as part of the Caldwell Solar project. This project has not yet been reviewed by KHC/SHPO.

This property is recommended *Not Eligible* for the NRHP. It is not a notable example of a mid-twentiethcentury house in Caldwell County. It does not display the distinctive characteristics of a type of building design that is rare or innovative in the region or state; therefore, it is not eligible for the National Register under Criterion C. This property does not have an association with a significant person; therefore, it is not eligible for the NRHP under Criterion B. Finally, the property does not have an association significant to the history of Caldwell County, and is therefore not eligible under Criterion A.

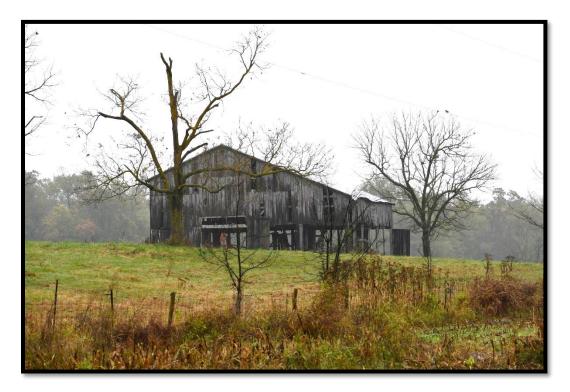
Plate 196. CA-45A, Barn, west (front) and south elevations, looking northeast.

An older transverse frame barn is the most visible building from the right-of-way. Built prior to 1952, this tobacco barn has vertical wood siding, a central aisle in the gable end, and a front gable roof clad with corrugated metal.¹²⁷ Large sections of the siding are missing, with the lower sections of some sections cut off. Two additional barns and five silos are visible in the distance at the end of the farm road. All of these facilities were built between 1967 and 1982.¹²⁸ The northernmost barn (B) is a wood frame building with a corrugated metal gable roof and metal sliding doors. The five corrugated metal grain bins (C) are southwest of this barn. A larger barn (D) is situated southeast of the grain bins. It has corrugated metal siding and a gable roof.

CRA determined this property Not Eligible as part of a 2019 survey for KYTC. Cardno concurs that this property is recommended *Not Eligible* for the NRHP. The loss of the older house and most of the older outbuildings has destroyed the architectural integrity of this property. It is not a notable example of a nineteenth or twentieth-century farm in Caldwell County. In addition, there are no buildings on this property that display the distinctive characteristics of a type of building design that are rare or innovative in the region or state; therefore, the property and each individual building(s) is not eligible for the National Register under Criterion C. This property does not have an association with a significant person; therefore, it is not eligible for the NRHP under Criterion B. Finally, the property does not have an association significant to the history of Caldwell County, and is therefore not eligible under Criterion A.

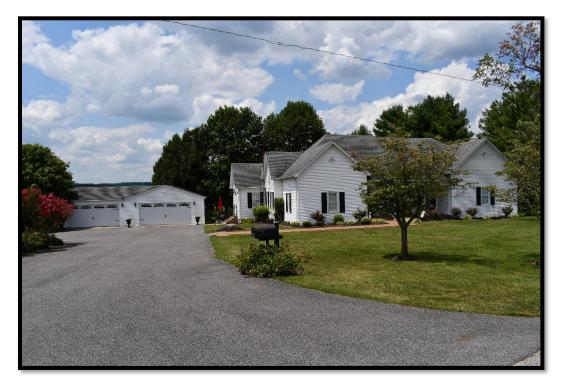
Plate 198. CA-507, House and garage, façades, looking west.

This property, which is located on a 74.25-acre parcel, includes a house, garage, and barn. The primary resource is a heavily modified T-plan, circa 1900 residence (**Plate 198**). The façade has a W-D-W-W fenestration pattern. Its multi-gabled roof has a central hip and it is covered with asphalts. The exterior is clad in vinyl siding and the visible sections of the foundation are constructed with concrete block. The windows throughout are of vinyl sash construction with 6/6 light patterns, which are flanked by non-operational shutters. This building has sustained multiple additions to all elevations, which have altered its original T-plan.

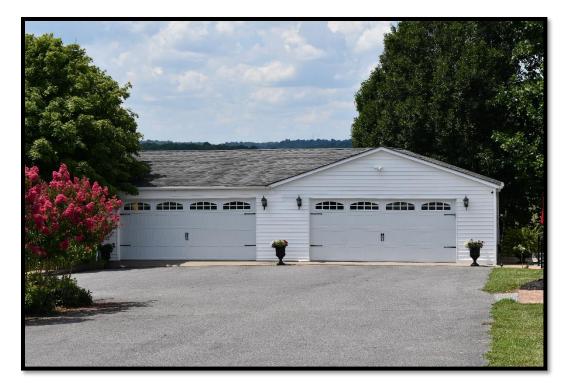
A garage (B), located to the immediate southwest of the primary resource, was constructed circa 1990 and replaced an earlier garage at this location (**Plate 200**). This building is a single story in height and has a cross-gabled roof with asphalt shingles. Two garage bays with modern overhead garage doors are located on its east elevation. The exterior is clad with vinyl siding.

Plate 200. CA-507B, Garage, looking west.

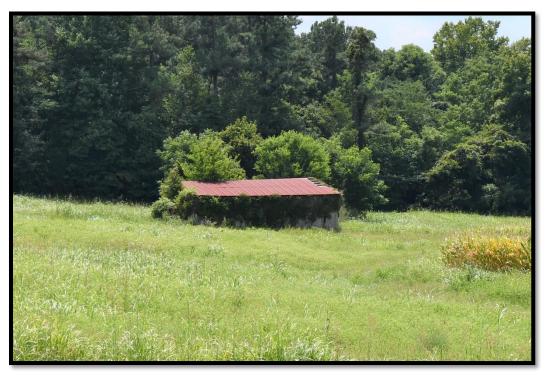
A barn (C), located on the southern section of the property, is situated within a group of trees and surrounded by overgrown vegetation (**Plate 201**). This building is a single story in height and has a shallow-pitched gable roof covered by metal panels. Its exterior is clad in vertical wood plank siding. This building's materials suggest it was constructed circa 1940, but it does not appear at this location on historic aerials of the property between 1984 and 1993.¹²⁹ This may indicate the resource was moved to this location.

Plate 201. CA-507C, Barn, looking southwest.

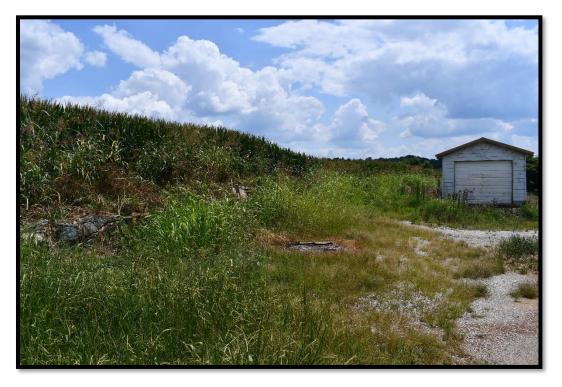
Plate 202. CA-508, Garage and landscape feature, looking south.

This parcel, located on the east side of Coleman Crider Road, is 138.39 acres in size. The primary resource is a circa 1945 concrete block garage which was associated with a farmstead that is no longer extant (**Plate 203**). This garage is a single story in height and rests on a poured concrete foundation. Its exterior is clad in metal siding and the shallow-pitched gabled roof is covered by metal panels. A stone wall (B), parged in sections, is located to the east of the resource (**Plate 204**). This may be the remnants of a landscape feature. It is surrounded by overgrown vegetation and is crumbling in sections. The visible sections are approximately twenty feet in length and two feet in height. Further investigations of the surrounding area revealed no other remnants of the former farmstead.

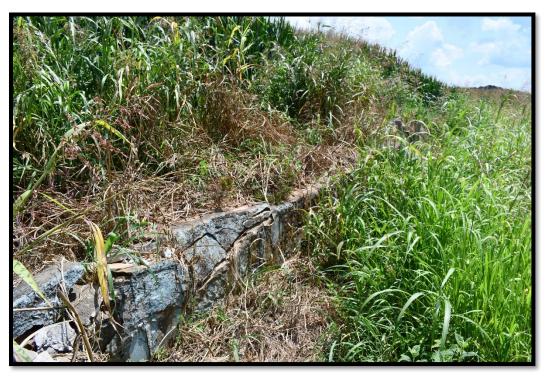
Plate 204. CA-508B, Stone landscape feature, looking southeast.

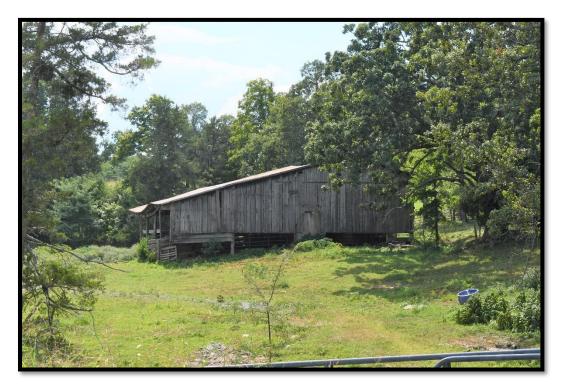
Plate 205. CA-509, Cattle barn, east elevation, looking west.

This 317.3-acre parcel contains a barn, equipment shed, and a manufactured house. Prior to circa 2000, this property consisted of a house and a number of domestic and agricultural outbuildings.¹³⁰ Presently, all that remains of the original farmstead is a cattle barn and an equipment barn. The primary resource is a circa 1960 cattle barn (Plate 205). This building is of wood pole construction and its exterior is clad in vertical wood planks. Its gabled roof has a metal panel roof covering, and an open-ended shed addition is present on the south elevation.

This property is recommended *Not Eligible* for the NRHP. The loss of the historic house and most of the historic outbuildings has destroyed the architectural integrity of this property. It is not a notable example of a mid-twentieth-century farm in Caldwell County. In addition, there are no buildings on this property that display the distinctive characteristics of a type of building design that are rare or innovative in the region or state; therefore, the property and each individual building(s) is not eligible for the National Register under Criterion C. This property does not have an association with a significant person; therefore, it is not eligible for the NRHP under Criterion B. Finally, the property does not have an association significant to the history of Caldwell County, and is therefore not eligible under Criterion A.

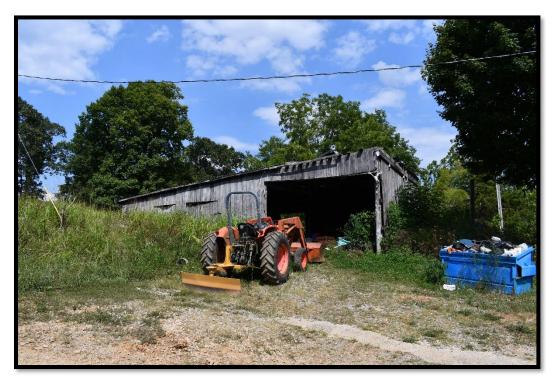
Plate 206. CA-509B, Equipment shed, west elevation, looking east.

The second resource is a circa 1940 wood frame equipment shed (B) (Plate 206). This building has a north sloping shed roof covered by metal panels. A single-bay opening is present on the west elevation. Its exterior is clad with vertical wood plank siding.

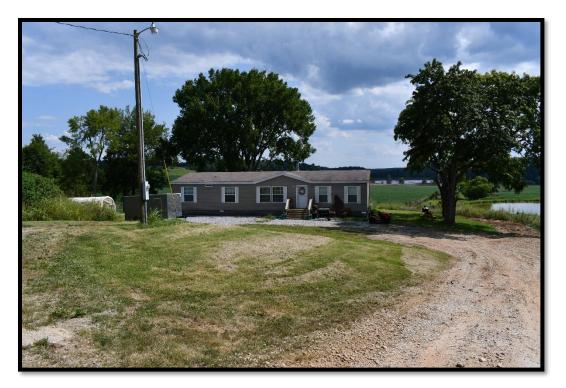
The final resource on the property is a circa 2018 manufactured home (C) (**Plate 207**). This resource replaced an earlier residence that is no longer extant. This building is a single story in height, and the façade has a W-W-W-D-W-W fenestration pattern. Its side-gabled roof is covered by asphalt shingles and its exterior is clad in vinyl siding. The windows throughout are of vinyl sash construction with an 8/1 light pattern.

Plate 207. CA-509C, Manufactured house, façade, looking south.

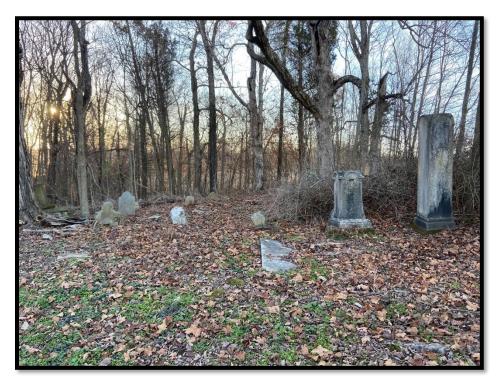
Plate 208. CA-9, Blue Cemetery, looking west.

According to *Caldwell County, Kentucky* History, the Elkhorn Tavern was a stop on the Trail of Tears Northern Route, which extended approximately along the route of US 91 through Caldwell County. During their forced encampment near the tavern, several Cherokee peoples died and were reportedly interred on the property.¹³² It is unclear, from perusal of numerous secondary sources, if the burials are adjacent to this cemetery or if they are across Skinframe Creek Road. More research would need to be accomplished to determine their existence, number, and location. No above-ground features or remains were located during the historic architectural survey. The accompanying archaeological study deals with the below-ground remains or features associated with this event.

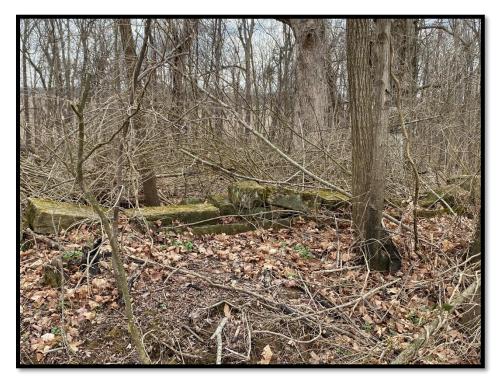
Plate 209. CA-9, Blue Cemetery. Stone wall looking NW.

Cardno also surveyed this property in 2020 as part of the Caldwell Solar project. This project has not yet been reviewed by KHC/SHPO. This cemetery was also previously recorded in 1992 as a secondary resource on the old Elk Horn Tavern property. At the time of the survey, the only remaining building o was the Elk Horn Tavern smokehouse. This building is no longer extant and the cemetery is the only extant resource.

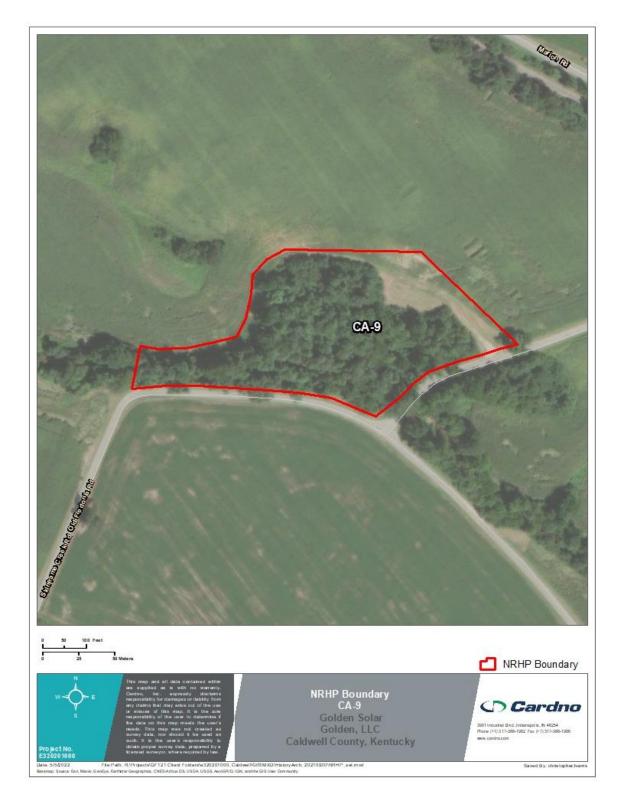
The recommended NRHP boundary includes an approximately 4.2 acre wooded area on which the cemetery is situated. This boundary encompasses the above-ground contributing elements historically associated with the property. As well, the proposed NRHP boundary includes a large buffer outside the stone wall to account for potential burials of enslaved African Americans, if they are present.

Figure 15. Proposed NRHP Boundary for the Blue Cemetery (CA-9).
