## SP223740: U3 BFP 3B volute replacement (EPS rep onsite 3/13/24)

### **CLOSING REPORT**

<b>CUSTOMER</b>	: East Kentucky Power Cooperative	<b>REPORT DATE</b>	: 12/23/24
<b>PLANT NAME</b>	: Spurlock Station	<b>REPORT NO.</b>	: 57566-CR1
<b>CITY / STATE</b>	: Maysville, Kentucky	<b>CUST. ORDER</b>	: SP13068
<b>EQUIPMENT</b>	: 8 X 10 X 14 HDB 11-Stage	<b>COPY</b>	: Jody McCord
<b>SERVICE</b>	: Boiler Feed	<b>FILE</b>	: 57566
<b>MANF.</b>	: Byron Jackson	<b>PAGE</b>	: 1 of 5 total pages
<b>SERIAL NO.</b>	: Unit 3

**East Kentucky Power Cooperative – Spurlock Generating Station**  
Boiler Feed Pump Repair  
Byron Jackson 8X10X14 HDB -11

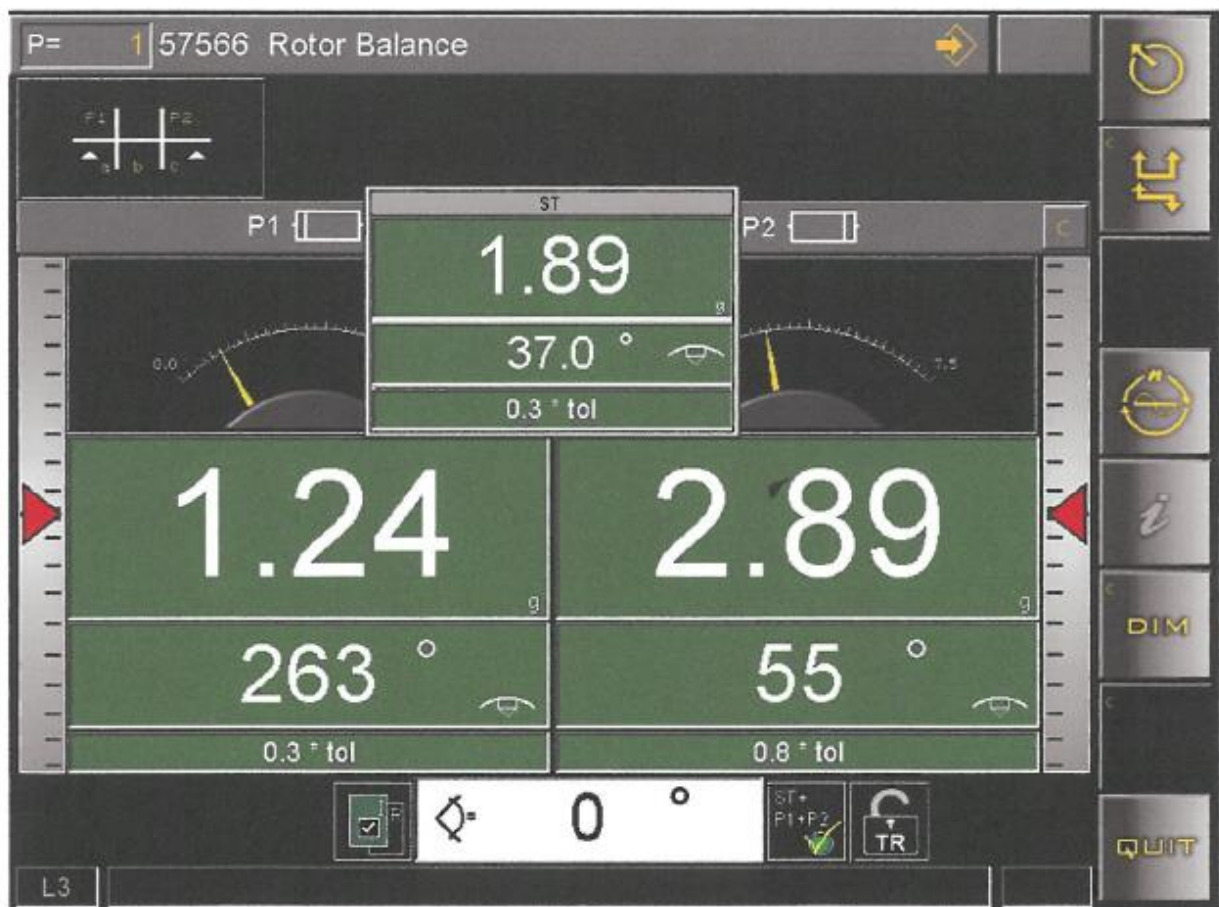
*Rotor Balance  
10-1*

The rotating element was dynamically balanced as an assembly. The results of that operation are located on pages 2 and 3 of this report.

Customer : XYZ S.p.A		Date : 09/28/2024 05:50:49
Prog. N° 1	57566 Rotor Balance	
ISO G: 1.00	Total Weight: 1025.00 lb	Service Speed: 3600 rpm

P1 (g)	ST (g)	P2 (g)
<b>22.61</b>	<b>44.17</b>	<b>22.02</b>
<b>24.7°</b>	<b>32.9°</b>	<b>41.2°</b>

P1 (g)	ST (g)	P2 (g)
<b>1.24</b>	<b>1.89</b>	<b>2.89</b>
<b>262.9°</b>	<b>36.8°</b>	<b>54.9°</b>

Measuring speed = 582 rpm
