RE: Notice and Report of an Incident occurring on August 21, 2014, at Campbellsville University, Campbellsville, Taylor County, Kentucky

Re: Campbellsville Fire Department Injury Incident
14-ES-E-024-KU

KPSC INVESTIGATION REPORT

Transmission Line Contact with Injuries

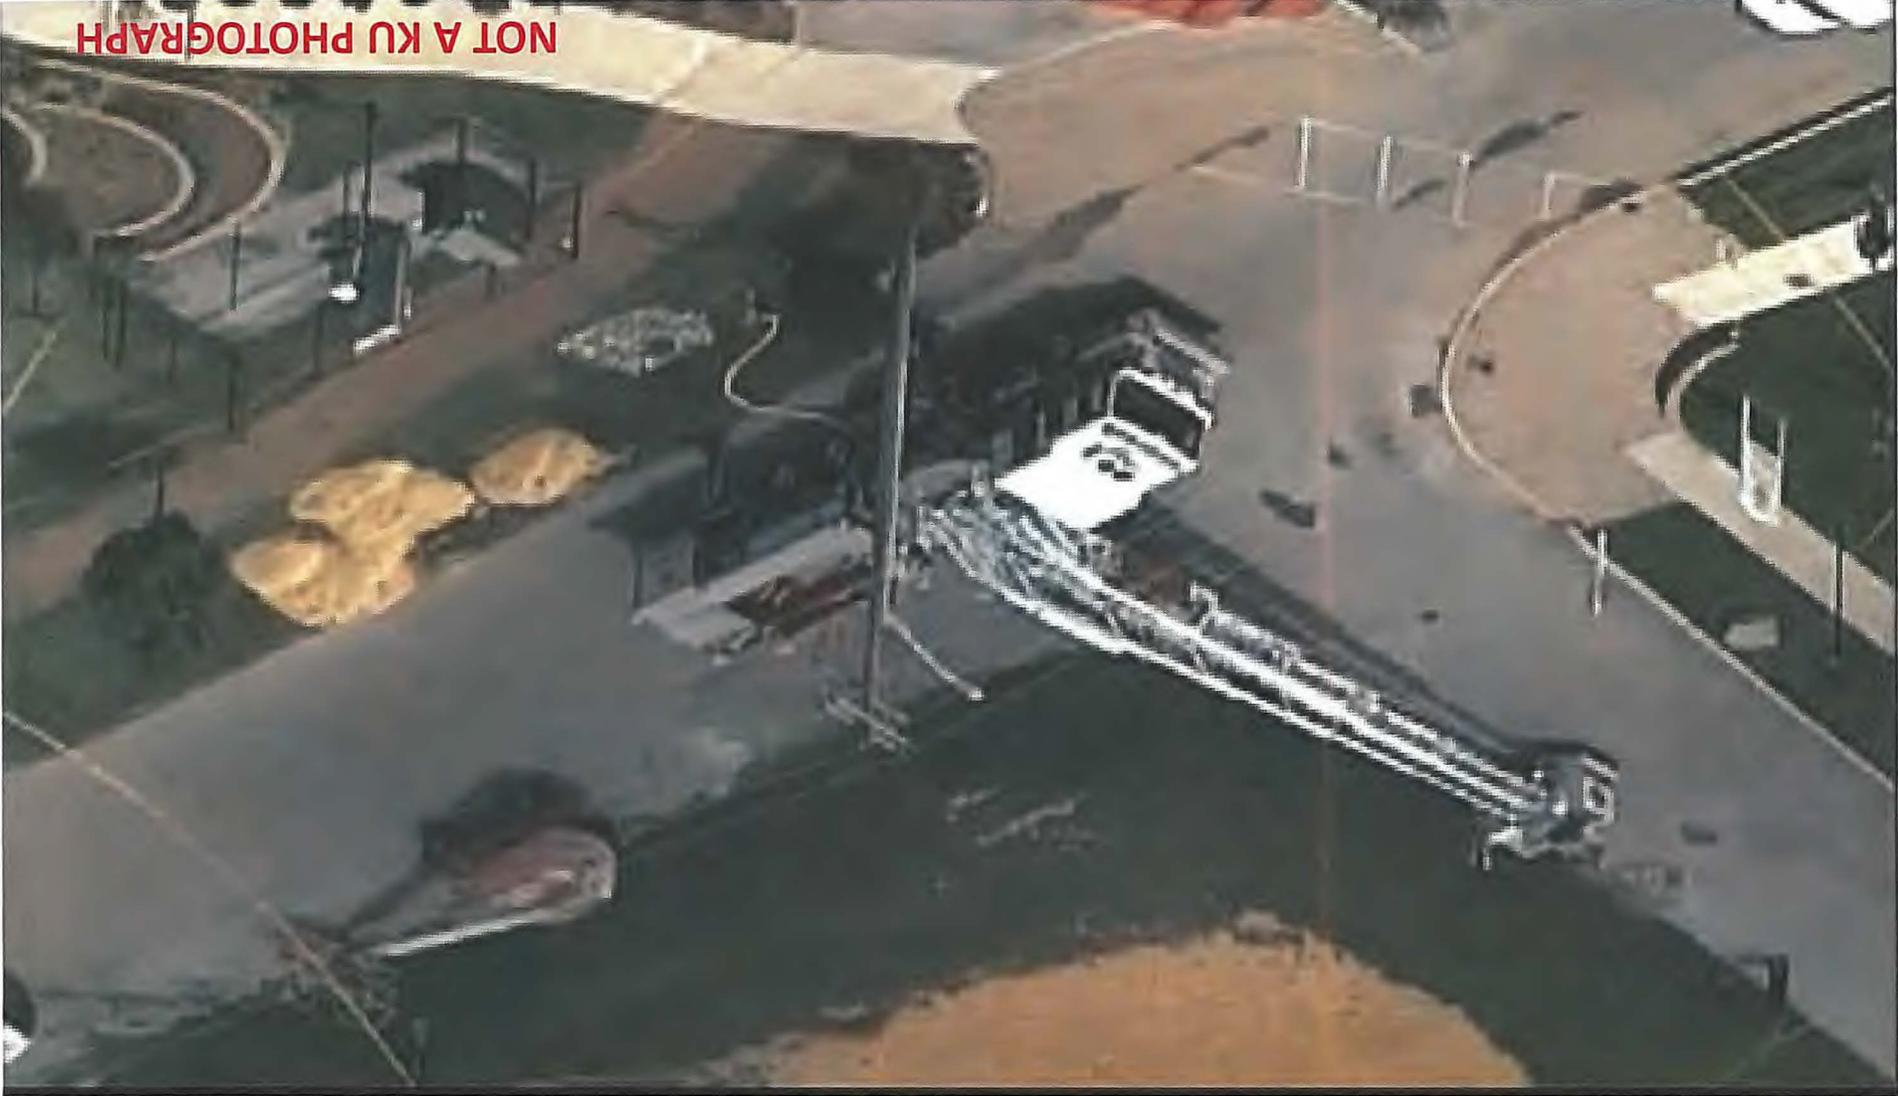
Note location
of 69kV lines

NOT A KU PHOTOGRAPH
