FIELD VISIT REPORT

KENTUCKY PUBLIC SERVICE COMMISSION (KPSC)

Evaluation of Kentucky Power's (Ky. Power) performance during the December 2009 snow storm.

KPSC Photographs of Affected Area

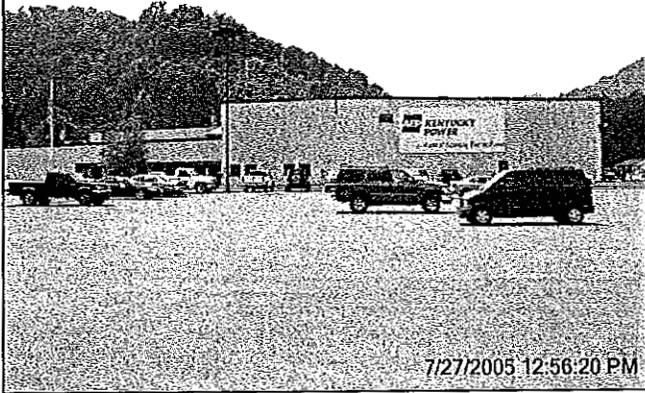
1

PIKEVILLE OPERATIONS CENTER

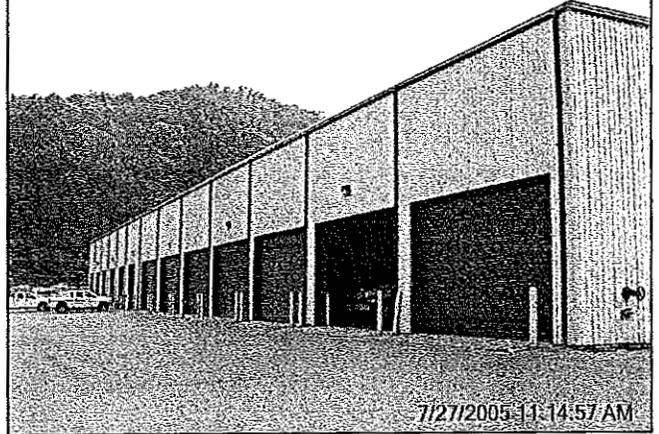
2

VEHICLE STORAGE BAYS-PIKEVILLE OPS. CENTER
